# FIRE TEST REPORT

## FR 5670

FIRE RESISTANCE OF PIPE PENETRATIONS IN A 150 MM THICK CONCRETE FLOOR SLAB

Snap Fire Systems Pty Ltd  
Building A  
1343 Wynnum Road  
Tingalpa  
QLD 4173  
Australia

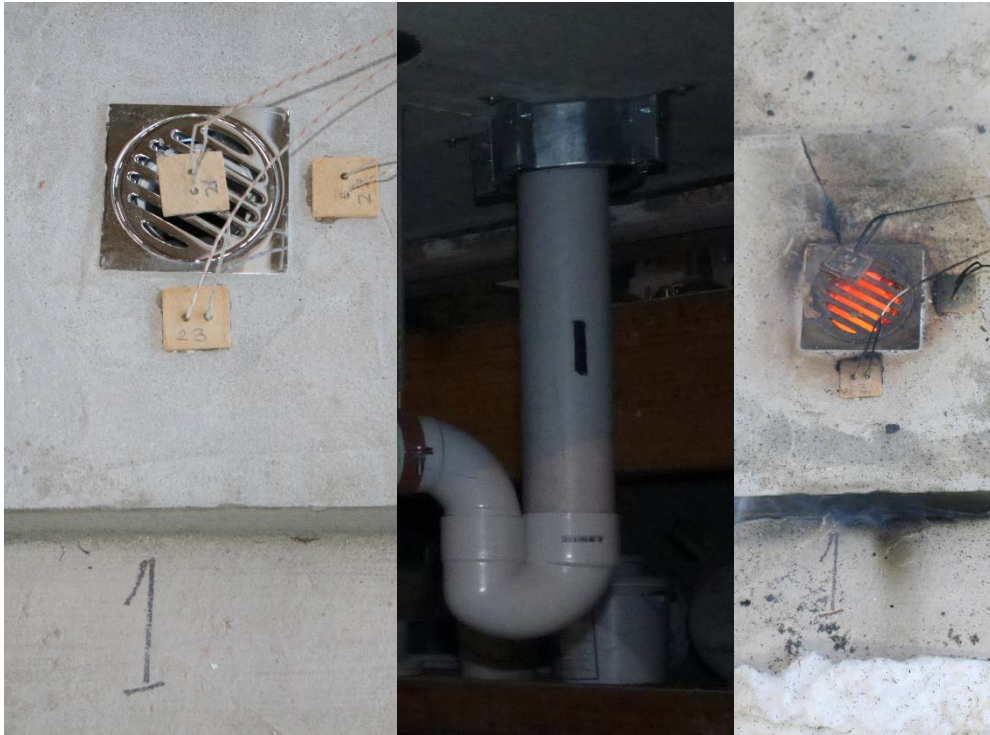
**Photo 7: Specimen 1, left to right, unexposed, exposed and unexposed post test**

153:40	1	A cotton pad test was applied over the top of the grille. There was a slight discolouration of the cotton pad. No Failure
179:18	1	Another cotton pad test was applied over the top of the grille. There was a slight discolouration of the cotton pad, No failure.

188:00	1	The cotton pad test was applied and there was significant blackening, no failure. But flaming was visible below grille.
192:50	5	A large volume of smoke and ash was being emitted from the end of the pipe.

Time mm:ss	Specimen No.	Observation
		the top of the grille with a slight discolouration of the cotton pad.
216:45	1	A cotton pad test was applied over the top of the grille. Blackening with a small amount of glowing and no ignition. <b>This is deemed to be integrity failure in accordance with the standard.</b>
225:09	4	Black intumescent visible at base.
236:00	23	The (white) material in annular space was continuing to swell.
236:10	7	A steady volume of smoke was being emitted from the top of the pipe.
244:10	27	A cotton pad test was applied over the top of the grille. Slight blackening with no glowing and no ignition.
245:15		Test stopped

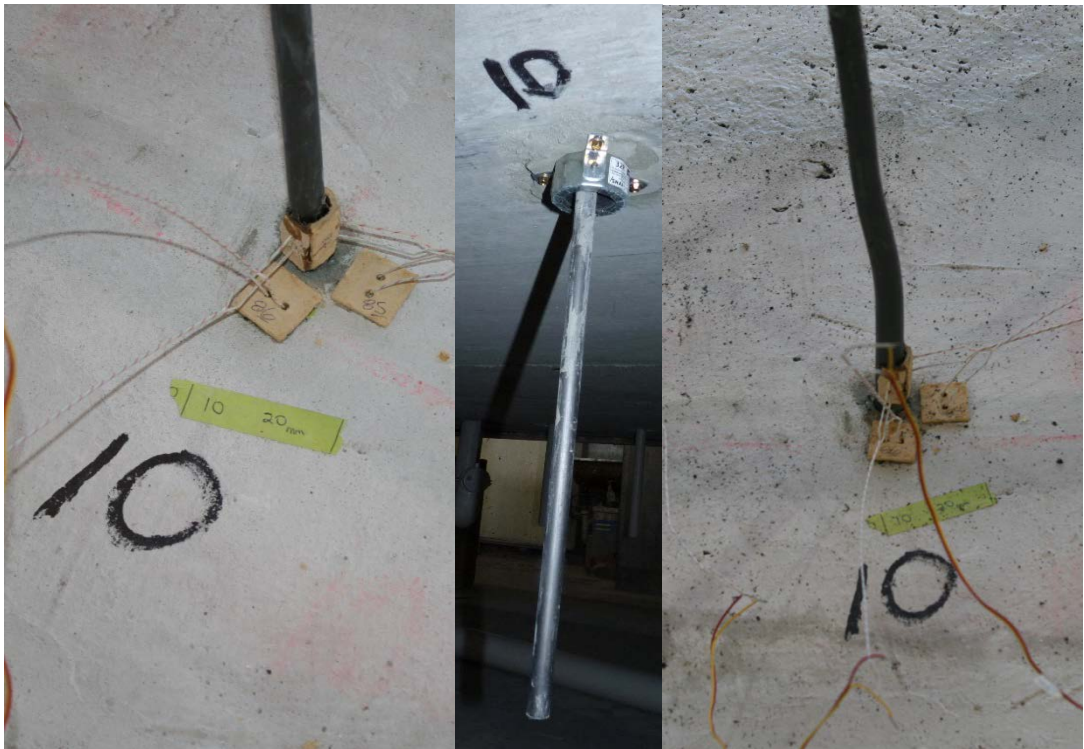
**Photo 16: Specimen 10, left to right, unexposed, exposed and unexposed post test**

55:52	10	The floor/pipe sealant was cracking.
