# Fire-resistance test on fire collars protecting a plasterboard wall penetrated by services

## Test Report

**Author:** Peter Gordon  
**Report number:** FSP 1978  
**Date:** 20 February 2019

**Client:** IG6 Pty Ltd as trustee for the IG6 IP Trust

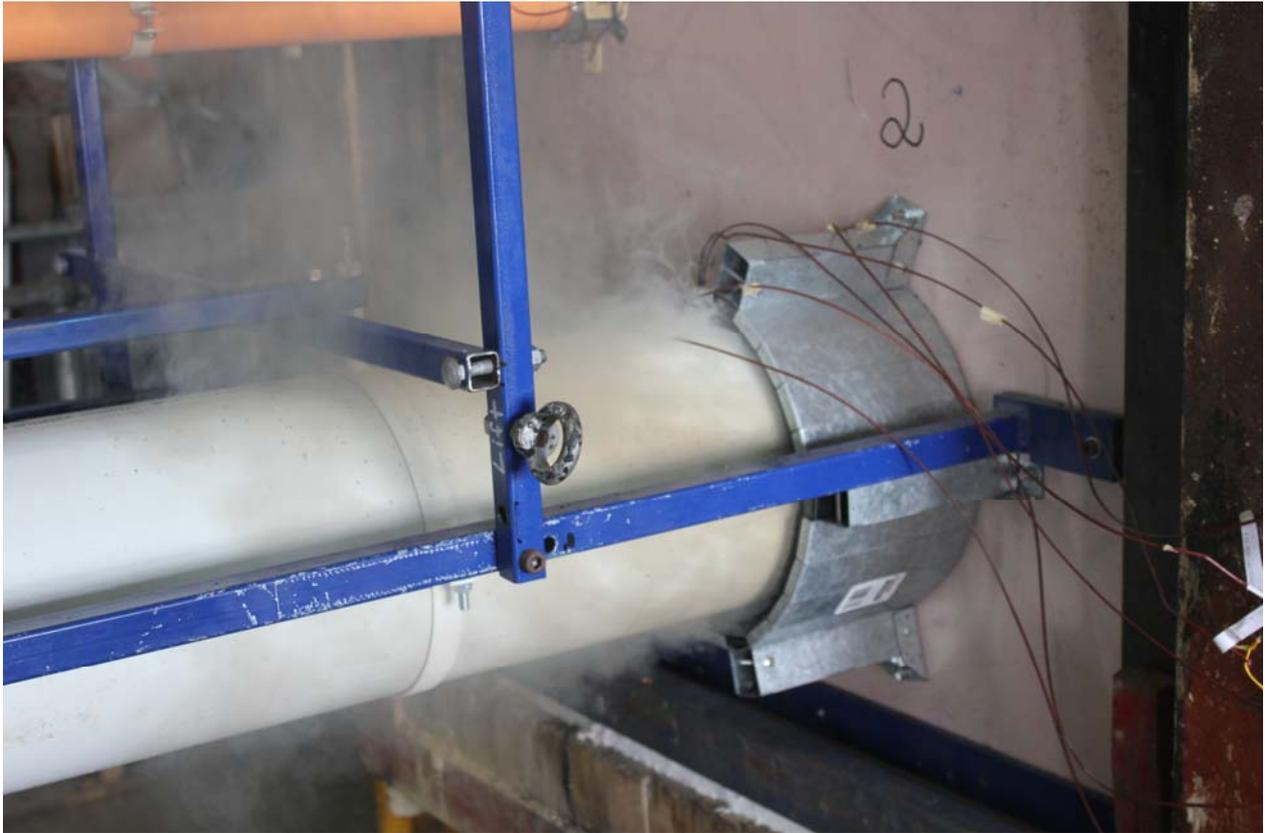
Time	Observation
1 minute -	Smoke is being emitted from inside the collar of Specimen 2 and furnace flues.
2 minutes -	Smoke being emitted from the collar of Specimen 2 has increased.

**PHOTOGRAPH 3 – SPECIMEN 2 AFTER 2 MINUTES OF TESTING**

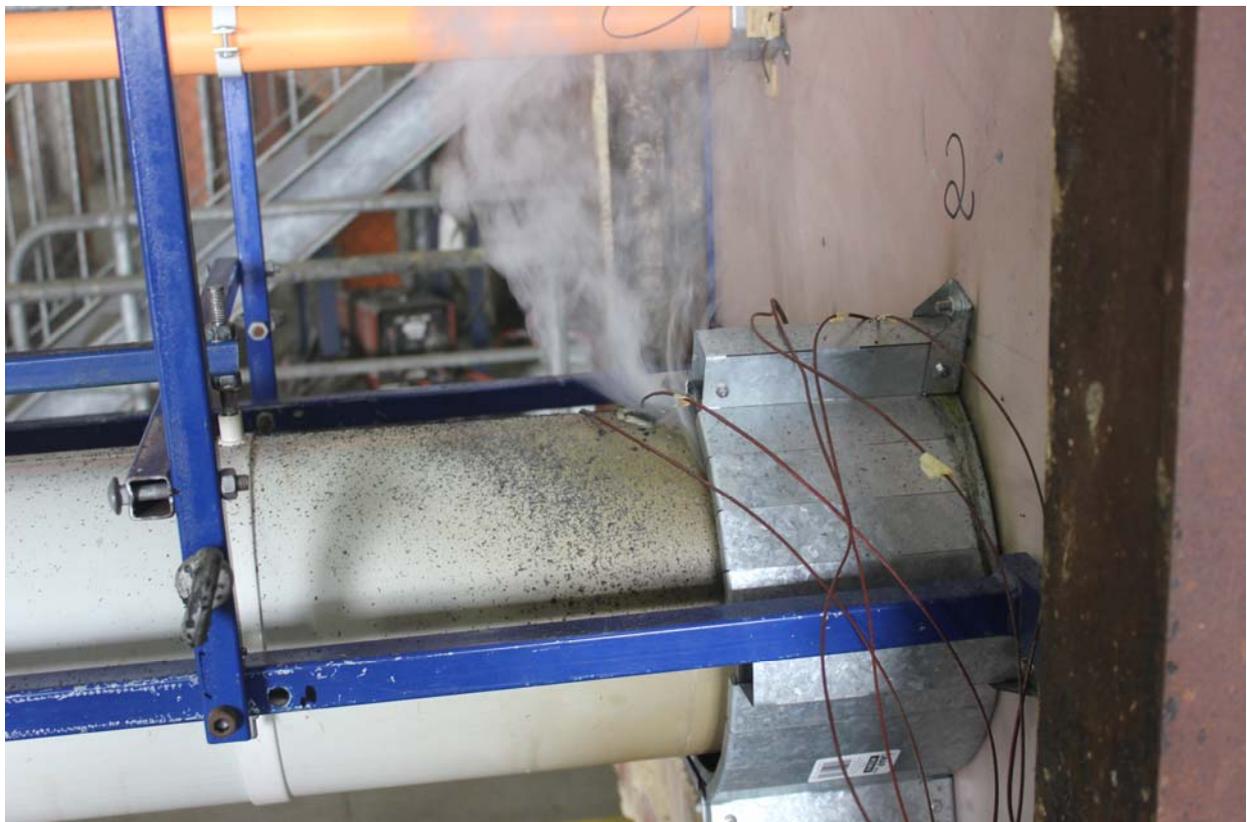
5:30 minutes -	Smoke fluing from Specimen 1 has ceased.
11 minutes -	Discolouration around the plasterboard wall around the collar of Specimen 2.
17 minutes -	Smoke fluing from Specimen 2 has reduced, however fluing of smoke between the collar and pipe continues, adjacent to Thermocouple #11.
21 minutes -	Smoke fluing from Specimen 2 has further reduced, however fluing of smoke between the collar and pipe continues.
60 minutes -	Fluing of smoke between the collar and pipe of Specimen 2 continues. Smoke is fluing from Specimen 1 again.
136 minutes -	Liquid has started dripping from the ends of the pipes of Specimens 1 and 2.
157 minutes -	<u>Insulation Failure of Specimen 1</u> – maximum temperature rise of 180K is exceeded from the plasterboard above the collar on the unexposed face. Discolouration of the plasterboard wall is visible around the collar of Specimen 1 on the top right side.
173 minutes -	<u>Insulation Failure of Specimen 2</u> – maximum temperature rise of 180K is exceeded from the plasterboard above the collar on the unexposed face.

**PHOTOGRAPH 4 – SPECIMENS AFTER 17 MINUTES OF TESTING**

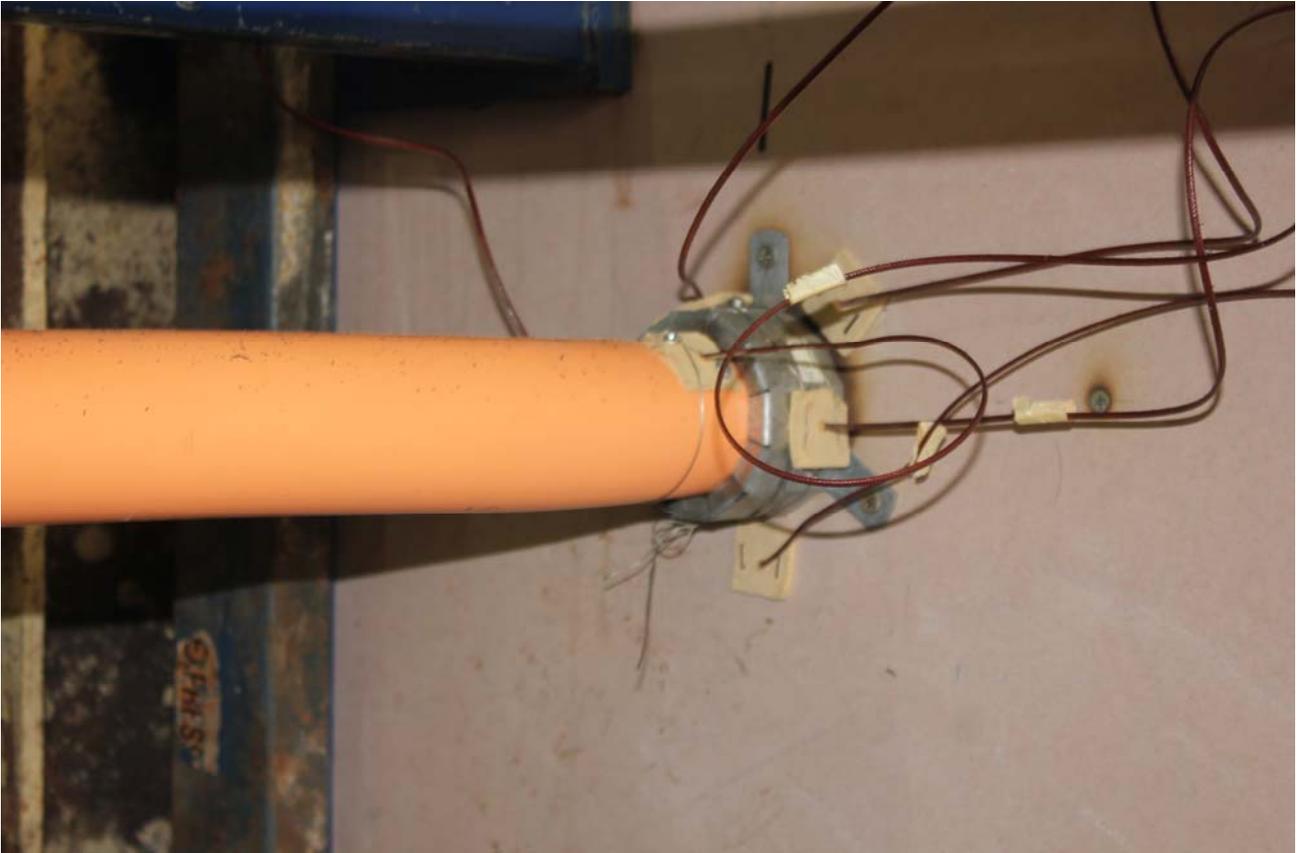
Structural adequacy	-	not applicable
Integrity	-	no failure at 181 minutes
Insulation	-	157 minutes

**PHOTOGRAPH 10 – SPECIMEN 1 AFTER 157 MINUTES OF TESTING**

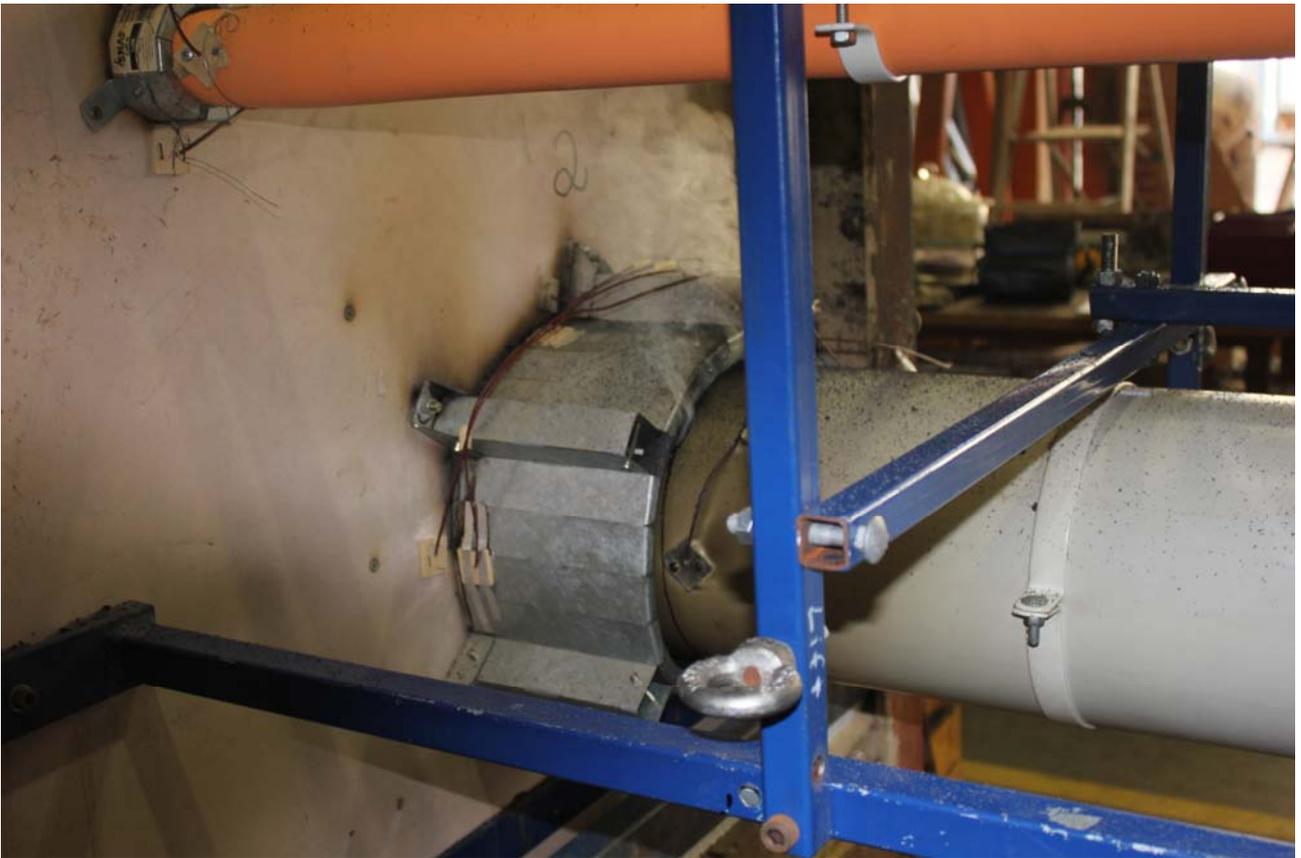
Structural adequacy	-	not applicable
Integrity	-	no failure at 181 minutes
Insulation	-	173 minutes

**PHOTOGRAPH 11 – SPECIMEN 2 AFTER 170 MINUTES OF TESTING**

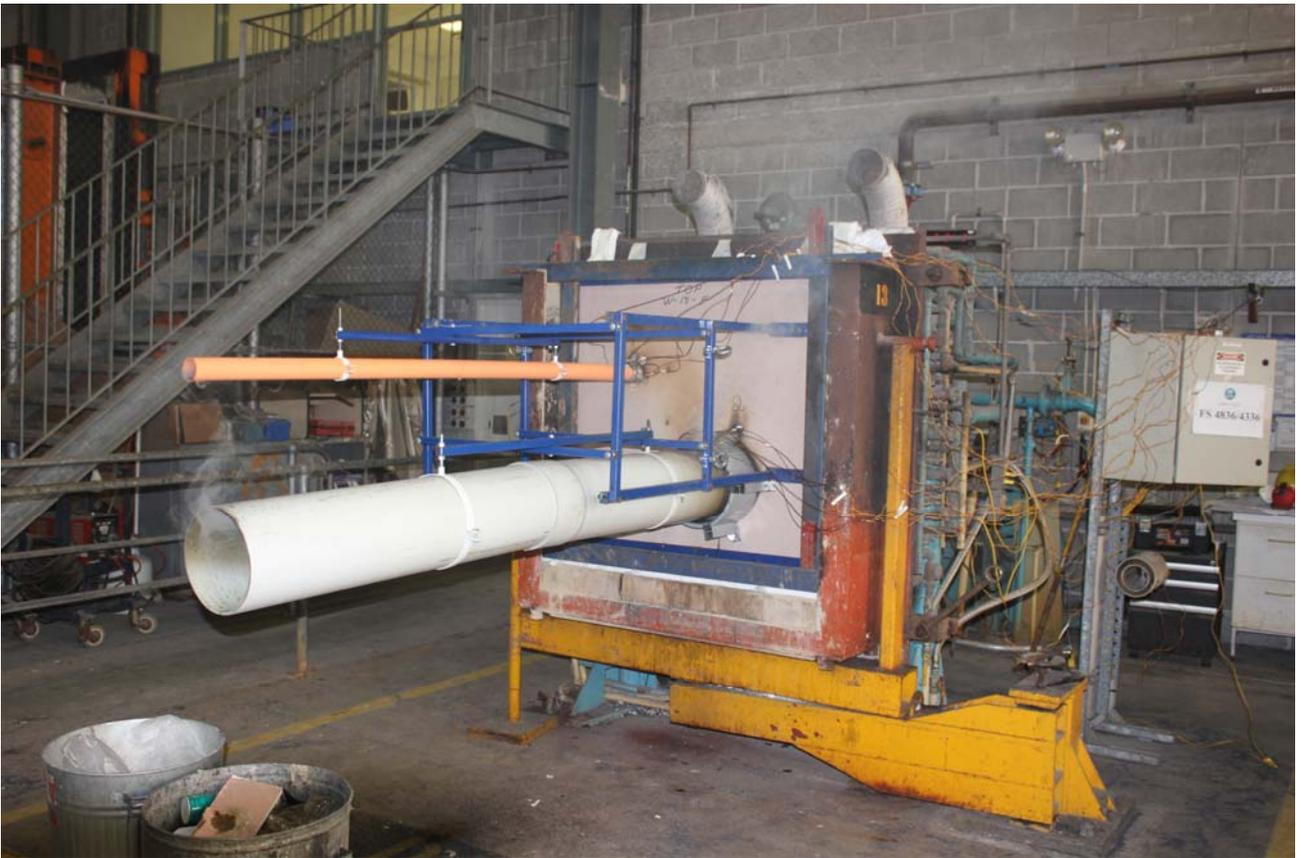
**PHOTOGRAPH 13 – UNEXPOSED FACE OF SPECIMENS AT THE CONCLUSION OF TESTING**

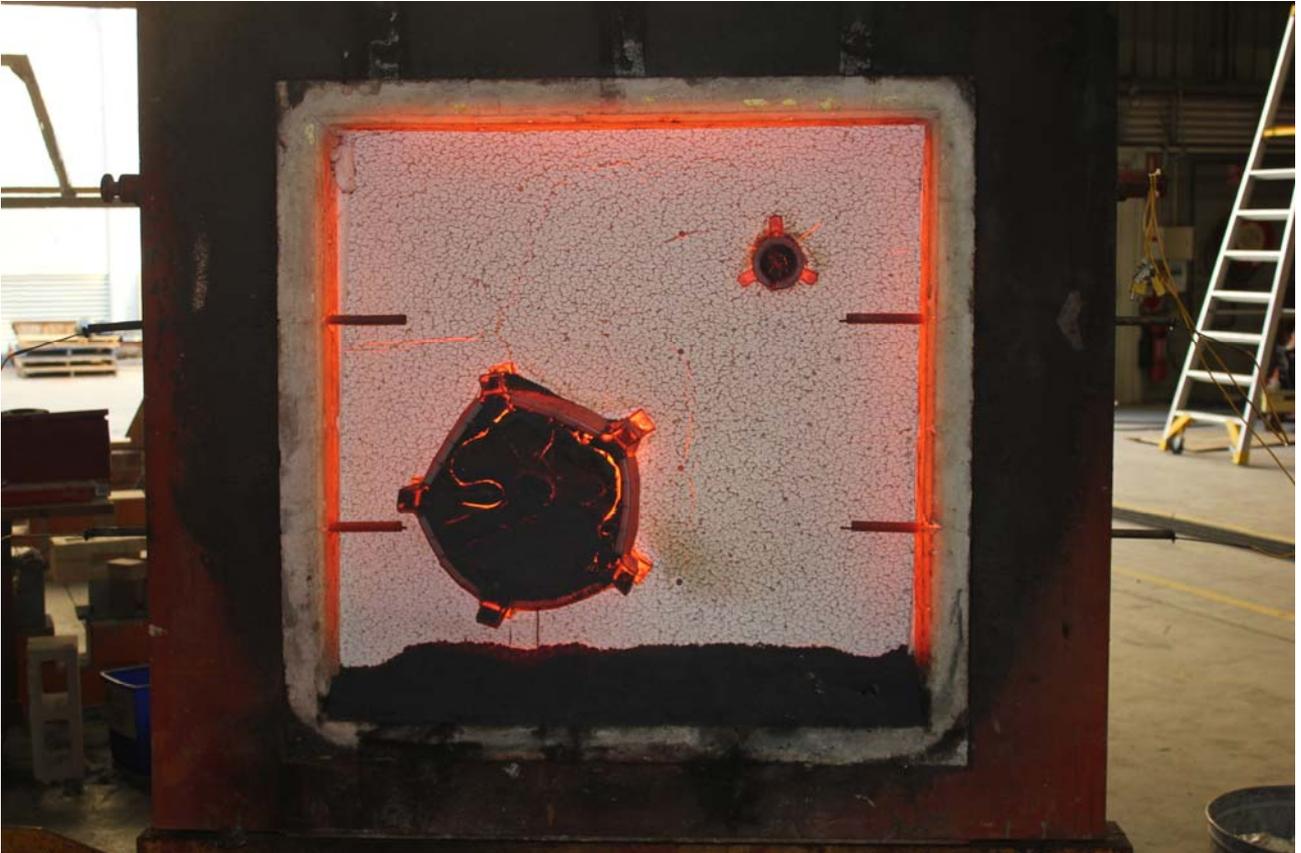
**PHOTOGRAPH 14 – EXPOSED FACE OF SPECIMENS AT CONCLUSION OF TESTING**

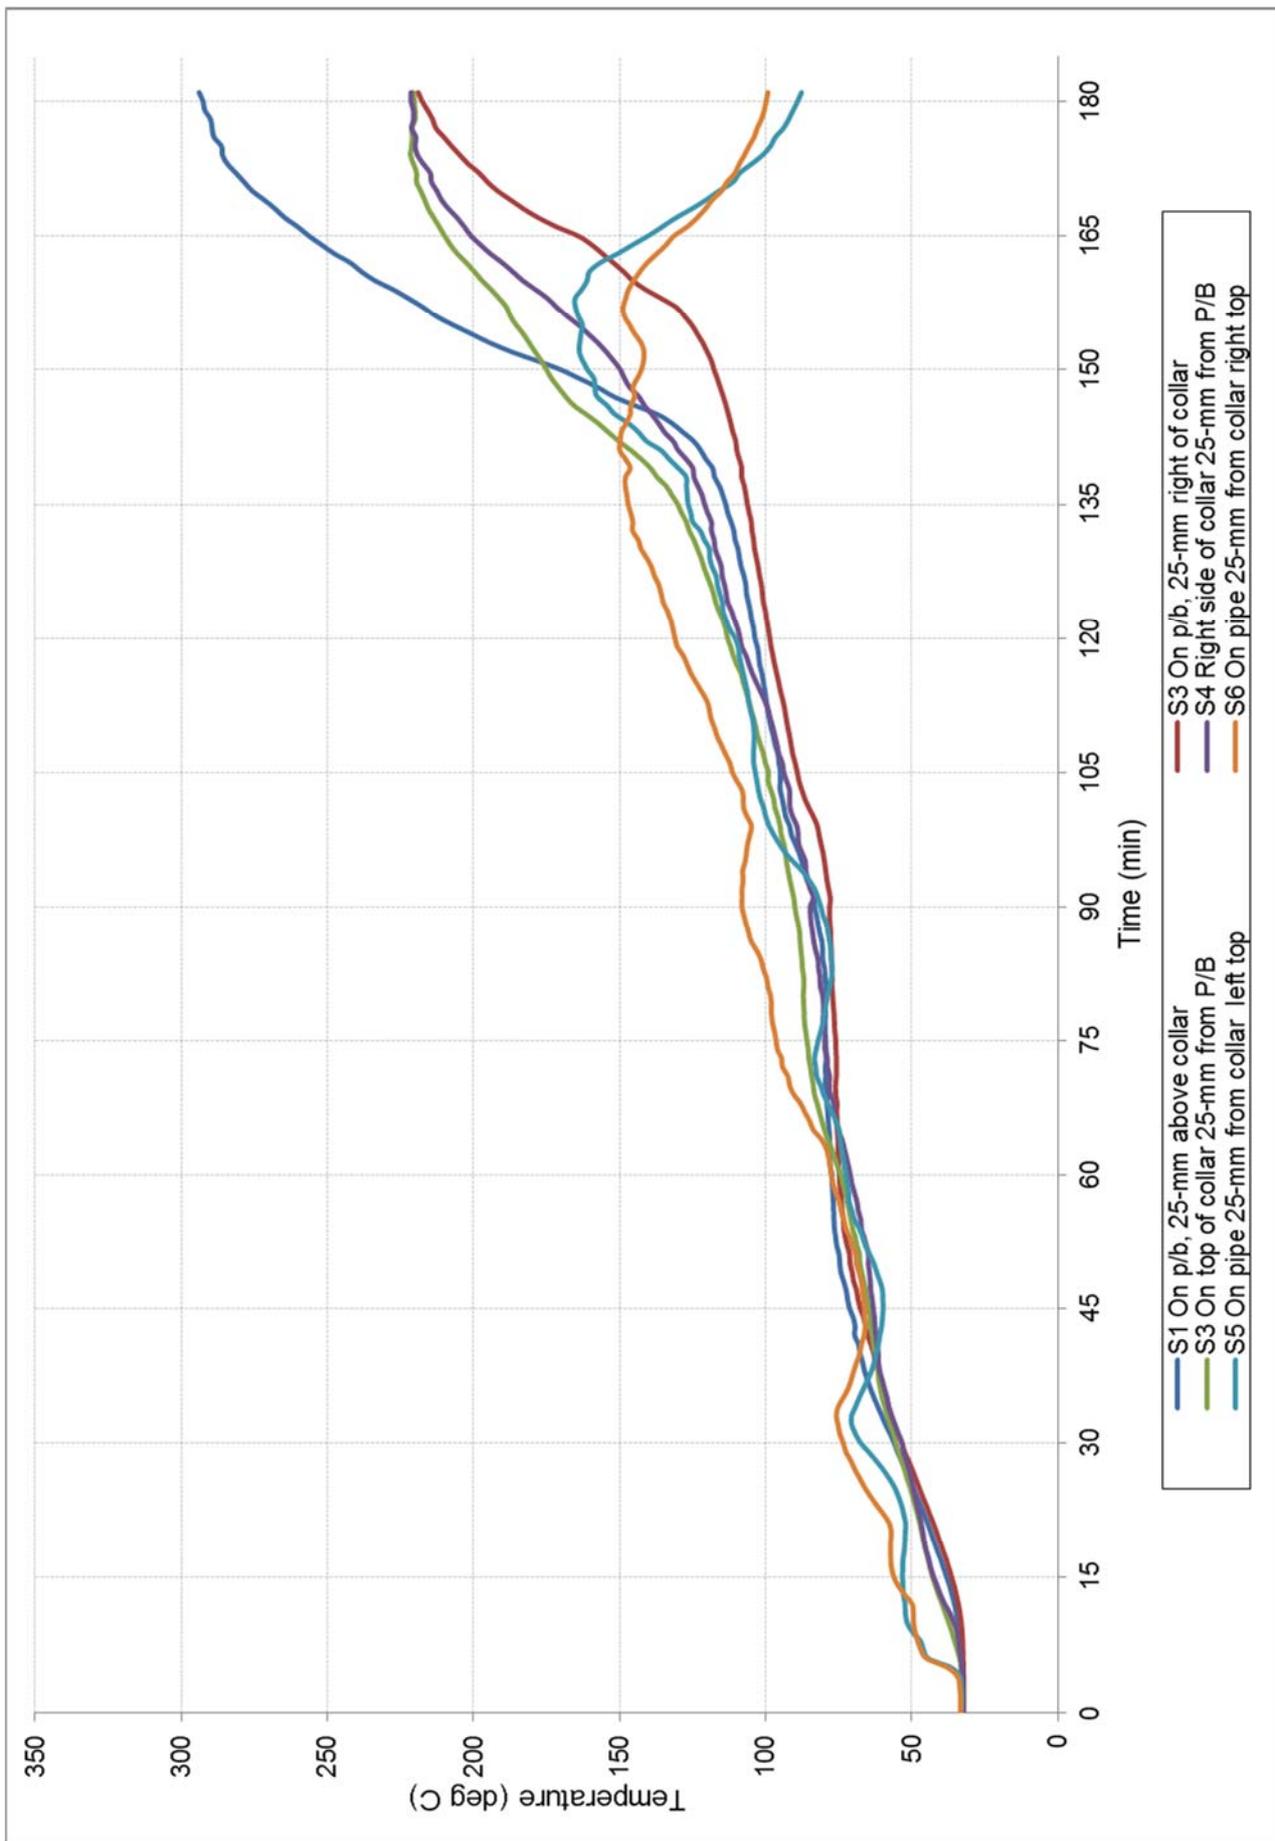
FIGURE 3 - SPECIMEN 1 TEMPERATURE

Figure 3 shows the curve of temperature versus time associated with Specimen 1.

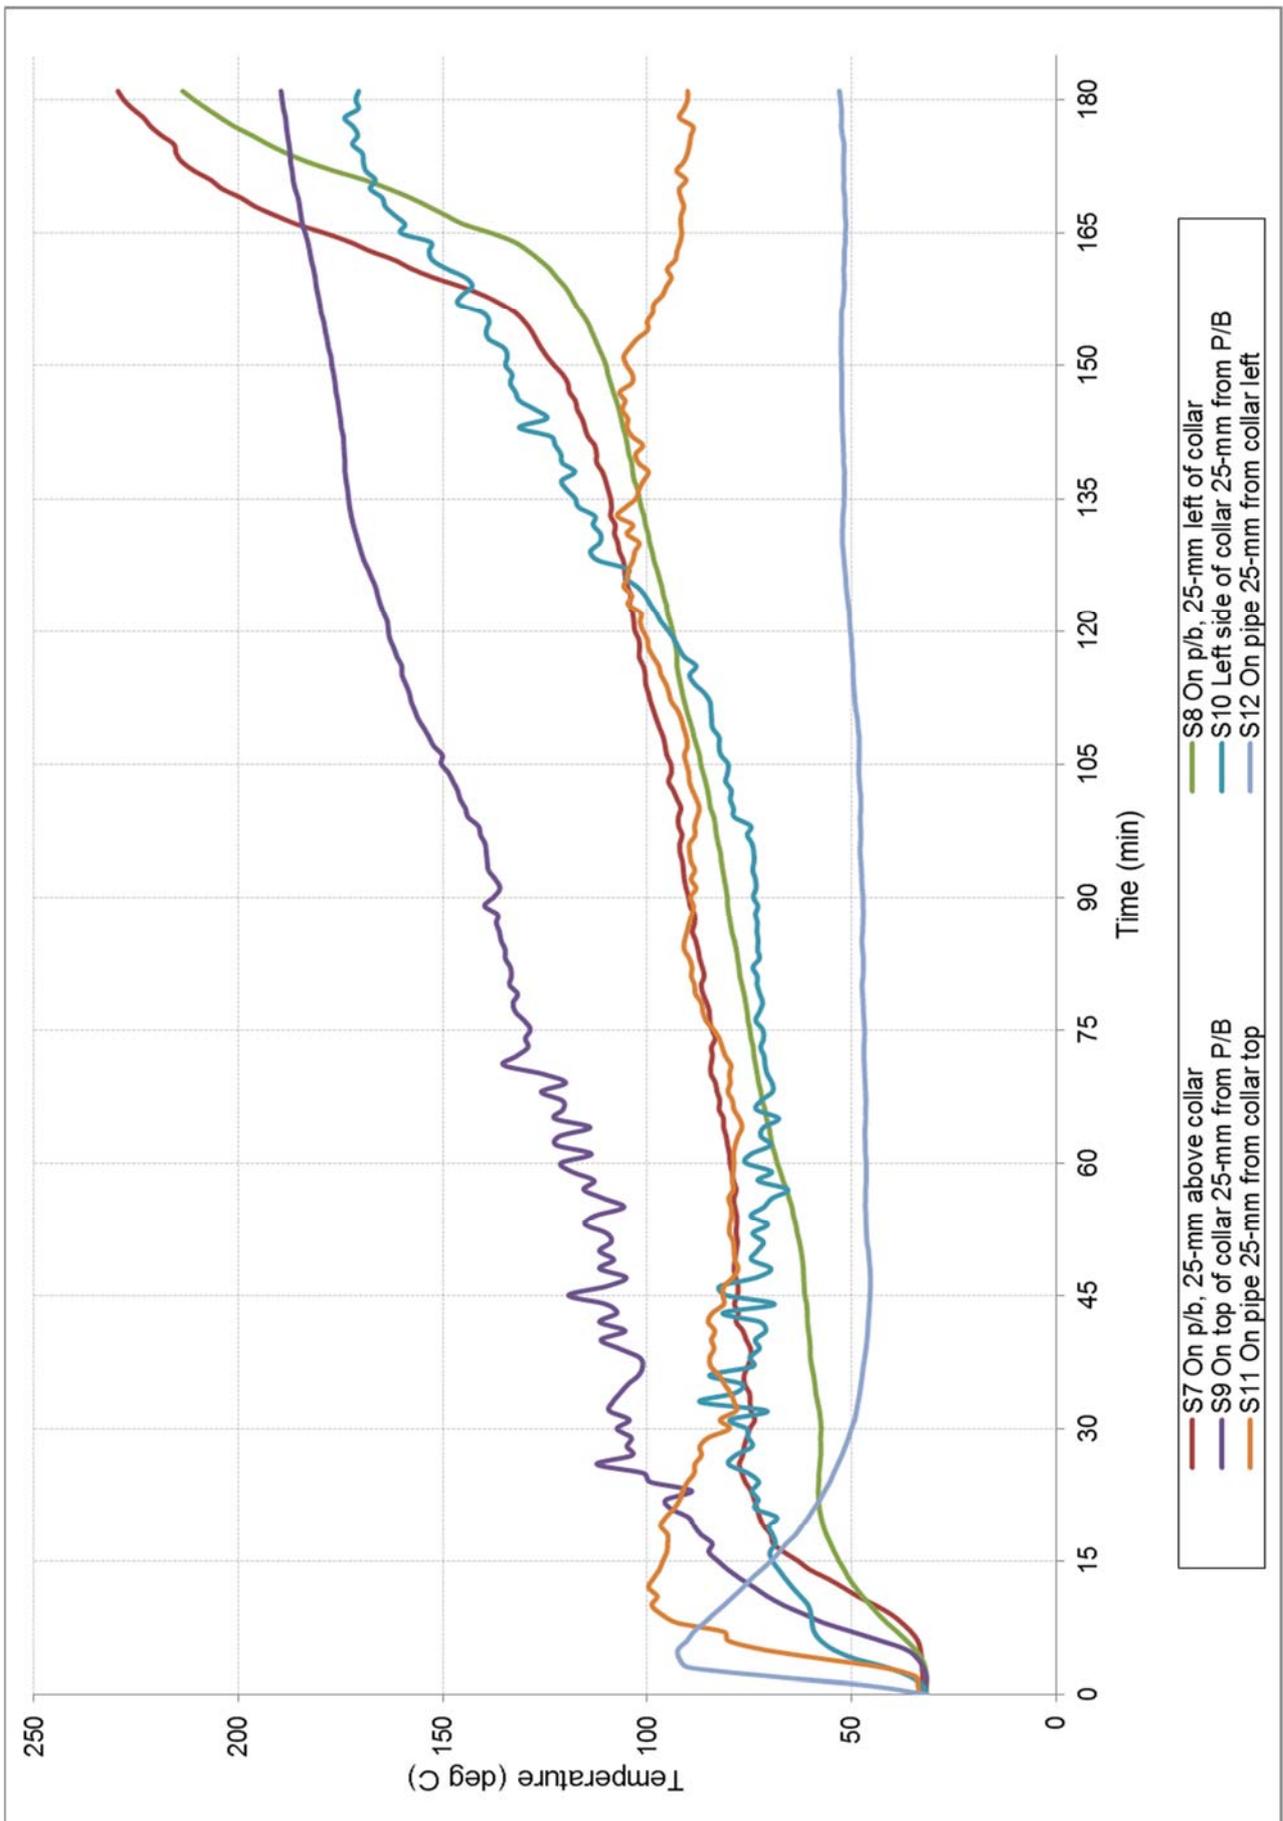
FIGURE 4 - SPECIMEN 2 TEMPERATURE

Figure 4 shows the curve of temperature versus time associated with Specimen 2.
