# Fire-resistance test on fire collars protecting a concrete slab penetrated by services

## Test Report

**Author:** Peter Gordon  
**Report number:** FSP 2270  
**Date:** 21 July 2022

**Client:** IG6 Pty Ltd

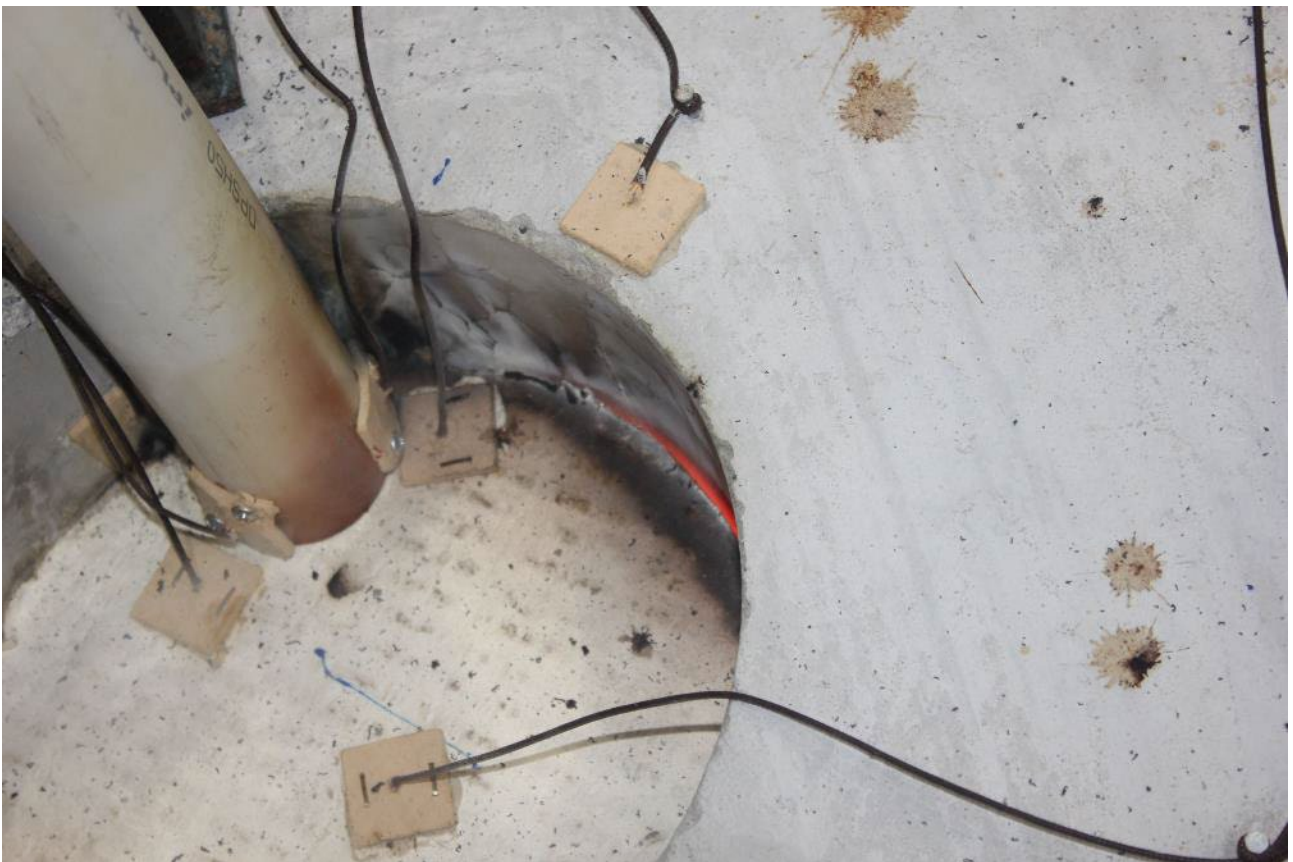
**PHOTOGRAPH 12 – SPECIMEN 4 AT 122 MINUTES INTO THE TEST**

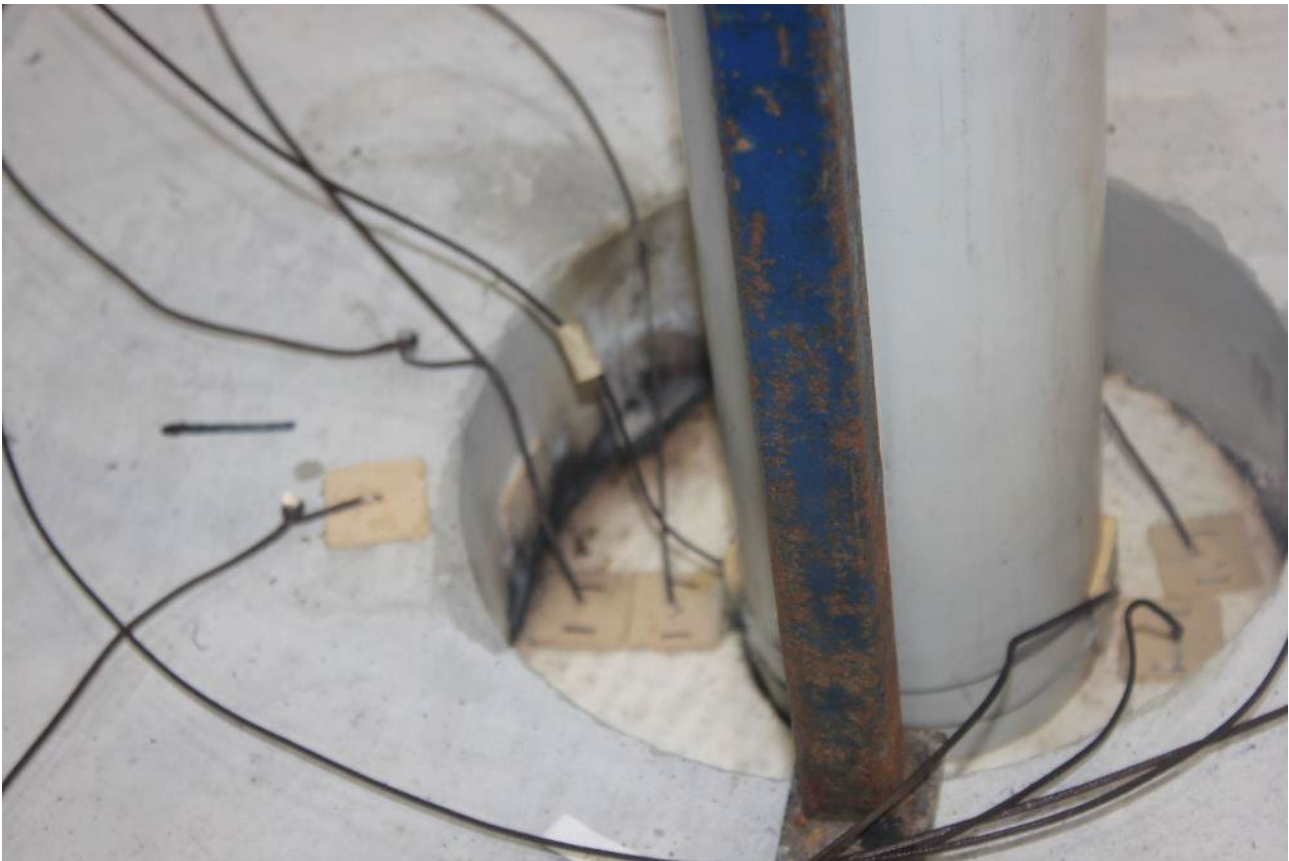
**PHOTOGRAPH 13 –SPECIMEN 1 AT 132 MINUTES INTO THE TEST**

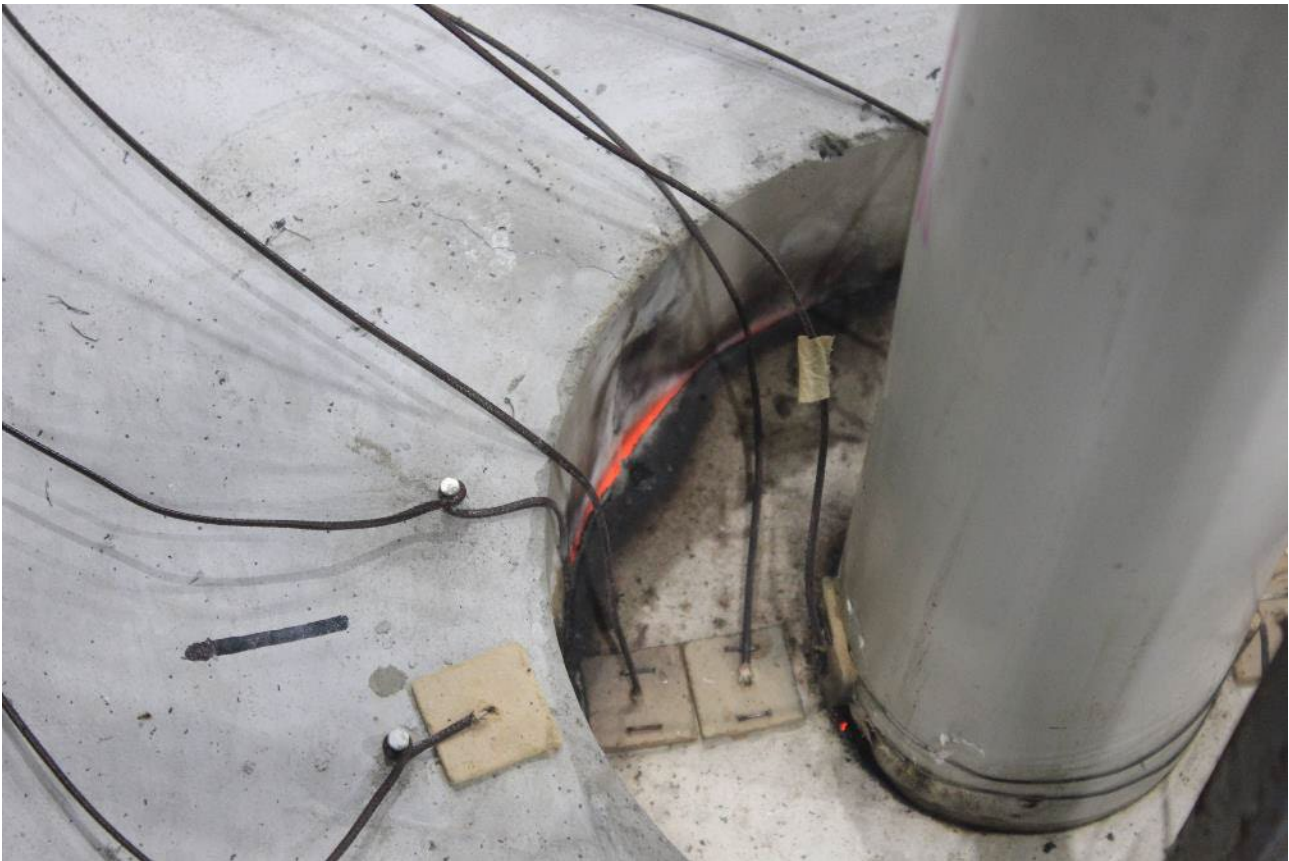
**PHOTOGRAPH 15 – SPECIMEN 1 AT 160 MINUTES INTO THE TEST**

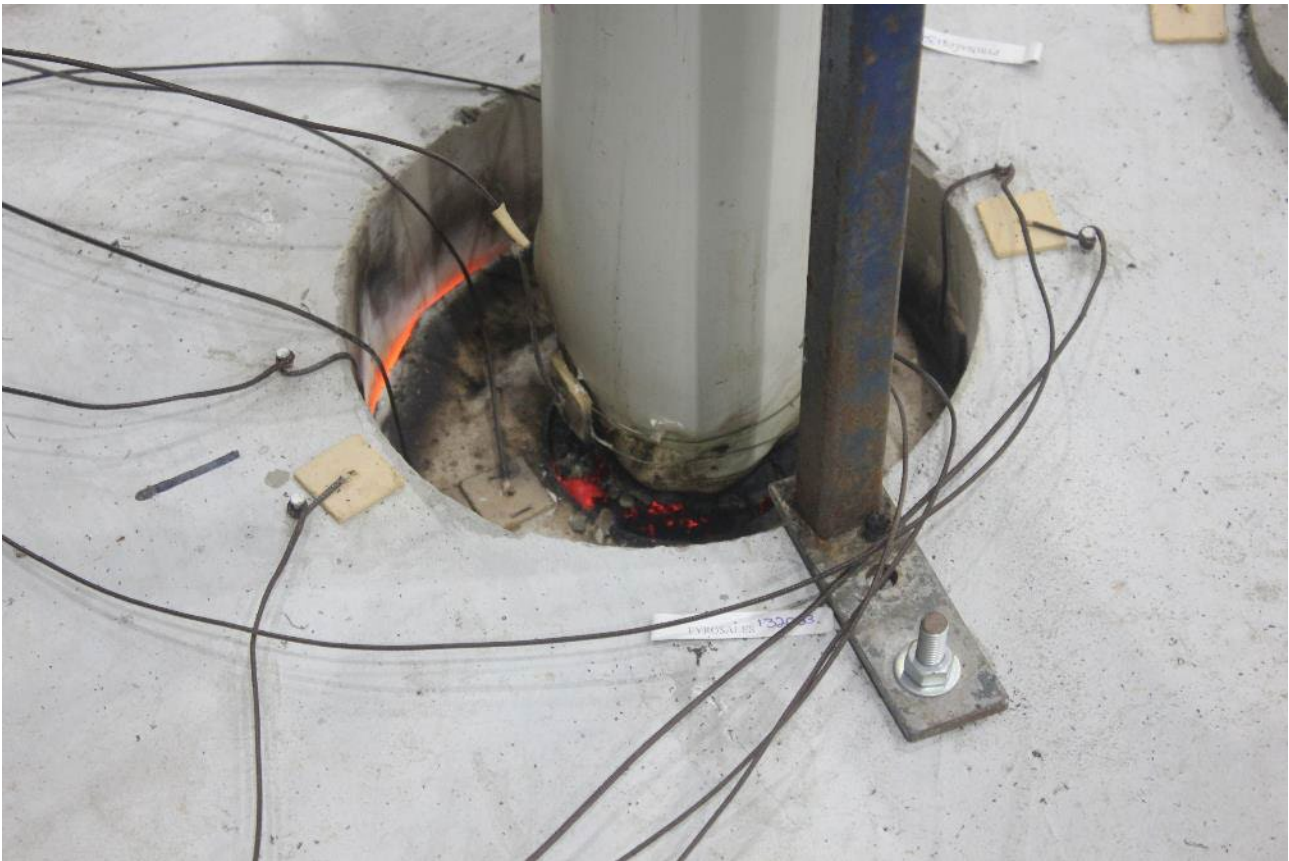
**PHOTOGRAPH 17 – SPECIMEN 1 AT 181 MINUTES INTO THE TEST**

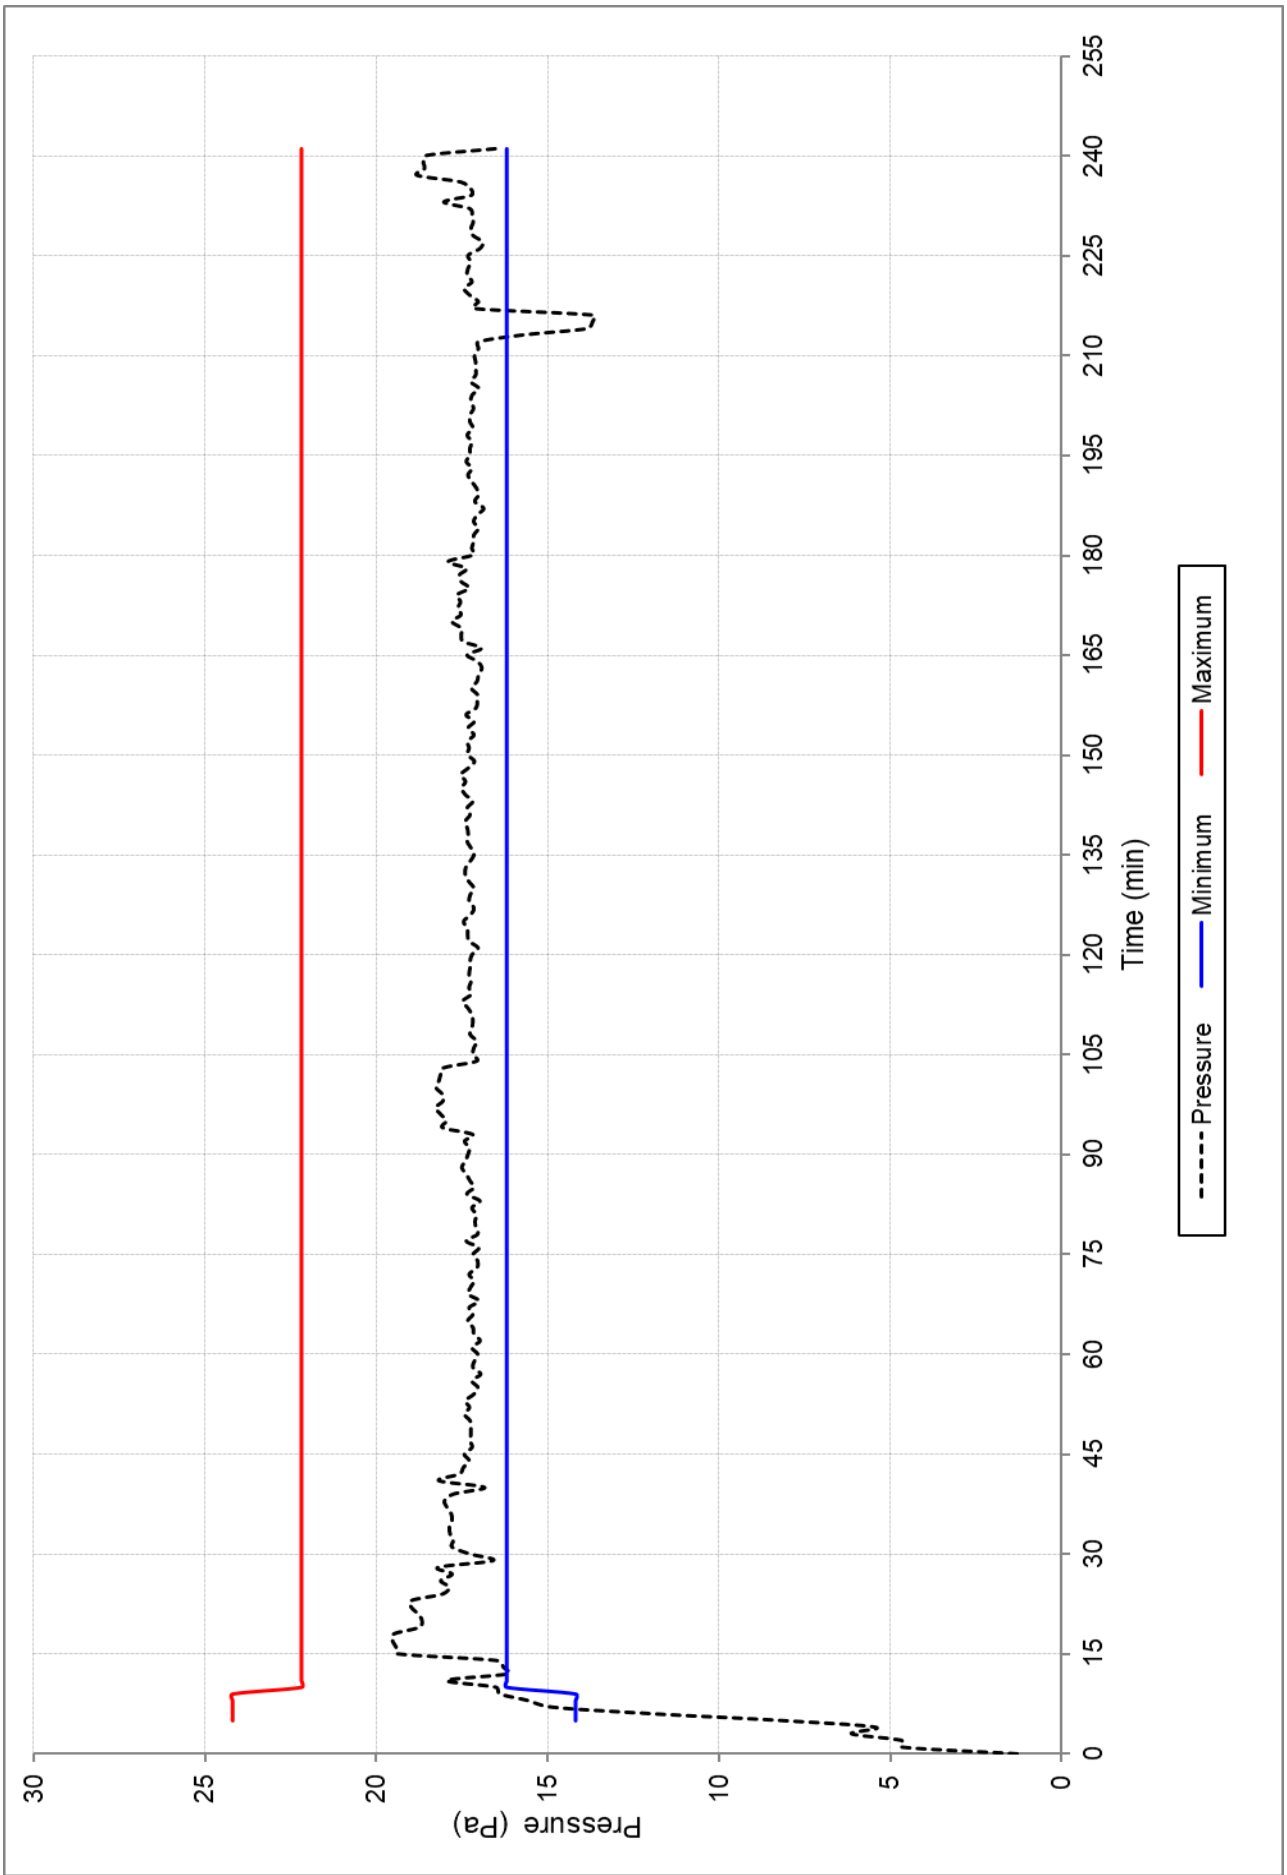
The furnace pressure was below the tolerances of the requirements of AS 1530.4-2014 for periods of time as shown in Figure 3. The test laboratory confirms that this departure in furnace pressure would not have significantly affected the results of this test.

FIGURE 3 – FURNACE PRESSURE

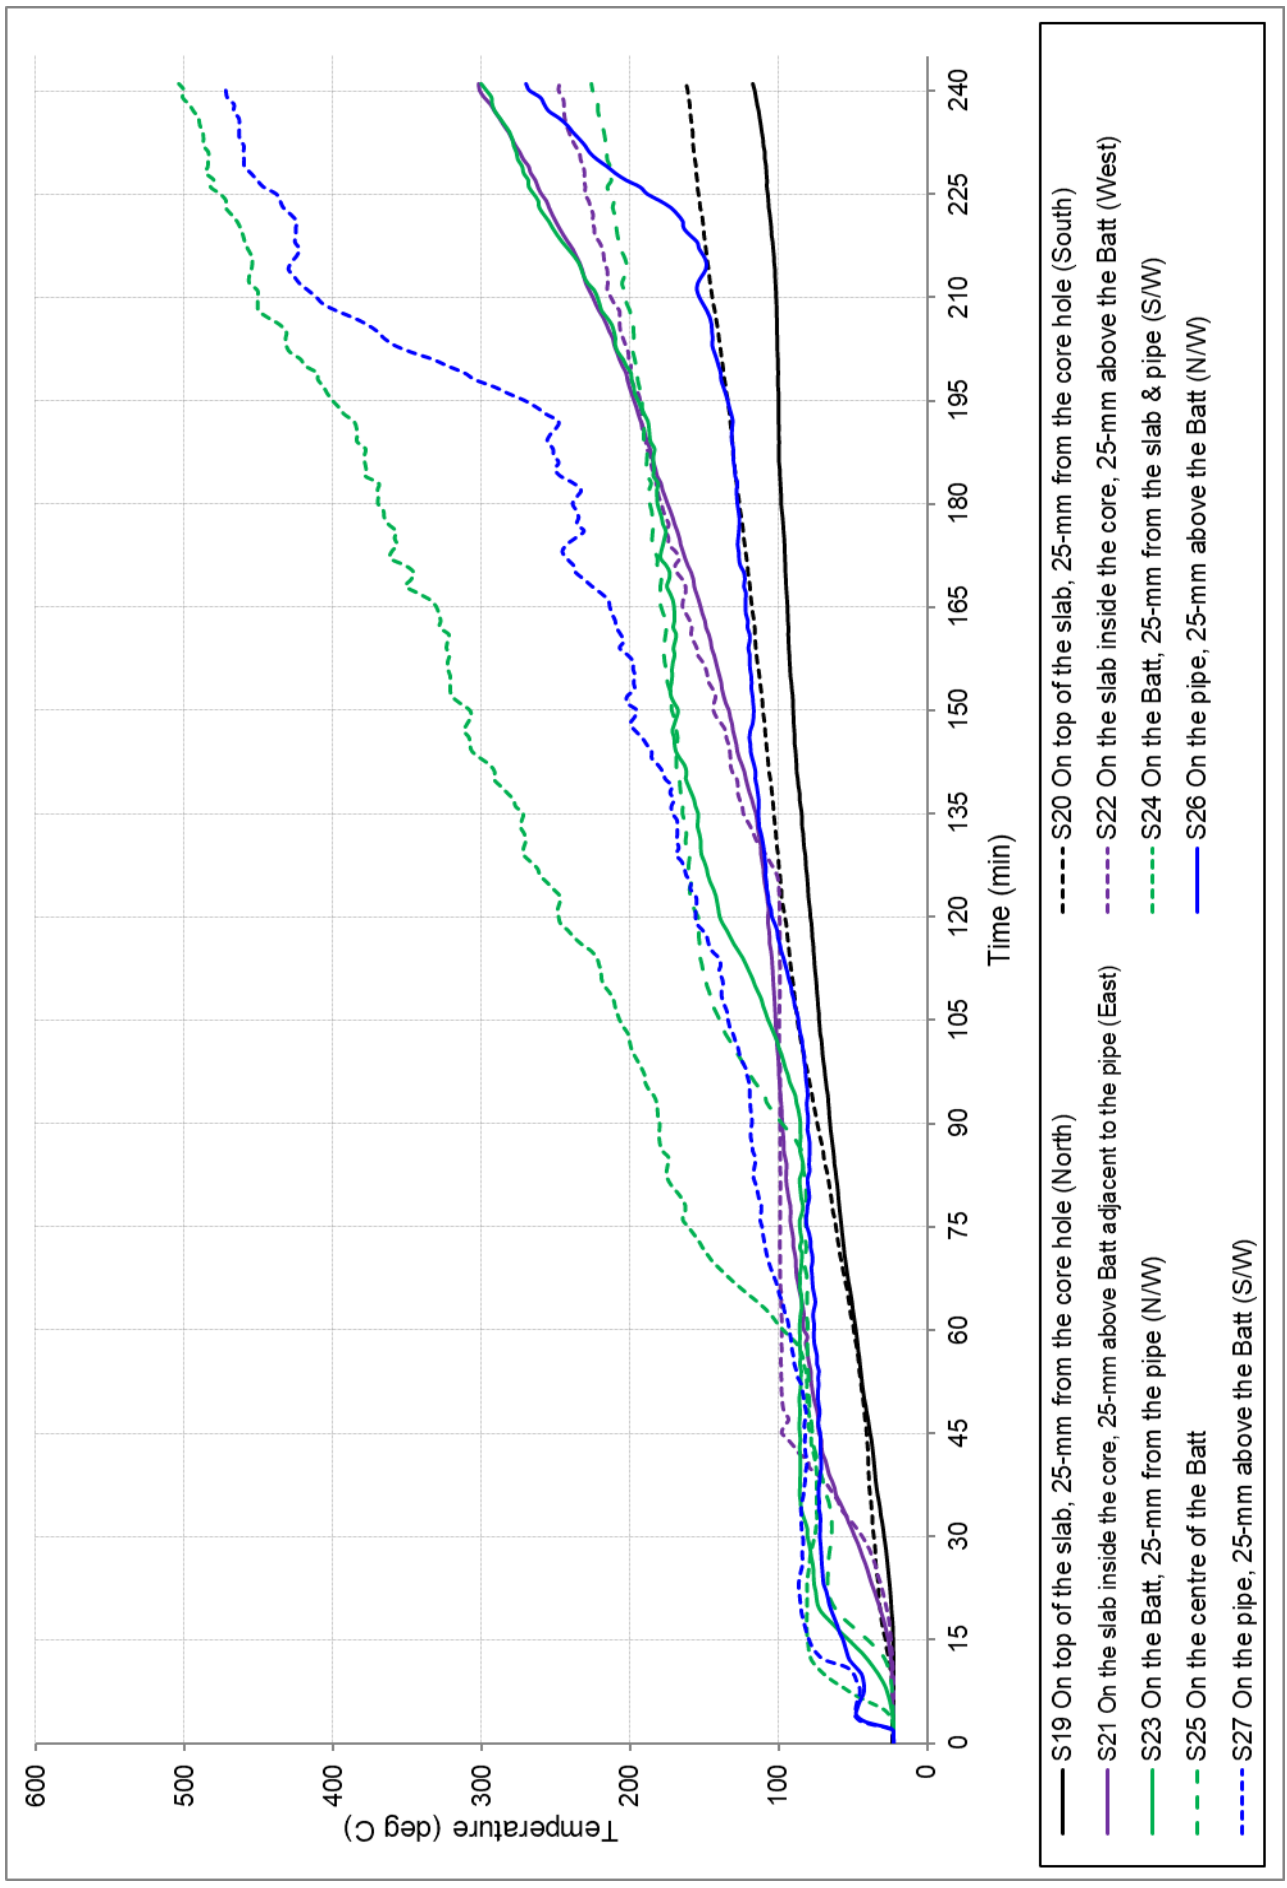
FIGURE 7 – SPECIMEN TEMPERATURE – ASSOCIATED WITH SPECIMEN 4
