**FIRE-RESISTANCE TEST ON
FIRE COLLARS PROTECTING A CONCRETE SLAB
PENETRATED BY SERVICES**

**Report number FSP 1576
CSIRO job number SP3628
Date of issue 26 APRIL 2013**

**Client
SNAP FIRE SYSTEMS PTY LTD.**

SPONSORED INVESTIGATION No. FSP 1576**FIRE-RESISTANCE TEST ON FIRE COLLARS PROTECTING A
CONCRETE SLAB PENETRATED BY SERVICES****SUMMARY****IDENTIFICATION OF SPECIMEN:**

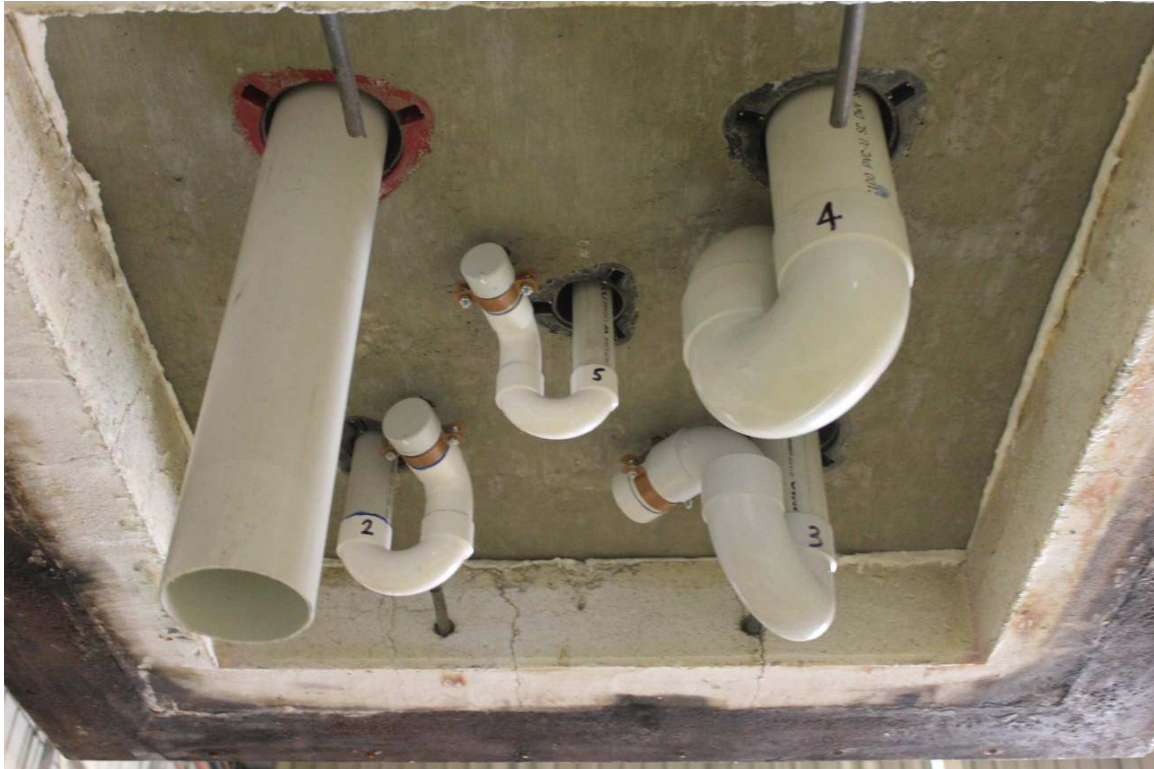
Photograph 1 – Exposed face of the specimen prior to testing

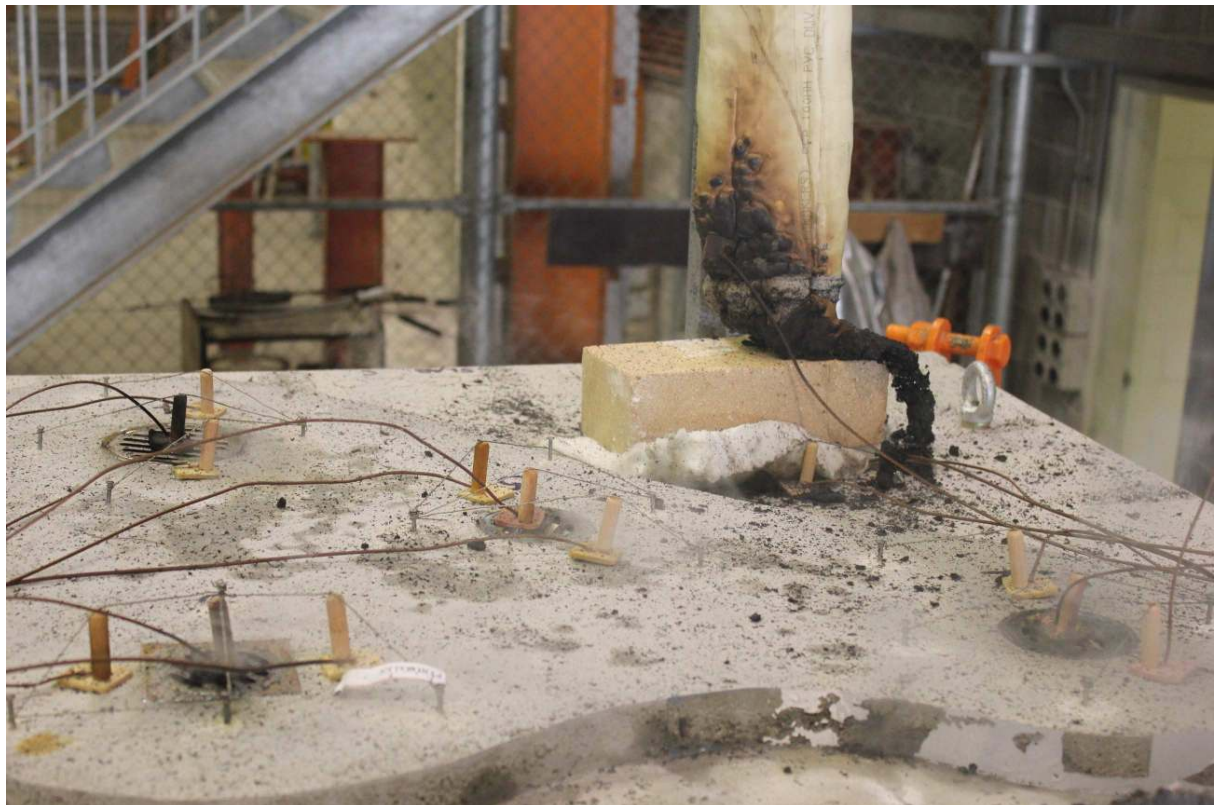
Photograph 4 – Specimens after 120 minutes of testing

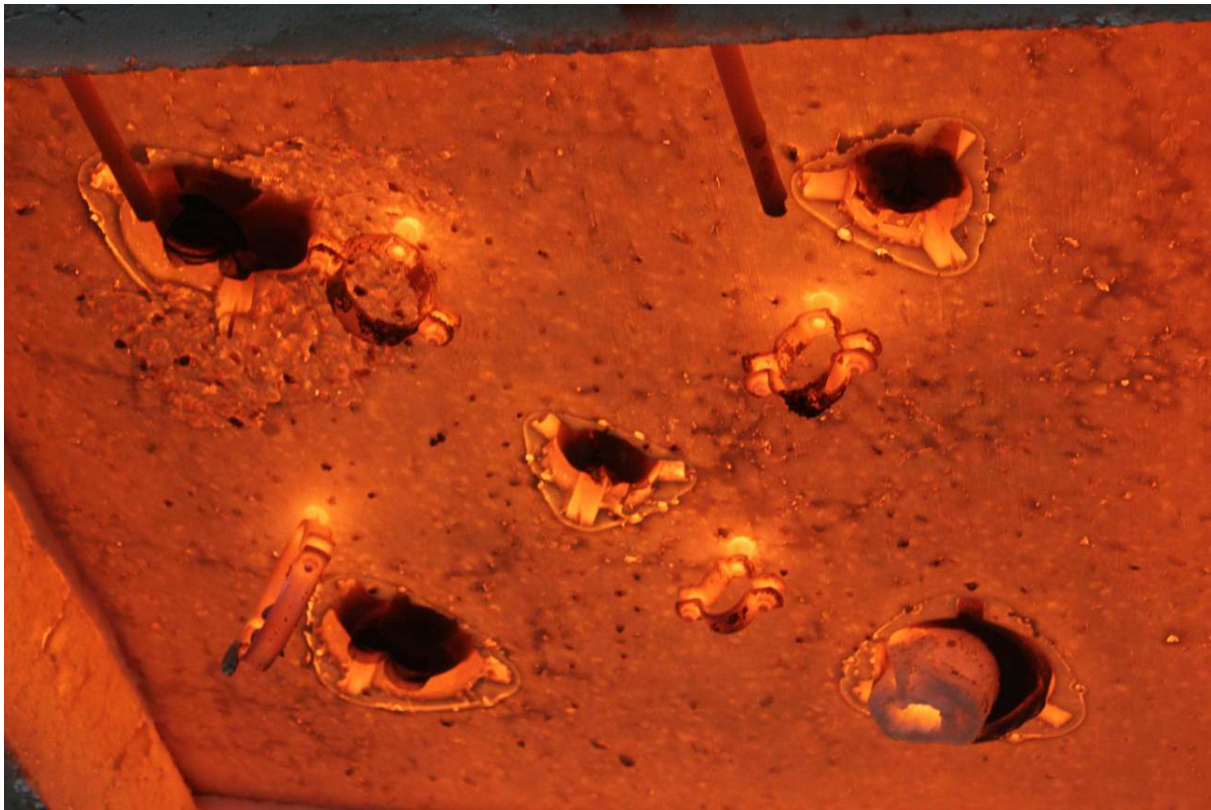
Photograph 7 – Exposed face of the specimens at the conclusion of testing
