# Fire-resistance test on fire collars protecting a concrete slab penetrated by services

## Test Report

**Author:** Mario Lara  
**Report number:** FSP 1601a  
**Date:** 11 April 2014  
(This report supersedes version dated 25 March 2014)

## Sponsored Investigation No. FSP 1601a

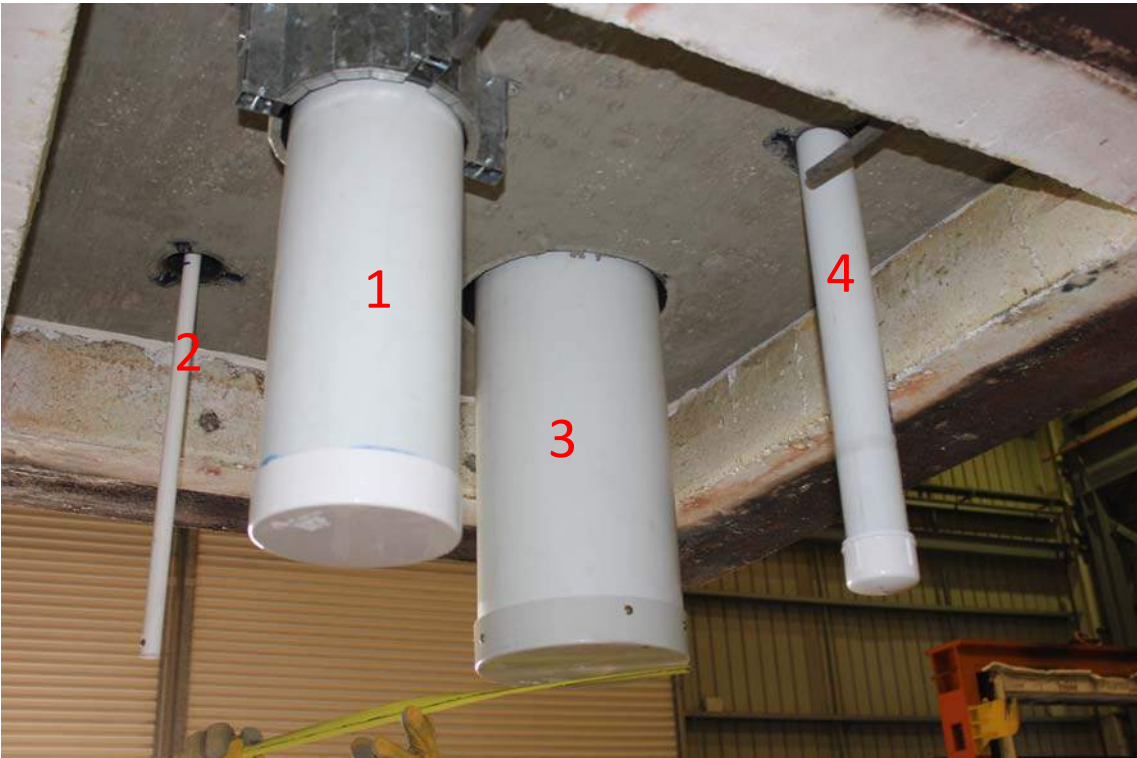
PHOTOGRAPH 1 – EXPOSED FACE OF SPECIMENS PRIOR TO TESTING

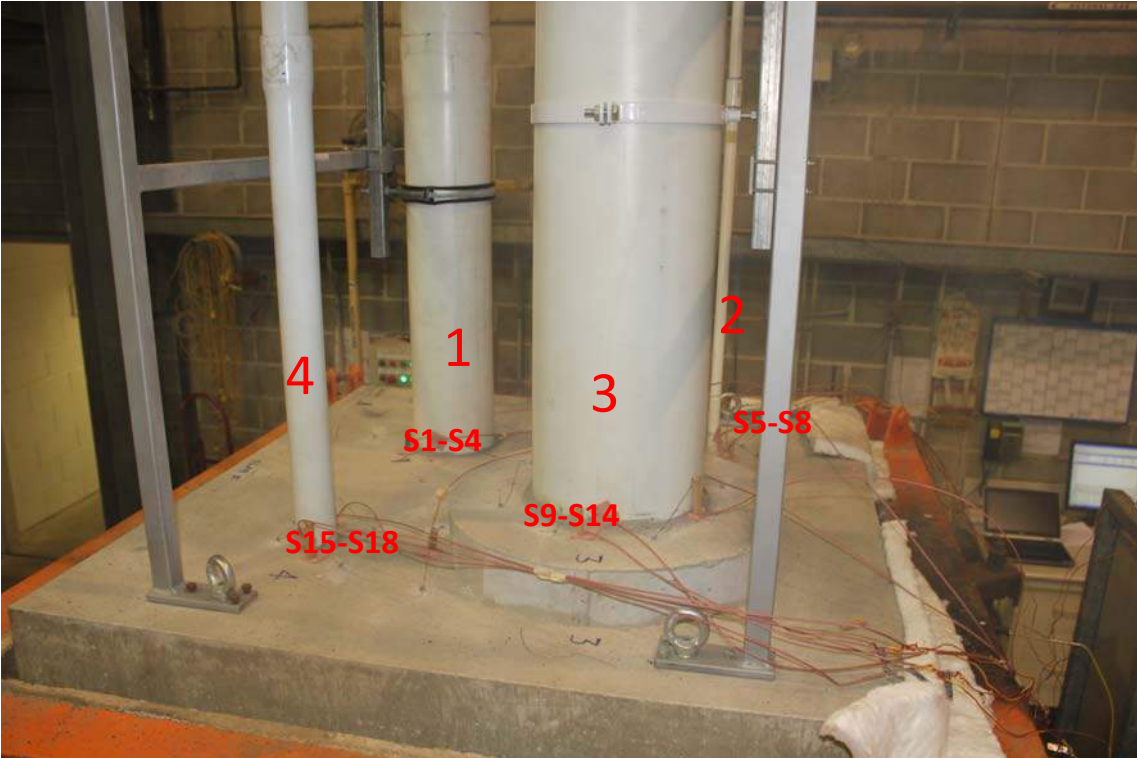
PHOTOGRAPH 2 – UNEXPOSED FACE OF SPECIMENS PRIOR TO TESTING

Location of the thermocouples on the unexposed face of the specimen is shown in photograph 2.

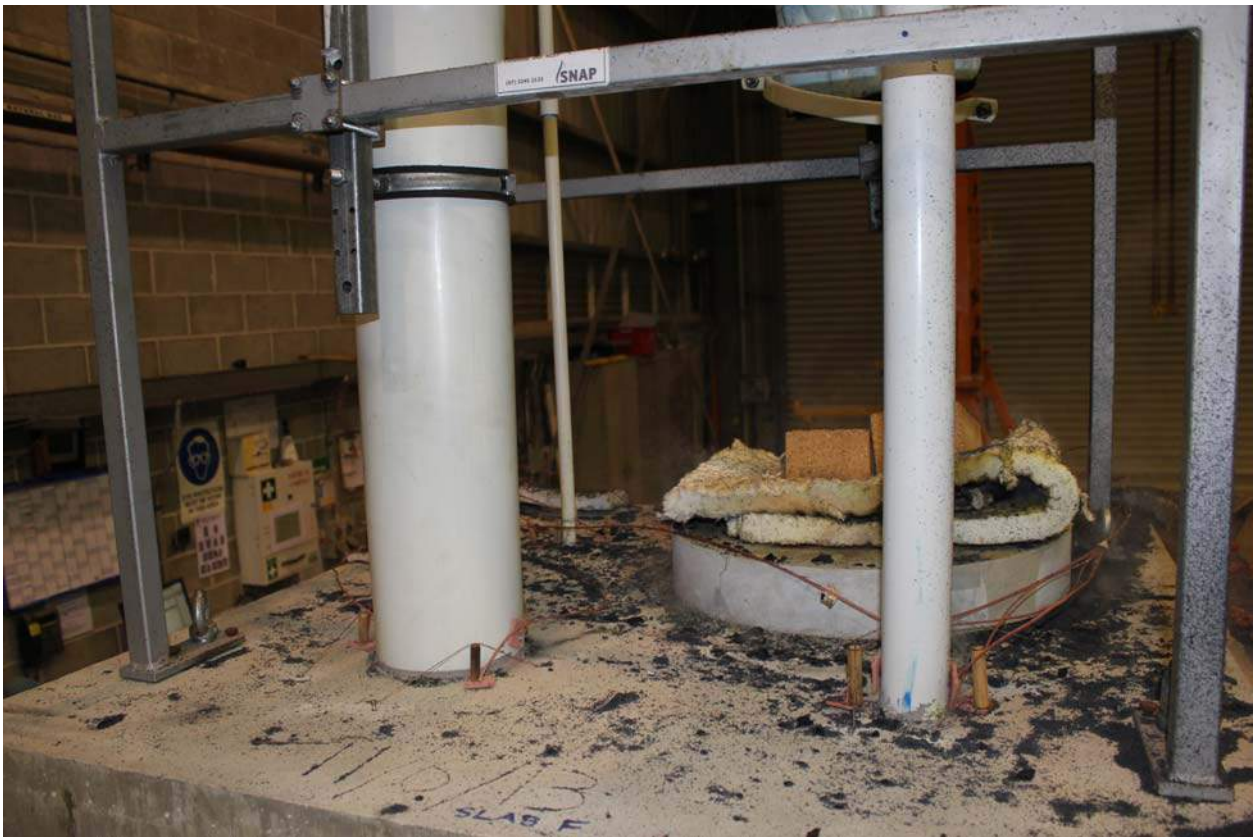
**PHOTOGRAPH 4 – SPECIMENS AFTER 120 MINUTES OF TESTING**

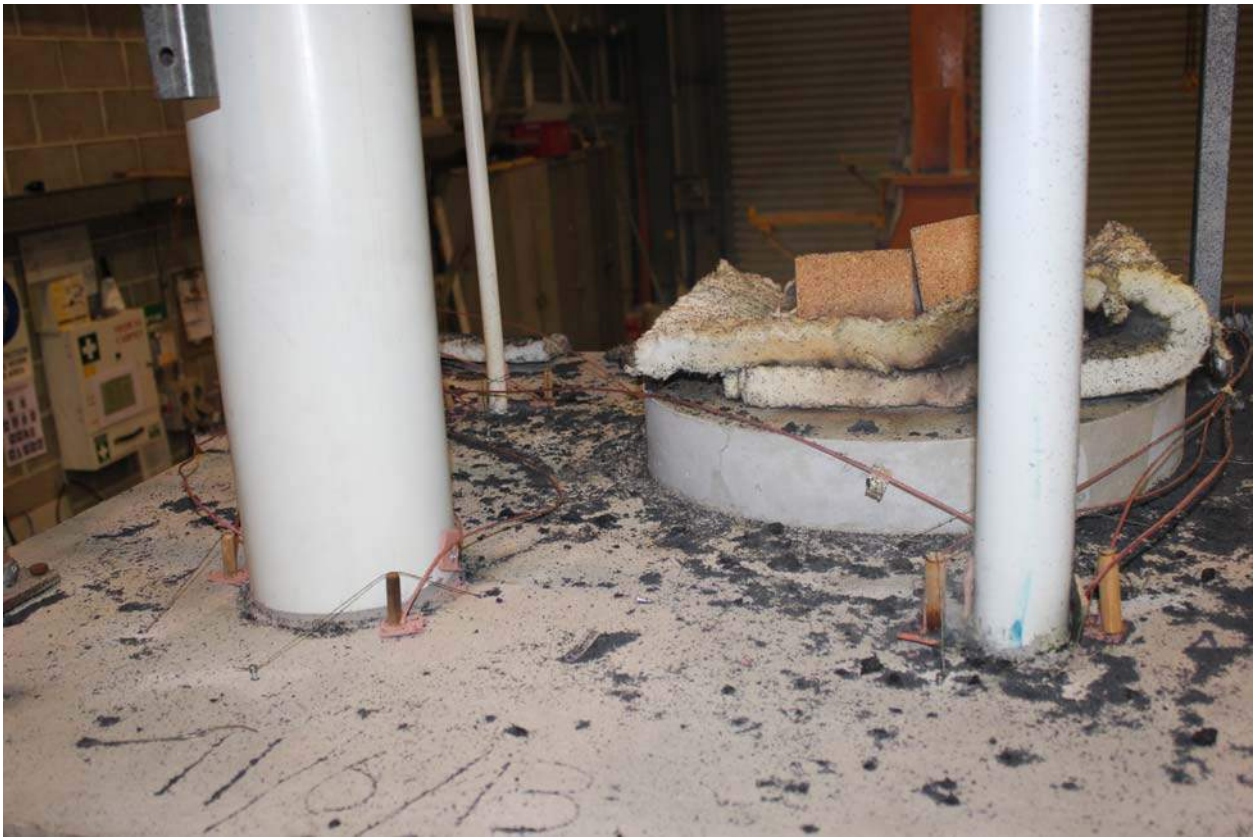
**PHOTOGRAPH 5 – SPECIMENS AFTER 180 MINUTES OF TESTING**

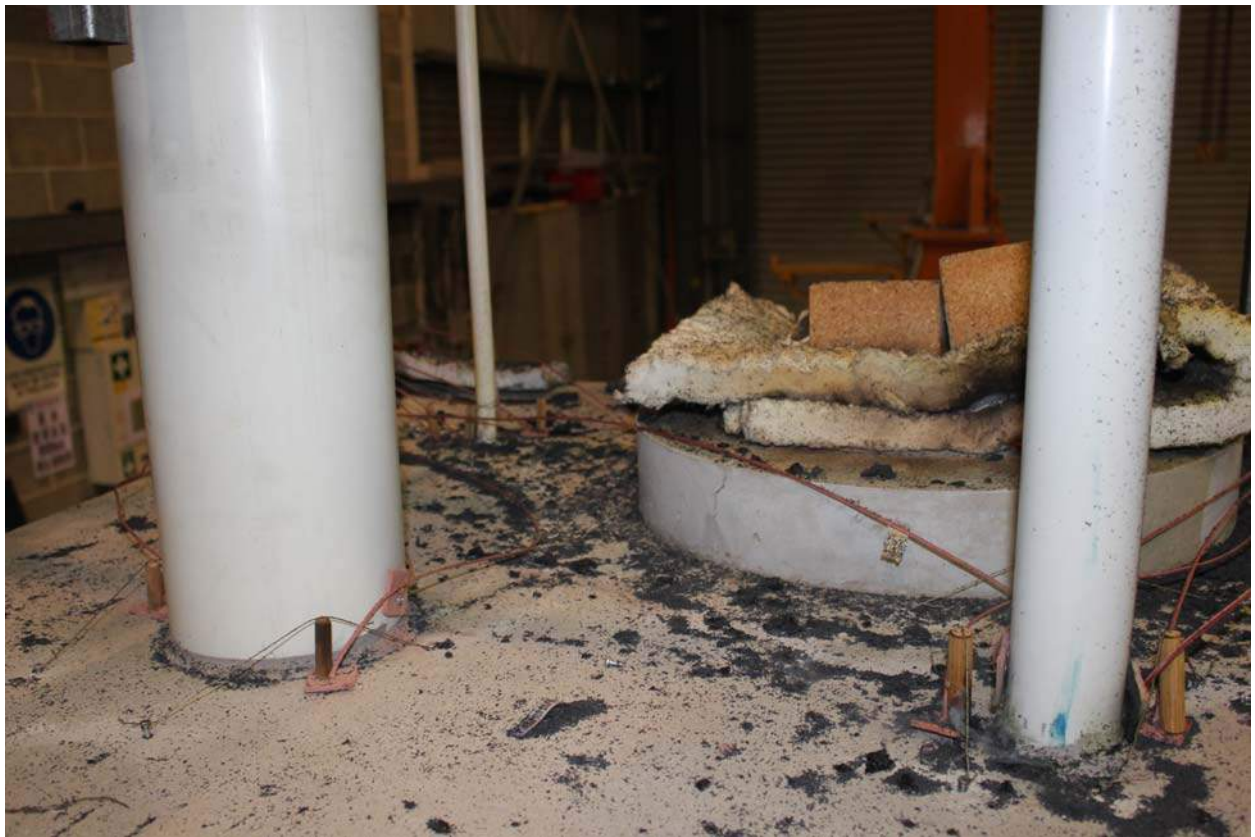
**PHOTOGRAPH 6 – SPECIMENS AFTER 240 MINUTES OF TESTING**

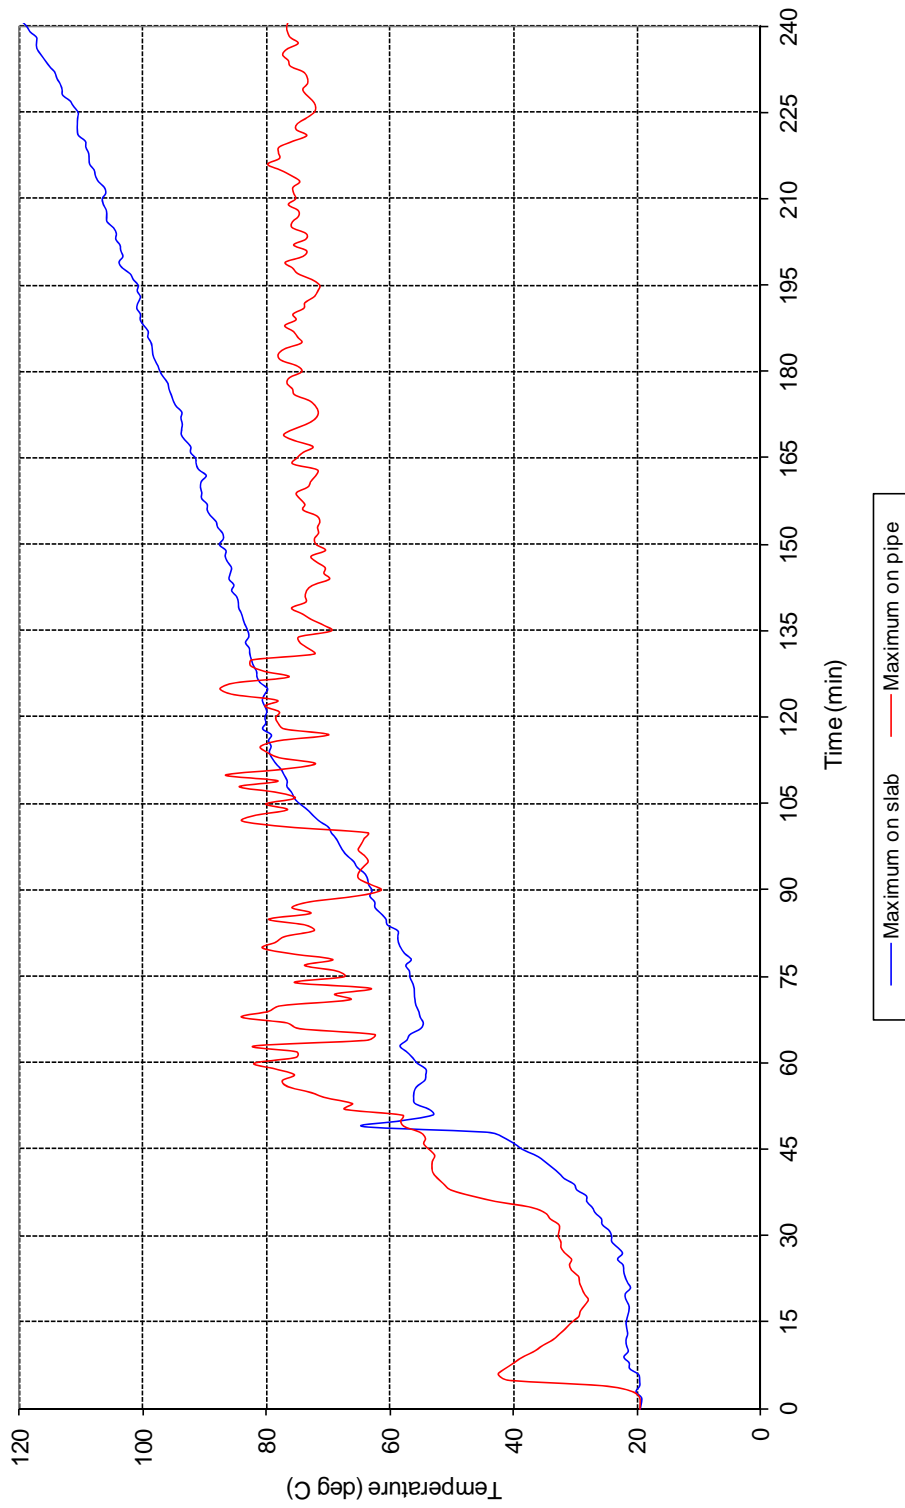
**FIGURE 5 – SPECIMEN TEMPERATURE – ASSOCIATED WITH PENETRATION 4**

Figure 5 shows the curve of maximum temperature versus time associated with Penetration #4.
