**FIRE-RESISTANCE TEST ON  
FIRE COLLARS PROTECTING A CONCRETE SLAB  
PENETRATED BY SERVICES**

**Report number FSP 1564  
CSIRO job number SP3609  
Date of issue 30 JANUARY 2013**

**Client  
SNAP FIRE SYSTEMS PTY LTD.**

**SPONSORED INVESTIGATION No. FSP 1564****FIRE-RESISTANCE TEST ON FIRE COLLARS PROTECTING A  
CONCRETE SLAB PENETRATED BY SERVICES****SUMMARY****IDENTIFICATION OF SPECIMEN:**

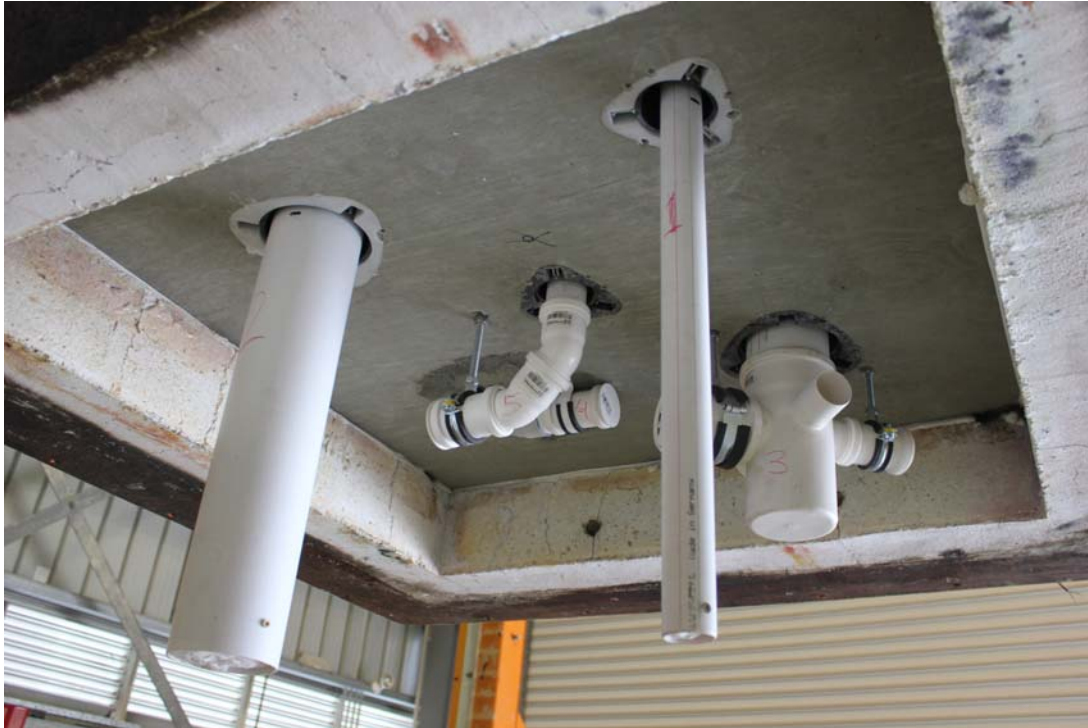
Photograph 1 – Exposed face of the specimen prior to testing

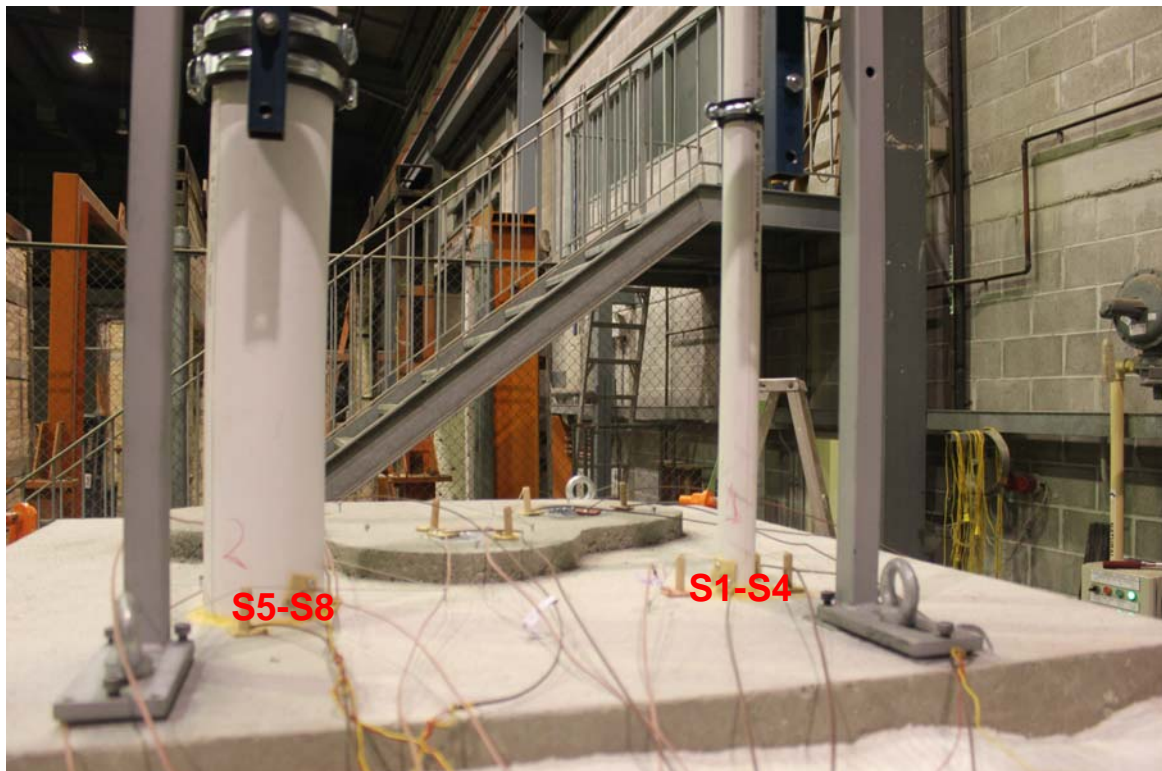
Photograph 2 – Unexposed face of penetrations #1 and #2 prior to testing

Location of the thermocouples on the unexposed face of the specimen is shown in photographs 2 & 3.

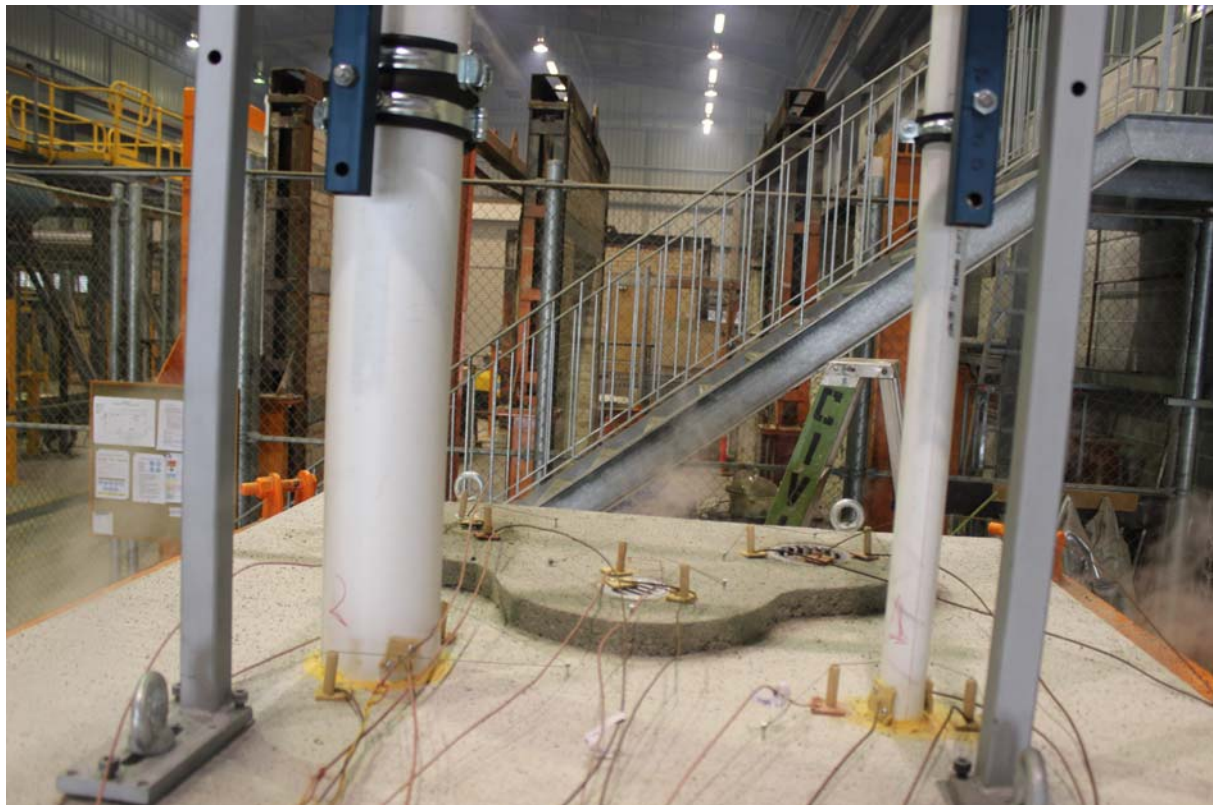
Photograph 4 – Specimens after 60 minutes of testing

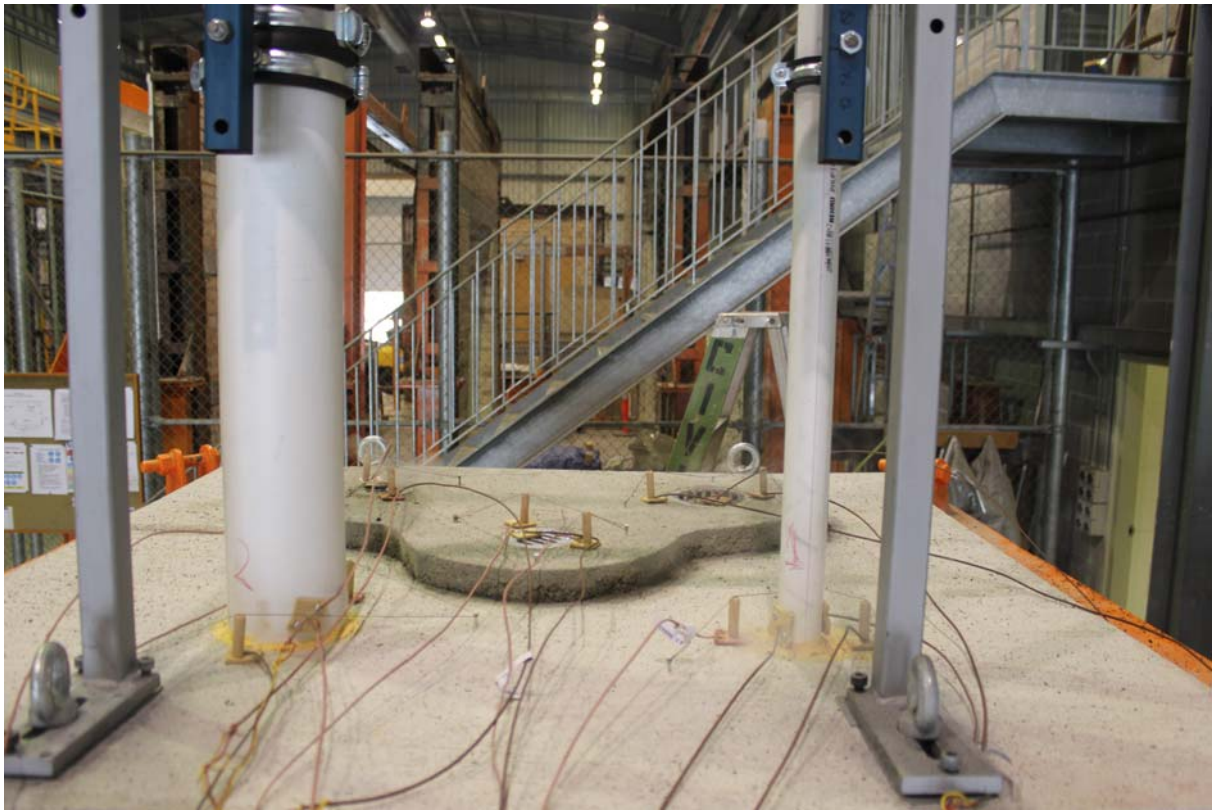
Photograph 5 – Specimens after 120 minutes of testing

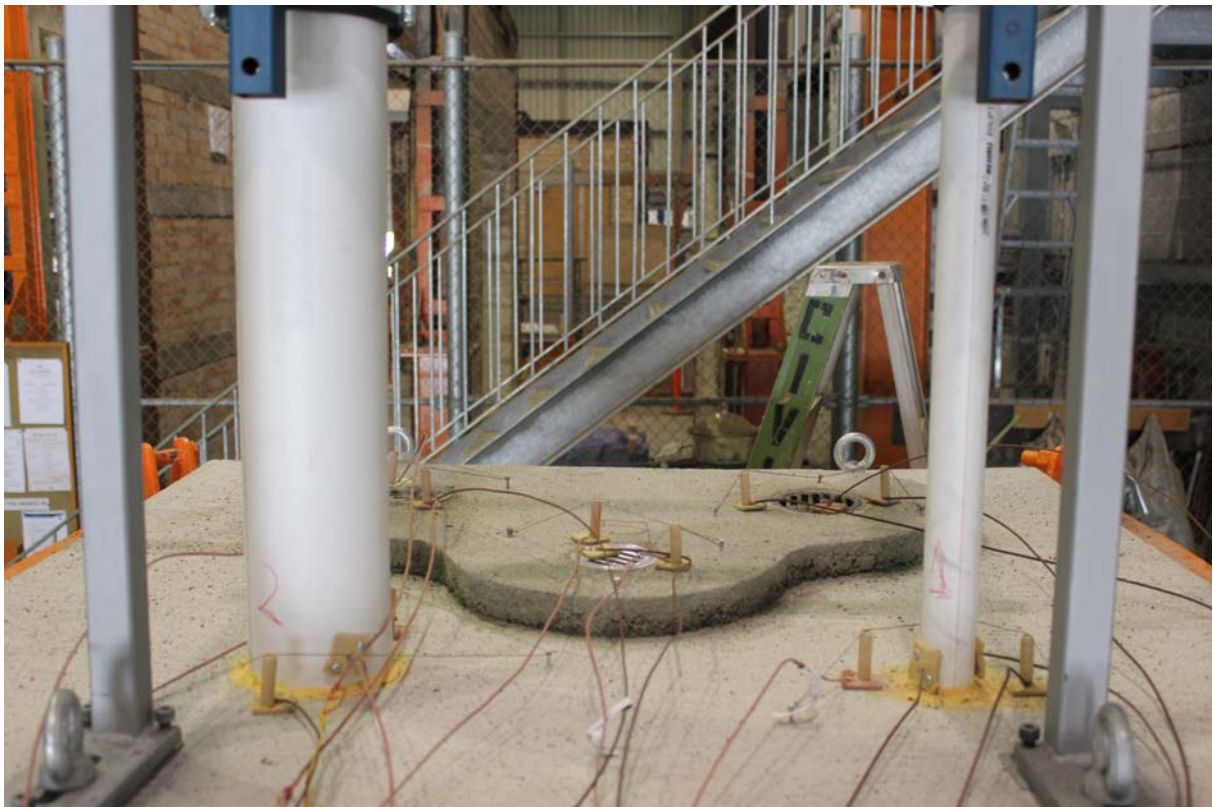
Photograph 6 – Specimens after 180 minutes of testing

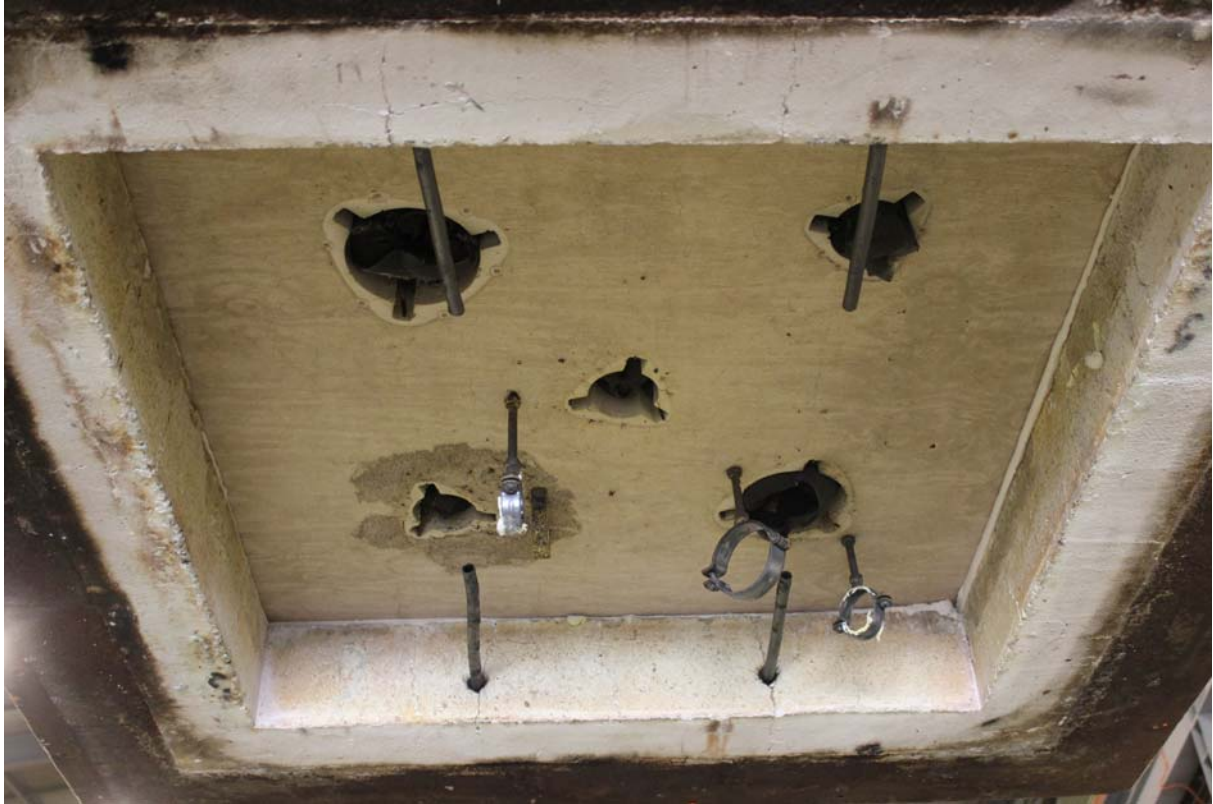
Photograph 8 – Exposed face of the specimens at the conclusion of testing
