Fire-resistance test on fire collars protecting a concrete slab penetrated by services

Test Report

Author: Mario Lara-Ledermann
Report number: FSP 1641
Date: 25 July 2014

Client: Snap Fire Systems Pty Ltd

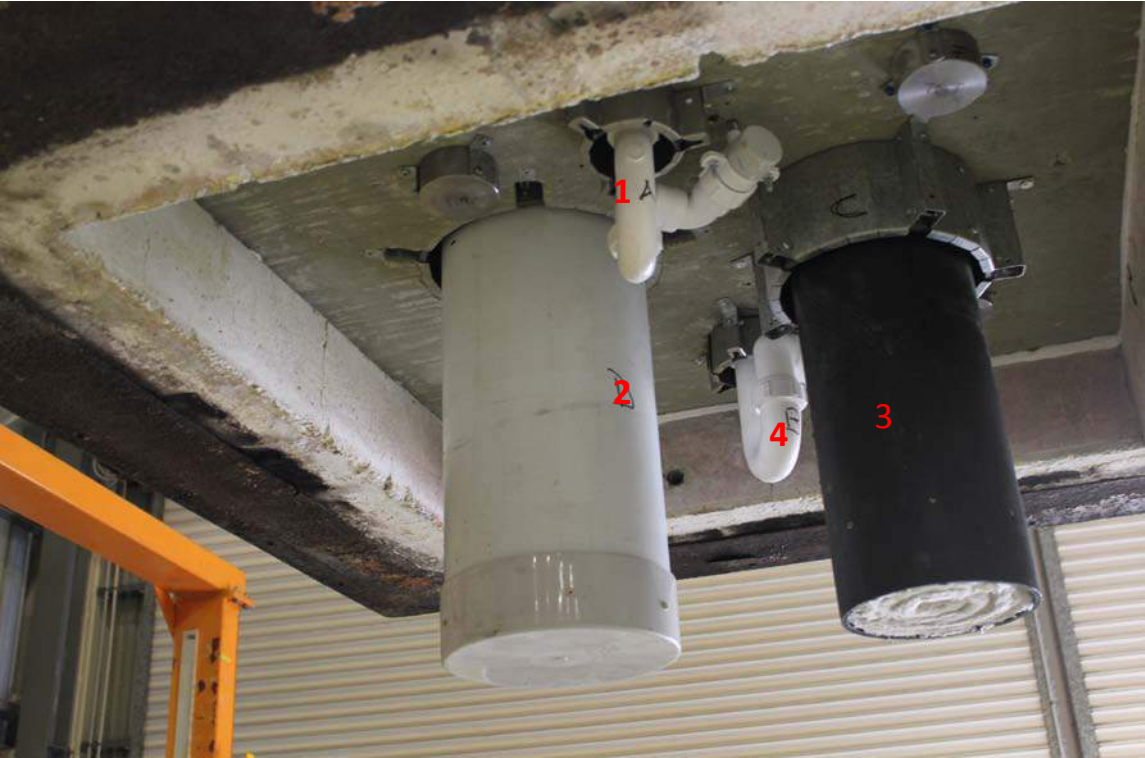
PHOTOGRAPH 1 – EXPOSED FACE OF SPECIMENS PRIOR TO TESTING

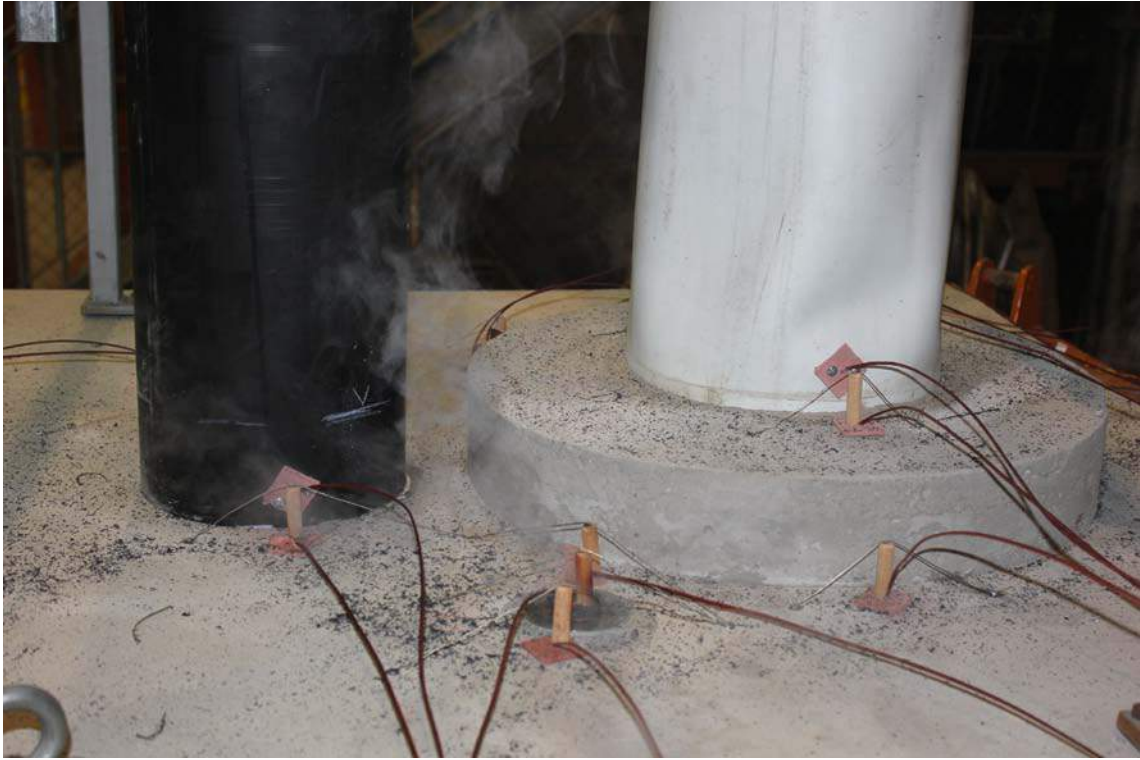
PHOTOGRAPH 3 – SPECIMENS AFTER 60 MINUTES OF TESTING

- 60 minutes - Very little smoke is visible from pipes or grates.
- 90 minutes - No change to specimen.
- 110 minutes - Light smoke/steam is fluing from Penetrations 2, 3 and 4.

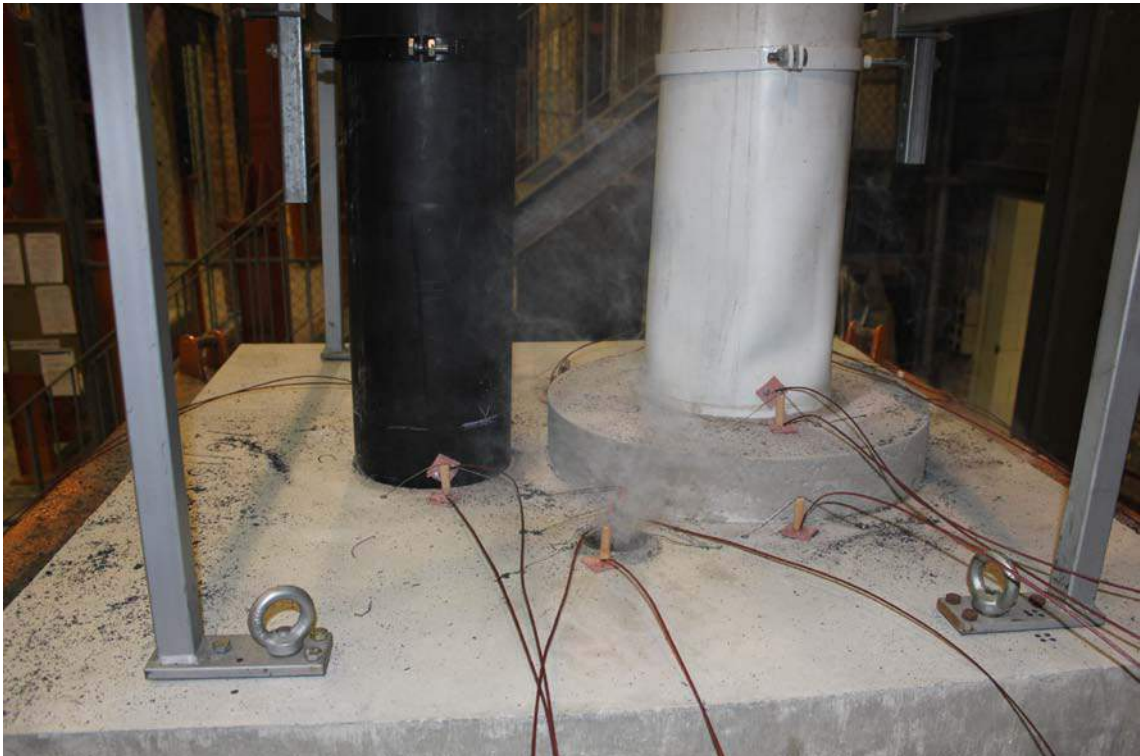
PHOTOGRAPH 4 – SPECIMENS AFTER 120 MINUTES OF TESTING

- 120 minutes - No visible change to unexposed face of specimen.
- 180 minutes - Little visible change. Light smoke/steam is visible from pipes and grates.

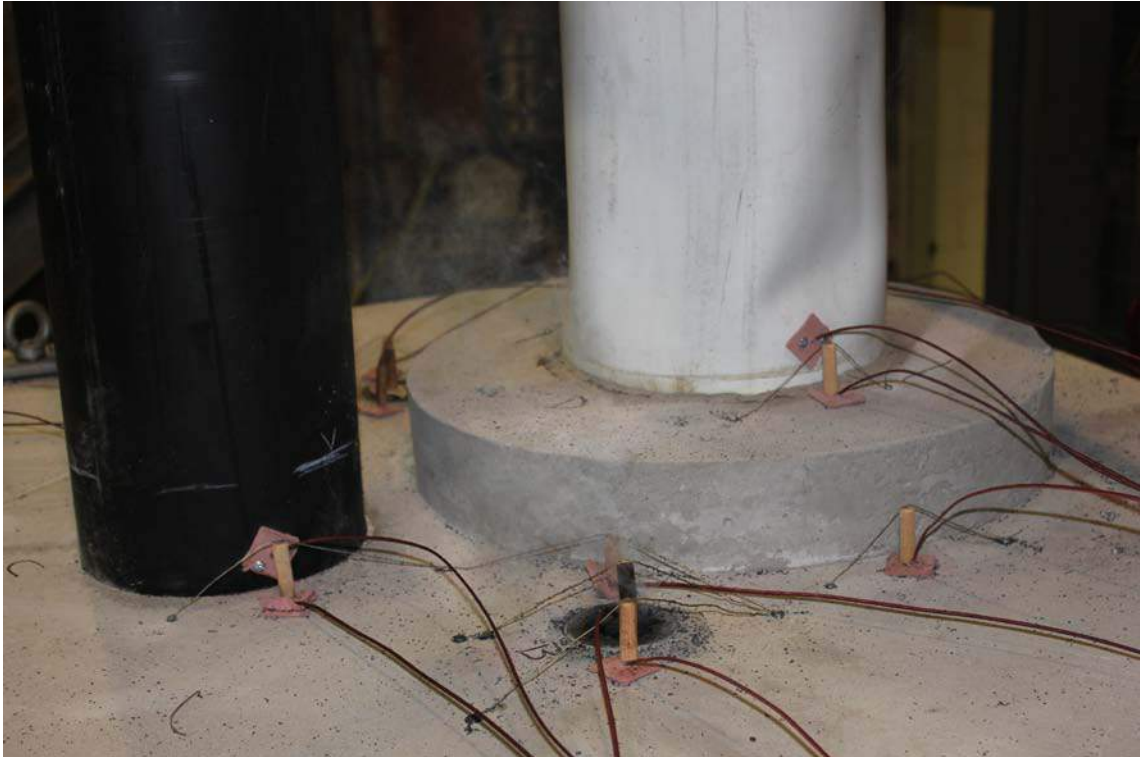
PHOTOGRAPH 5 – SPECIMENS AFTER 180 MINUTES OF TESTING

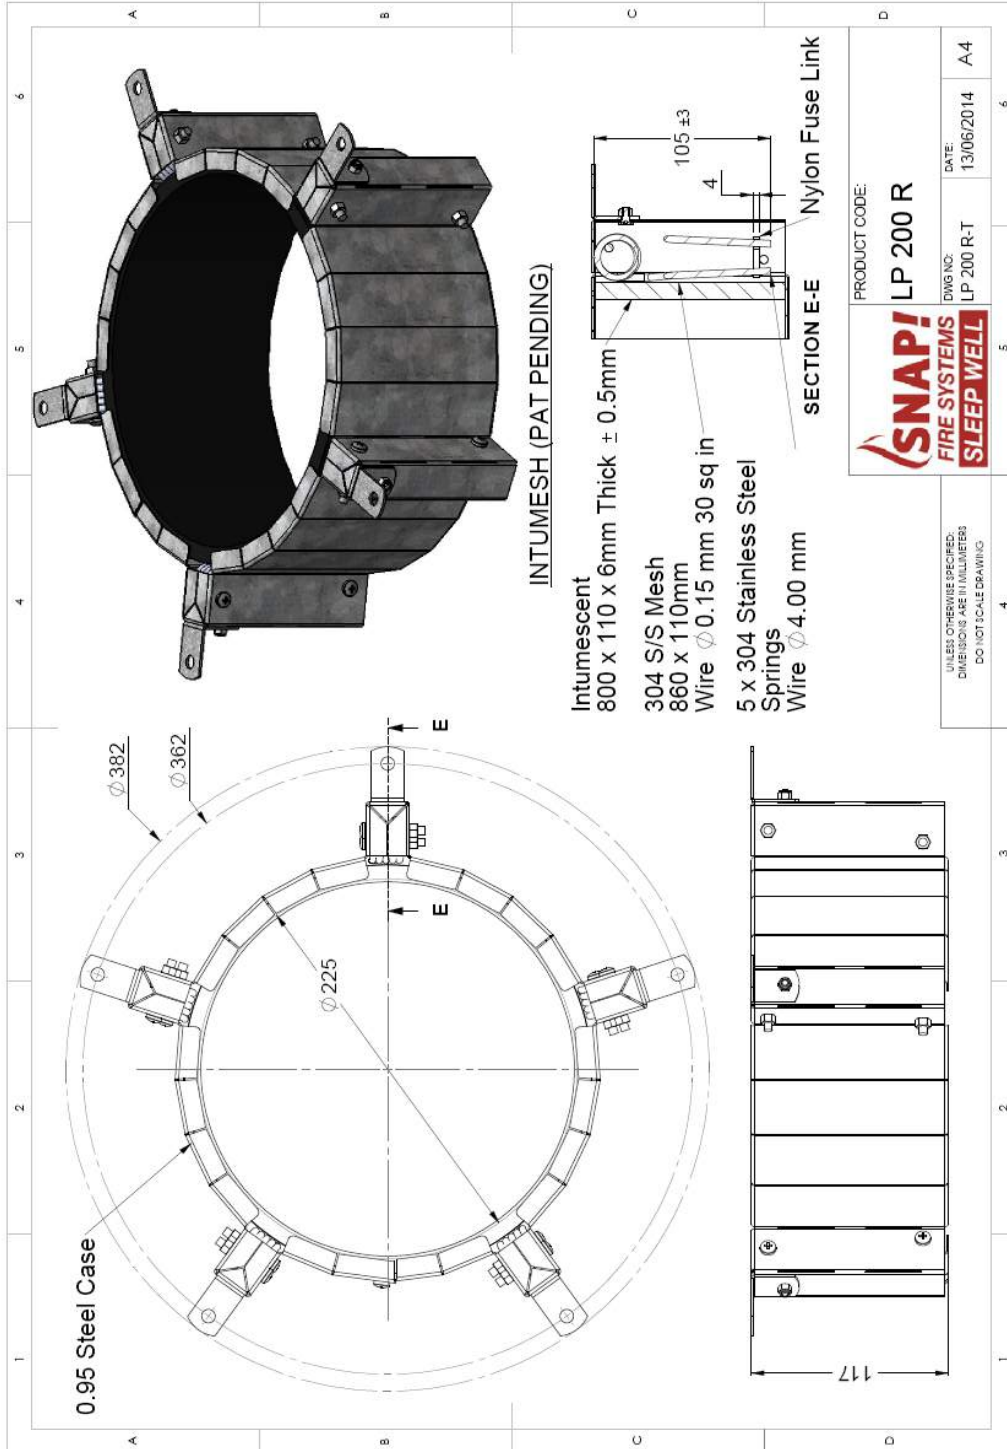
DRAWING NUMBERED LP 200 R-T, DATED 13 JUNE 2014, BY SNAP FIRE SYSTEMS PTY LTD.

The SNAP Retrofit LP 200 R fire collar comprised a 0.95-mm steel casing with a 225-mm inner diameter and a 362-mm diameter base flange. The 117-mm high collar casing incorporated 800-mm x 110-mm x 6-mm thick Intumesh intumescent material. The closing mechanism comprised five stainless steel springs, with nylon fuse links and an 860-mm x 110-mm stainless steel mesh as shown in drawing numbered LP 200 R-T dated 13 June 2014, by SNAP Fire Systems. One collar was fixed to the underside of the slab with PBZ0635 fasteners.

Drawing numbered LP 200 R-T, dated 13 June 2014, by Snap Fire Systems Pty Ltd.
