Fire-resistance test on fire collars protecting a concrete slab penetrated by services

Test Report

Author: Mario Lara-Ledermann
Report number: FSP 1652
Date: 10 September 2014

Sponsored Investigation No. FSP 1652

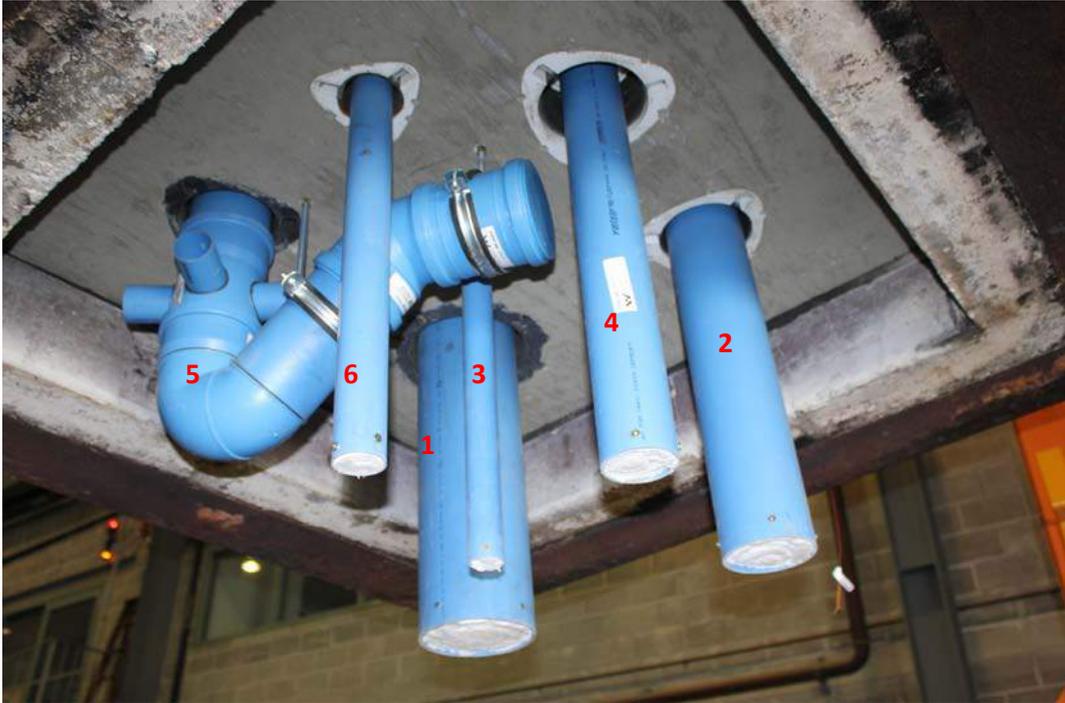
PHOTOGRAPH 1 – EXPOSED FACE OF SPECIMENS PRIOR TO TESTING

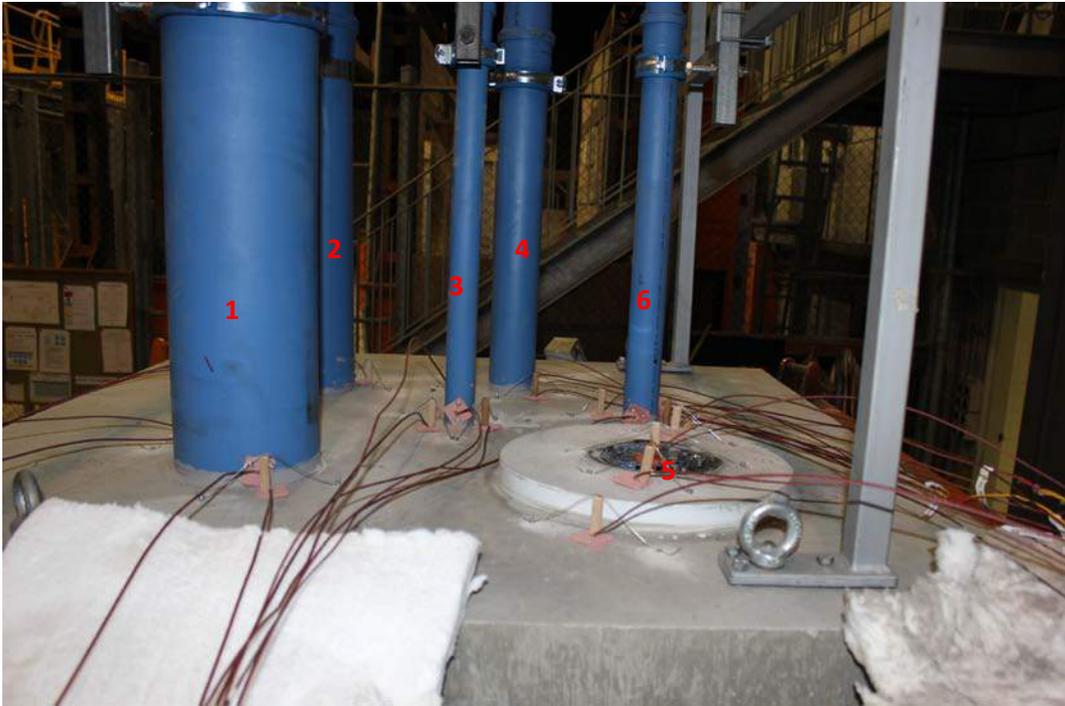
PHOTOGRAPH 2 – UNEXPOSED FACE OF SPECIMENS PRIOR TO TESTING

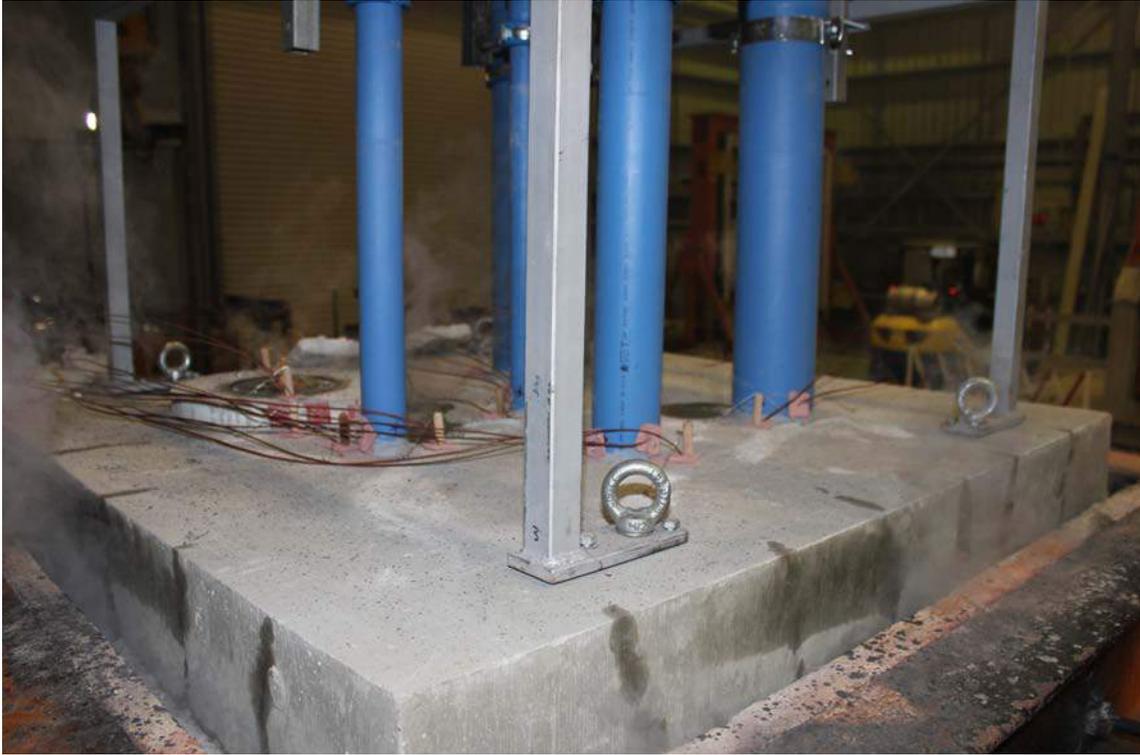
PHOTOGRAPH 3 – SPECIMENS AFTER 60 MINUTES OF TESTING

Time	Observation
3 minutes	- Smoke is visible from Penetration 2 and Penetration 4.
4 minutes	- Smoke is visible from Penetration 5 (floor waste). - Cotton wool pad applied over Penetration 5 (floor waste) – No ignition.
5 minutes	- Smoke is visible from Penetrations 1 and 2. Penetration 4 has ceased fluing.
11 minutes	- Light smoke is visible from Penetration 1.
12 minutes	- Spalling noises can be heard from the specimen.
15 minutes	- Smoke is fluing from Penetration 5.
44 minutes	- Penetrations are no longer fluing.
48 minutes	- Smoke is being emitted from Penetrations 3 and 5.
57 minutes	- Water is pooling on the unexposed face of the slab.
183 minutes	- <u>Insulation failure of Penetration 1: maximum temperature rise limit of 180°C measured on the slab.</u>
241 minutes	- Test terminated

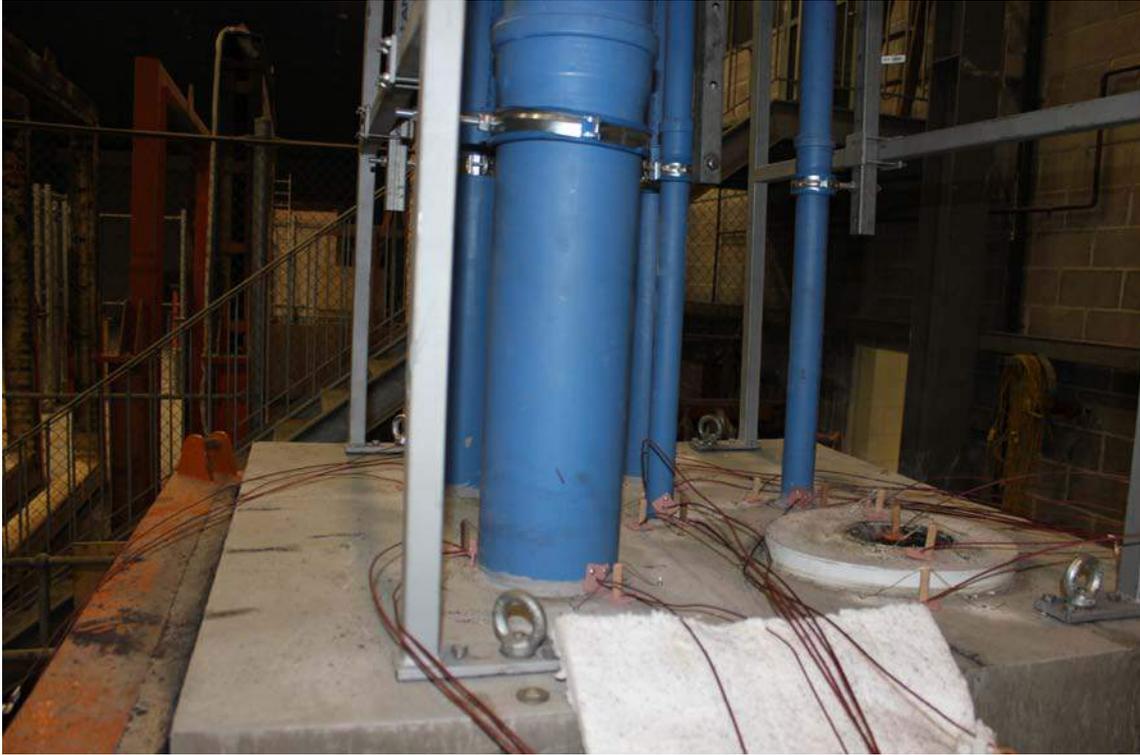
PHOTOGRAPH 5 – SPECIMENS AFTER 180 MINUTES OF TESTING

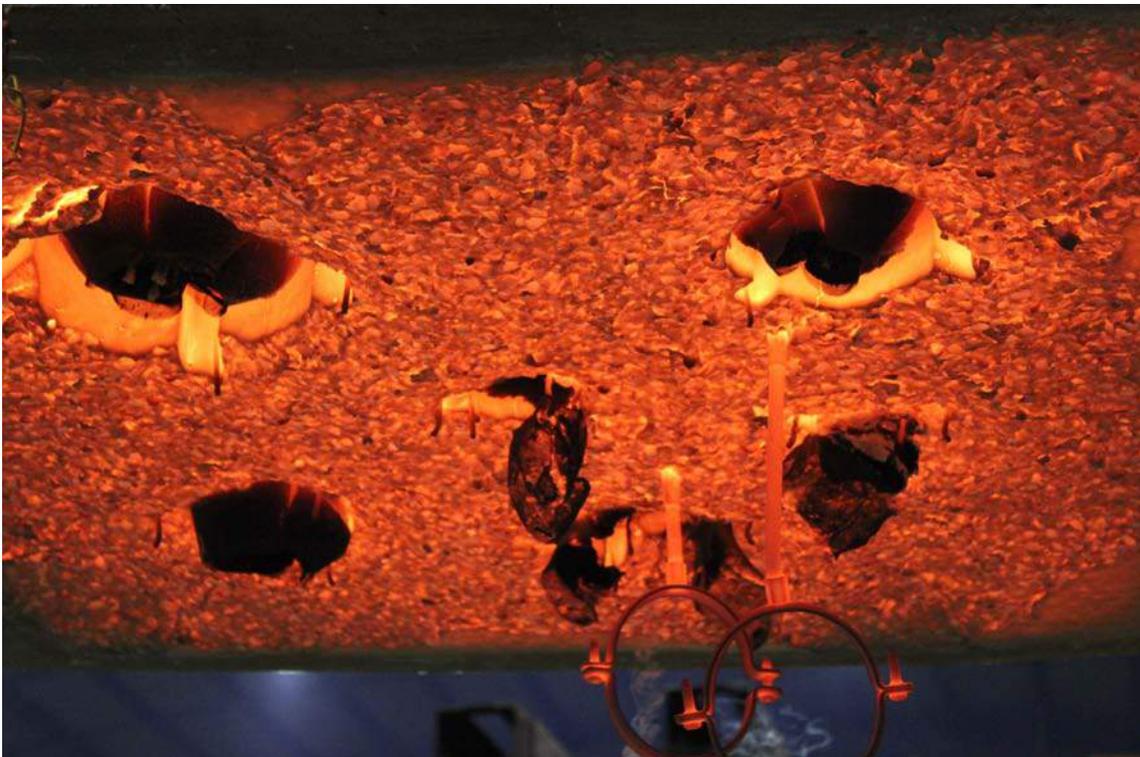
PHOTOGRAPH 6 – EXPOSED FACE OF SPECIMENS AT CONCLUSION OF TESTING
