Fire-resistance test on fire collars protecting a concrete slab penetrated by services

Test Report

Author: Mario Lara-Ledermann
Report number: FSP 1657
Date: 24 November 2014

Sponsored Investigation No. FSP 1657

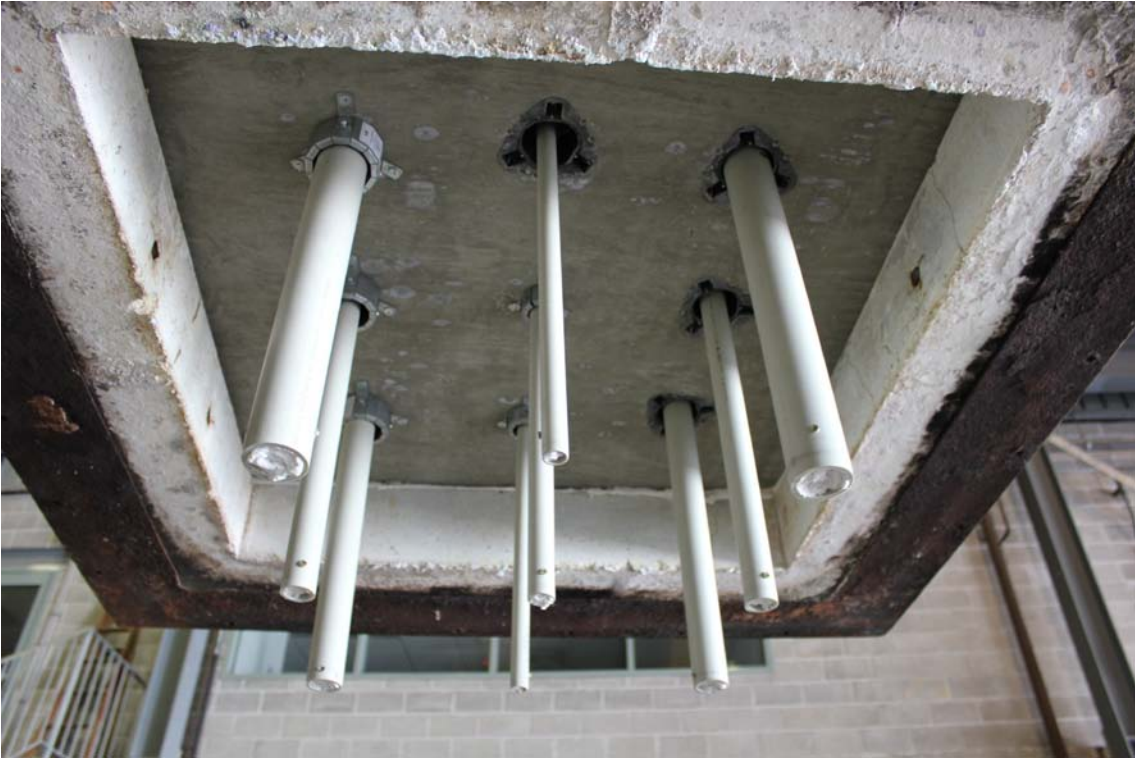
PHOTOGRAPH 1 – EXPOSED FACE OF SPECIMENS PRIOR TO TESTING

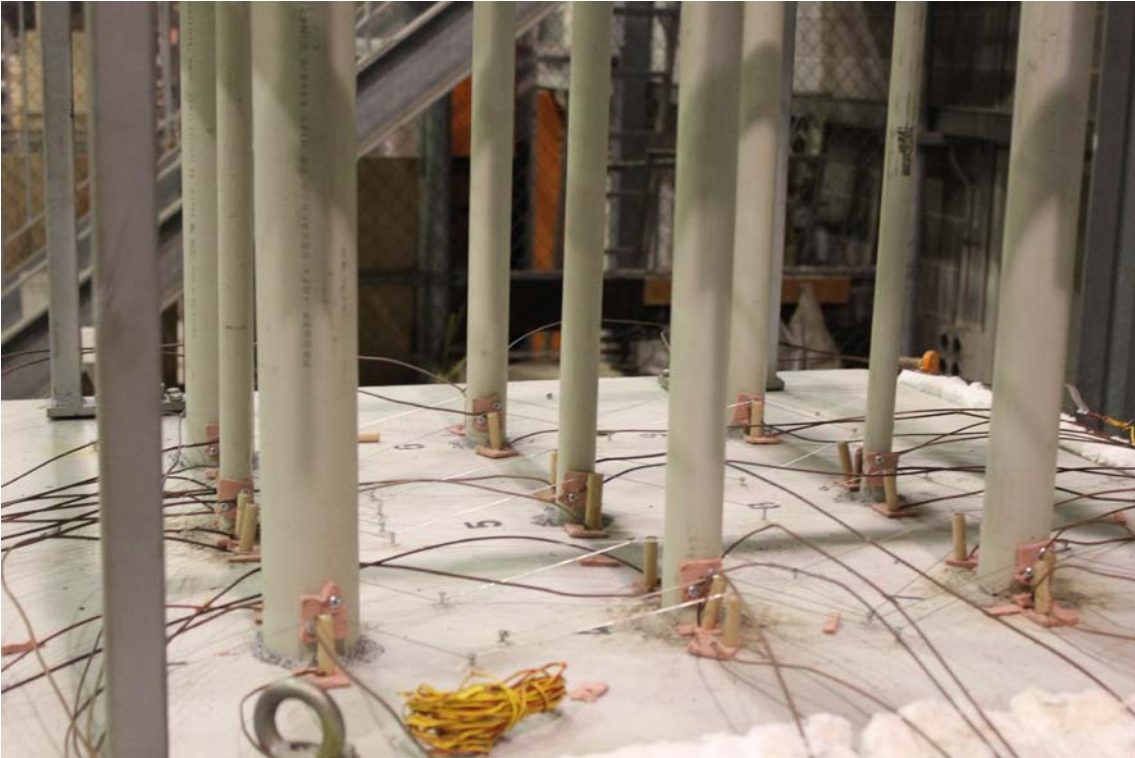
PHOTOGRAPH 2 – UNEXPOSED FACE OF SPECIMENS PRIOR TO TESTING

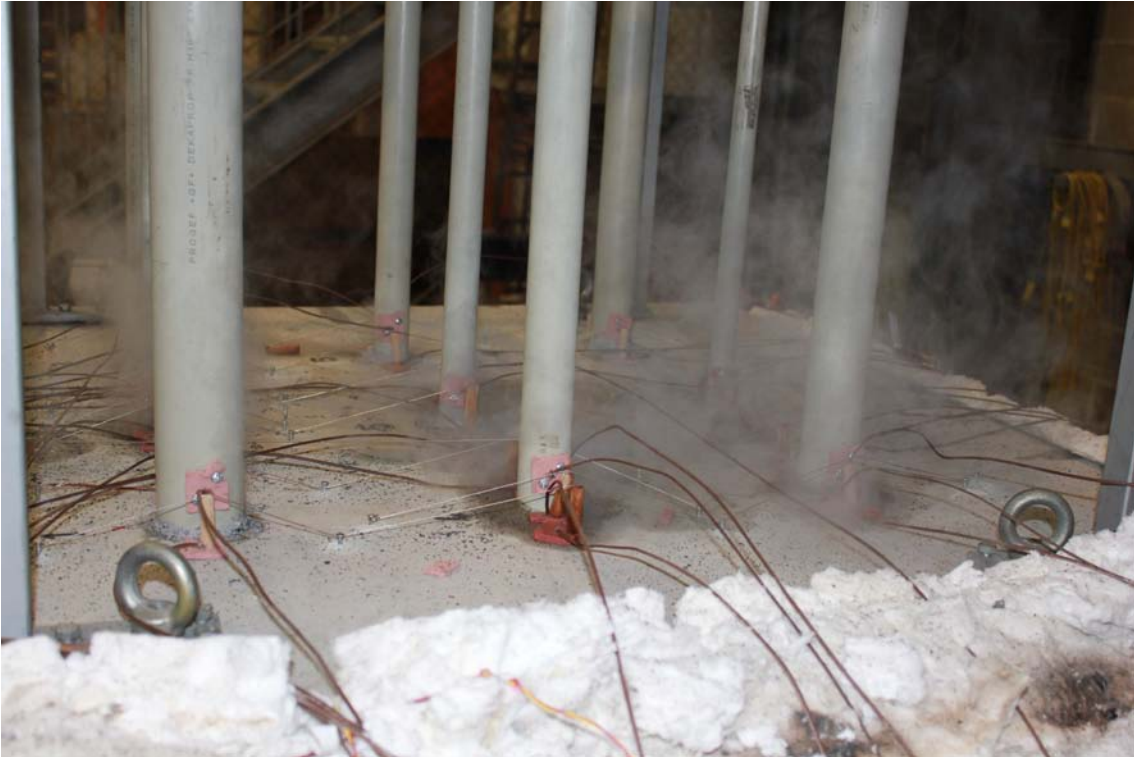
PHOTOGRAPH 3 – SPECIMENS AFTER 60 MINUTES OF TESTING

Time	Observation
2 minutes -	Light smoke is visible from Penetrations 2 and 5 and the furnace flues.
3 minutes -	Smoke is visible from Penetration 9 only.
4 minutes -	Smoke is visible from Penetration 6 only.
6 minutes -	Smoke is visible from Penetrations 3, 7 and 9.
8 minutes -	Light smoke is visible from Penetrations 3 and 6. Increased smoke is visible from the furnace flues.
10 minutes -	No smoke is visible from the unexposed ends of the penetrations.
12 minutes -	Spalling noise is audible from the slab. Smoke quantity from the furnace flues has decreased.
14 minutes -	Further spalling noises can be heard from the slab.
17 minutes -	Little smoke is visible from the furnace flues. No penetrations are fluing. Spalling continues on the slab.
27 minutes -	Steam/moisture is visible from Penetrations 2, 5 and 8. Spalling noises has ceased.
50 minutes -	Steam/moisture is visible from Penetrations 2, 4, 5, 7 and 8.

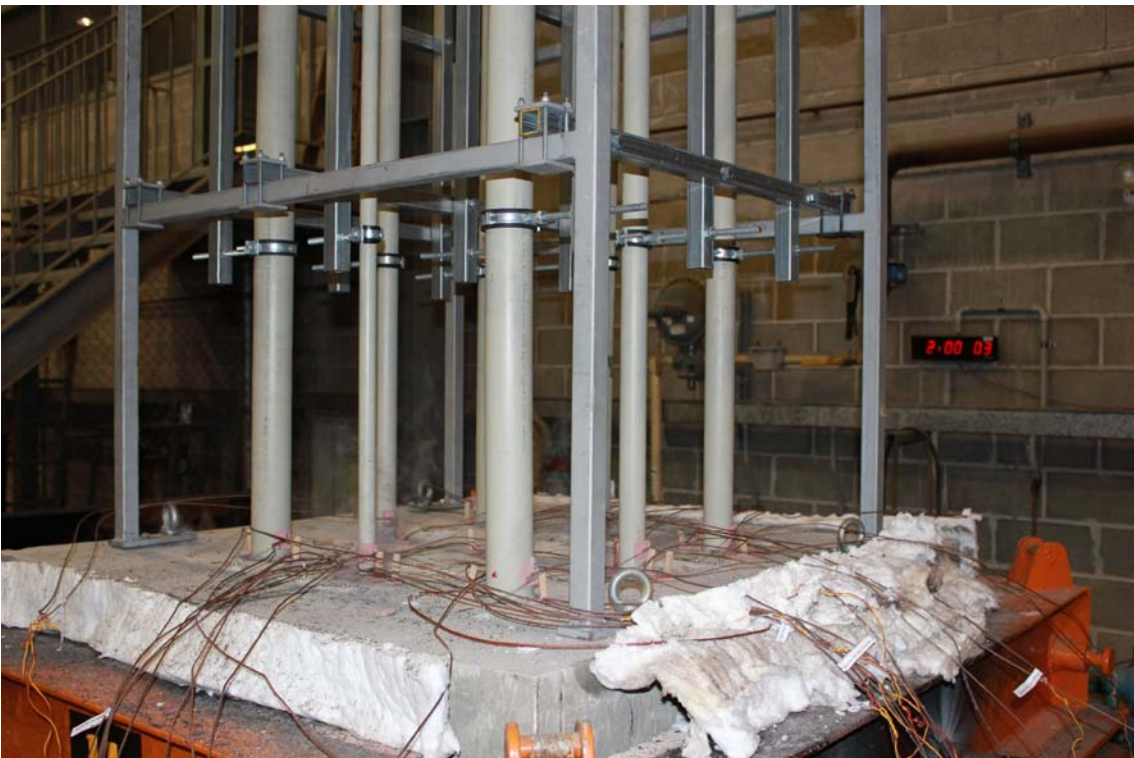
PHOTOGRAPH 4 – SPECIMENS AFTER 120 MINUTES OF TESTING

75 minutes -	Little visible change noted on the unexposed face.
80 minutes -	The slab has dried out around the Penetrations.
120 minutes -	Little visible change noted on the unexposed face.
180 minutes -	The sealant at the base of Penetrations 5 and 8 has deformed slightly.
203 minutes -	Light smoke is visible from the base of Penetration 5.
241 minutes -	Test terminated

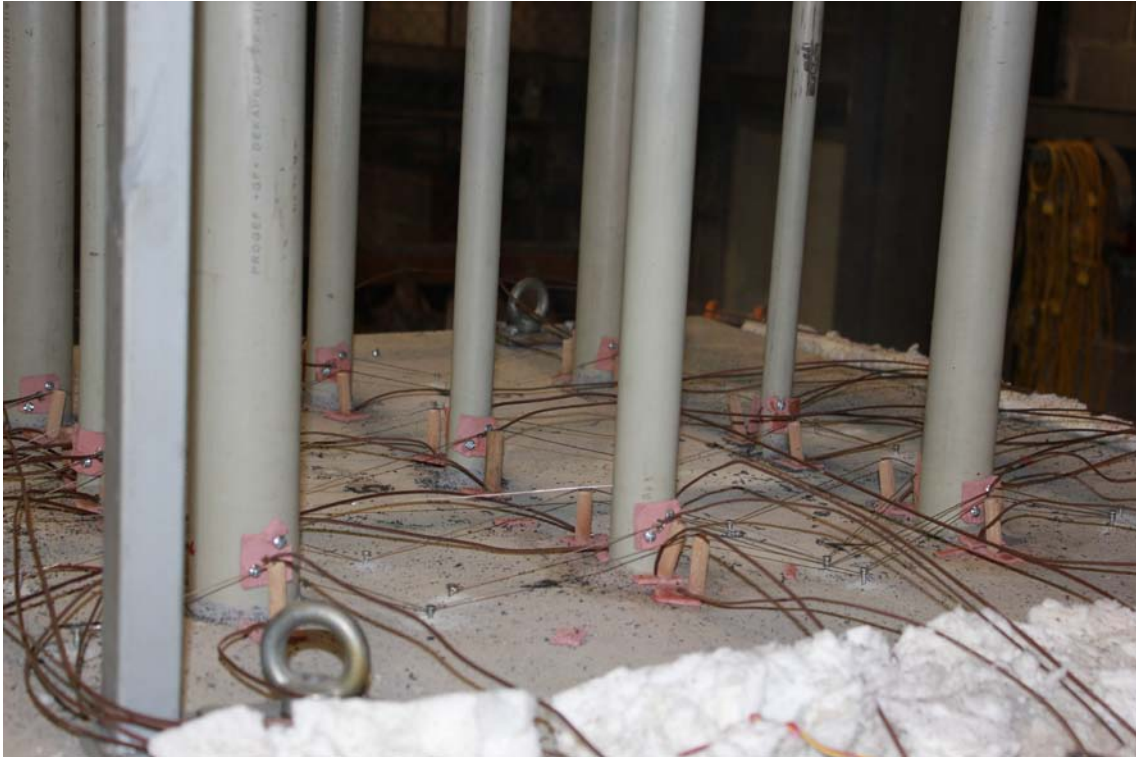
PHOTOGRAPH 5 – SPECIMENS AFTER 180 MINUTES OF TESTING

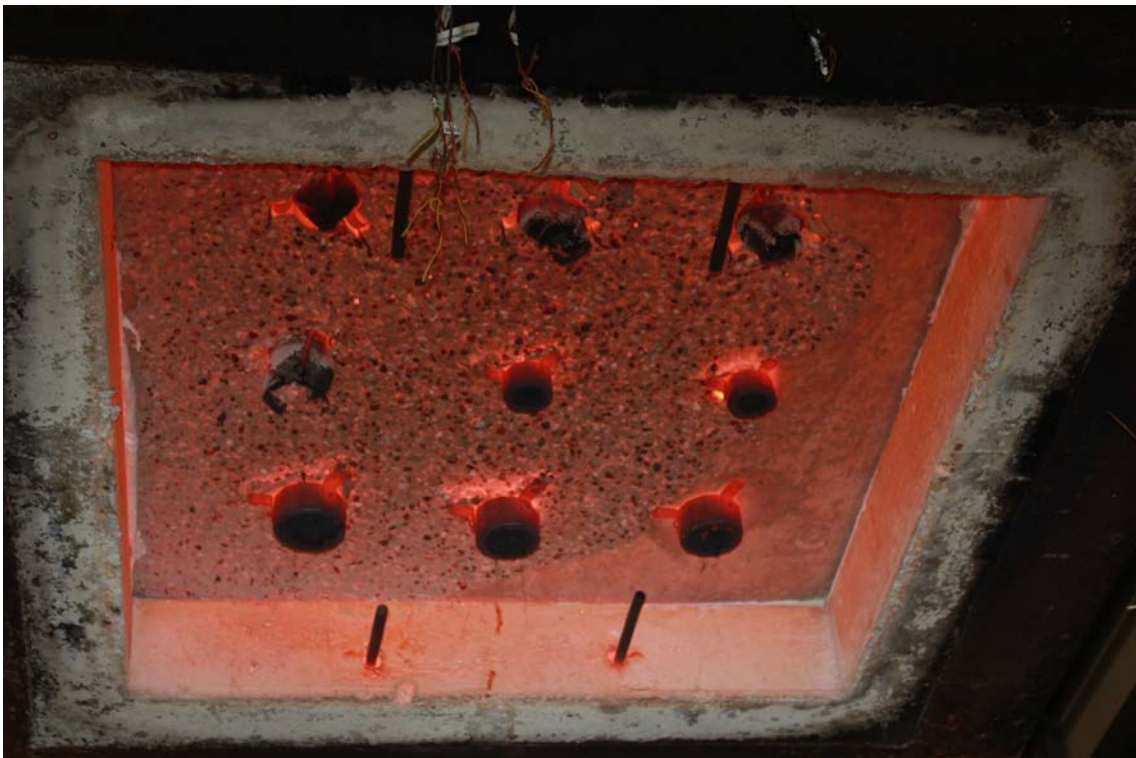
PHOTOGRAPH 6 – EXPOSED FACE OF SPECIMENS AT CONCLUSION OF TESTING

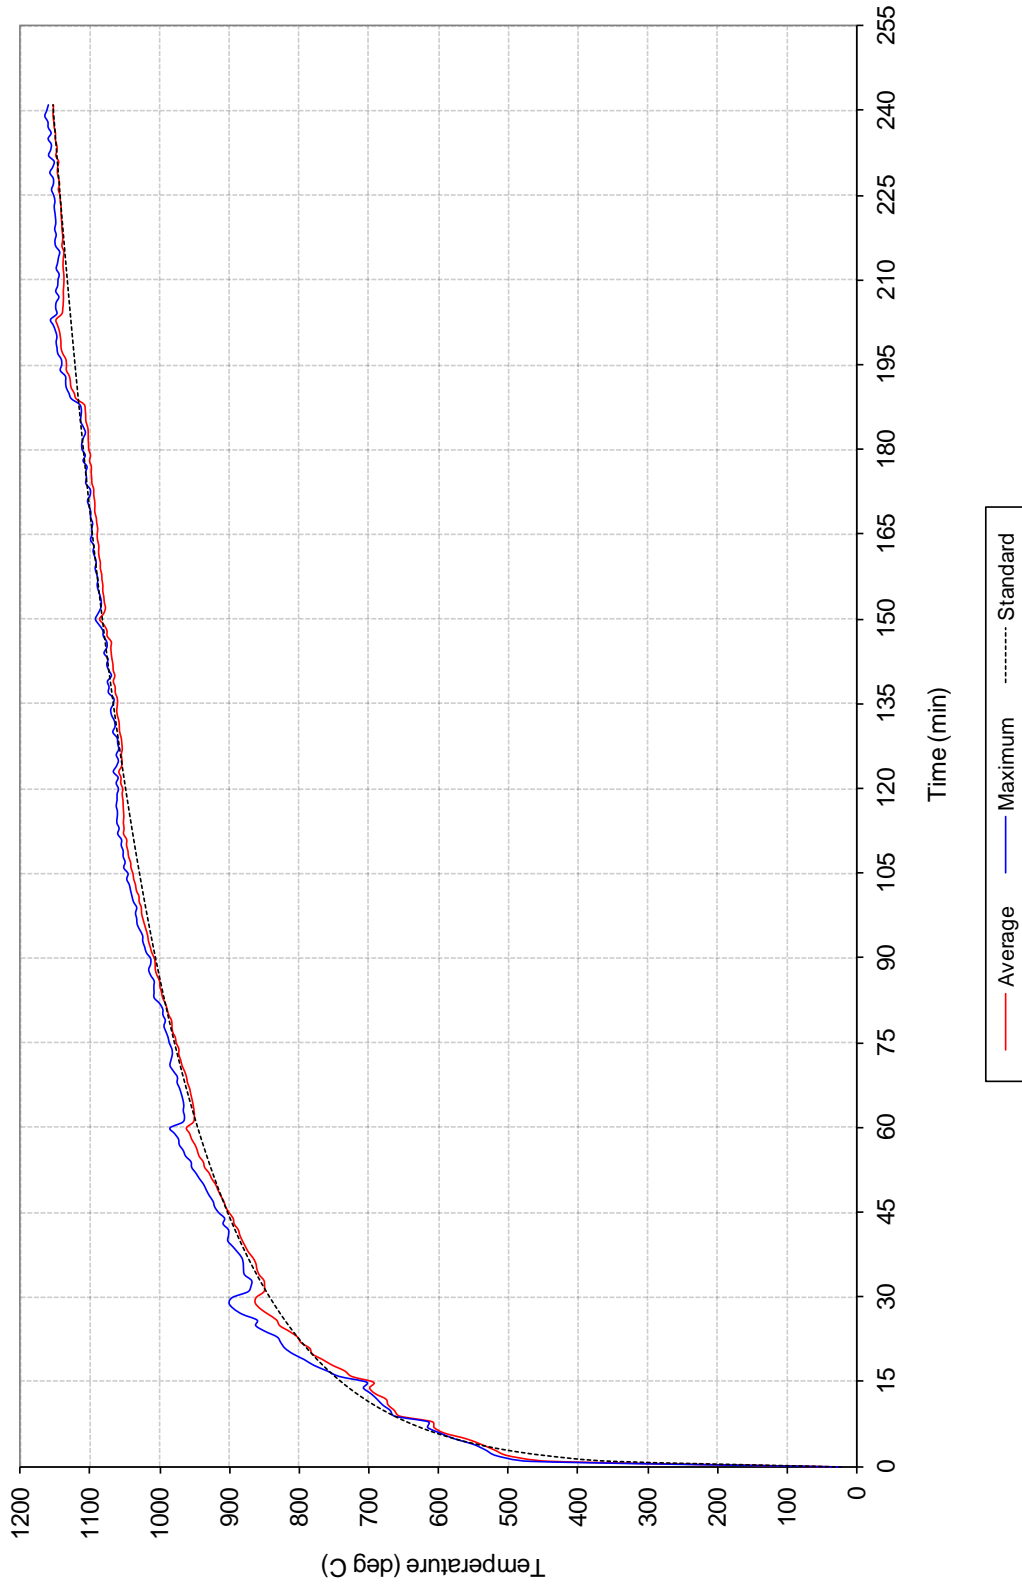
FIGURE 1 – FURNACE TEMPERATURE

The temperature in the furnace chamber was measured by four type K, 3-mm diameter, and 310 stainless steel Mineral Insulated Metal Sheathed (MIMS) thermocouples. Each thermocouple was housed in high-nickel steel tubes opened at the exposed end.

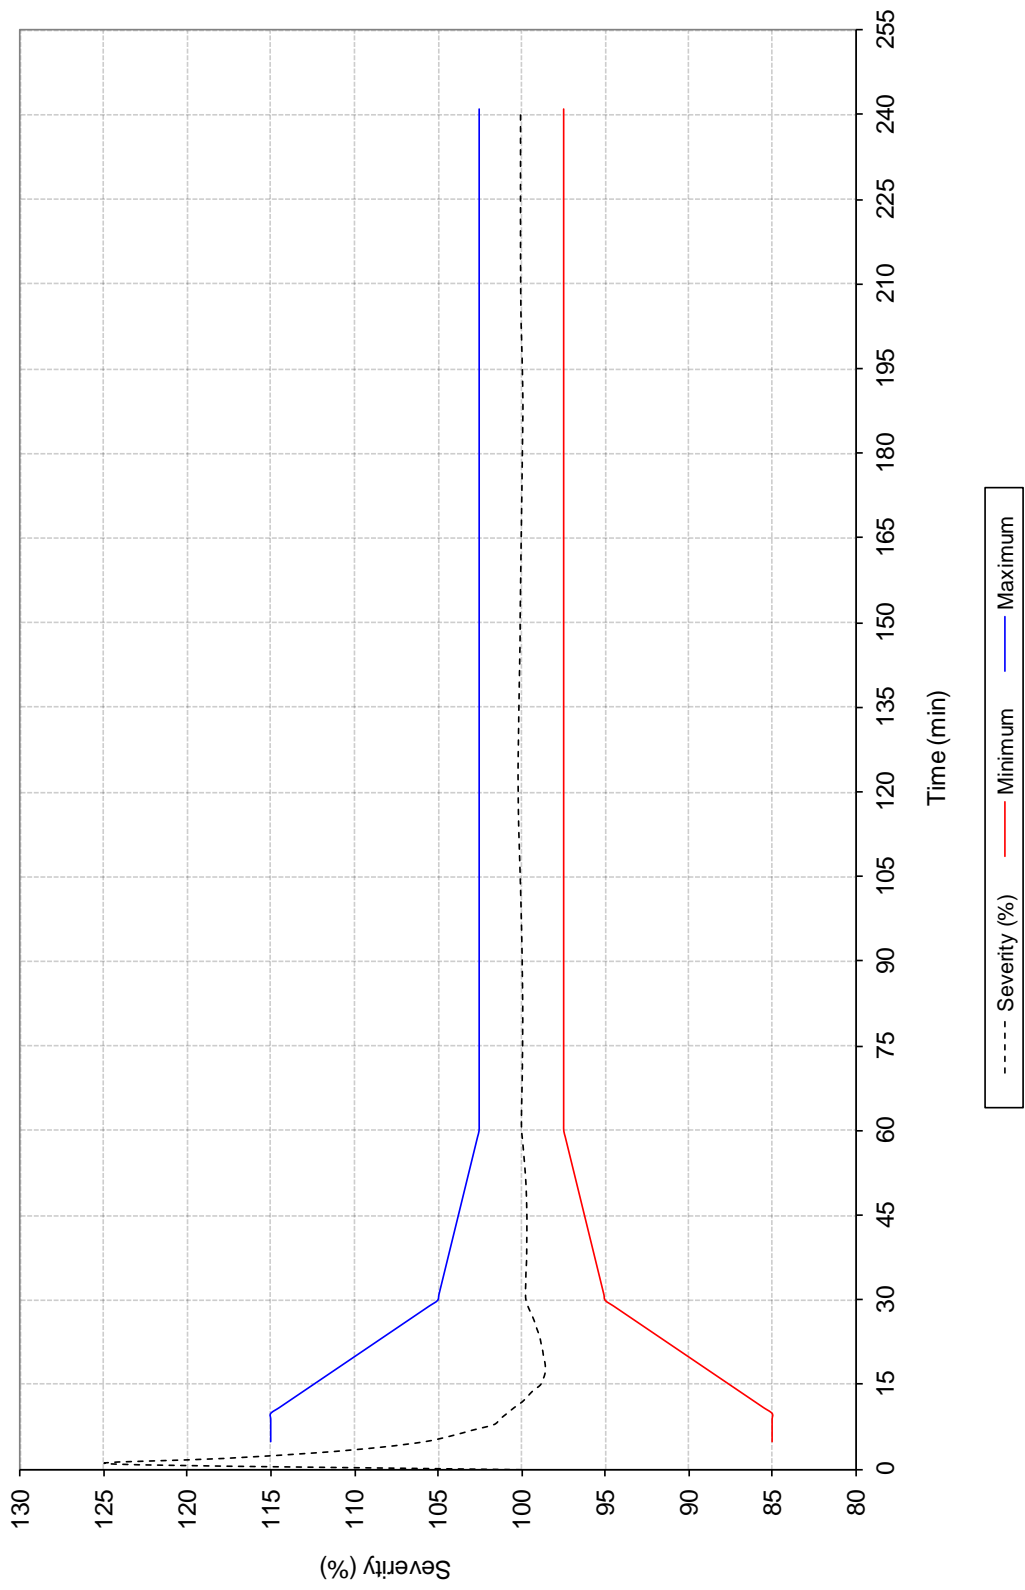
FIGURE 2 – FURNACE SEVERITY

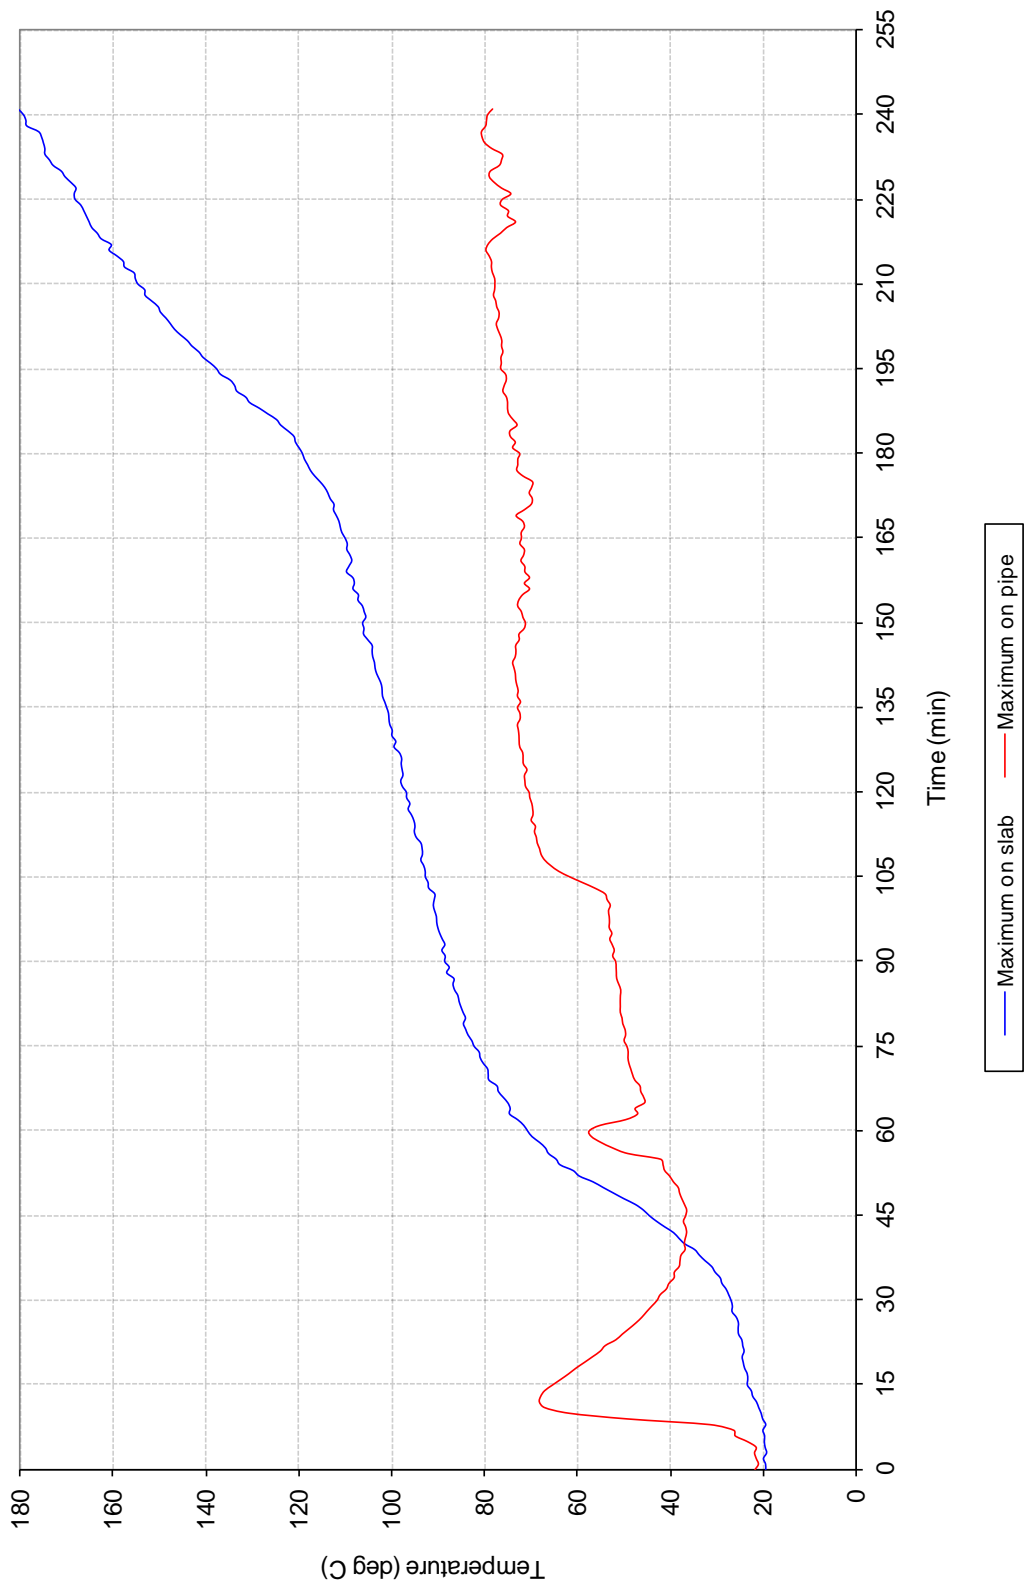
FIGURE 3 – SPECIMEN TEMPERATURE – ASSOCIATED WITH PENETRATION 1

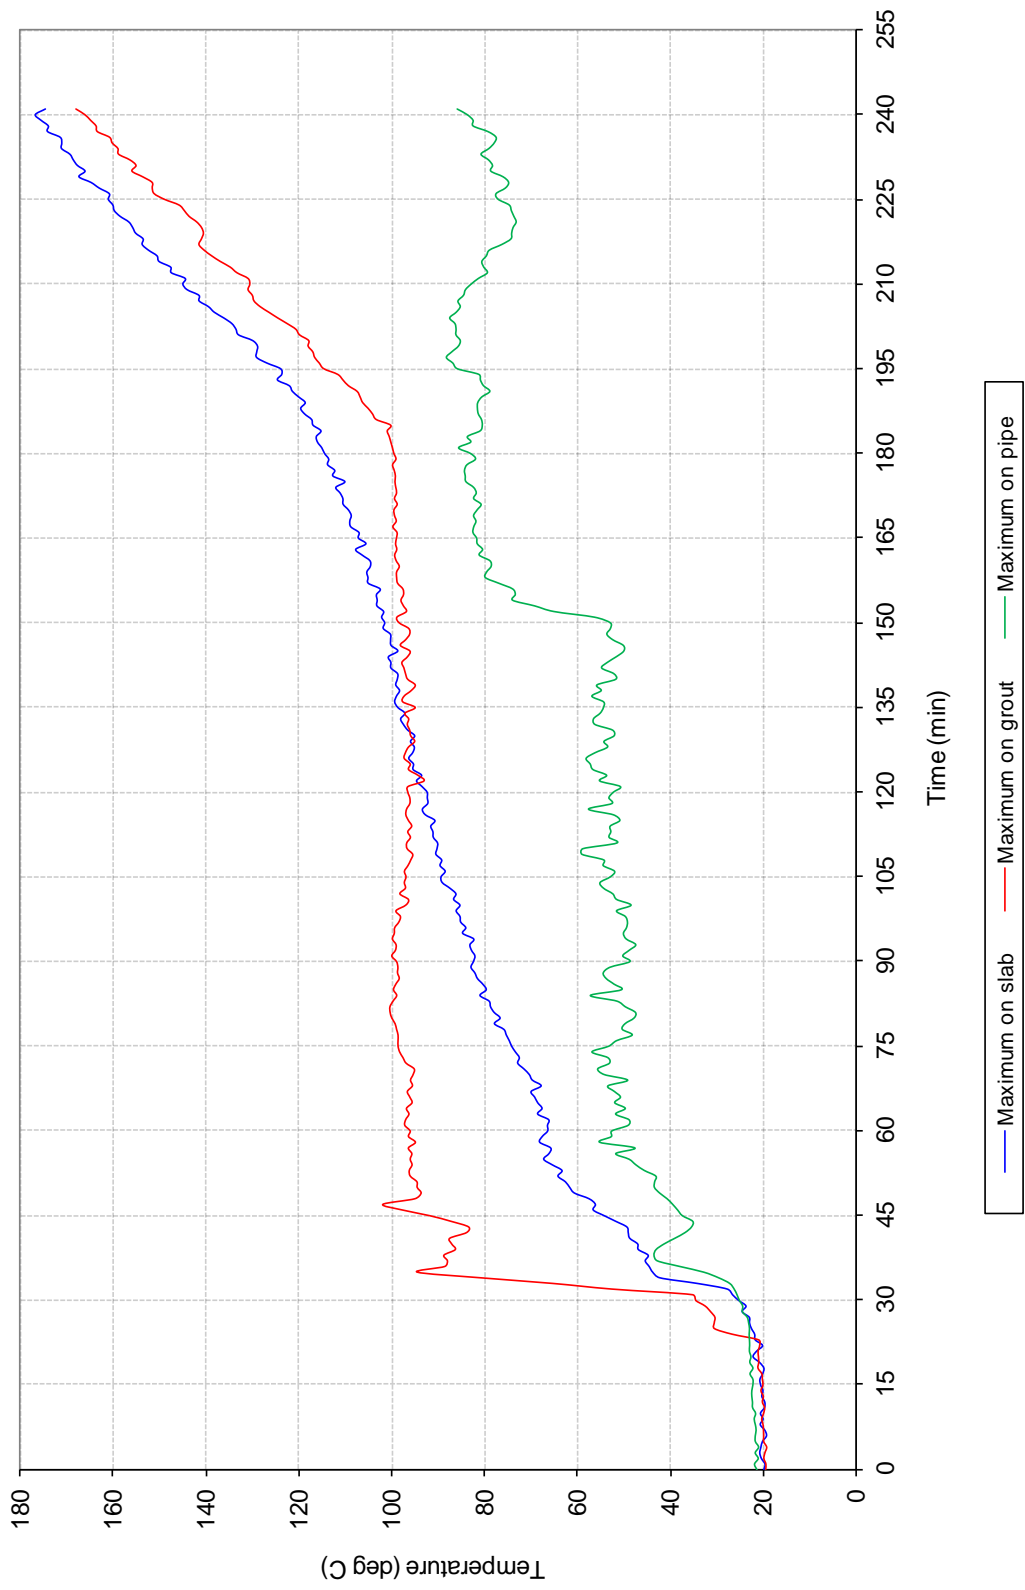
FIGURE 4 – SPECIMEN TEMPERATURE – ASSOCIATED WITH PENETRATION 2

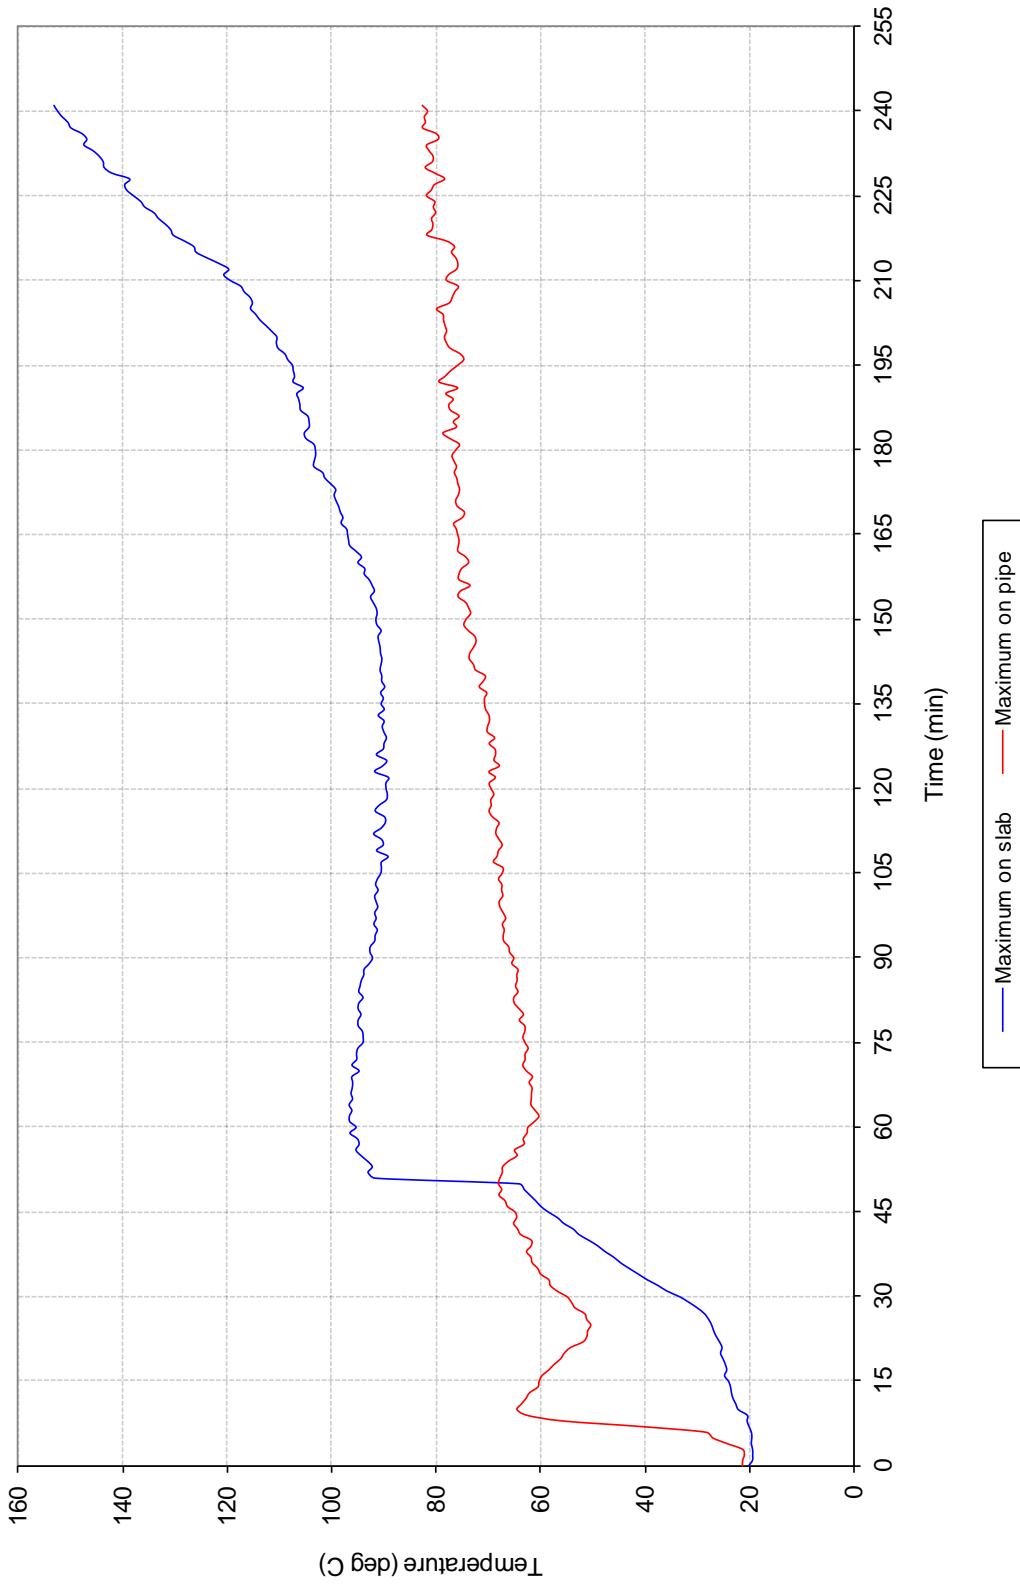
FIGURE 5 – SPECIMEN TEMPERATURE – ASSOCIATED WITH PENETRATION 3

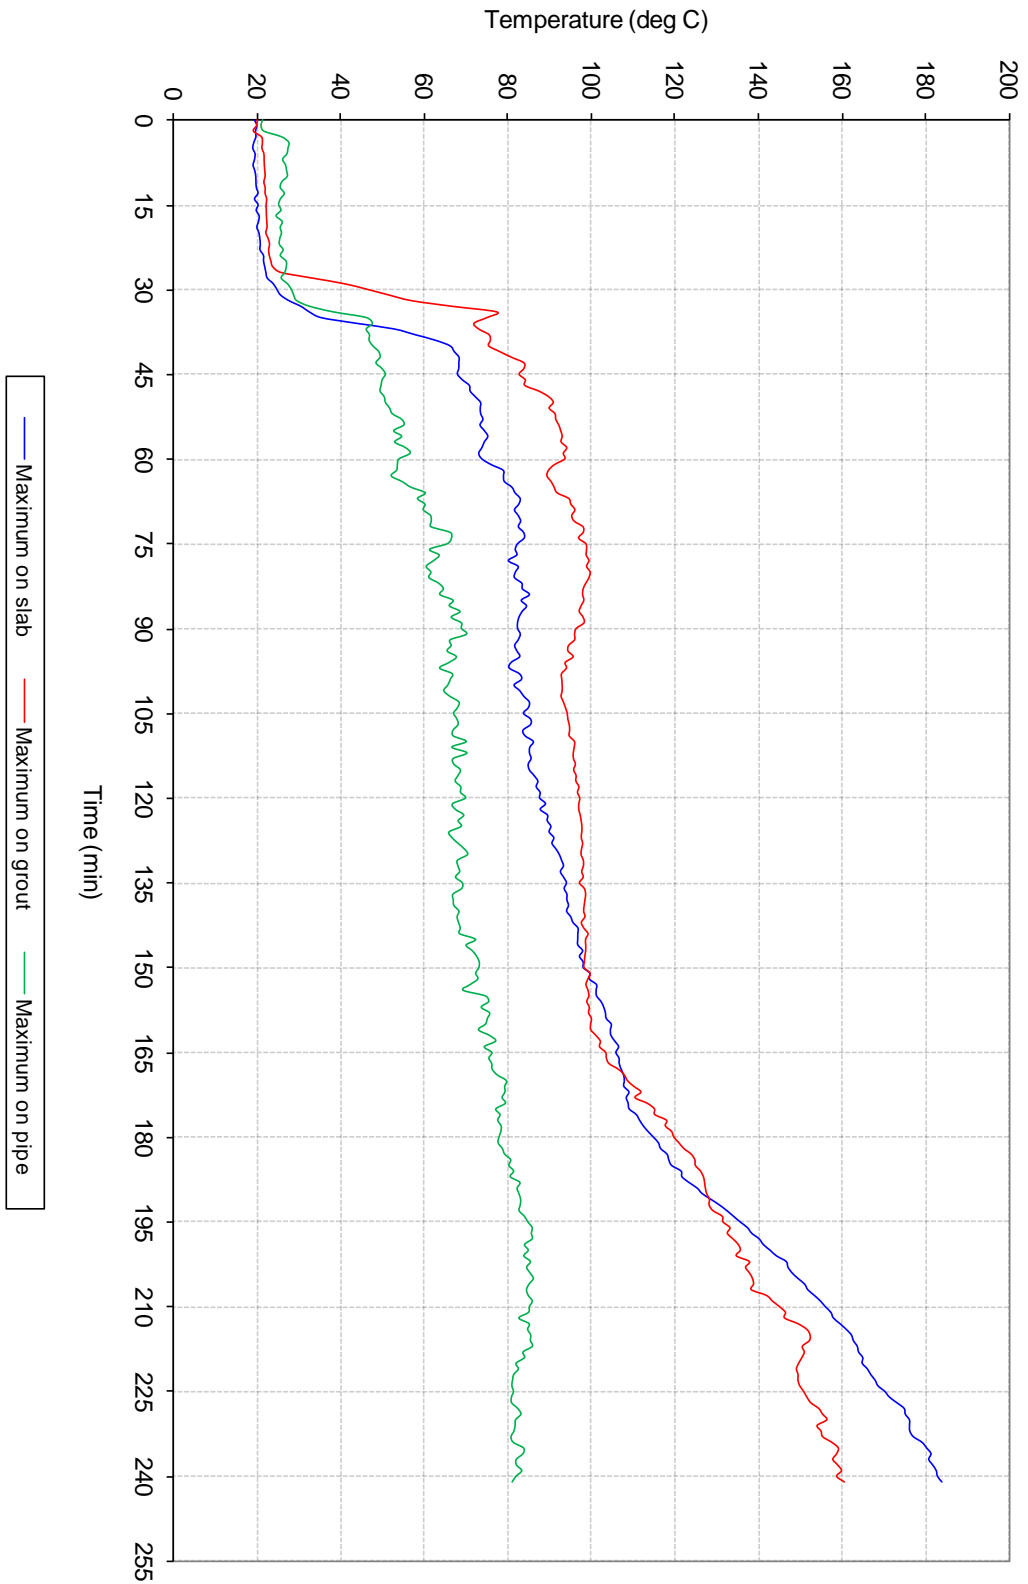
FIGURE 6 – SPECIMEN TEMPERATURE – ASSOCIATED WITH PENETRATION 4

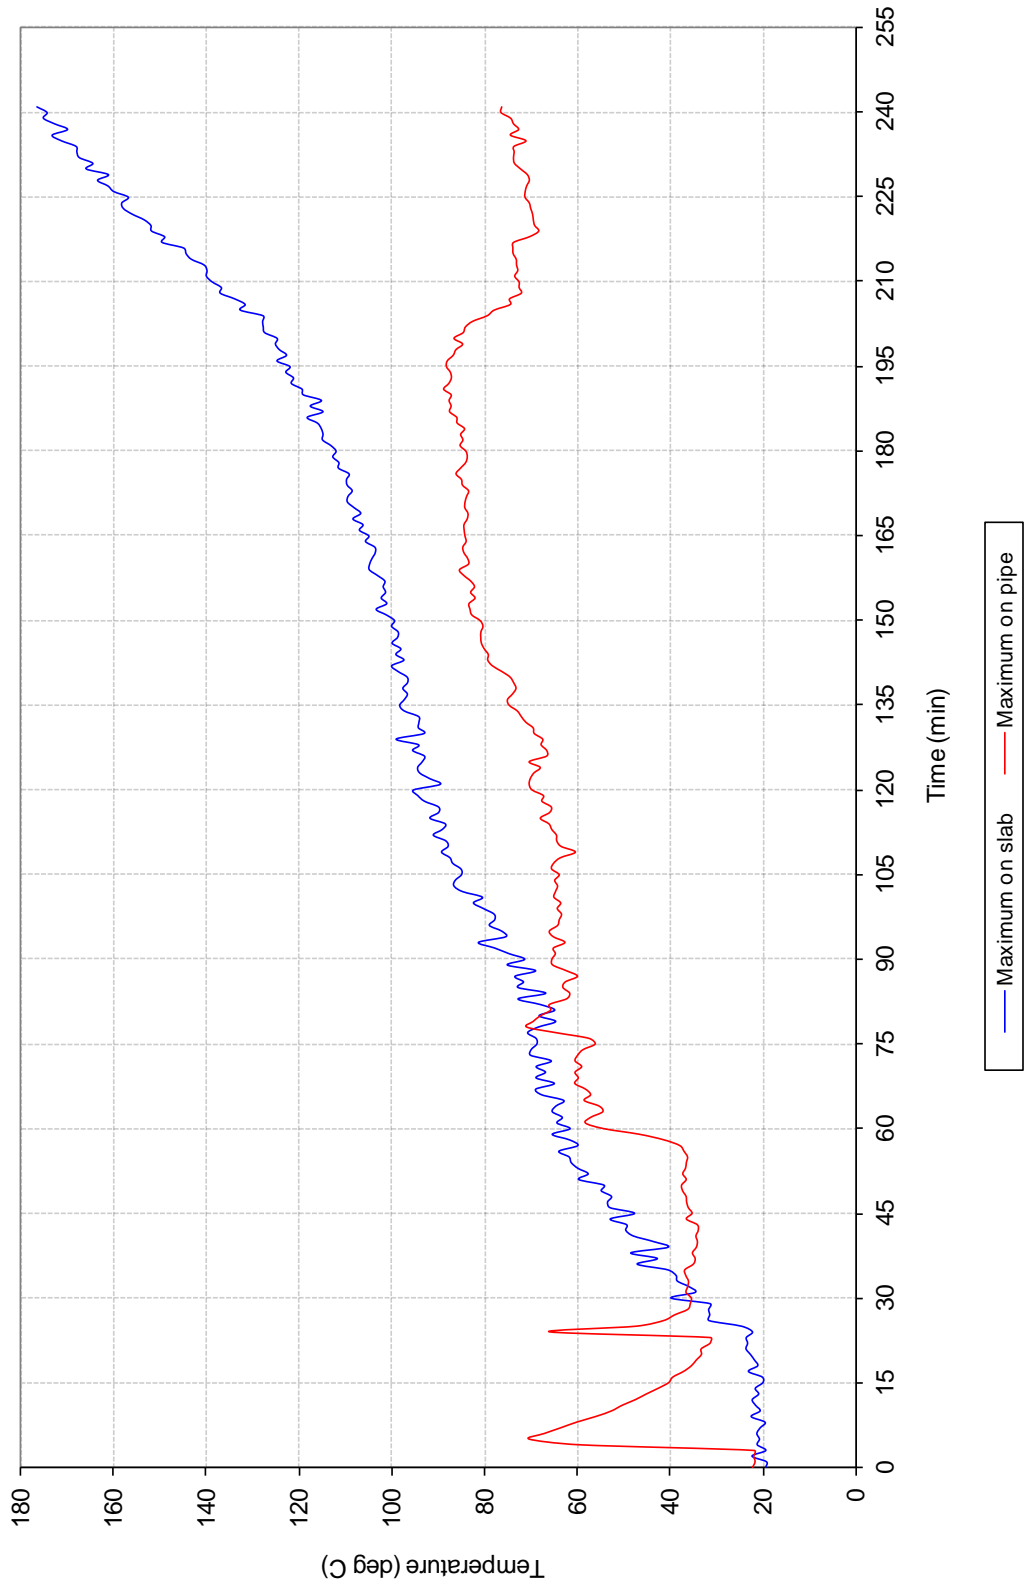
FIGURE 7 – SPECIMEN TEMPERATURE – ASSOCIATED WITH PENETRATION 5

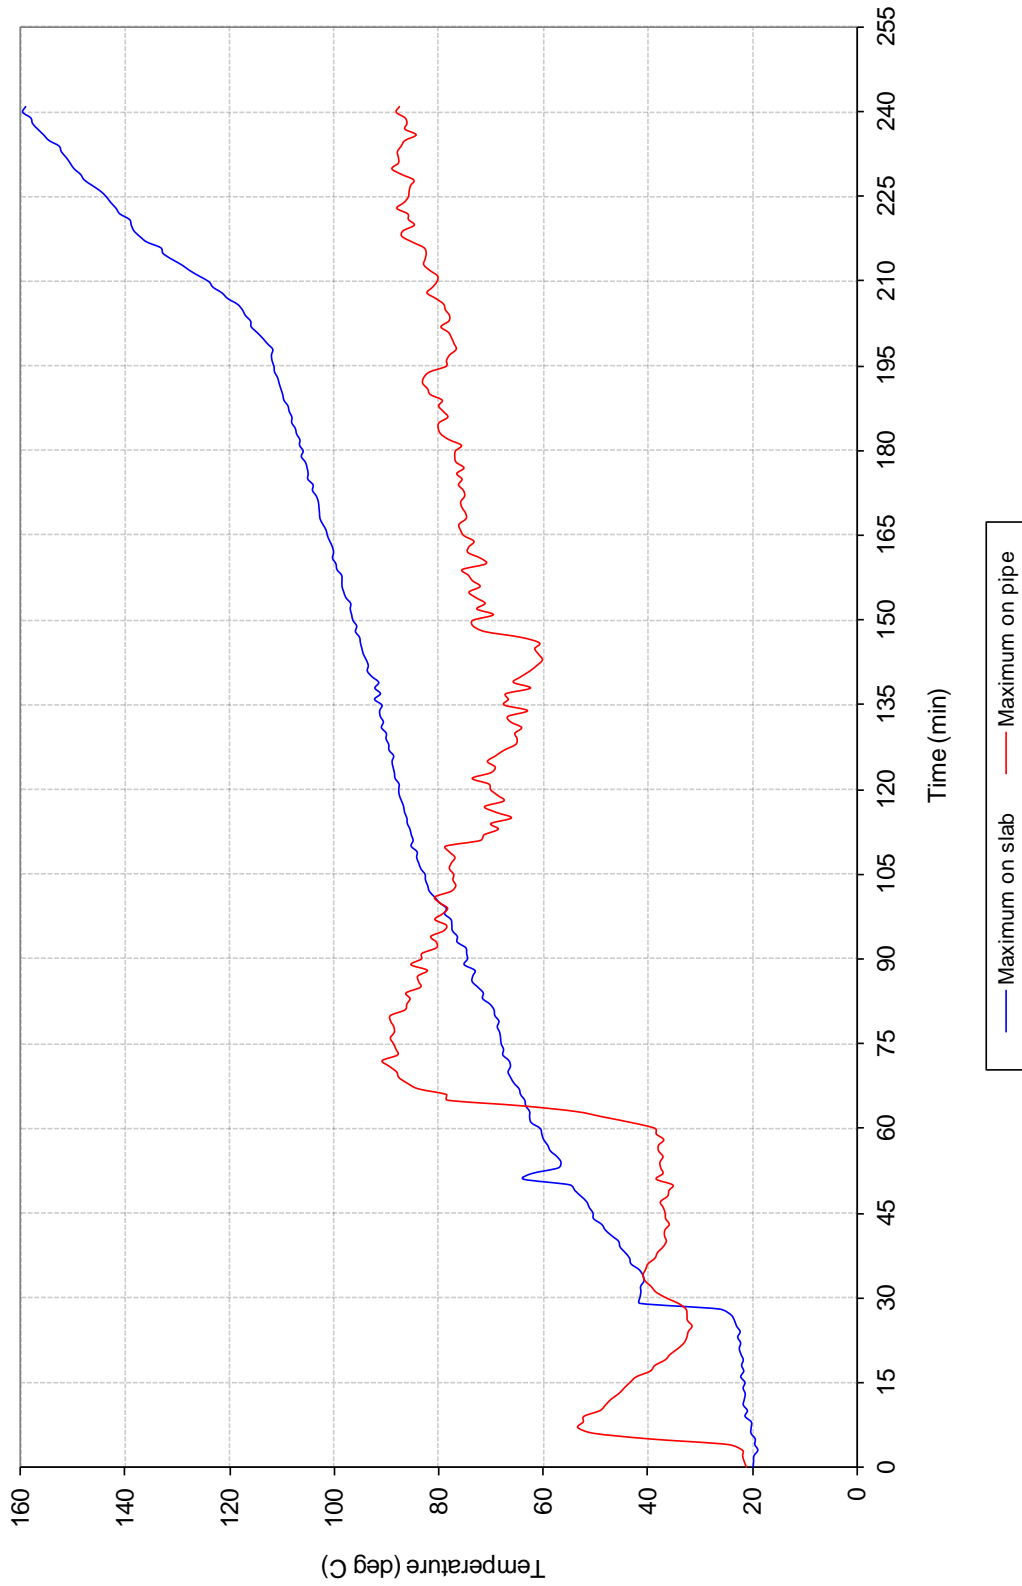
FIGURE 8 – SPECIMEN TEMPERATURE – ASSOCIATED WITH PENETRATION 6

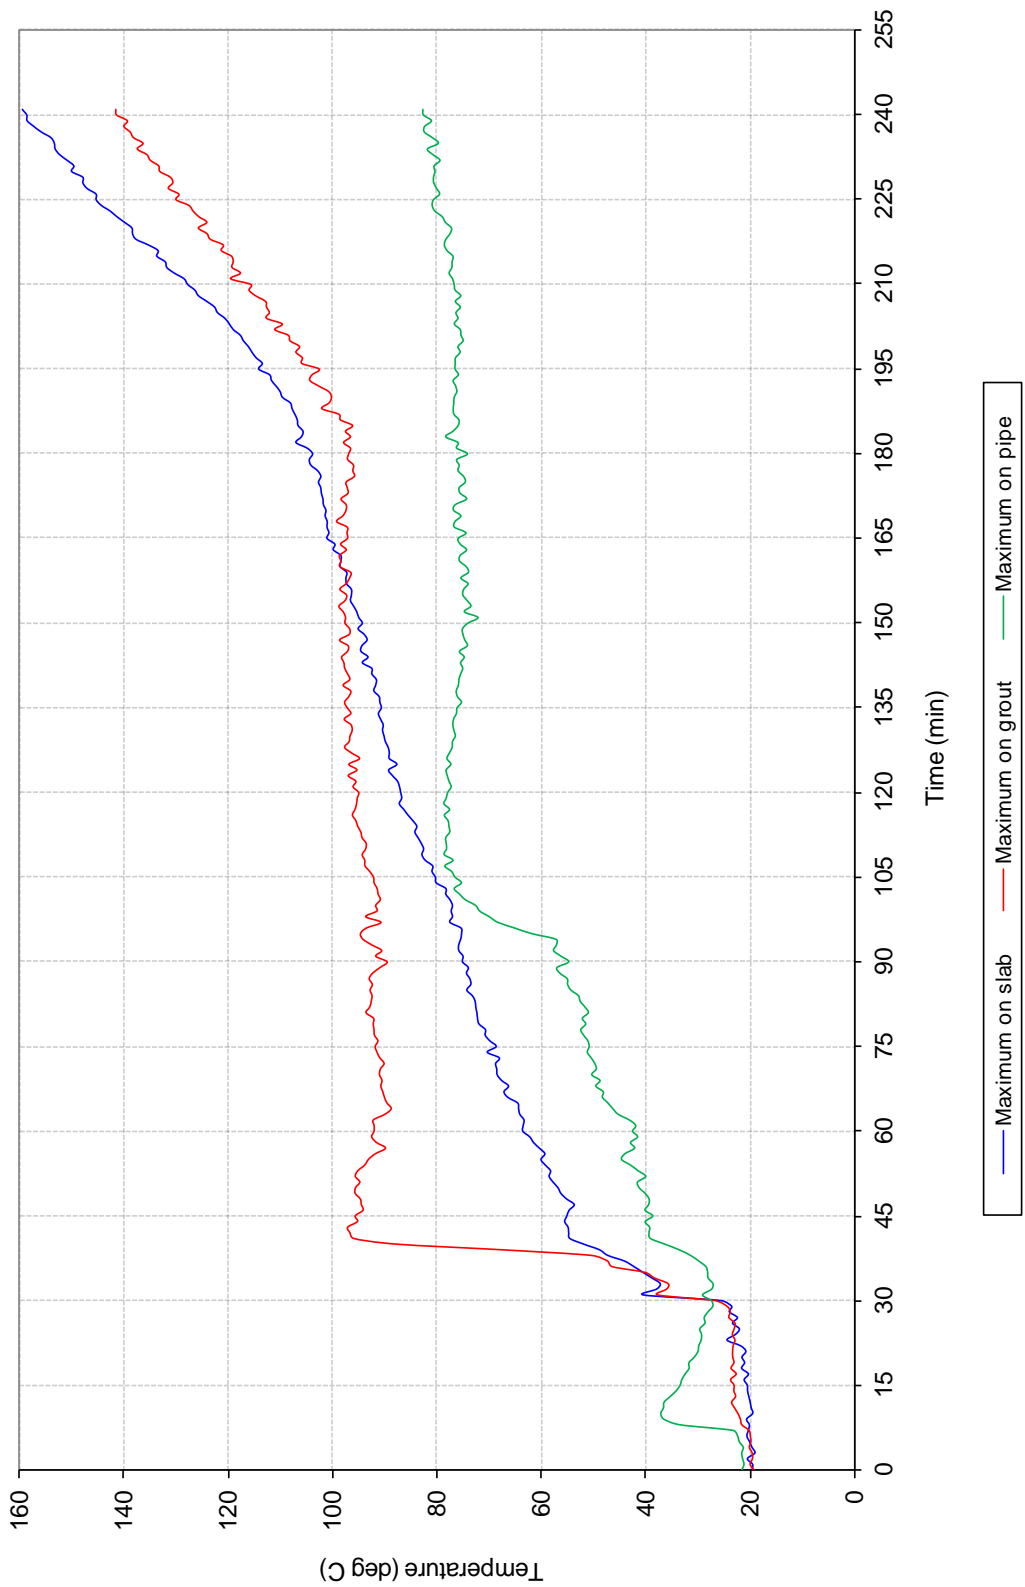
FIGURE 9 – SPECIMEN TEMPERATURE – ASSOCIATED WITH PENETRATION 7

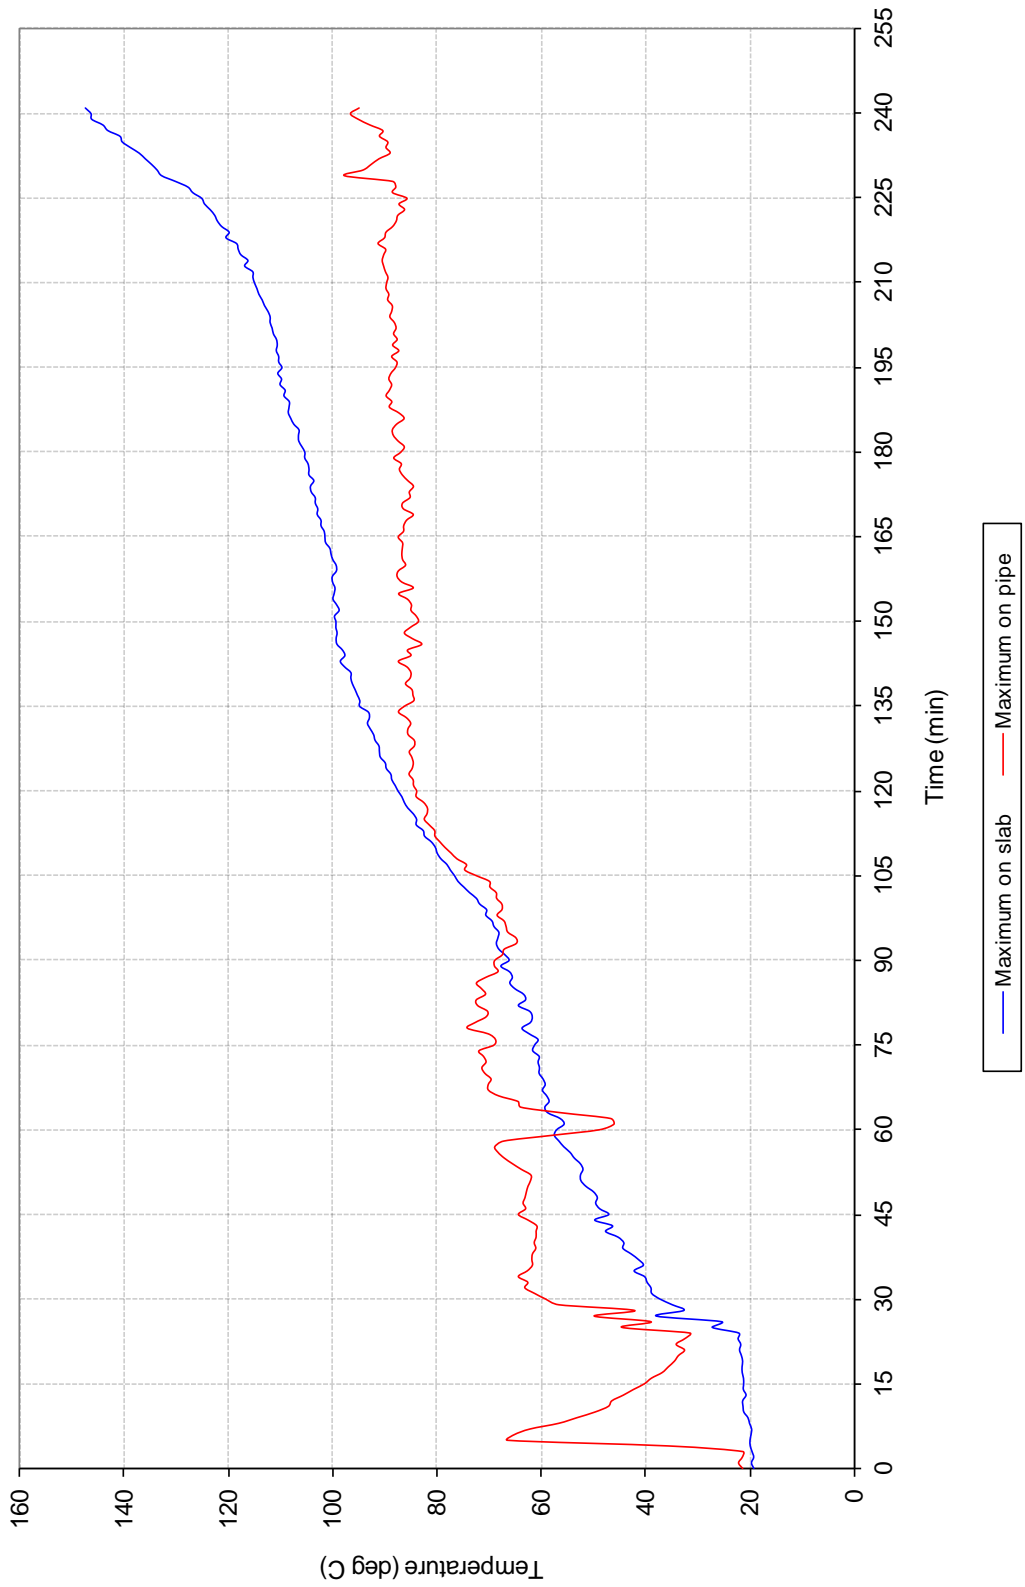
FIGURE 10 – SPECIMEN TEMPERATURE – ASSOCIATED WITH PENETRATION 8
