Fire-resistance test on fire collars protecting a concrete slab penetrated by services

Test Report

Author: Mario Lara-Ledermann
Report number: FSP 1657
Date: 24 November 2014

Sponsored Investigation No. FSP 1657

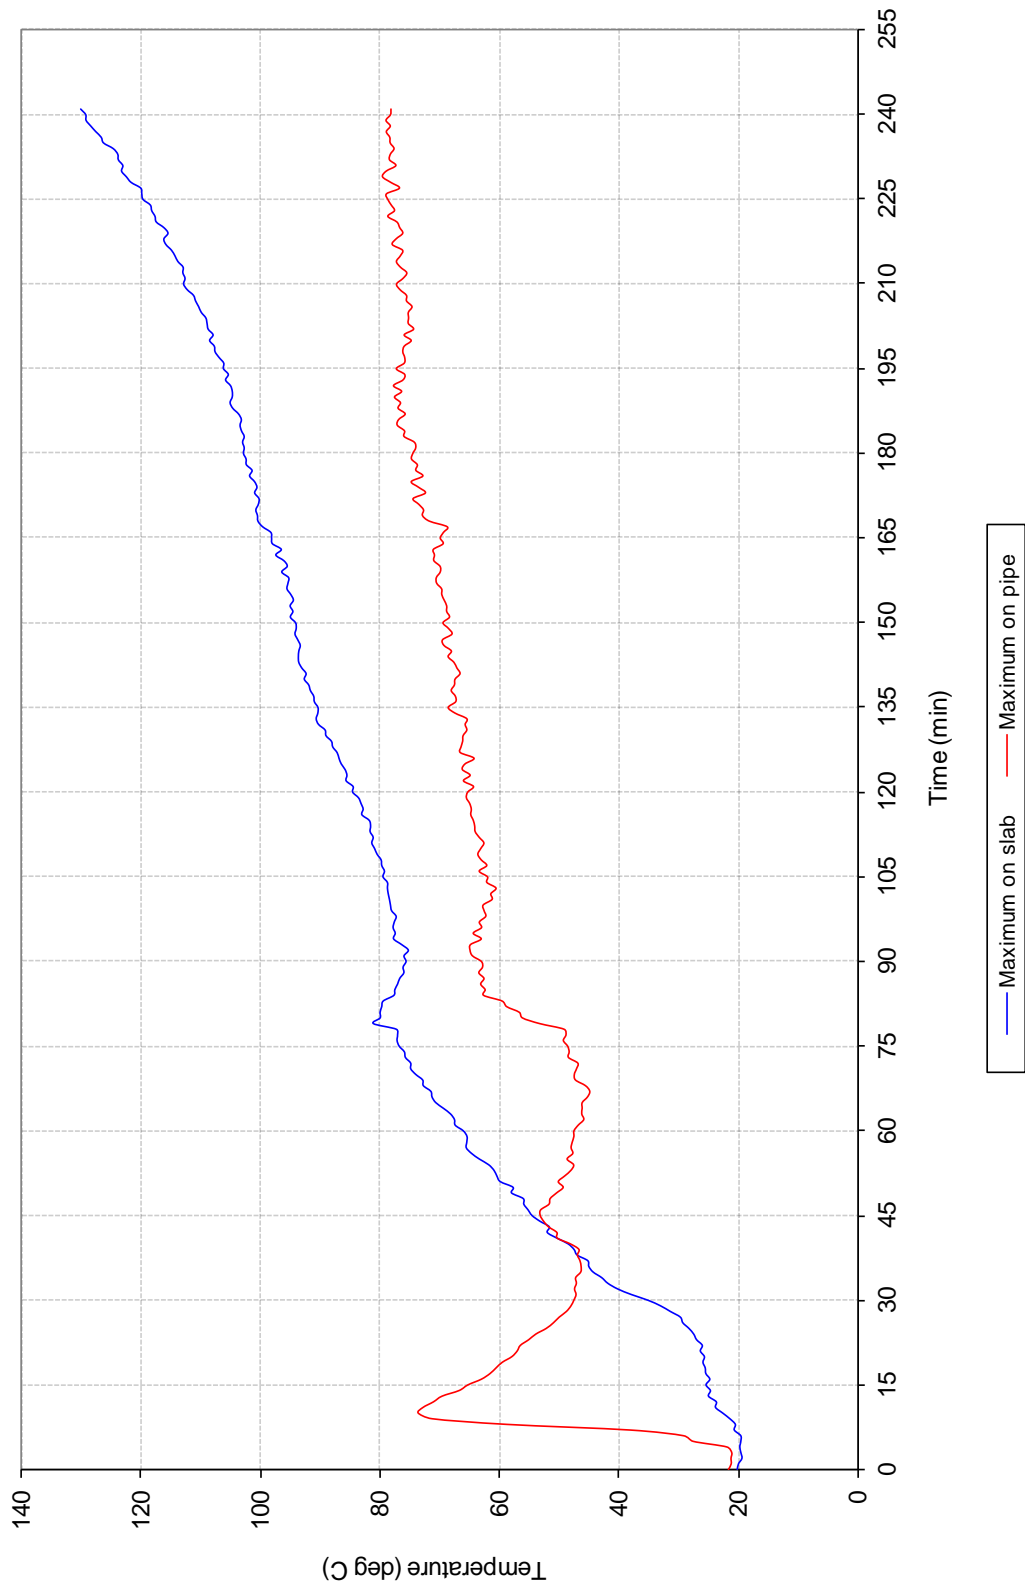
FIGURE 11 – SPECIMEN TEMPERATURE – ASSOCIATED WITH PENETRATION 9

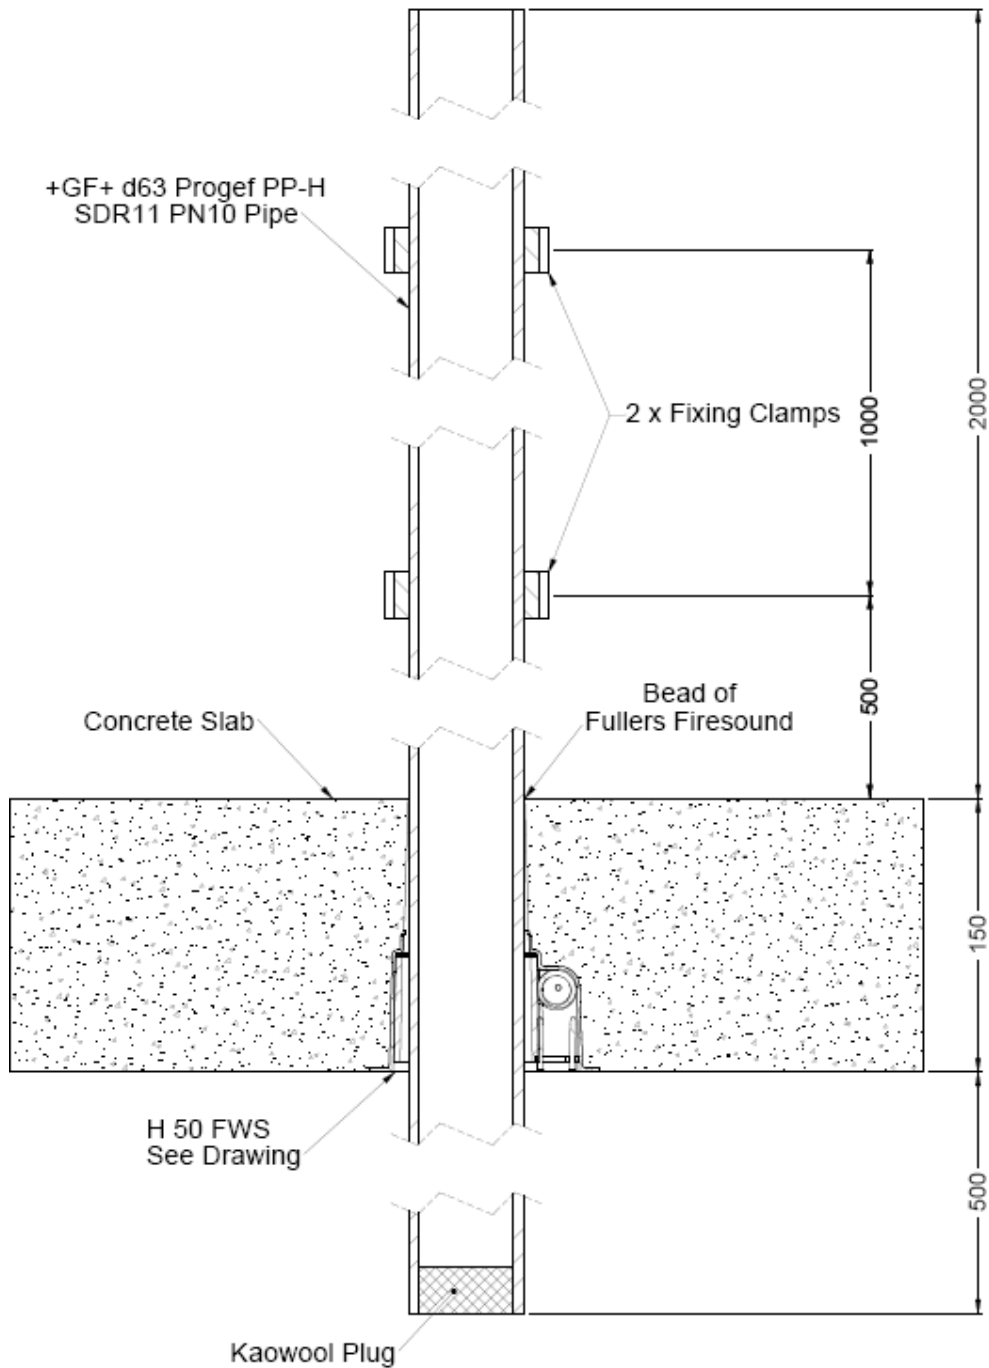
Penetration #1
PP-H (63mm ϕ) Stack - Date 10-06-2014

DRAWING NUMBERED PENETRATION #1 – PP-H (63-MM OD) STACK” DATED 10 JUNE 2014, BY SNAP FIRE SYSTEMS PTY LTD

Penetration 1 – H 50 FWS cast in fire collar protecting a 63-mm diameter +GF+ Georg Fischer Progef Polypropylene PP-H stack pipe

The SNAP cast-in H 50 FWS fire collar comprised a 1.6-mm thick polypropylene casing with a 70.5-mm inner diameter and a 146-mm diameter base flange. The 75-mm high collar casing incorporated a 240-mm x 58-mm x 4-mm thick Intumesh intumescent material and a rubber ring seal. The closing mechanism incorporated three stainless steel springs, with nylon fuse links and a 280-mm x 58-mm stainless steel mesh as shown in drawing numbered H 50 FWS-T dated 26 September 2014, by SNAP Fire Systems.

The penetrating service comprised a 63-mm OD PP-H pipe, with a wall thickness of 6.2-mm fitted through the collar's sleeve. The pipe projected vertically 2000-mm above the concrete and 500-mm into the furnace chamber. The pipe was supported at 500-mm and 1000-mm from the unexposed face of the concrete slab as shown in drawing titled "Penetration #1 – PP-H (63-mm OD) Stack" dated 10 June 2014, by Snap Fire Systems Pty Ltd. On the exposed end, the pipe was capped with a Kaowool plug.

On the unexposed face, the annular gap between the pipe and the slab was sealed with a bead of Fullers Firesound fire sealant.

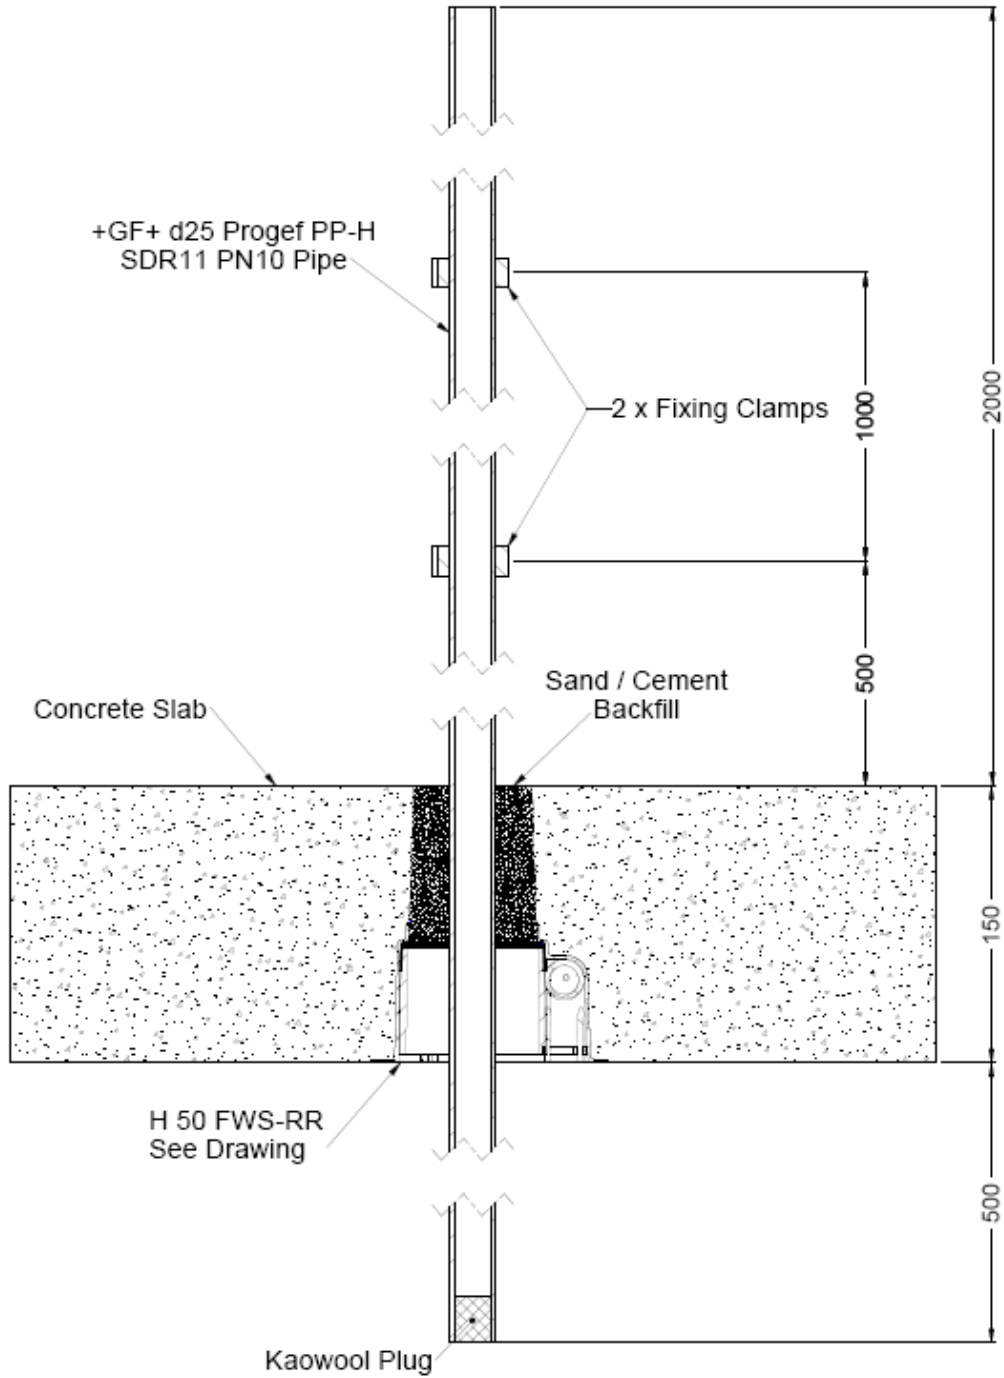
Penetration #2
PP-H (25mm ϕ) Stack - Date 10-06-2014

DRAWING NUMBERED PENETRATION #2 – PP-H (25-MM OD) STACK” DATED 10 JUNE 2014, BY SNAP FIRE SYSTEMS PTY LTD

Penetration 2 – H 50 FWS-RR cast-in fire collar protecting a 25-mm diameter +GF+ Georg Fischer Progef Polypropylene PP-H stack pipe

The SNAP cast-in H 50 FWS-RR fire collar comprised a 1.6-mm thick polypropylene casing with a 70.5-mm inner diameter and a 146-mm diameter base flange. The 75-mm high collar casing incorporated a 240-mm x 58-mm x 4-mm thick Intumesh intumescent material. The closing mechanism incorporated three stainless steel springs, with nylon fuse links and a 280-mm x 58-mm stainless steel mesh as shown in drawing numbered H 50 FWS-RR-T dated 26 September 2014, by SNAP Fire Systems.

The penetrating service comprised a 25-mm OD PP-H pipe, with a wall thickness of 2.7-mm fitted through the collar's sleeve. The pipe projected vertically 2000-mm above the concrete and 500-mm into the furnace chamber. The pipe was supported at 500-mm and 1000-mm from the unexposed face of the concrete slab as shown in drawing titled "Penetration #2 – PP-H (25-mm OD) Stack" dated 10 June 2014, by Snap Fire Systems Pty Ltd. On the exposed end, the pipe was capped with a Kaowool plug.

The annular gap between the pipe and the slab was backfilled with sand and cement compound.

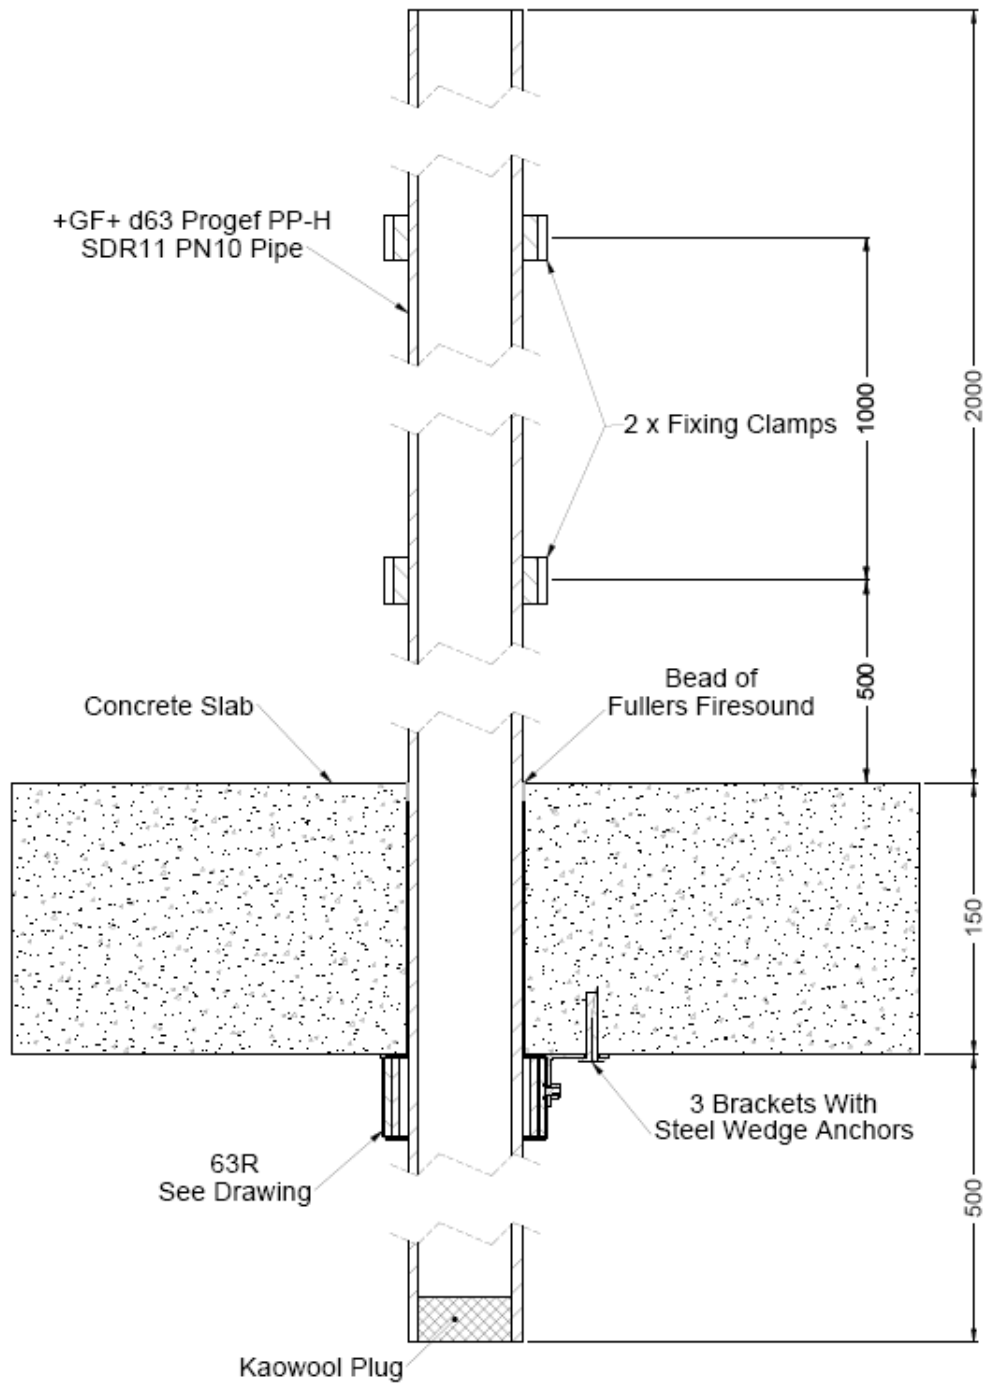
Penetration #3
PP-H (63mm ϕ) Stack - Date 10-06-2014

DRAWING NUMBERED PENETRATION #3 – PP-H (63-MM OD) STACK” DATED 10 JUNE 2014, BY SNAP FIRE SYSTEMS PTY LTD

Penetration 3 – 63 R retrofitted fire collar protecting a 63-mm diameter +GF+ Georg Fischer Progef Polypropylene PP-H stack pipe

The SNAP Retrofit 63 R fire collar comprised a 0.75-mm steel casing with a 72-mm inner diameter and three fixing brackets clipped onto the collar casing. The 47-mm high collar casing incorporated 230-mm x 43-mm x 4-mm thick Intumesh intumescent material and a 240-mm x 42-mm stainless steel mesh as shown in drawing numbered 63 R-T dated 4 November 2013, by SNAP Fire Systems. The collar was fixed to the underside of the slab with 3 brackets with Steel Wedge Anchors.

The penetrating service comprised a 63-mm OD PP-H pipe, with a wall thickness of 6.2-mm fitted through the collar's sleeve. The pipe projected vertically, 2000-mm above the concrete slab. The pipe was supported at 500-mm and 1000-mm from the unexposed face of the concrete slab as shown in drawing titled "Penetration #3 – PP-H (63-mm OD) Stack" dated 10 June 2014, by Snap Fire Systems Pty Ltd. On the exposed end, the pipe was capped with a Kaowool Plug.

On the unexposed face, the annular gap between the pipe and the slab was sealed with a bead of Fullers Firesound fire sealant.

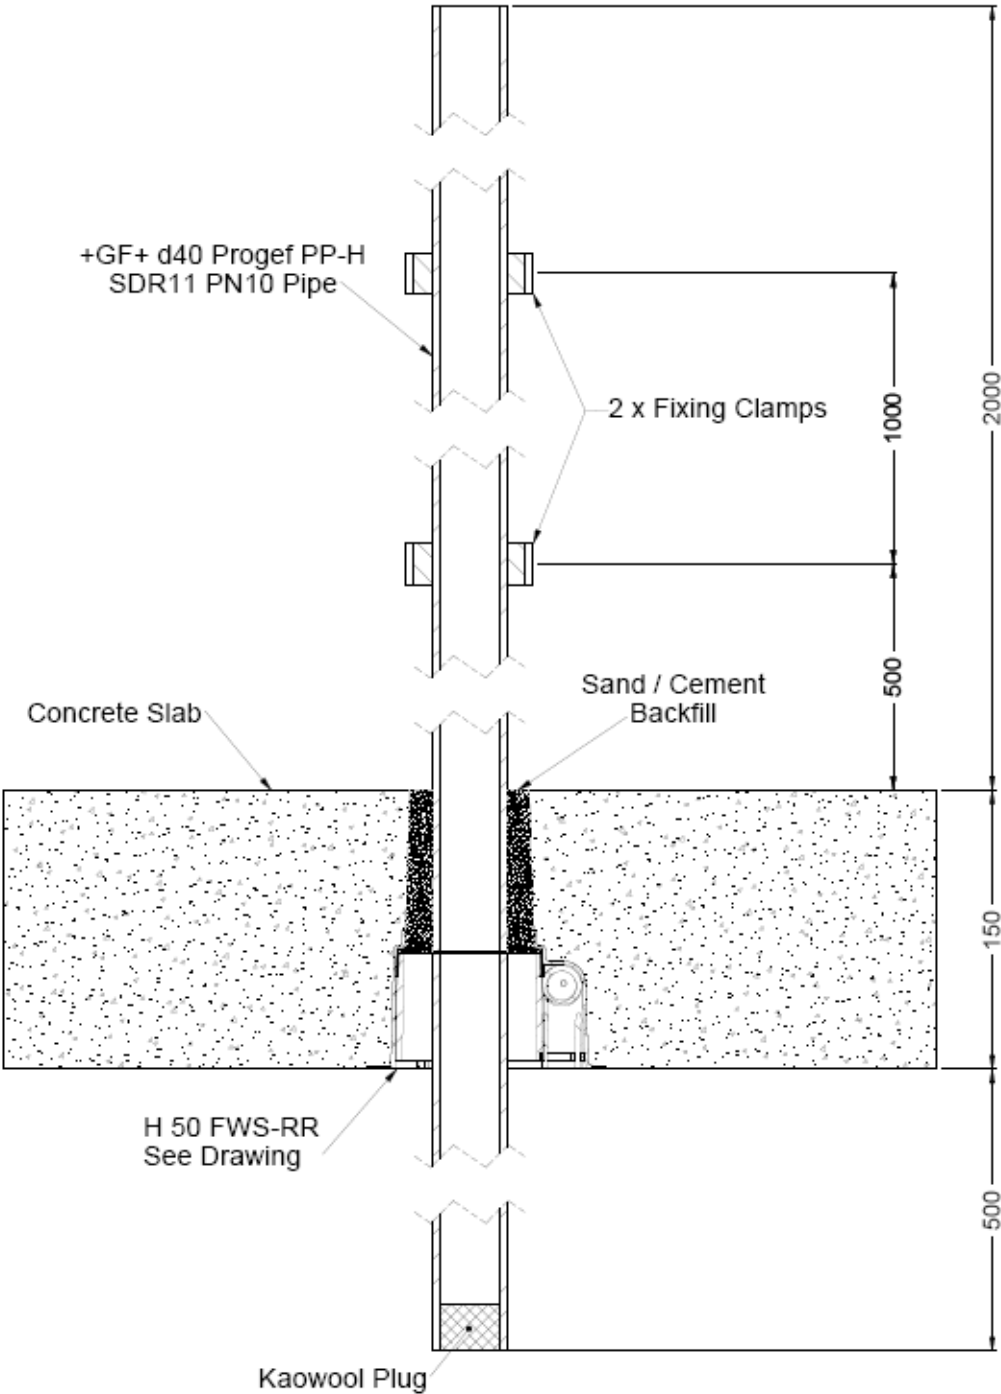
Penetration #4
PP-H (40mm ϕ) Stack - Date 10-06-2014

DRAWING NUMBERED PENETRATION #4 – PP-H (40-MM OD) STACK” DATED 10 JUNE 2014, BY SNAP FIRE SYSTEMS PTY LTD

Penetration 4 – H 50 FWS-RR cast-in fire collar protecting a 40-mm diameter +GF+ Georg Fischer Progef Polypropylene PP-H stack pipe

The SNAP cast-in H 50 FWS-RR fire collar comprised a 1.6-mm thick polypropylene casing with a 70.5-mm inner diameter and a 146-mm diameter base flange. The 75-mm high collar casing incorporated a 240-mm x 58-mm x 4-mm thick Intumesh intumescent material. The closing mechanism comprised three stainless steel springs, with nylon fuse links and a 280-mm x 58-mm stainless steel mesh as shown in drawing numbered H 50 FWS-RR-T dated 26 September 2014, by SNAP Fire Systems.

The penetrating service comprised a 40-mm OD PP-H pipe, with a wall thickness of 4.8-mm fitted through the collar's sleeve. The pipe projected vertically, 2000-mm above the concrete slab. The pipe was supported at 500-mm and 1000-mm from the unexposed face of the concrete slab as shown in drawing titled "Penetration #4 – PP-H (40-mm OD) Stack" dated 10 June 2014, by Snap Fire Systems Pty Ltd. On the exposed end, the pipe was capped with a Kaowool Plug.

The annular gap between the pipe and the slab was backfilled with sand and cement compound.

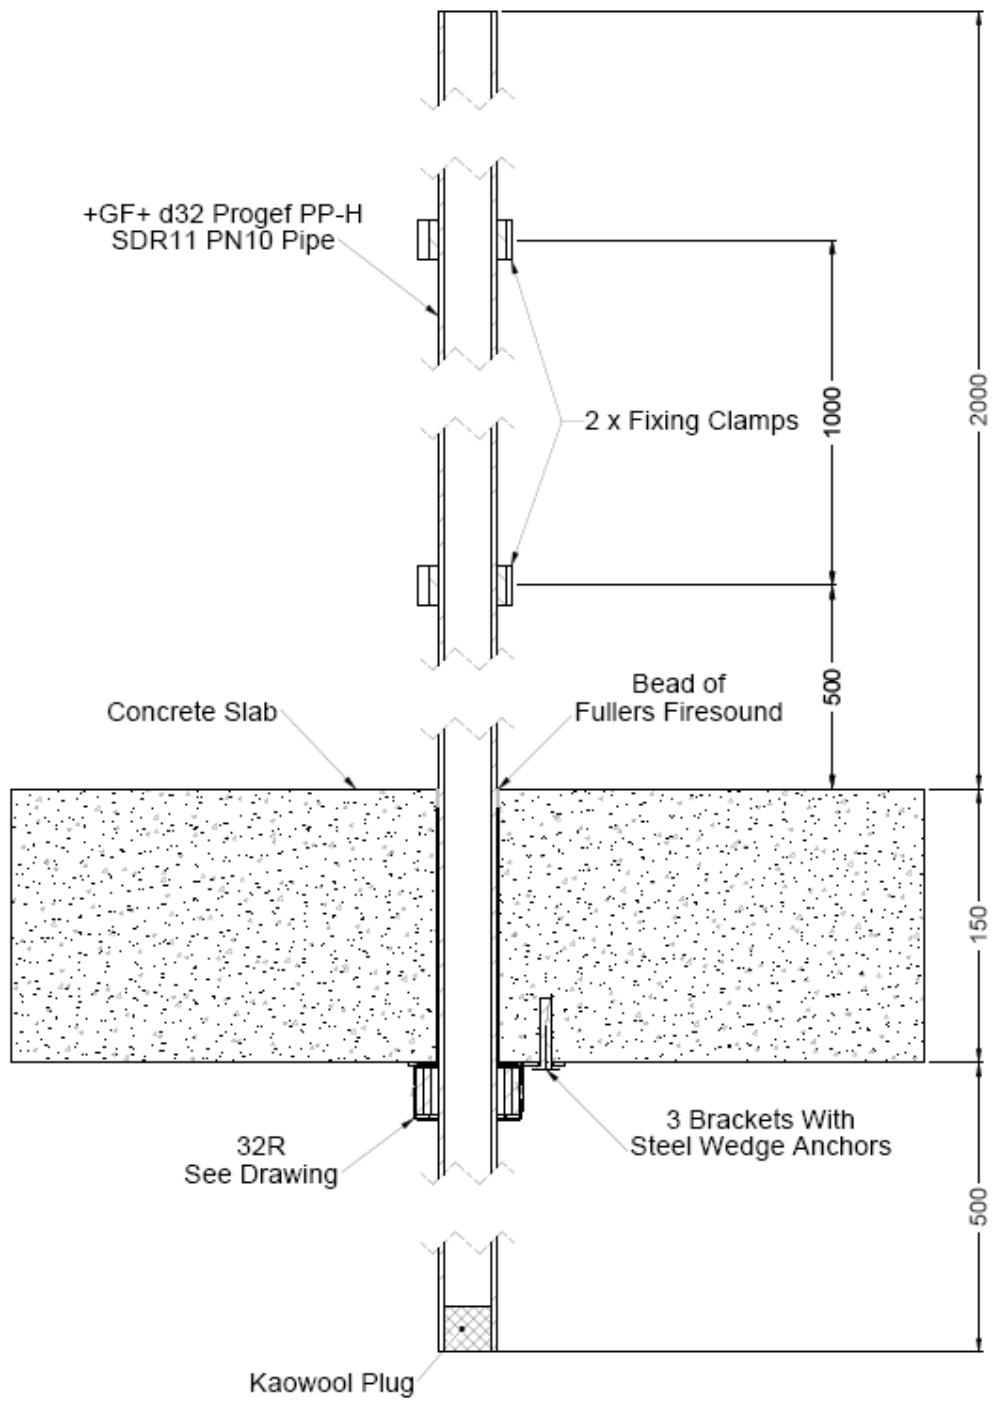
Penetration #5
PP-H (32mm ϕ) Stack - Date 10-06-2014

DRAWING NUMBERED PENETRATION #5 – PP-H (32-MM OD) STACK” DATED 10 JUNE 2014, BY SNAP FIRE SYSTEMS PTY LTD

Penetration 5 – 32 R retrofitted fire collar protecting a 32-mm diameter +GF+ Georg Fischer Progef Polypropylene PP-H stack pipe

The SNAP Retrofit 32 R fire collar comprised a 0.75-mm steel casing with a 40-mm inner diameter and three fixing brackets clipped onto the collar casing. The 32-mm high collar casing incorporated 135-mm x 26-mm x 4-mm thick Intumesh intumescent material and a 135-mm x 25-mm stainless steel mesh as shown in drawing numbered 32 R-T dated 2 July 2014, by SNAP Fire Systems. The collar was fixed to the underside of the slab with 3 brackets with Steel Wedge Anchors.

The penetrating service comprised a 32-mm OD PP-H pipe, with a wall thickness of 3.8-mm fitted through the collar's sleeve. The pipe projected vertically, 2000-mm above the concrete slab. The pipe was supported at 500-mm and 1000-mm from the unexposed face of the concrete slab as shown in drawing titled "Penetration #5 – PP-H (32-mm OD) Stack" dated 10 June 2014, by Snap Fire Systems Pty Ltd. On the exposed end, the pipe was capped with a Kaowool Plug.

On the unexposed face, the annular gap between the pipe and the slab was sealed with a bead of Fullers Firesound fire sealant.

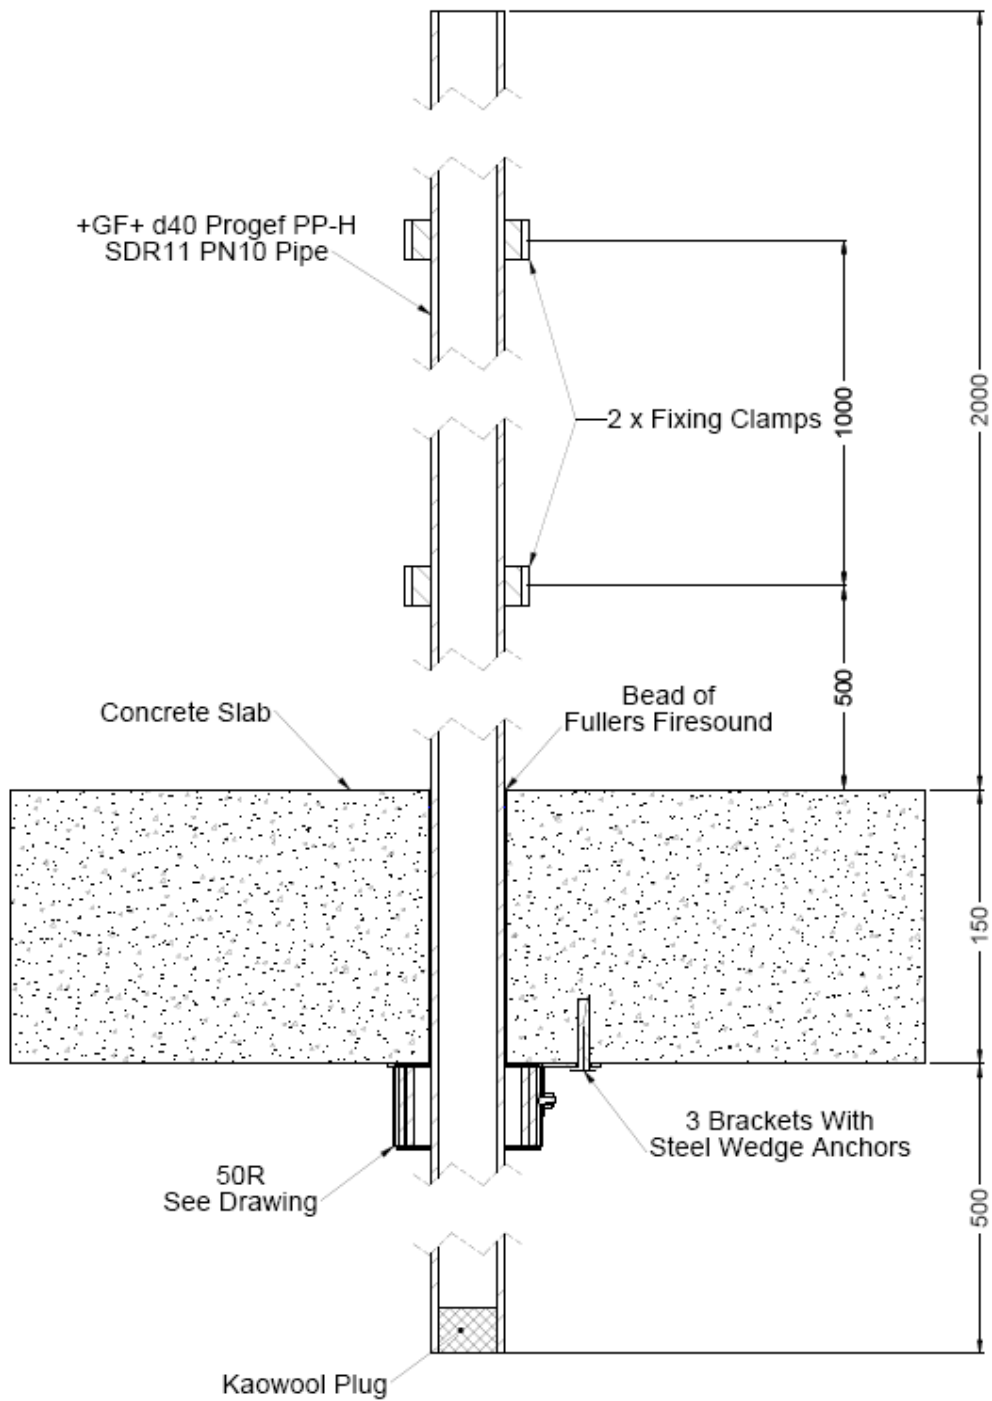
Penetration #6
PP-H (40mm ϕ) Stack - Date 10-06-2014

DRAWING NUMBERED PENETRATION #6 – PP-H (40-MM OD) STACK” DATED 10 JUNE 2014, BY SNAP FIRE SYSTEMS PTY LTD

Penetration 6 – 50 R retrofitted fire collar protecting a 40-mm diameter +GF+ Georg Fischer Progef Polypropylene PP-H stack pipe

The SNAP Retrofit 50 R fire collar comprised a 0.75-mm steel casing with a 62-mm inner diameter and three fixing brackets fixed onto the collar casing. The 47-mm high collar casing incorporated 200-mm x 43-mm x 4-mm thick Intumesh intumescent material and a 210-mm x 42-mm stainless steel mesh as shown in drawing numbered 50 R-T dated 4 November 2013, by SNAP Fire Systems. The collar was fixed to the underside of the slab with 3 brackets with Steel Wedge Anchors.

The penetrating service comprised a 40-mm OD PP-H pipe, with a wall thickness of 3.9-mm fitted through the collar's sleeve. The pipe projected vertically, 2000-mm above the concrete slab. The pipe was supported at 500-mm and 1000-mm from the unexposed face of the concrete slab as shown in drawing titled "Penetration #6 – PP-H (40-mm OD) Stack" dated 10 June 2014, by Snap Fire Systems Pty Ltd. On the exposed end, the pipe was capped with a Kaowool Plug.

On the unexposed face, the annular gap between the pipe and the slab was sealed with a bead of Fullers Firesound fire sealant.

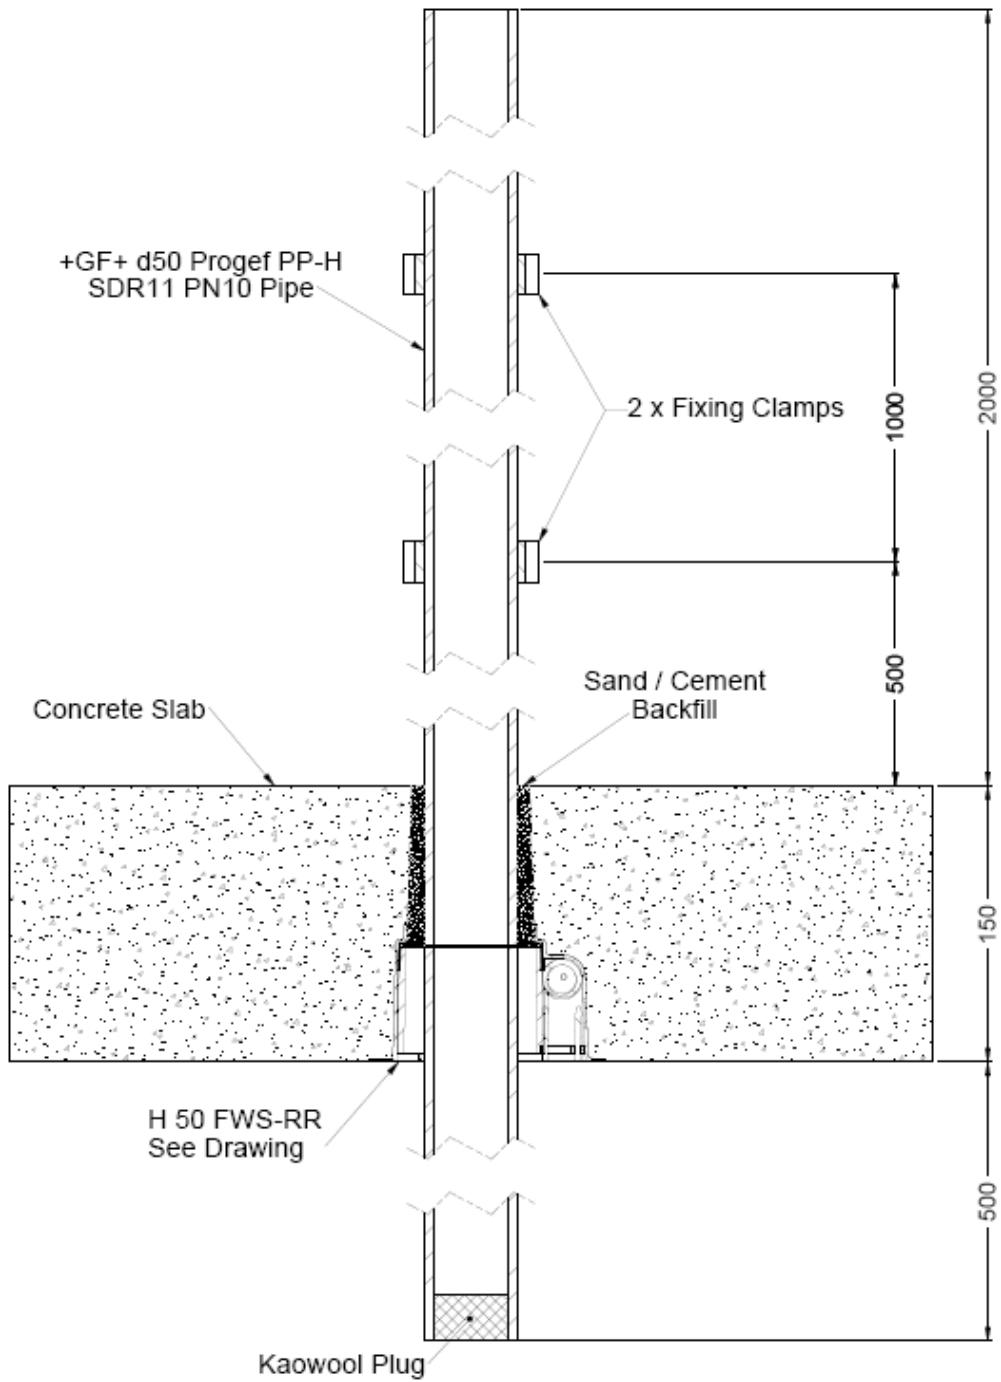
Penetration #7
PP-H (50mm \varnothing) Stack - Date 10-06-2014

DRAWING NUMBERED PENETRATION #7 – PP-H (50-MM OD) STACK” DATED 10 JUNE 2014, BY SNAP FIRE SYSTEMS PTY LTD

Penetration 7 – H 50 FWS-RR cast-in fire collar protecting a 50-mm diameter +GF+ Georg Fischer Progef Polypropylene PP-H stack pipe

The SNAP cast-in H 50 FWS-RR fire collar comprised a 1.6-mm thick polypropylene casing with a 70.5-mm inner diameter and a 146-mm diameter base flange. The 75-mm high collar casing incorporated a 240-mm x 58-mm x 4-mm thick Intumesh intumescent material. The closing mechanism comprised three stainless steel springs, with nylon fuse links and a 280-mm x 58-mm stainless steel mesh as shown in drawing numbered H 50 FWS-RR-T dated 26 September 2014, by SNAP Fire Systems.

The penetrating service comprised a 50-mm OD PP-H pipe, with a wall thickness of 5.1-mm fitted through the collar's sleeve. The pipe projected vertically, 2000-mm above the concrete slab. The pipe was supported at 500-mm and 1000-mm from the unexposed face of the concrete slab as shown in drawing titled "Penetration #7 – PP-H (50-mm OD) Stack" dated 10 June 2014, by Snap Fire Systems Pty Ltd. On the exposed end, the pipe was capped with a Kaowool Plug.

The annular gap between the pipe and the slab was backfilled with sand and cement compound.

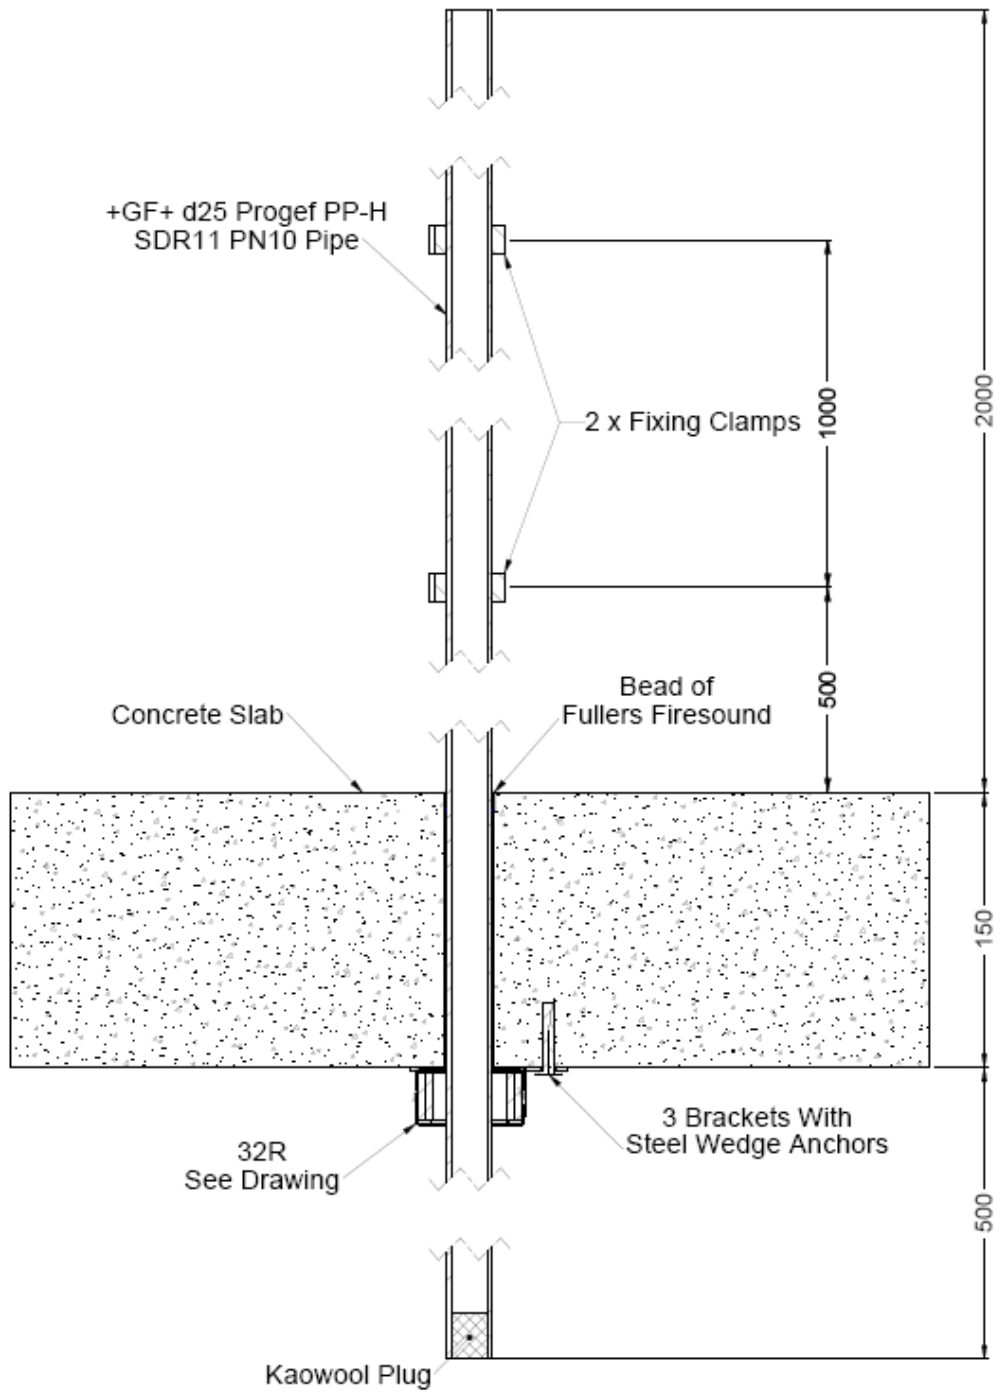
Penetration #8
PP-H (25mm ϕ) Stack - Date 10-06-2014

DRAWING NUMBERED PENETRATION #8 – PP-H (25-MM OD) STACK” DATED 10 JUNE 2014, BY SNAP FIRE SYSTEMS PTY LTD

Penetration 8 – 32 R retrofitted fire collar protecting a 25-mm diameter +GF+ Georg Fischer Progef Polypropylene PP-H stack pipe

The SNAP Retrofit 32 R fire collar comprised a 0.75-mm steel casing with a 40-mm inner diameter and three fixing brackets clipped onto the collar casing. The 32-mm high collar casing incorporated 135-mm x 26-mm x 4-mm thick Intumesh intumescent material and 135-mm x 25-mm stainless steel mesh as shown in drawing numbered 32 R-T dated 2 July 2014, by SNAP Fire Systems. The collar was fixed to the underside of the slab with 3 brackets with Steel Wedge Anchors.

The penetrating service comprised a 25-mm OD PP-H pipe, with a wall thickness of 2.7-mm fitted through the collar's sleeve. The pipe projected vertically, 2000-mm above the concrete slab. The pipe was supported at 500-mm and 1000-mm from the unexposed face of the concrete slab as shown in drawing titled "Penetration #8 – PP-H (25-mm OD) Stack" dated 10 June 2014, by Snap Fire Systems Pty Ltd. On the exposed end, the pipe was capped with a Kaowool Plug.

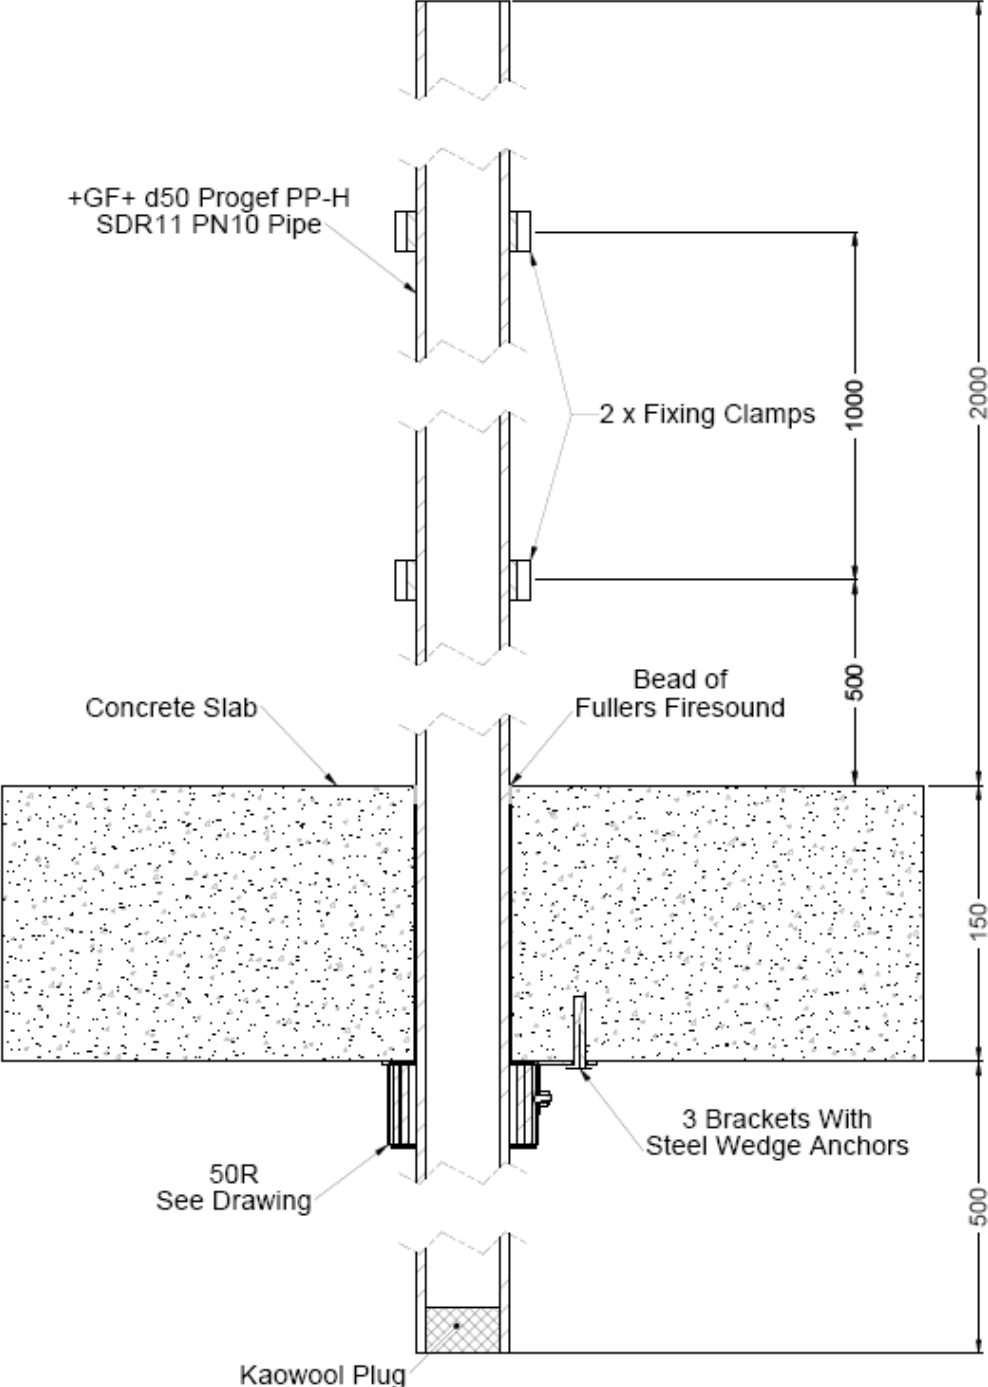
Penetration #9
 PP-H (50mm \varnothing) Stack - Date 10-06-2014

DRAWING NUMBERED PENETRATION #9 – PP-H (50-MM OD) STACK” DATED 10 JUNE 2014, BY SNAP FIRE SYSTEMS PTY LTD

Penetration 9 – 50 R retrofitted fire collar protecting a 50-mm diameter +GF+ Georg Fischer Progef Polypropylene PP-H stack pipe

The SNAP Retrofit 50 R fire collar comprised a 0.75-mm steel casing with a 62-mm inner diameter and three fixing brackets fixed onto the collar casing. The 47-mm high collar casing incorporated 200-mm x 43-mm x 4-mm thick Intumesh intumescent material and a 210-mm x 42-mm stainless steel mesh as shown in drawing numbered 50 R-T dated 4 November 2013, by SNAP Fire Systems. The collar was fixed to the underside of the slab with 3 brackets with Steel Wedge Anchors.

The penetrating service comprised a 50-mm OD PP-H pipe, with a wall thickness of 5.3-mm fitted through the collar's sleeve. The pipe projected vertically, 2000-mm above the concrete slab. The pipe was supported at 500-mm and 1000-mm from the unexposed face of the concrete slab as shown in drawing titled "Penetration #9 – PP-H (50-mm OD) Stack" dated 10 June 2014, by Snap Fire Systems Pty Ltd. On the exposed end, the pipe was capped with a Kaowool Plug.

On the unexposed face, the annular gap between the pipe and the slab was sealed with a bead of Fullers Firesound fire sealant.
