Fire-resistance test on fire collars protecting a plasterboard wall penetrated by services

Test Report

Author: Mario Lara-Ledermann
Report number: FSP 1658
Date: 15 January 2015

Sponsored Investigation No. FSP 1658

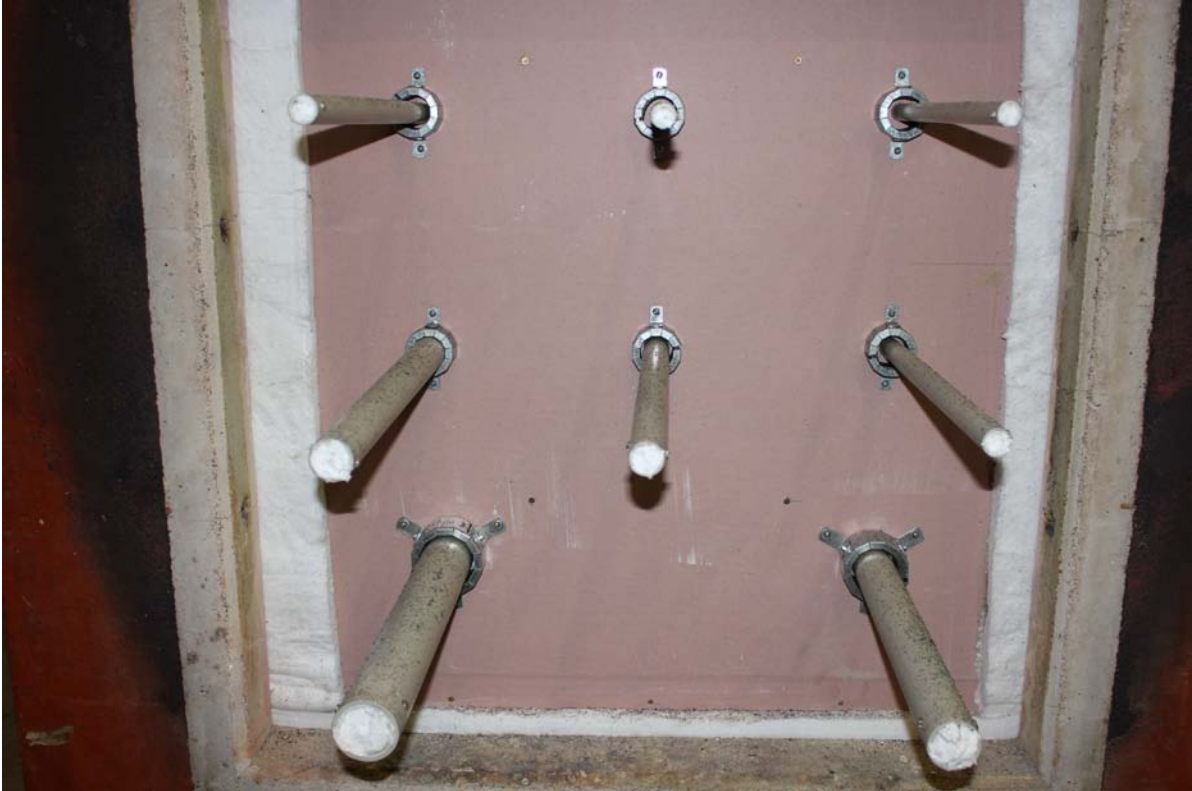
PHOTOGRAPH 1 – EXPOSED FACE OF SPECIMENS PRIOR TO TESTING

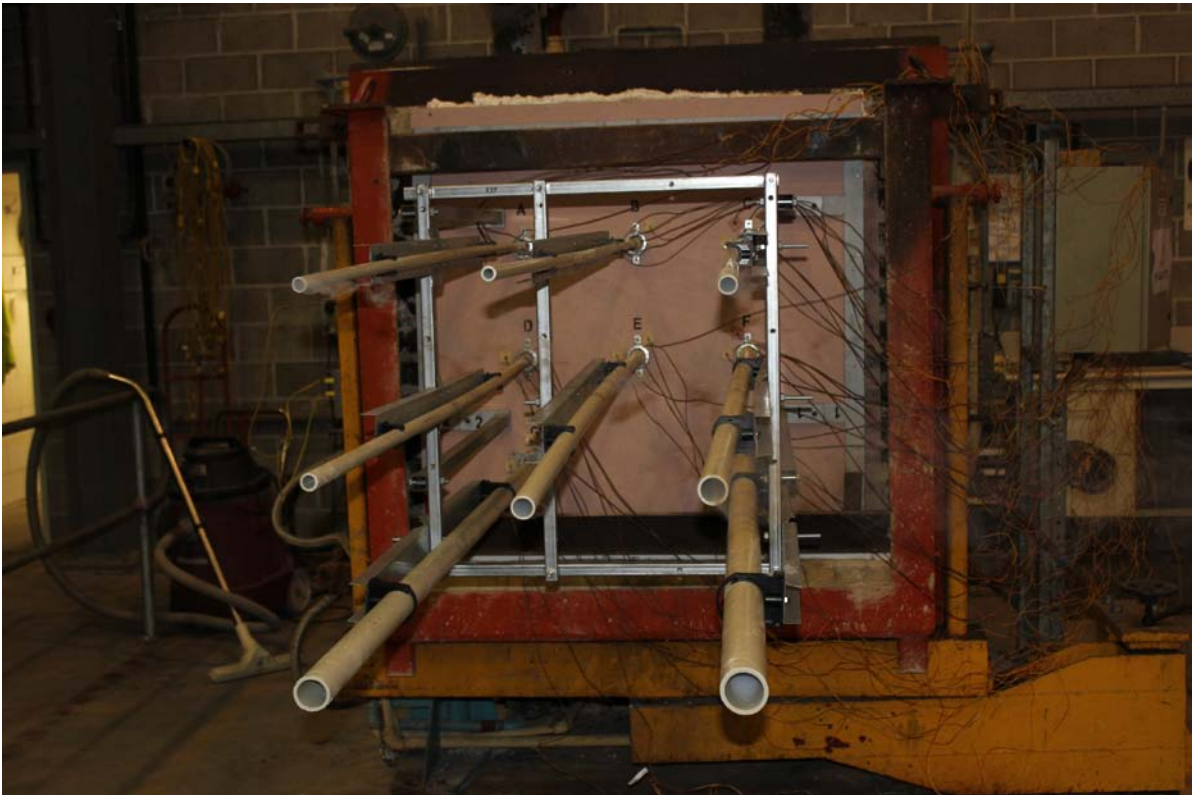
PHOTOGRAPH 2 – UNEXPOSED FACE OF SPECIMENS PRIOR TO TESTING

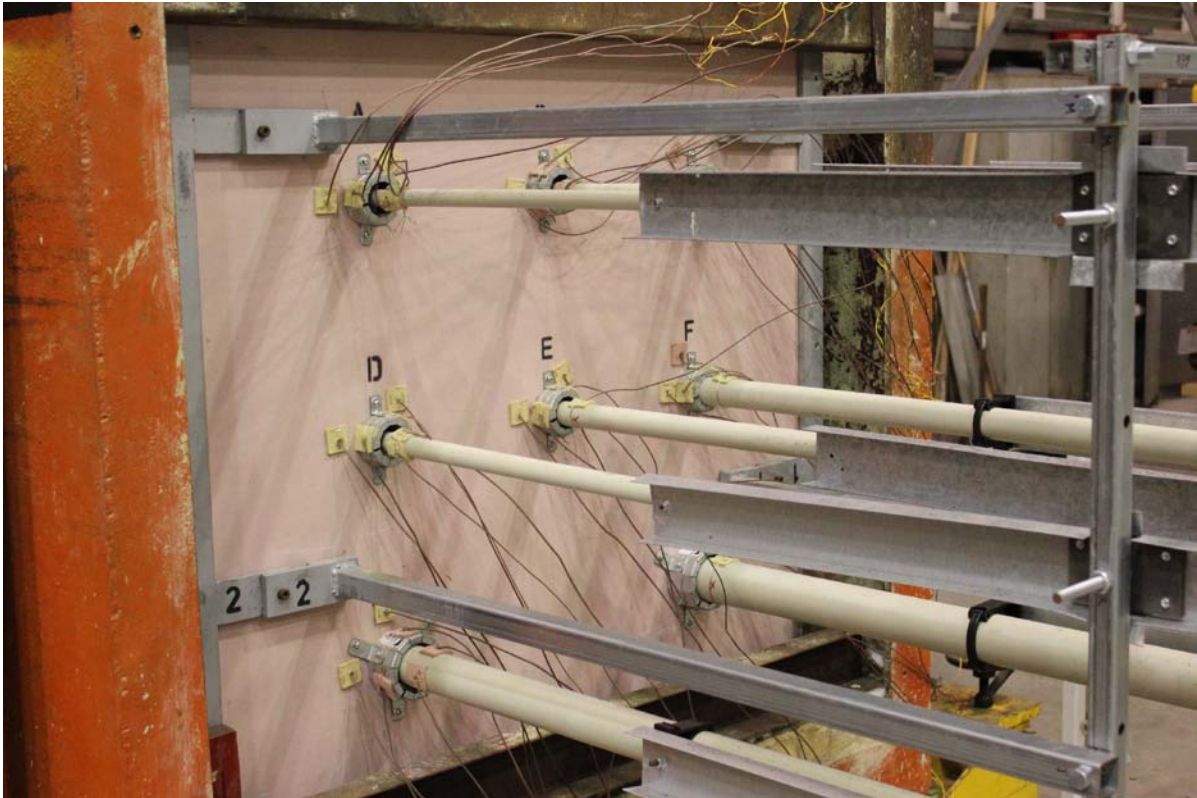
PHOTOGRAPH 3 – SPECIMENS AFTER 60 MINUTES OF TESTING

Time	Observation
3 minutes -	Fluing is visible from Penetrations # A, B, C, and E.
4 minutes -	Fluing is visible from Penetrations # F, and E only.
8 minutes -	Fluing is visible from Penetration # H only.
11 minutes -	Fluing has ceased from all penetrations.
60 minutes -	No apparent changes observed from the specimen.
171 minutes -	Fluing is visible from Penetrations # B, and G only.
173 minutes -	Fluing is visible from Penetrations # B, F, and G. Some glowing visible on base of Penetration# E.
175 minutes -	Cotton pad test applied on Penetration #E – no failure.

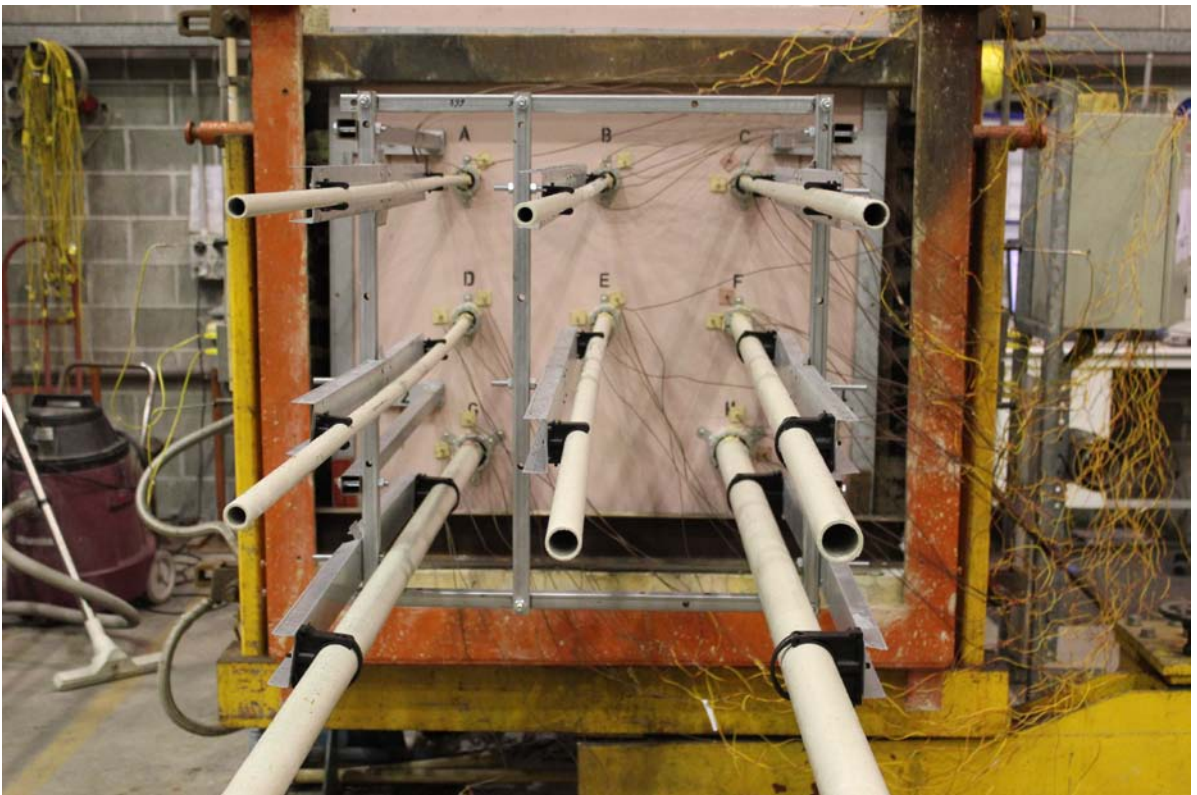
PHOTOGRAPH 4 – SPECIMENS AFTER 120 MINUTES OF TESTING

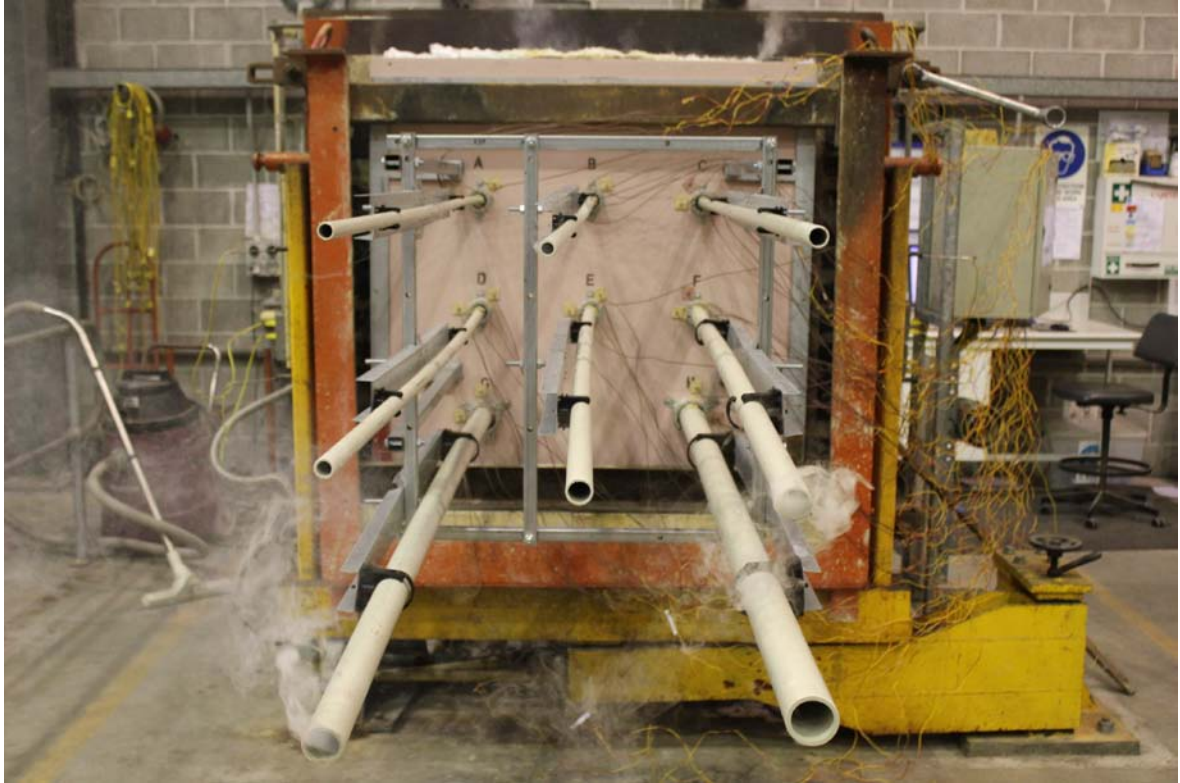
PHOTOGRAPH 5 – SPECIMENS AFTER 180 MINUTES OF TESTING

- 179 minutes - Some glowing visible on base of Penetration #G.
Cotton pad test applied on Penetration #G – no failure.
- 181 minutes - Test terminated.

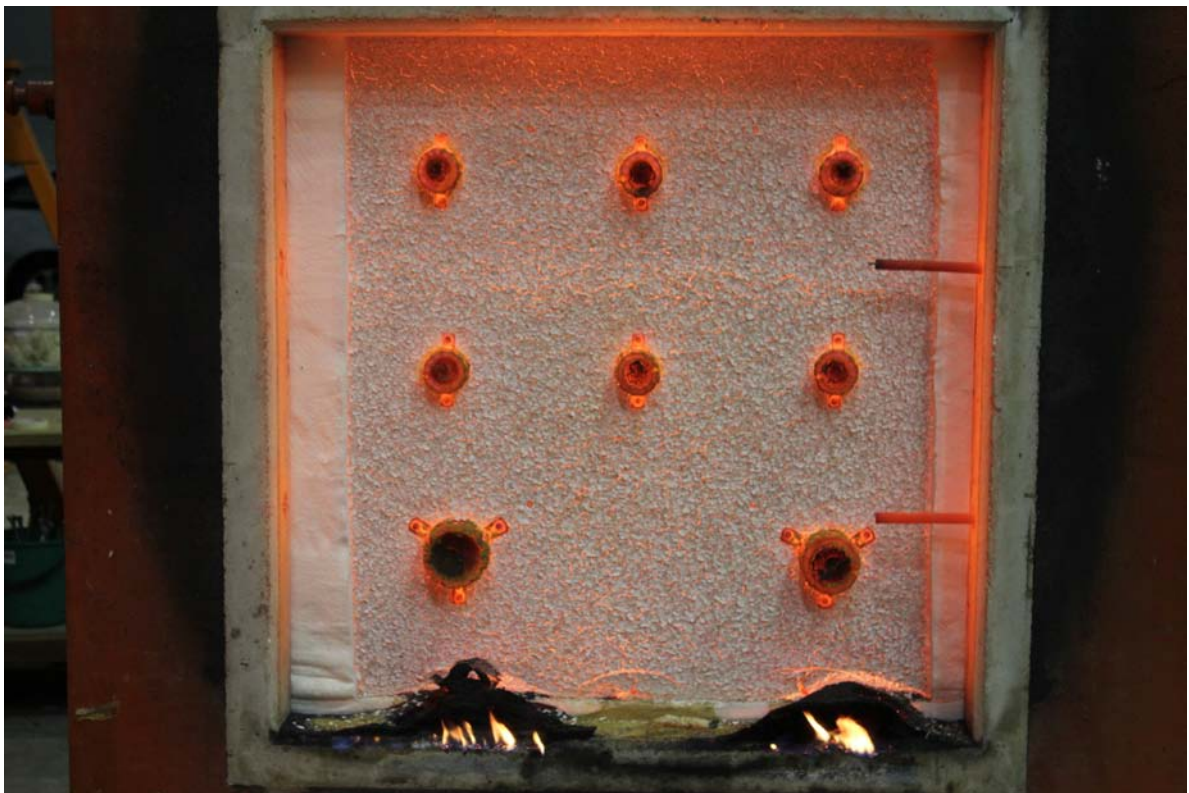
PHOTOGRAPH 6 – EXPOSED FACE OF SPECIMENS AT CONCLUSION OF TESTING

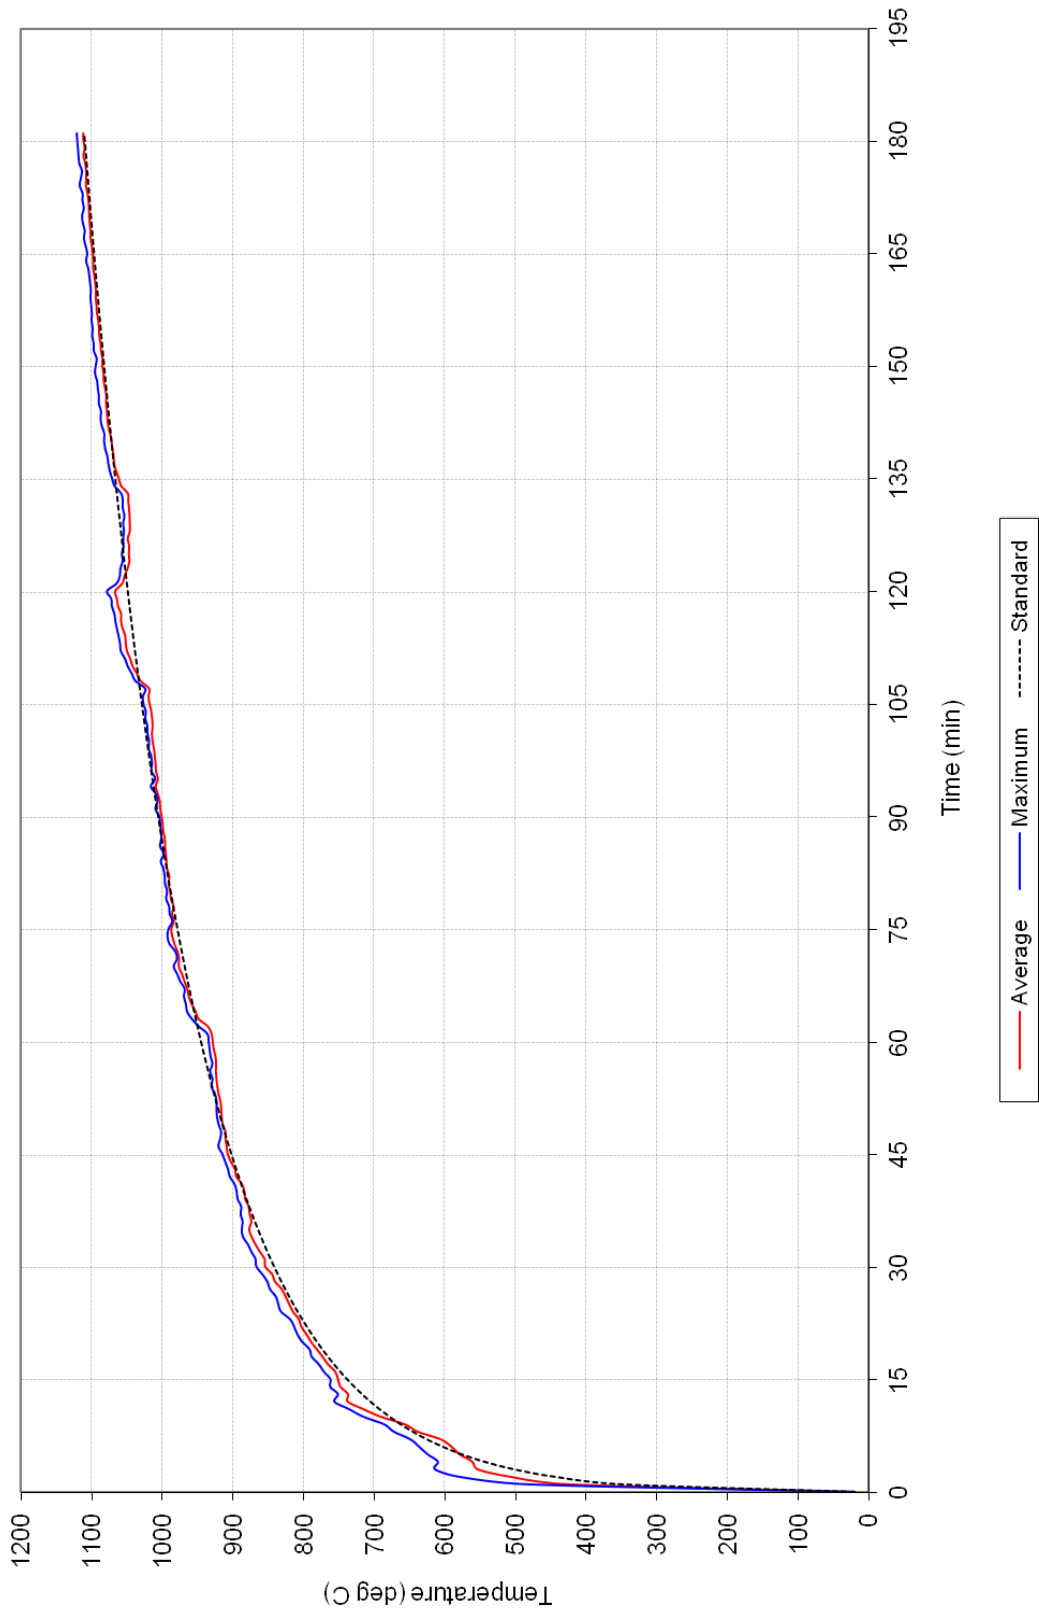
FIGURE 1 – FURNACE TEMPERATURE

The temperature in the furnace chamber was measured by four type K, 3-mm diameter, and 310 stainless steel Mineral Insulated Metal Sheathed (MIMS) thermocouples. Each thermocouple was housed in high-nickel steel tubes opened at the exposed end.

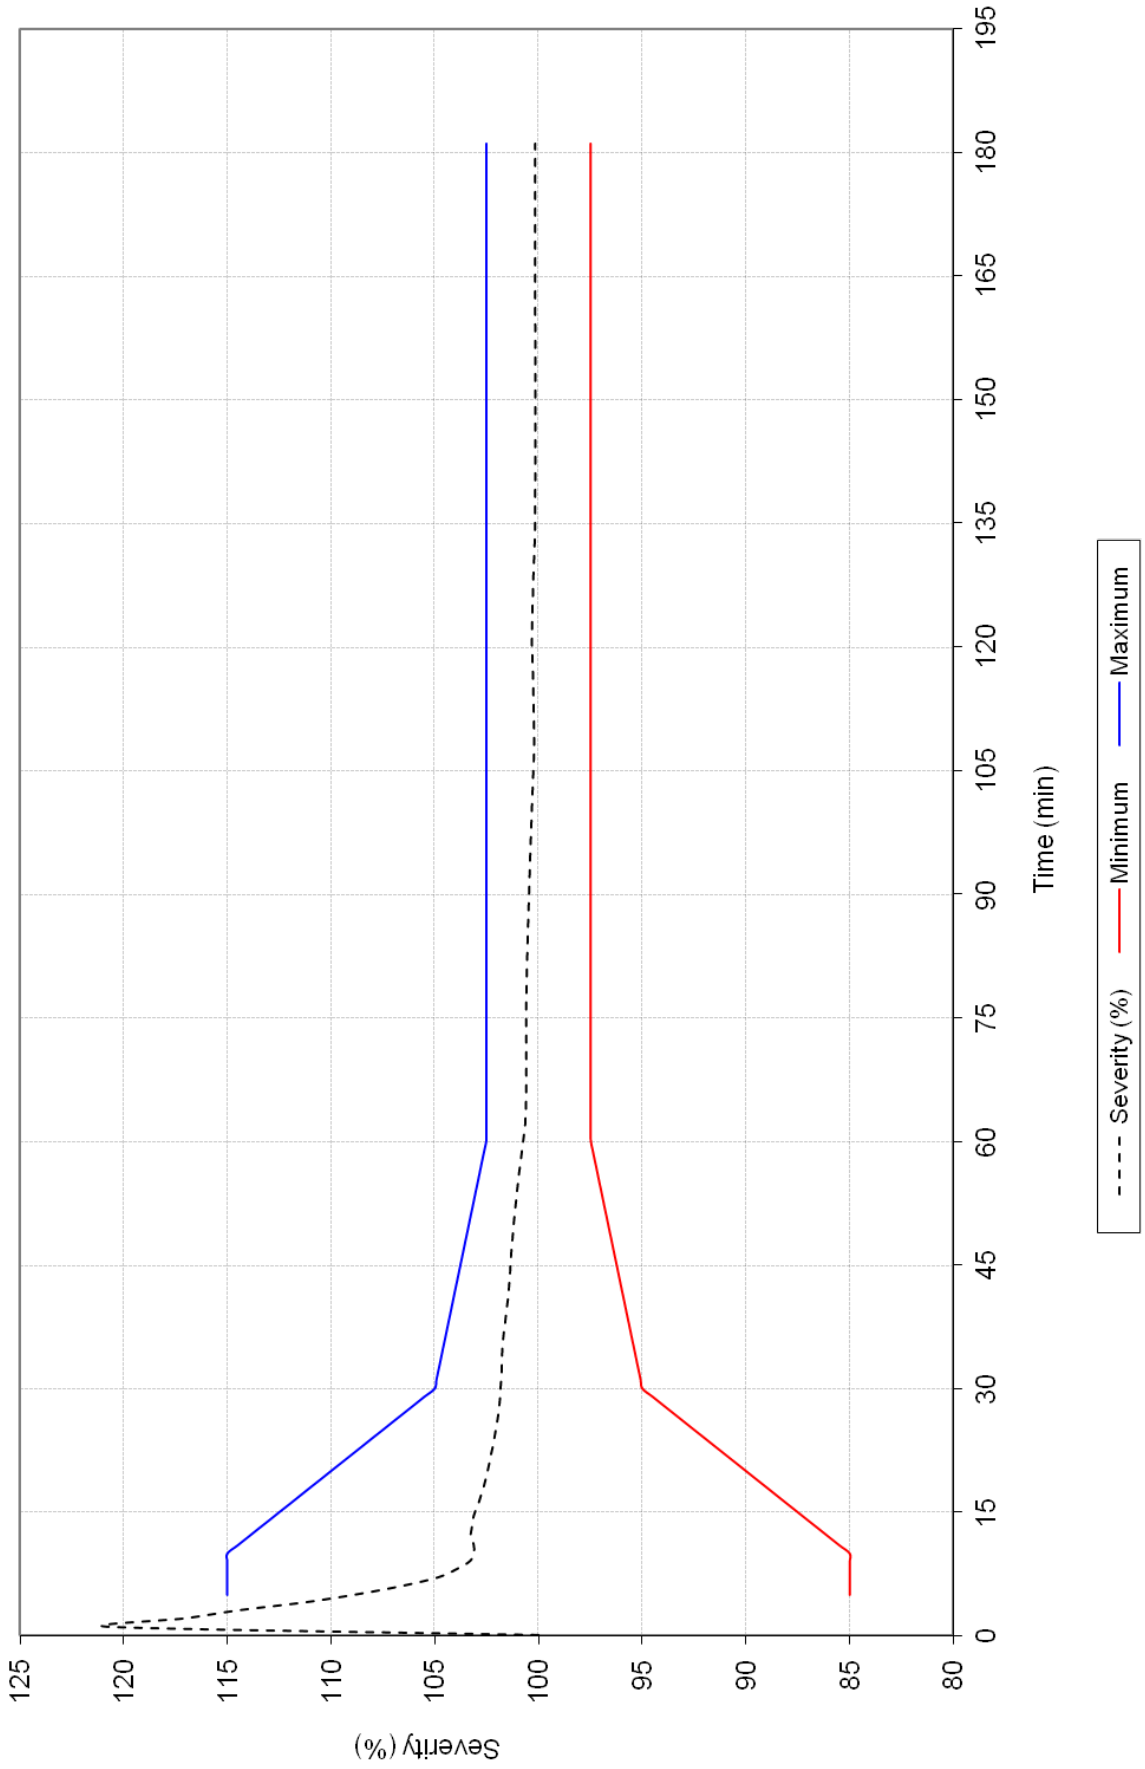
FIGURE 2 – FURNACE SEVERITY

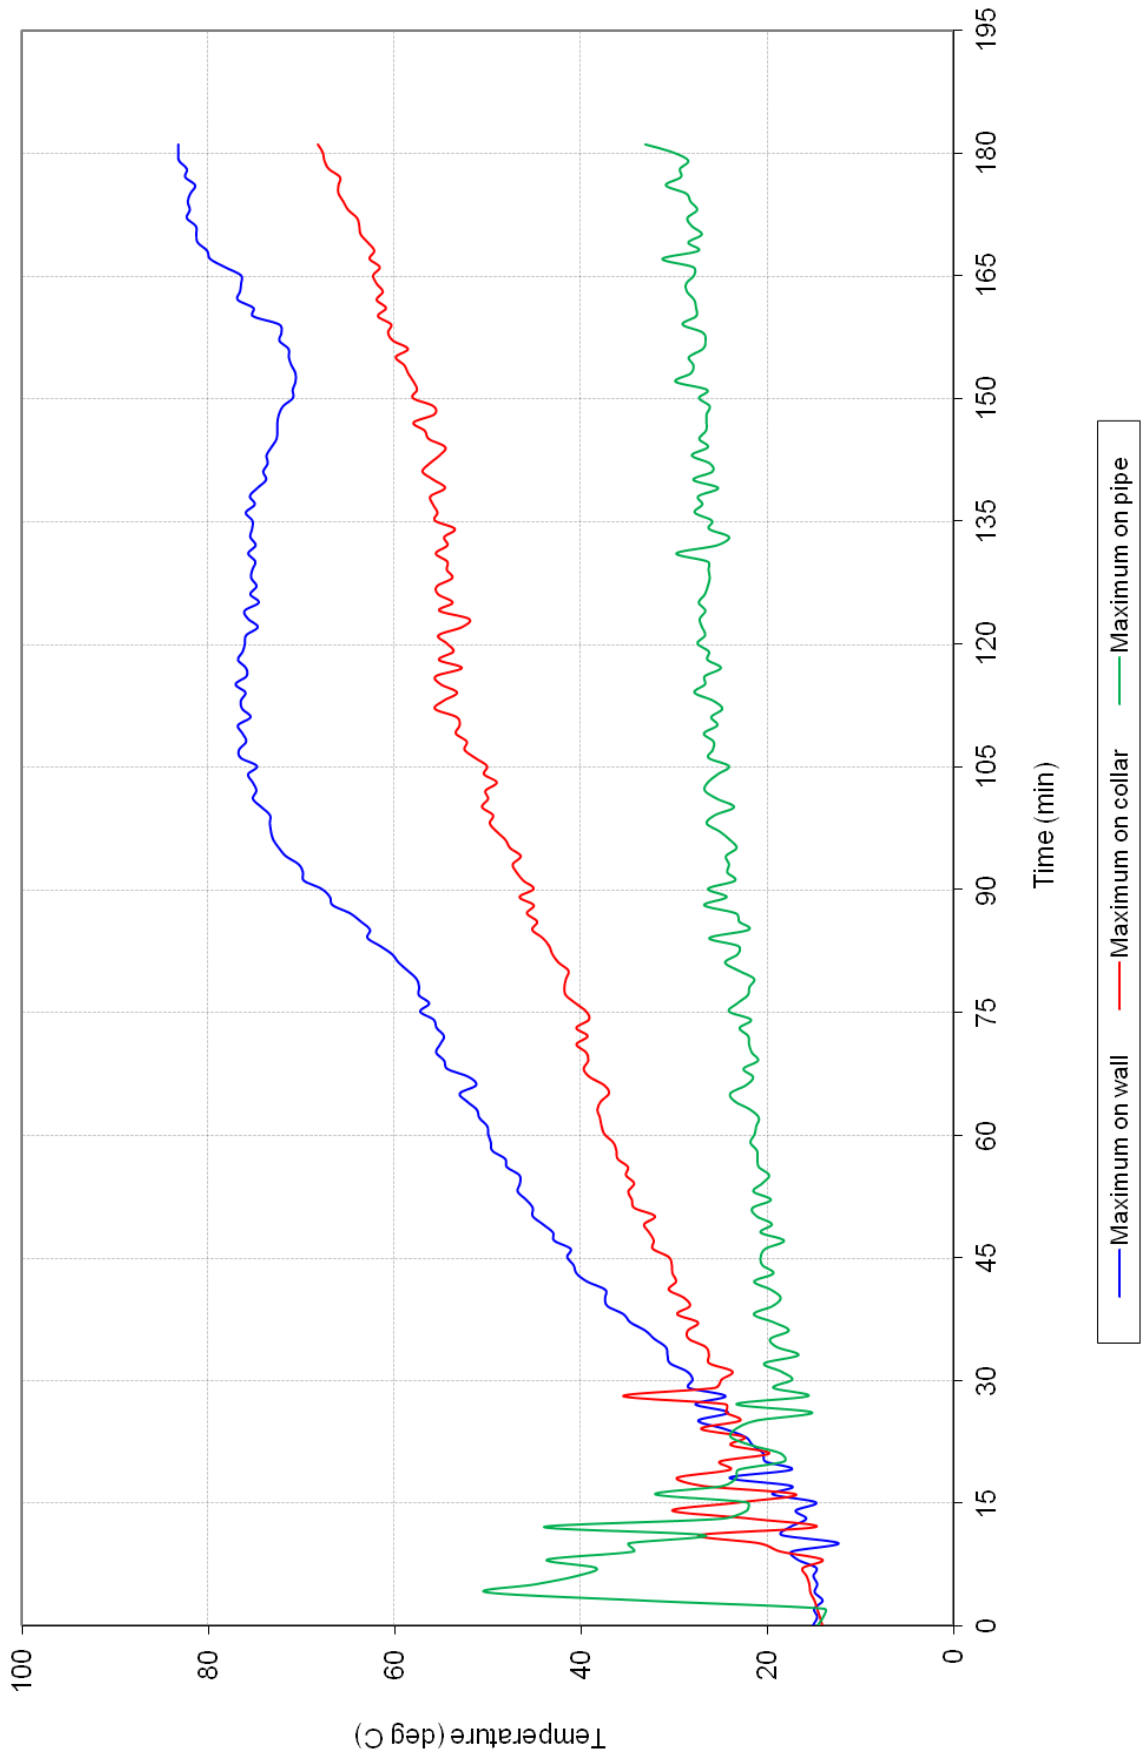
FIGURE 3 – SPECIMEN TEMPERATURE – ASSOCIATED WITH PENETRATION #A

<u>Penetration #A – 32R retrofitted fire collar protecting a 20-mm diameter +GF+ d20 Progef PP-H SDR 11 PN10 pipe</u>		
Structural adequacy	-	not applicable
Integrity	-	no failure at 180 minutes
Insulation	-	no failure at 180 minutes

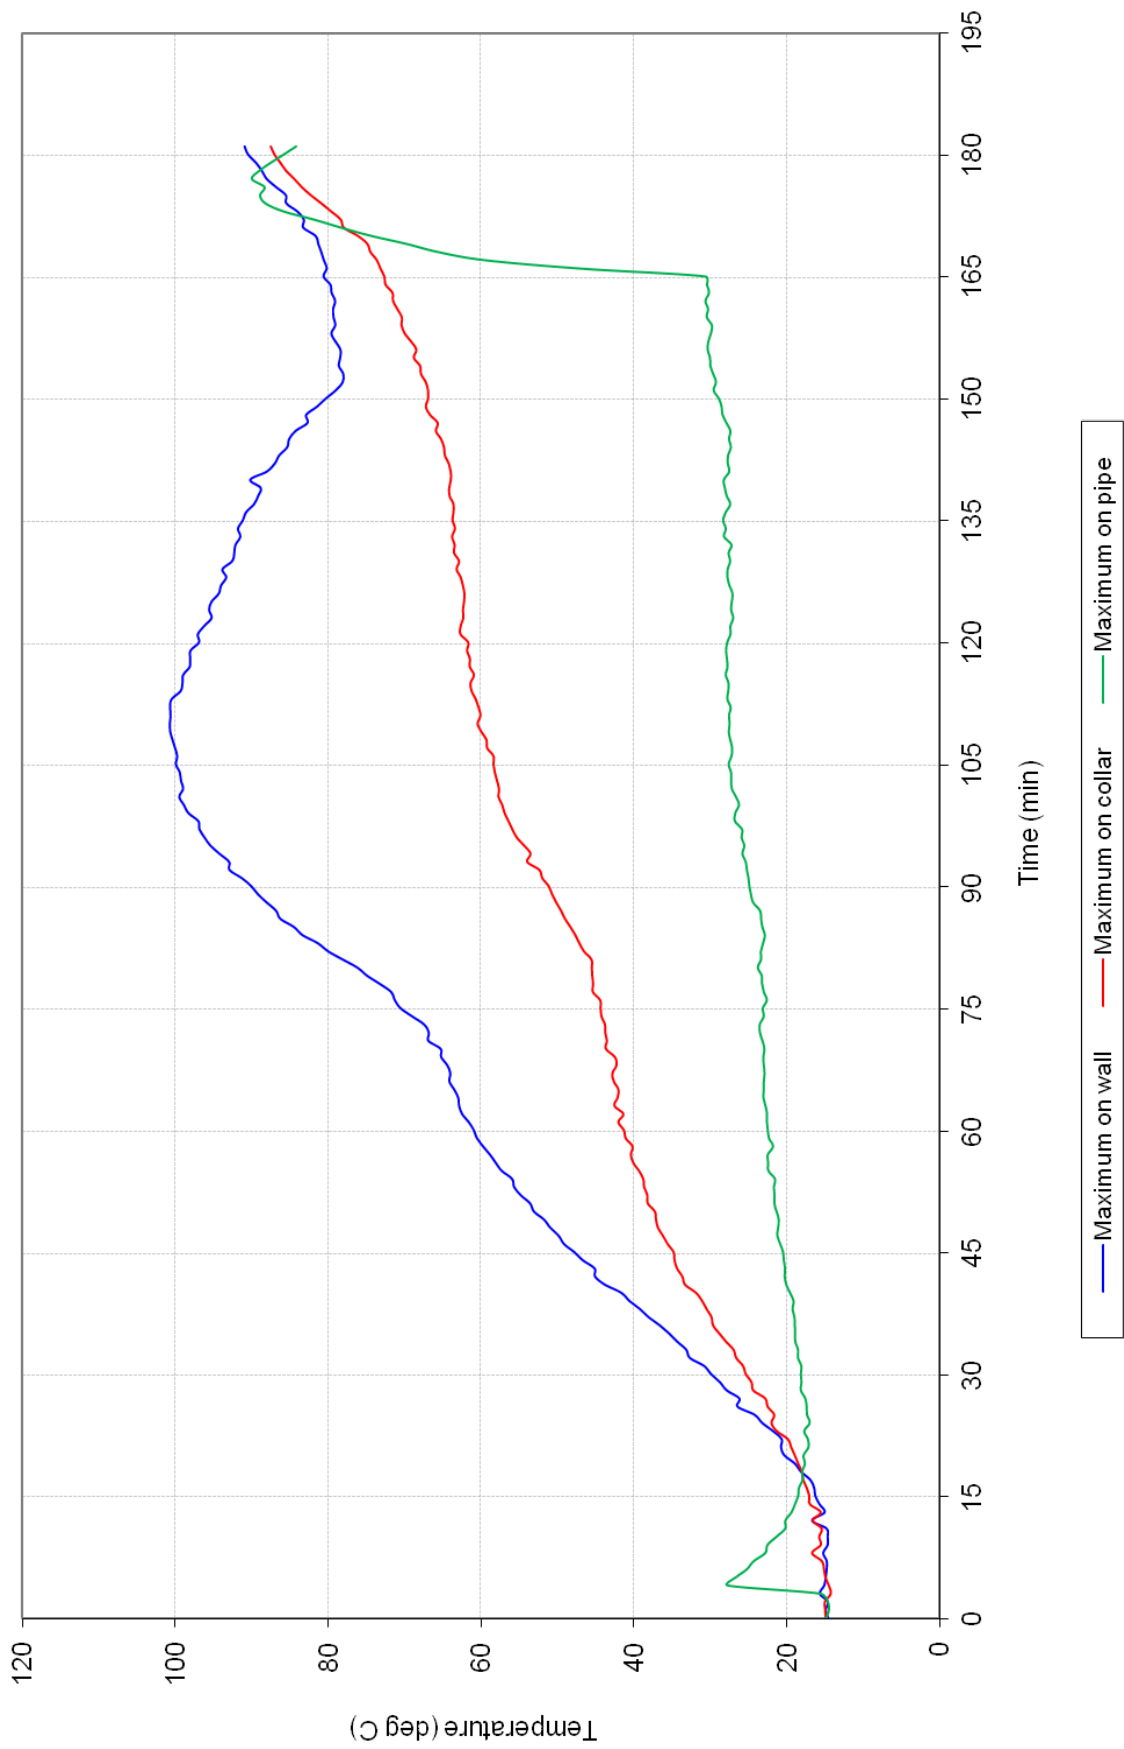
FIGURE 4 – SPECIMEN TEMPERATURE – ASSOCIATED WITH PENETRATION #B

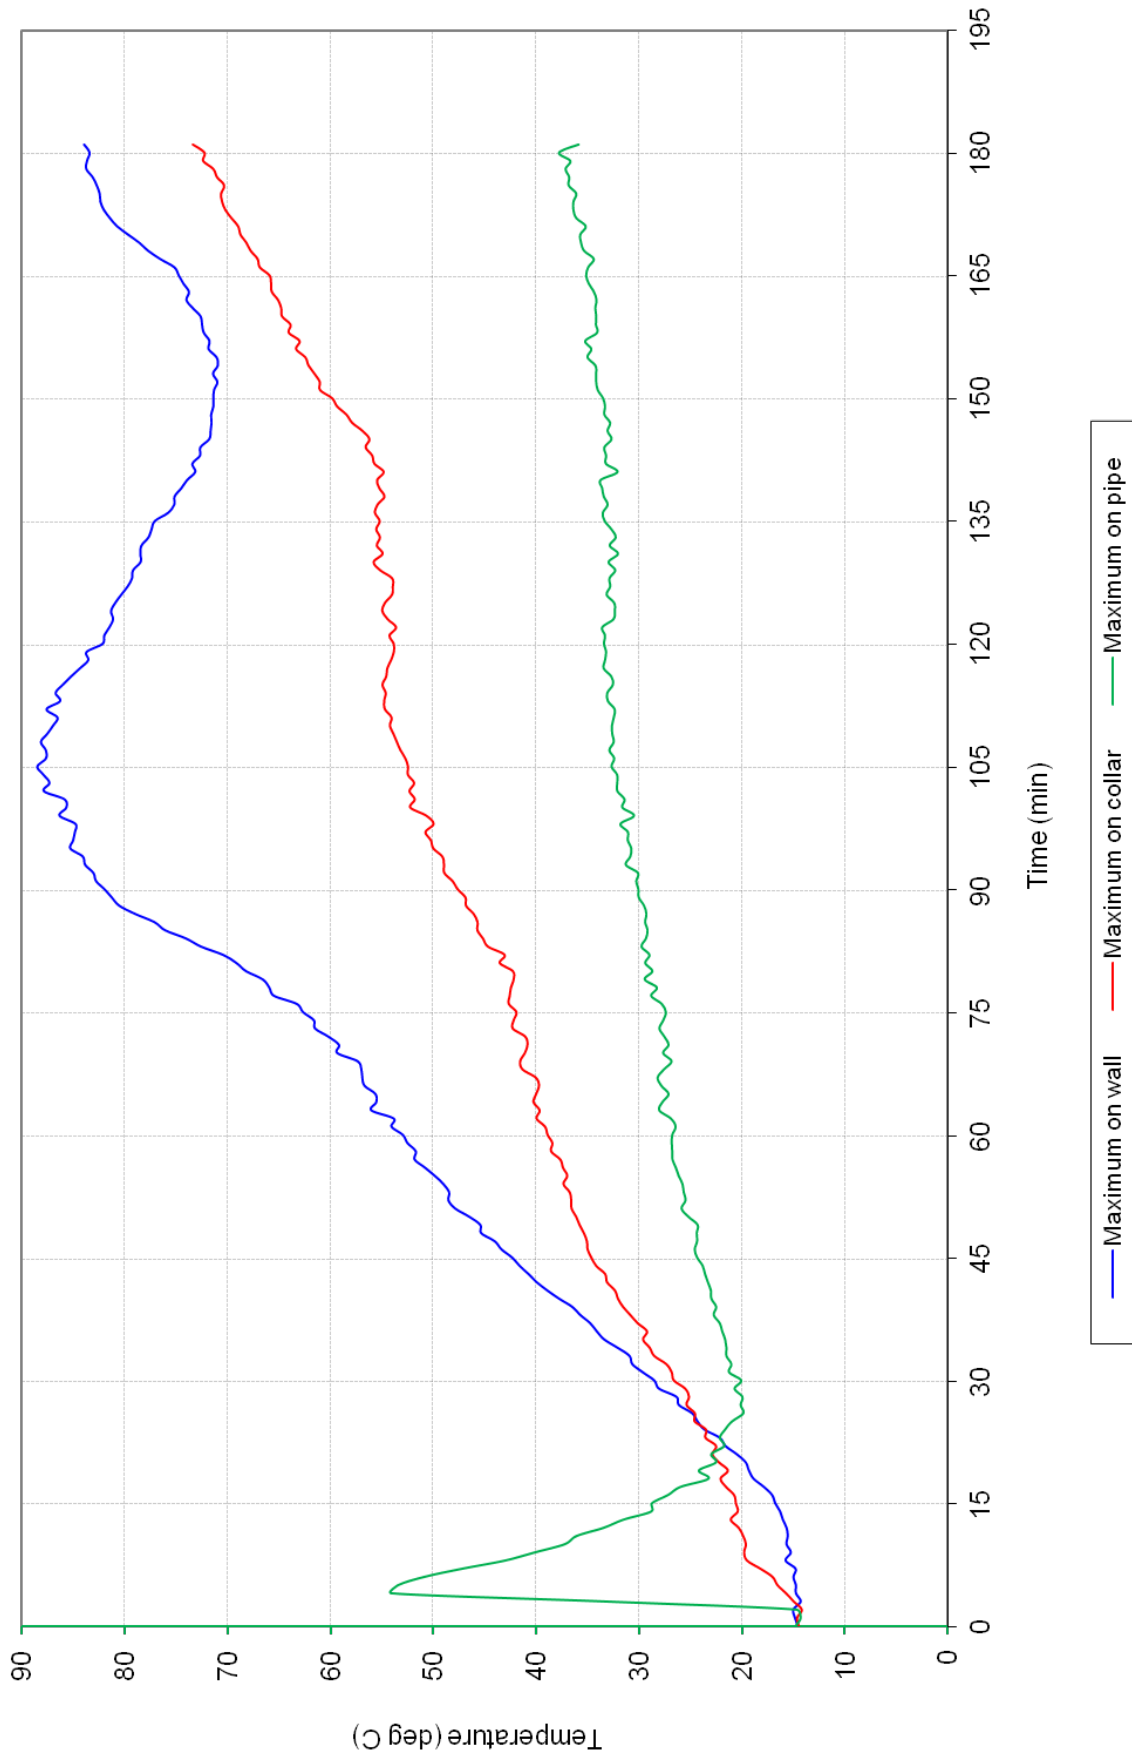
FIGURE 5 – SPECIMEN TEMPERATURE – ASSOCIATED WITH PENETRATION #C

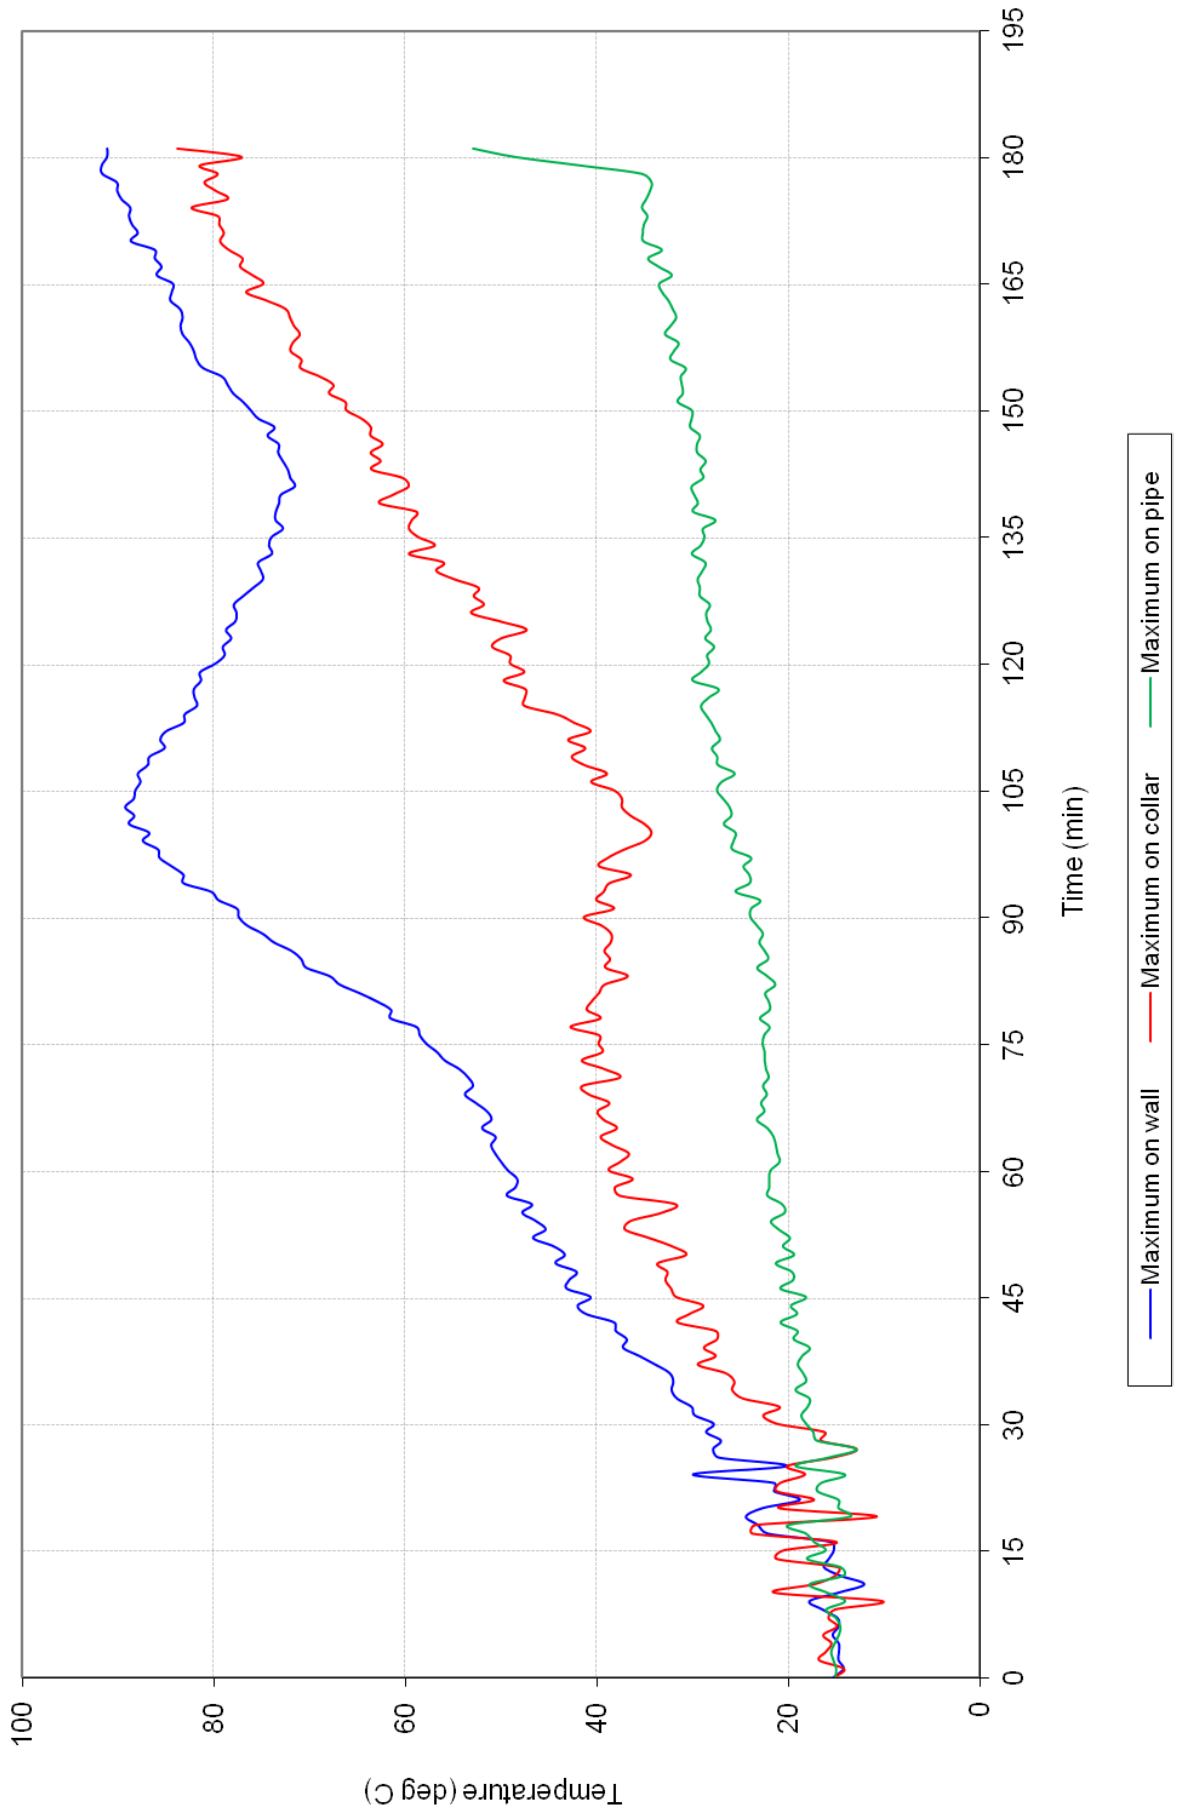
FIGURE 6 – SPECIMEN TEMPERATURE – ASSOCIATED WITH PENETRATION #D

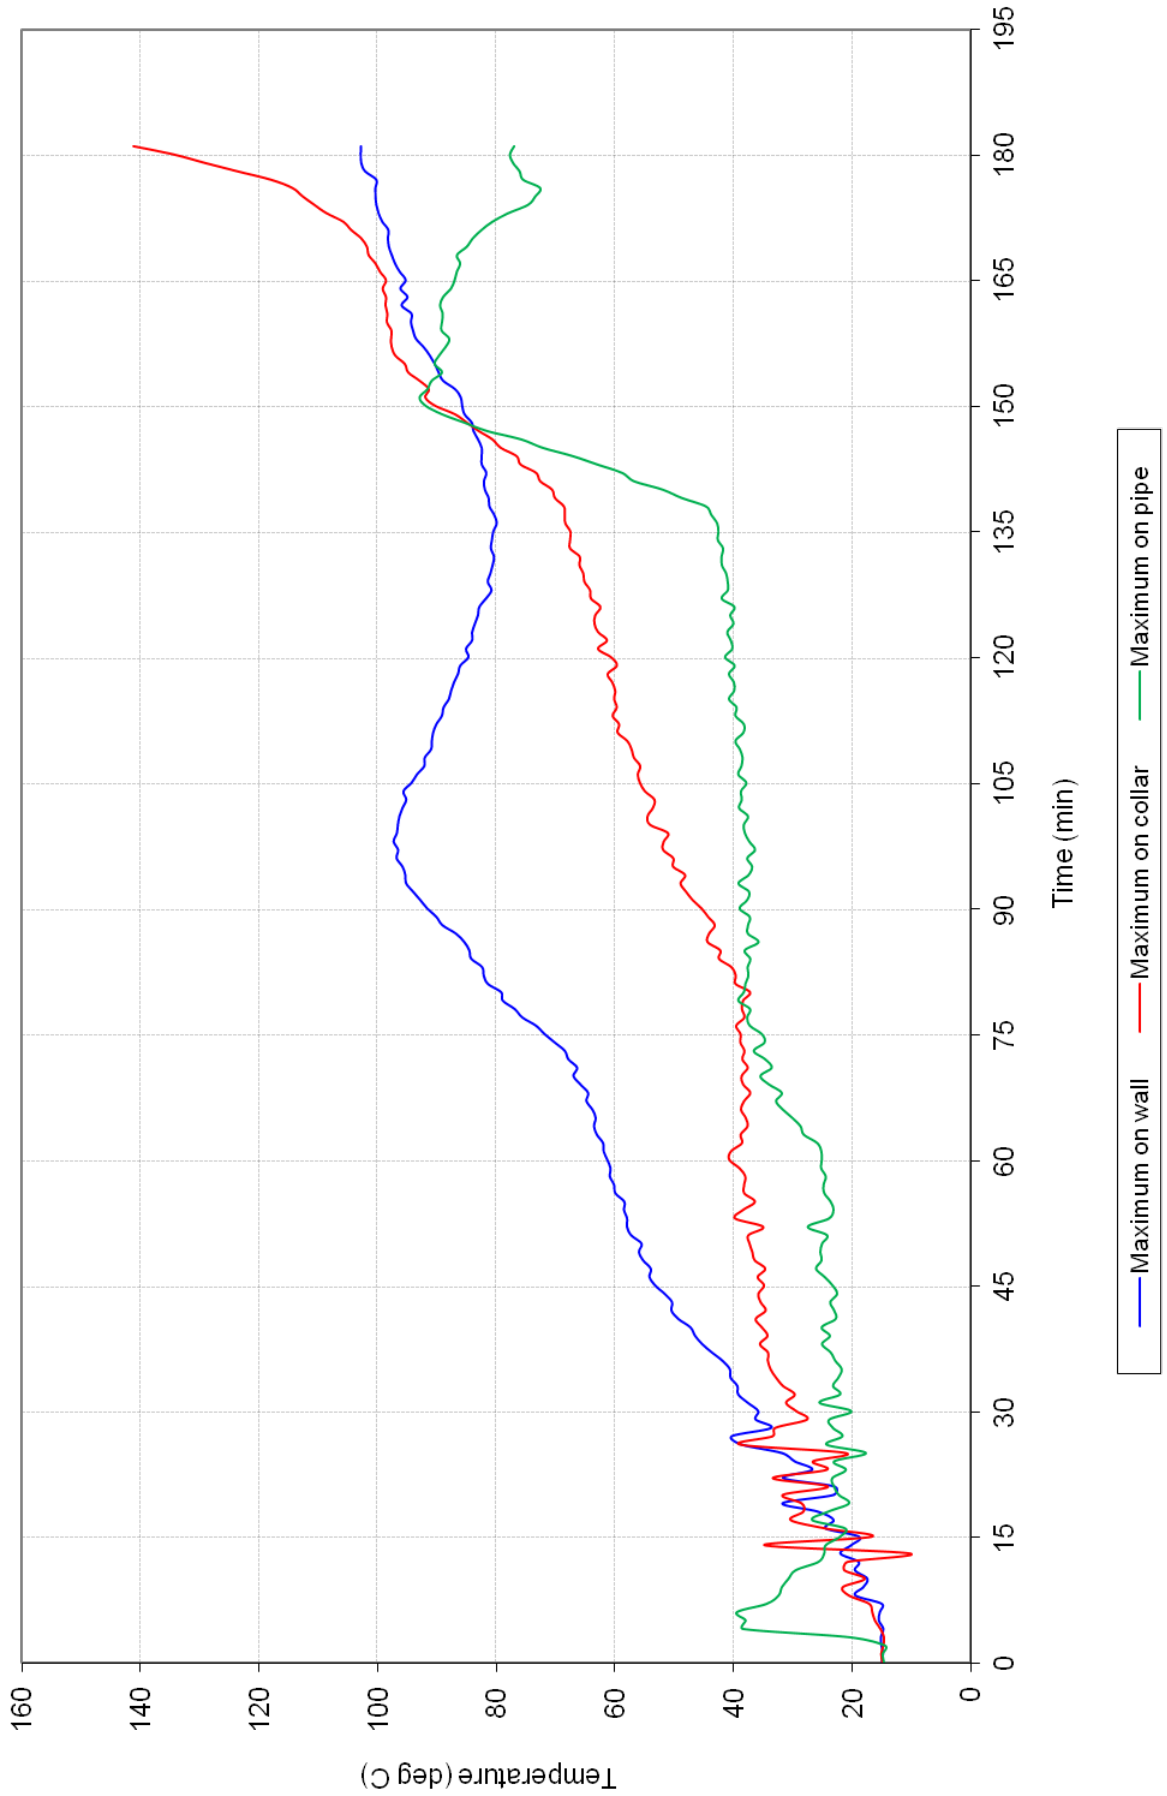
FIGURE 7 – SPECIMEN TEMPERATURE – ASSOCIATED WITH PENETRATION #E

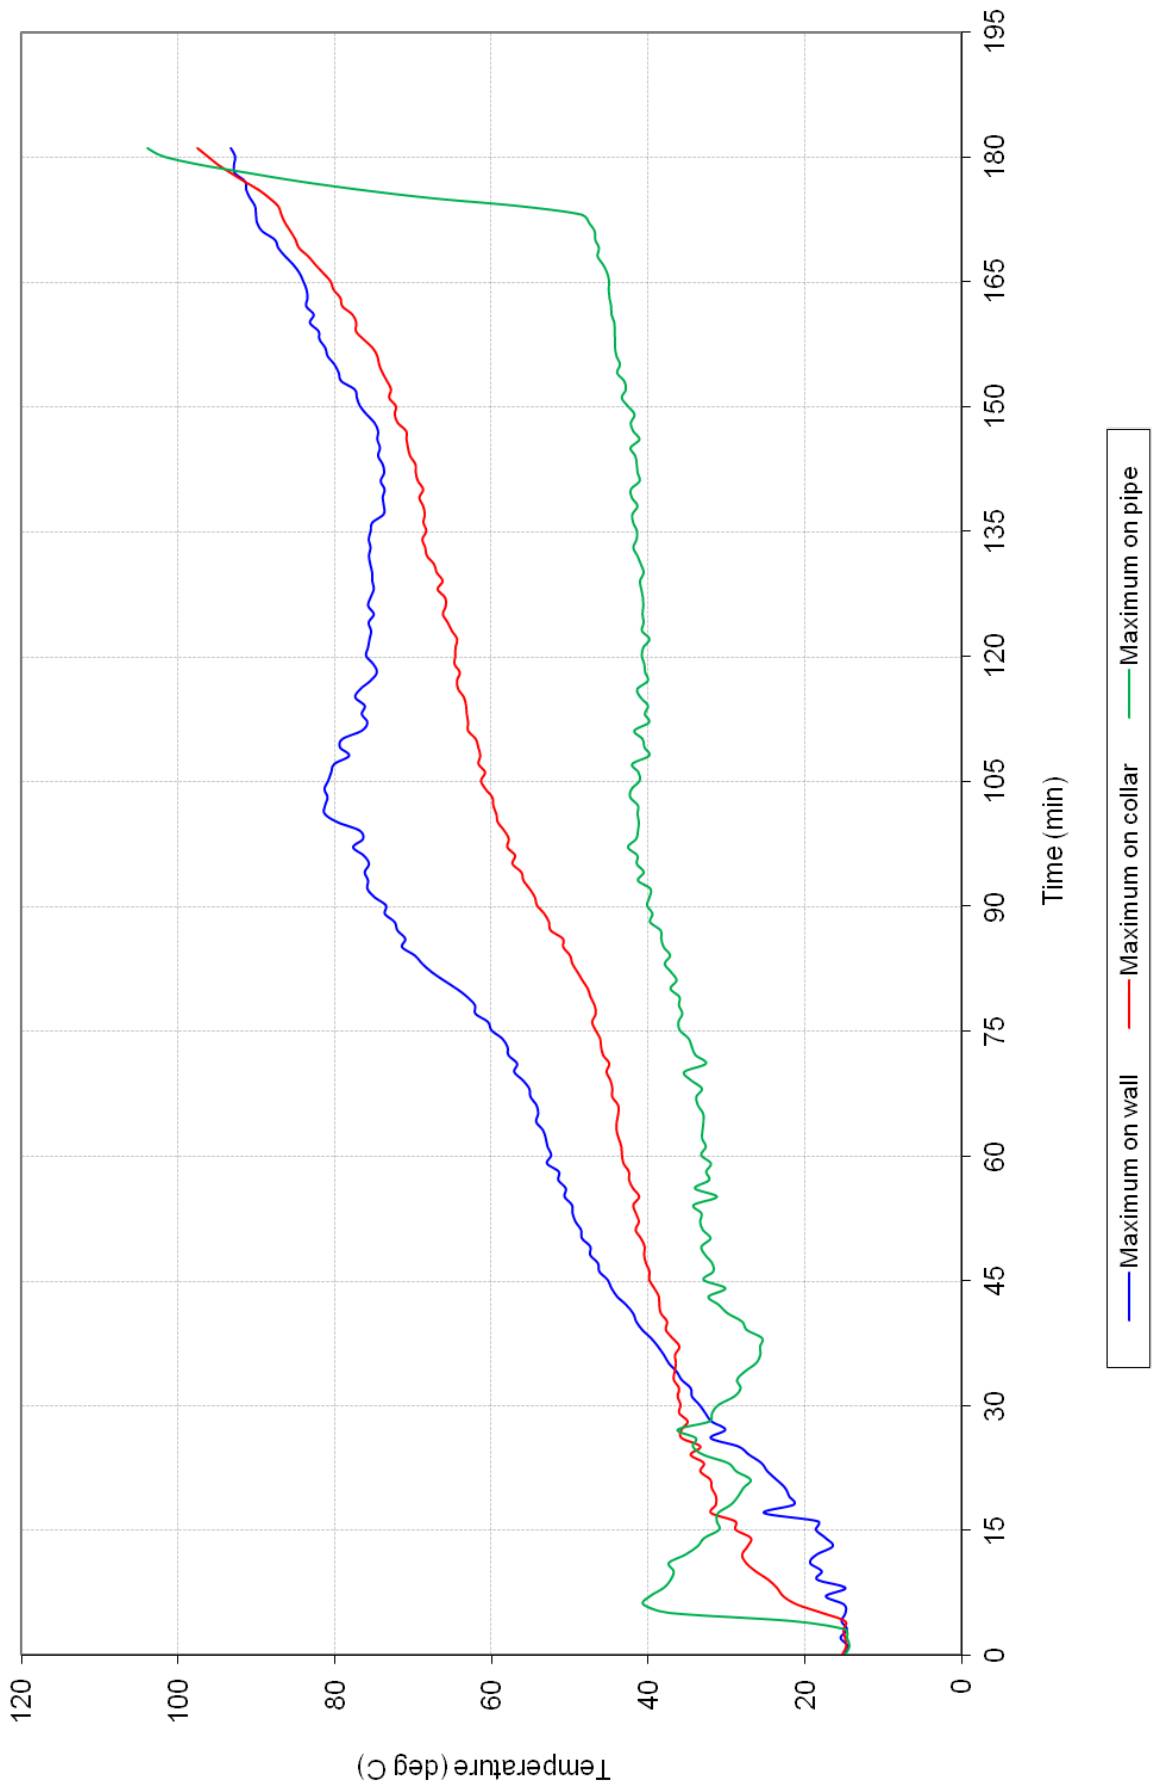
FIGURE 8 – SPECIMEN TEMPERATURE – ASSOCIATED WITH PENETRATION #F
