Fire-resistance test on fire collars protecting a plasterboard wall penetrated by services

Test Report

Author: Mario Lara-Ledermann
Report number: FSP 1658
Date: 15 January 2015

Sponsored Investigation No. FSP 1658

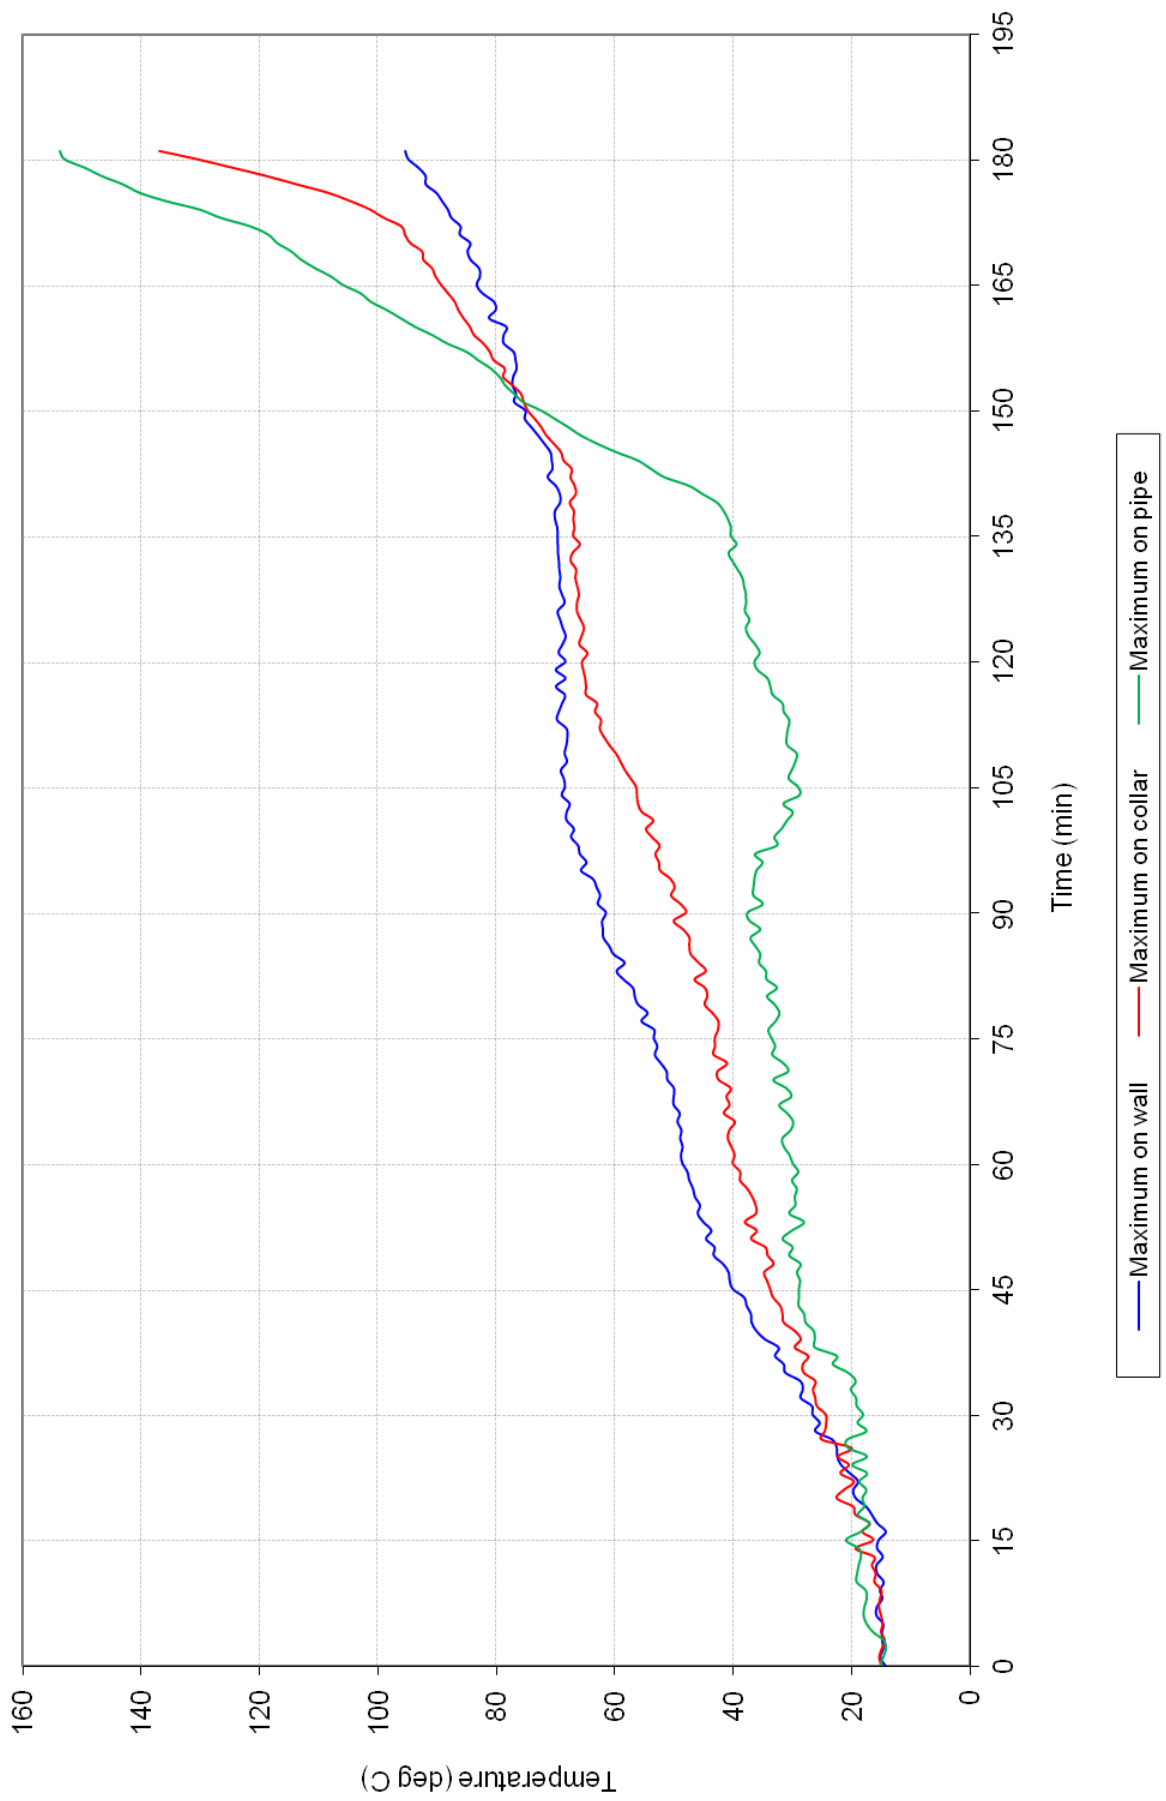
FIGURE 9 – SPECIMEN TEMPERATURE – ASSOCIATED WITH PENETRATION #G

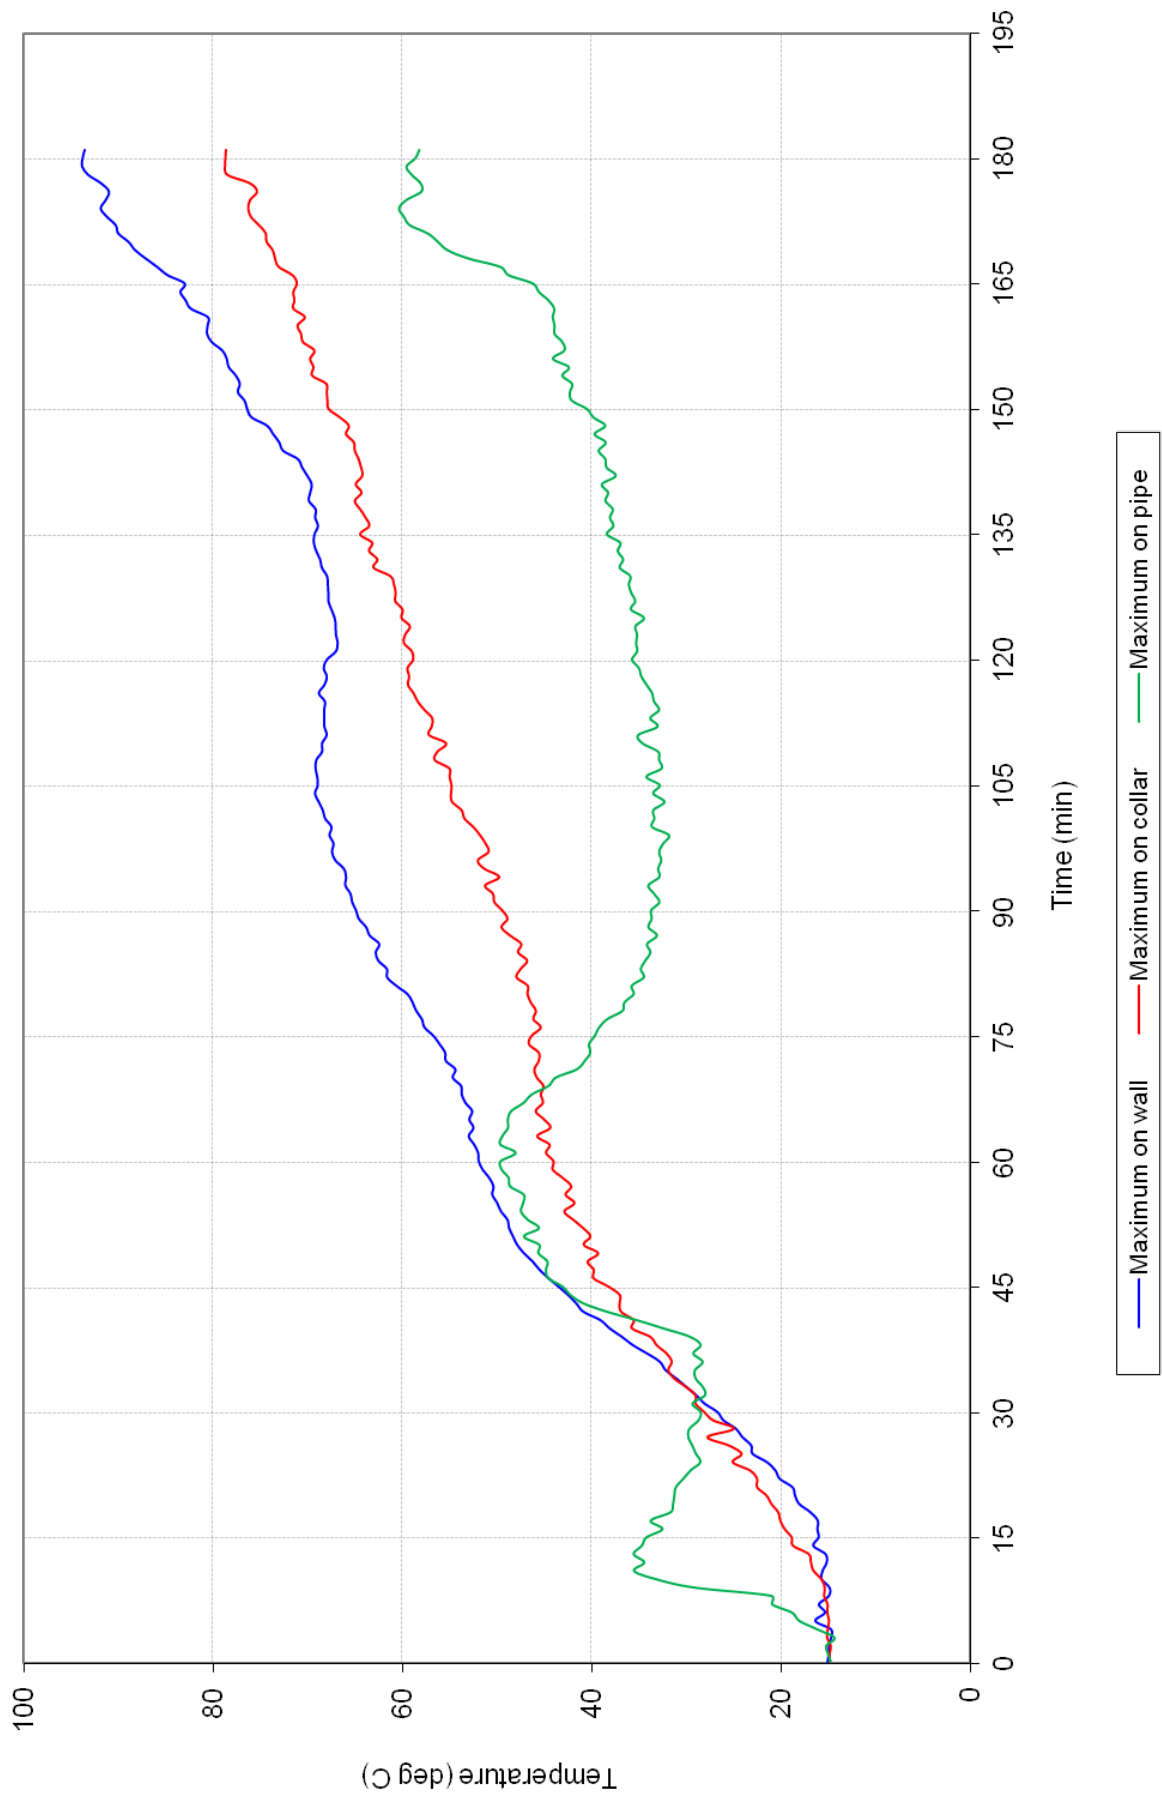
FIGURE 10 – SPECIMEN TEMPERATURE – ASSOCIATED WITH PENETRATION #H

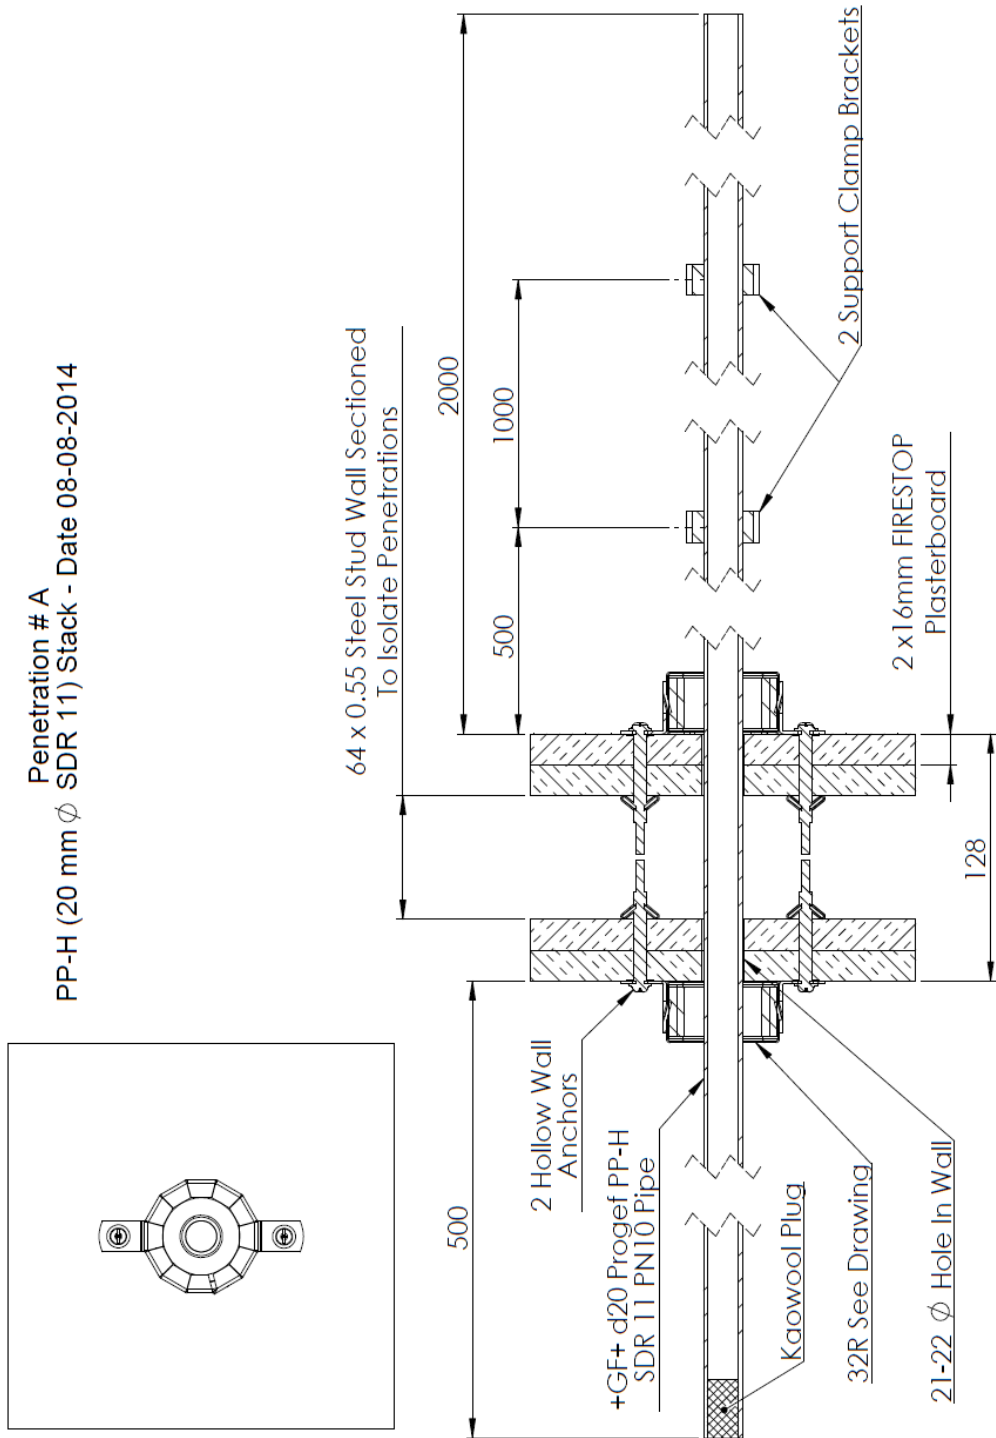
DRAWING TITLED “PENETRATION #A – PP-H (20 MM ϕ SDR 11) STACK”, DATED 08/08/2014 SUPPLIED BY SNAP FIRE SYSTEMS PTY LTD

Penetration #A – 32R retrofitted fire collar protecting a 20-mm diameter +GF+ Georg Fischer Progef Polypropylene PP-H SDR 11 PN10 stack pipe

The SNAP Retrofit 32R fire collar comprised a 0.75-mm steel casing with a 40-mm inner diameter and a 106-mm diameter base flange. The 32-mm high collar casing incorporated a closing mechanism that was comprised of two soft Intumesh intumescent wraps lined within the internal circumference of the collar. The inner and outer wraps were 4-mm thick x 26-mm wide x 135-mm long, and 4-mm thick x 26-mm wide x 154-mm long, respectively. Between the wraps was a layer of 304 stainless steel mesh 135 mm long x 25-mm wide with wire mesh diameter of 0.15-mm, as shown in drawing numbered 32R-T dated 2 July 2014, by SNAP Fire Systems. One collar was fixed to each side of the plasterboard wall in a back-to-back configuration using two hollow wall anchors.

The penetrating service comprised a 20-mm nominal diameter PP-H pipe, with a wall thickness of 2.3-mm, fitted through the collar's sleeve and penetrating the plasterboard wall through a 21-mm diameter cut-out hole as shown in drawing titled "Penetration #A PP-H (20-mm Ø SDR 11) Stack" dated 8 August 2014, by SNAP Fire Systems. The pipe projected horizontally, approximately 2000-mm away from the unexposed face of the plasterboard wall and approximately 500-mm into the furnace chamber. The pipe was supported at nominally 500-mm from the unexposed face of the plasterboard wall by two support clamp brackets spaced apart at nominally 1000-mm. The pipe was open at the unexposed end and capped on the exposed end with a ceramic fibre (Kaowool) plug.

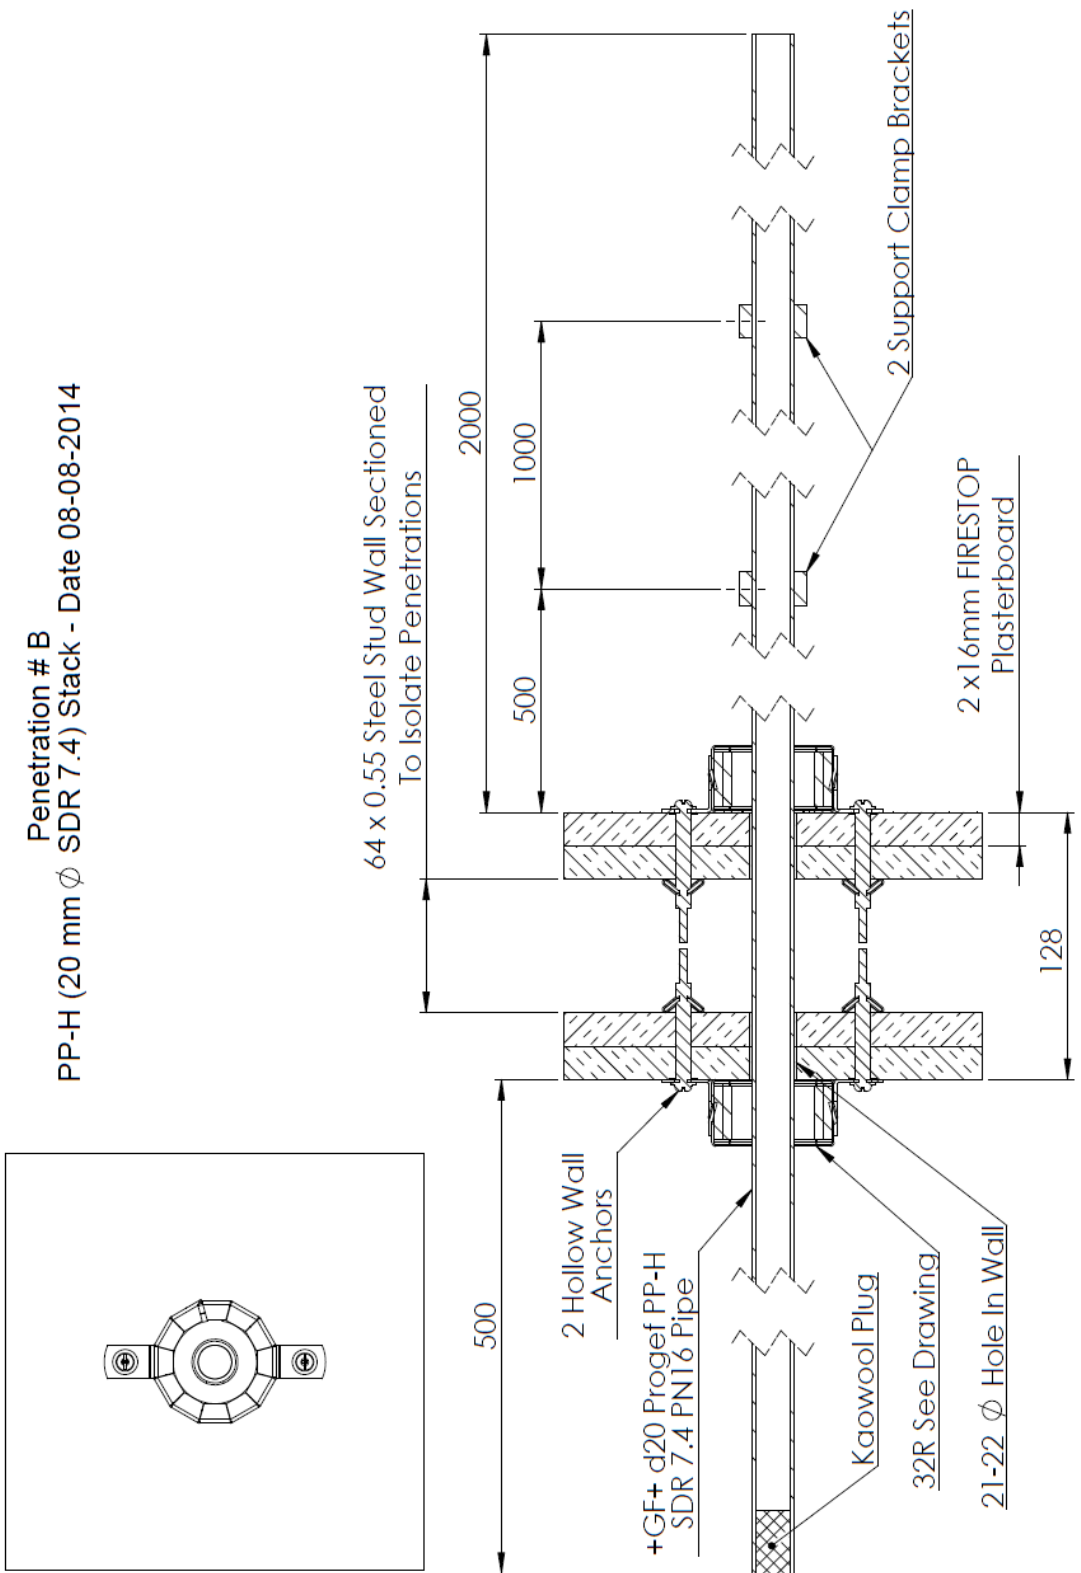
DRAWING TITLED "PENETRATION #B – PP-H (20 MM ϕ SDR 7.4) STACK", DATED 08/08/2014 SUPPLIED BY SNAP FIRE SYSTEMS PTY LTD

Penetration #B – 32R retrofitted fire collar protecting a 20-mm diameter +GF+ Georg Fischer Progef Polypropylene PP-H SDR 7.4 PN16 stack pipe

The SNAP Retrofit 32R fire collar comprised a 0.75-mm steel casing with a 40-mm inner diameter and a 106-mm diameter base flange. The 32-mm high collar casing incorporated a closing mechanism that was comprised of two soft Intumesh intumescent wraps lined within the internal circumference of the collar. The inner and outer wraps were 4-mm thick x 26-mm wide x 135-mm long, and 4-mm thick x 26-mm wide x 154-mm long, respectively. Between the wraps was a layer

of 304 stainless steel mesh 135 mm long x 25-mm wide with wire mesh diameter of 0.15-mm, as shown in drawing numbered 32R-T dated 2 July 2014, by SNAP Fire Systems. One collar was fixed to each side of the plasterboard wall in a back-to-back configuration using two hollow wall anchors.

The penetrating service comprised a 20-mm nominal diameter PP-H pipe, with a wall thickness of 3.5-mm, fitted through the collar's sleeve and penetrating the plasterboard wall through a 21-mm diameter cut-out hole as shown in drawing titled "Penetration #B PP-H (20-mm Ø SDR 7.4) Stack" dated 8 August 2014, by SNAP Fire Systems. The pipe projected horizontally, approximately 2000-mm away from the unexposed face of the plasterboard wall and approximately 500-mm into the furnace chamber. The pipe was supported at nominally 500-mm from the unexposed face of the plasterboard wall by two support clamp brackets spaced apart at nominally 1000-mm. The pipe was open at the unexposed end and capped on the exposed end with a ceramic fibre (Kaowool) plug.

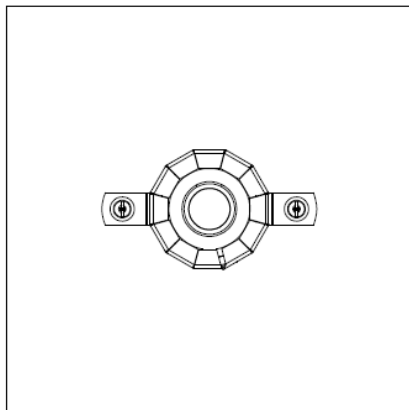
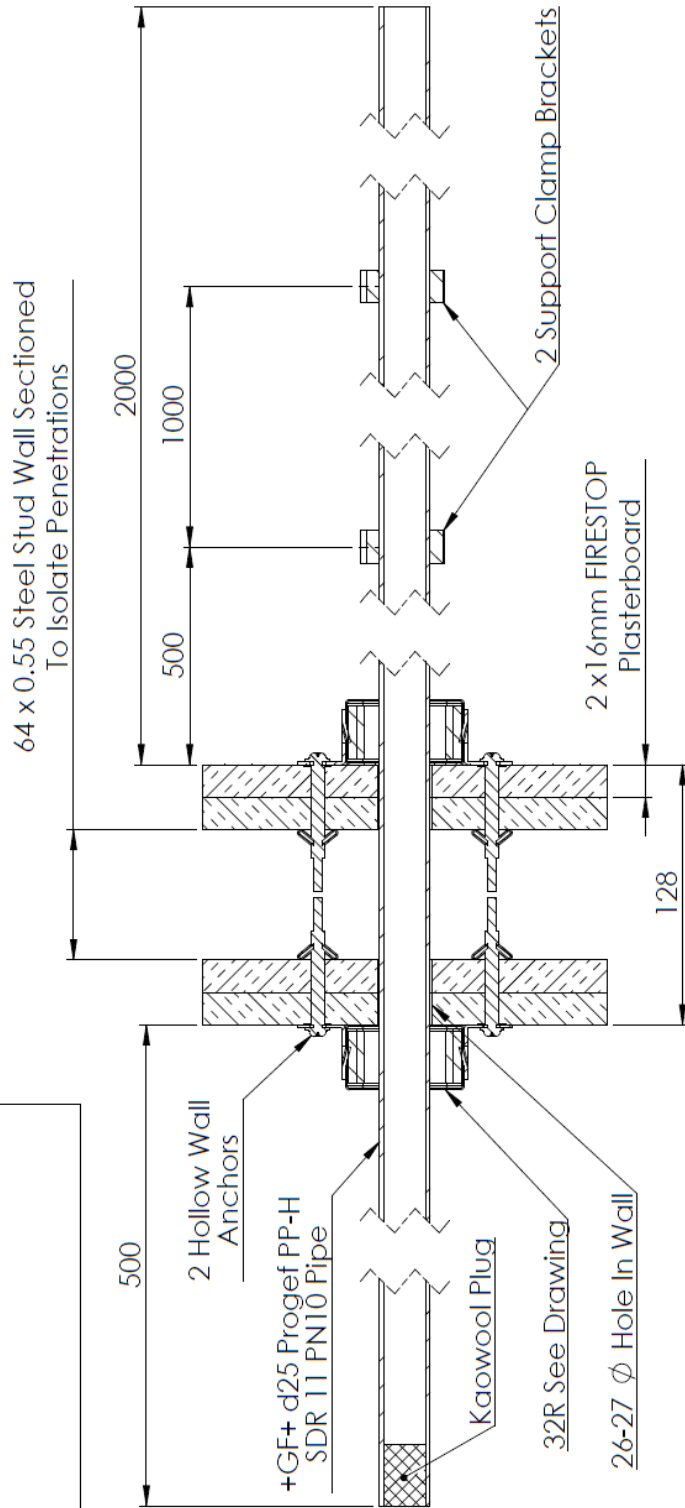
Penetration # C
 PP-H (25 mm ϕ SDR 11) Stack - Date 08-08-2014

DRAWING TITLED "PENETRATION #C – PP-H (25 MM ϕ SDR 11) STACK", DATED 08/08/2014 SUPPLIED BY SNAP FIRE SYSTEMS PTY LTD

Penetration #C – 32R retrofitted fire collar protecting a 25-mm diameter +GF+ Georg Fischer Progef Polypropylene PP-H SDR 11 PN10 stack pipe

The SNAP Retrofit 32R fire collar comprised a 0.75-mm steel casing with a 40-mm inner diameter and a 106-mm diameter base flange. The 32-mm high collar casing incorporated a closing mechanism that was comprised of two soft Intumesh intumescent wraps lined within the internal circumference of the collar. The inner and outer wraps were 4-mm thick x 26-mm wide x 135-mm long, and 4-mm thick x 26-mm wide x 154-mm long, respectively. Between the wraps was a layer of 304 stainless steel mesh 135 mm long x 25-mm wide with wire mesh diameter of 0.15-mm, as shown in drawing numbered 32R-T dated 2 July 2014, by SNAP Fire Systems. One collar was fixed to each side of the plasterboard wall in a back-to-back configuration using two hollow wall anchors.

The penetrating service comprised a 25-mm nominal diameter PP-H pipe, with a wall thickness of 2.9-mm, fitted through the collar's sleeve and penetrating the plasterboard wall through a 26-mm diameter cut-out hole as shown in drawing titled "Penetration #C PP-H (25-mm Ø SDR 11) Stack" dated 8 August 2014, by SNAP Fire Systems. The pipe projected horizontally, approximately 2000-mm away from the unexposed face of the plasterboard wall and approximately 500-mm into the furnace chamber. The pipe was supported at nominally 500-mm from the unexposed face of the plasterboard wall by two support clamp brackets spaced apart at nominally 1000-mm. The pipe was open at the unexposed end and capped on the exposed end with a ceramic fibre (Kaowool) plug.

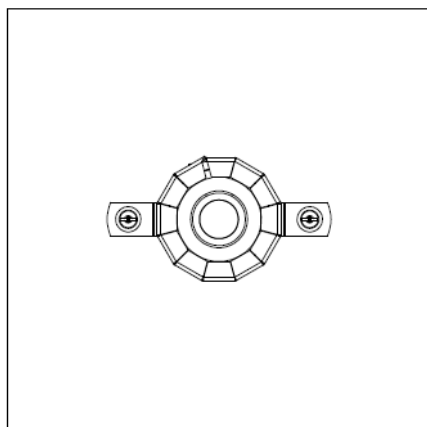
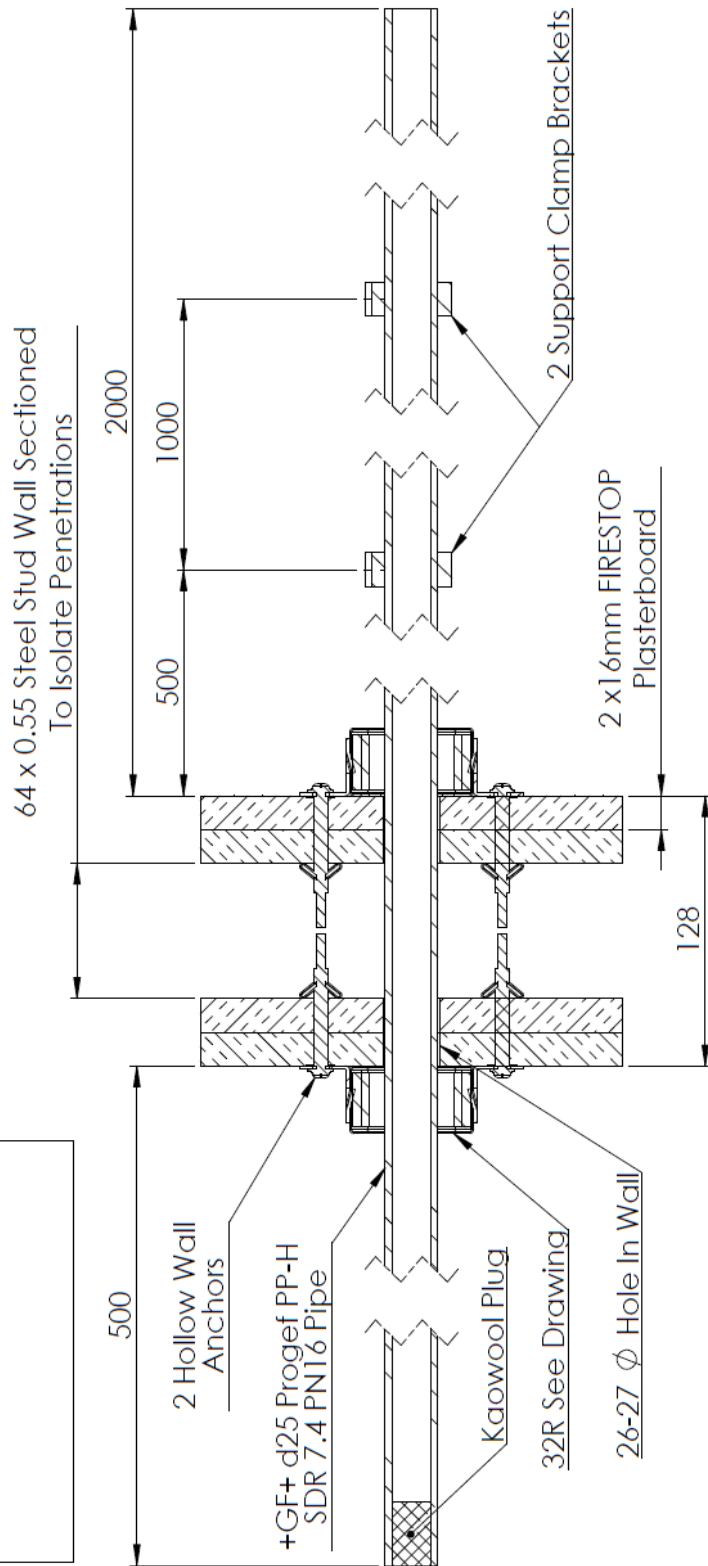
Penetration # D
 PP-H (25 mm ϕ SDR 7.4) Stack - Date 08-08-2014

DRAWING TITLED "PENETRATION #D – PP-H (25 MM ϕ SDR 7.4) STACK", DATED 08/08/2014 SUPPLIED BY SNAP FIRE SYSTEMS PTY LTD

Penetration #D – 32R retrofitted fire collar protecting a 25-mm diameter +GF+ Georg Fischer Progef Polypropylene PP-H SDR 7.4 PN16 stack pipe

The SNAP Retrofit 32R fire collar comprised a 0.75-mm steel casing with a 40-mm inner diameter and a 106-mm diameter base flange. The 32-mm high collar casing incorporated a closing mechanism that was comprised of two soft Intumesh intumescent wraps lined within the internal circumference of the collar. The inner and outer wraps were 4-mm thick x 26-mm wide x 135-mm long, and 4-mm thick x 26-mm wide x 154-mm long, respectively. Between the wraps was a layer of 304 stainless steel mesh 135 mm long x 25-mm wide with wire mesh diameter of 0.15-mm, as shown in drawing numbered 32R-T dated 2 July 2014, by SNAP Fire Systems. One collar was fixed to each side of the plasterboard wall in a back-to-back configuration using two hollow wall anchors.

The penetrating service comprised a 25-mm nominal diameter PP-H pipe, with a wall thickness of 3.5-mm, fitted through the collar's sleeve and penetrating the plasterboard wall through a 26-mm diameter cut-out hole as shown in drawing titled "Penetration #D PP-H (25-mm Ø SDR 7.4) Stack" dated 8 August 2014, by SNAP Fire Systems. The pipe projected horizontally, approximately 2000-mm away from the unexposed face of the plasterboard wall and approximately 500-mm into the

furnace chamber. The pipe was supported at nominally 500-mm from the unexposed face of the plasterboard wall by two support clamp brackets spaced apart at nominally 1000-mm. The pipe was open at the unexposed end and capped on the exposed end with a ceramic fibre (Kaowool) plug.

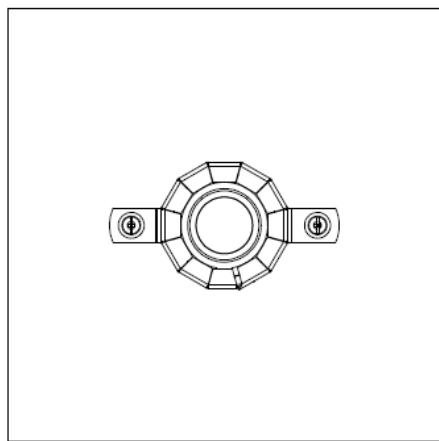
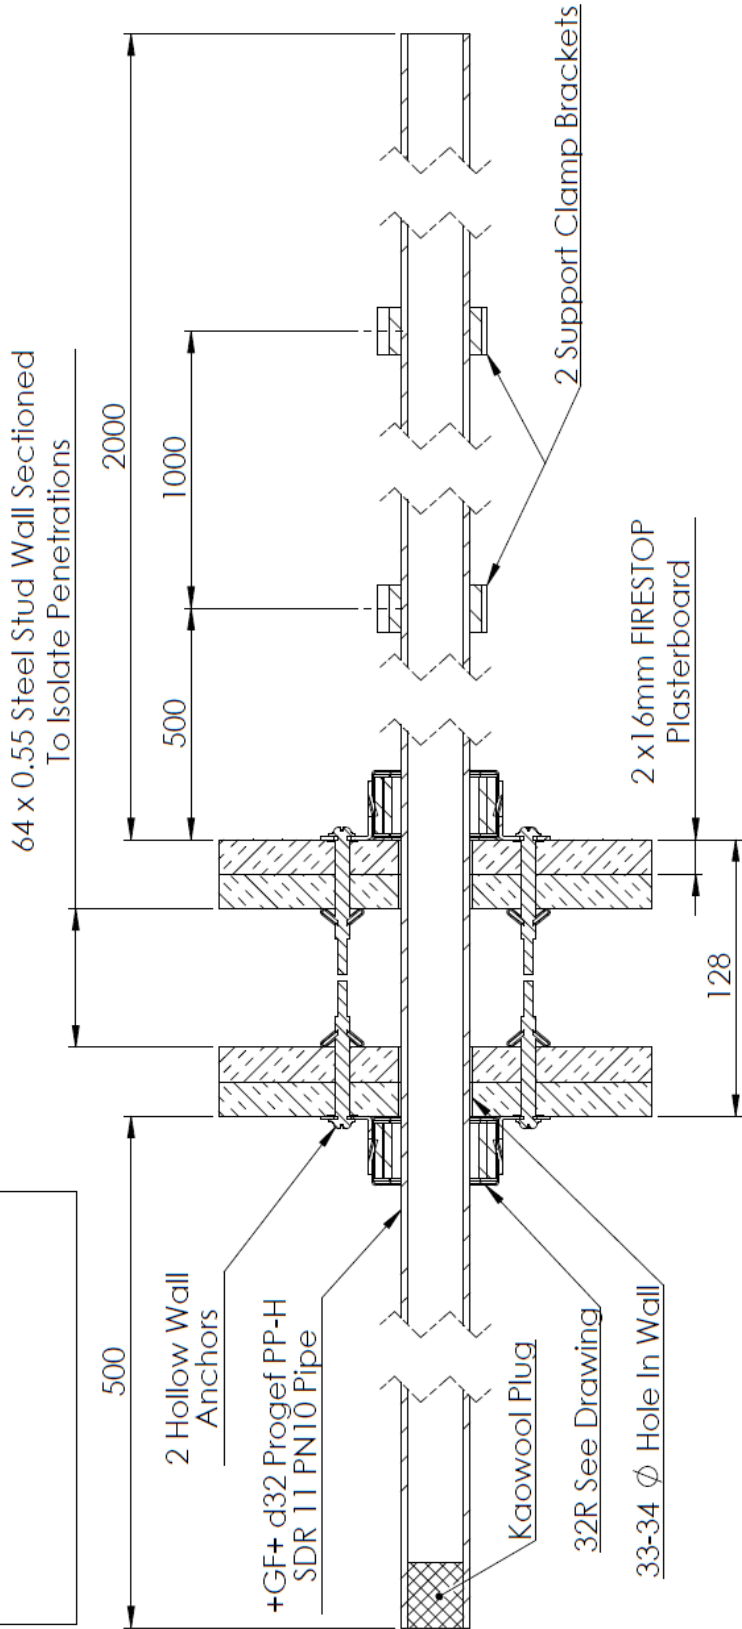
Penetration # E
 PP-H (32 mm ϕ SDR 11) Stack - Date 08-08-2014

DRAWING TITLED "PENETRATION #E – PP-H (32 MM ϕ SDR 11) STACK", DATED 08/08/2014 SUPPLIED BY SNAP FIRE SYSTEMS PTY LTD

Penetration #E – 32R retrofitted fire collar protecting a 32-mm diameter +GF+ Georg Fischer Progef Polypropylene PP-H SDR 11 PN10 stack pipe

The SNAP Retrofit 32R fire collar comprised a 0.75-mm steel casing with a 40-mm inner diameter and a 106-mm diameter base flange. The 32-mm high collar casing incorporated a closing mechanism that was comprised of two soft Intumesh intumescent wraps lined within the internal circumference of the collar. The inner and outer wraps were 4-mm thick x 26-mm wide x 135-mm long, and 4-mm thick x 26-mm wide x 154-mm long, respectively. Between the wraps was a layer of 304 stainless steel mesh 135 mm long x 25-mm wide with wire mesh diameter of 0.15-mm, as shown in drawing numbered 32R-T dated 2 July 2014, by SNAP Fire Systems. One collar was fixed to each side of the plasterboard wall in a back-to-back configuration using two hollow wall anchors.

The penetrating service comprised a 32-mm nominal diameter PP-H pipe, with a wall thickness of 3.8-mm, fitted through the collar's sleeve and penetrating the plasterboard wall through a 33-mm diameter cut-out hole as shown in drawing titled "Penetration #E PP-H (32-mm Ø SDR 11) Stack" dated 8 August 2014, by SNAP Fire Systems. The pipe projected horizontally, approximately 2000-mm away from the unexposed face of the plasterboard wall and approximately 500-mm into the furnace chamber. The pipe was supported at nominally 500-mm from the unexposed face of the plasterboard wall by two support clamp brackets spaced apart at nominally 1000-mm. The pipe was open at the unexposed end and capped on the exposed end with a ceramic fibre (Kaowool) plug.

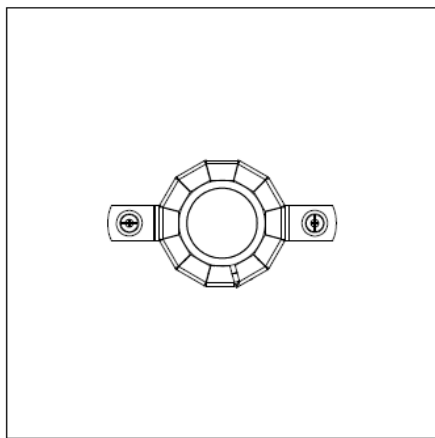
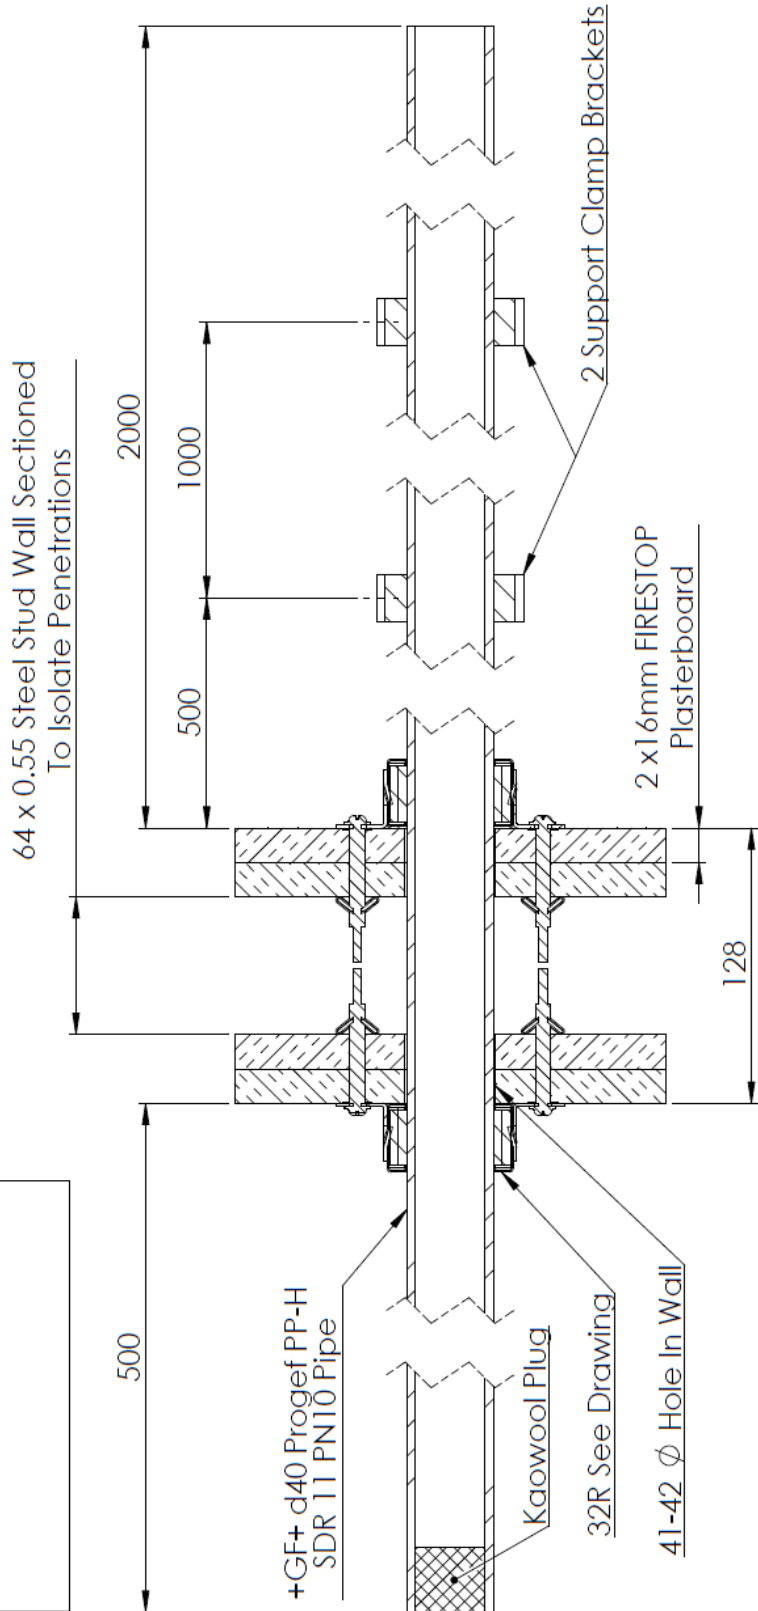
Penetration # F
 PP-H (40 mm ϕ SDR 11) Stack - Date 08-08-2014

DRAWING TITLED "PENETRATION # F – PP-H (40 MM ϕ SDR 11) STACK", DATED 08/08/2014 SUPPLIED BY SNAP FIRE SYSTEMS PTY LTD

Penetration #F – 32R retrofitted fire collar protecting a 40-mm diameter +GF+ Georg Fischer Progef Polypropylene PP-H SDR 11 PN10 stack pipe

The SNAP Retrofit 32R fire collar comprised a 0.75-mm steel casing with a 40-mm inner diameter and a 106-mm diameter base flange. The 32-mm high collar casing incorporated a closing mechanism that was comprised of two soft Intumesh intumescent wraps lined within the internal circumference of the collar. The inner and outer wraps were 4-mm thick x 26-mm wide x 135-mm long, and 4-mm thick x 26-mm wide x 154-mm long, respectively. Between the wraps was a layer of 304 stainless steel mesh 135 mm long x 25-mm wide with wire mesh diameter of 0.15-mm, as shown in drawing numbered 32R-T dated 2 July 2014, by SNAP Fire Systems. One collar was fixed to each side of the plasterboard wall in a back-to-back configuration using two hollow wall anchors.

The penetrating service comprised a 40-mm nominal diameter PP-H pipe, with a wall thickness of 4.1-mm, fitted through the collar's sleeve and penetrating the plasterboard wall through a 41-mm diameter cut-out hole as shown in drawing titled "Penetration #F PP-H (40-mm Ø SDR 11) Stack" dated 8 August 2014, by SNAP Fire Systems. The pipe projected horizontally, approximately 2000-mm away from the unexposed face of the plasterboard wall and approximately 500-mm into the furnace chamber. The pipe was supported at nominally 500-mm from the unexposed face of the plasterboard wall by two support clamp brackets spaced apart at nominally 1000-mm. The pipe was open at the unexposed end and capped on the exposed end with a ceramic fibre (Kaowool) plug.

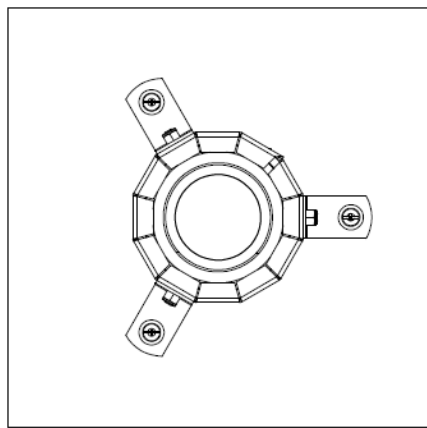
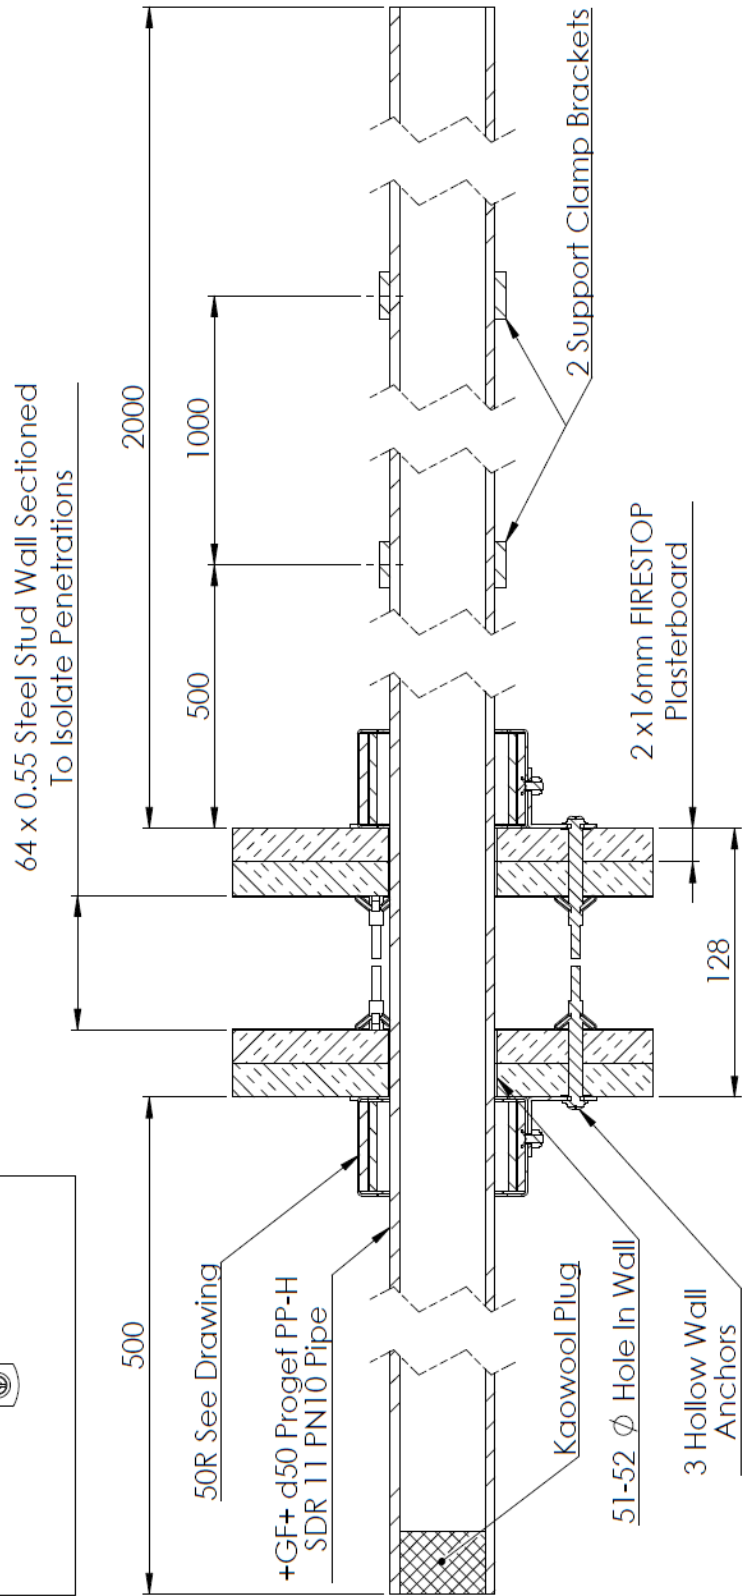
Penetration # G
 PP-H (50 mm ϕ SDR 11) Stack - Date 08-08-2014

DRAWING TITLED "PENETRATION #G – PP-H (50 MM ϕ SDR 11) STACK", DATED 08/08/2014 SUPPLIED BY SNAP FIRE SYSTEMS PTY LTD

Penetration #G – 50R retrofitted fire collar protecting a 50-mm diameter +GF+ Georg Fischer Progef Polypropylene PP-H SDR 11 PN10 stack pipe

The SNAP Retrofit 50R fire collar comprised a 0.75-mm steel casing with a 62-mm inner diameter and a 149-mm diameter base flange. The 47-mm high collar casing incorporated a closing mechanism that was comprised of two soft Intumesh intumescent wraps lined within the internal circumference of the collar. The inner and outer wraps were 4-mm thick x 43-mm wide x 200-mm long, and 4-mm thick x 43-mm wide x 220-mm long, respectively. Between the wraps was a layer of 304 stainless steel mesh 210 mm long x 42-mm wide with wire mesh diameter of 0.15-mm, as shown in drawing numbered 50R-T dated 4 November 2013, by SNAP Fire Systems. One collar was fixed to each side of the plasterboard wall in a back-to-back configuration using three hollow wall anchors.

The penetrating service comprised a 50-mm nominal diameter PP-H pipe, with a wall thickness of 5.1-mm, fitted through the collar's sleeve and penetrating the plasterboard wall through a 51-mm diameter cut-out hole as shown in drawing titled "Penetration #G PP-H (50-mm Ø SDR 11) Stack" dated 8 August 2014, by SNAP Fire Systems. The pipe projected horizontally, approximately 2000-mm away from the unexposed face of the plasterboard wall and approximately 500-mm into the furnace chamber. The pipe was supported at nominally 500-mm from the unexposed face of the plasterboard wall by two support clamp brackets spaced apart at nominally 1000-mm. The pipe was open at the unexposed end and capped on the exposed end with a ceramic fibre (Kaowool) plug.

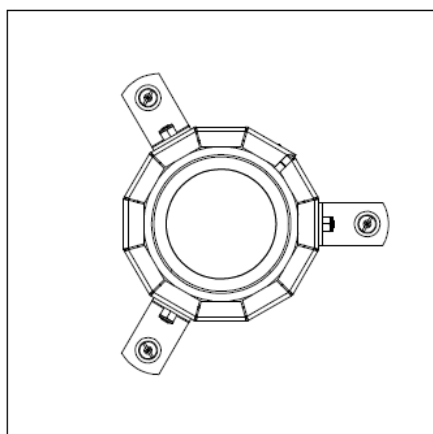
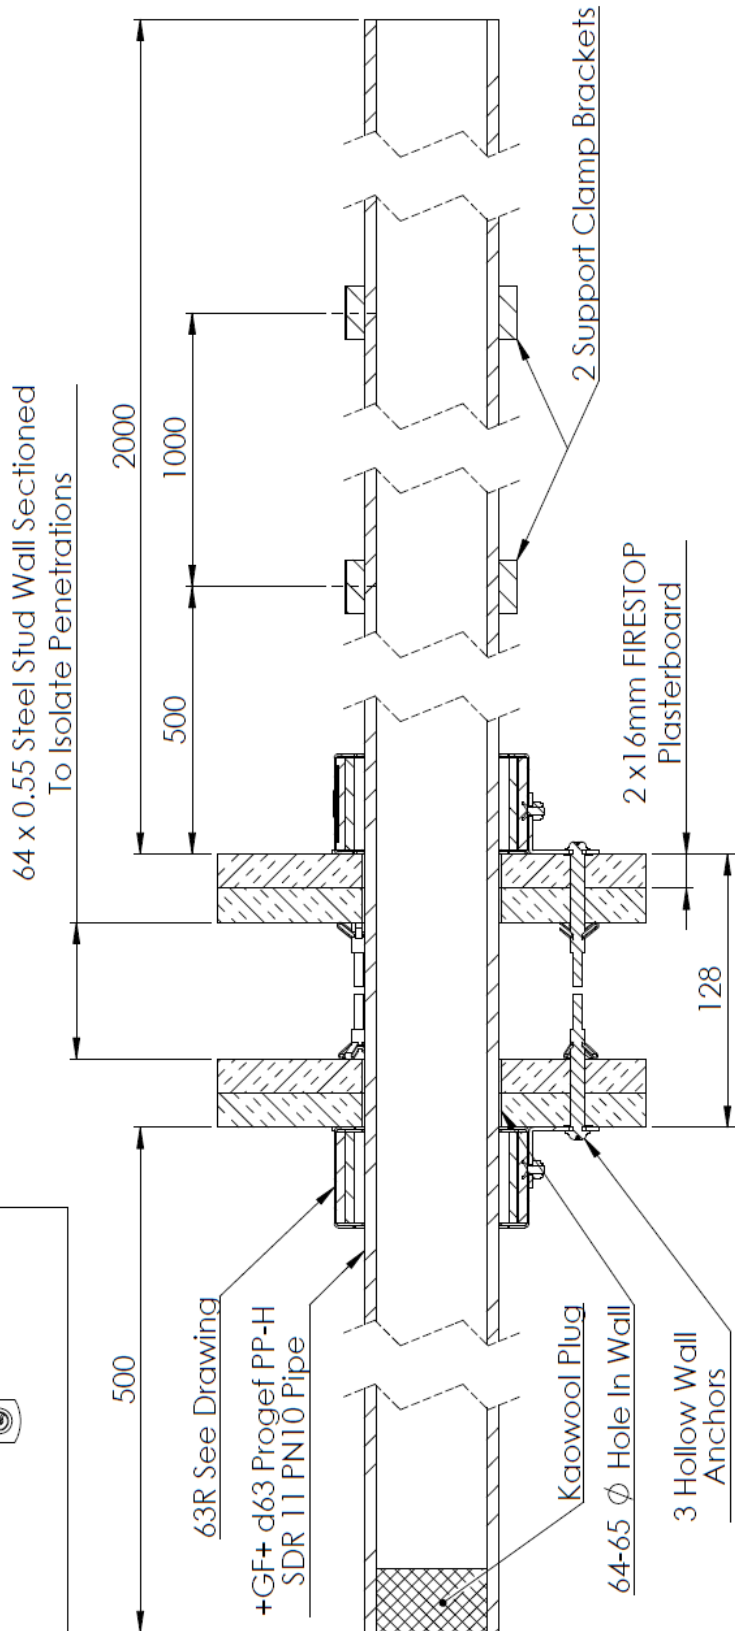
Penetration # H
 PP-H (63 mm ϕ SDR 11) Stack - Date 08-08-2014

DRAWING TITLED "PENETRATION #H – PP-H (63 MM ϕ SDR 11) STACK", DATED 08/08/2014 SUPPLIED BY SNAP FIRE SYSTEMS PTY LT

Penetration #H – 63R retrofitted fire collar protecting a 63-mm diameter +GF+ Georg Fischer Progef Polypropylene PP-H SDR 11 PN10 stack pipe

The SNAP Retrofit 63R fire collar comprised a 0.75-mm steel casing with a 72-mm inner diameter and a 157-mm diameter base flange. The 47-mm high collar casing incorporated a closing mechanism that was comprised of two soft Intumesh intumescent wraps lined within the internal circumference of the collar. The inner and outer wraps were 4-mm thick x 43-mm wide x 230-mm long, and 4-mm thick x 43-mm wide x 255-mm long, respectively. Between the wraps was a layer of 304 stainless steel mesh 240 mm long x 42-mm wide with wire mesh diameter of 0.15-mm, as shown in drawing numbered 63R-T dated 15 November 2014, by SNAP Fire Systems. One collar was fixed to each side of the plasterboard wall in a back-to-back configuration using three hollow wall anchors.

The penetrating service comprised a 63-mm nominal diameter PP-H pipe, with a wall thickness of 6.7-mm, fitted through the collar's sleeve and penetrating the plasterboard wall through a 64-mm diameter cut-out hole as shown in drawing titled "Penetration #H PP-H (63-mm Ø SDR 11) Stack" dated 8 August 2014, by SNAP Fire Systems. The pipe projected horizontally, approximately 2000-mm away from the unexposed face of the plasterboard wall and approximately 500-mm into the furnace chamber. The pipe was supported at nominally 500-mm from the unexposed face of the plasterboard wall by two support clamp brackets spaced apart at nominally 1000-mm. The pipe was open at the unexposed end and capped on the exposed end with a ceramic fibre (Kaowool) plug.
