Fire-resistance test on fire collars protecting a concrete slab penetrated by services

Test Report

Author: Mario Lara-Ledermann
Report number: FSP 1696
Date: 31 August 2015

Client: Snap Fire Systems Pty Ltd

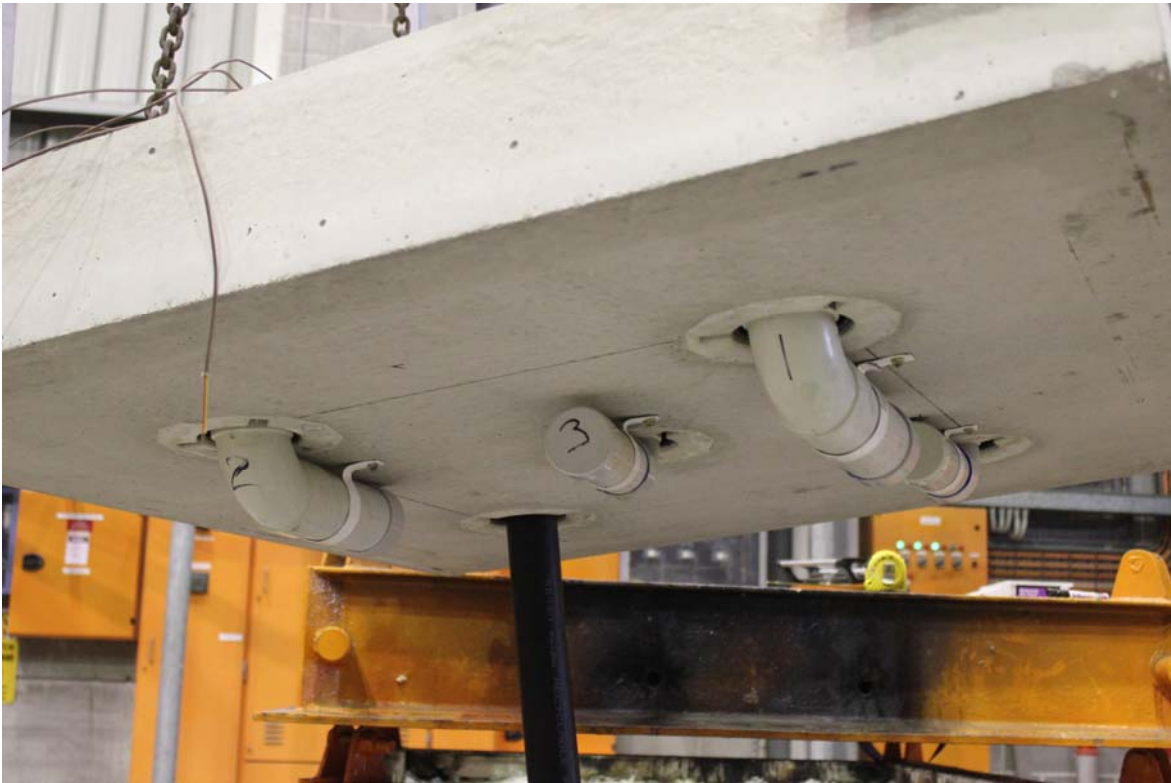
PHOTOGRAPH 1 – EXPOSED FACE OF SPECIMENS PRIOR TO TESTING

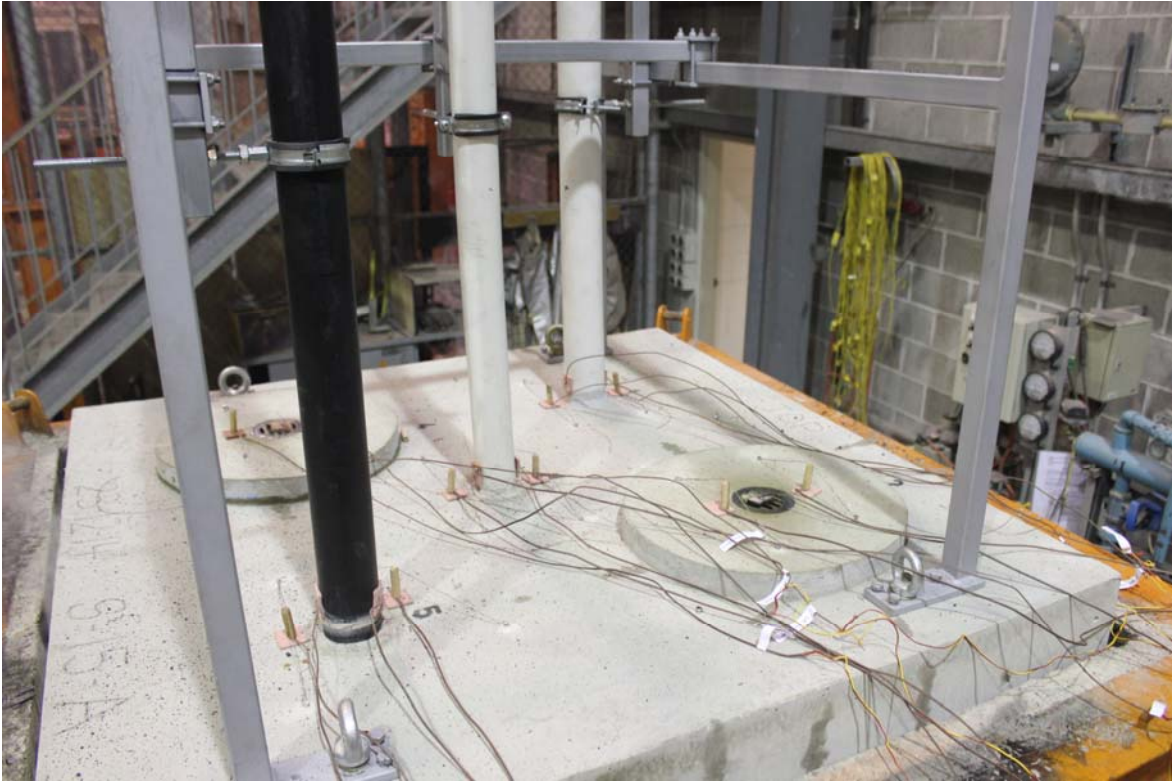
PHOTOGRAPH 3 – SPECIMENS AFTER 60 MINUTES OF TESTING

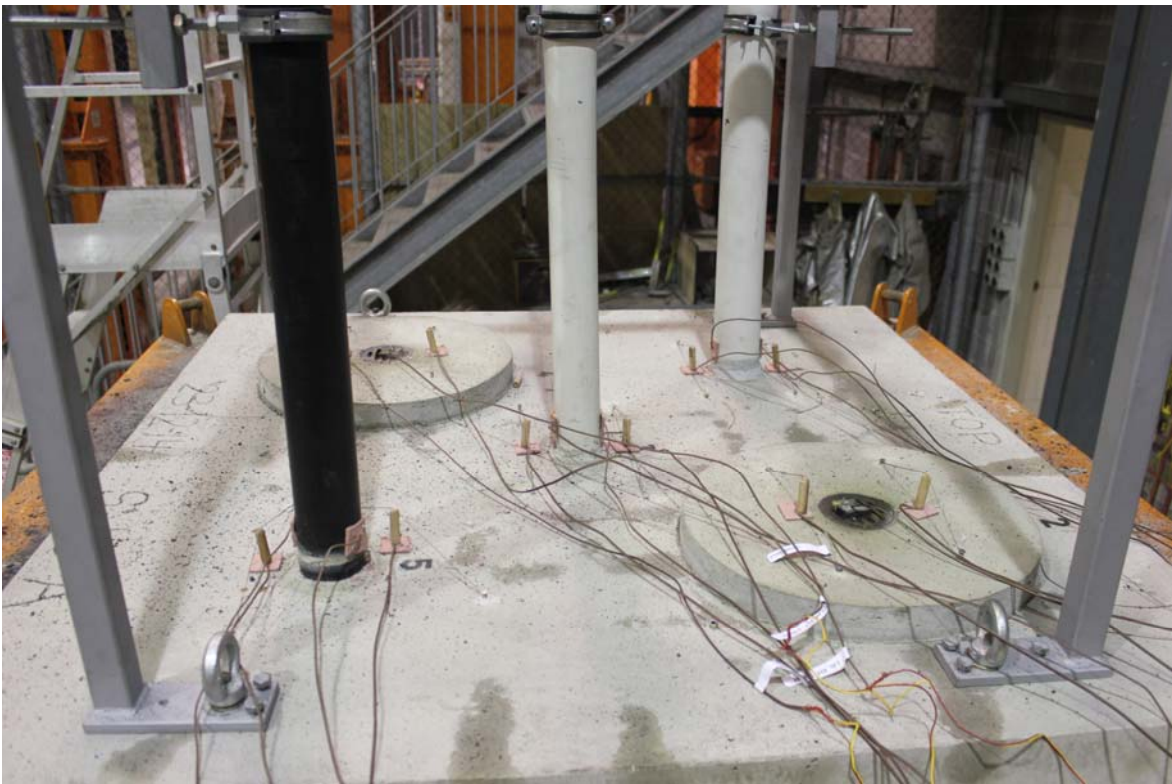
PHOTOGRAPH 4 – SPECIMENS AFTER 120 MINUTES OF TESTING

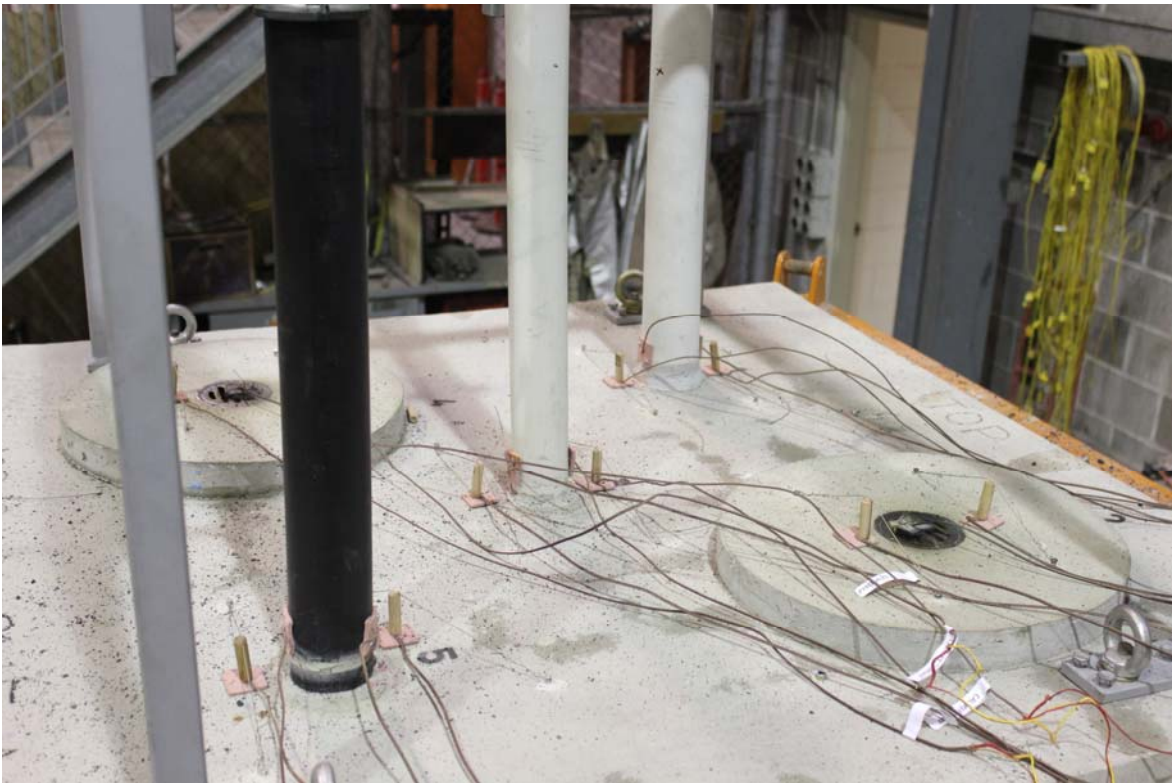
PHOTOGRAPH 5 – SPECIMENS AFTER 180 MINUTES OF TESTING
