**FIRE-RESISTANCE TEST ON  
FIRE COLLARS PROTECTING A CONCRETE SLAB  
PENETRATED BY SERVICES**

**Report number FSP 1592  
CSIRO job number SP3648  
Date of issue 18 JULY 2013**

**Client  
SNAP FIRE SYSTEMS PTY LTD.**

**SPONSORED INVESTIGATION No. FSP 1592****FIRE-RESISTANCE TEST ON FIRE COLLARS PROTECTING A  
CONCRETE SLAB PENETRATED BY SERVICES****SUMMARY****IDENTIFICATION OF SPECIMEN:**

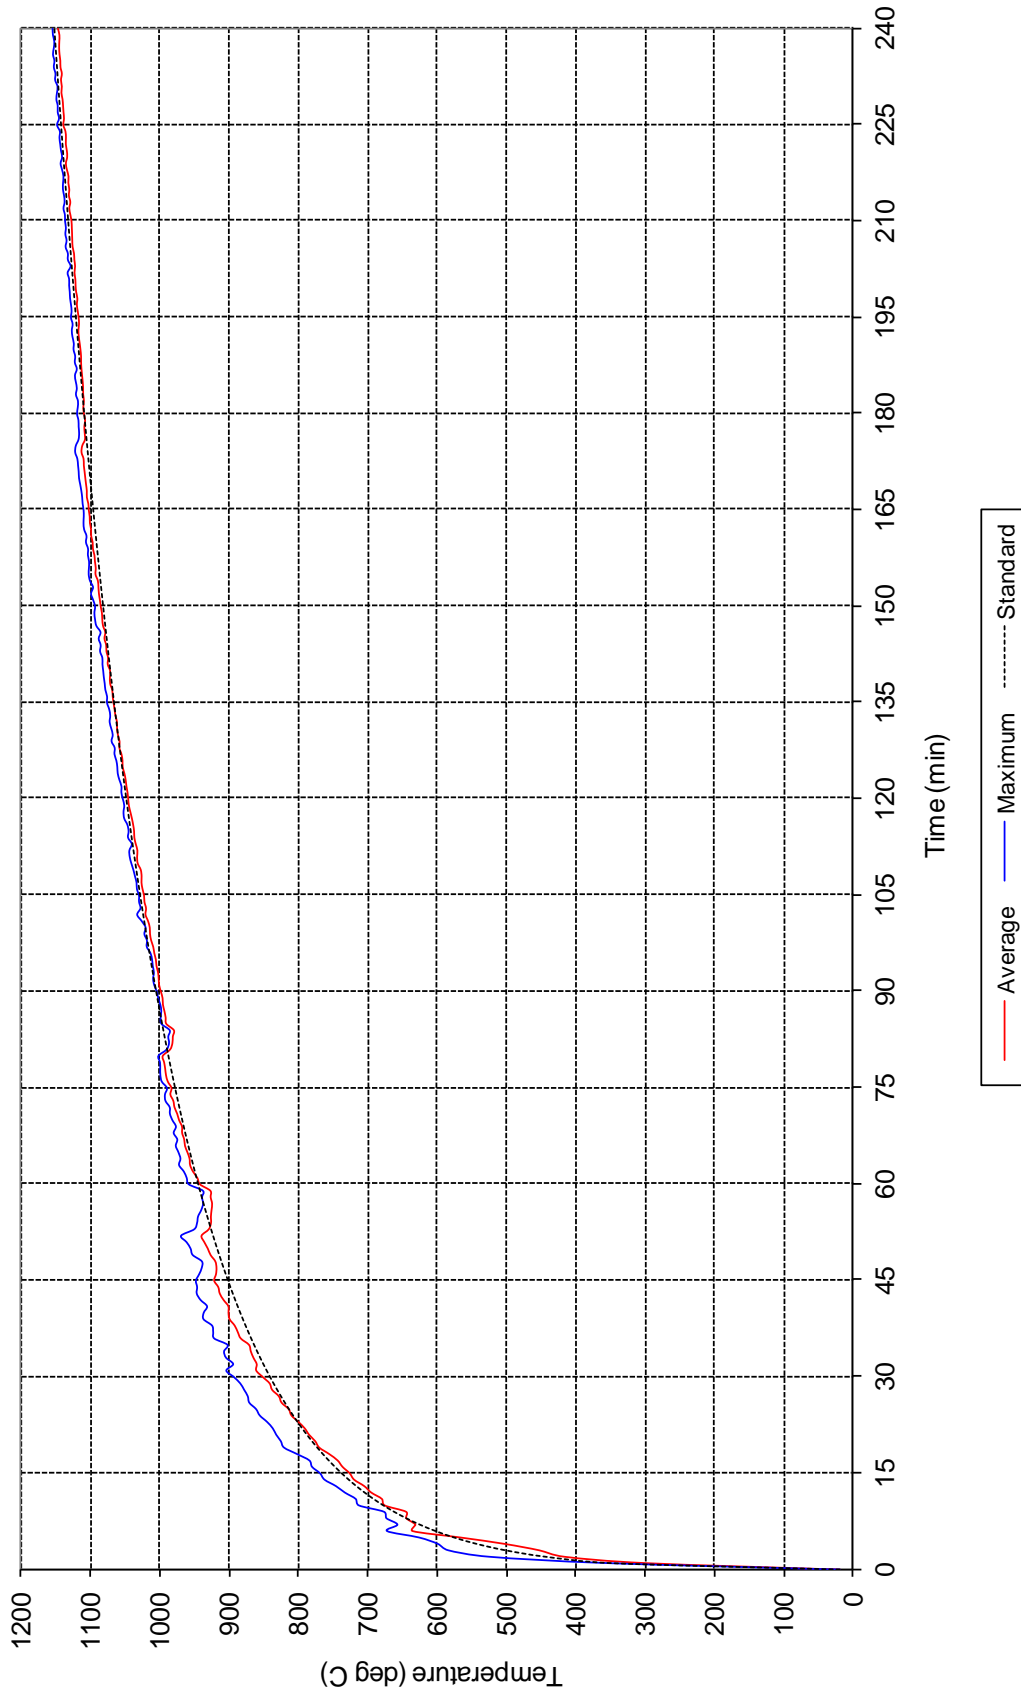
Figure 1 - Furnace temperature

Figure 1 shows the standard curves of temperature versus time for heating the furnace chamber and the actual curves of average and maximum temperature versus time recorded during the heating period.
