Fire-resistance test on fire collars protecting a concrete slab penetrated by services

Test Report

Author: Mario Lara
Report number: FSP 1601a
Date: 11 April 2014
(This report supersedes version dated 25 March 2014)

Sponsored Investigation No. FSP 1601a

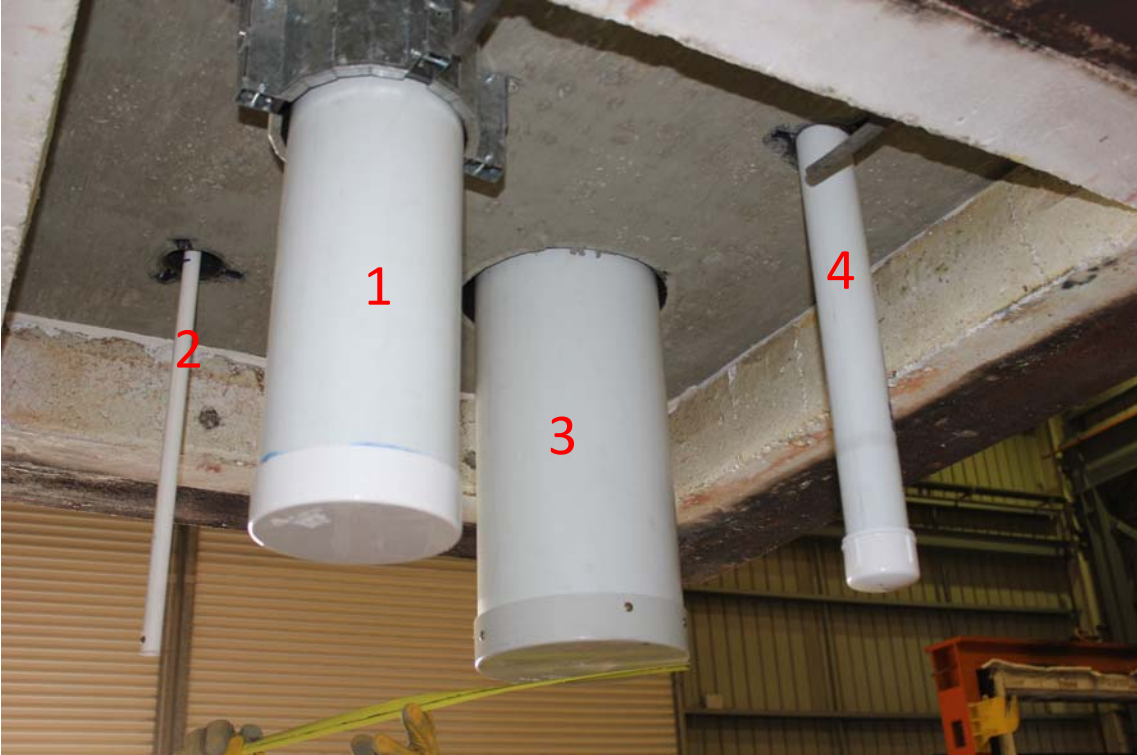
PHOTOGRAPH 1 – EXPOSED FACE OF SPECIMENS PRIOR TO TESTING

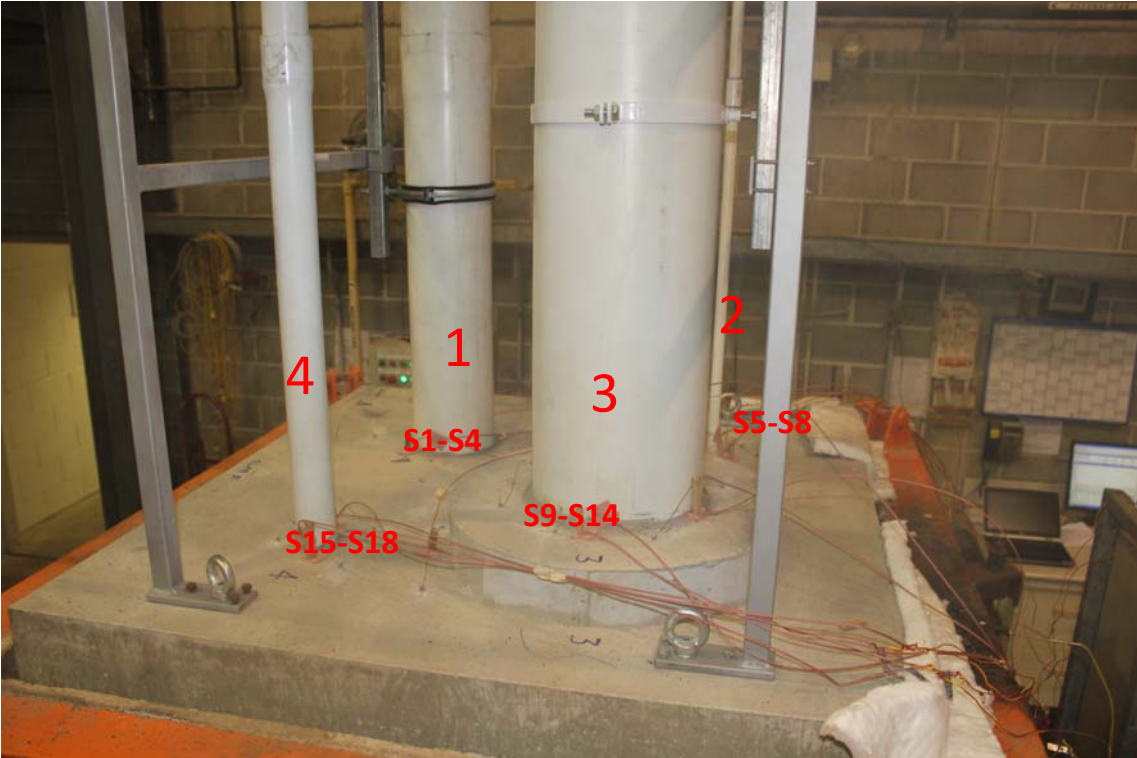
PHOTOGRAPH 2 – UNEXPOSED FACE OF SPECIMENS PRIOR TO TESTING

Location of the thermocouples on the unexposed face of the specimen is shown in photograph 2.

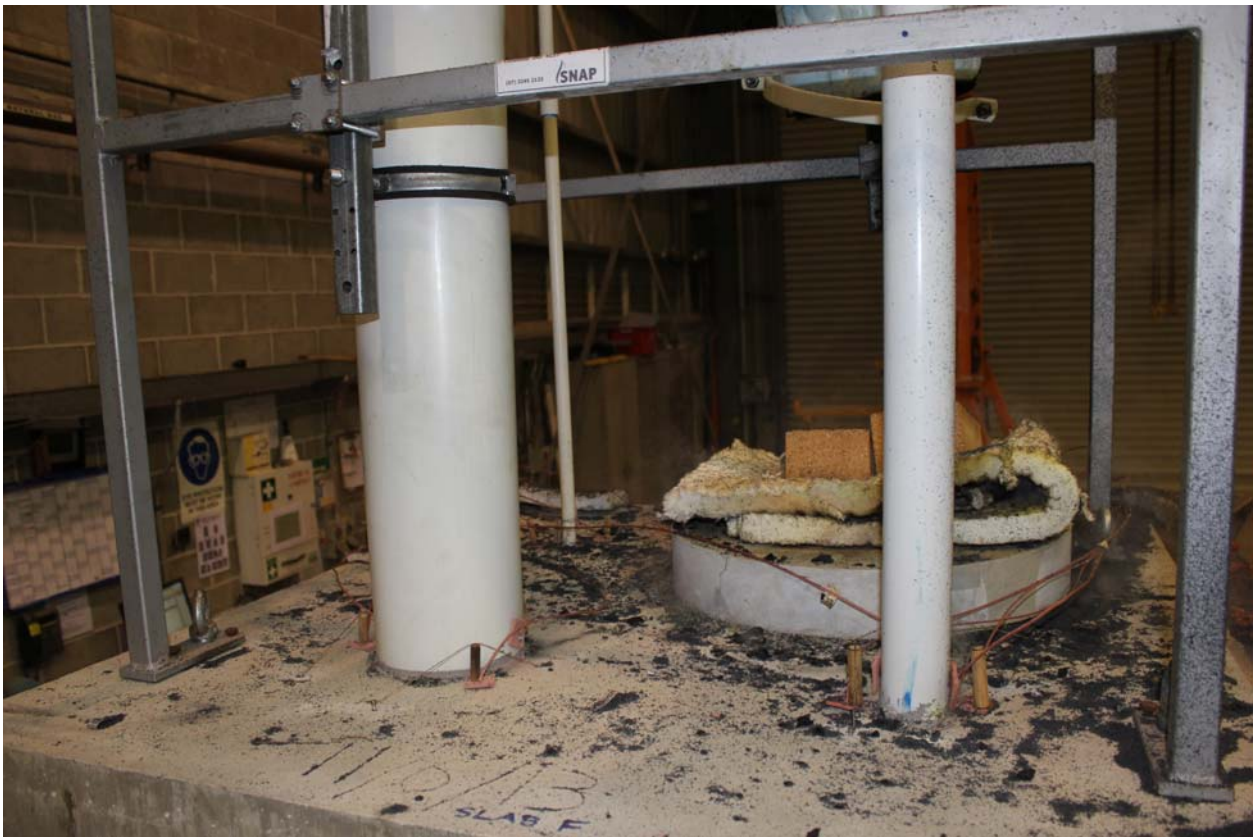
PHOTOGRAPH 4 – SPECIMENS AFTER 120 MINUTES OF TESTING

- 2 minutes - Smoke is fluing from Penetration 1.
- 10 minutes - Smoke is fluing from all pipes.
- 60 minutes - No change to the specimen.
- 120 minutes - No change to the specimen.
- 180 minutes - No change to the specimen.
- 241 minutes - Test terminated.

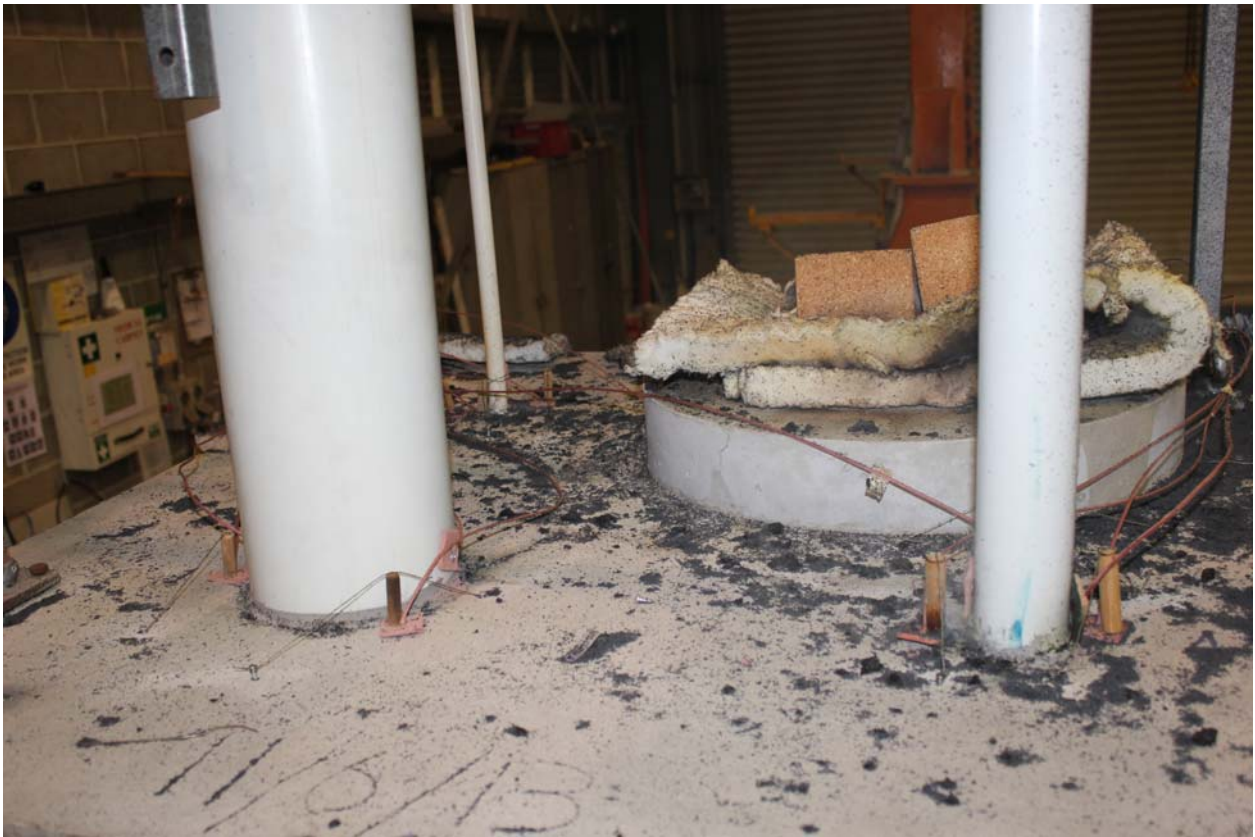
PHOTOGRAPH 5 – SPECIMENS AFTER 180 MINUTES OF TESTING

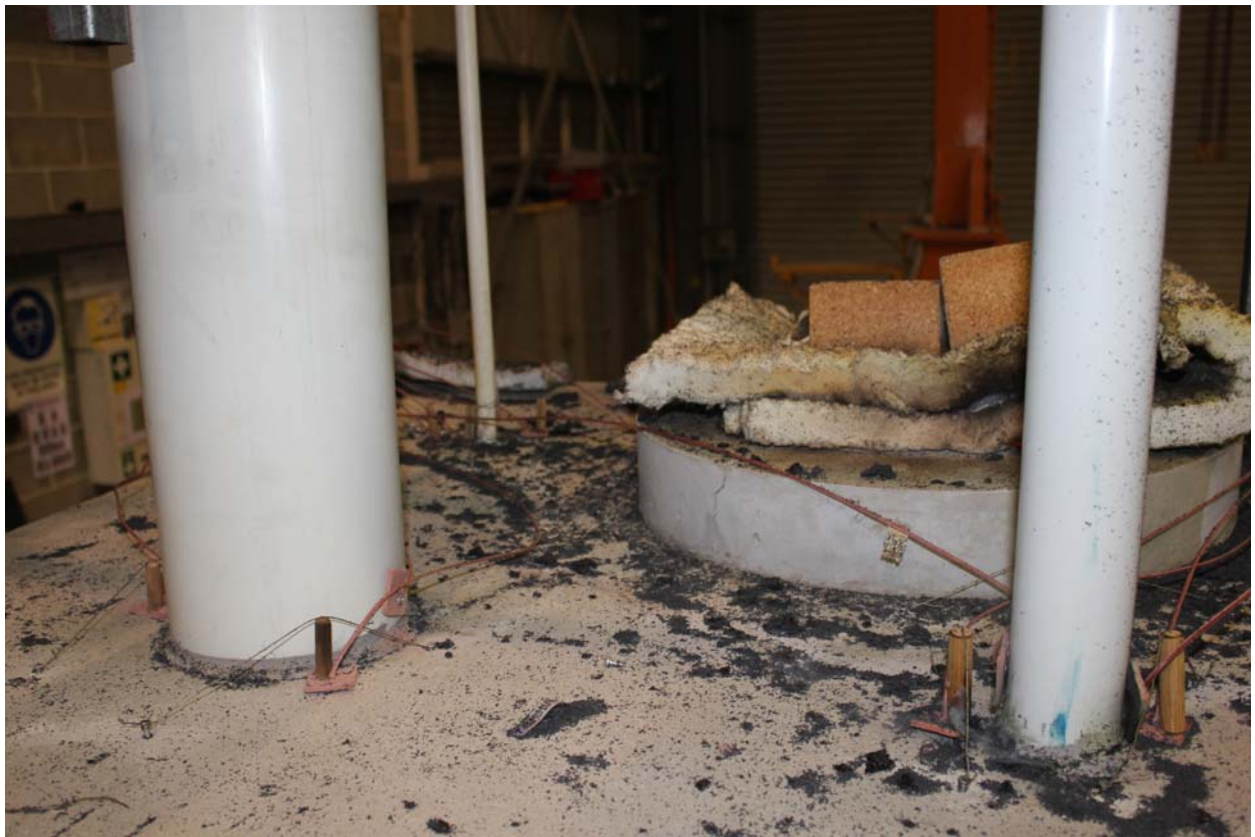
PHOTOGRAPH 6 – SPECIMENS AFTER 240 MINUTES OF TESTING
