Fire-resistance test on fire collars protecting a concrete slab penetrated by services

Test Report

Author: Mario Lara
Report number: FSP 1615
Date: 13 March 2014

Client: Snap Fire Systems Pty Ltd

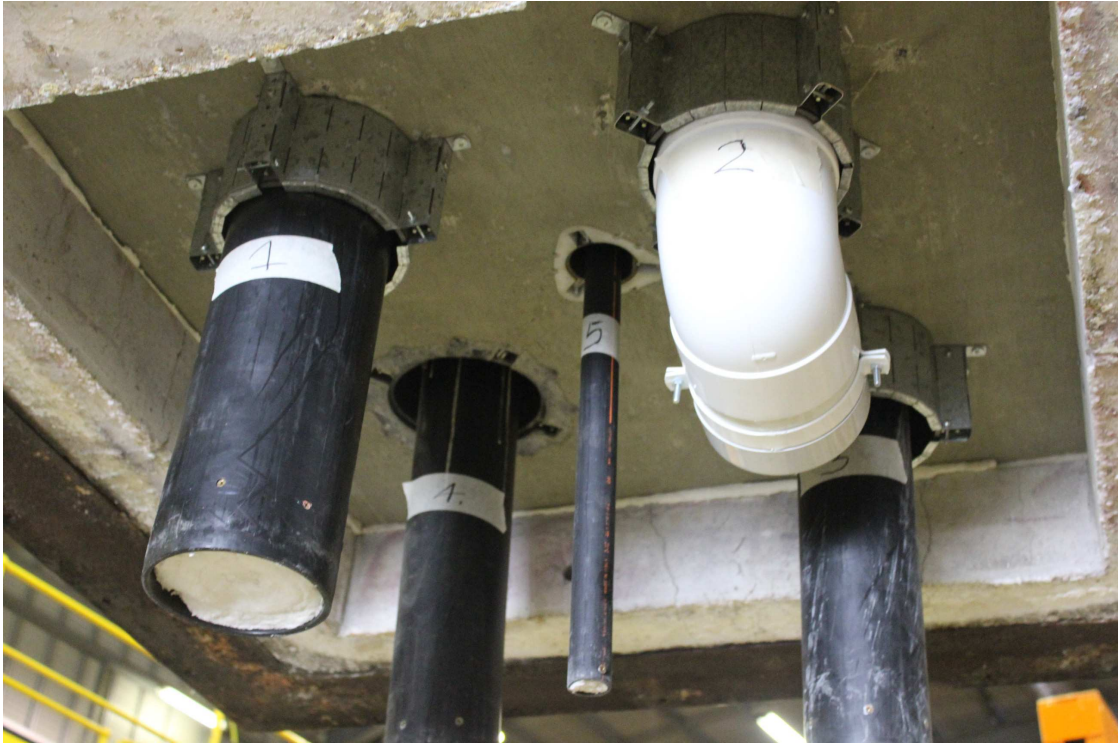
PHOTOGRAPH 1 – EXPOSED FACE OF SPECIMENS PRIOT TO TESTING

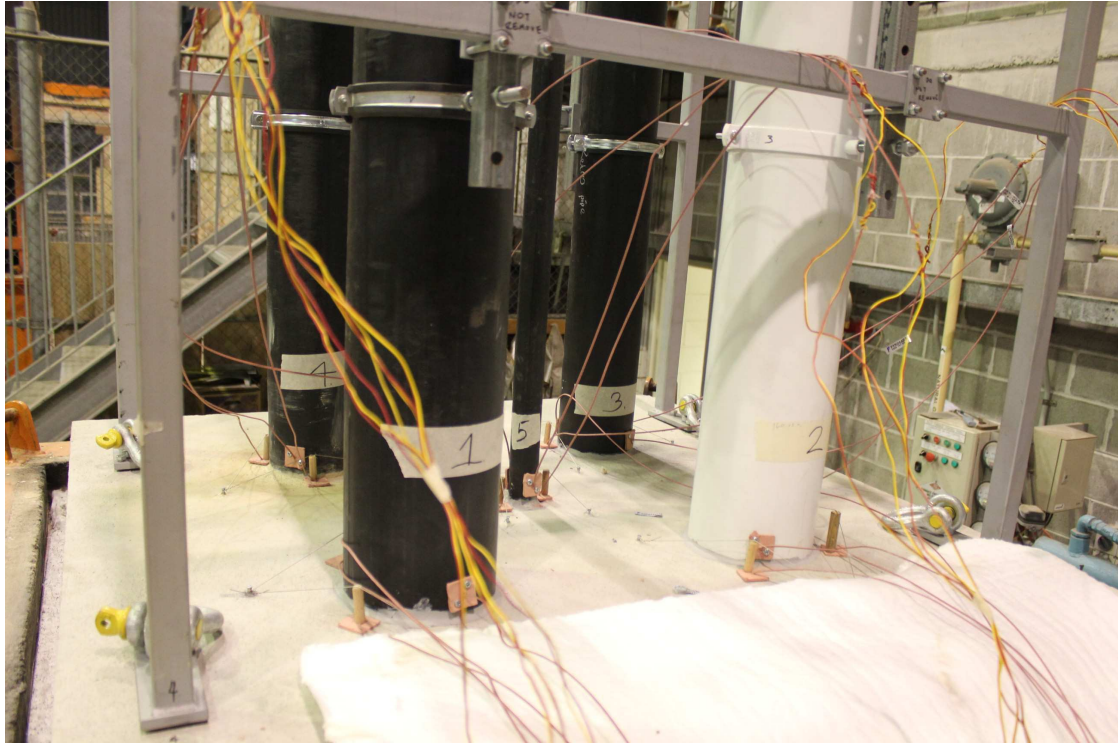
PHOTOGRAPH 2 – UNEXPOSED FACE OF SPECIMENS PRIOR TO TESTING

Location of the thermocouples on the unexposed face of the specimen is shown in photograph 2.

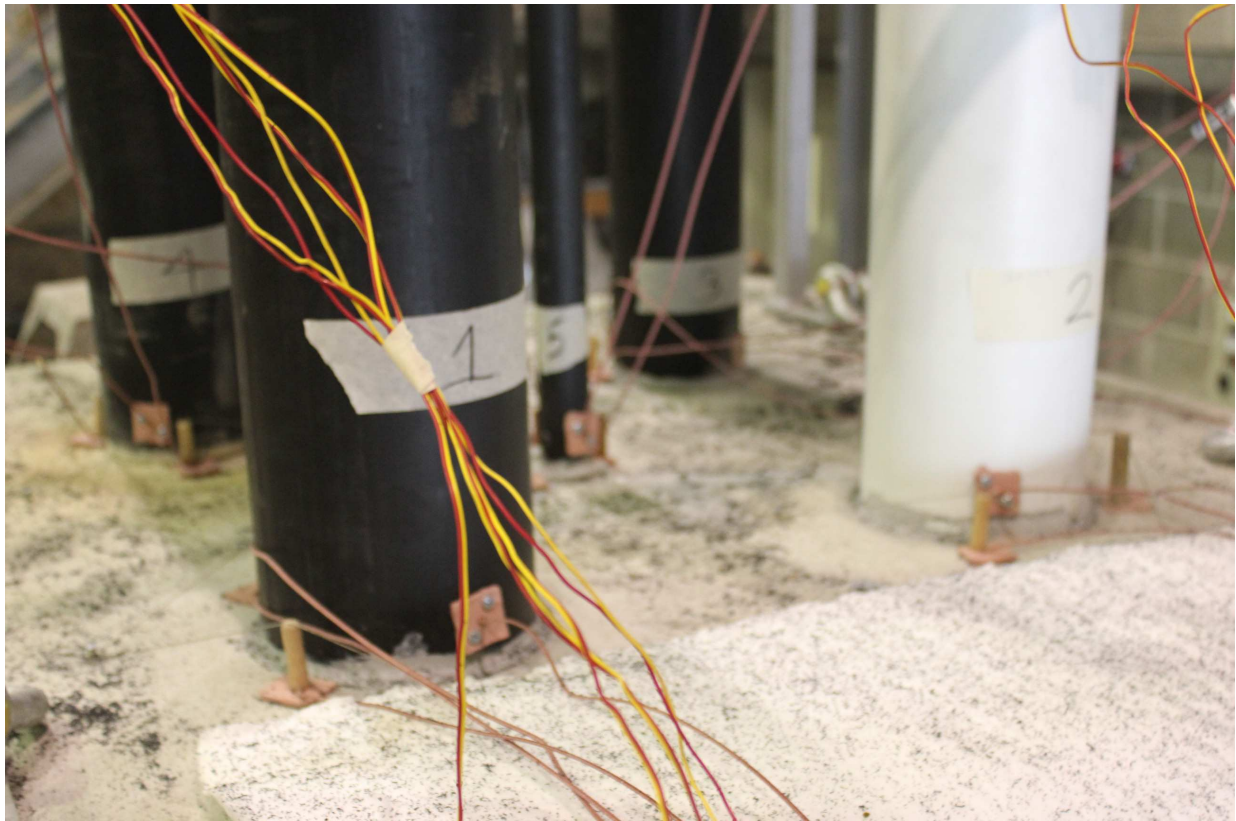
PHOTOGRAPH 3 – SPECIMENS AFTER 60 MINUTES OF TESTING

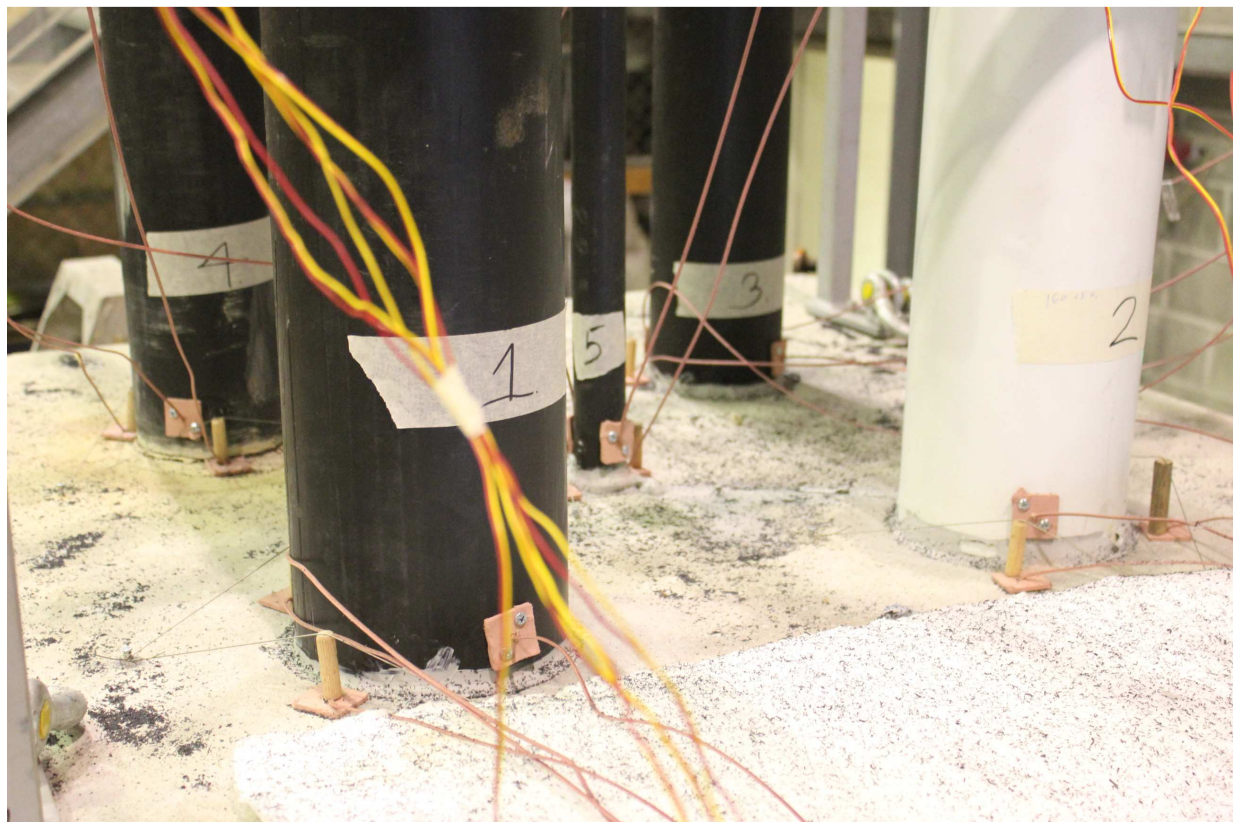
PHOTOGRAPH 4 – SPECIMENS AFTER 120 MINUTES OF TESTING

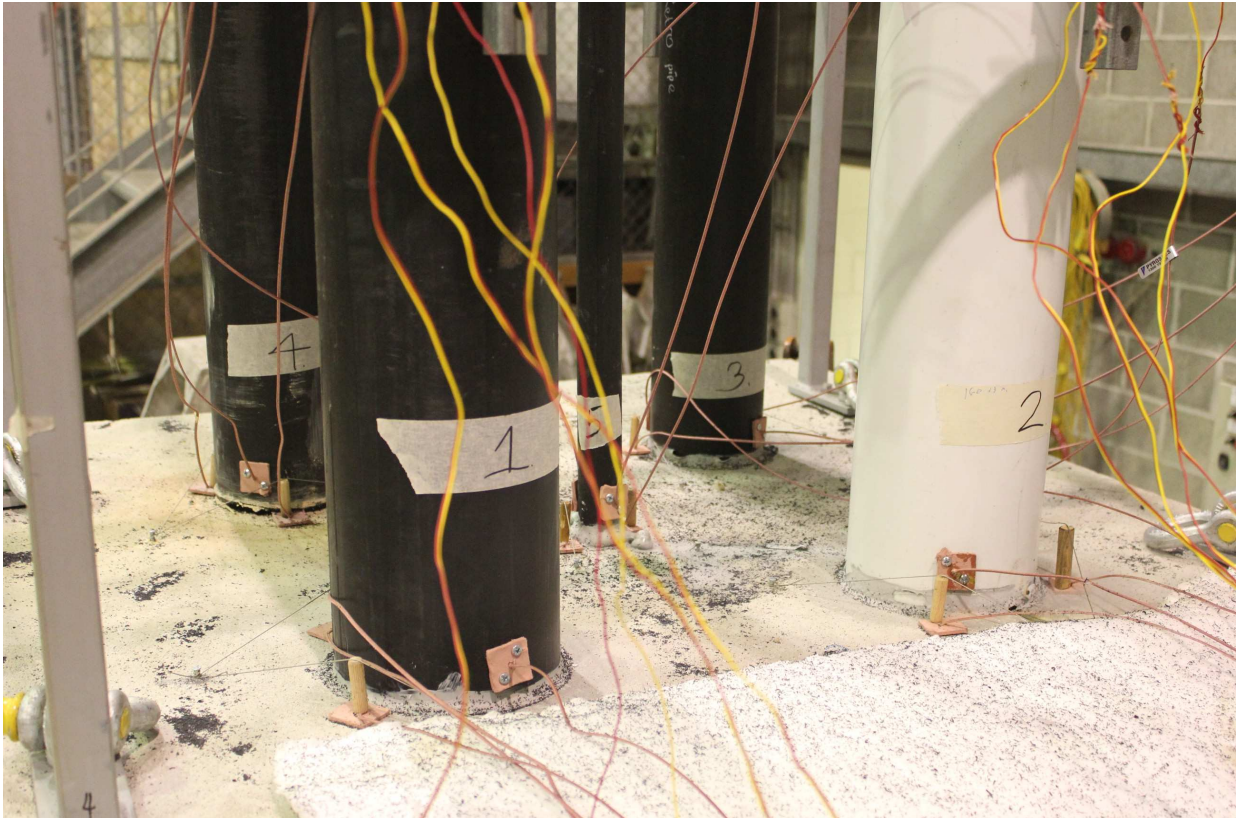
PHOTOGRAPH 5 – SPECIMENS AFTER 180 MINUTES OF TESTING

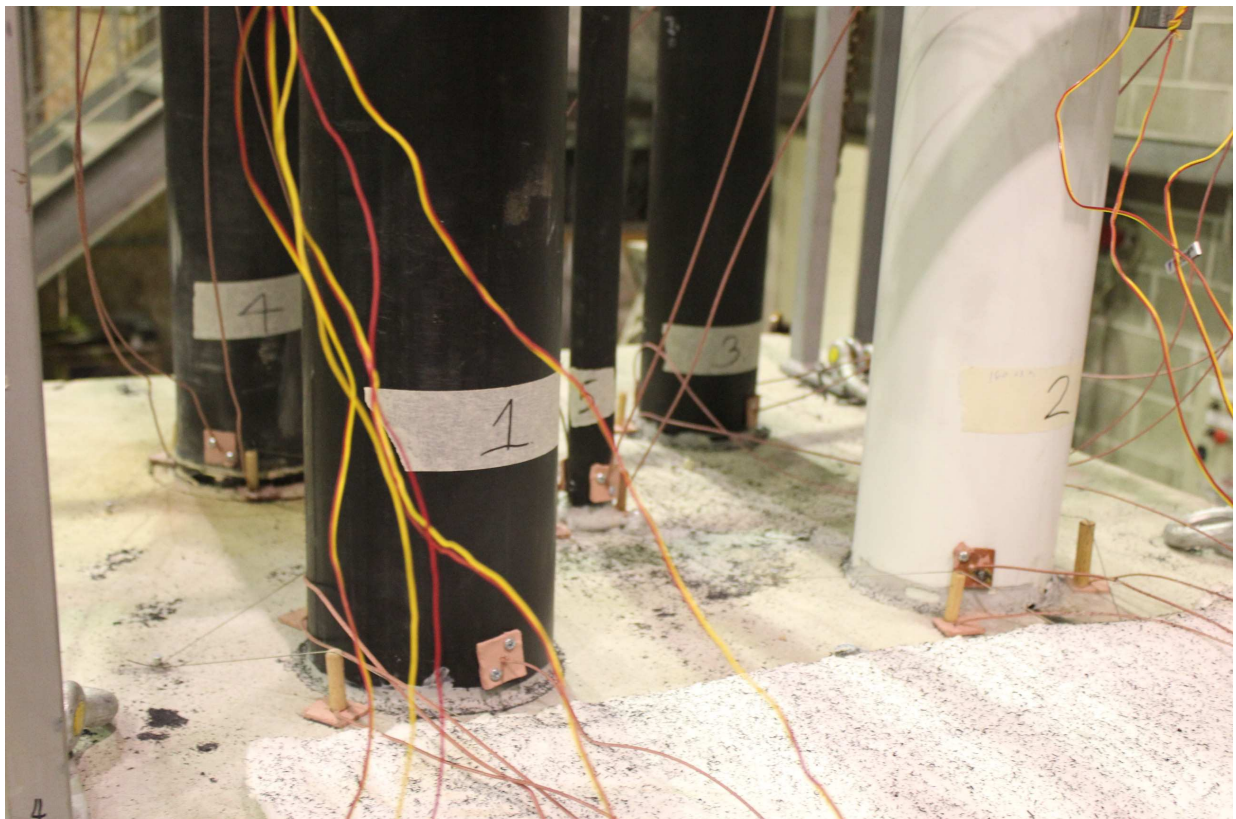
PHOTOGRAPH 6 – SPECIMENS AFTER 240 MINUTES OF TESTING

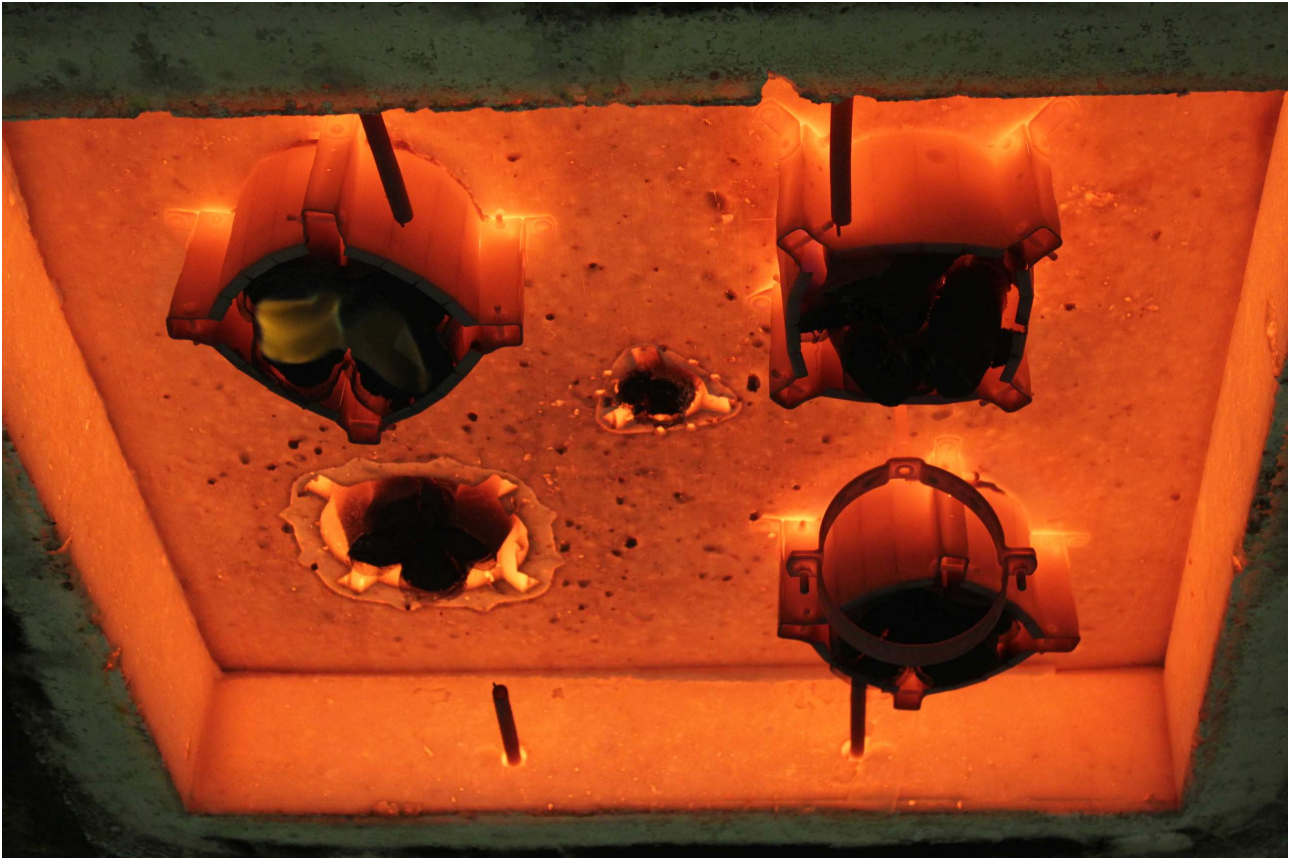
PHOTOGRAPH 7 – EXPOSED FACE OF SPECIMENS AT CONCLUSION OF TESTING

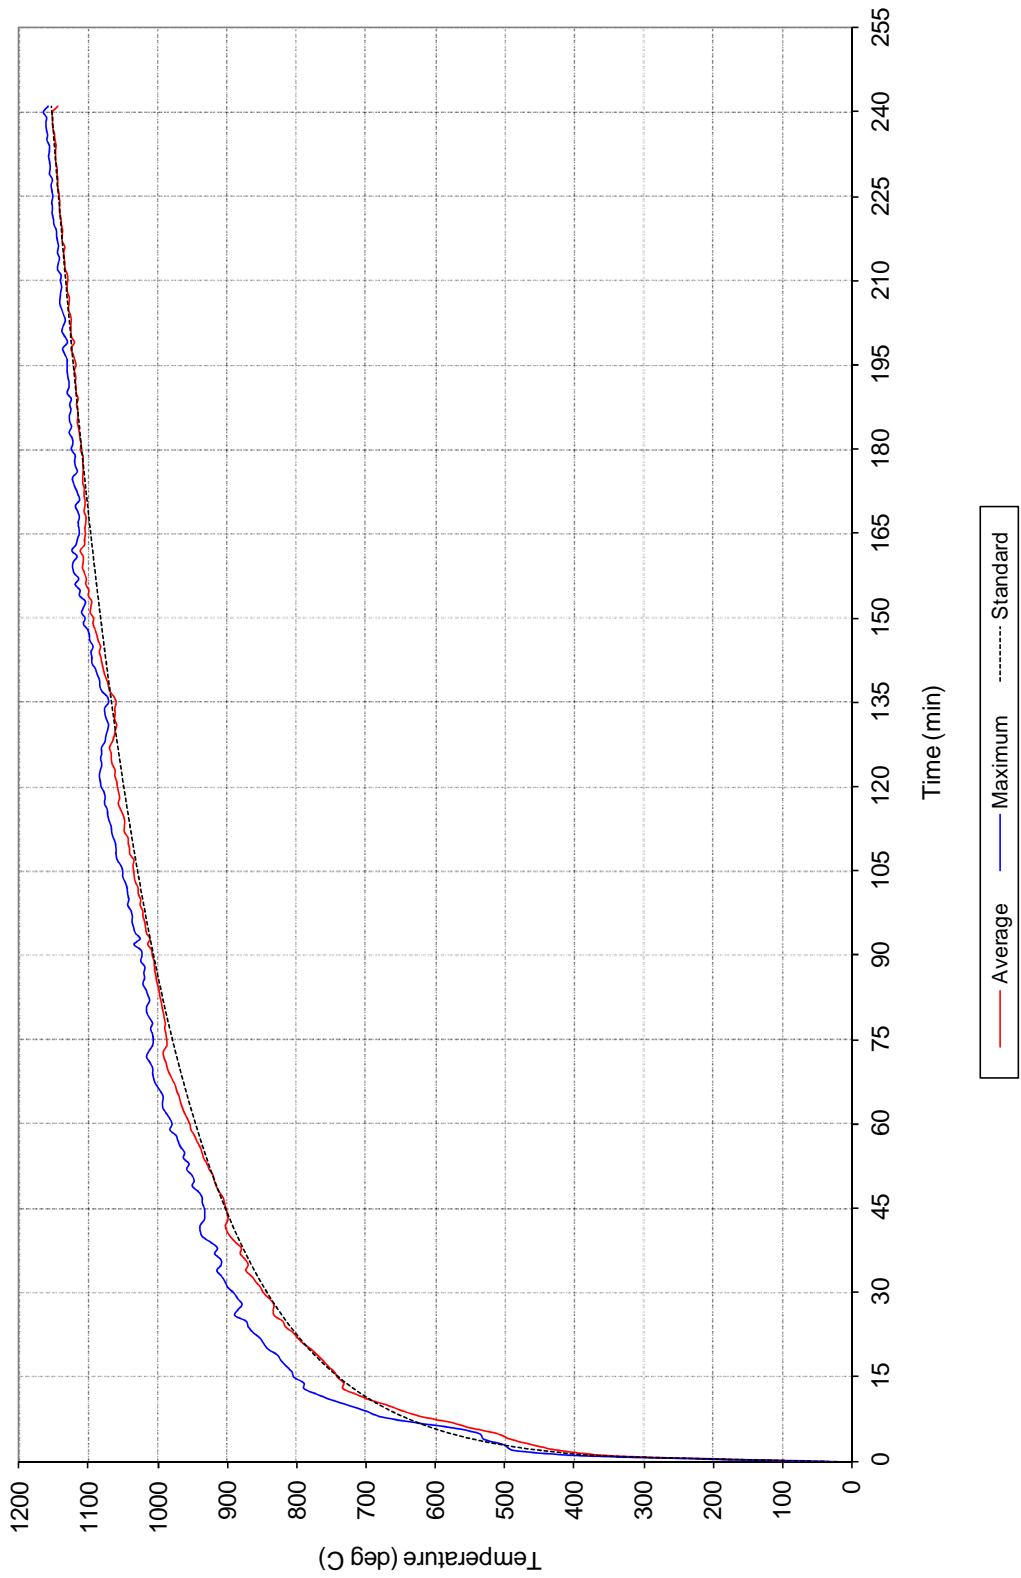
FIGURE 1 – FURNACE TEMPERATURE

Figure 1 shows the standard curves of temperature versus time for heating the furnace chamber and the actual curves of average and maximum temperature versus time recorded during the heating period.

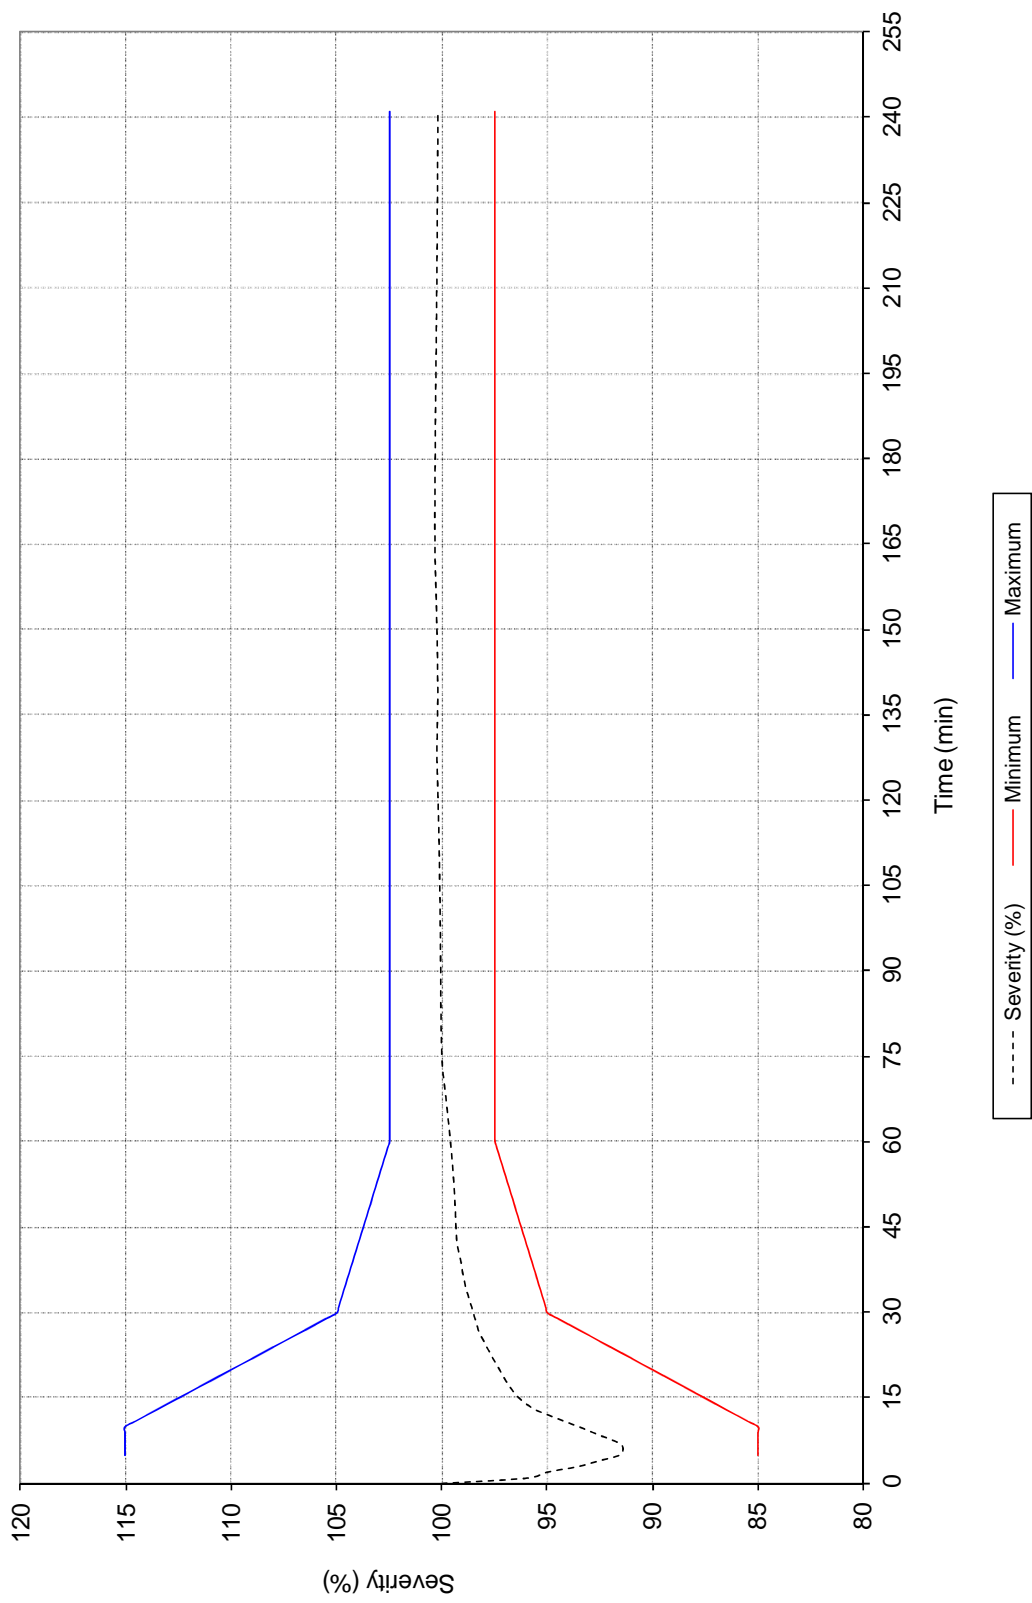
FIGURE 2 – FURNACE SEVERITY

Figure 2 shows the curve of furnace severity versus time during the heating period.

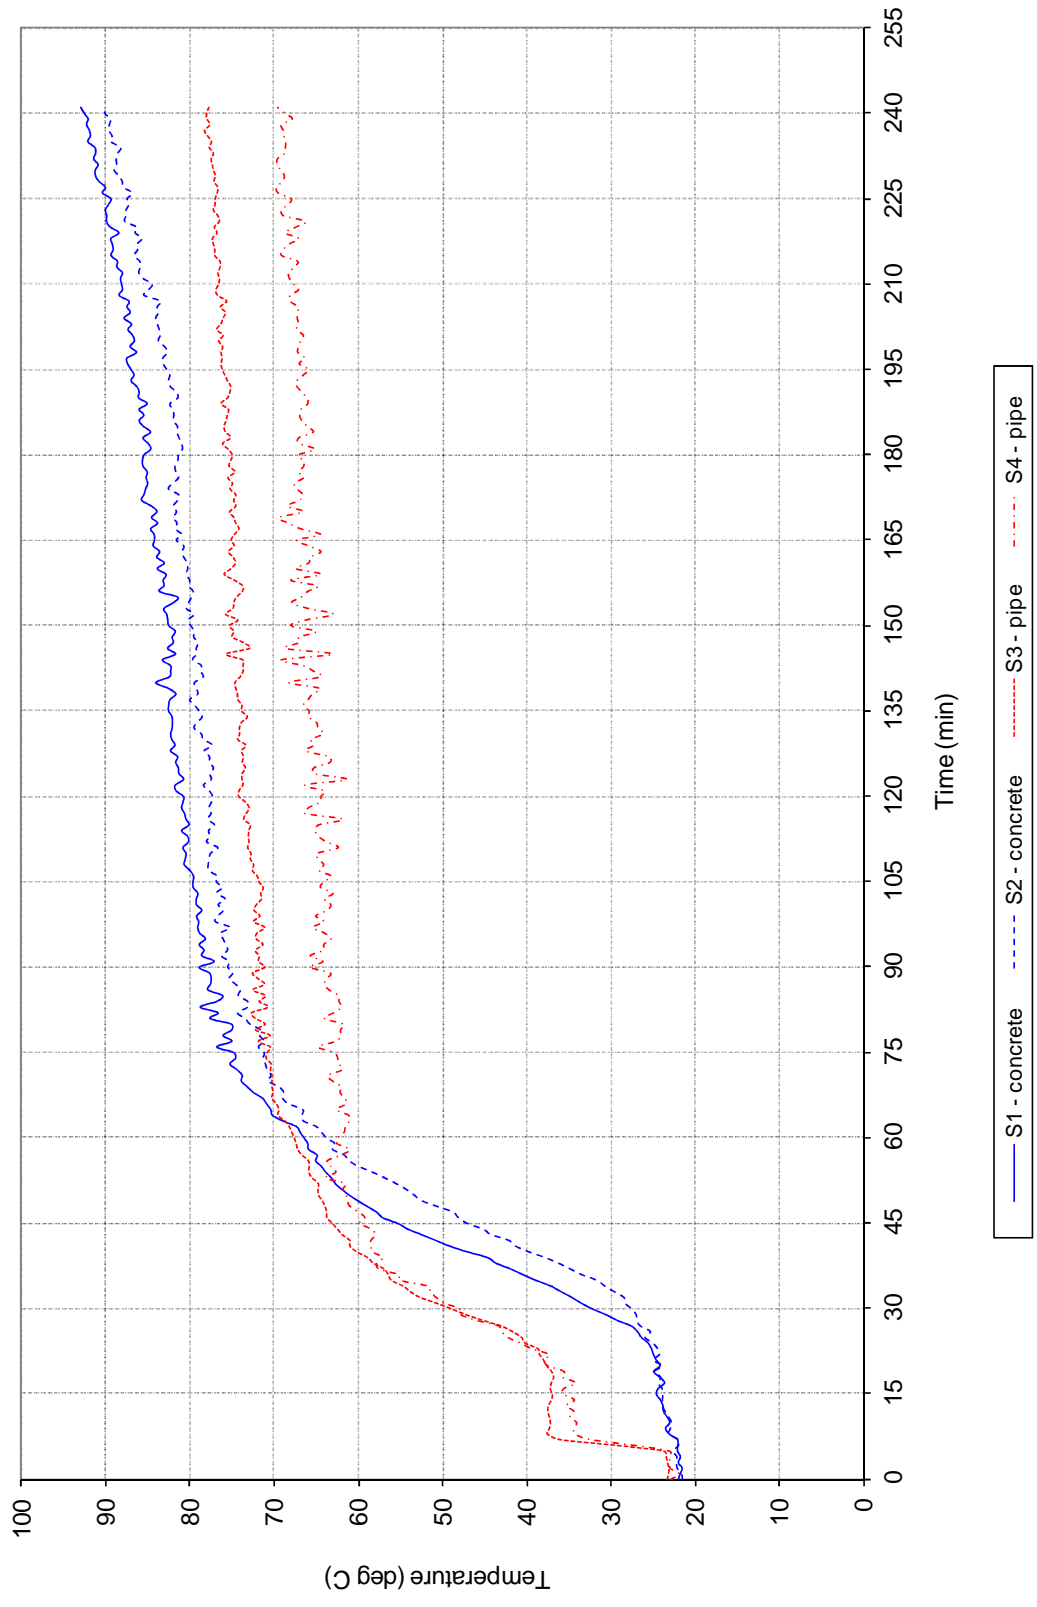
FIGURE 3 – SPECIMEN TEMPERATURE – ASSOCIATED WITH PENETRATION 1

Figure 3 shows curves of temperature versus time associated with Penetration #1.

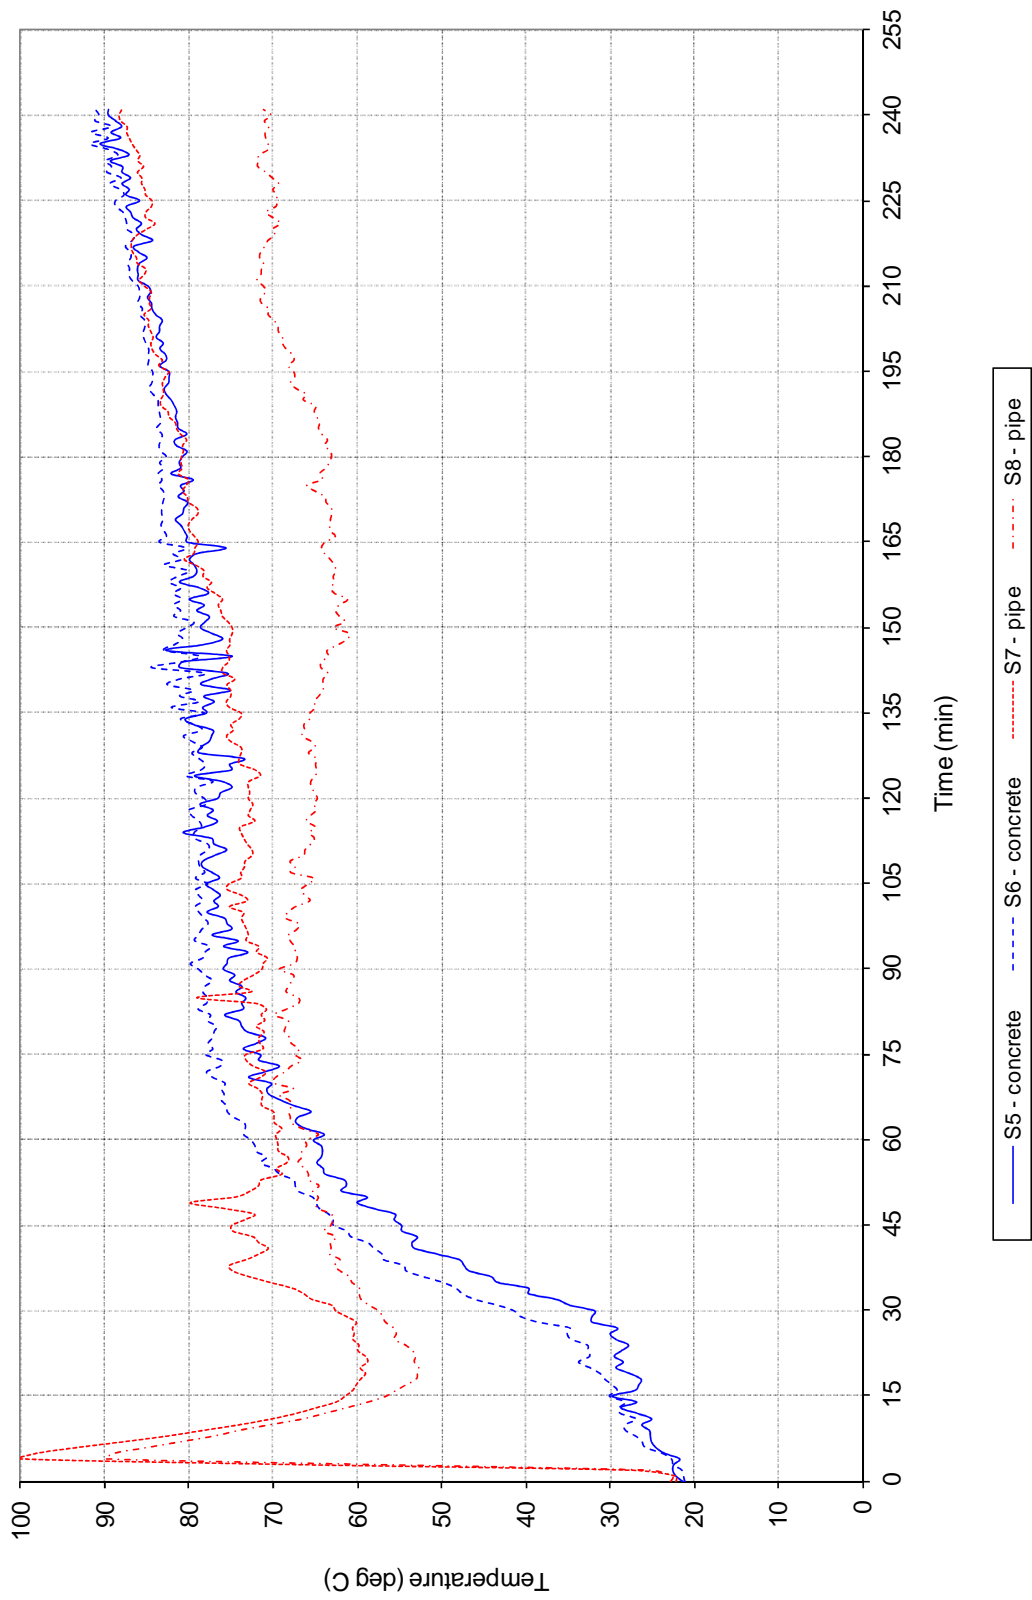
FIGURE 4 – SPECIMEN TEMPERATURE – ASSOCIATED WITH PENETRATION 2

Figure 4 shows curves of temperature versus time associated with Penetration #2.

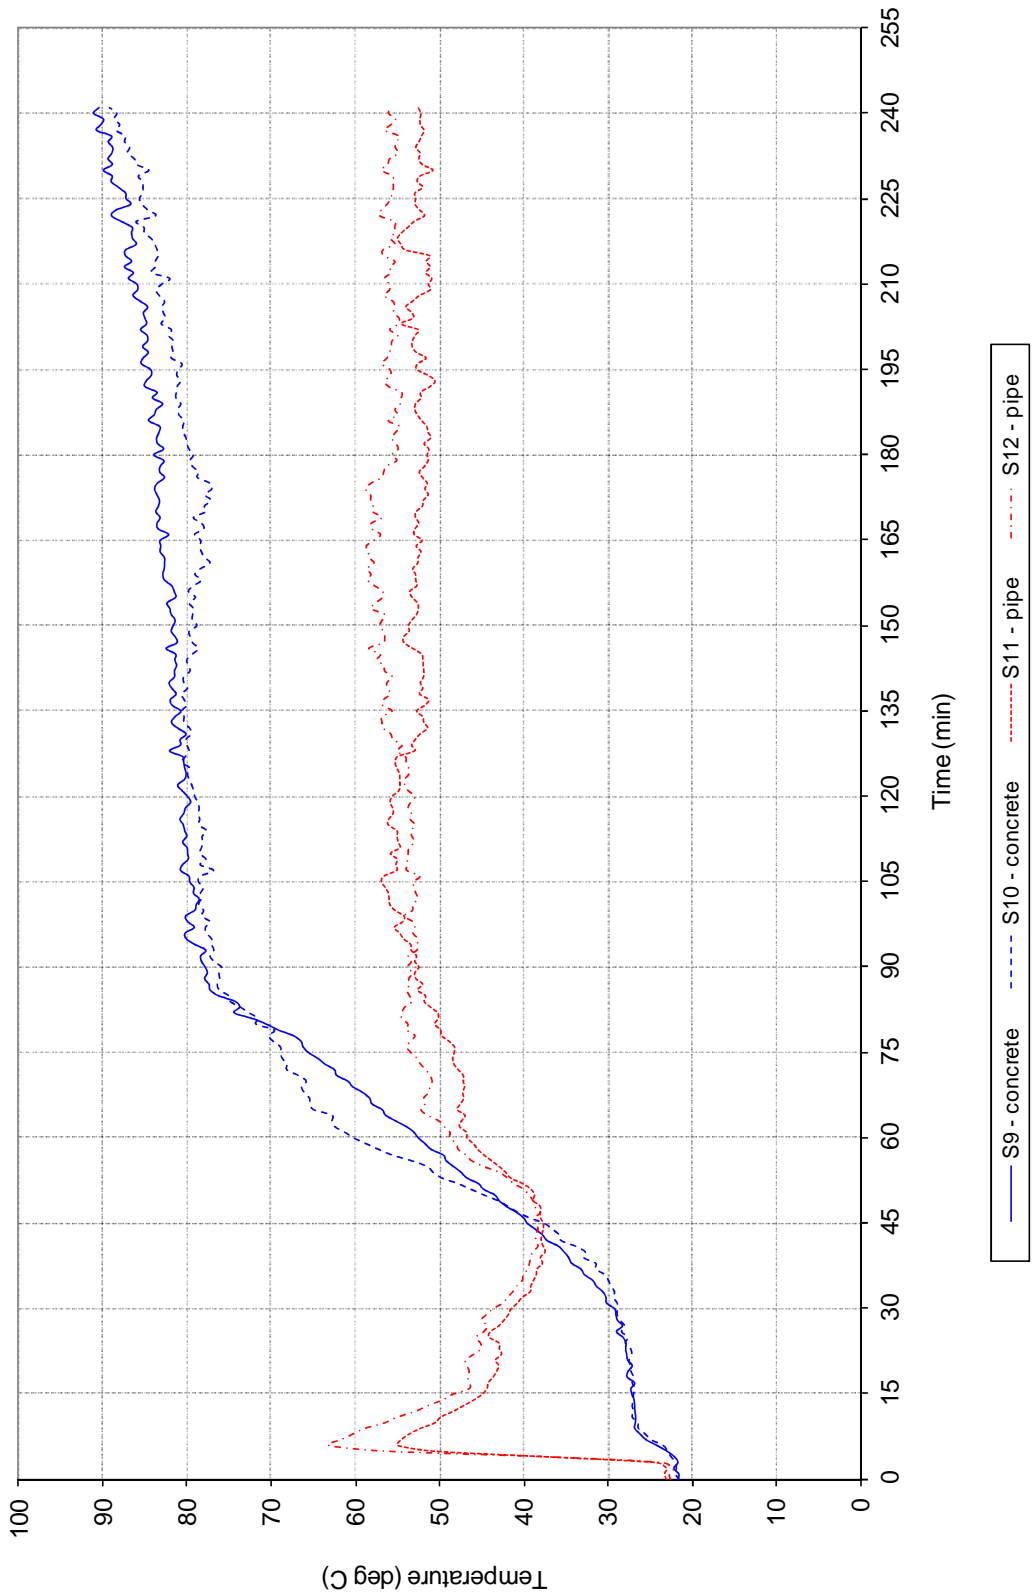
FIGURE 5 – SPECIMEN TEMPERATURE – ASSOCIATED WITH PENETRATION 3

Figure 5 shows curves of temperature versus time associated with Penetration #3.

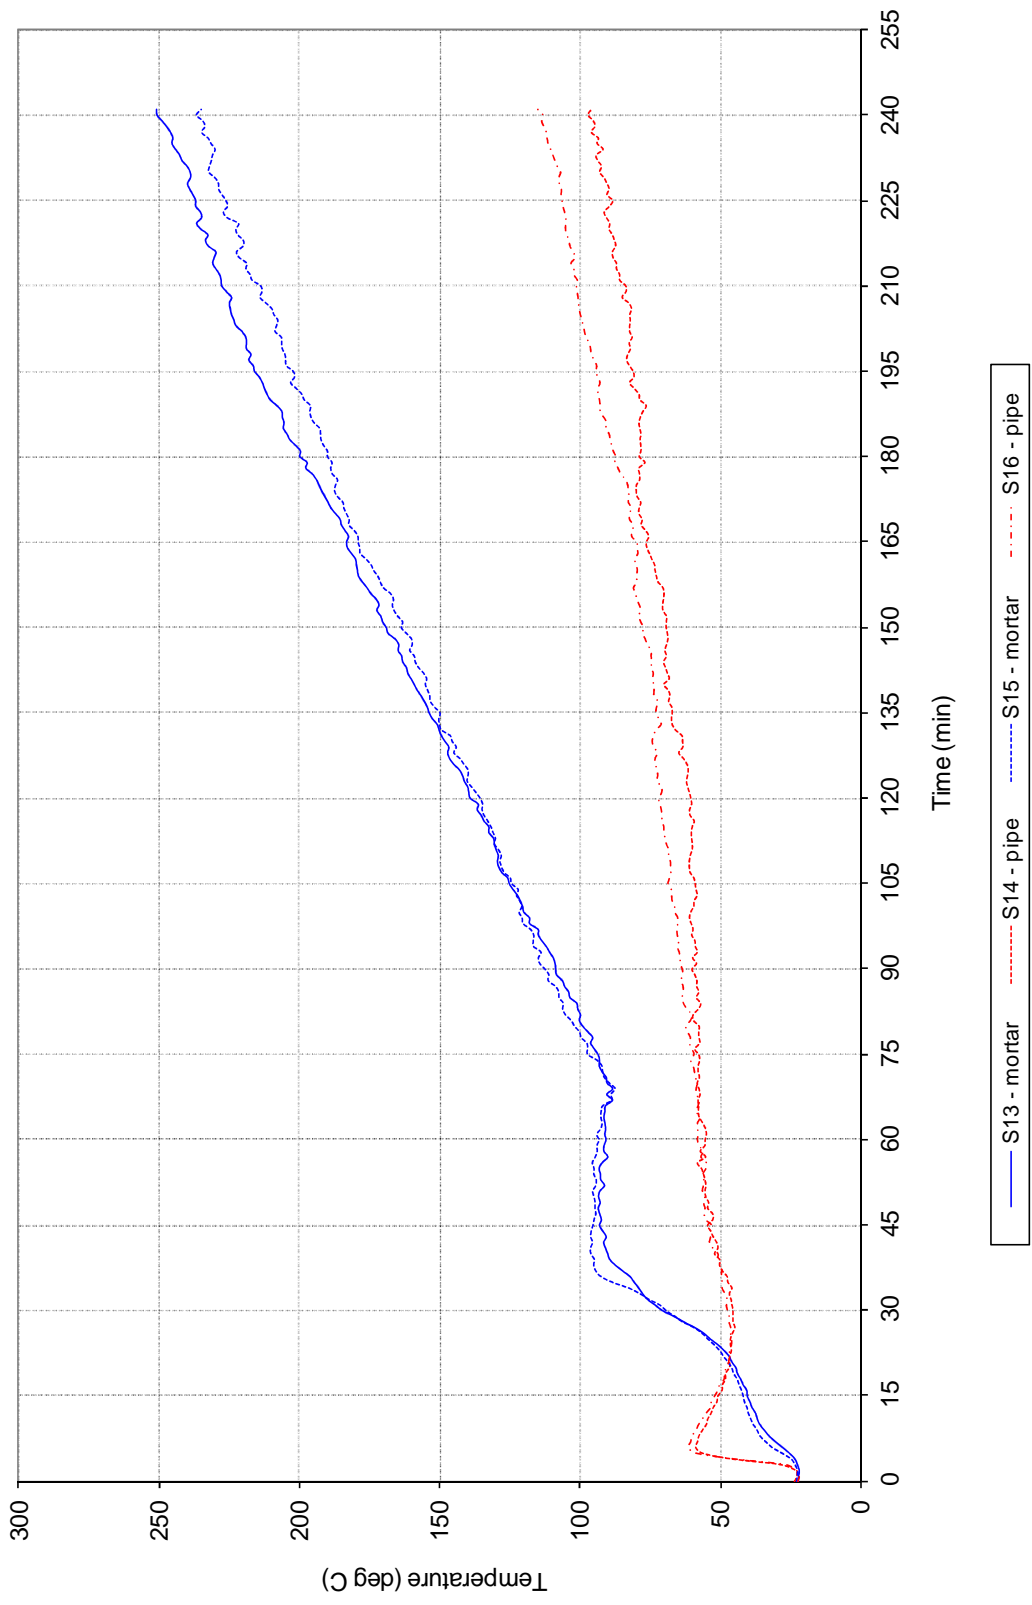
FIGURE 6 – SPECIMEN TEMPERATURE – ASSOCIATED WITH PENETRATION 4

- 183 minutes - Insulation failure of Penetration 4 – maximum temperature rise of 180 K is reached on the unexposed face of the slab, 25-mm from the base of the pipe.

Figure 6 shows curves of temperature versus time associated with Penetration #4.

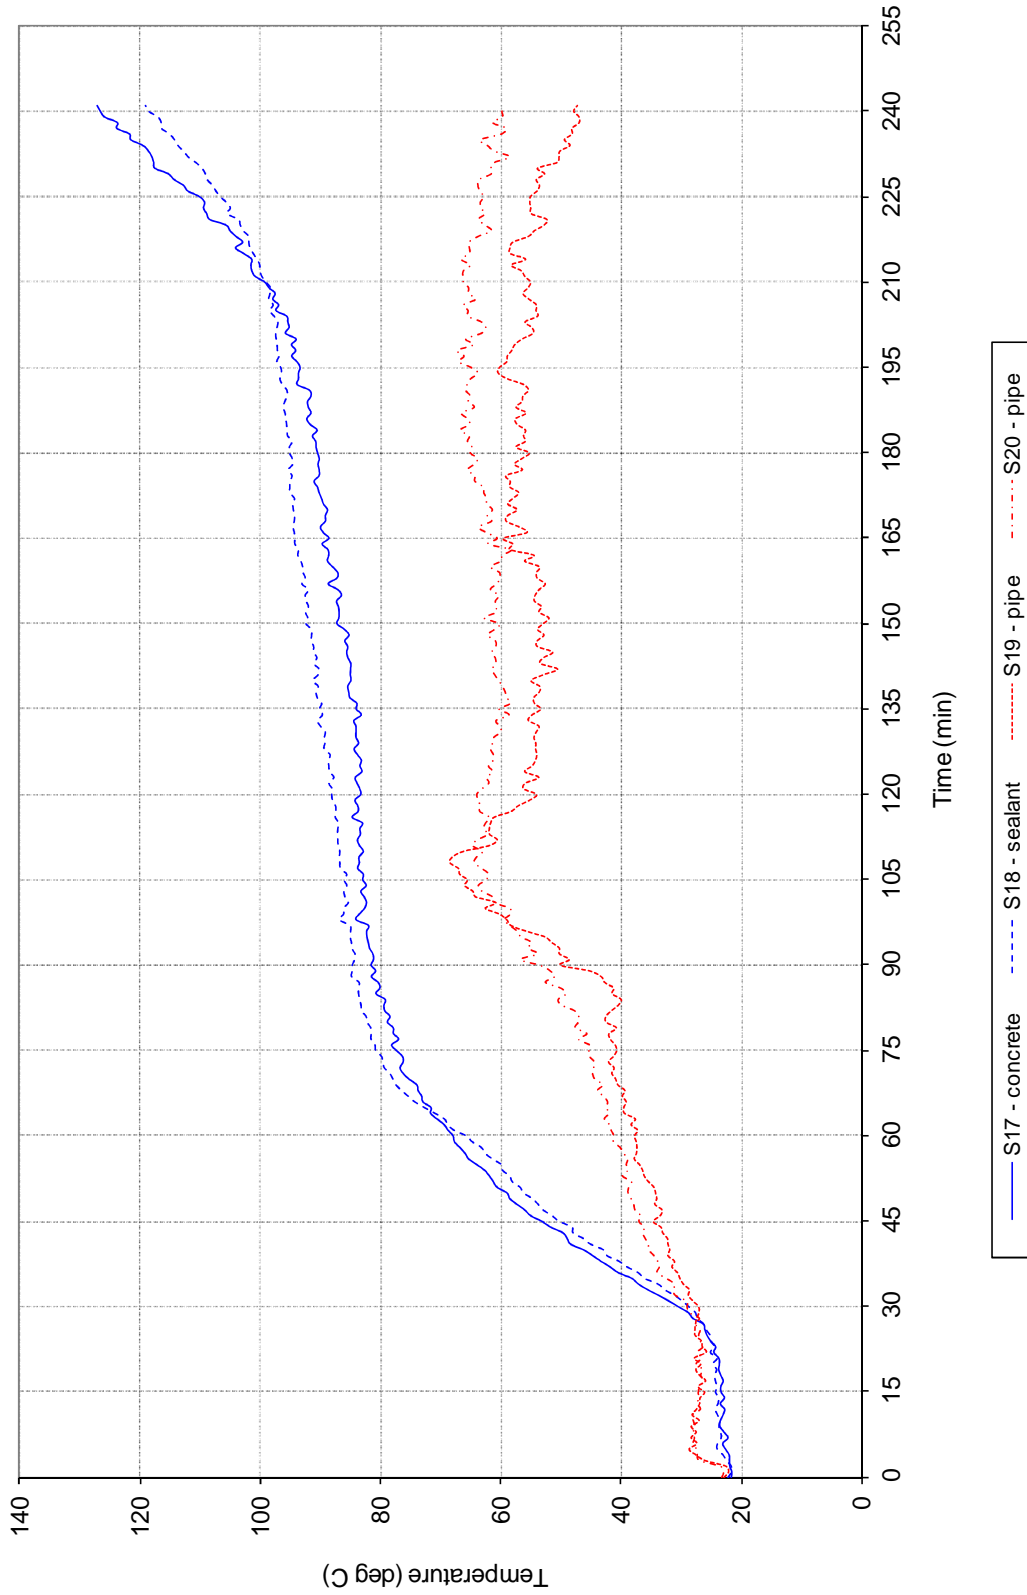
FIGURE 7 – SPECIMEN TEMPERATURE – ASSOCIATED WITH PENETRATION 5

Figure 7 shows curves of temperature versus time associated with Penetration #5.

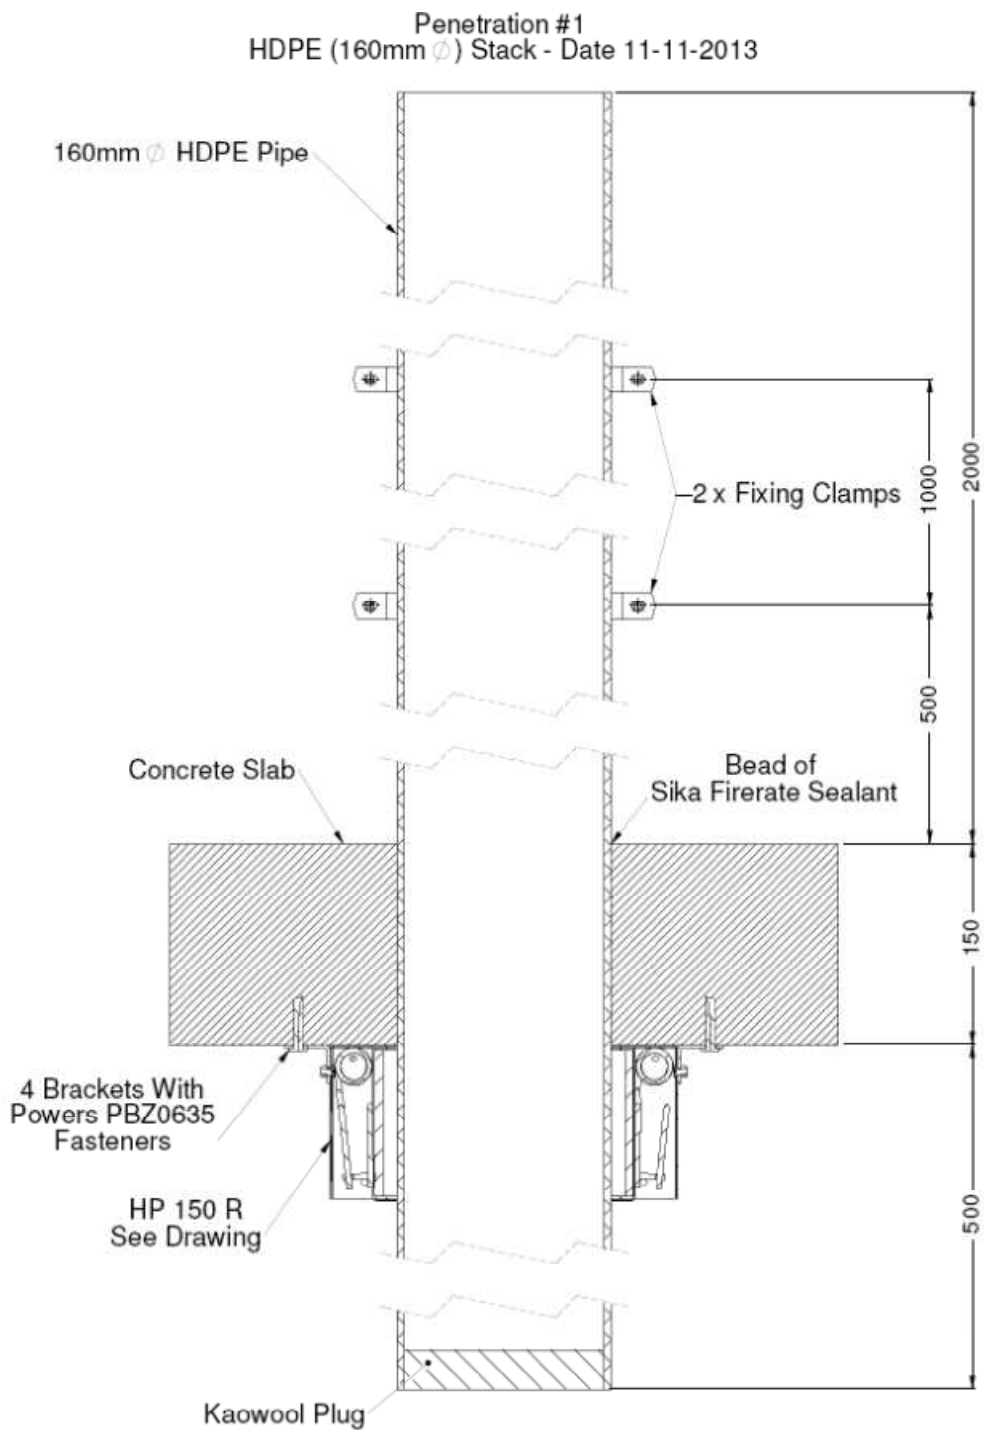
DRAWING TITLED "PENETRATION #1 – HDPE 160-MM STACK" DATED 11 NOVEMBER 2013, BY SNAP FIRE SYSTEMS PTY LTD.

Penetration 1 – HP 150 R retrofitted fire collar protecting a 160-mm high-density polyethylene (HDPE) pipe

The SNAP retrofitted HP 150 R fire collar comprised a 0.95-mm steel case with a 175-mm inner diameter and a 308-mm diameter base flange. The 117-mm high collar casing incorporated a 588-mm x 110-mm x 6-mm thick intumescent material. The closing mechanism comprised four stainless steel springs, a nylon fuse link and a 640-mm x 109-mm stainless steel mesh as shown in drawing numbered H 150 R-T, dated 23 January 2014, by SNAP Fire Systems. The fire collar was fixed to the slab by four brackets with PBZ0635 fasteners.

The penetrating service comprised a 160-mm high-density polyethylene (HDPE) pipe, with a measured wall thickness of 6-mm fitted through the collar's sleeve. The pipe projected vertically 2000-mm above the concrete slab and 500-mm into the furnace chamber. The pipe was supported at 500-mm and 1000-mm from the unexposed face of the concrete slab. The pipe was open at the unexposed end and capped with kaowool plug on the exposed end.

On the unexposed face, the 5-mm gap between the pipe and the slab was filled with a bead of Sika Firerate Sealant.

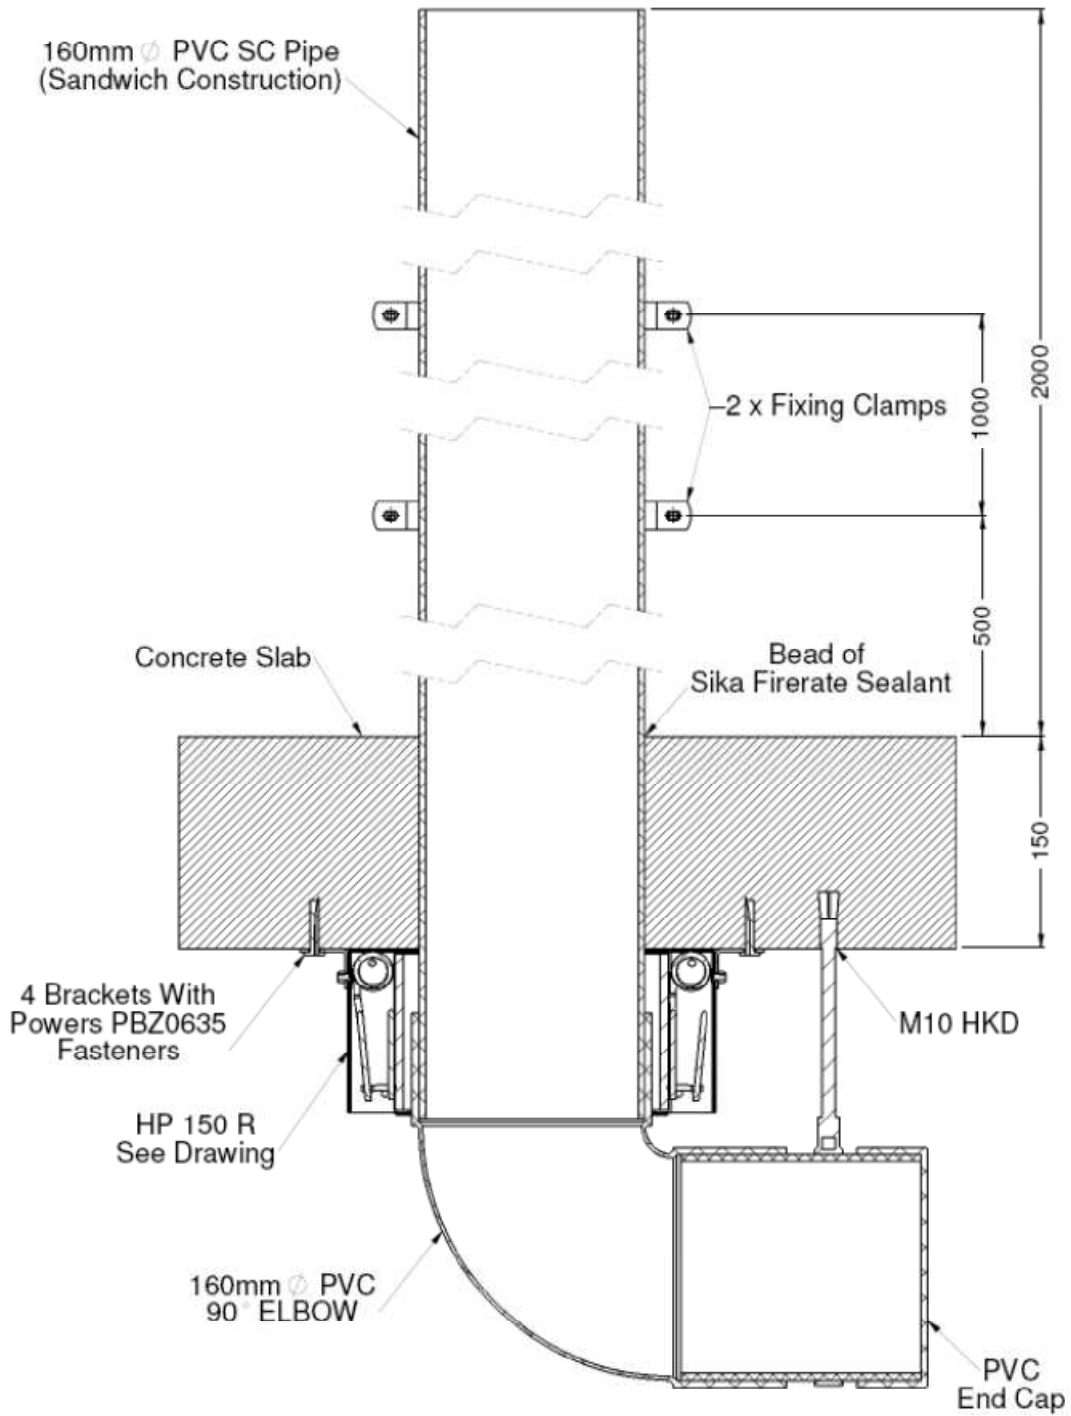
DRAWING TITLED "PENETRATION #2 – PVC SC 160-MM STACK WITH FITTING" DATED 11 NOVEMBER 2013, BY SNAP FIRE SYSTEMS PTY LTD.

Penetration 2 – HP 150 R retrofitted fire collar protecting a 160-mm Polyvinyl Chloride (PVC) Sandwich Construction (SC) pipe with fitting inside the collar

The penetrating service comprised a 160-mm PVC Sandwich Construction (SC) stack pipe, with a wall thickness of 3-mm fitted through the collar's sleeve. The pipe projected vertically 2000-mm above the concrete slab and 500-mm into the furnace chamber. The pipe was supported at 500-mm and 1000-mm from the unexposed face of the concrete slab. The pipe was open at the unexposed end and capped on the exposed end.

On the exposed side of the slab a PVC 90° elbow was connected to the penetrating pipe, supported by M10 HKD and nut clip, fixed to the concrete slab as shown in drawing titled "Penetration #2 – PVC SC (160-mm) Stack with Fitting", dated 11 November 2013, by Snap Fire Systems Pty Ltd. The pipe was open at the unexposed end and capped on the exposed end.

On the unexposed face, the narrow gap between the pipe and the slab was filled with Sika Firerate Sealant.
