Fire-resistance test on fire collars protecting a concrete slab penetrated by services

Test Report

Author: Mario Lara
Report number: FSP 1615
Date: 13 March 2014

Client: Snap Fire Systems Pty Ltd

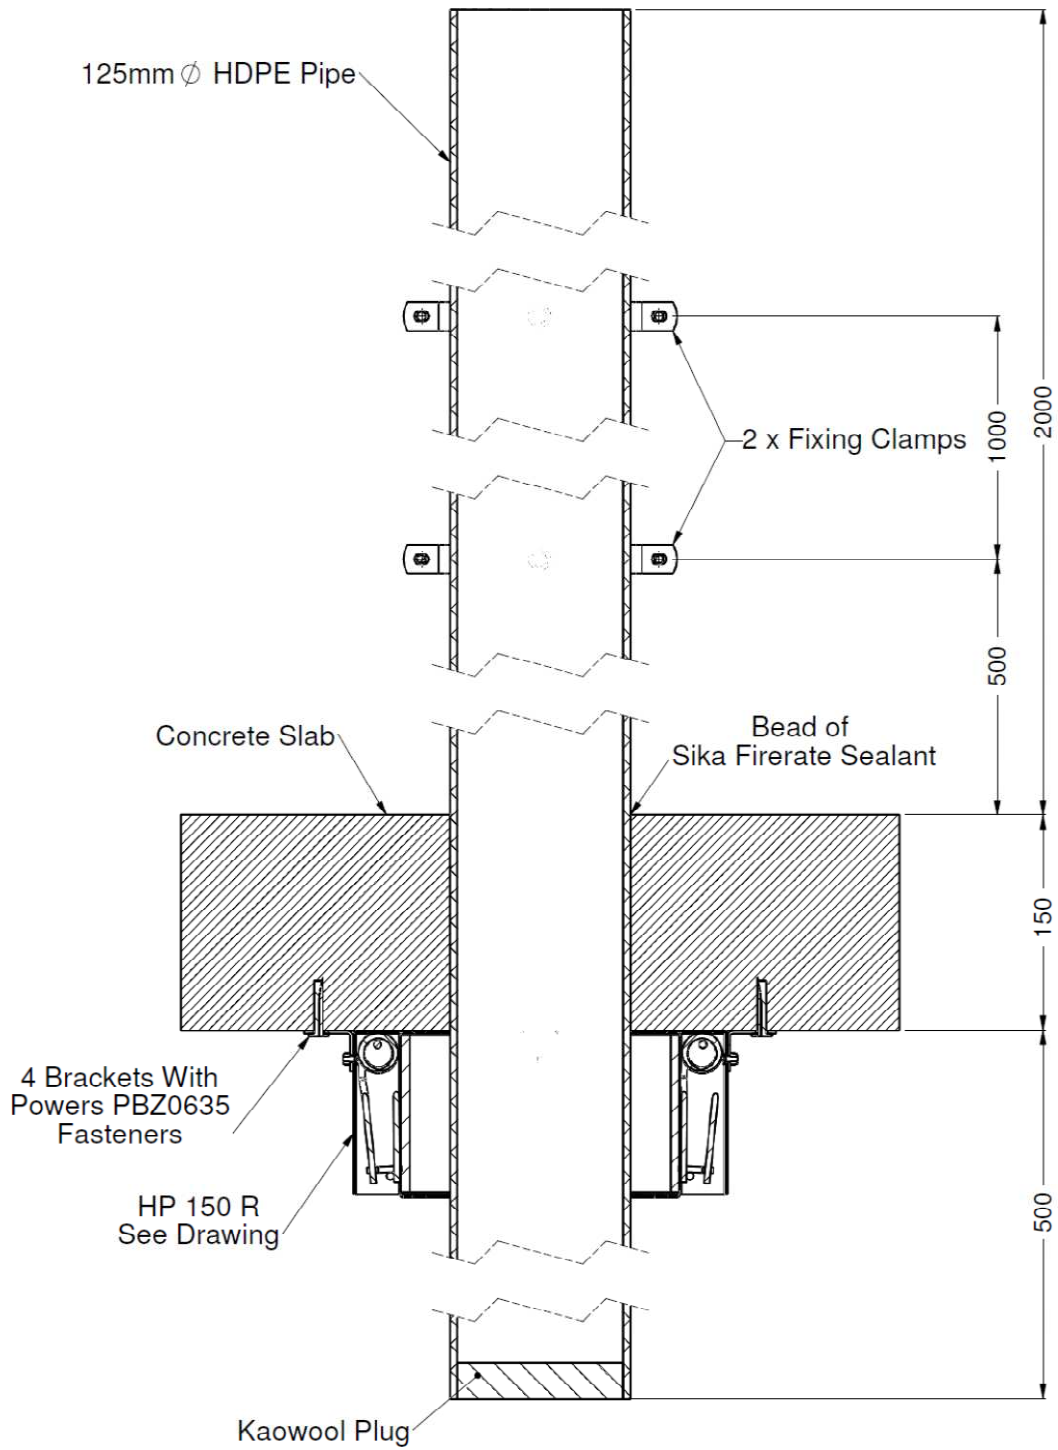
DRAWING TITLED "PENETRATION #3 – HDPE 125-MM STACK" DATED 11 NOVEMBER 2013, BY SNAP FIRE SYSTEMS PTY LTD.

Penetration 3 – HP 150 R retrofitted fire collar protecting a 125-mm high-density polyethylene (HDPE) pipe

The penetrating service comprised a 125-mm high-density polyethylene (HDPE) pipe, with a wall thickness of 5-mm fitted through the collar's sleeve. The pipe projected vertically 2000-mm above the concrete slab and 500-mm into the furnace chamber. The pipe was supported at 500-mm and 1000-mm from the unexposed face of the concrete slab. The pipe was open at the unexposed end and capped with Kaowool plug on the exposed end.

On the unexposed face, the 5-mm gap between the pipe and the slab was filled with a bead of Sika Firerate Sealant.

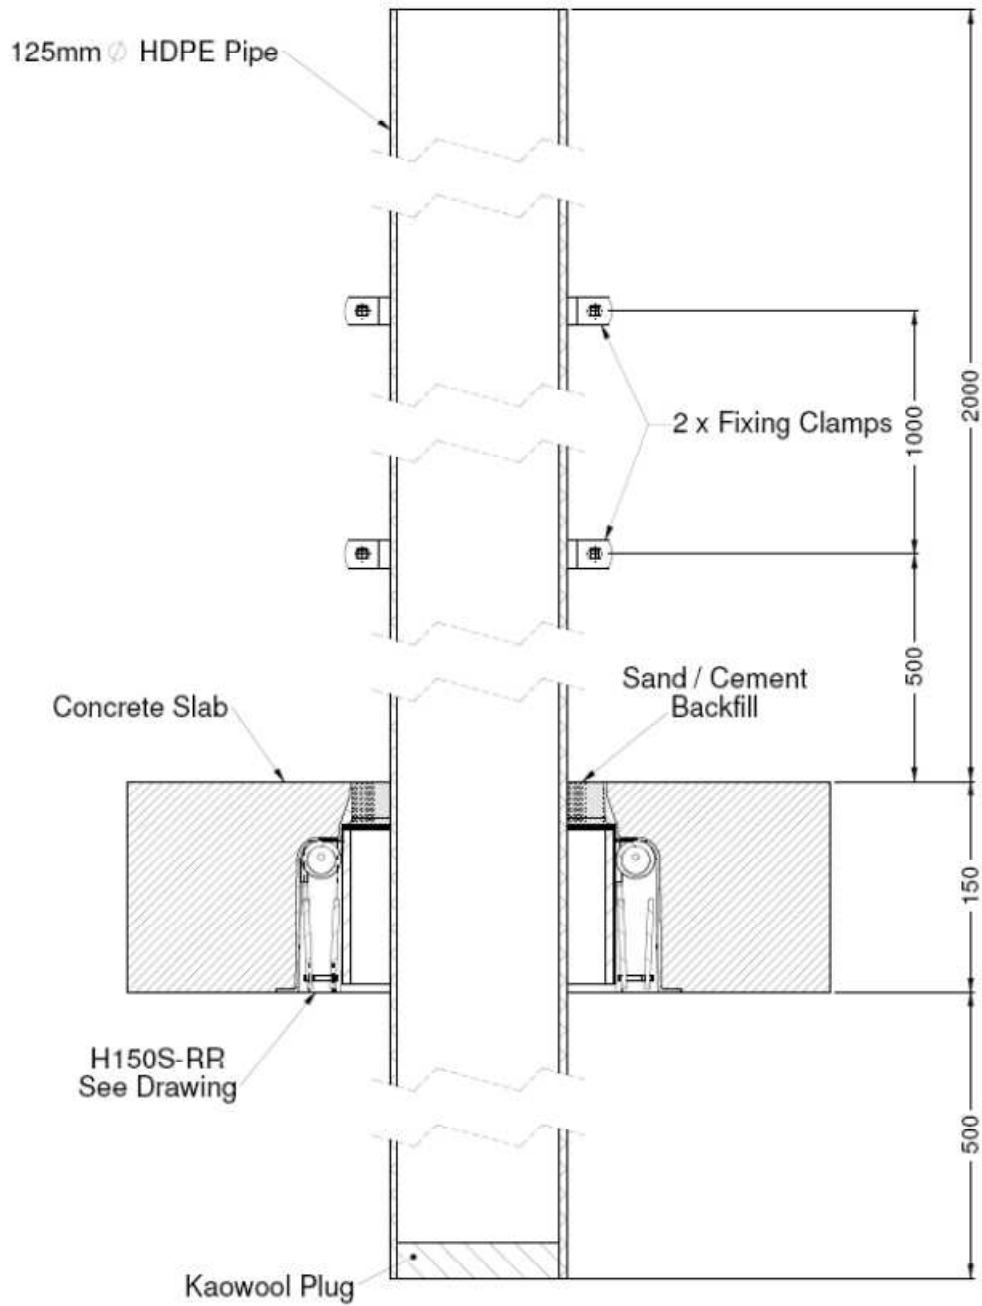
DRAWING TITLED "PENETRATION #4 – HDPE 125-MM STACK" DATED 11 NOVEMBER 2013, BY SNAP FIRE SYSTEMS PTY LTD.

Penetration 4 – H 150 S-RR cast-in fire collar protecting a 125-mm high-density polyethylene (HDPE) pipe

The penetrating service comprised a 125-mm high-density polyethylene (HDPE) pipe, with a measured wall thickness of 5-mm fitted through the collar's sleeve. The pipe projected vertically 2000-mm above the concrete slab and 500-mm into the furnace chamber. The pipe was supported at 500-mm and 1000-mm from the unexposed face of the concrete slab. The pipe was open at the unexposed end and capped with Kaowool plug on the exposed end.

On the unexposed face, the 20-mm gap between the pipe and the collar sleeve was filled with sand/cement backfill.

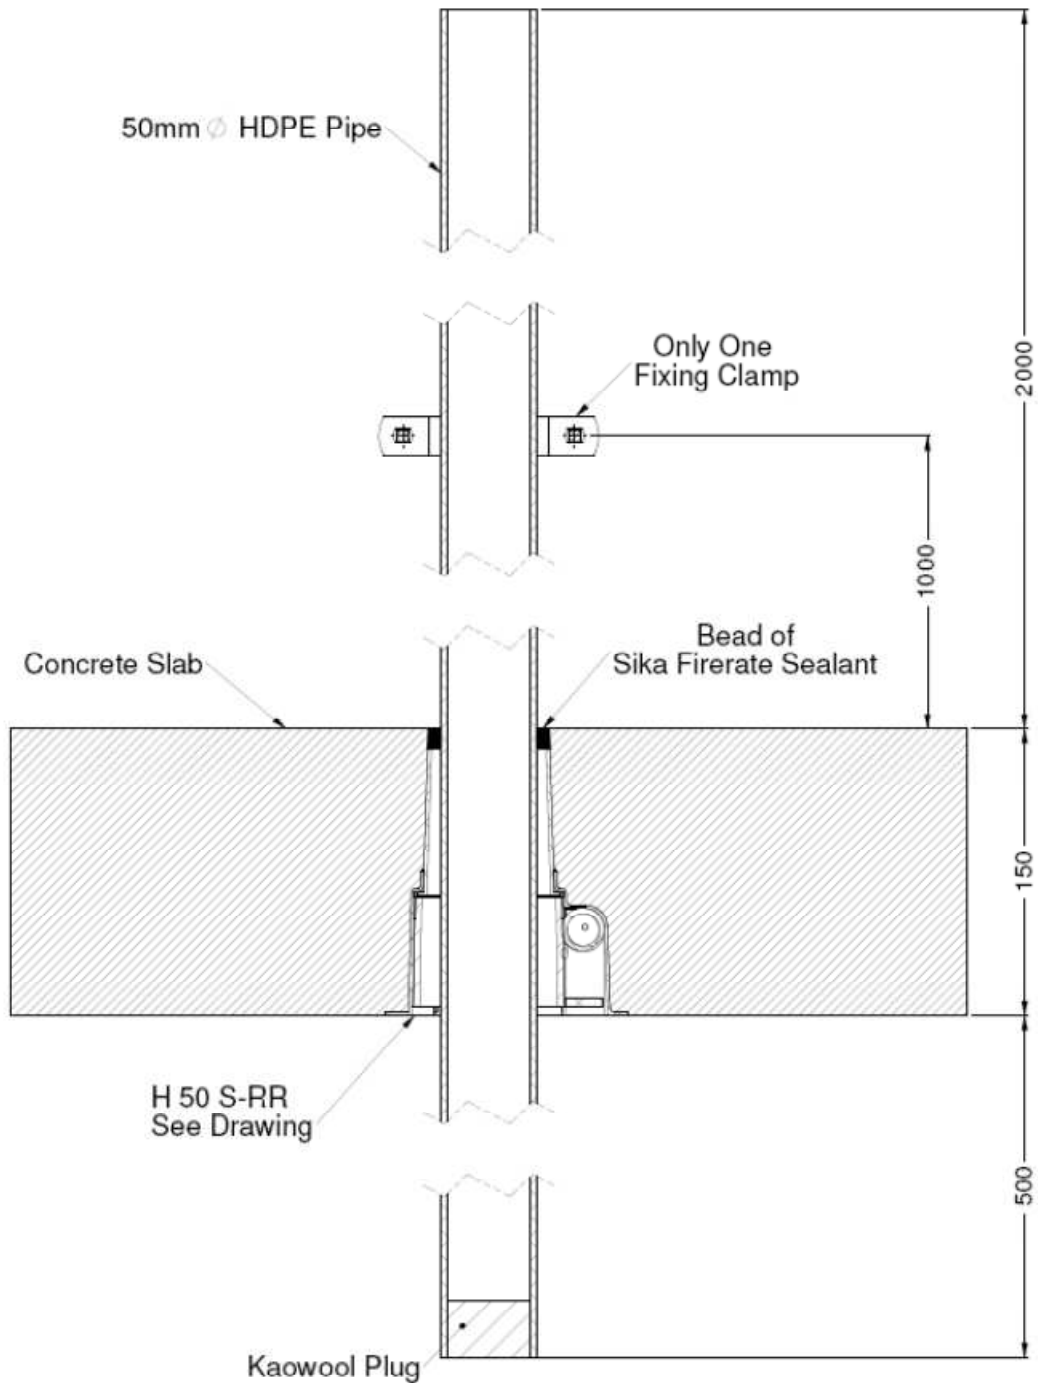
DRAWING TITLED "PENETRATION #5 – HDPE 50-MM STACK" DATED 11 NOVEMBER 2013, BY SNAP FIRE SYSTEMS PTY LTD.

Penetration 5 – H 50 S-RR cast-in fire collar protecting a 50-mm high-density polyethylene (HDPE) pipe

The penetrating service comprised a 50-mm high-density polyethylene (HDPE) pipe, with a measured wall thickness of 4-mm fitted through the collar's sleeve. The pipe projected vertically, 2000-mm above the concrete slab and 500-mm into the furnace chamber. The pipe was supported at 1000-mm from the unexposed face of the concrete slab. The pipe was open at the unexposed end and capped with kaowool plug on the exposed end.

On the unexposed face, the 10-mm gap between the pipe and the slab was filled with Sika Firerate Sealant to a 10-mm depth.

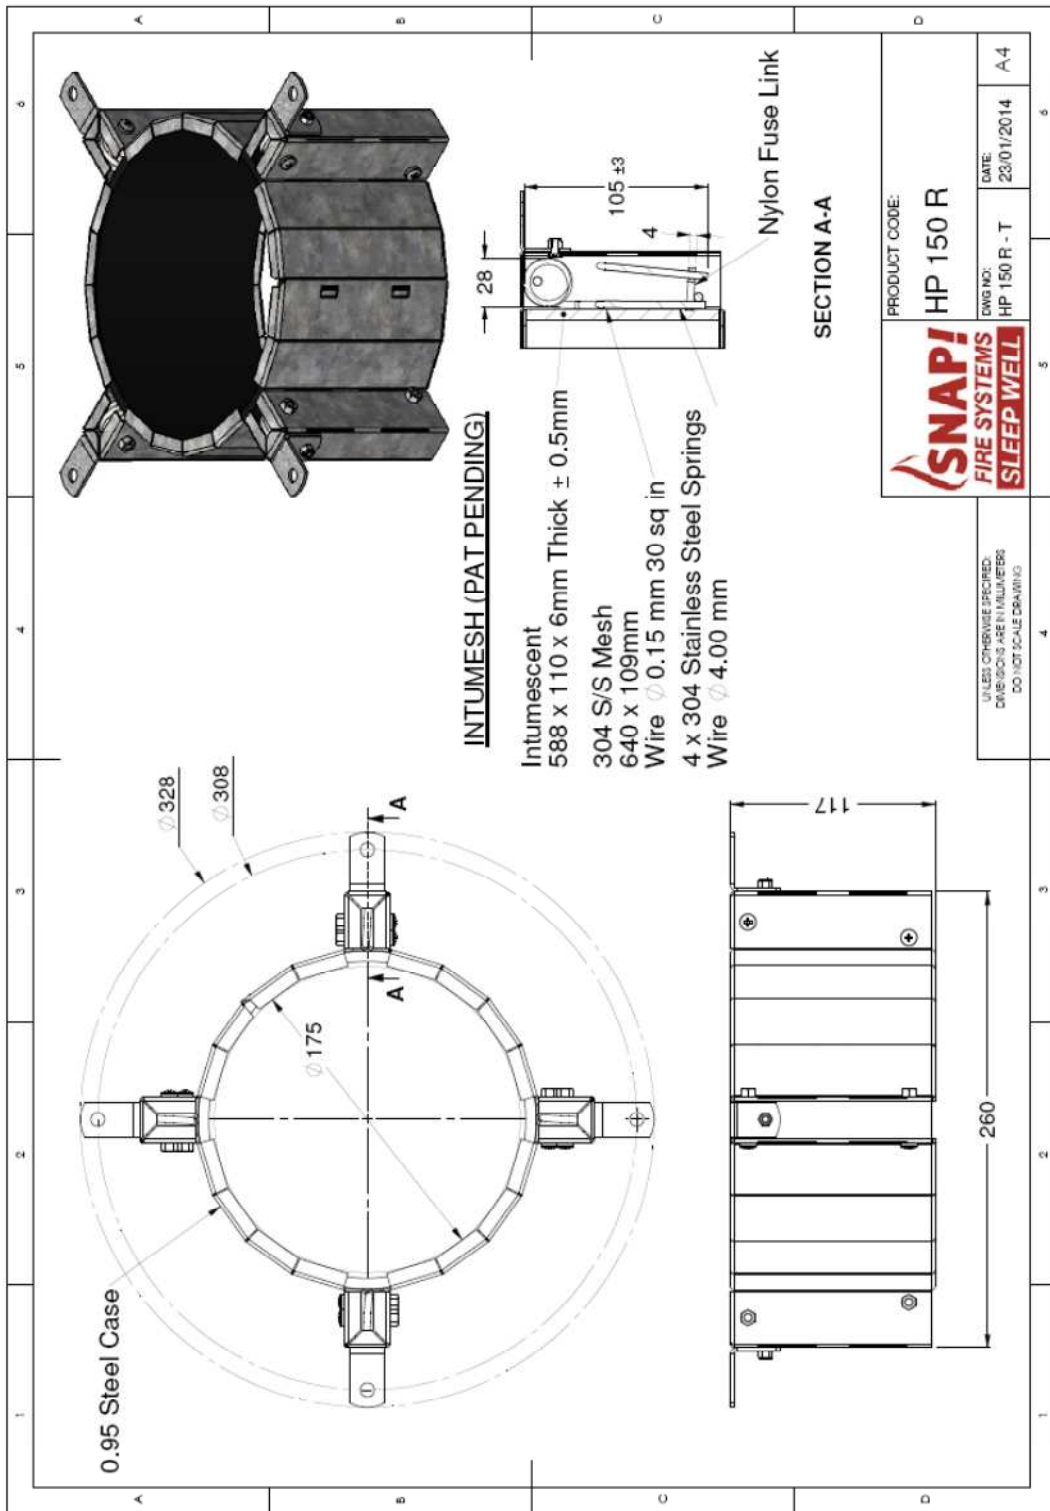
DRAWING NUMBERED HP 150 R-T, DATED 23 JANUARY 2014, BY SNAP FIRE SYSTEMS PTY LTD.

The SNAP retrofitted HP 150 R fire collar comprised a 0.95-mm steel case with a 175-mm inner diameter and a 308-mm diameter base flange. The 117-mm high collar casing incorporated a 588-mm x 110-mm x 6-mm thick intumescent material. The closing mechanism comprised four stainless steel springs, a nylon fuse link and a 640-mm x 109-mm stainless steel mesh as shown in drawing numbered H 150 R-T, dated 23 January 2014, by SNAP Fire Systems. The fire collar was fixed to the slab by four brackets with PBZ0635 fasteners.

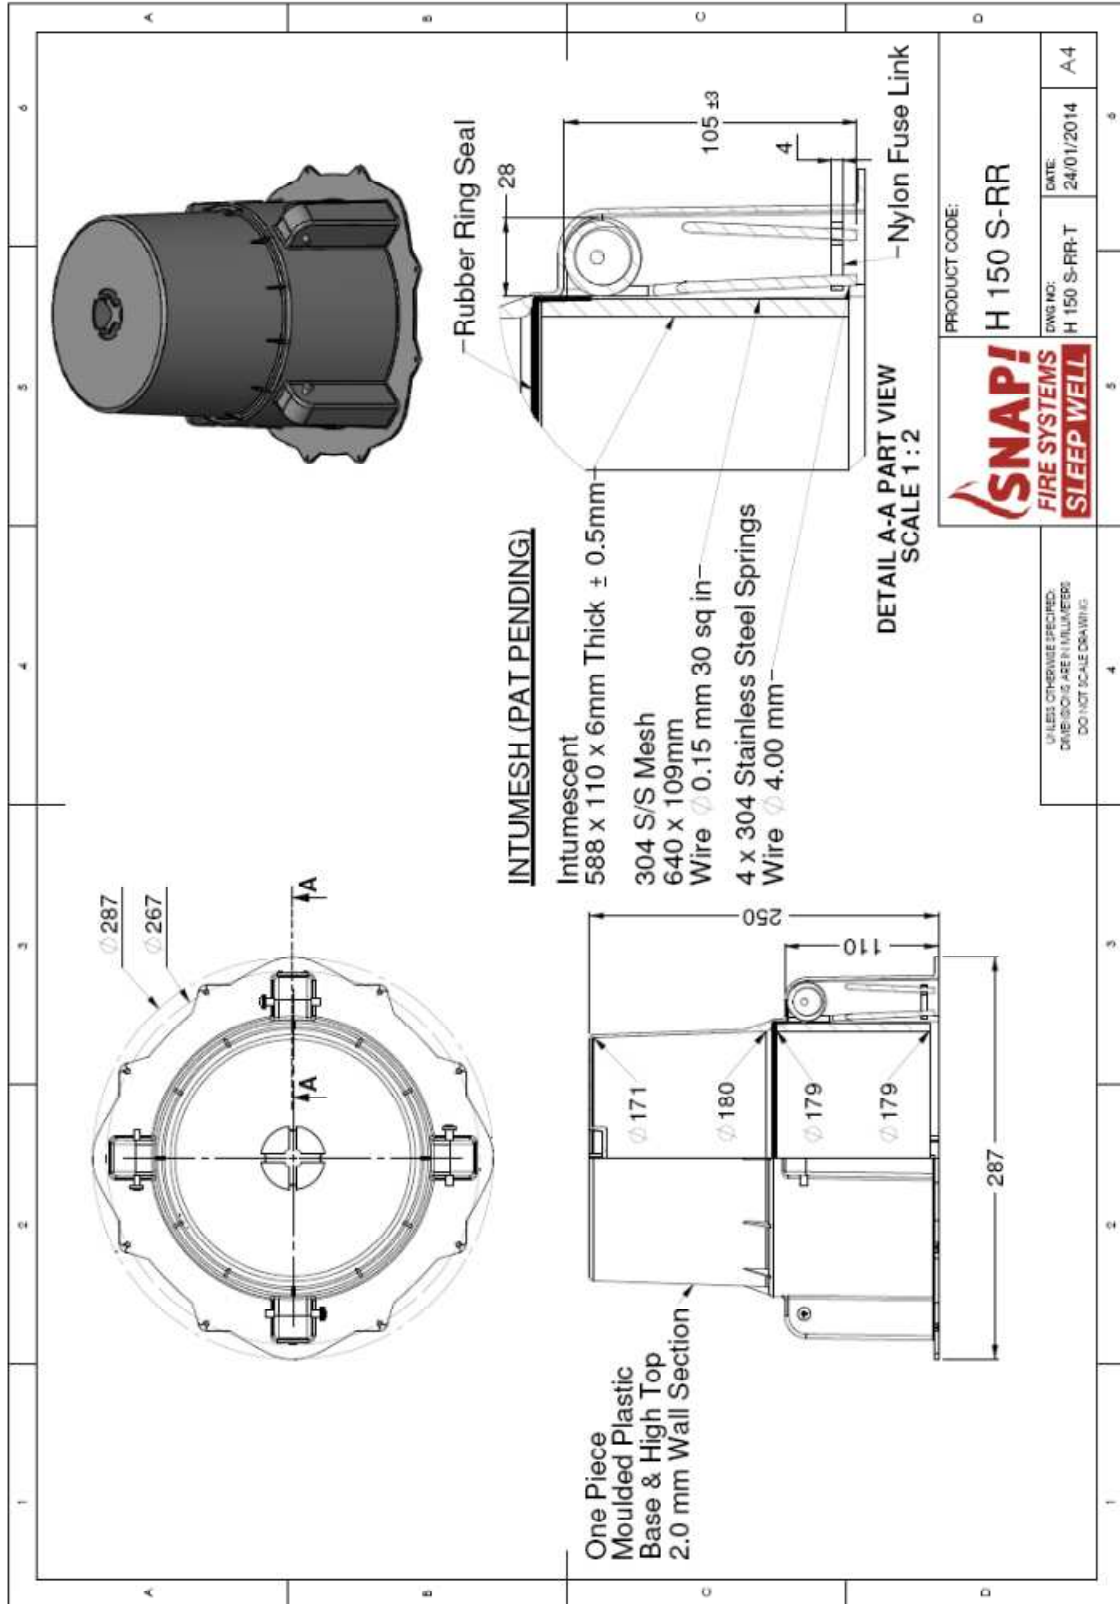
DRAWING NUMBERED HP 150 S-RR-T, DATED 24 JANUARY 2014, BY SNAP FIRE SYSTEMS PTY LTD.

The SNAP Cast-in H 150 S-RR fire collar comprised a 2-mm thick polypropylene casing with a 179-mm inner diameter and a 267-mm diameter base flange. The 110-mm high collar casing incorporated a 588-mm x 110-mm x 6-mm thick intumescent material. The closing mechanism comprised four stainless steel springs, a nylon fuse link and a 640-mm x 109-mm stainless steel mesh as shown in drawing numbered H 150 S-RR-T, dated 24 January 2014, by SNAP Fire Systems.

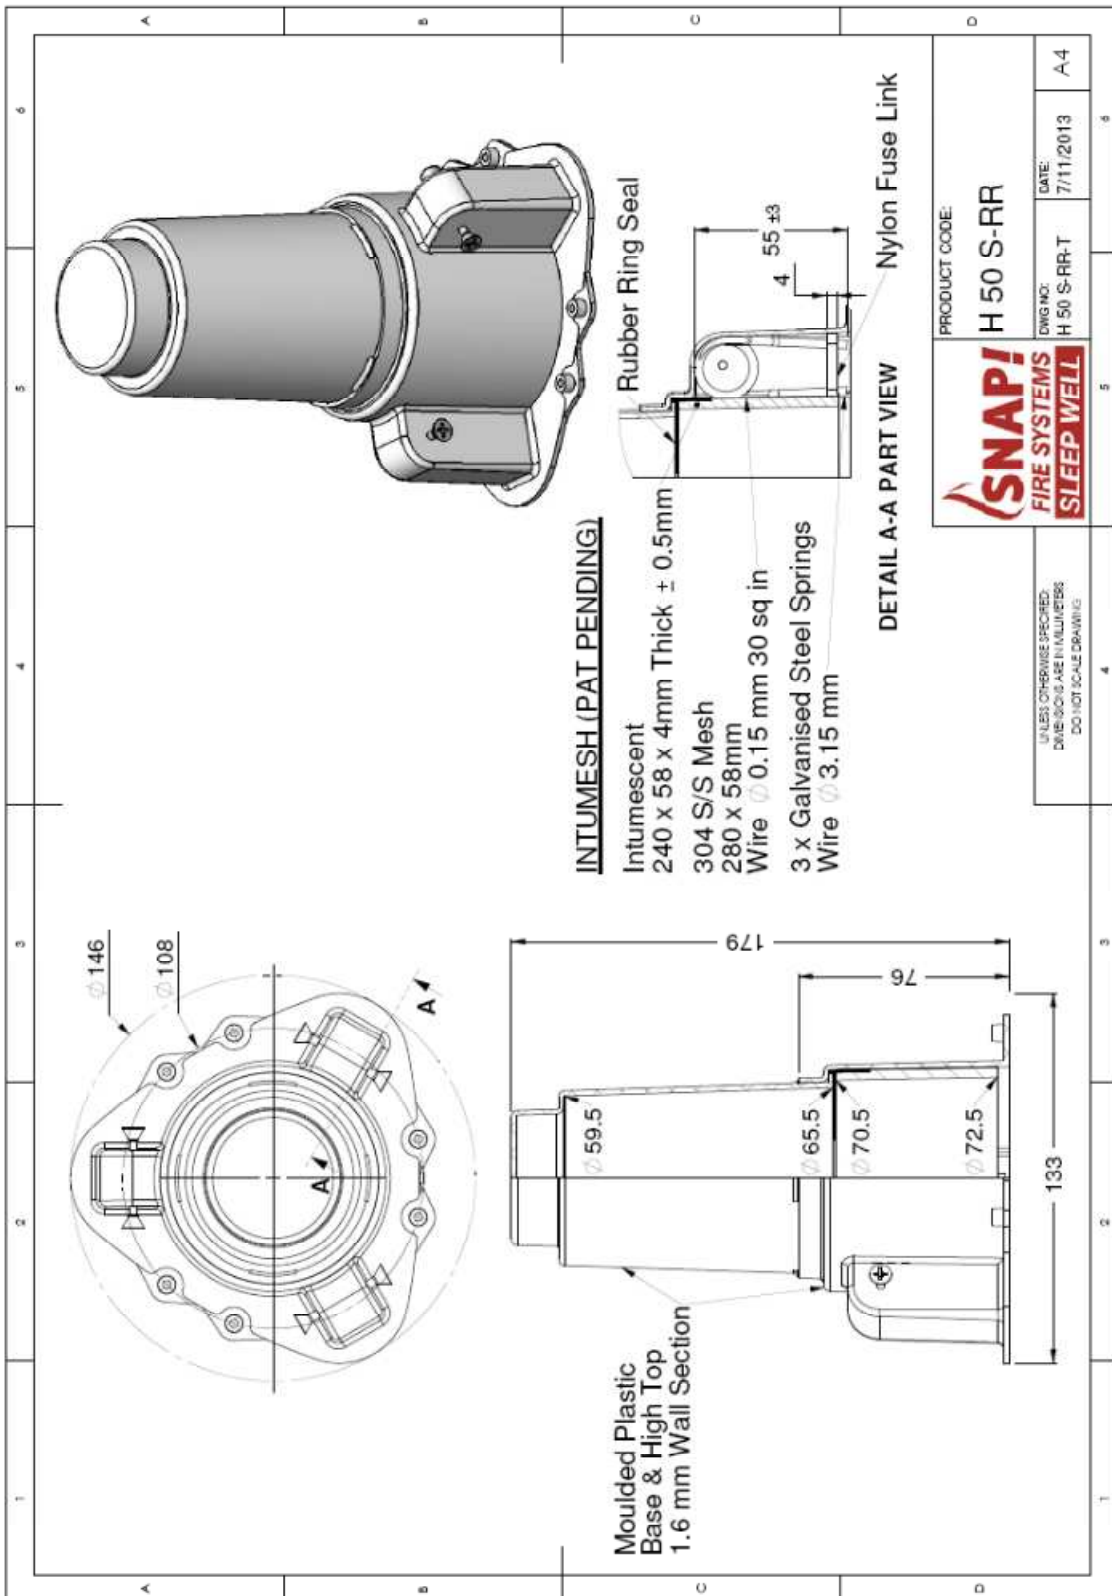
DRAWING NUMBERED H 50 S-RR-T, DATED 7 NOVEMBER 2013, BY SNAP FIRE SYSTEMS PTY LTD.

The SNAP Cast-in H 50 S-RR fire collar comprised a 1.6 mm thick HDPE casing with a 70.5-mm inner diameter and a 146-mm diameter base flange. The 76-mm high collar casing incorporated a 240-mm x 58-mm x 4-mm thick intumescent material. The closing mechanism comprised three galvanised steel springs, a nylon fuse link and a 280-mm x 58-mm stainless steel mesh as shown in drawing numbered H 50 S-RR-T, dated 7 November 2014, by SNAP Fire Systems.
