Fire-resistance test on fire collars protecting a plasterboard wall penetrated by services

Test Report

Author: Russell Collins
Report number: FSP 1748
Date: 24 October 2016

Sponsored Investigation No. FSP 1748

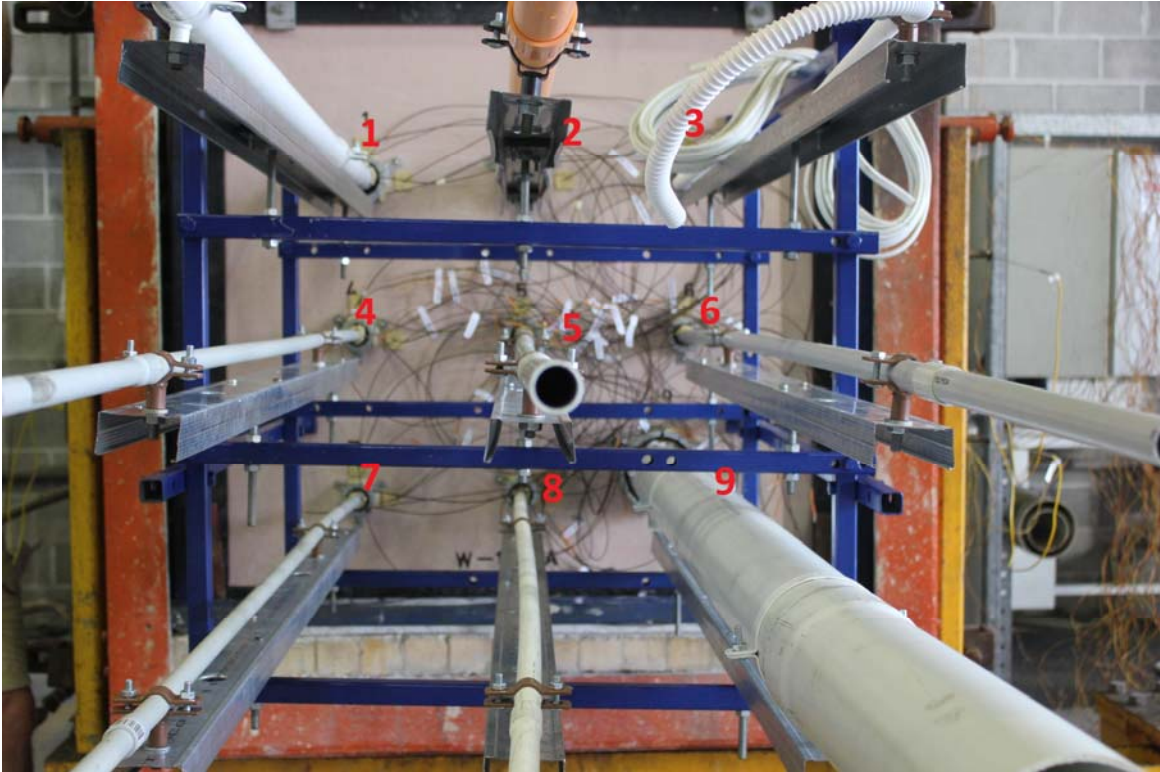
PHOTOGRAPH 1 – UNEXPOSED FACE OF SPECIMENS PRIOR TO TESTING

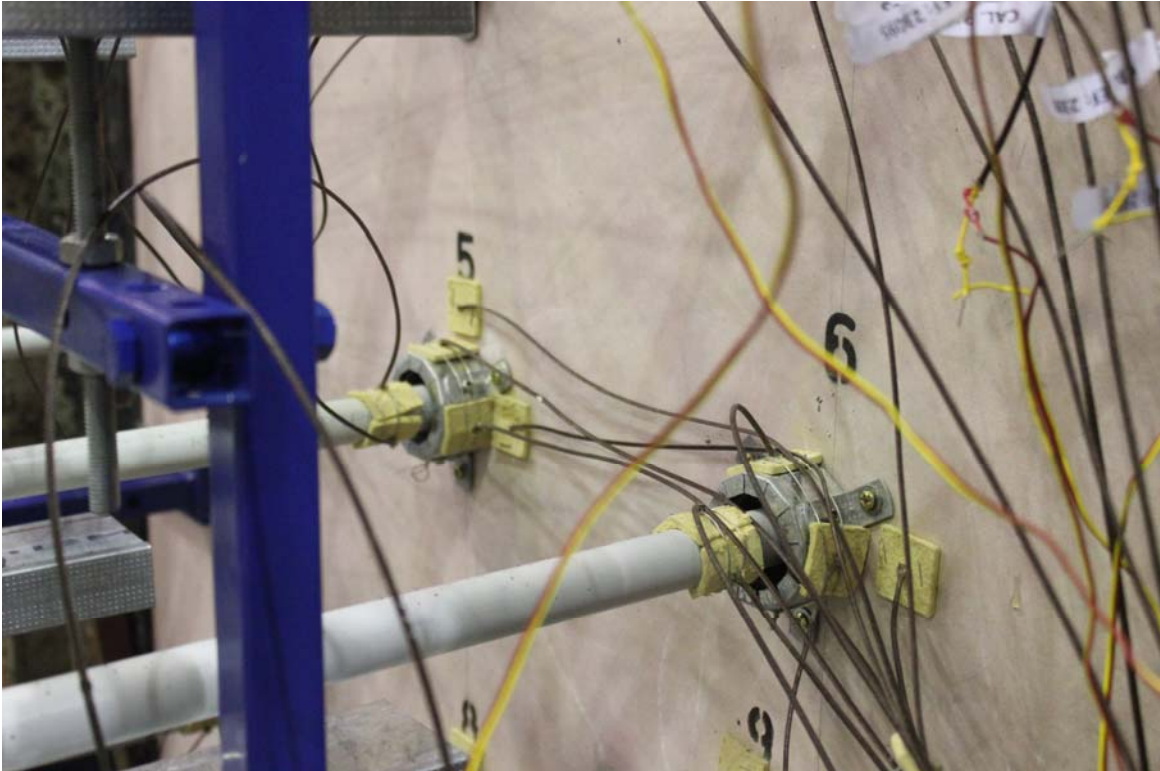
PHOTOGRAPH 2 – SPECIMENS AFTER 60 MINUTES OF TESTING

- 60 minutes - Slight fluing is visible from end of Penetration # 1.
- 65 minutes - Slight fluing is visible from end of Penetration # 5.
- 75 minutes - Slight fluing is visible from end of Penetration # 9.

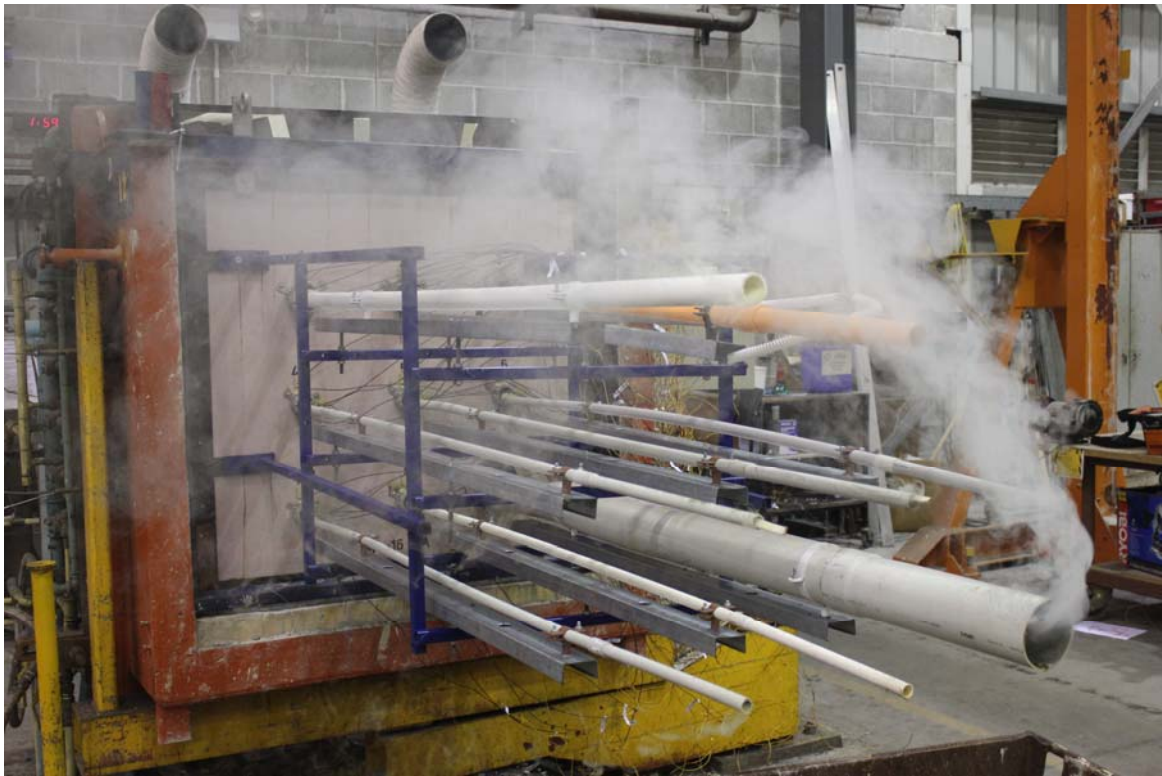
PHOTOGRAPH 3 – SPECIMENS AFTER 120 MINUTES OF TESTING

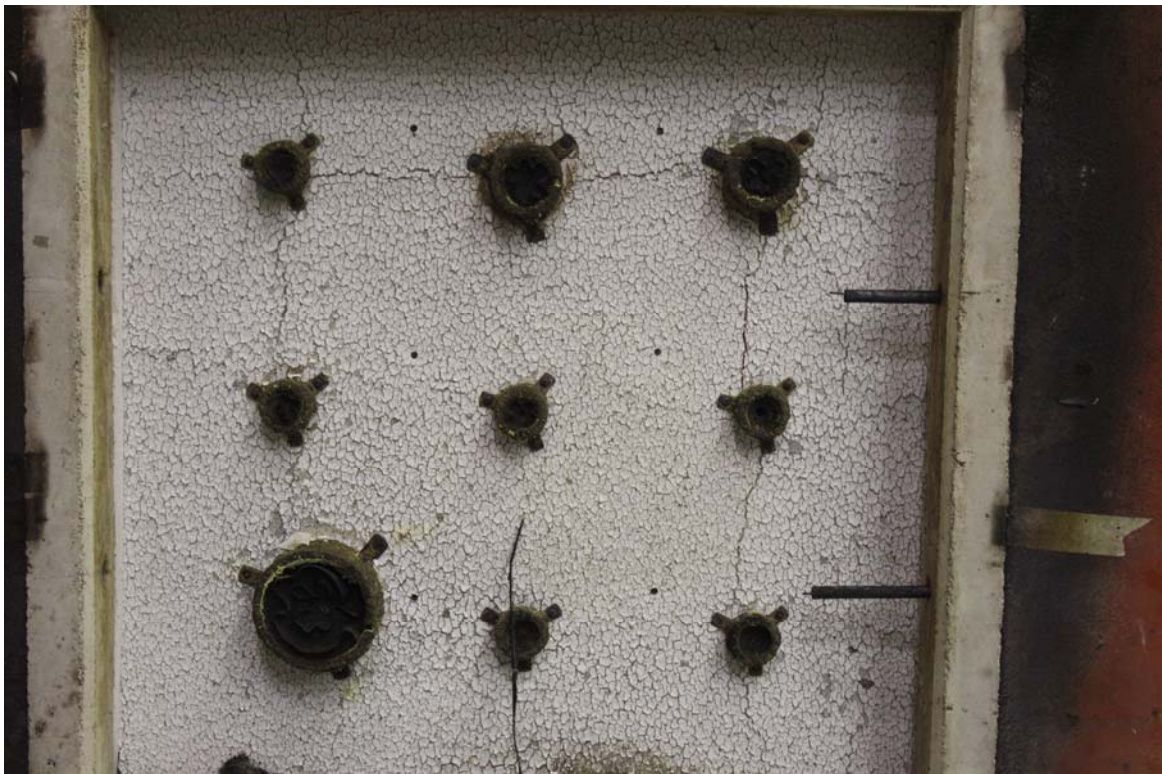
PHOTOGRAPH 4 – EXPOSED FACE OF SPECIMENS AT CONCLUSION OF TESTING

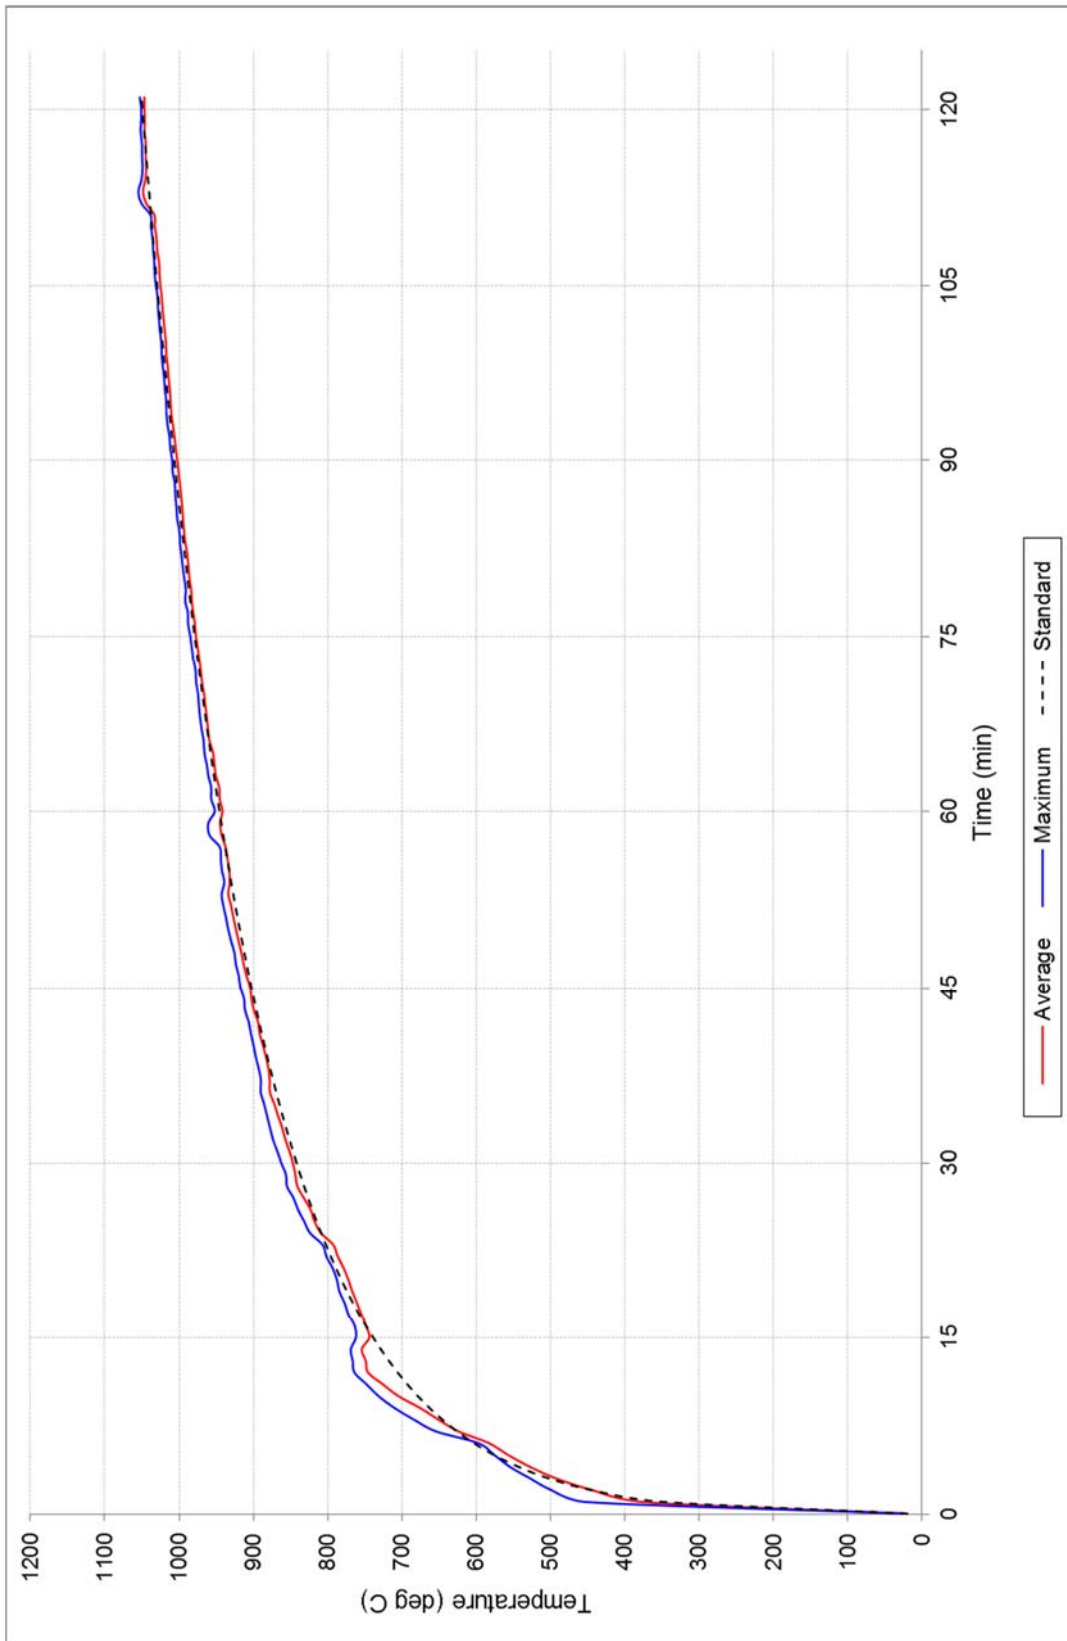
FIGURE 1 – FURNACE TEMPERATURE

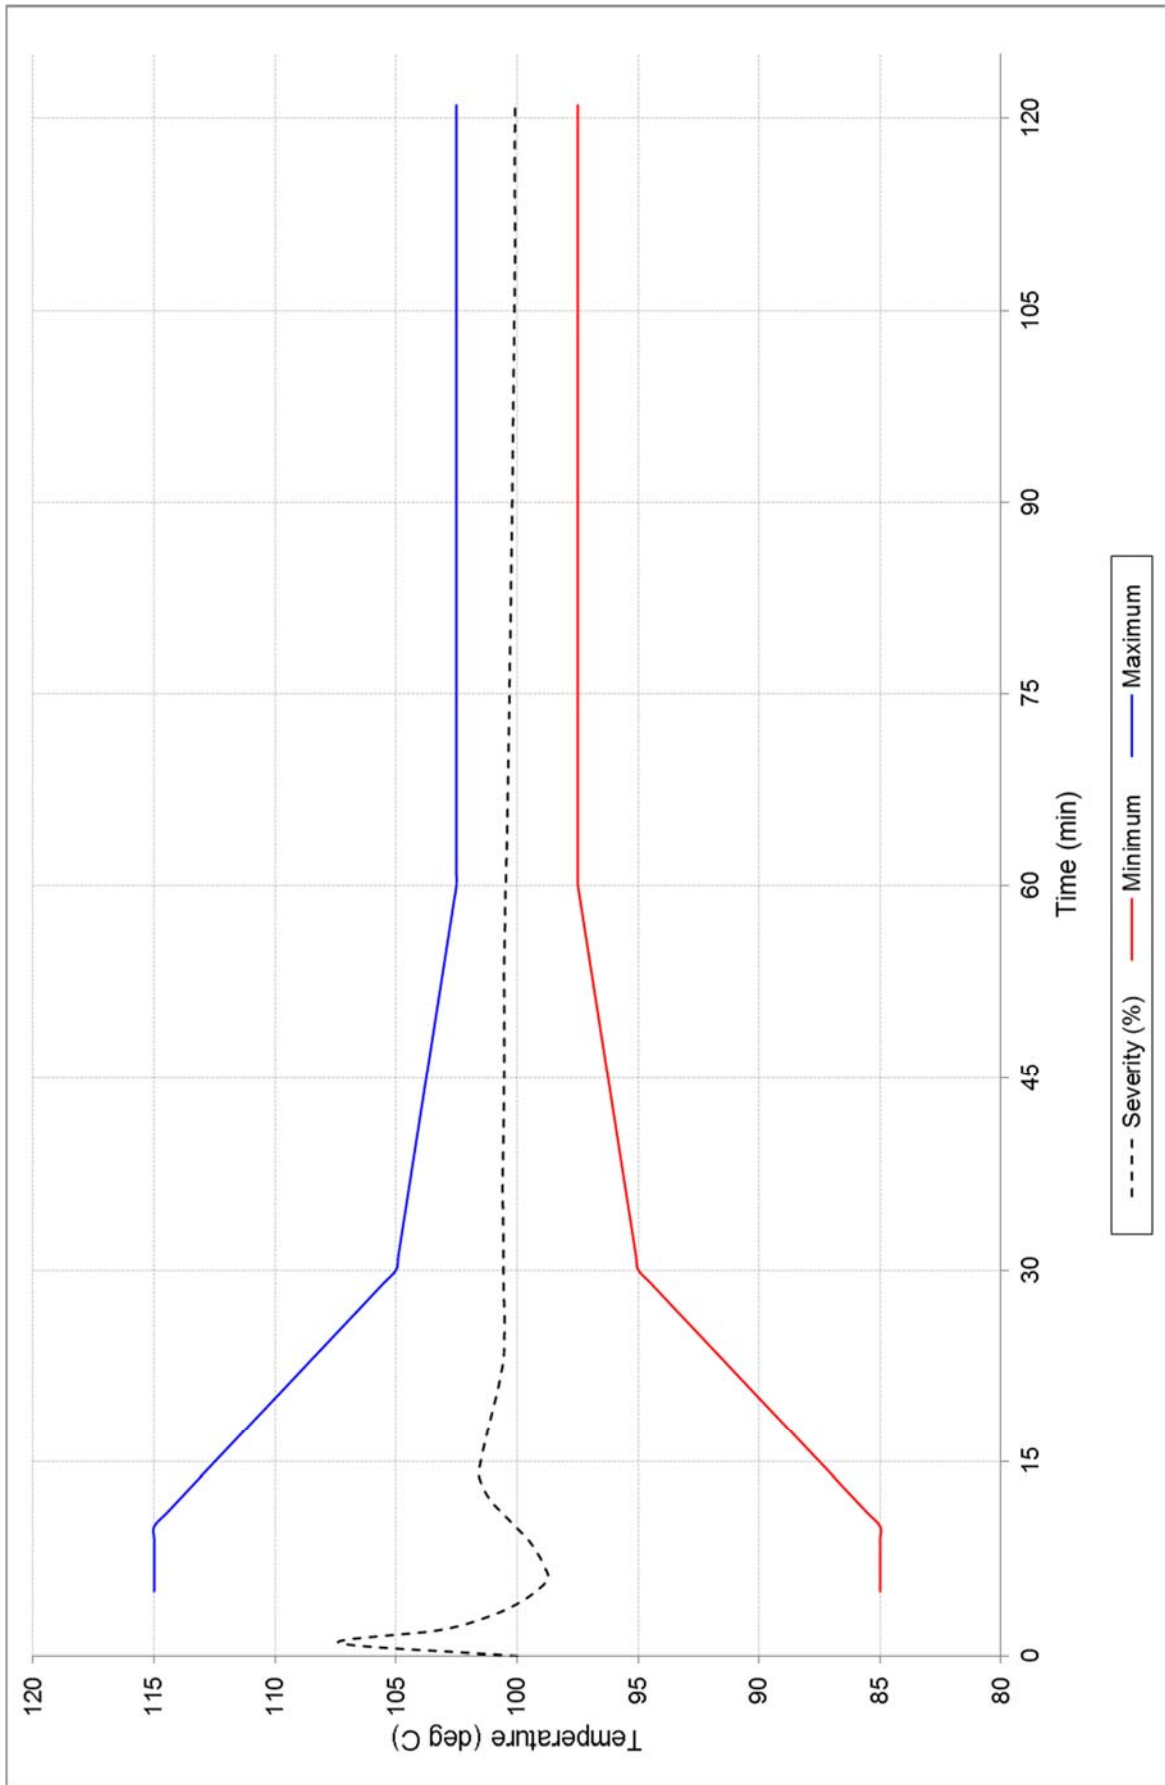
FIGURE 2 – FURNACE SEVERITY

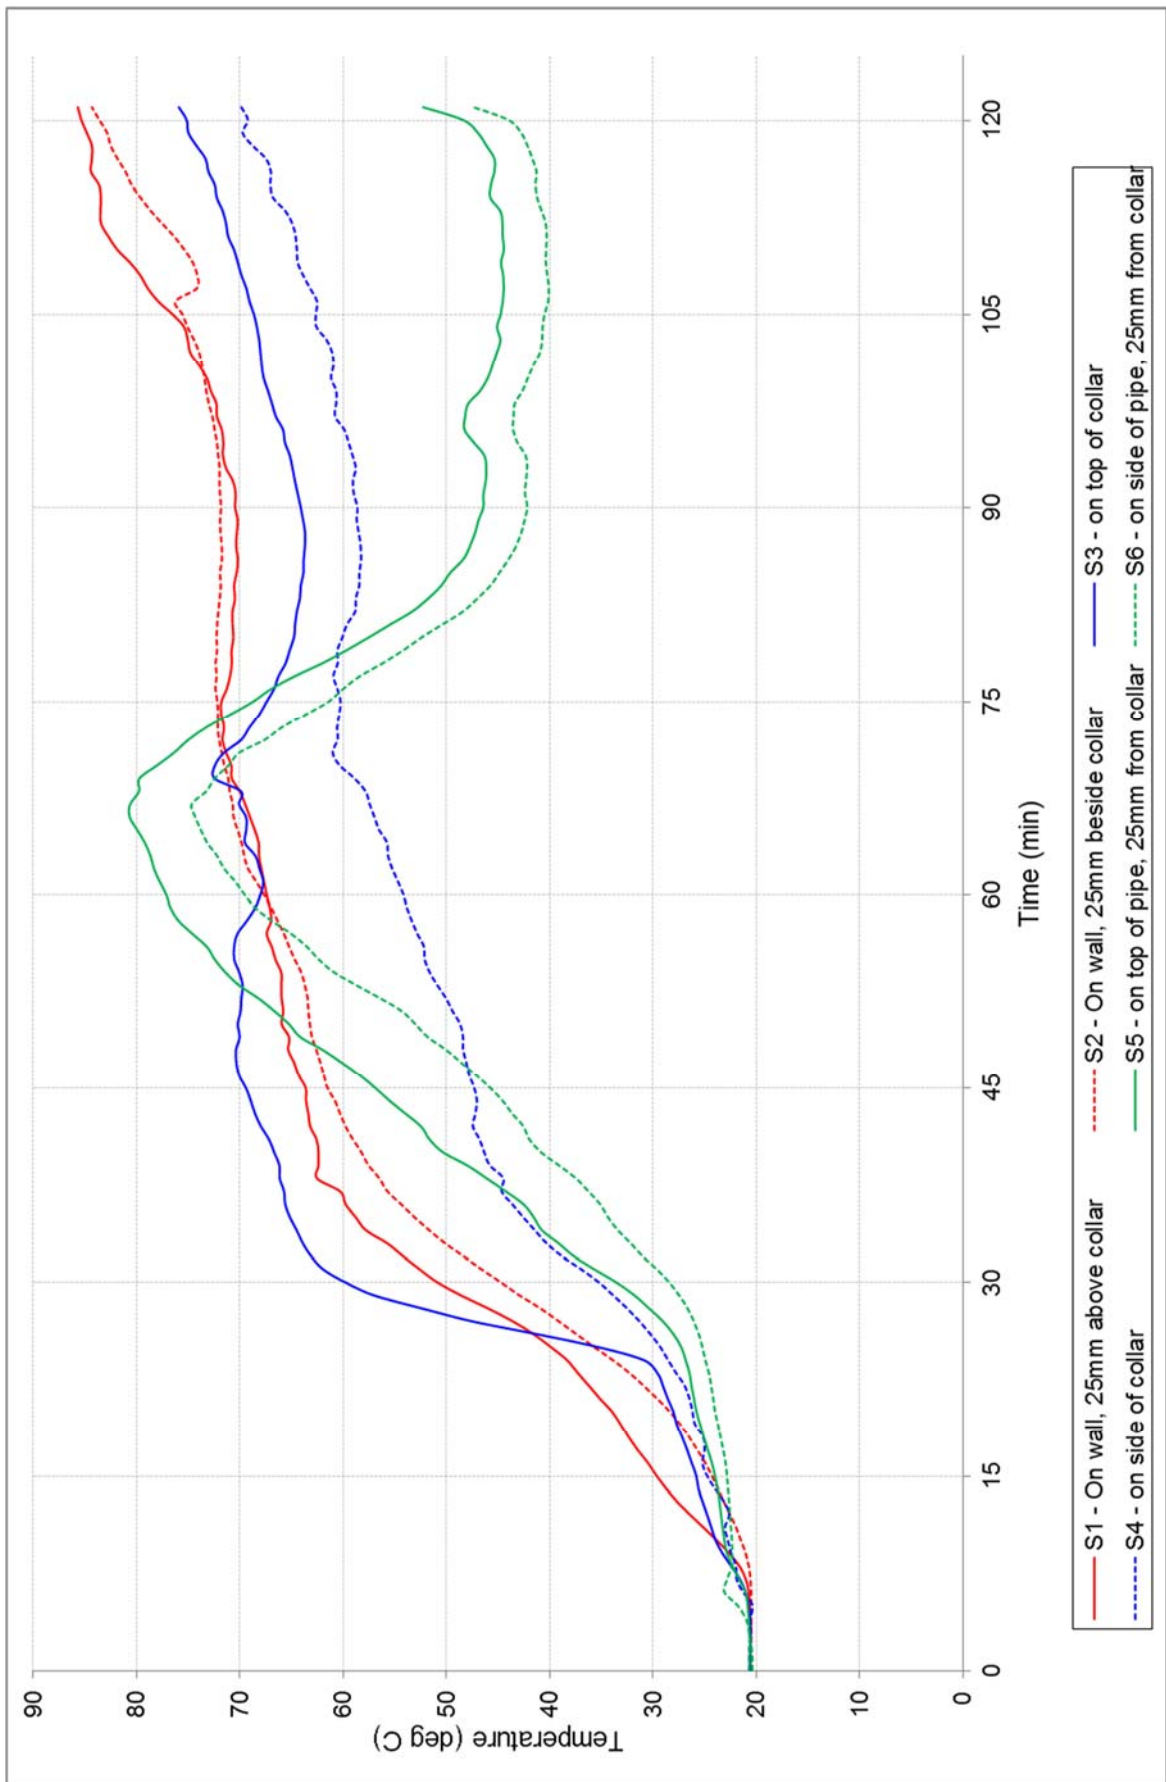
FIGURE 3 – SPECIMEN TEMPERATURE – ASSOCIATED WITH PENETRATION # 1

Integrity - no failure at 121 minutes

Insulation - no failure at 121 minutes

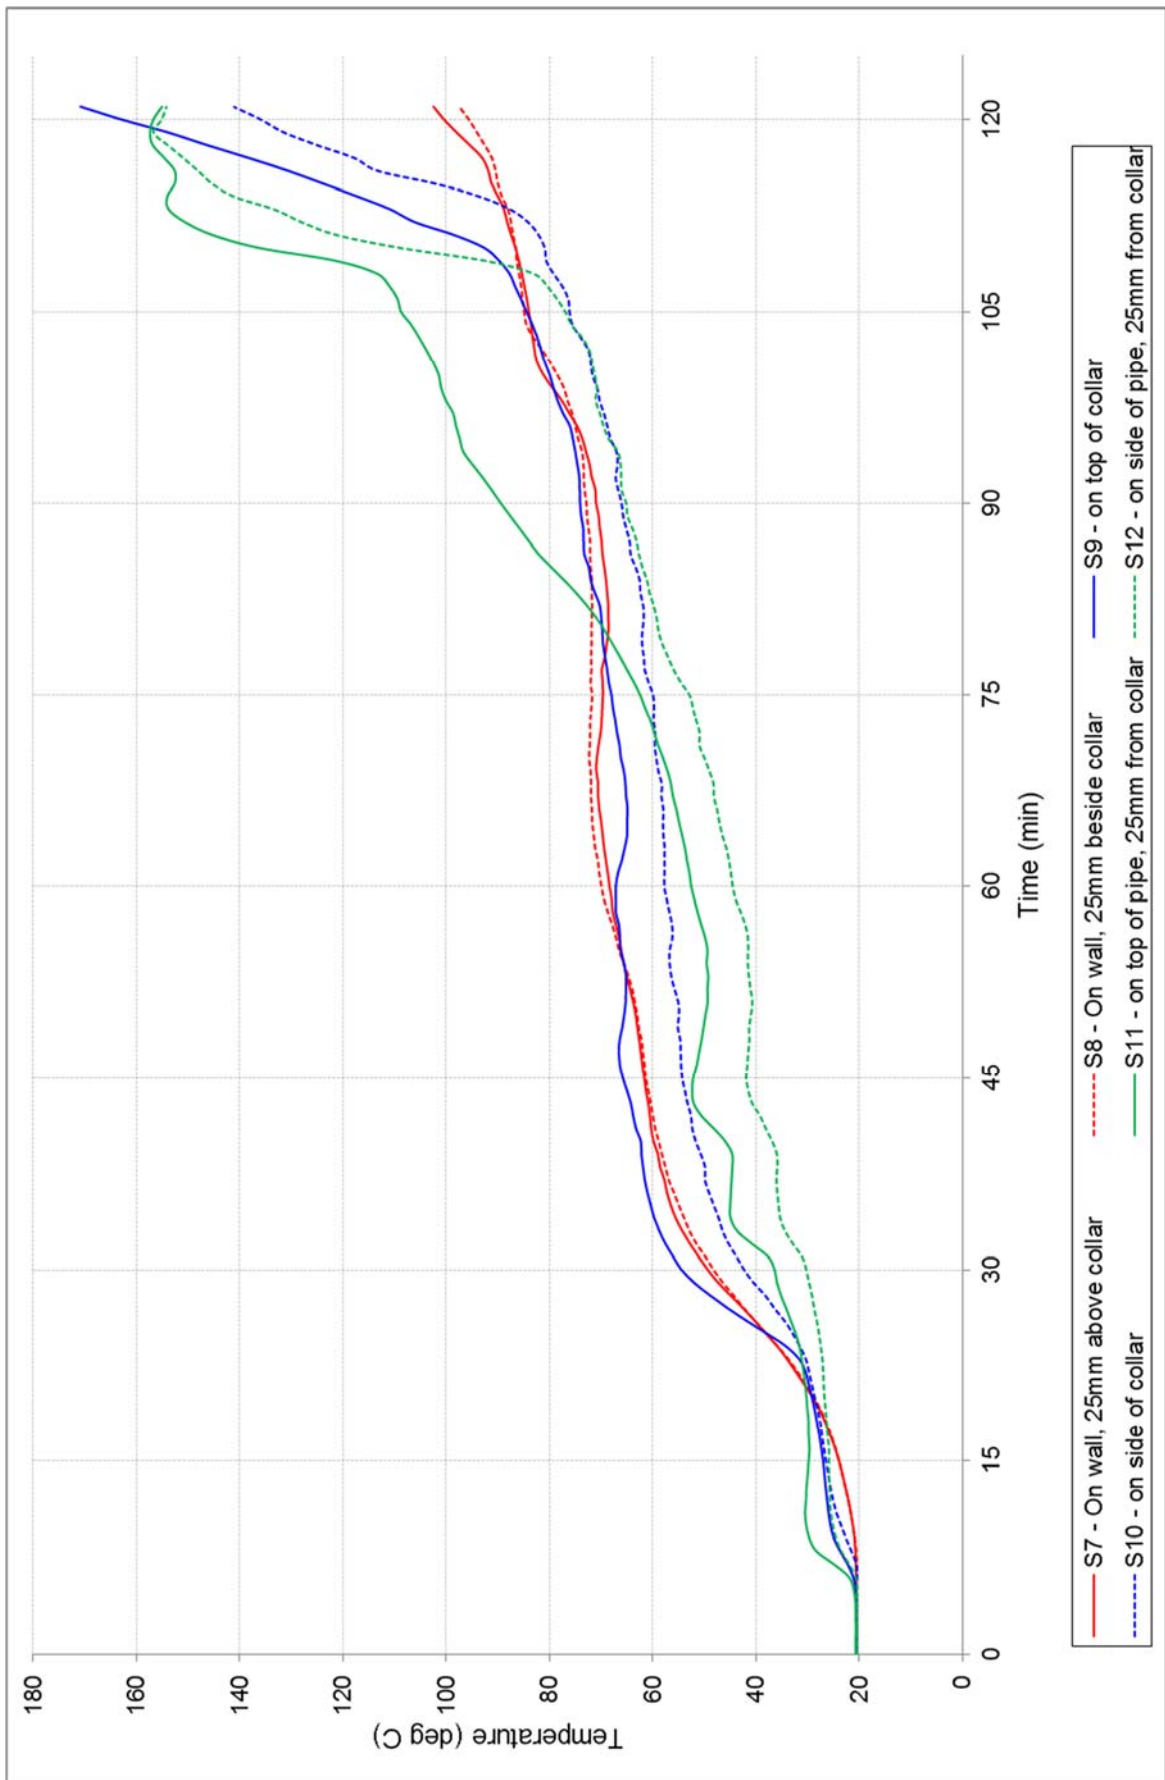
FIGURE 4 – SPECIMEN TEMPERATURE – ASSOCIATED WITH PENETRATION # 2

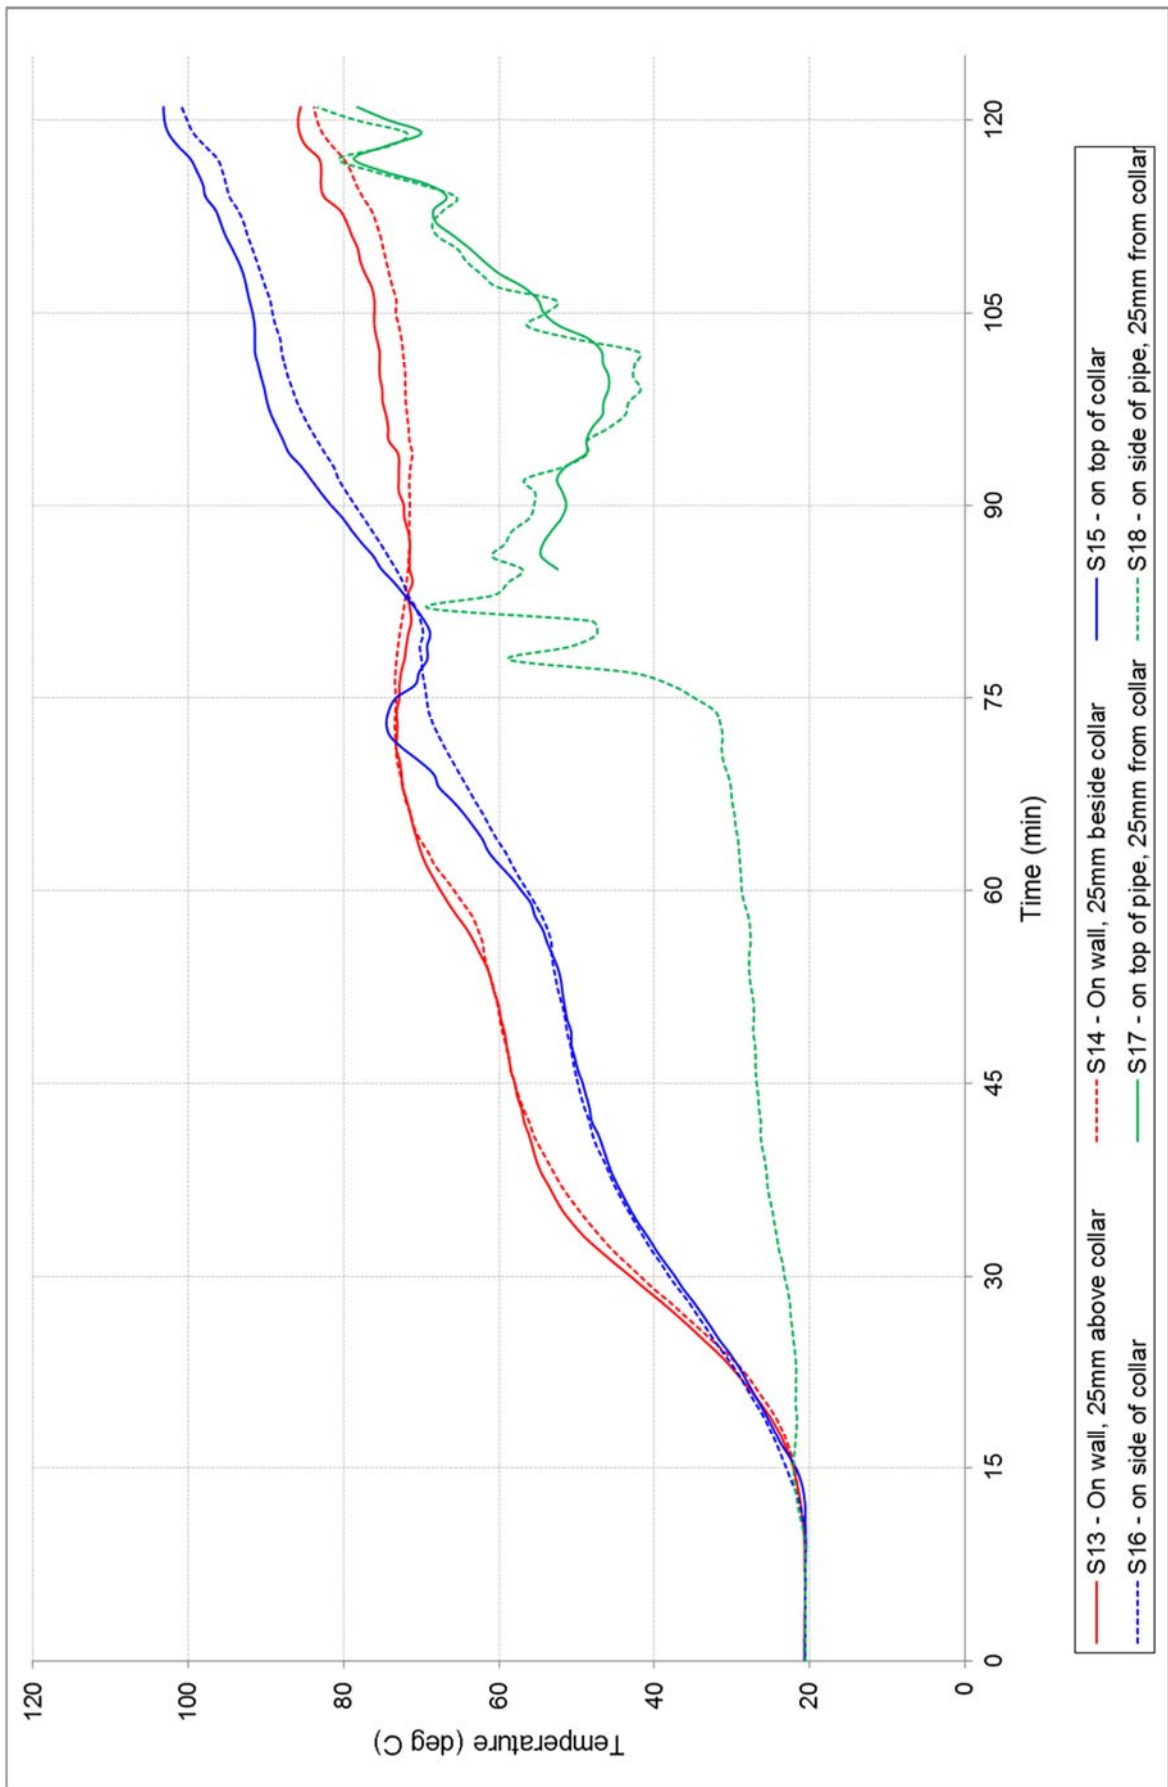
FIGURE 5 – SPECIMEN TEMPERATURE – ASSOCIATED WITH PENETRATION # 3

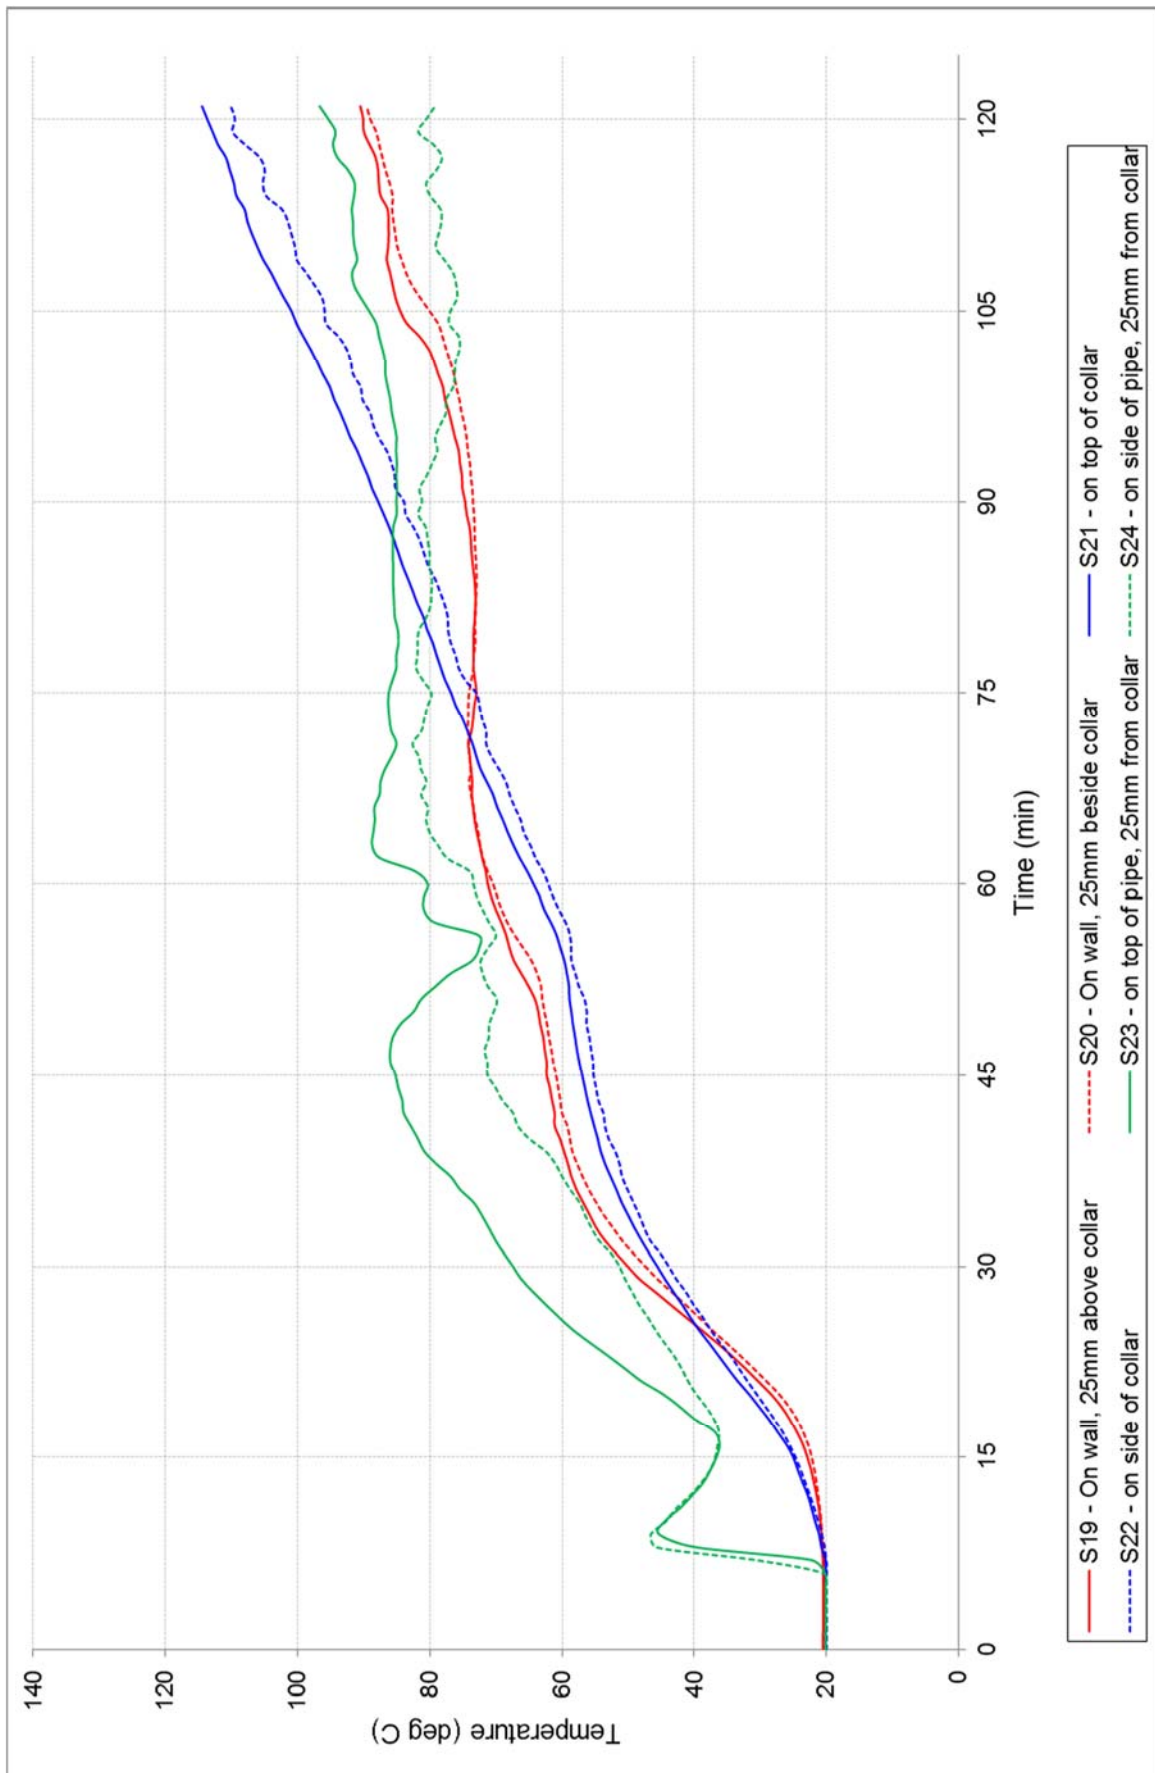
FIGURE 6 – SPECIMEN TEMPERATURE – ASSOCIATED WITH PENETRATION # 4

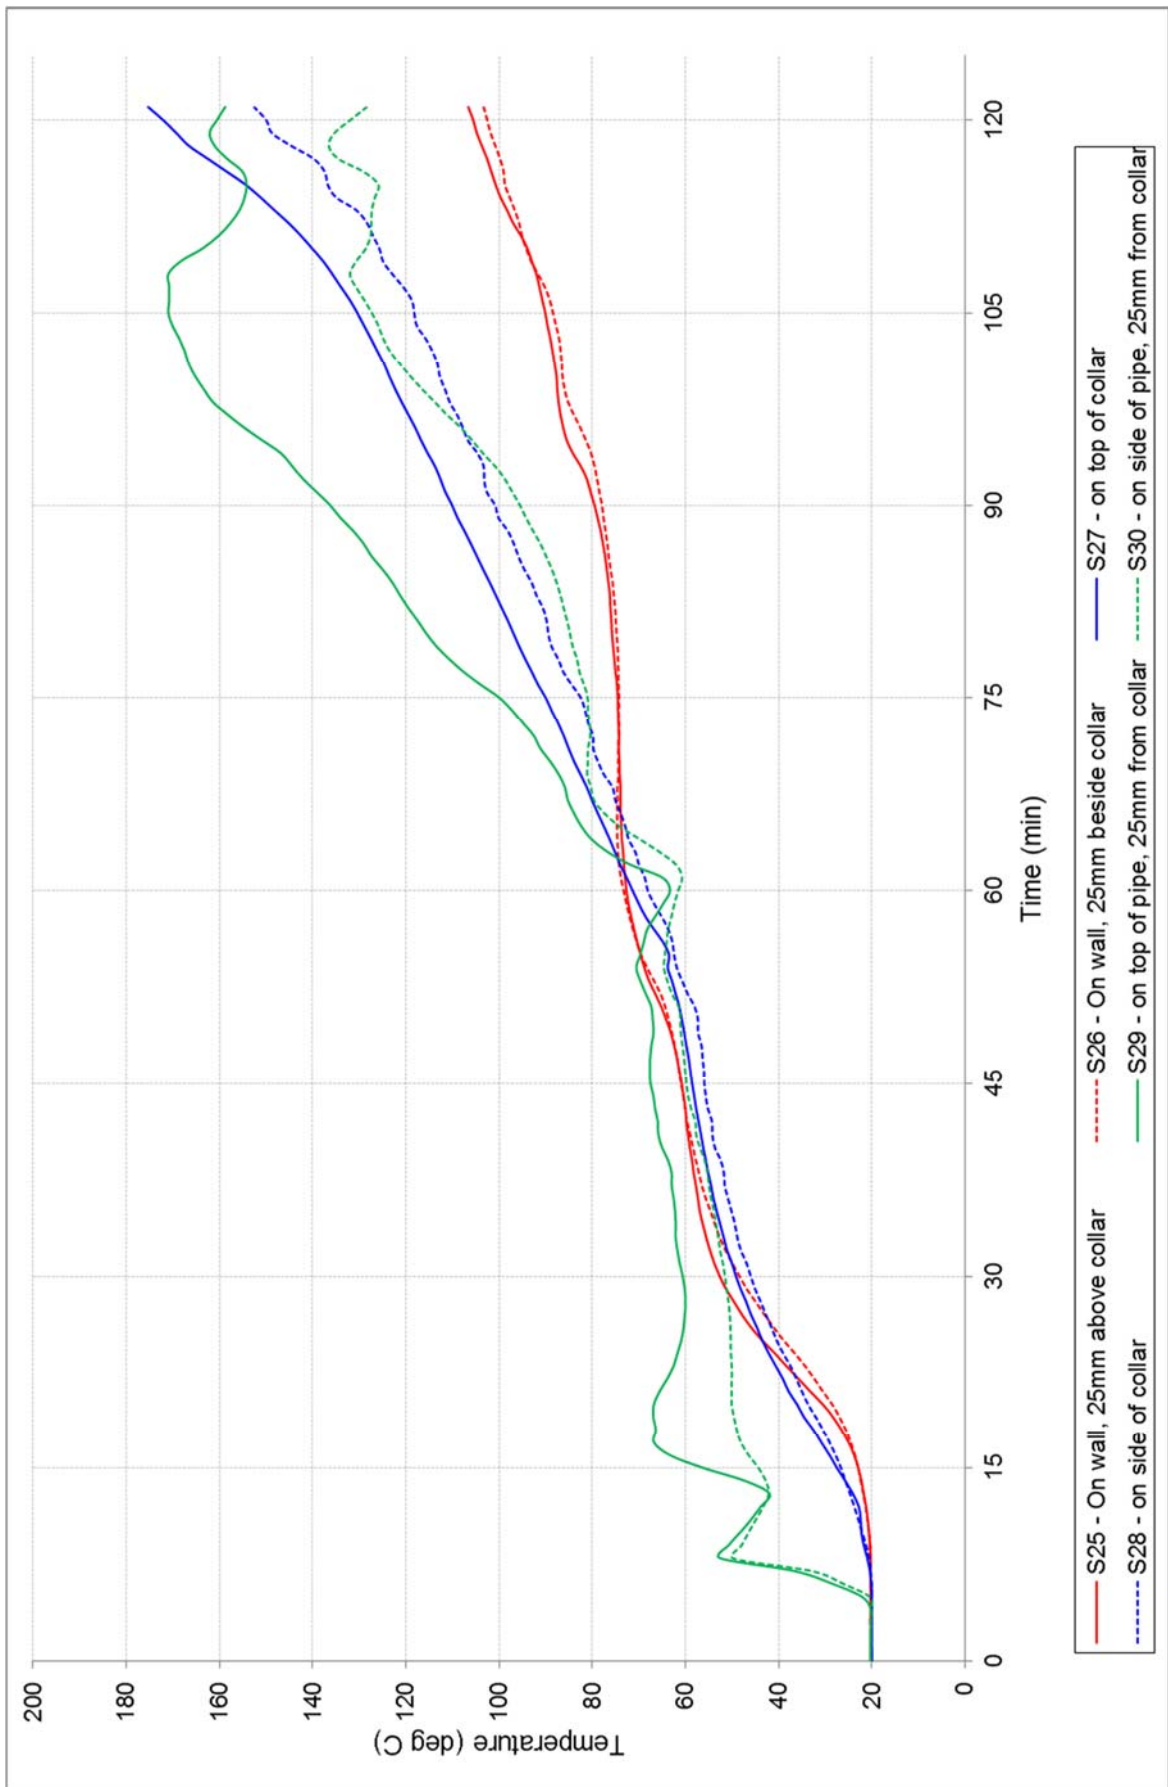
FIGURE 7 – SPECIMEN TEMPERATURE – ASSOCIATED WITH PENETRATION # 5

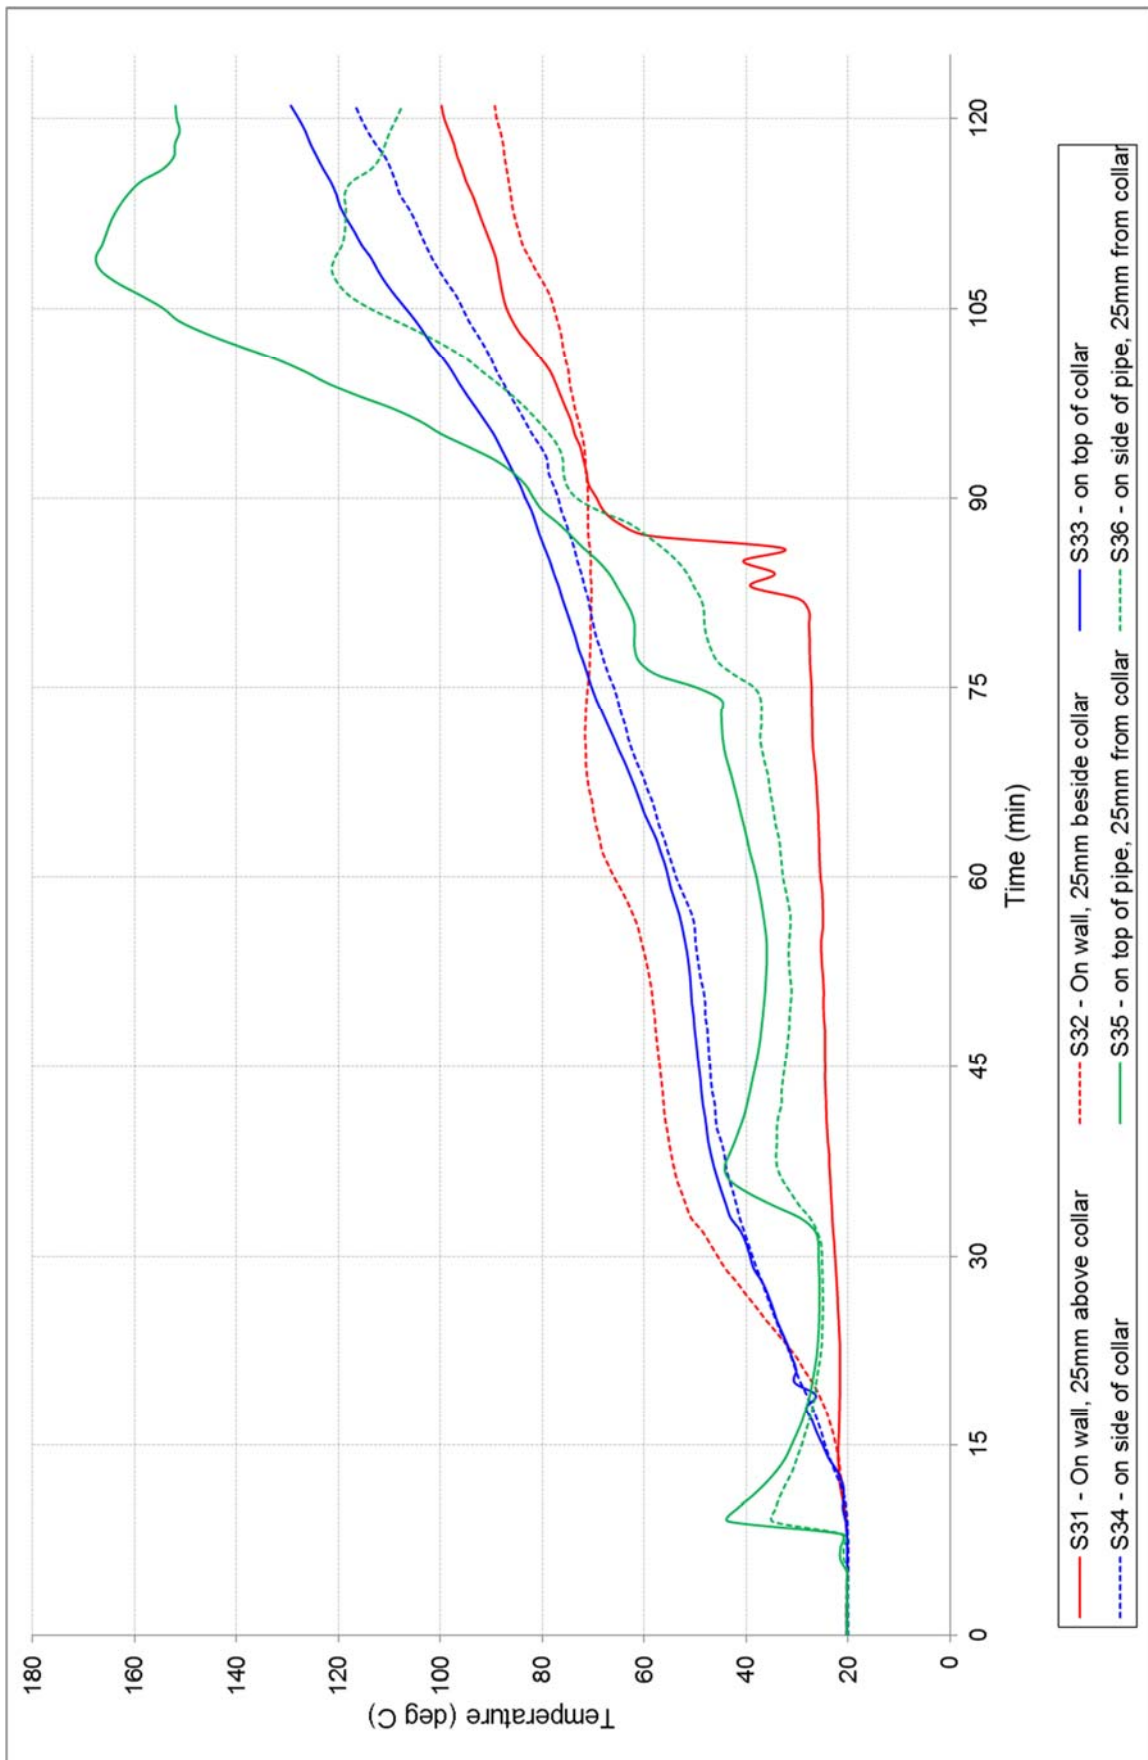
FIGURE 8 – SPECIMEN TEMPERATURE – ASSOCIATED WITH PENETRATION # 6

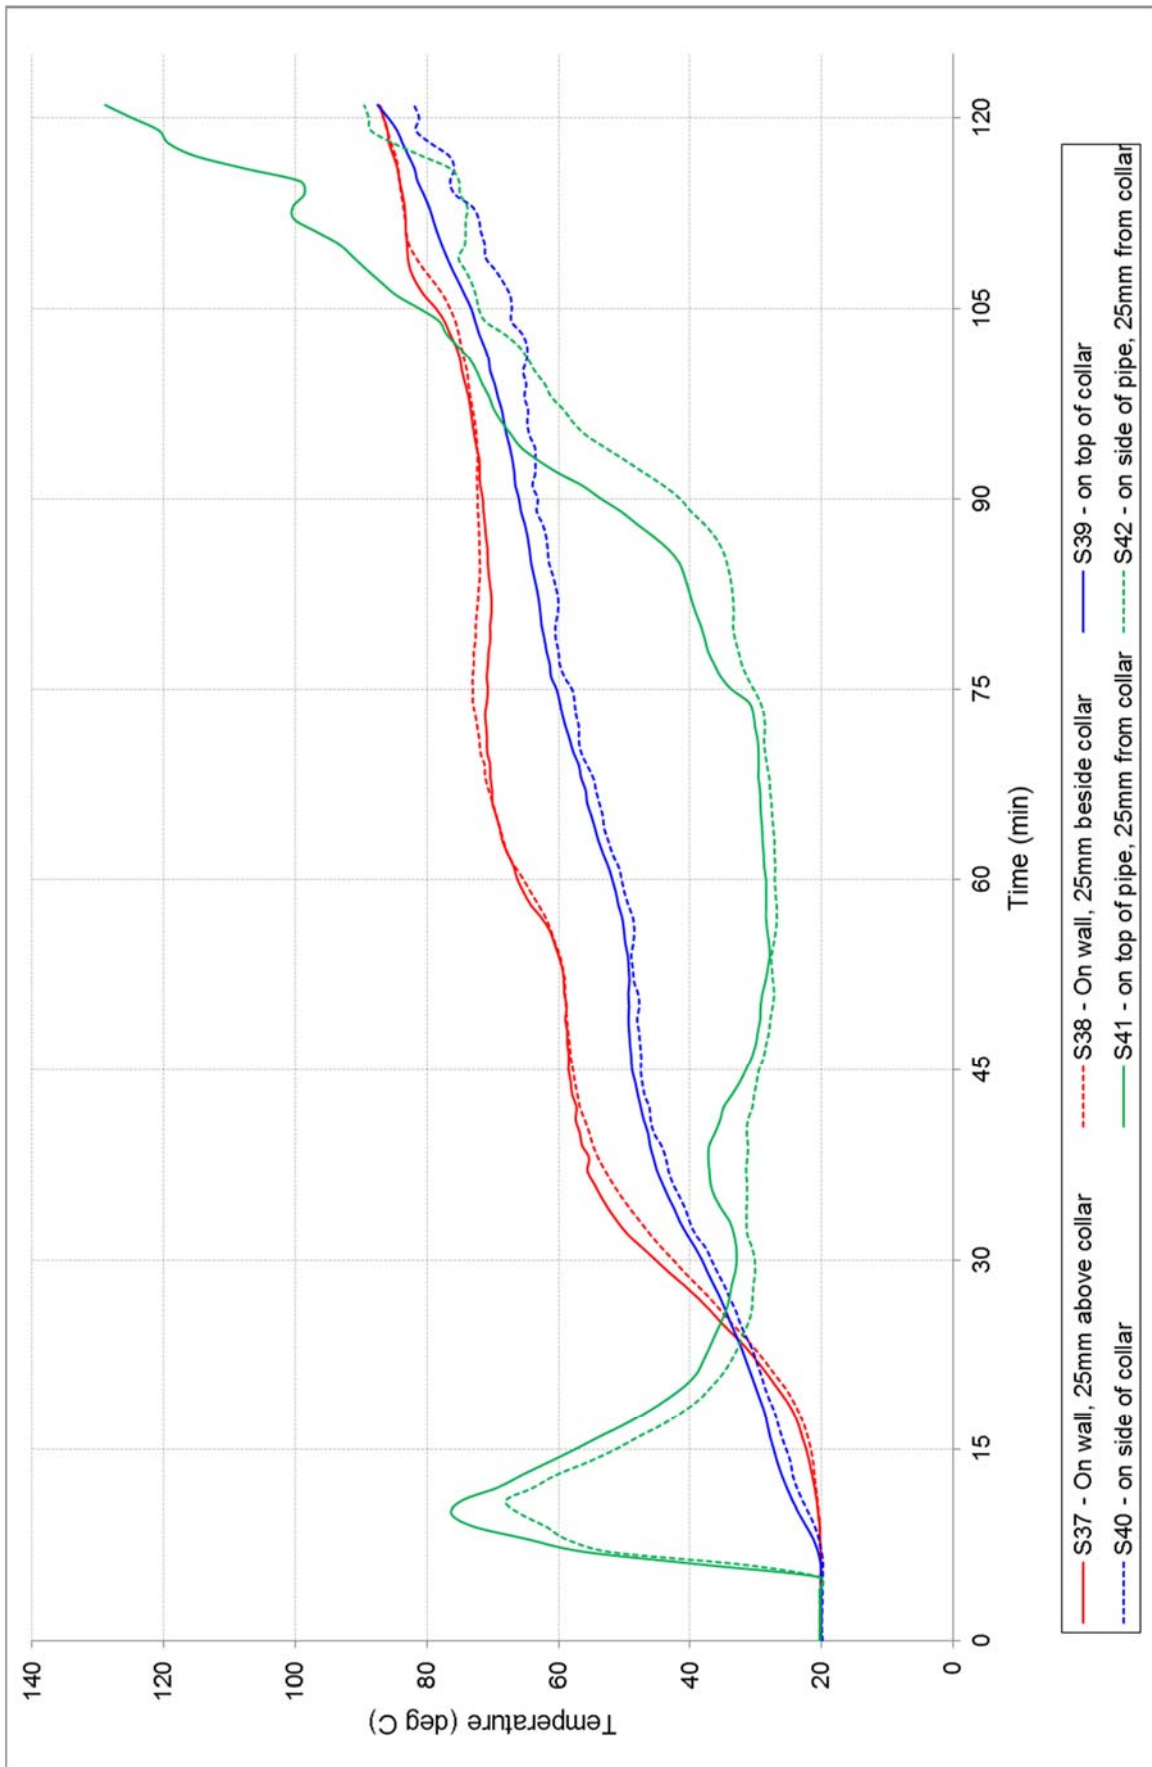
FIGURE 9 – SPECIMEN TEMPERATURE – ASSOCIATED WITH PENETRATION # 7
