Fire-resistance test on fire collars protecting a plasterboard wall penetrated by services

Test Report

Author: Russell Collins
Report number: FSP 1748
Date: 24 October 2016

Sponsored Investigation No. FSP 1748

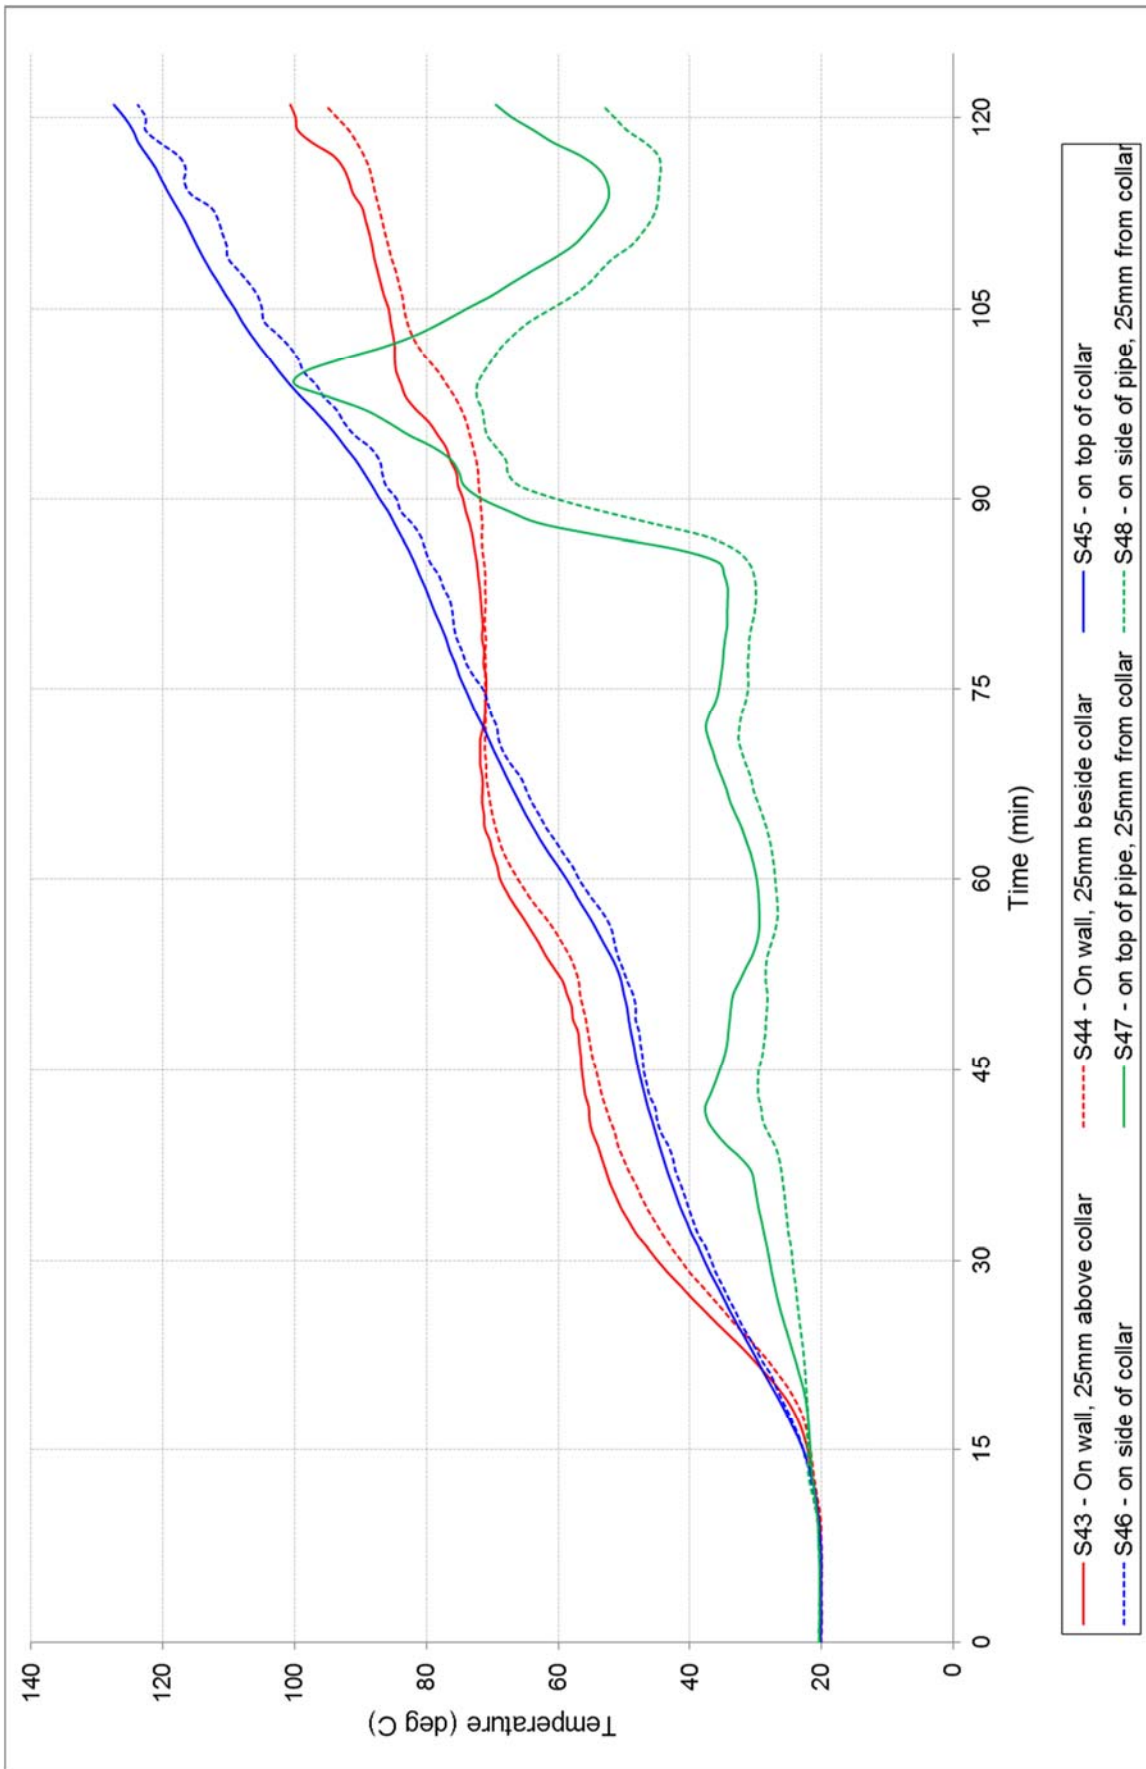
FIGURE 10 – SPECIMEN TEMPERATURE – ASSOCIATED WITH PENETRATION # 8

Specimen 8 – rigid PVC 15mm conduit pipe protected with Snap 32R	On wall – 25-mm above collar	S43
	On wall – 25-mm beside collar	S44
	On top of collar	S45
	On side of collar	S46
	On top of pipe 25-mm from collar	S47
	On side of pipe 25-mm from collar	S48
Specimen 9 – rigid PVC 100mm water pipe protected with Snap 110R	On wall – 25-mm above collar	S49
	On wall – 25-mm beside collar	S50
	On top of collar	S51
	On side of collar	S52
	On top of pipe 25-mm from collar	S53
	On side of pipe 25-mm from collar	S54

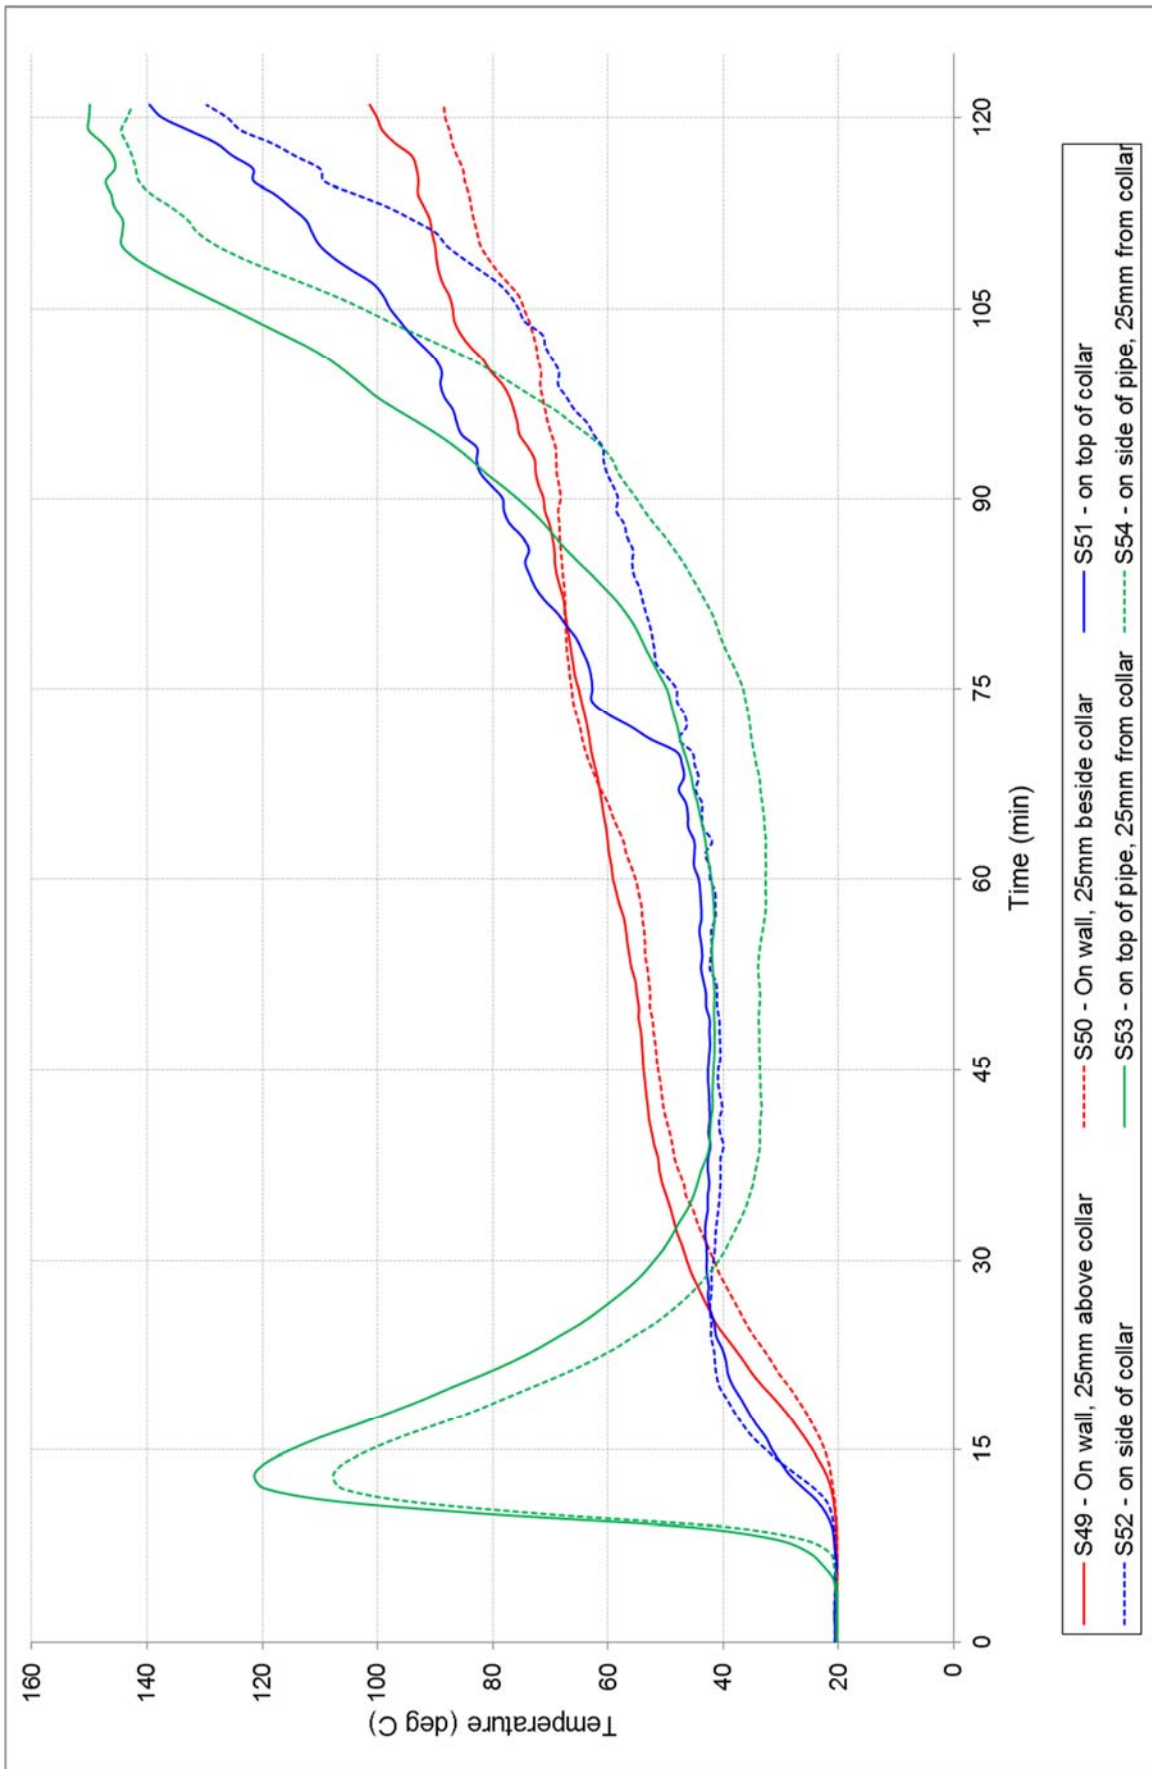
FIGURE 11 – SPECIMEN TEMPERATURE – ASSOCIATED WITH PENETRATION # 9

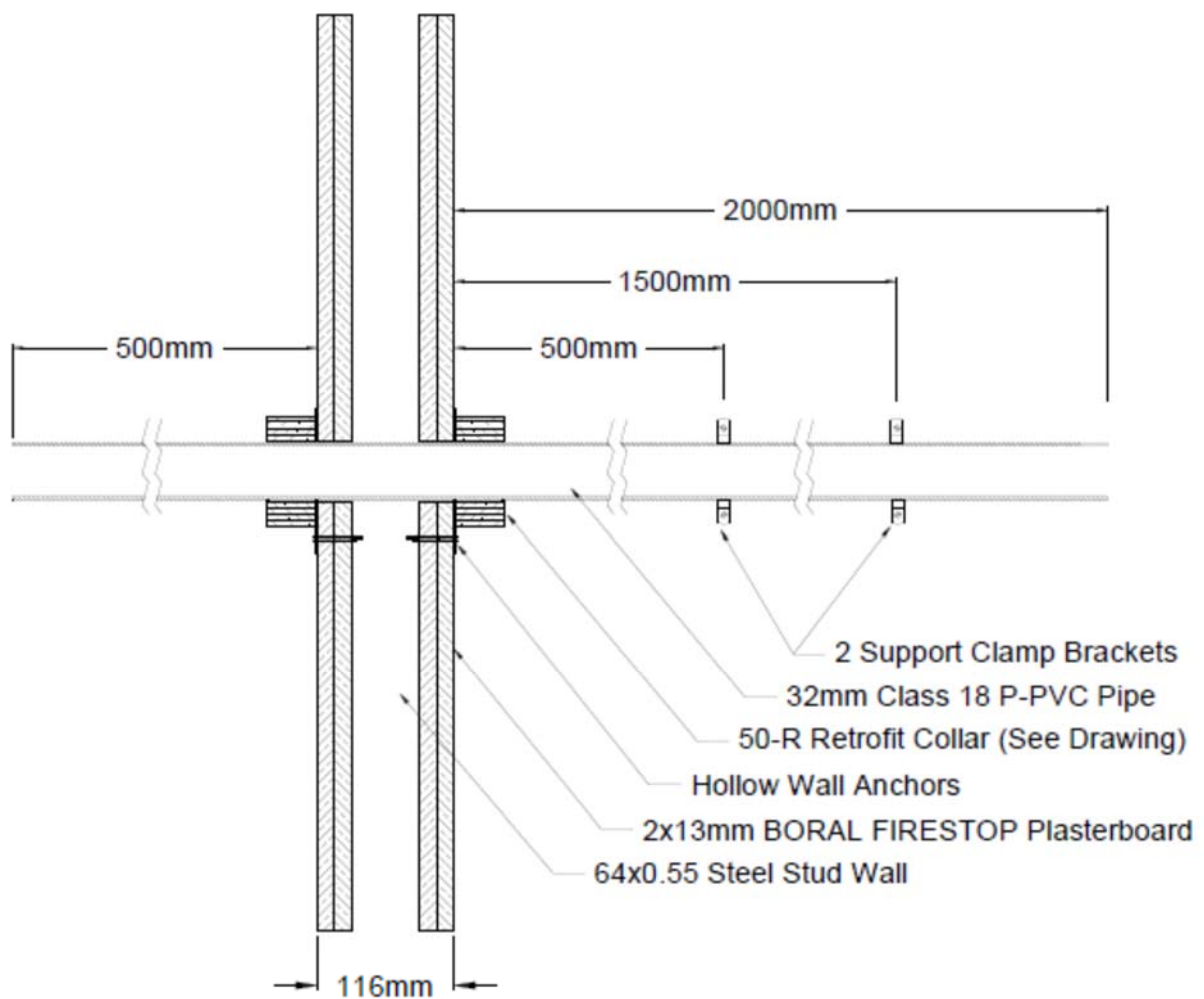
Test Wall W-16-A Penetration # 1
32mm Class 18 P-PVC Pipe – 50R Retrofit Collar
23 MAY 2016

DRAWING TITLED "TEST WALL W-16-A PENETRATION # 1 – 32-MM CLASS 18 P-PVC PIPE – 50R RETROFIT COLLAR", DATED 23 MAY 2016, BY SNAP FIRE SYSTEMS PTY LTD.

Penetration # 1 – 50R retrofitted fire collar protecting a 32-mm Class 18 Polyvinyl Chloride (P-PVC) Pipe

The SNAP Retrofit 50R fire collar comprised a 0.75-mm steel casing with a 62-mm inner diameter and a 149-mm diameter base flange. The 47-mm high collar casing incorporated a closing mechanism that was comprised of two soft Intumesh intumescent wraps lined within the internal circumference of the collar. The inner and outer strips were 4-mm thick x 43-mm wide x 200-mm long, and 4-mm thick x 43-mm wide x 220-mm long, respectively. Between the strips was a layer of 304 stainless steel mesh 210-mm long x 42-mm wide with wire mesh diameter of 0.15-mm, as shown in drawing numbered 50R-T dated 4 November 2014, by Snap Fire Systems Pty Ltd. One collar was fixed to each side of the plasterboard wall in a back-to-back configuration using three hollow wall anchors.

The penetrating service comprised a 32-mm nominal diameter Class 18 P-PVC Pipe, with a wall thickness of 3.6-mm, fitted through the collar's sleeve and penetrating the plasterboard wall through a 50-mm diameter cut-out hole as shown in drawing titled "Test Wall W-16-A Penetration # 1 – 32-mm Class 18 P-PVC Pipe – 50R Retrofit Collar", dated 23 May 2016, by Snap Fire Systems Pty Ltd. The pipe projected horizontally, approximately 2000-mm away from the unexposed face of the plasterboard wall and approximately 500-mm into the furnace chamber. The pipe was supported at nominally 500-mm from the unexposed face of the plasterboard wall by two support clamp brackets spaced apart at nominally 1000-mm. The pipe was open at the unexposed and exposed end.

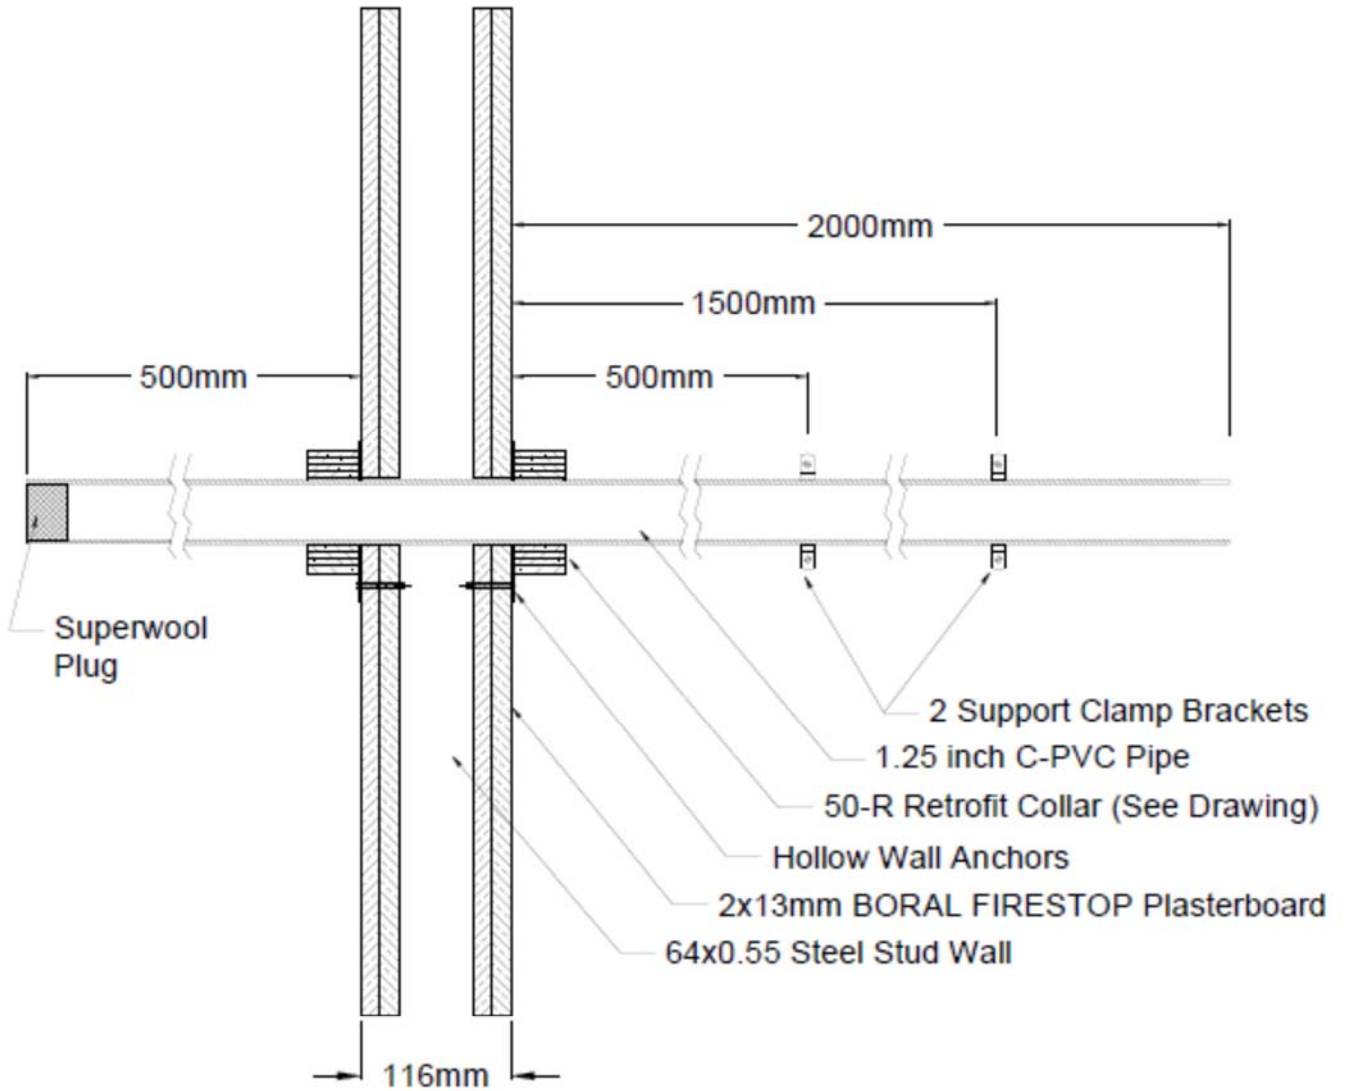
Test Wall W-16-A Penetration # 2
1.25 inch C-PVC Pipe – 50R Retrofit Collar
23 MAY 2016

DRAWING TITLED "TEST WALL W-16-A PENETRATION # 2 – 1.25 INCH C-PVC PIPE – 50R RETROFIT COLLAR", DATED 23 MAY 2016, BY SNAP FIRE SYSTEMS PTY LTD.

Penetration # 2 – 50R retrofitted fire collar protecting a 1.25 inch Polyvinyl Chloride (C-PVC) Pipe

The SNAP Retrofit 50R fire collar comprised a 0.75-mm steel casing with a 62-mm inner diameter and a 149-mm diameter base flange. The 47-mm high collar casing incorporated a closing mechanism that was comprised of two soft Intumesh intumescent wraps lined within the internal circumference of the collar. The inner and outer strips were 4-mm thick x 43-mm wide x 200-mm long, and 4-mm thick x 43-mm wide x 220-mm long, respectively. Between the strips was a layer of 304 stainless steel mesh 210-mm long x 42-mm wide with wire mesh diameter of 0.15-mm, as shown in drawing numbered 50R-T dated 4 November 2014, by Snap Fire Systems Pty Ltd. One collar was fixed to each side of the plasterboard wall in a back-to-back configuration using three hollow wall anchors.

The penetrating service comprised a 1.25 inch C-PVC Pipe, with a wall thickness of 3.5-mm, fitted through the collar's sleeve and penetrating the plasterboard wall through a 50-mm diameter cut-out hole as shown in drawing titled "Test Wall W-16-A Penetration # 2 – 1.25 inch C-PVC Pipe – 50R Retrofit Collar", dated 23 May 2016, by Snap Fire Systems Pty Ltd. The pipe projected horizontally, approximately 2000-mm away from the unexposed face of the plasterboard wall and approximately 500-mm into the furnace chamber. The pipe was supported at nominally 500-mm from the unexposed face of the plasterboard wall by two support clamp brackets spaced apart at nominally 1000-mm. The pipe was open at the unexposed end and capped on the exposed end with a ceramic fibre (Superwool) plug.

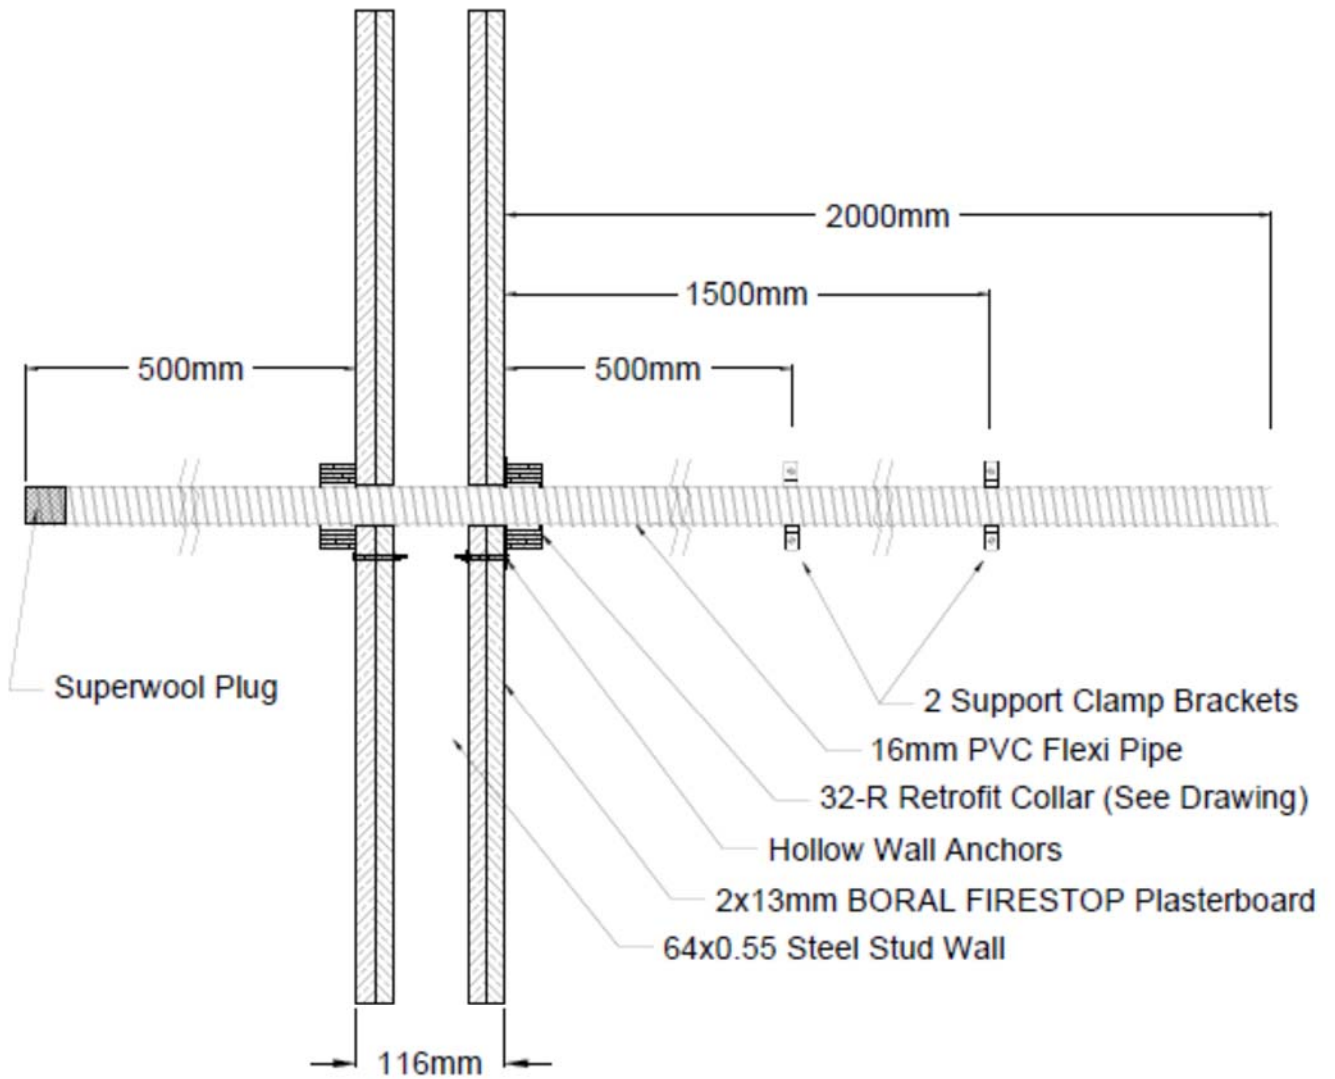
Test Wall W-16-A Penetration # 3
 16mm PVC Flexi Pipe – 32R Retrofit Collar
 23 MAY 2016

DRAWING TITLED "TEST WALL W-16-A PENETRATION # 3 – 16-MM PVC FLEXI PIPE – 32R RETROFIT COLLAR", DATED 23 MAY 2016, BY SNAP FIRE SYSTEMS PTY LTD.

Penetration # 3 – 32R retrofitted fire collar protecting a 16-mm Polyvinyl Chloride (PVC) Flexi Pipe

The SNAP Retrofit 32R fire collar comprised a 0.75-mm steel casing with a 40-mm inner diameter and a 106-mm diameter base flange. The 32-mm high collar casing incorporated a closing mechanism that was comprised of two soft Intumesh intumescent strips lined within the internal circumference of the collar. The inner and outer strips were 4-mm thick x 26-mm wide x 135-mm long, and 4-mm thick x 26-mm wide x 154-mm long, respectively. Between the strips was a layer of 304 stainless steel mesh 135-mm long x 25-mm wide with wire mesh diameter of 0.15-mm, as shown in drawing numbered 32R-T dated 12 February 2015, by Snap Fire Systems Pty Ltd. One collar was fixed to each side of the plasterboard wall in a back-to-back configuration using three hollow wall anchors.

The penetrating service comprised a 16-mm nominal diameter PVC Flexi Pipe, with a wall thickness of 1.8-mm, fitted through the collar's sleeve and penetrating the plasterboard wall through a 20-mm diameter cut-out hole as shown in drawing titled "Test Wall W-16-A Penetration # 3 – 16-mm PVC Flexi Pipe – 32R Retrofit Collar", dated 23 May 2016, by Snap Fire Systems Pty Ltd. The pipe projected horizontally, approximately 2000-mm away from the unexposed face of the plasterboard wall and approximately 500-mm into the furnace chamber. The pipe was supported at nominally 500-mm from the unexposed face of the plasterboard wall by two support clamp brackets spaced apart at nominally 1000-mm. The pipe was open at the unexposed end and capped on the exposed end with a ceramic fibre (Superwool) plug.

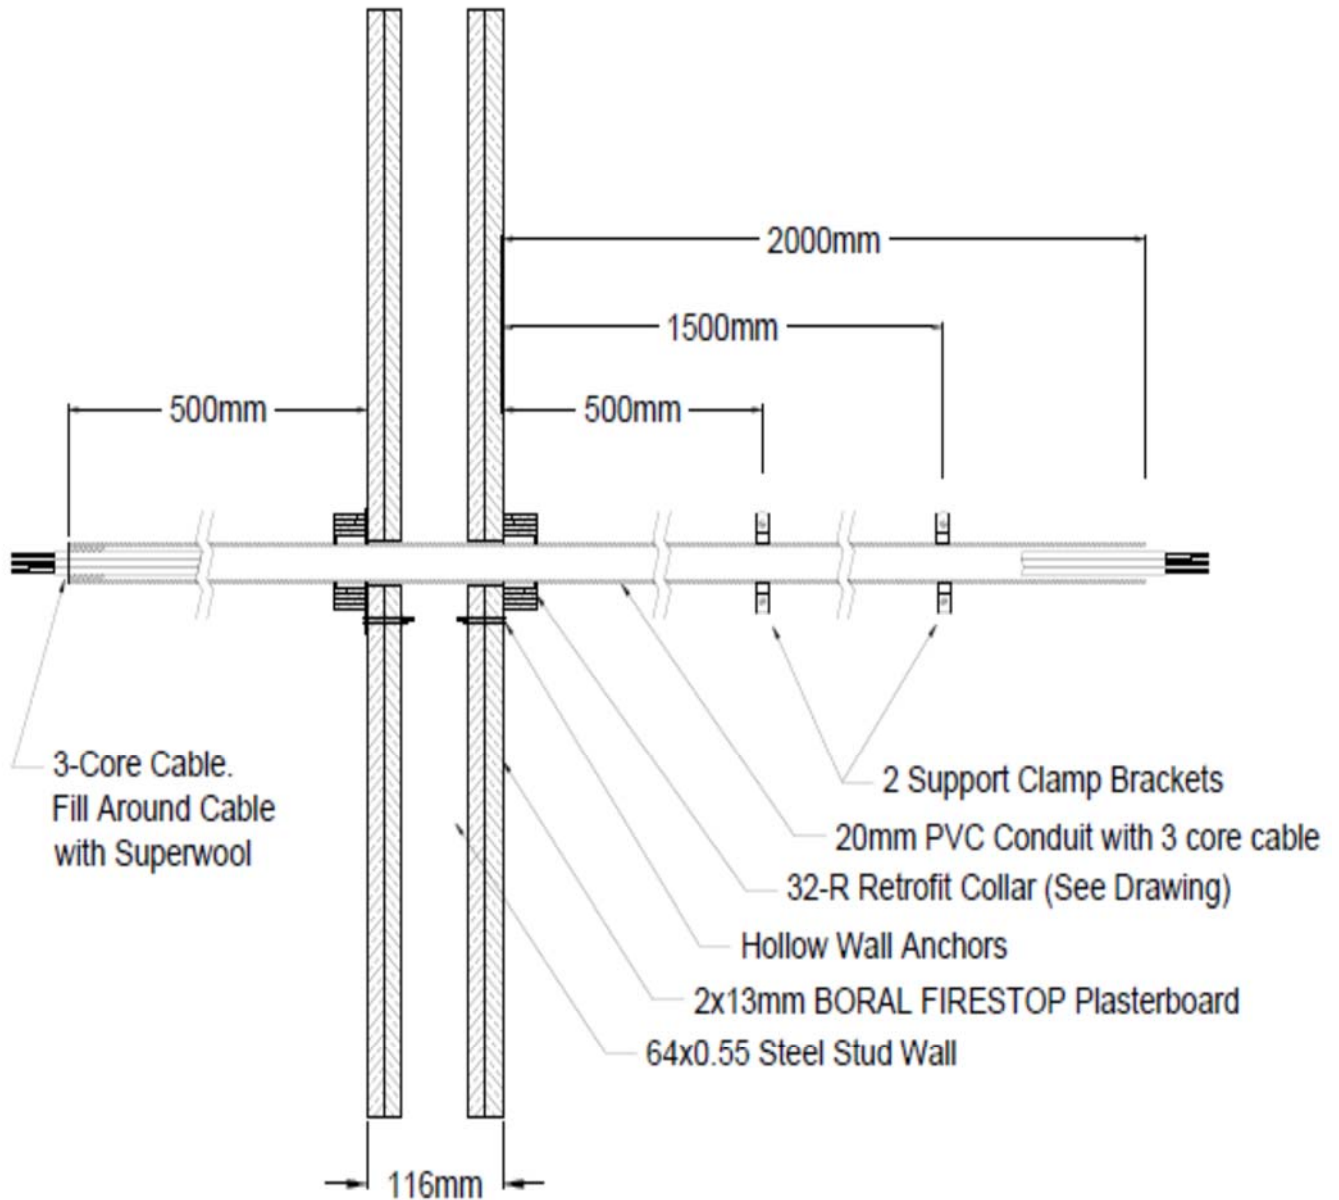
Test Wall W-16-A Penetration # 4
20mm PVC Conduit with 3 core cable -32R Retrofit collar
23 MAY 2016

DRAWING TITLED "TEST WALL W-16-A PENETRATION # 4 – 20-MM PVC CONDUIT WITH 3 CORE CABLE – 32R RETROFIT COLLAR", DATED 23 MAY 2016, BY SNAP FIRE SYSTEMS PTY LTD.

Penetration # 4 – 32R retrofitted fire collar protecting a 20-mm Polyvinyl Chloride (PVC) Conduit with 3 core cable

The SNAP Retrofit 32R fire collar comprised a 0.75-mm steel casing with a 40-mm inner diameter and a 106-mm diameter base flange. The 32-mm high collar casing incorporated a closing mechanism that was comprised of two soft Intumescent strips lined within the internal circumference of the collar. The inner and outer strips were 4-mm thick x 26-mm wide x 135-mm long, and 4-mm thick x 26-mm wide x 154-mm long, respectively. Between the strips was a layer of 304 stainless steel mesh 135-mm long x 25-mm wide with wire mesh diameter of 0.15-mm, as shown in drawing numbered 32R-T dated 12 February 2015, by Snap Fire Systems Pty Ltd. One collar was fixed to each side of the plasterboard wall in a back-to-back configuration using three hollow wall anchors.

The penetrating service comprised a 20-mm nominal diameter PVC Conduit with 3 core cable, with a wall thickness of 1.8-mm, fitted through the collar's sleeve and penetrating the plasterboard wall through a 25-mm diameter cut-out hole as shown in drawing titled "Test Wall W-16-A Penetration # 4 – 20-mm PVC Conduit with 3 core cable – 32R Retrofit Collar", dated 23 May 2016, by Snap Fire Systems Pty Ltd. The pipe projected horizontally, approximately 2000-mm away from the unexposed face of the plasterboard wall and approximately 500-mm into the furnace chamber. The pipe was supported at nominally 500-mm from the unexposed face of the plasterboard wall by two support clamp brackets spaced apart at nominally 1000-mm. The pipe was open at the unexposed end and capped on the exposed end with a ceramic fibre (Superwool) plug.

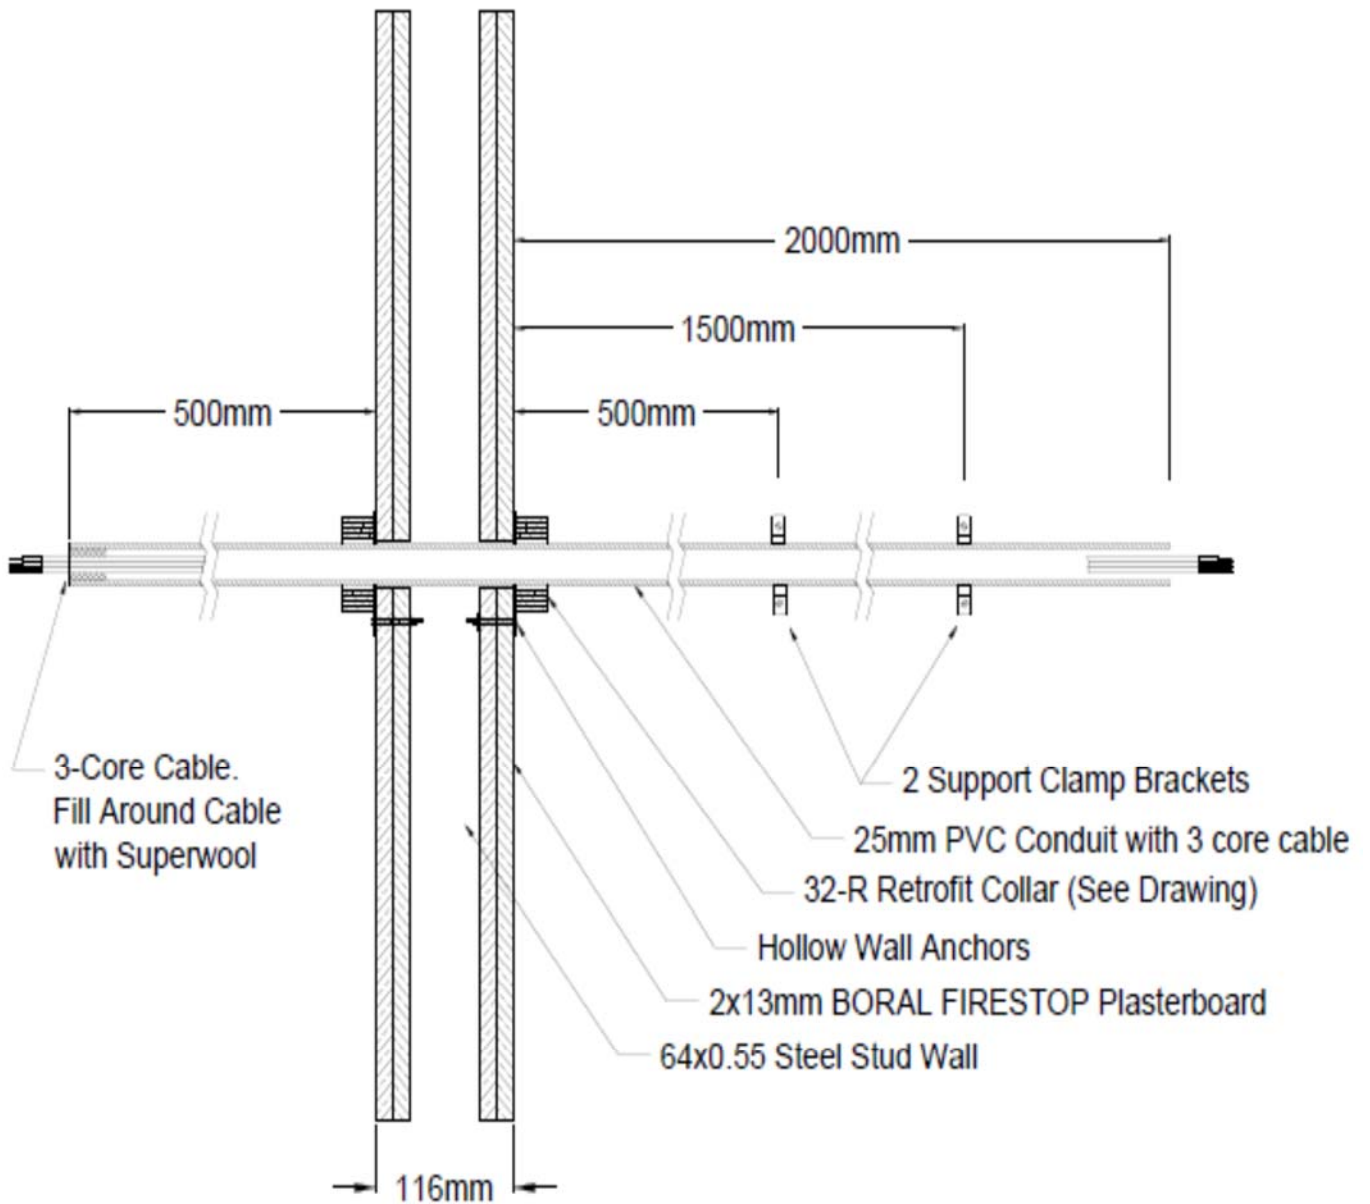
Test Wall W-16-A Penetration # 5
 25mm PVC Conduit with 3 core cable -32R Retrofit collar
 23 MAY 2016

DRAWING TITLED "TEST WALL W-16-A PENETRATION # 5 – 25-MM PVC CONDUIT WITH 3 CORE CABLE – 32R RETROFIT COLLAR", DATED 23 MAY 2016, BY SNAP FIRE SYSTEMS PTY LTD.

Penetration # 5 – 32R retrofitted fire collar protecting a 25-mm Polyvinyl Chloride (PVC) Conduit with 3 core cable

The SNAP Retrofit 32R fire collar comprised a 0.75-mm steel casing with a 40-mm inner diameter and a 106-mm diameter base flange. The 32-mm high collar casing incorporated a closing mechanism that was comprised of two soft Intumescent strips lined within the internal circumference of the collar. The inner and outer strips were 4-mm thick x 26-mm wide x 135-mm long, and 4-mm thick x 26-mm wide x 154-mm long, respectively. Between the strips was a layer of 304 stainless steel mesh 135-mm long x 25-mm wide with wire mesh diameter of 0.15-mm, as shown in drawing numbered 32R-T dated 12 February 2015, by Snap Fire Systems Pty Ltd. One collar was fixed to each side of the plasterboard wall in a back-to-back configuration using three hollow wall anchors.

The penetrating service comprised a 25-mm nominal diameter PVC Conduit with 3 core cable, with a wall thickness of 2-mm, fitted through the collar's sleeve and penetrating the plasterboard wall through a 30-mm diameter cut-out hole as shown in drawing titled "Test Wall W-16-A Penetration # 5 – 25-mm PVC Conduit with 3 core cable – 32R Retrofit Collar", dated 23 May 2016, by Snap Fire Systems Pty Ltd. The pipe projected horizontally, approximately 2000-mm away from the unexposed face of the plasterboard wall and approximately 500-mm into the furnace chamber. The pipe was supported at nominally 500-mm from the unexposed face of the plasterboard wall by two support clamp brackets spaced apart at nominally 1000-mm. The pipe was open at the unexposed end and capped on the exposed end with a ceramic fibre (Superwool) plug.

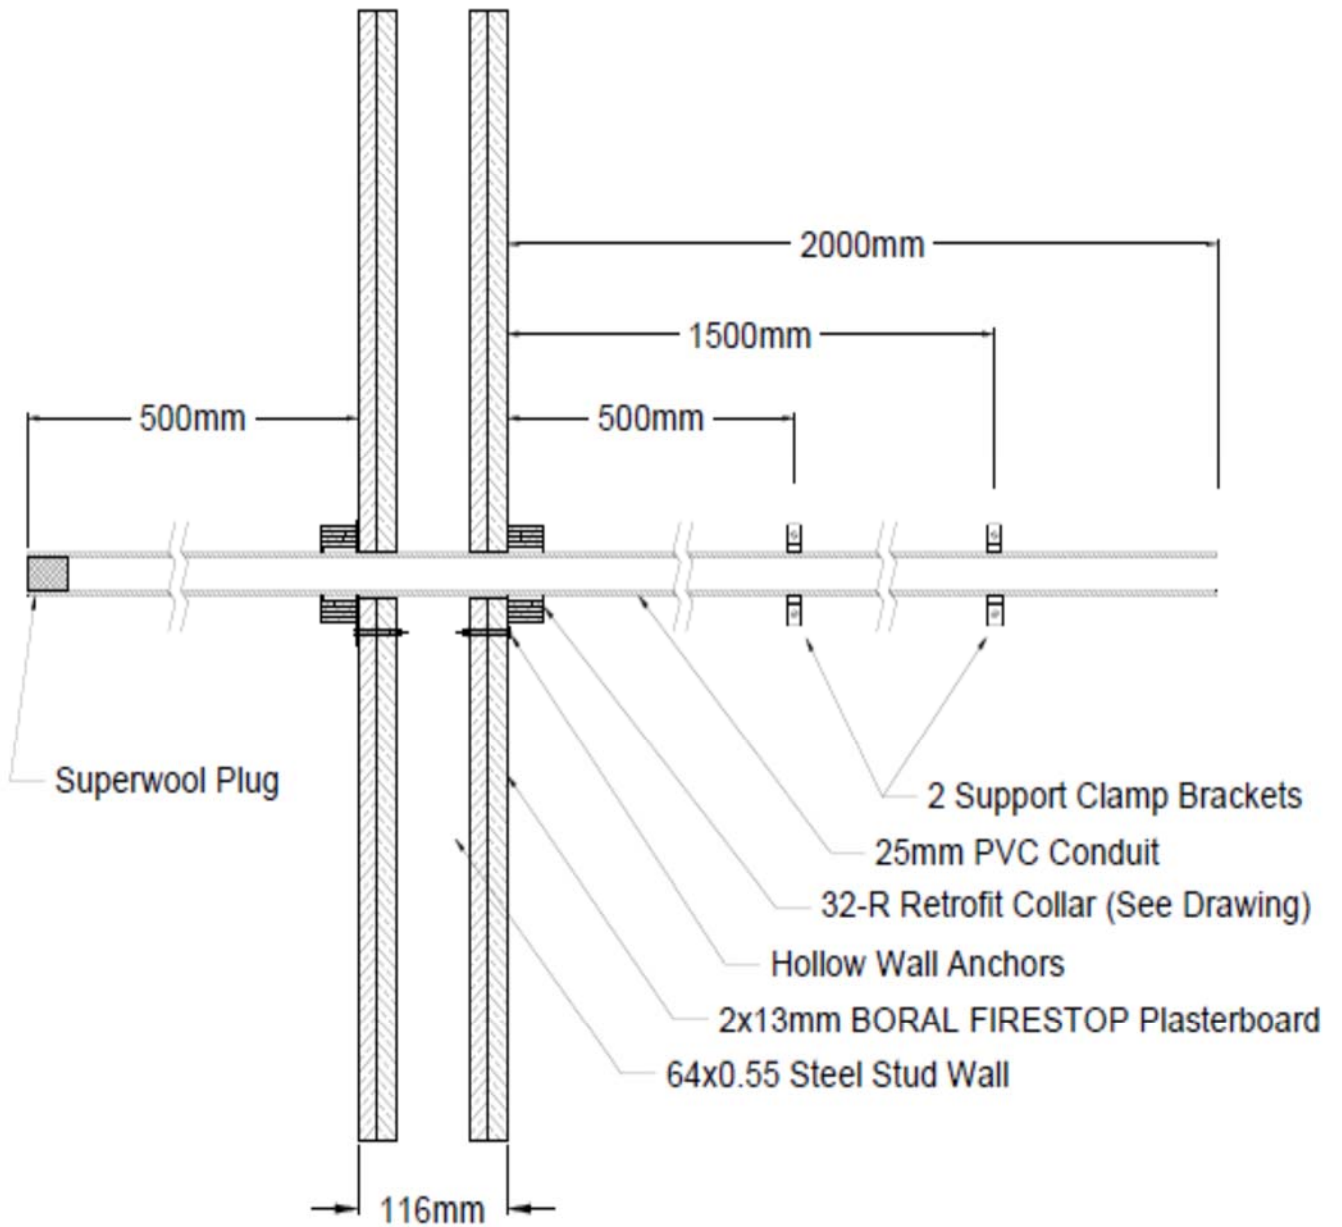
Test Wall W-16-A Penetration # 6
 25mm PVC Conduit - 32R Retrofit collar
 23 MAY 2016

DRAWING TITLED "TEST WALL W-16-A PENETRATION # 6 – 25-MM PVC CONDUIT – 32R RETROFIT COLLAR", DATED 23 MAY 2016, BY SNAP FIRE SYSTEMS PTY LTD.

Penetration # 6 – 32R retrofitted fire collar protecting a 25-mm Polyvinyl Chloride (PVC) Conduit

The SNAP Retrofit 32R fire collar comprised a 0.75-mm steel casing with a 40-mm inner diameter and a 106-mm diameter base flange. The 32-mm high collar casing incorporated a closing mechanism that was comprised of two soft Intumesch intumescent strips lined within the internal circumference of the collar. The inner and outer strips were 4-mm thick x 26-mm wide x 135-mm long, and 4-mm thick x 26-mm wide x 154-mm long, respectively. Between the strips was a layer of 304 stainless steel mesh 135-mm long x 25-mm wide with wire mesh diameter of 0.15-mm, as shown in drawing numbered 32R-T dated 12 February 2015, by Snap Fire Systems Pty Ltd. One collar was fixed to each side of the plasterboard wall in a back-to-back configuration using three hollow wall anchors.

The penetrating service comprised a 25-mm nominal diameter PVC Conduit, with a wall thickness of 2-mm, fitted through the collar's sleeve and penetrating the plasterboard wall through a 30-mm diameter cut-out hole as shown in drawing titled "Test Wall W-16-A Penetration # 6 – 25-mm PVC Conduit – 32R Retrofit Collar", dated 23 May 2016, by Snap Fire Systems Pty Ltd. The pipe projected horizontally, approximately 2000-mm away from the unexposed face of the plasterboard wall and approximately 500-mm into the furnace chamber. The pipe was supported at nominally 500-mm from the unexposed face of the plasterboard wall by two support clamp brackets spaced apart at nominally 1000-mm. The pipe was open at the unexposed end and capped on the exposed end with a ceramic fibre (Superwool) plug.

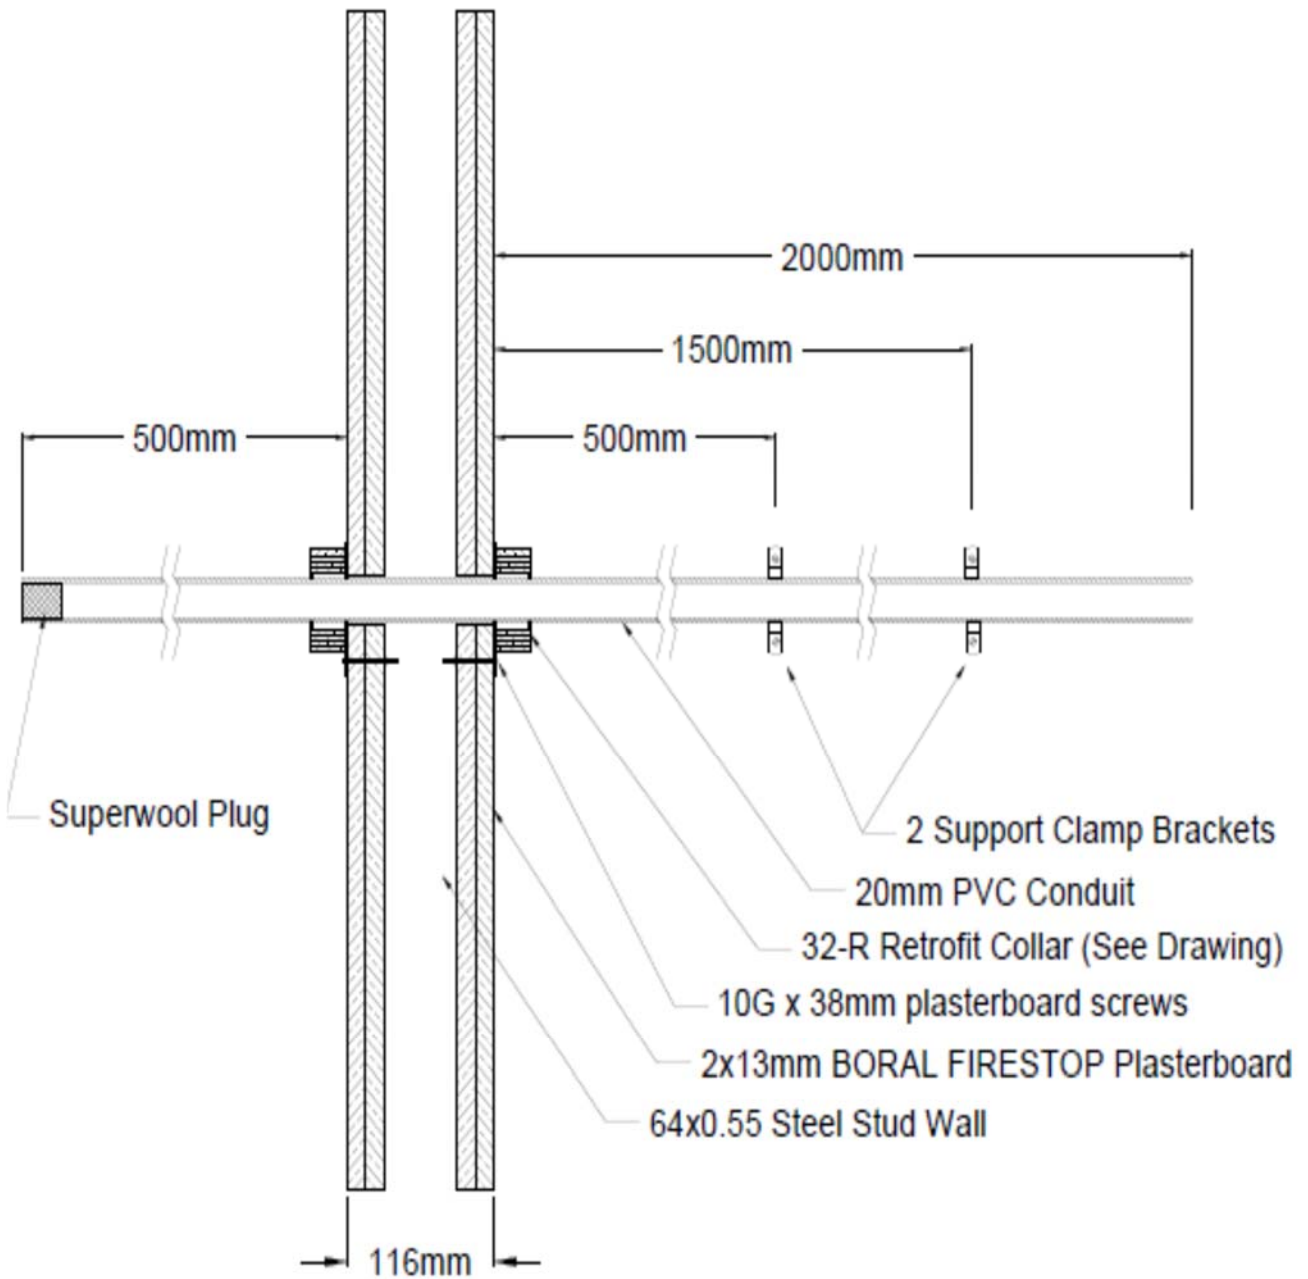
Test Wall W-16-A Penetration # 7
 20mm PVC Conduit - 32R Retrofit collar
 23 MAY 2016

DRAWING TITLED “TEST WALL W-16-A PENETRATION # 7 – 20-MM PVC CONDUIT – 32R RETROFIT COLLAR”, DATED 23 MAY 2016, BY SNAP FIRE SYSTEMS PTY LTD.

Penetration # 7 – 32R retrofitted fire collar protecting a 20-mm Polyvinyl Chloride (PVC) Conduit

The SNAP Retrofit 32R fire collar comprised a 0.75-mm steel casing with a 40-mm inner diameter and a 106-mm diameter base flange. The 32-mm high collar casing incorporated a closing mechanism that was comprised of two soft Intumesch intumescent strips lined within the internal circumference of the collar. The inner and outer strips were 4-mm thick x 26-mm wide x 135-mm long, and 4-mm thick x 26-mm wide x 154-mm long, respectively. Between the strips was a layer of 304 stainless steel mesh 135-mm long x 25-mm wide with wire mesh diameter of 0.15-mm, as shown in drawing numbered 32R-T dated 12 February 2015, by Snap Fire Systems Pty Ltd. One collar was fixed to each side of the plasterboard wall in a back-to-back configuration using three 10g x 38-mm course thread plasterboard screws.

The penetrating service comprised a 20-mm nominal diameter PVC Conduit, with a wall thickness of 2-mm, fitted through the collar's sleeve and penetrating the plasterboard wall through a 25-mm diameter cut-out hole as shown in drawing titled "Test Wall W-16-A Penetration # 7 – 20-mm PVC Conduit – 32R Retrofit Collar", dated 23 May 2016, by Snap Fire Systems Pty Ltd. The pipe projected horizontally, approximately 2000-mm away from the unexposed face of the plasterboard wall and approximately 500-mm into the furnace chamber. The pipe was supported at nominally 500-mm from the unexposed face of the plasterboard wall by two support clamp brackets spaced apart at nominally 1000-mm. The pipe was open at the unexposed end and capped on the exposed end with a ceramic fibre (Superwool) plug.

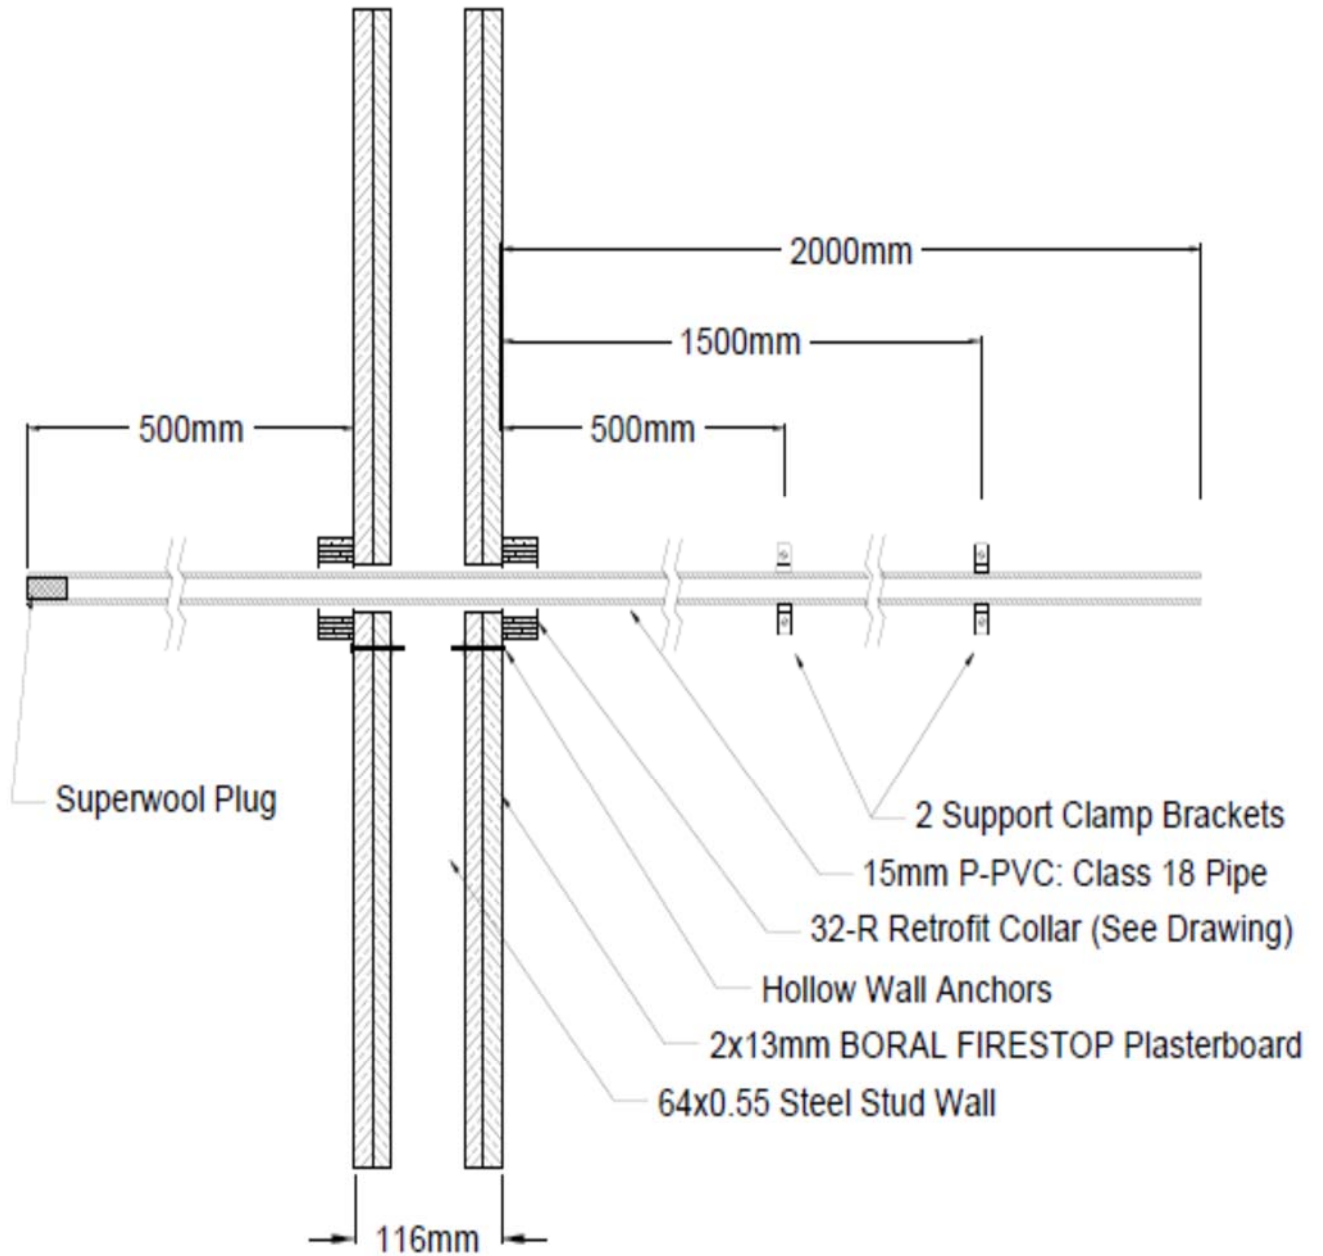
Test Wall W-16-A Penetration # 8
 15mm P-PVC: Class 18 Pipe - 32R Retrofit collar
 23 MAY 2016

DRAWING TITLED "TEST WALL W-16-A PENETRATION # 8 – 15-MM P-PVC CLASS 18 PIPE – 32R RETROFIT COLLAR", DATED 23 MAY 2016, BY SNAP FIRE SYSTEMS PTY LTD.

Penetration # 8 – 32R retrofitted fire collar protecting a 15-mm Polyvinyl Chloride (P-PVC) Class 18 Pipe

The SNAP Retrofit 32R fire collar comprised a 0.75-mm steel casing with a 40-mm inner diameter and a 106-mm diameter base flange. The 32-mm high collar casing incorporated a closing mechanism that was comprised of two soft Intumesch intumescent strips lined within the internal circumference of the collar. The inner and outer strips were 4-mm thick x 26-mm wide x 135-mm long, and 4-mm thick x 26-mm wide x 154-mm long, respectively. Between the strips was a layer of 304 stainless steel mesh 135-mm long x 25-mm wide with wire mesh diameter of 0.15-mm, as shown in drawing numbered 32R-T dated 12 February 2015, by Snap Fire Systems Pty Ltd. One collar was fixed to each side of the plasterboard wall in a back-to-back configuration using three hollow wall anchors.

The penetrating service comprised a 15-mm nominal diameter P-PVC Class 18 Pipe, with a wall thickness of 1.8-mm, fitted through the collar's sleeve and penetrating the plasterboard wall through a 20-mm diameter cut-out hole as shown in drawing titled "Test Wall W-16-A Penetration # 8 – 15-mm P-PVC Class 18 Pipe – 32R Retrofit Collar", dated 23 May 2016, by Snap Fire Systems Pty Ltd. The pipe projected horizontally, approximately 2000-mm away from the unexposed face of the plasterboard wall and approximately 500-mm into the furnace chamber. The pipe was supported at nominally 500-mm from the unexposed face of the plasterboard wall by two support clamp brackets spaced apart at nominally 1000-mm. The pipe was open at the unexposed end and capped on the exposed end with a ceramic fibre (Superwool) plug.
