Fire-resistance test on fire collars protecting a plasterboard wall penetrated by services

Test Report

Author: Russell Collins
Report number: FSP 1748
Date: 24 October 2016

Sponsored Investigation No. FSP 1748

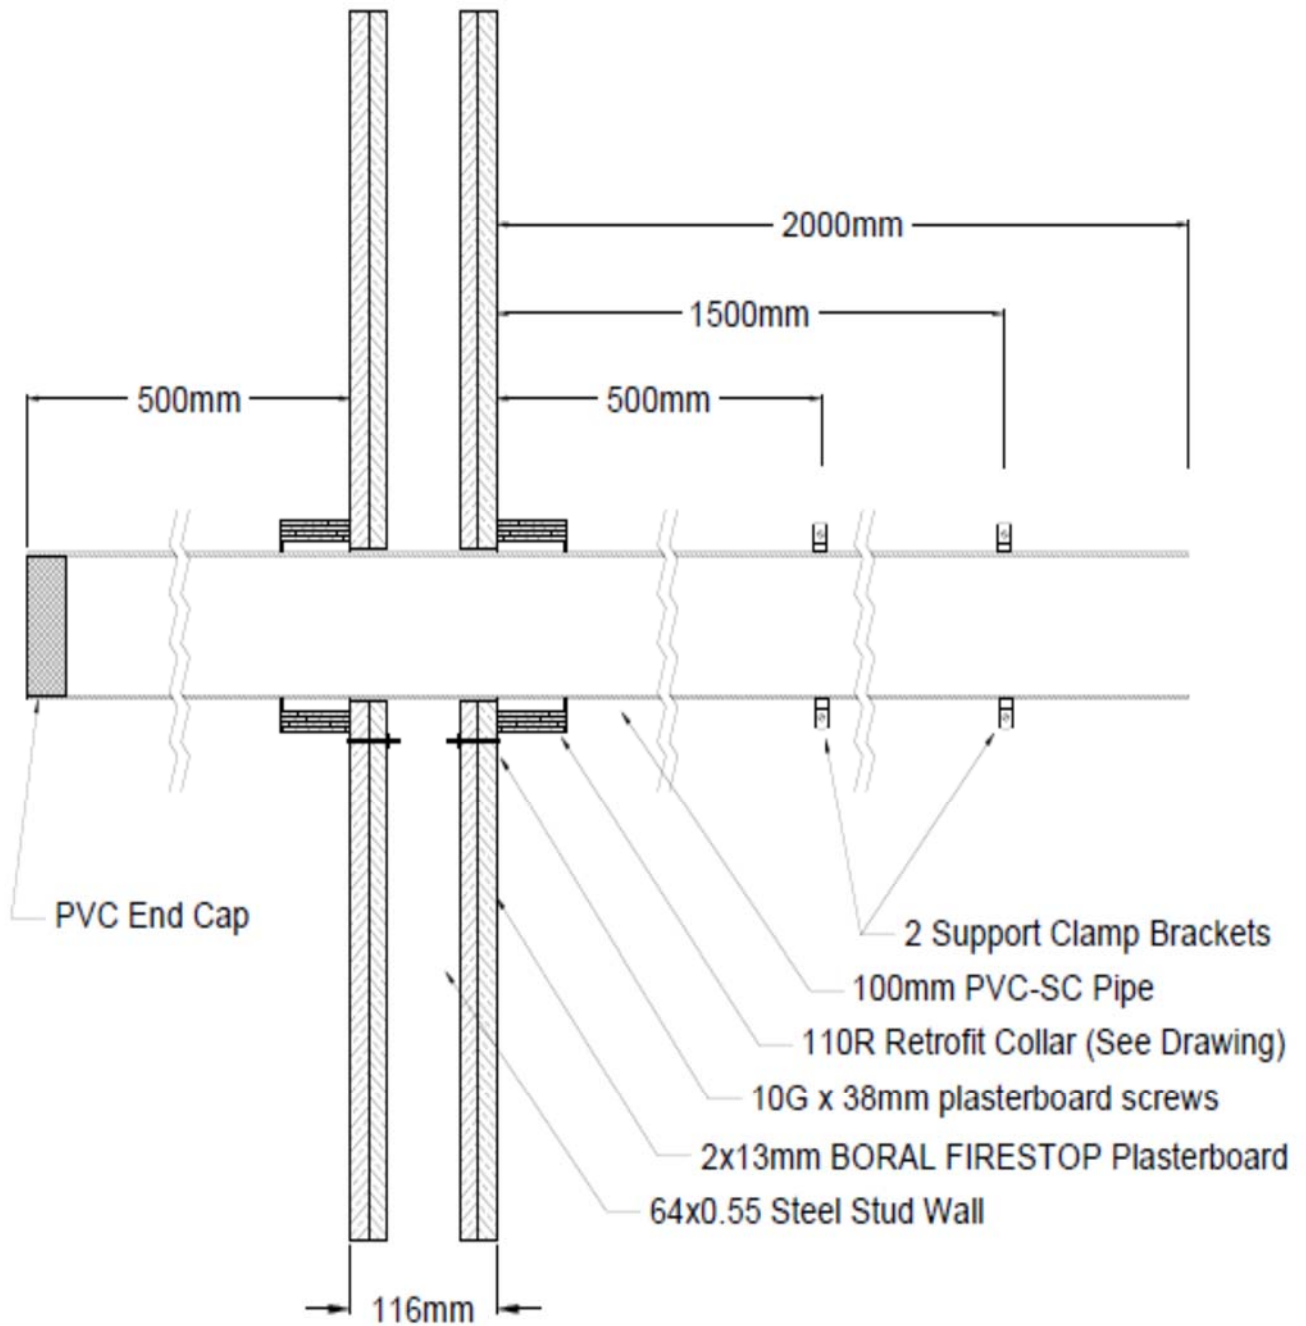
Test Wall W-16-A Penetration # 9
 100mm PVC-SC Pipe – 110R Retrofit Collar
 23 MAY 2016

DRAWING TITLED "TEST WALL W-16-A PENETRATION # 9 – 100-MM PVC-SC PIPE – 110R RETROFIT COLLAR", DATED 9 OCTOBER 2015, BY SNAP FIRE SYSTEMS PTY LTD.

Penetration # 9 – 110R retrofitted fire collar protecting a 100-mm Polyvinyl Chloride (PVC-SC) Pipe

The SNAP Retrofit 110R fire collar comprised a 0.75-mm steel casing with a 122-mm inner diameter and a 209-mm diameter base flange. The 62-mm high collar casing incorporated a closing mechanism that was comprised of three soft Intumesch intumescent strips lined within the internal circumference of the collar. The inner and outer strips were 2.5-mm thick x 58-mm wide x 424-mm long, a 2.5-mm thick x 58-mm wide x 407-mm long, and 2.5-mm thick x 58-mm wide x 389-mm long respectively. Between the strips was a layer of 304 stainless steel mesh 415-mm long x 58-mm wide with wire mesh diameter of 0.15-mm, and 398-mm long x 58-mm wide with wire mesh diameter of 0.15-mm respectively as shown in drawing numbered 110R-T dated 9 October 2015, by Snap Fire Systems Pty Ltd. One collar was fixed to each side of the plasterboard wall in a back-to-back configuration using three 10g x 38-mm course thread plasterboard screws.

The penetrating service comprised a 100-mm nominal diameter PVC-SC Pipe, with a wall thickness of 3.3-mm, fitted through the collar's sleeve and penetrating the plasterboard wall through a 114-mm diameter cut-out hole as shown in drawing titled "Test Wall W-16-A Penetration # 9 – 100-mm PVC-SC Pipe – 110R Retrofit Collar", dated 9 October 2015, by Snap Fire Systems Pty Ltd. The pipe projected horizontally, approximately 2000-mm away from the unexposed face of the plasterboard wall and approximately 500-mm into the furnace chamber. The pipe was supported at nominally 500-mm from the unexposed face of the plasterboard wall by two support clamp brackets spaced apart at nominally 1000-mm. The pipe was open at the unexposed end and capped on the exposed end with a PVC End Cap.

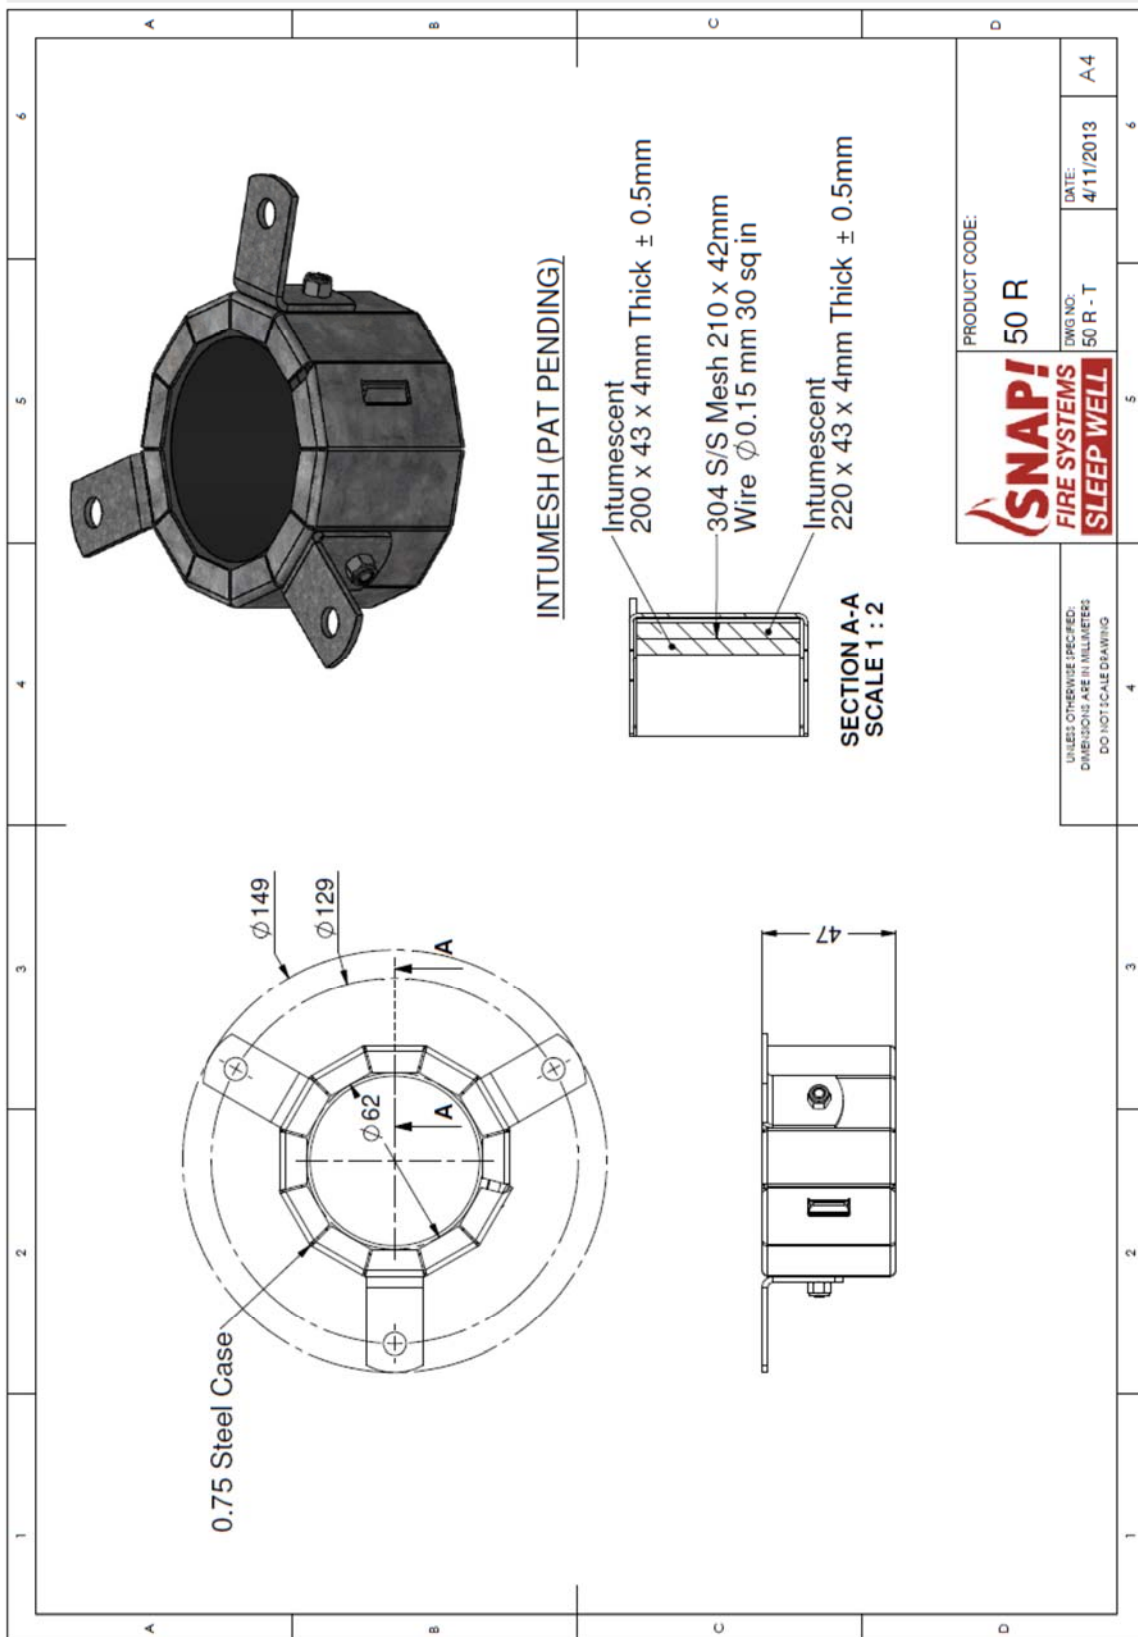
DRAWING NUMBERED 50R-T DATED 4 NOVEMBER 2014, BY SNAP FIRE SYSTEMS PTY LTD.

The SNAP Retrofit 50R fire collar comprised a 0.75-mm steel casing with a 62-mm inner diameter and a 149-mm diameter base flange. The 47-mm high collar casing incorporated a closing mechanism that was comprised of two soft Intumesh intumescent wraps lined within the internal circumference of the collar. The inner and outer strips were 4-mm thick x 43-mm wide x 200-mm long, and 4-mm thick x 43-mm wide x 220-mm long, respectively. Between the strips was a layer of 304 stainless steel mesh 210-mm long x 42-mm wide with wire mesh diameter of 0.15-mm, as shown in drawing numbered 50R-T dated 4 November 2014, by Snap Fire Systems Pty Ltd. One collar was fixed to each side of the plasterboard wall in a back-to-back configuration using three hollow wall anchors.

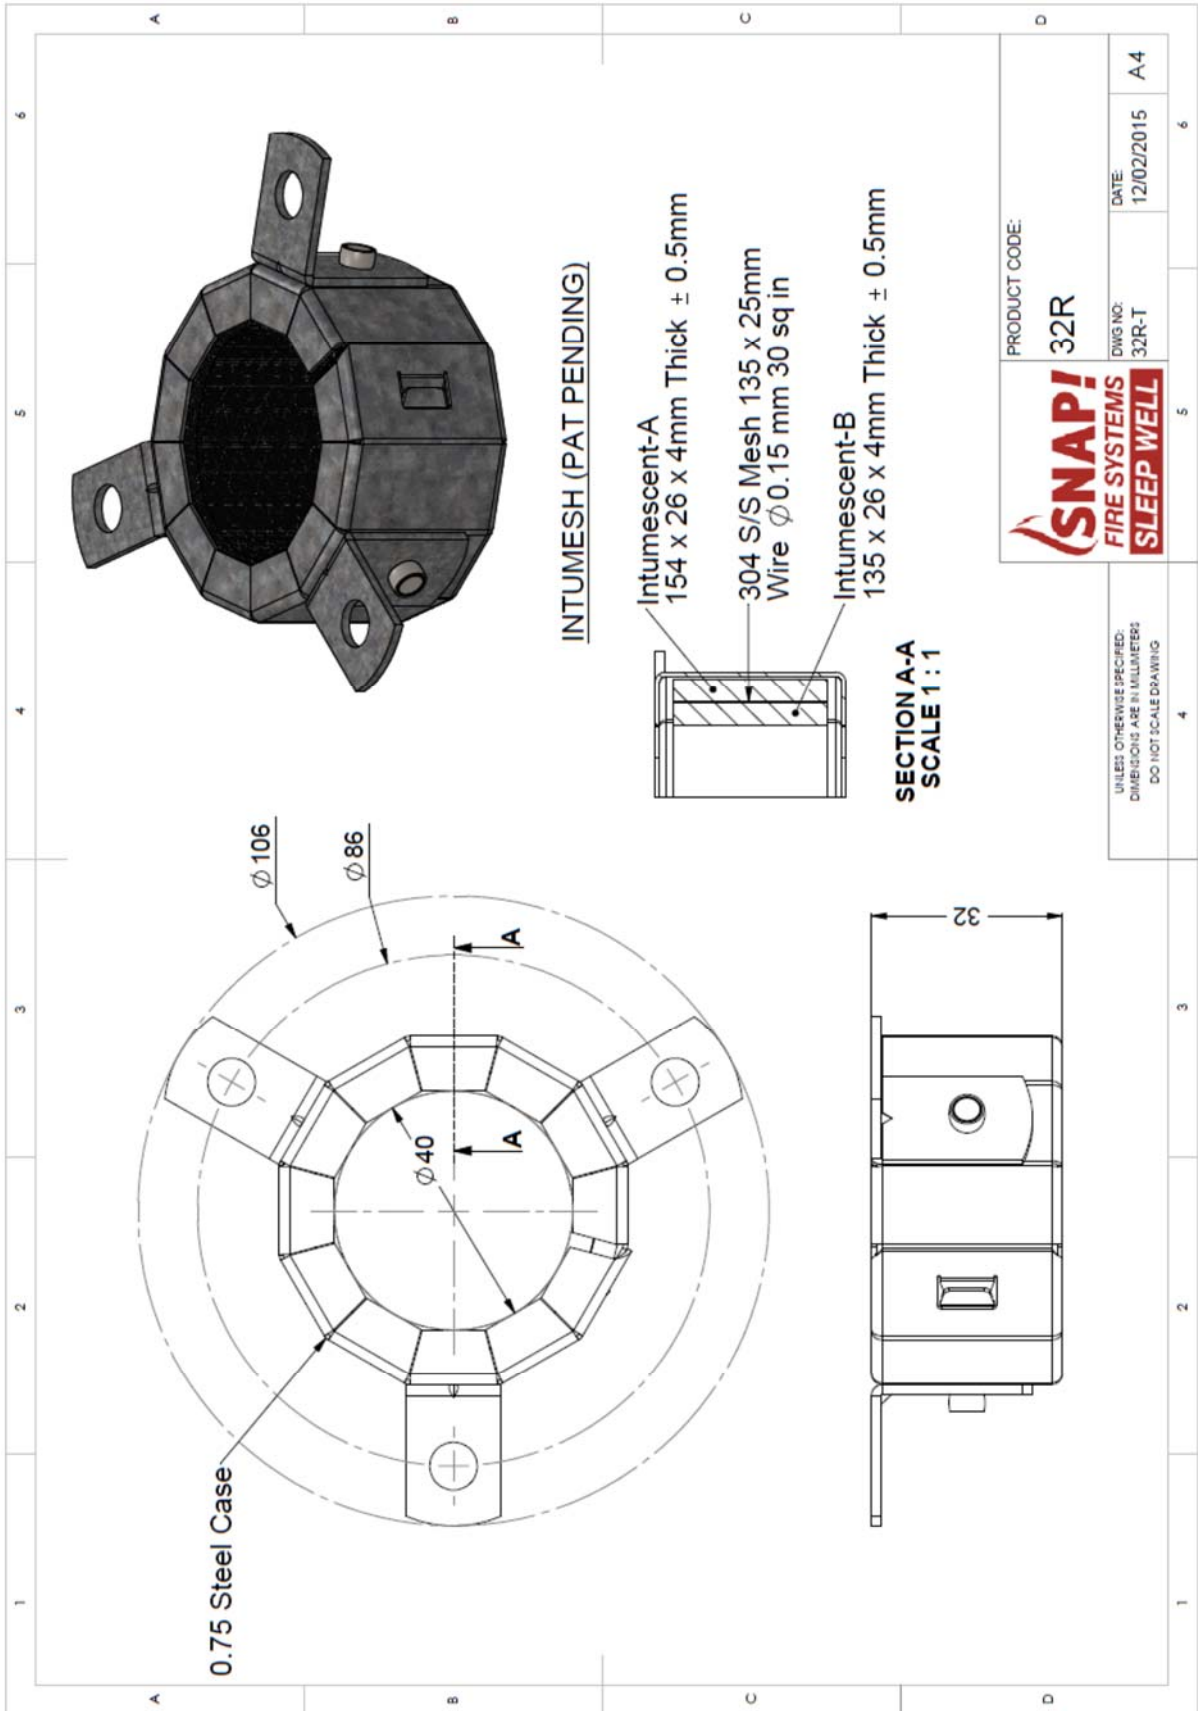
DRAWING NUMBERED 32R-T DATED 12 FEBRUARY 2015, BY SNAP FIRE SYSTEMS PTY LTD.

The SNAP Retrofit 32R fire collar comprised a 0.75-mm steel casing with a 40-mm inner diameter and a 106-mm diameter base flange. The 32-mm high collar casing incorporated a closing mechanism that was comprised of two soft Intumesh intumescent strips lined within the internal circumference of the collar. The inner and outer strips were 4-mm thick x 26-mm wide x 135-mm long, and 4-mm thick x 26-mm wide x 154-mm long, respectively. Between the strips was a layer of 304 stainless steel mesh 135-mm long x 25-mm wide with wire mesh diameter of 0.15-mm, as shown in drawing numbered 32R-T dated 12 February 2015, by Snap Fire Systems Pty Ltd. One collar was fixed to each side of the plasterboard wall in a back-to-back configuration using three hollow wall anchors.

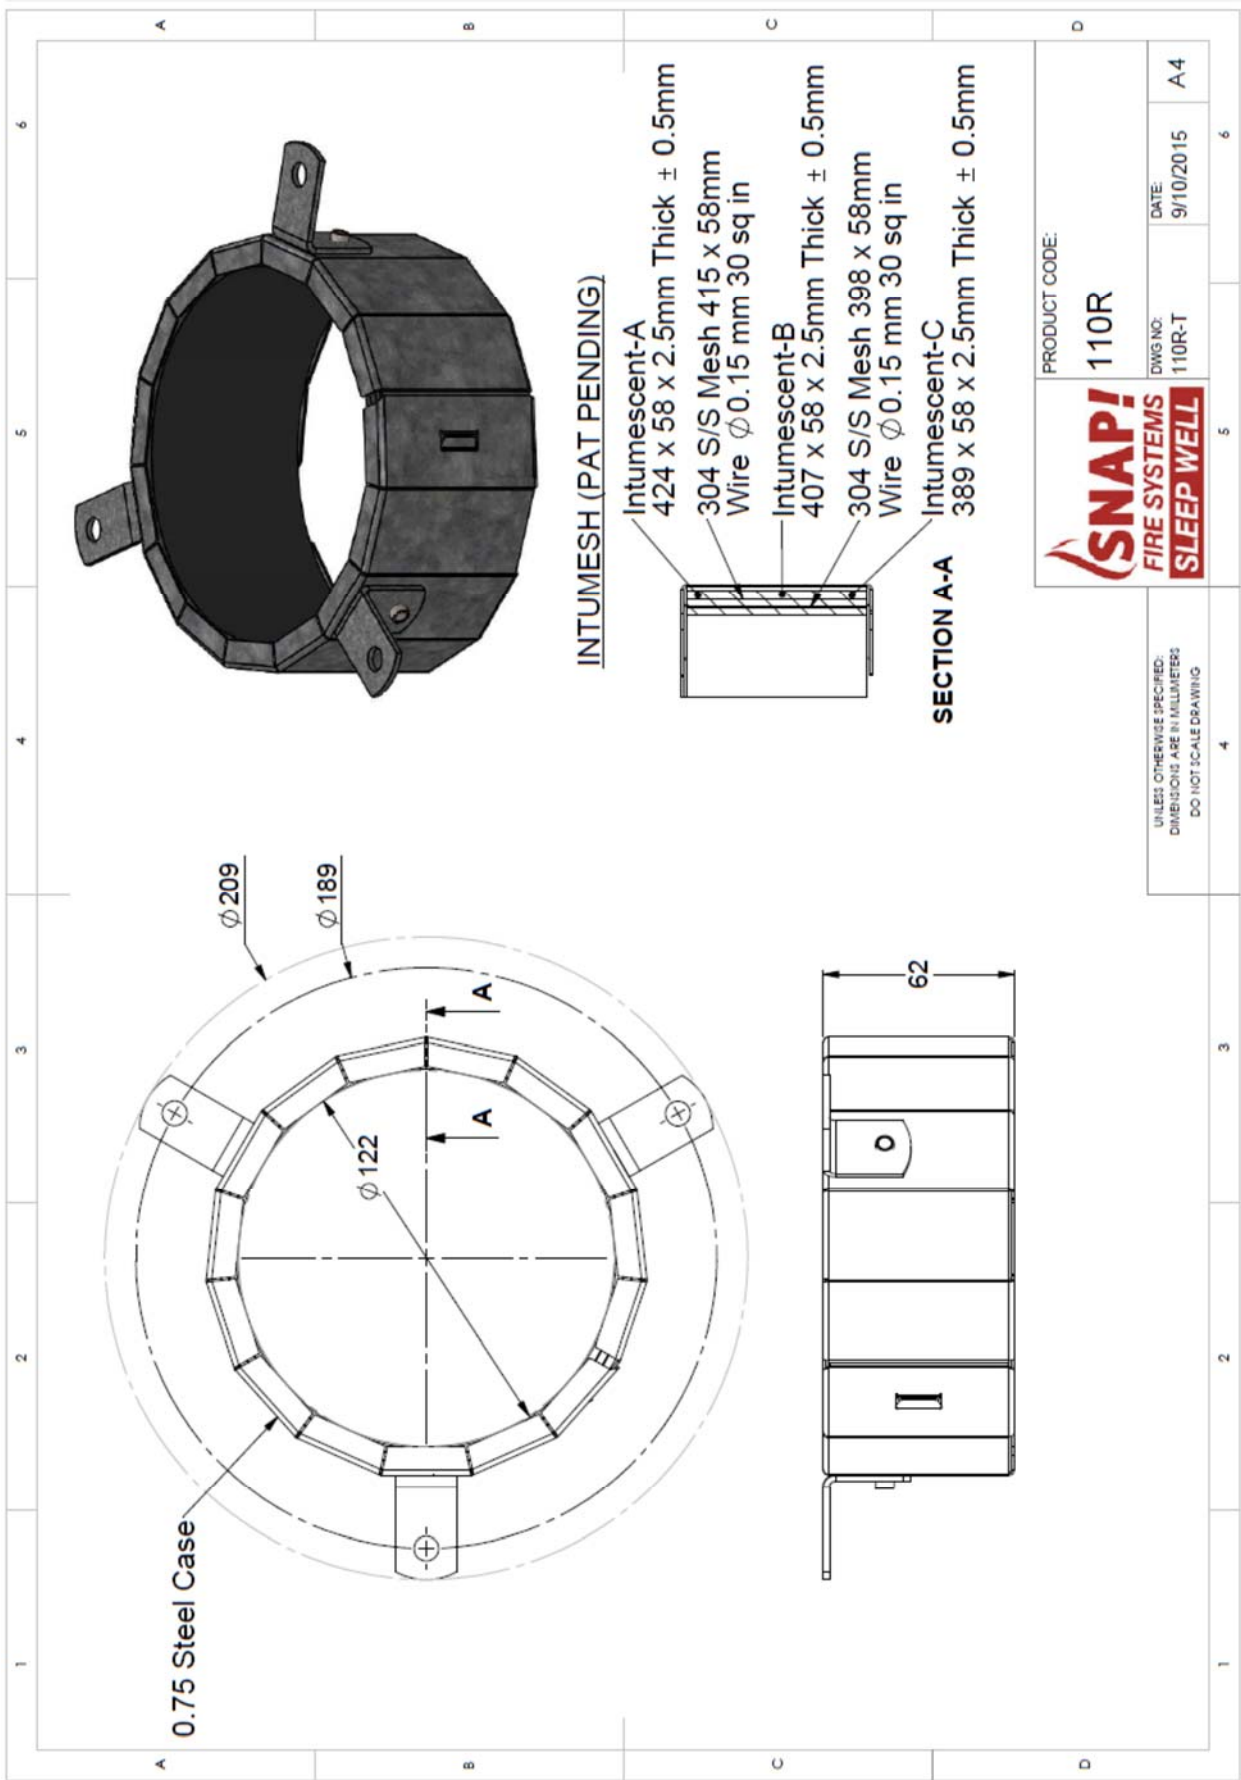
INTUMESH (PAT PENDING)

- Intumescent-A
424 x 58 x 2.5mm Thick ± 0.5mm
- 304 S/S Mesh 415 x 58mm
Wire φ 0.15 mm 30 sq in
- Intumescent-B
407 x 58 x 2.5mm Thick ± 0.5mm
- 304 S/S Mesh 398 x 58mm
Wire φ 0.15 mm 30 sq in
- Intumescent-C
389 x 58 x 2.5mm Thick ± 0.5mm
