Fire resistance test report

Penetration systems tested in accordance with AS 1530.4:2014

Test sponsor: Snap Fire Systems

Job number: FRT190069

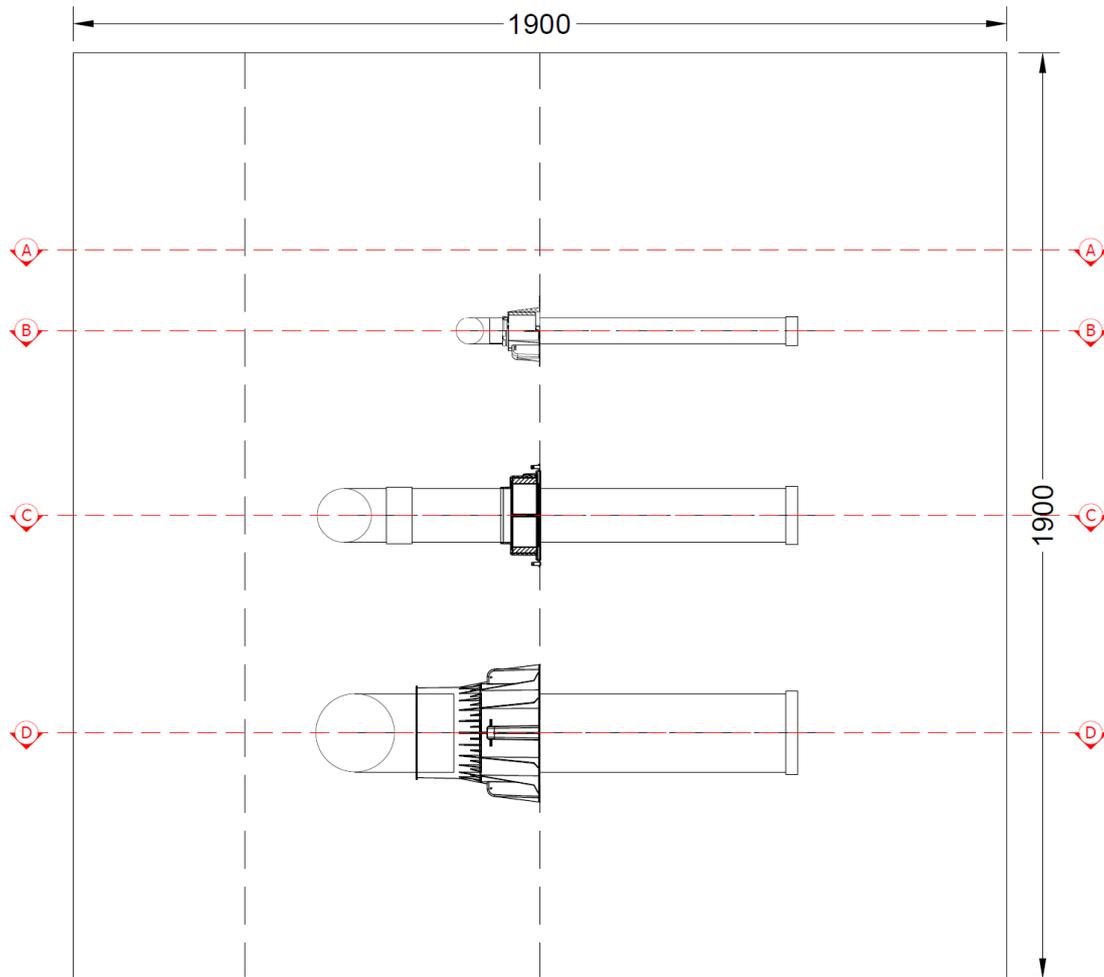
Figure 1 Plan view of the test specimen (unexposed side)

Service support	The pipe was supported on the unexposed side at 500mm and 1500mm from the slab using pipe clamps.	
	Local fire-stopping protection		
	Protection	Snap L50S low-top cast-in fire collar (item 6). See Figure 1 and Figure 3 in Appendix A for more details.

Service support	The pipe was supported on the unexposed side at 500mm and 1500mm from the slab using pipe clamps.
	Local fire-stopping protection	
	Protection	Combat Collar Clean 100 (item 7). See Figure 1 and Figure 4 in Appendix A for more details.
Penetration system C		
C	Service	Ø150mm uPVC Pipe (item 10)
	Service detail	<p>A short section of Ø150mm uPVC pipe (item 10) was inserted into the unexposed side of the fire collar (item 5) which finished flush with both sides of the fire collar. A 90° uPVC elbow (item 11) was then attached to the unexposed side of the pipe with the flared section of the elbow located within the fire collar (item 5). A vertical section of pipe was then inserted into the unexposed side of the elbow and extended 2000mm beyond the top of the floor slab (item 1). After the formwork was removed, a Ø150mm uPVC coupler (item 14) was inserted into the exposed side of the collar (item 5) and used to extend a 500mm length section of pipe (item 10) horizontally beyond the face of the beam.</p> <p>All pipe joints were secured using the pipe cement (item 17).</p> <p>The pipe protruded nominally 500mm from the exposed side of the beam and nominally 2000mm beyond the unexposed side of the floor slab. The pipe was capped with a PVC end cap on the exposed side only.</p>

Service support	The pipe was supported on the unexposed side at 500mm and 1500mm from the slab using pipe clamps.
	Local fire-stopping protection	
	Protection	Snap H150S – RR high top cast-in fire collar (item 5). See Figure 1 and Figure 5 in Appendix A for more details.

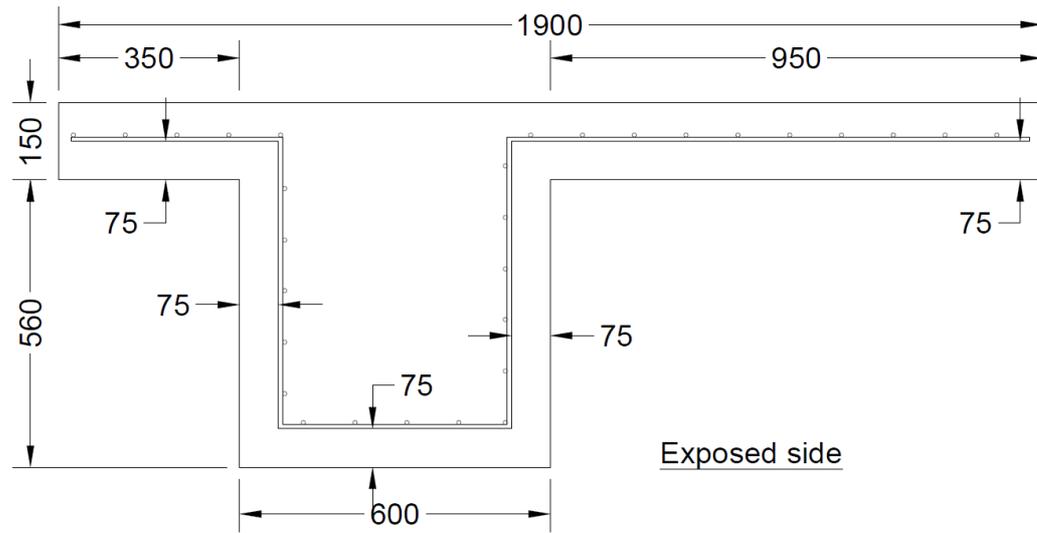
Figure 2 Cross-section of the test specimen (A-A)

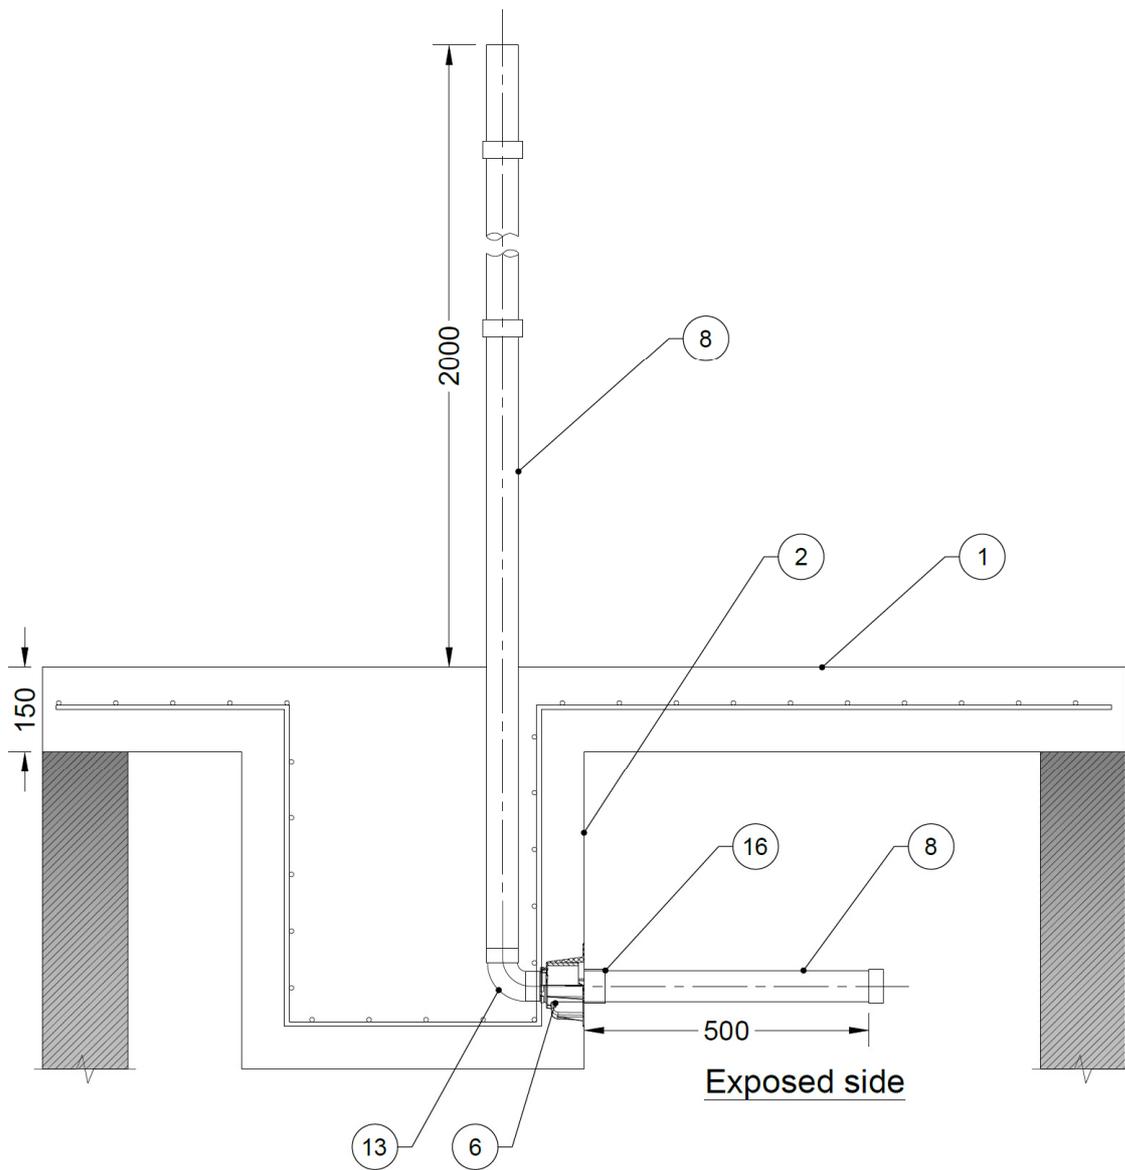
Figure 3 Cross-section B-B

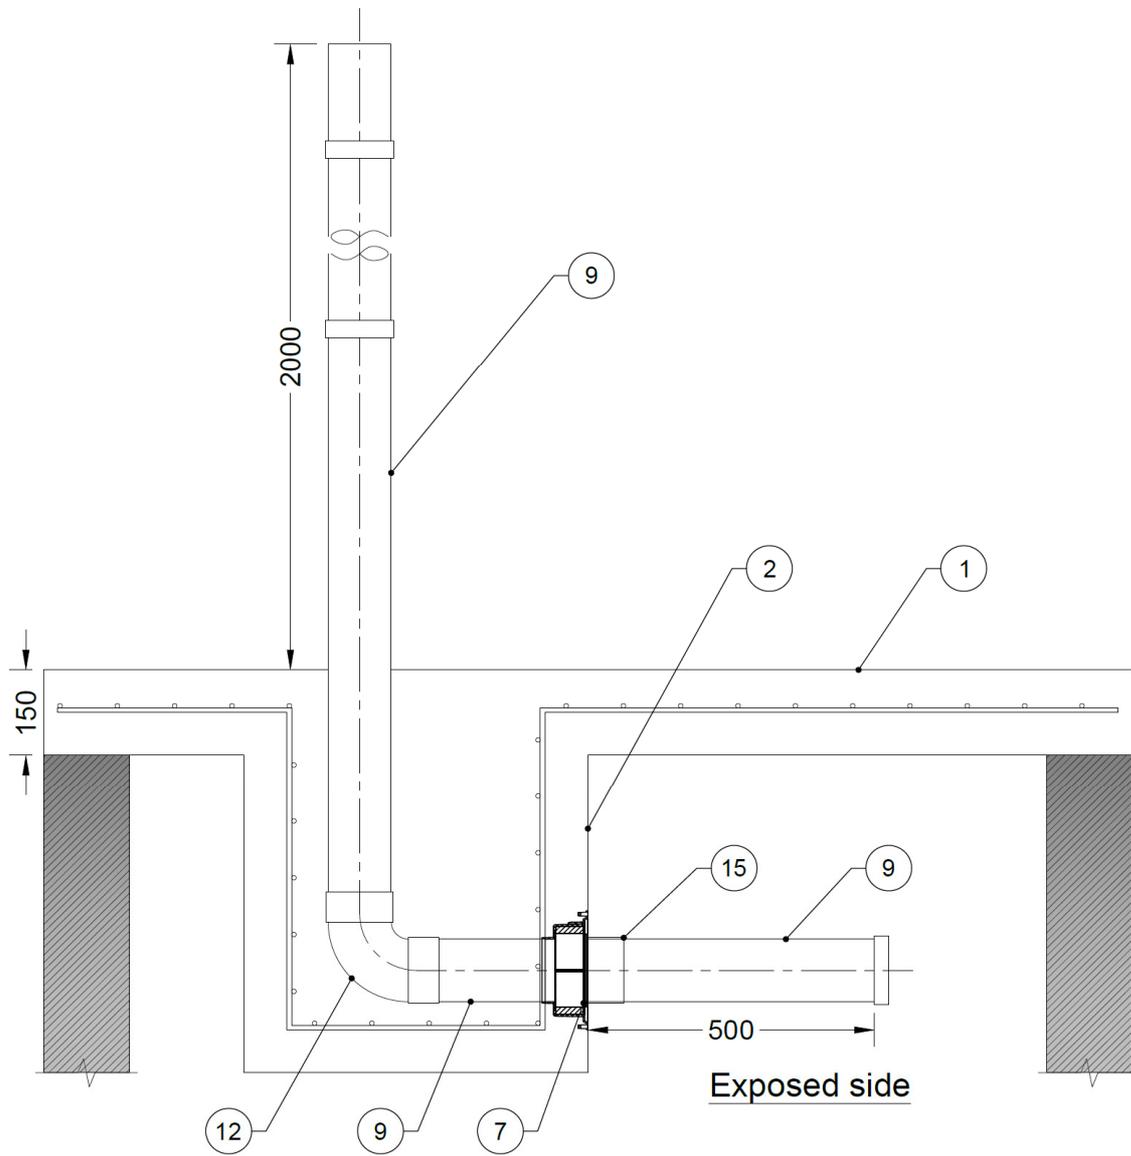
Figure 4 Cross-section C-C

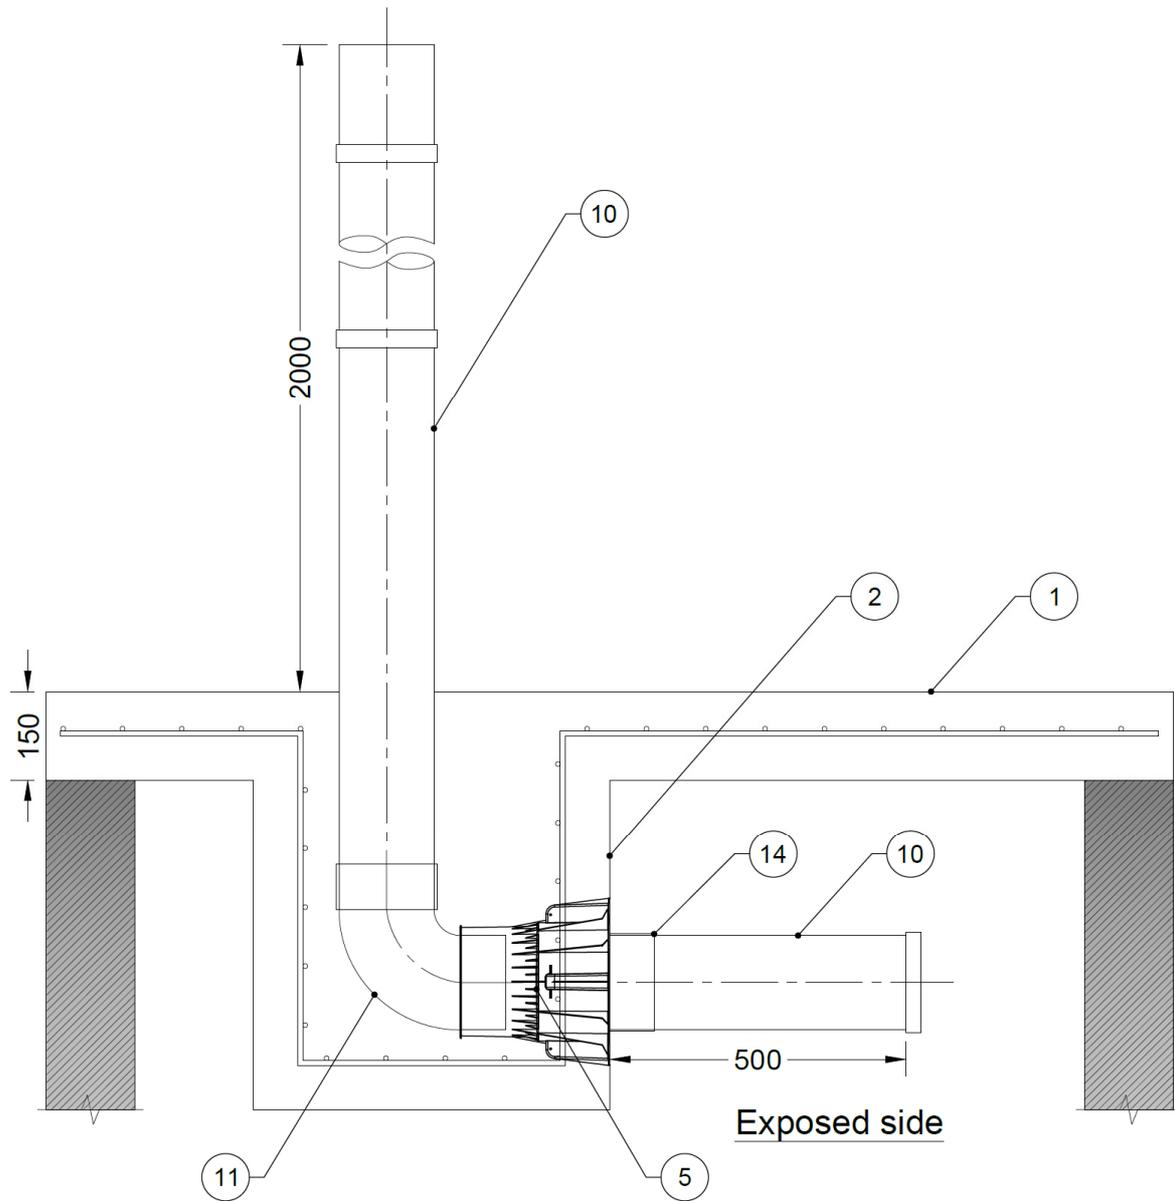
Figure 5 Cross-section D-D

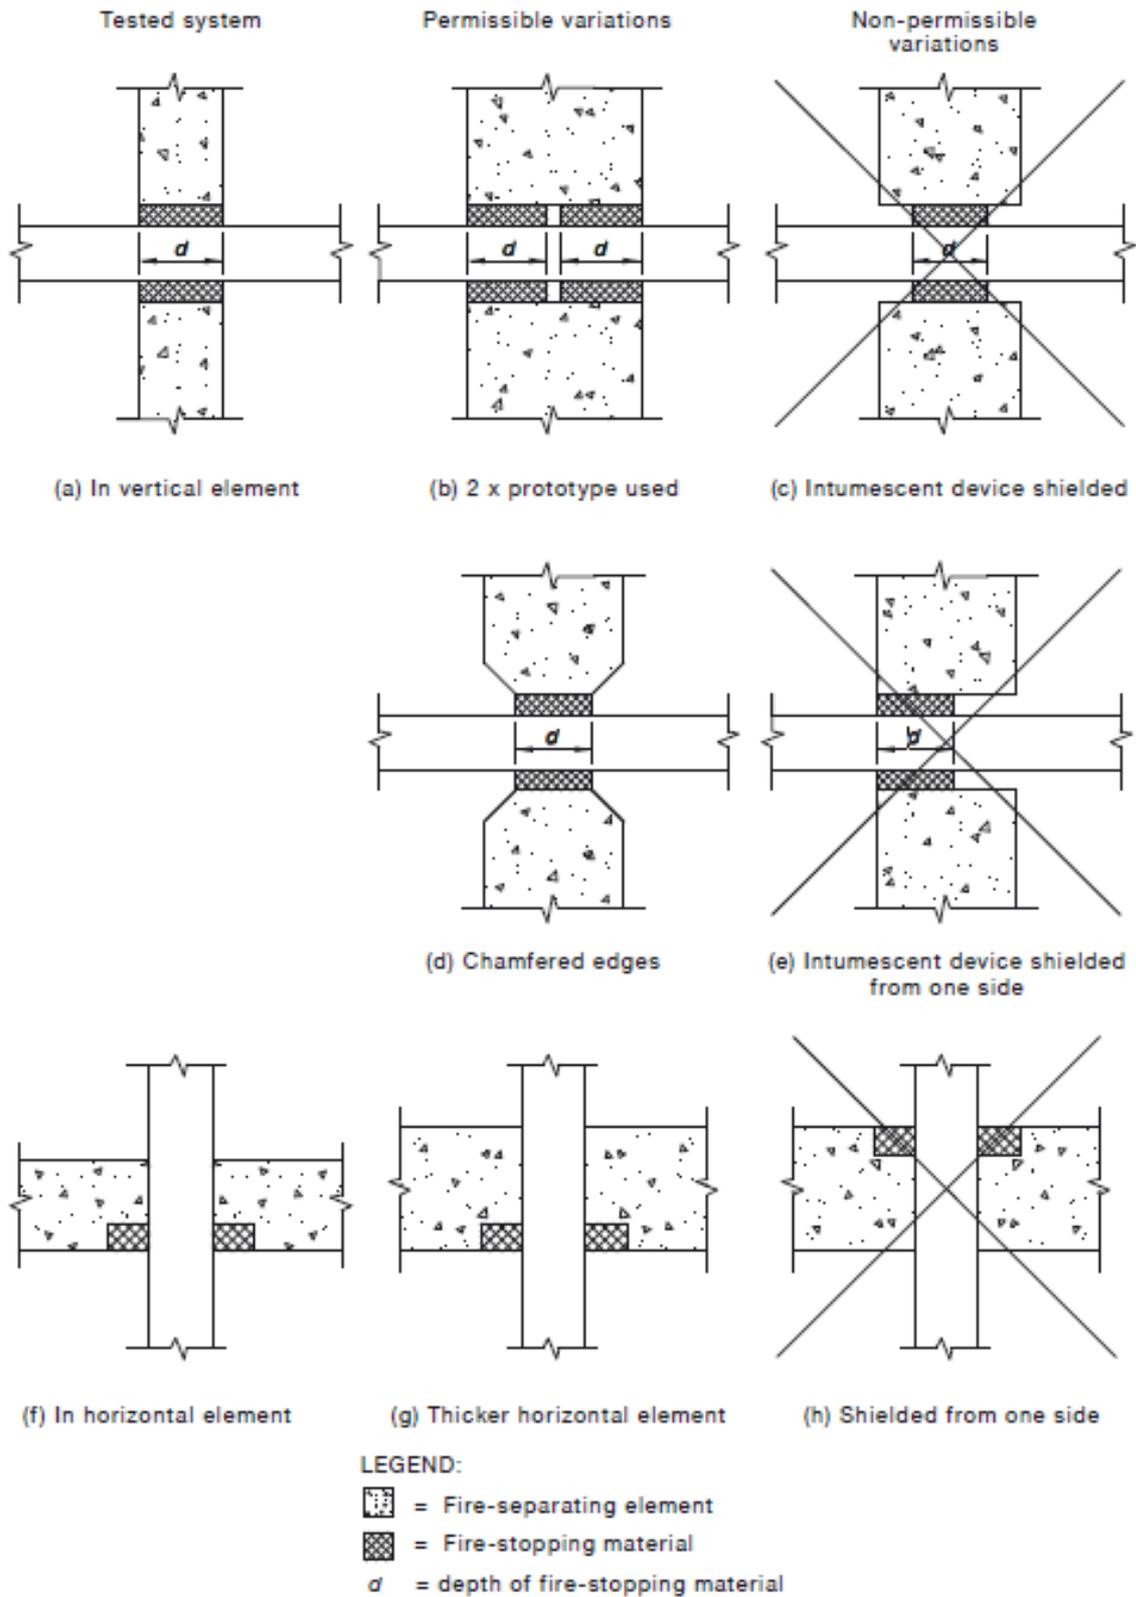
FIGURE 10.12.5.1 EQUIVALENT EXPOSURE OF UPVC PIPE FIRE-STOPPING SYSTEMS

In addition to the requirements of clause 10.12.2 of AS 1530.4:2014, test results may be directly applied to masonry and concrete elements thicker than the tested prototype when installed in accordance with Figure 10.12.5.1 of AS 1530.4:2014.

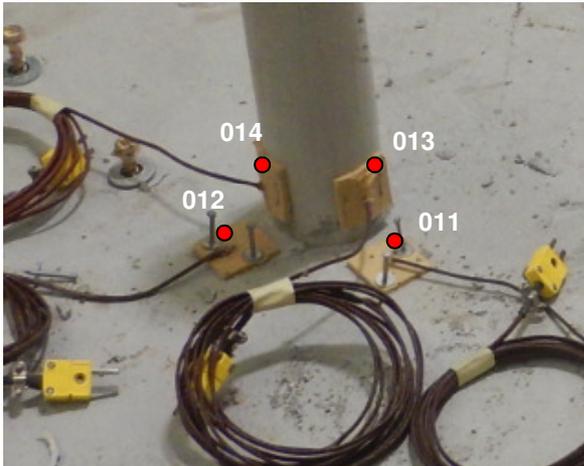
Figure 6 Penetration system A

Penetration system	T/C no.	Description
A	011	On the separating element, 25mm from the pipe.
	012	On the separating element, 25mm from the pipe.
	013	On the service, 25mm from the separating element.
	014	On the service, 25mm from the separating element.
B	021	On the separating element, 25mm from the pipe.
	022	On the separating element, 25mm from the pipe.
	023	On the service, 25mm from the separating element.
	024	On the service, 25mm from the separating element.
C	031	On the separating element, 25mm from the pipe.
	032	On the separating element, 25mm from the pipe.
	033	On the service, 25mm from the separating element.
	034	On the service, 25mm from the separating element.

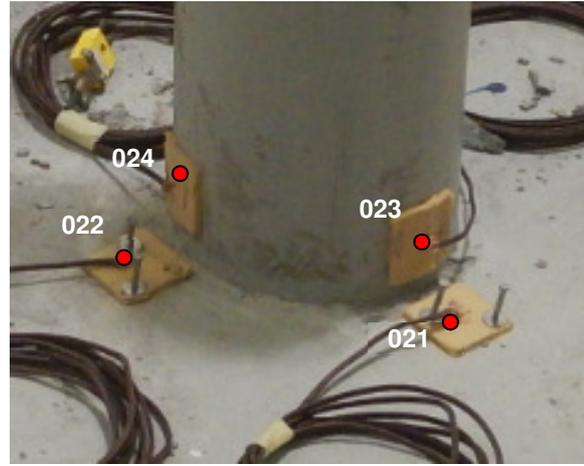
Figure 7 Penetration system B

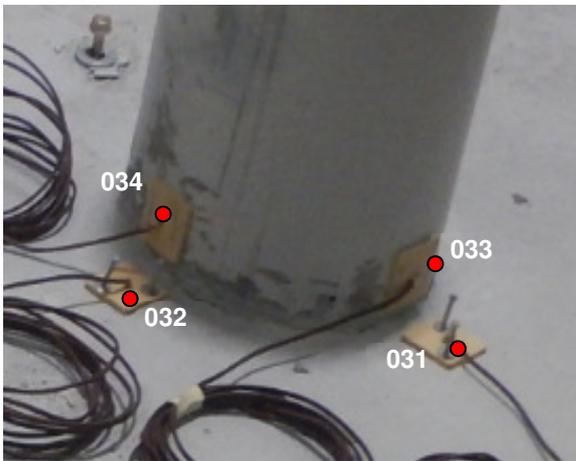
Figure 8 Penetration system C

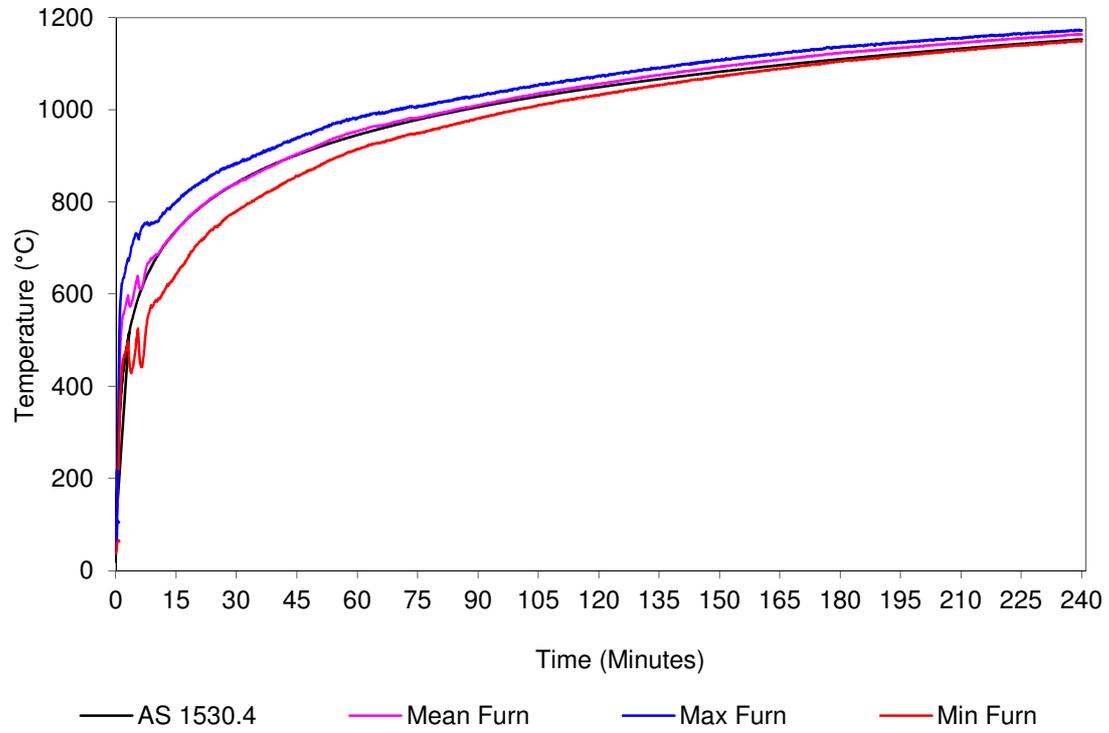
Figure 9 Furnace thermocouple temperature vs time

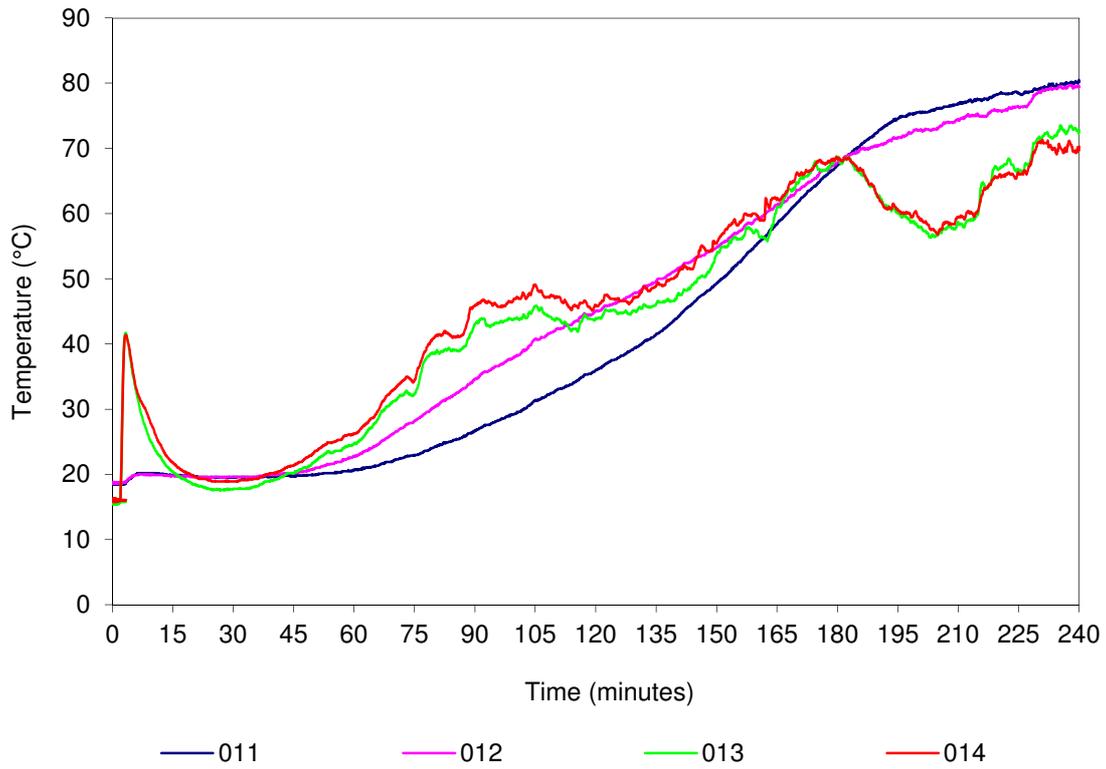
Figure 10 Penetration system A – temperature vs time

Penetration system	T/C no.	Description ²	Temp (°C) at t (minutes)					Limit ¹ (minutes)
			t=0	t=60	t=120	t=180	t=240	
A	011	On the separating element.	19	21	36	68	80	-
	012	On the separating element.	19	23	45	68	80	-
	013	On the service.	16	25	44	69	73	-
	014	On the service.	16	26	46	69	70	-
B	021	On the separating element.	19	26	35	51	64	-
	022	On the separating element.	19	25	31	40	55	-
	023	On the service.	17	52	57	69	74	-
	024	On the service.	17	53	58	71	76	-
C	031	On the separating element.	19	27	43	61	67	-
	032	On the separating element.	19	24	33	52	64	-
	033	On the service.	17	42	47	52	55	-
	034	On the service.	18	42	52	60	64	-

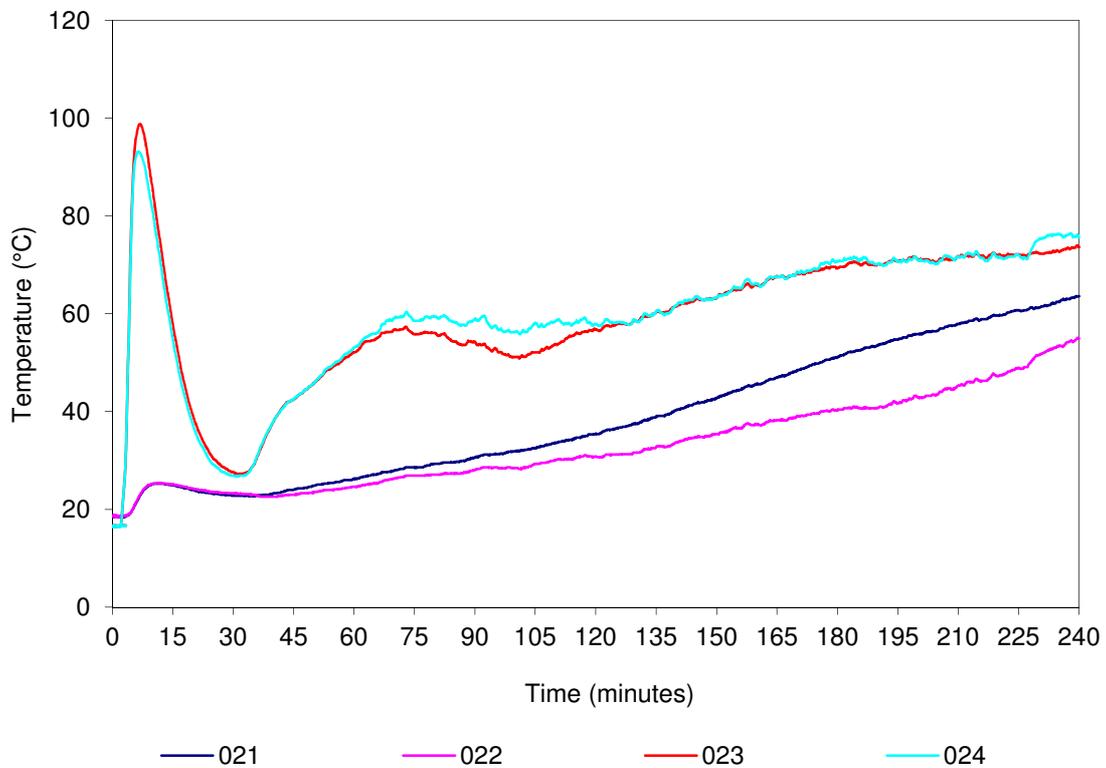
Figure 11 Penetration system B – temperature vs time

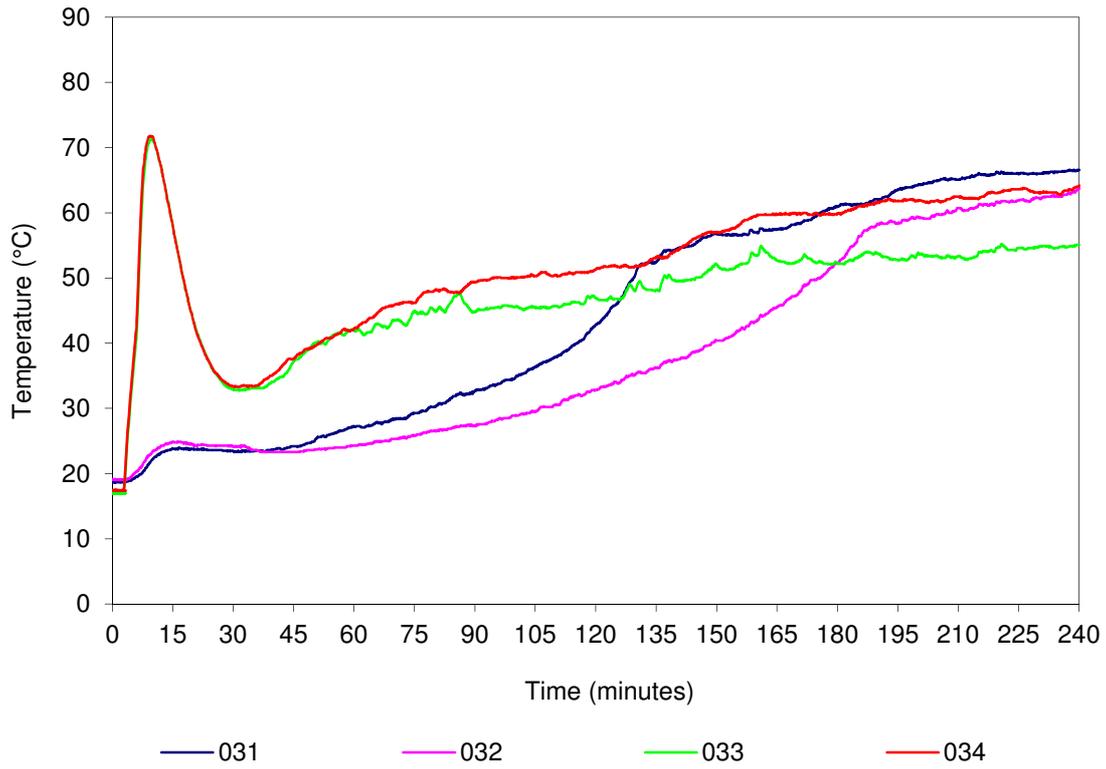
Figure 12 Penetration system C – temperature vs time

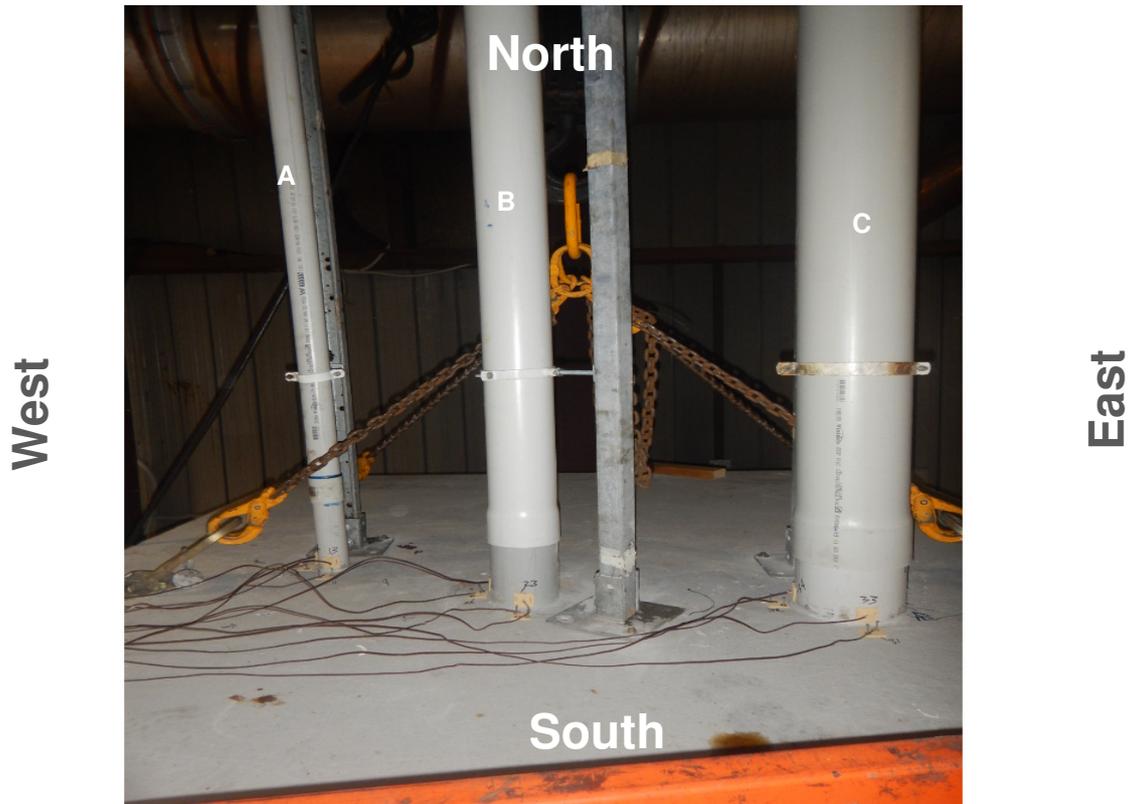
Figure 13 Unexposed face of specimen before the start of test

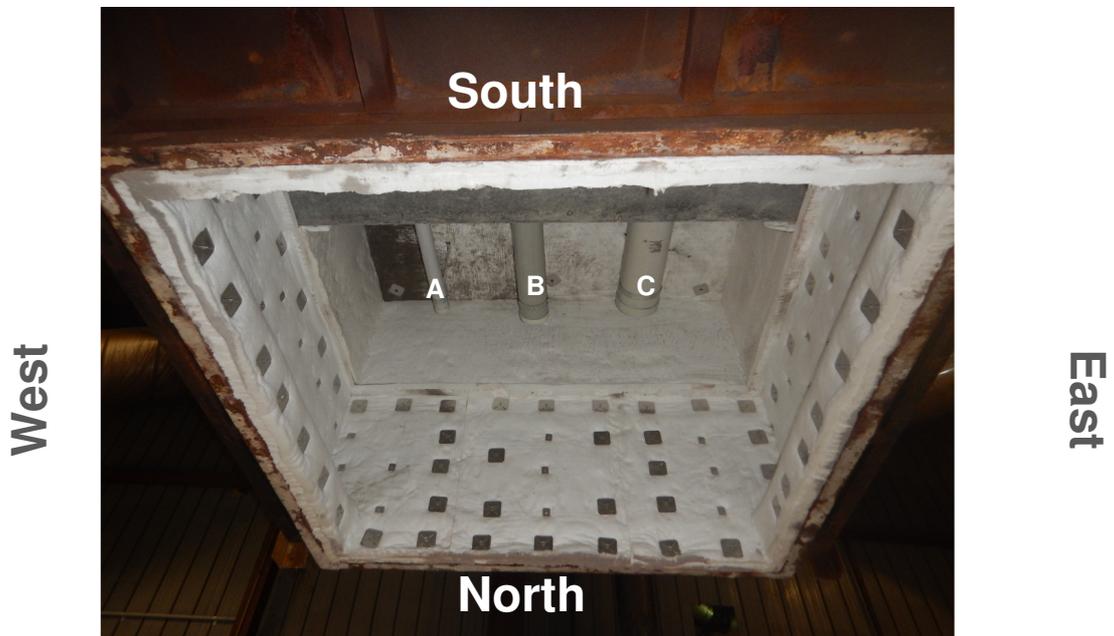
Figure 14 Exposed face of the specimen before the start of test

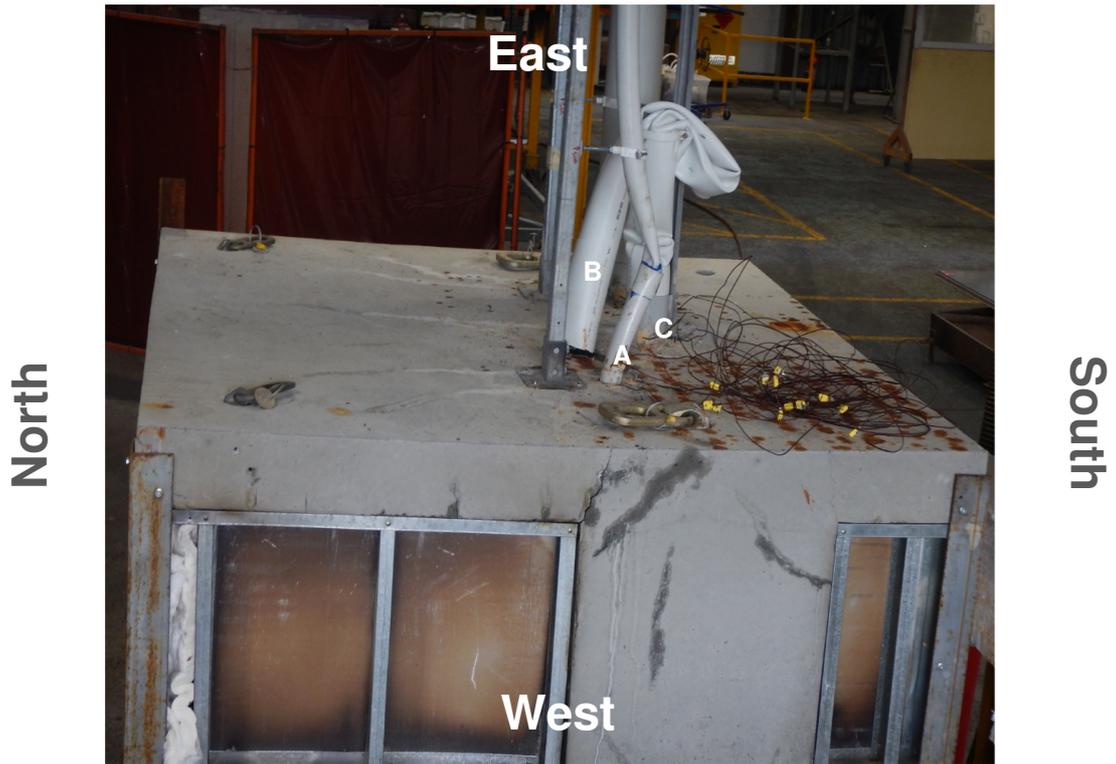
Figure 15 Unexposed face of specimen at the end of test

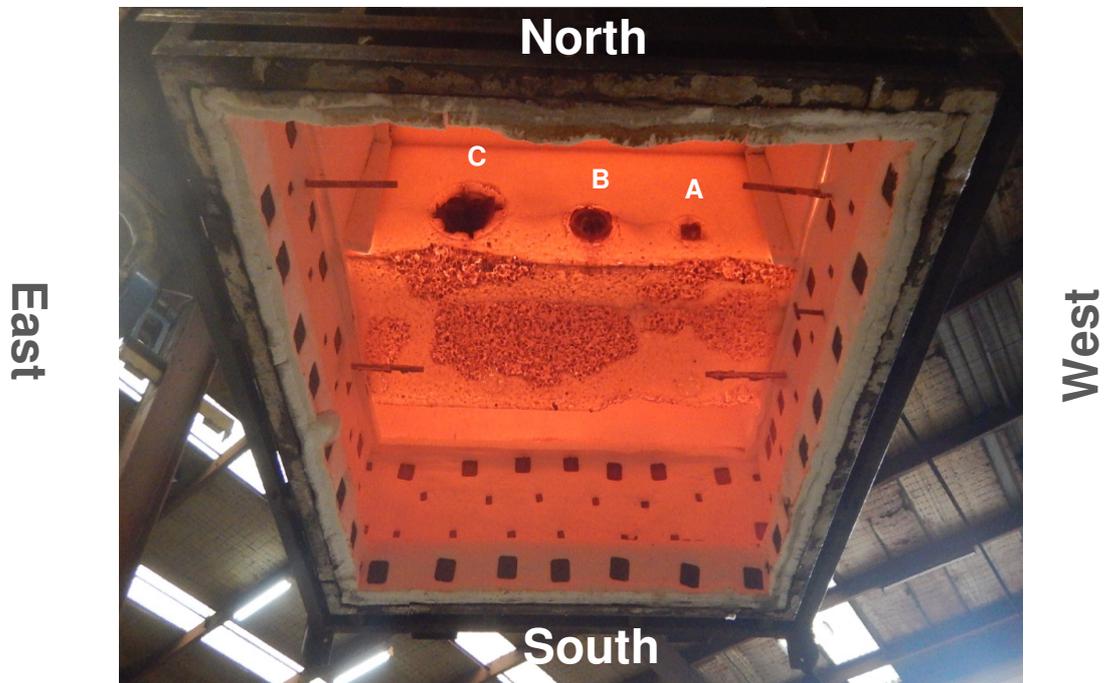
Figure 16 Exposed face of the specimen at the end of test
