**FIRE-RESISTANCE TEST ON
FIRE COLLARS PROTECTING A CONCRETE SLAB
PENETRATED BY SERVICES**

**Report number FSP 1575
CSIRO job number SP3629
Date of issue 22 MARCH 2013**

**Client
SNAP FIRE SYSTEMS PTY LTD.**

SPONSORED INVESTIGATION No. FSP 1575**FIRE-RESISTANCE TEST ON FIRE COLLARS PROTECTING A
CONCRETE SLAB PENETRATED BY SERVICES****SUMMARY****IDENTIFICATION OF SPECIMEN:**

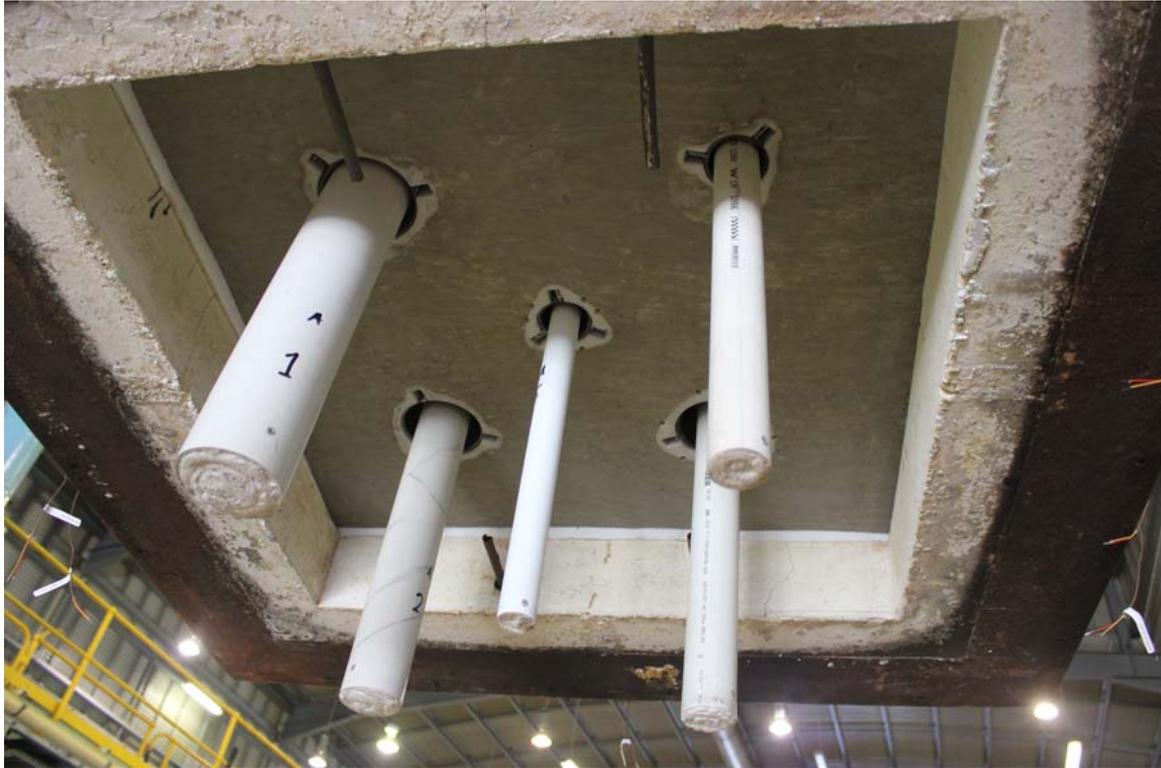
Photograph 1 – Exposed face of the specimen prior to testing

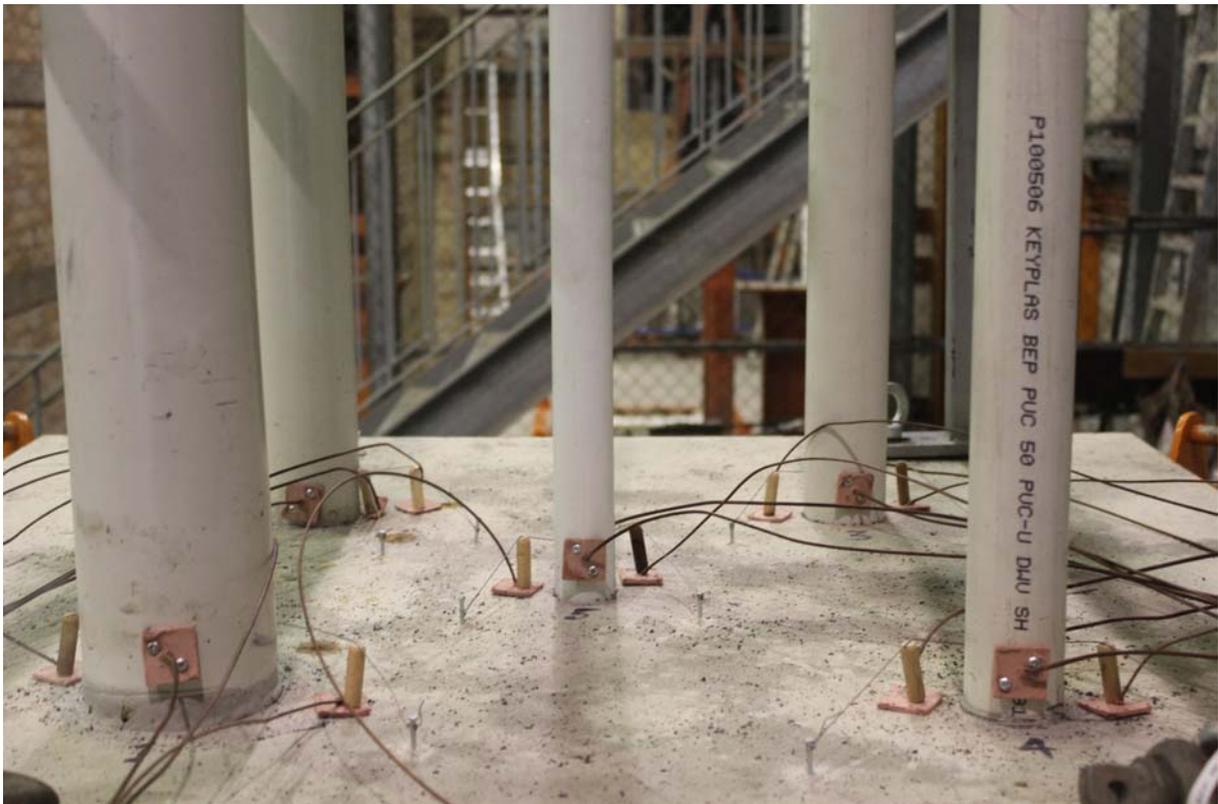
Photograph 4 – Specimens after 120 minutes of testing

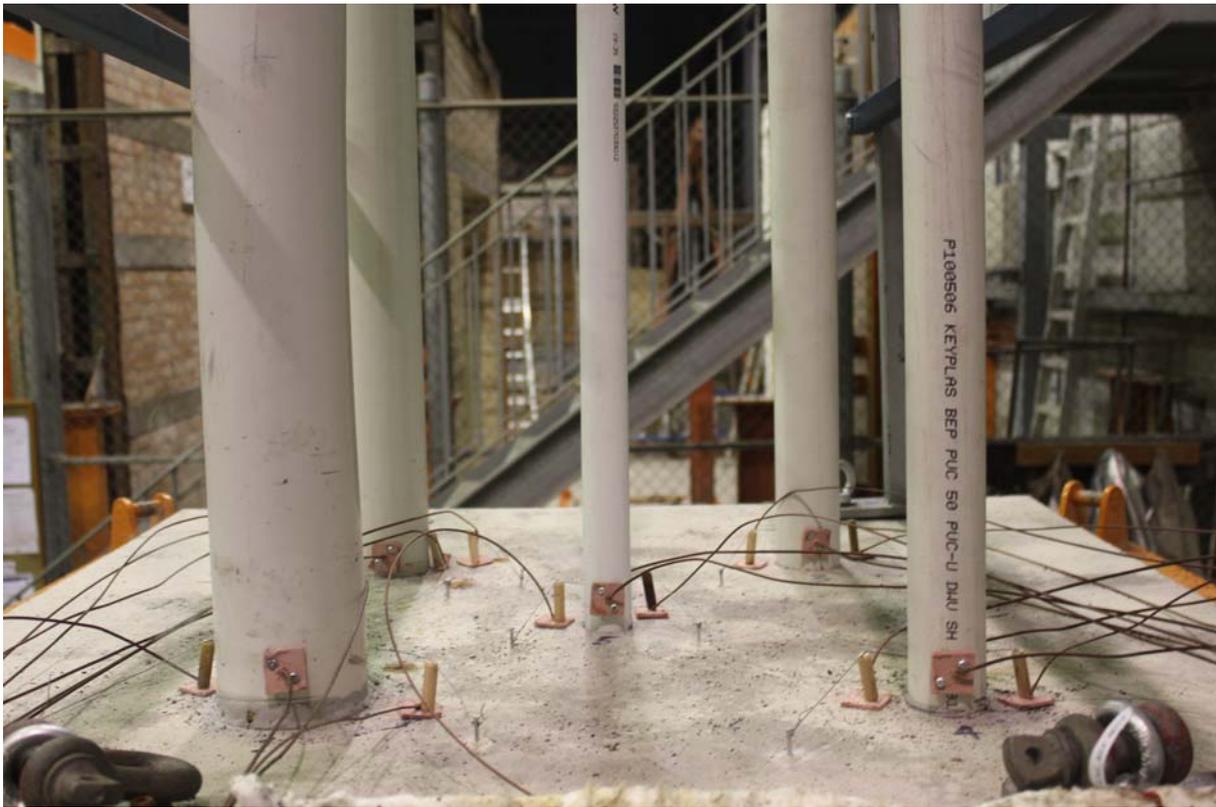
Photograph 5 – Specimens after 180 minutes of testing

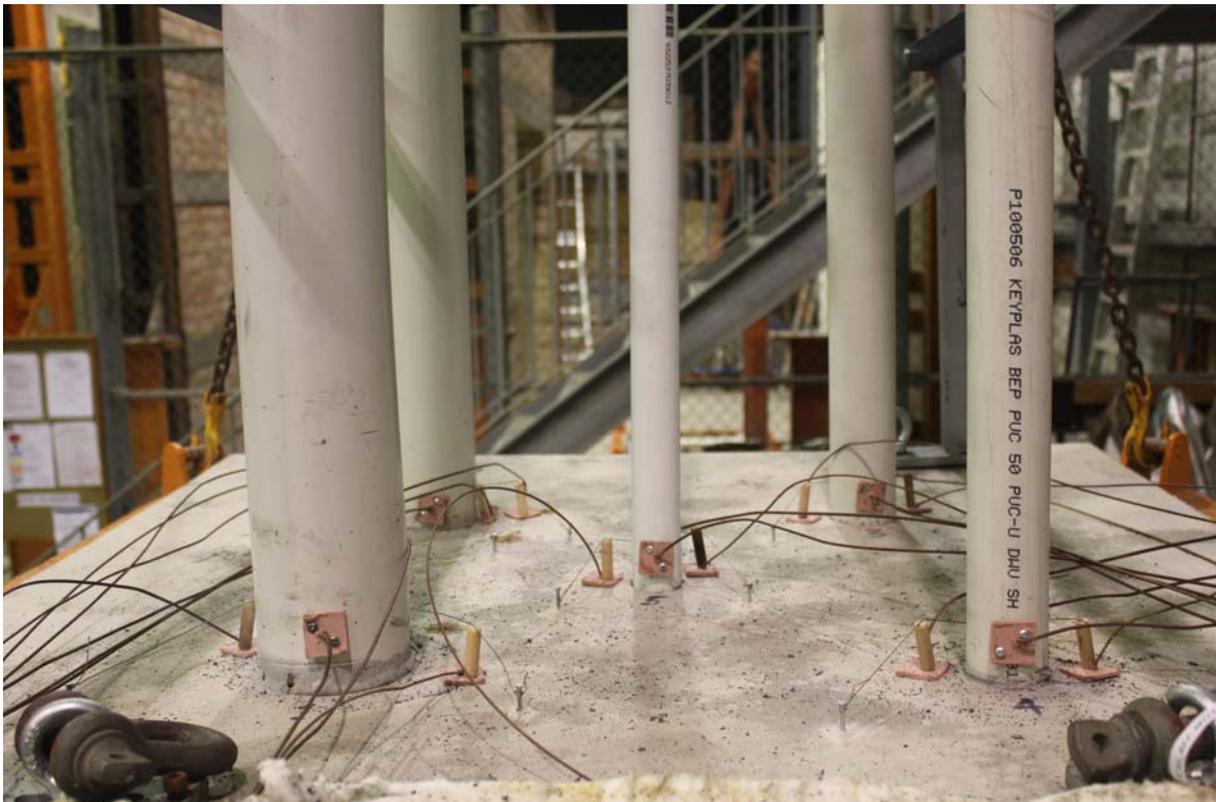
Photograph 6 – Specimens at the conclusion of testing

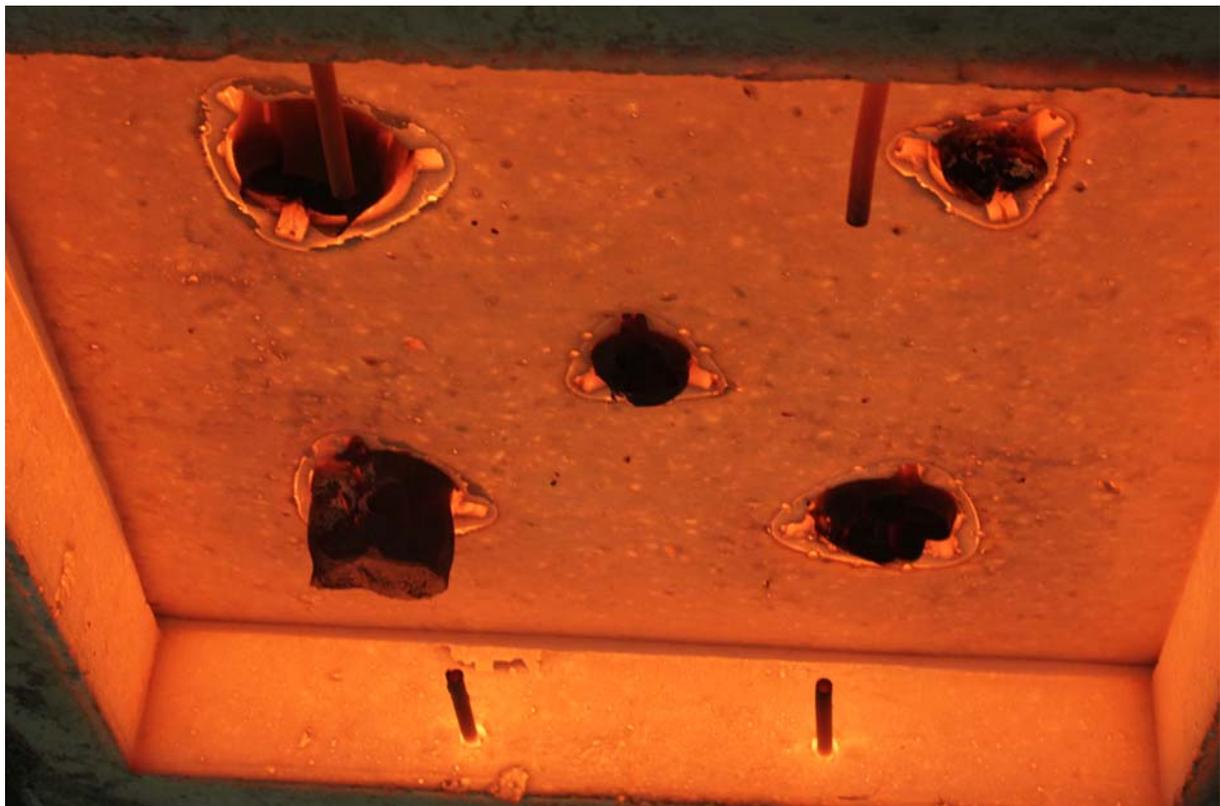
Photograph 7 – Exposed face of the specimens at the conclusion of testing

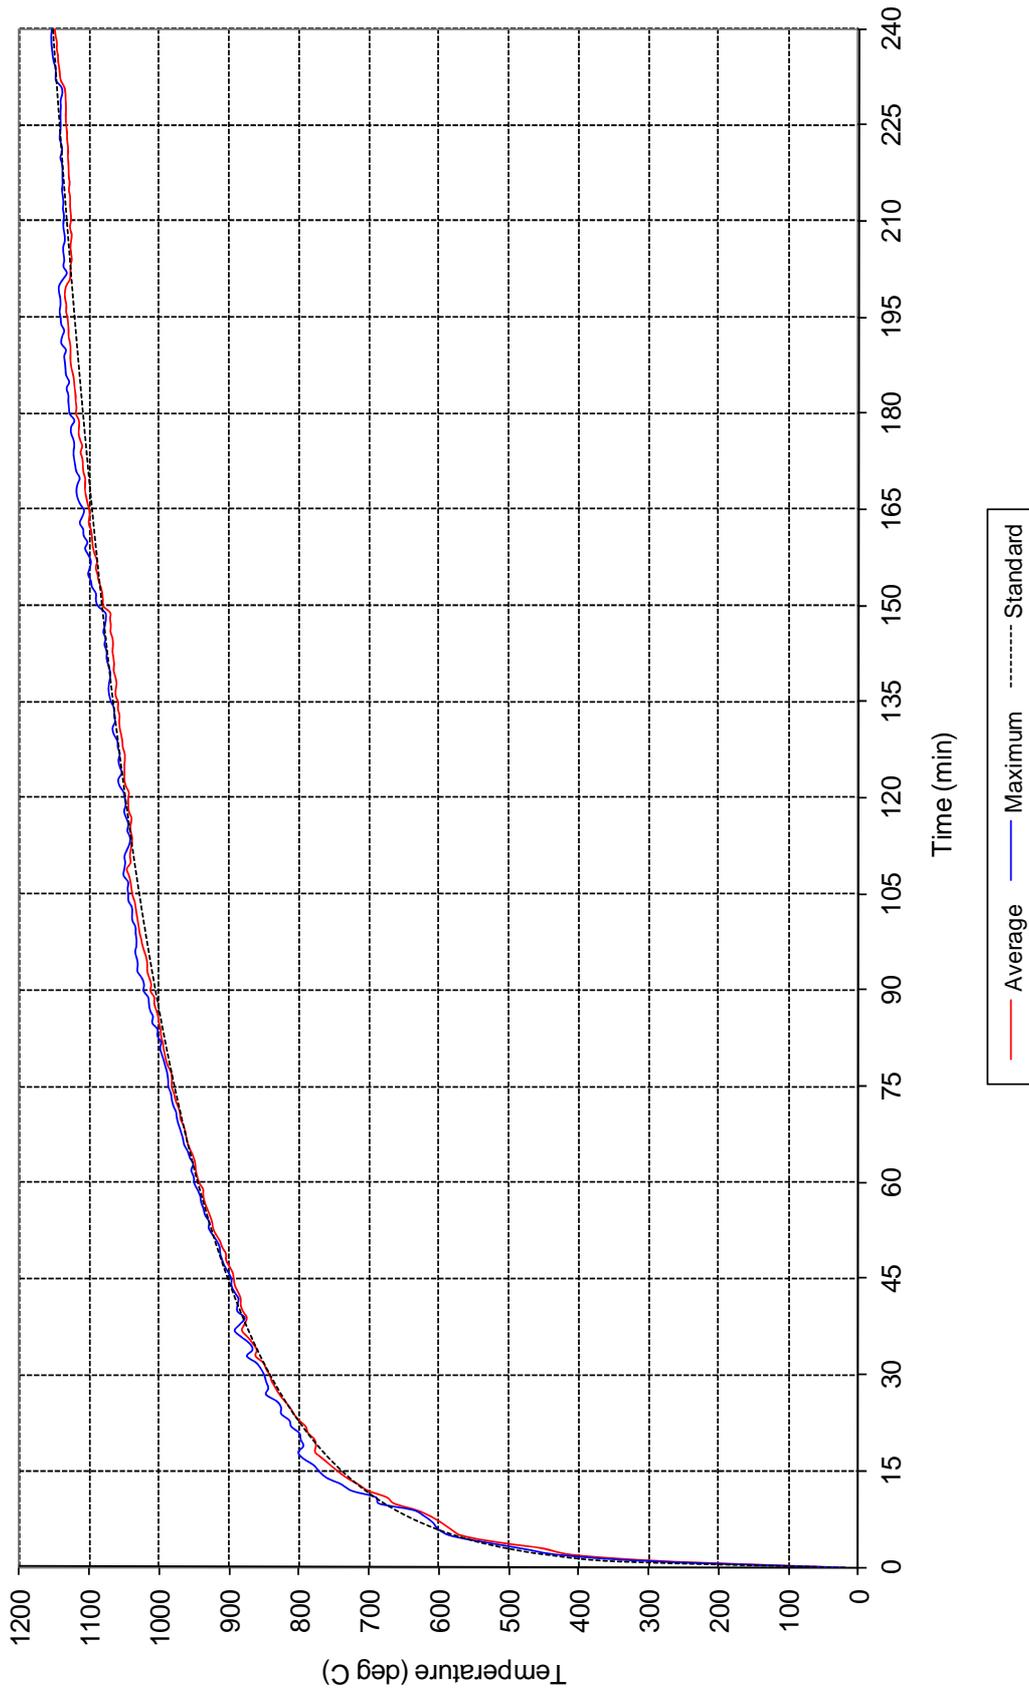
Figure 1 - Furnace temperature

Figure 1 shows the standard curves of temperature versus time for heating the furnace chamber and the actual curves of average and maximum temperature versus time recorded during the heating period.
