Fire-resistance test on fire collars protecting a concrete floor slab penetrated by services

Test Report

Author: Russell Collins
Report number: FSP 1771
Date: 25 January 2017

Client: Snap Fire Systems Pty Ltd

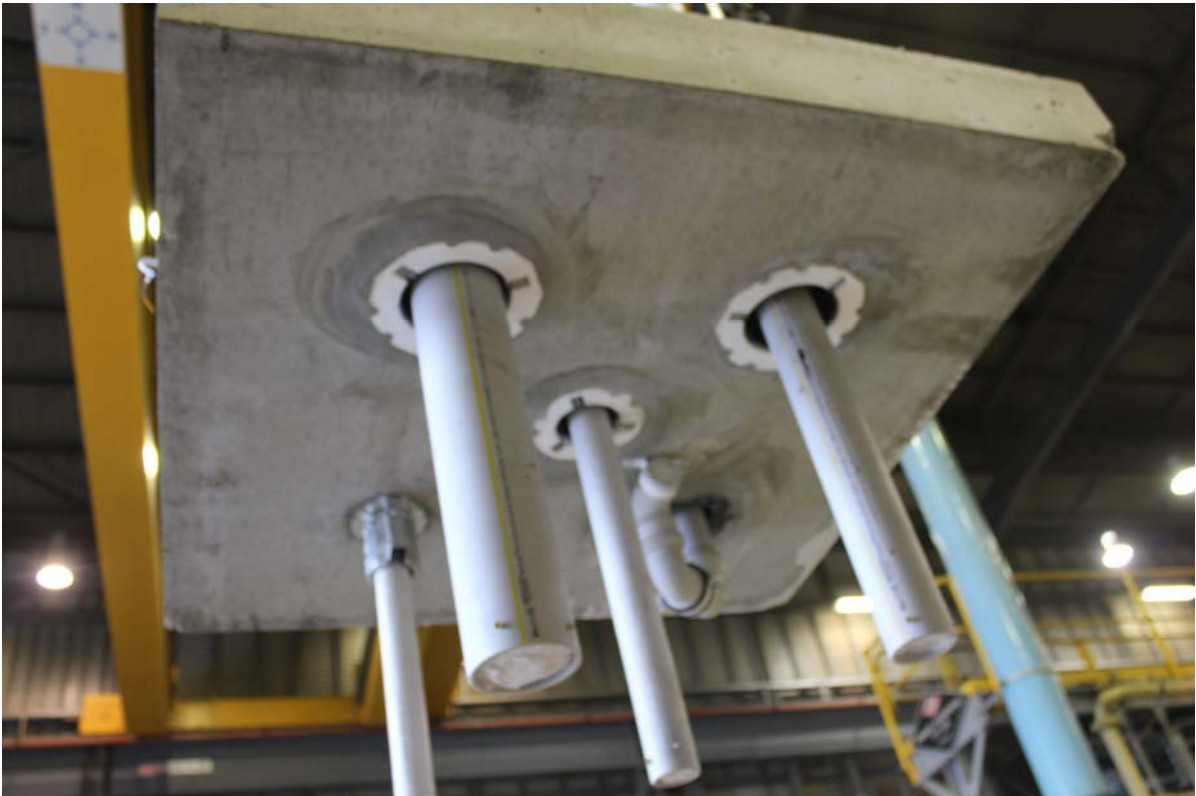
PHOTOGRAPH 1 – EXPOSED FACE OF SPECIMENS PRIOR TO TESTING

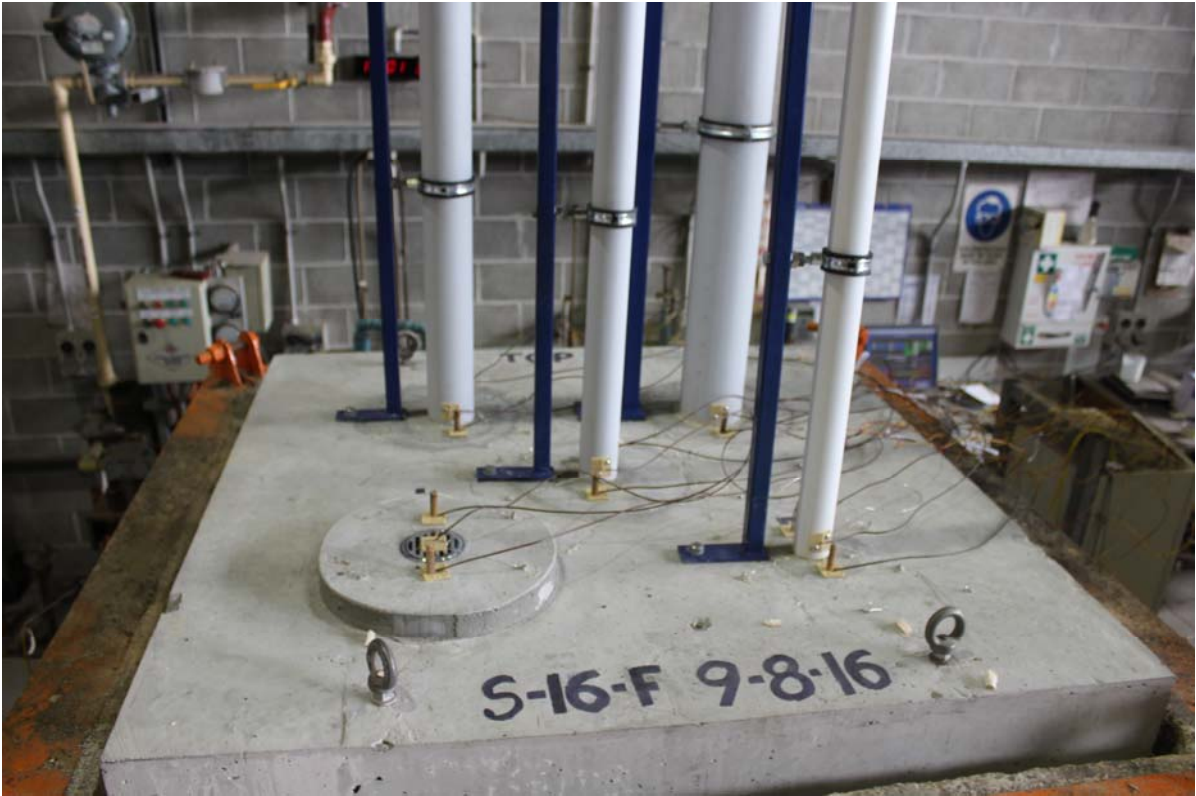
PHOTOGRAPH 2 – UNEXPOSED FACE OF SPECIMENS PRIOR TO TESTING

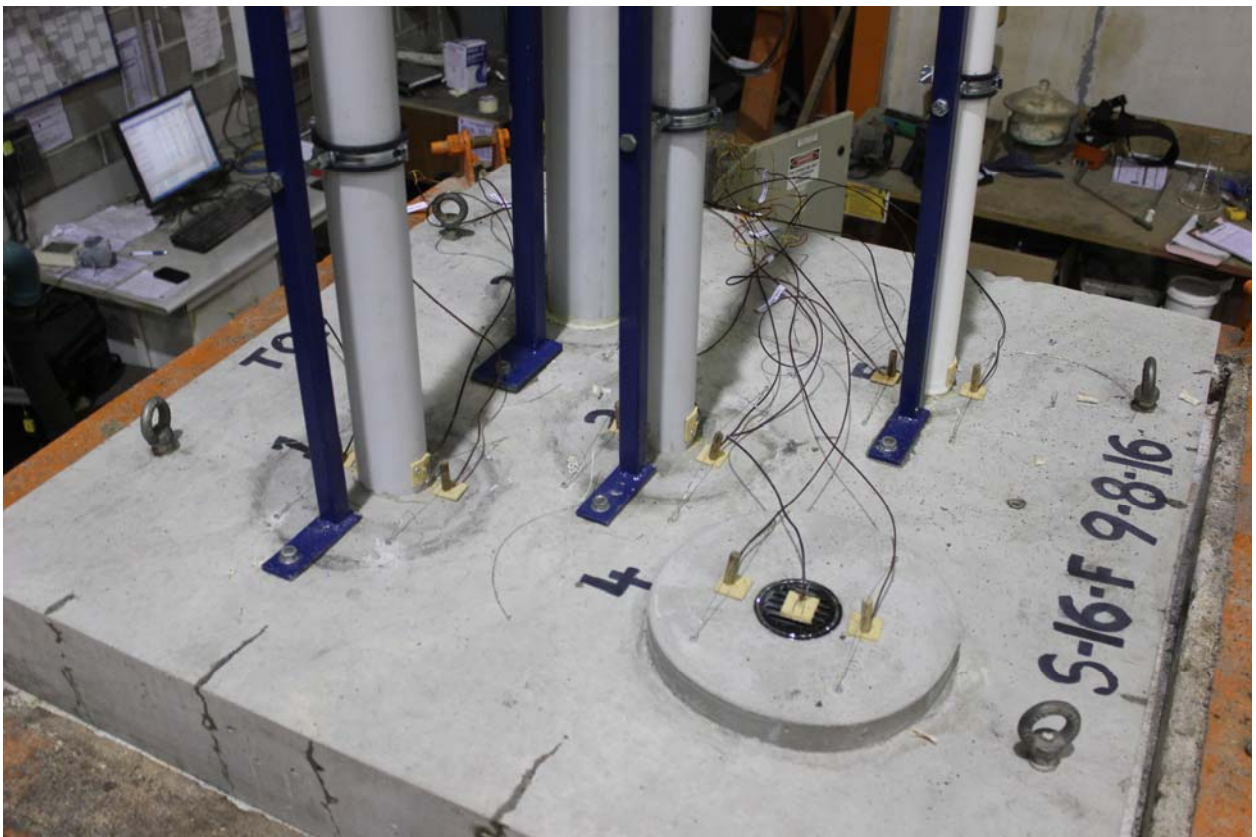
PHOTOGRAPH 4 – SPECIMENS AFTER 120 MINUTES OF TESTING

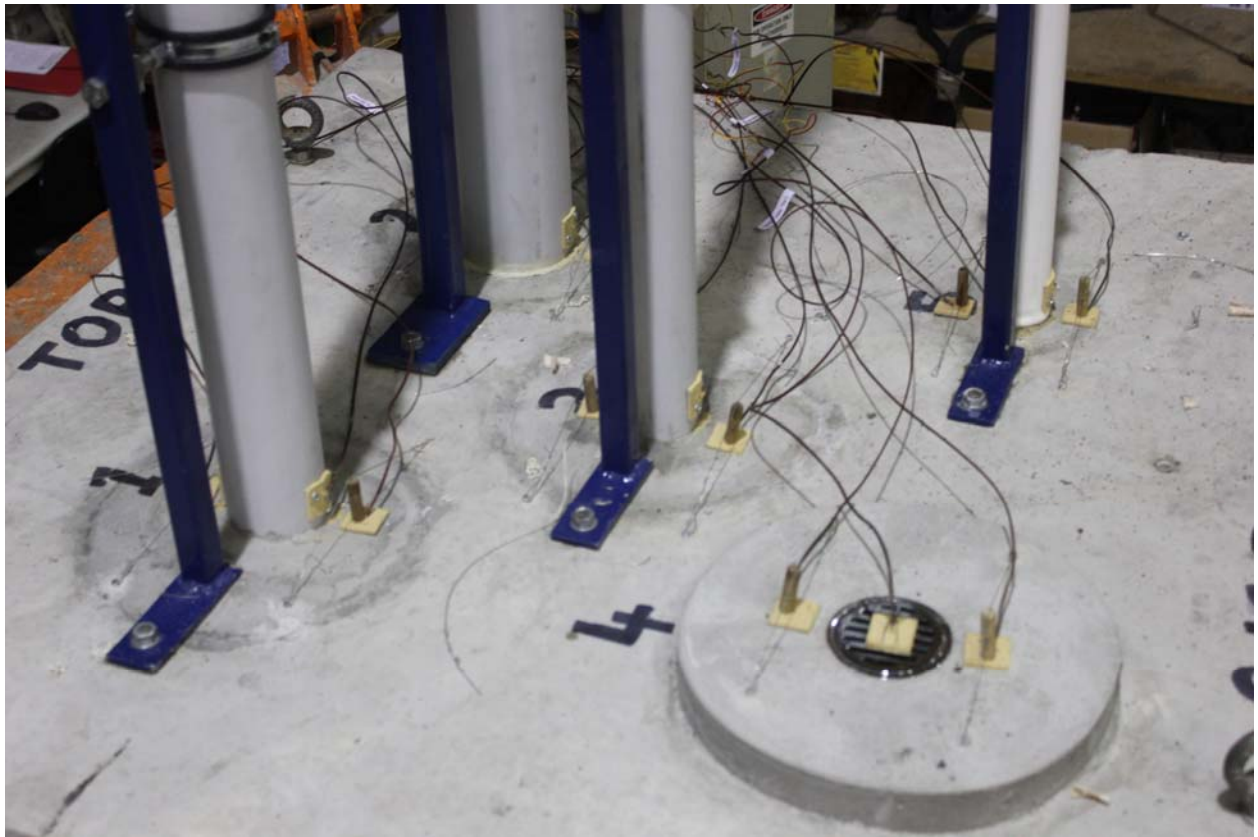
PHOTOGRAPH 5 – SPECIMENS AFTER 180 MINUTES OF TESTING
