Fire-resistance test on fire collars protecting a concrete floor slab penetrated by services

Test Report

Author: Chris Wojcik
Report number: FSP 1789
Date: 27 March 2017

Sponsored Investigation No. FSP 1789

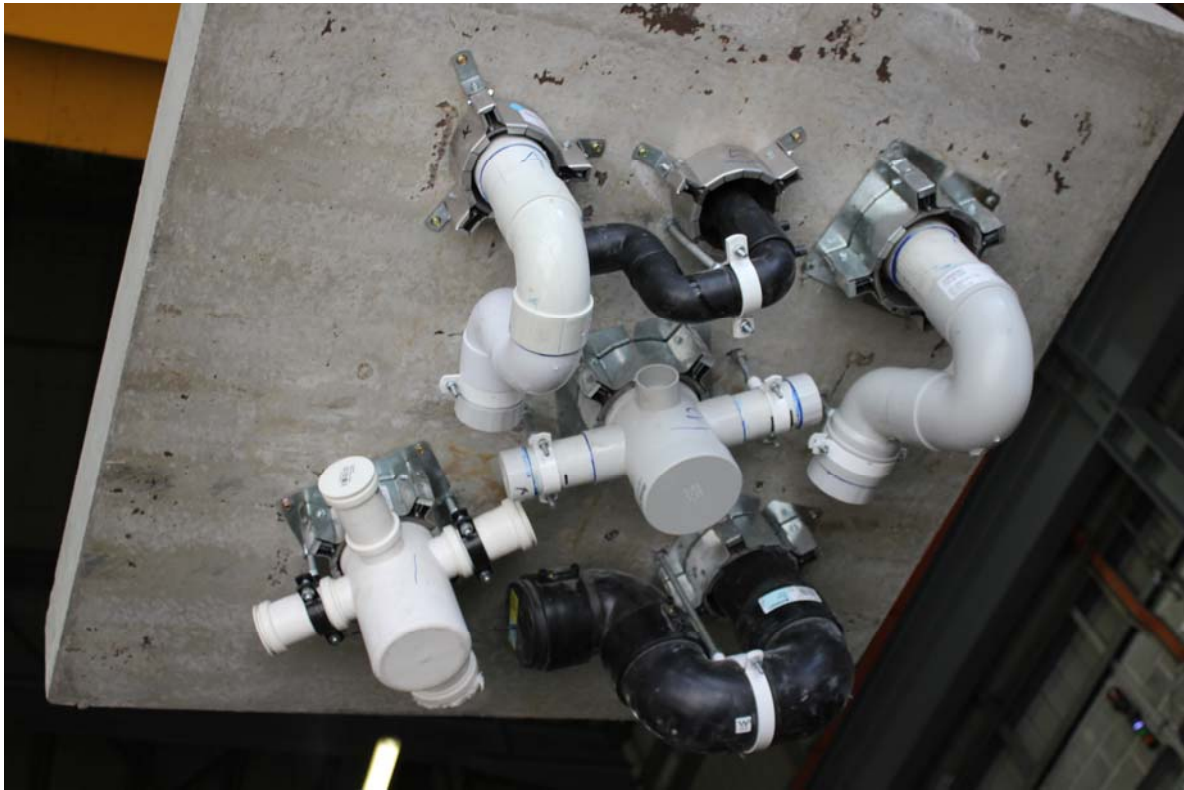
PHOTOGRAPH 1 – EXPOSED FACE OF SPECIMENS PRIOR TO TESTING

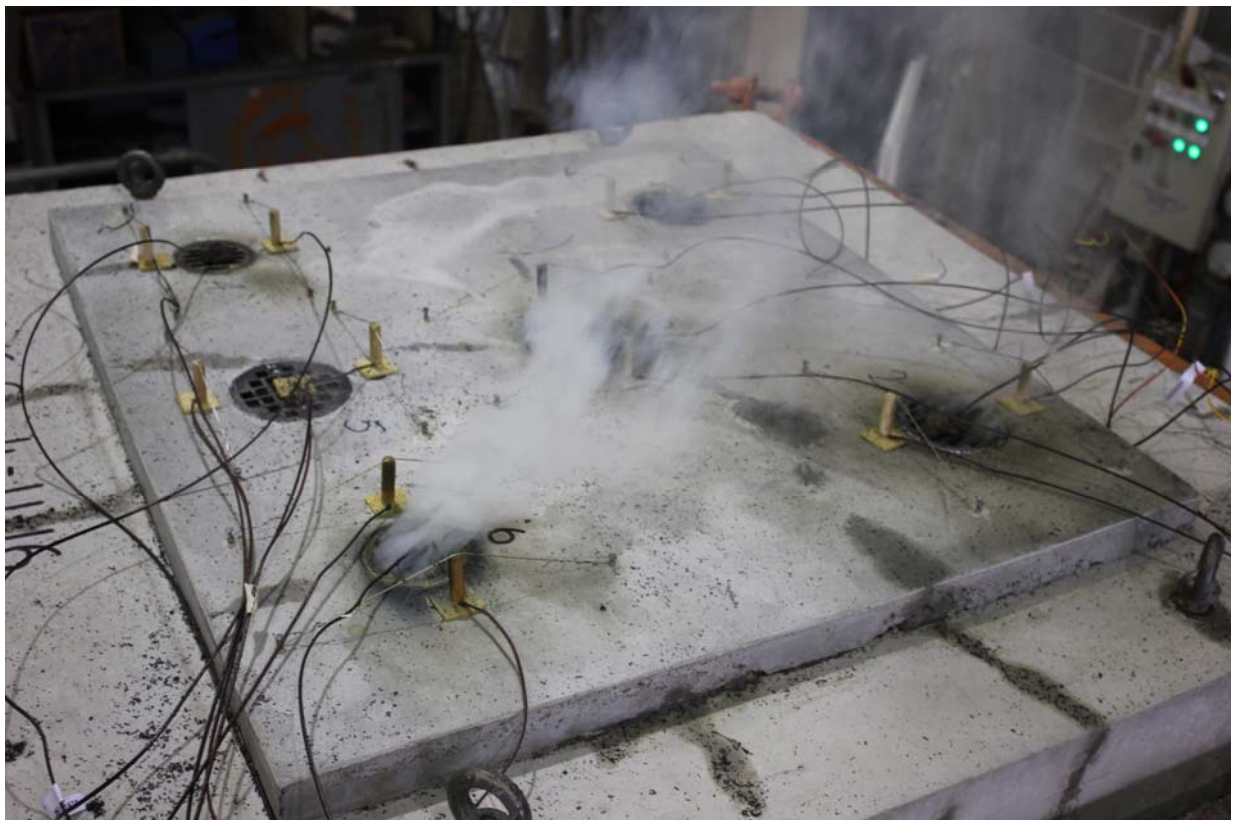
PHOTOGRAPH 4 – SPECIMENS AFTER 120 MINUTES OF TESTING

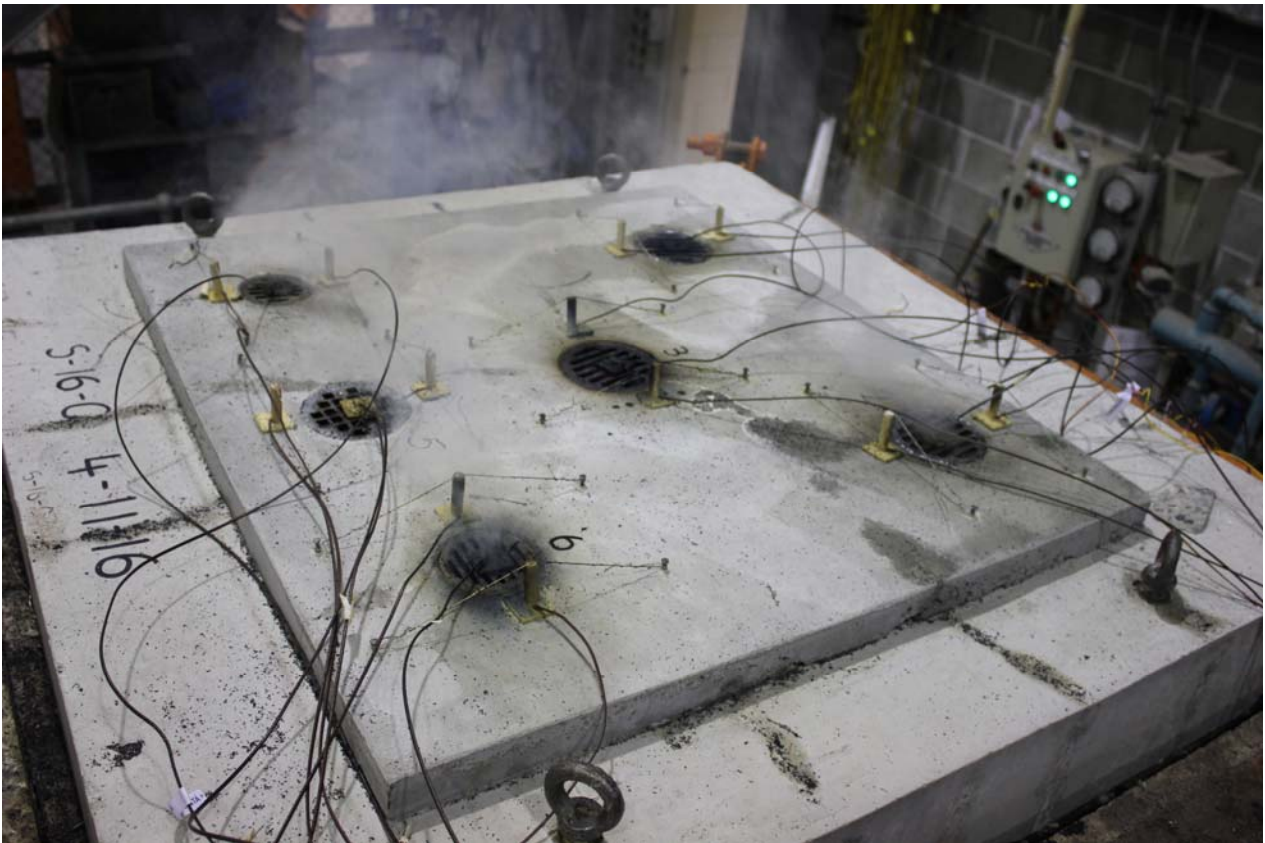
PHOTOGRAPH 5 – SPECIMENS AFTER 180 MINUTES OF TESTING

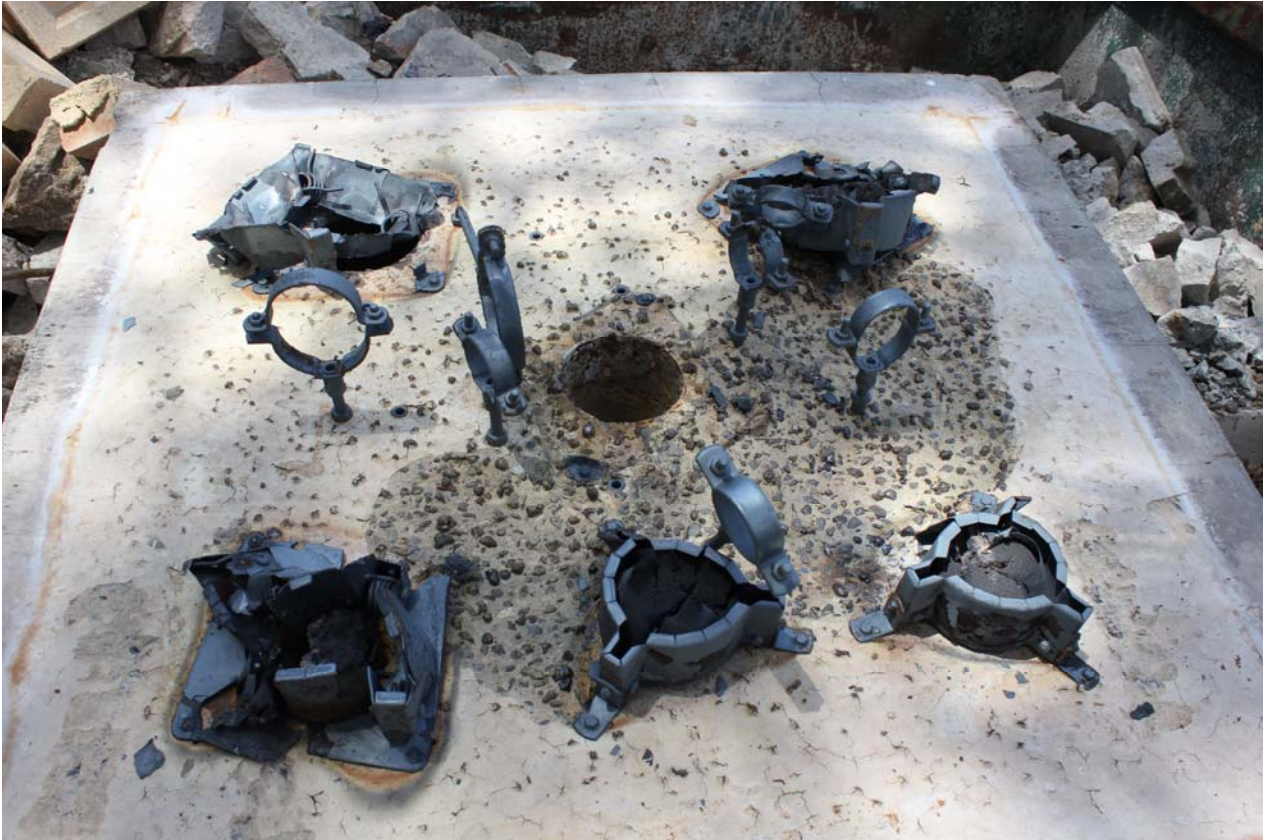
PHOTOGRAPH 7 – EXPOSED FACE OF SPECIMENS AT CONCLUSION OF TESTING

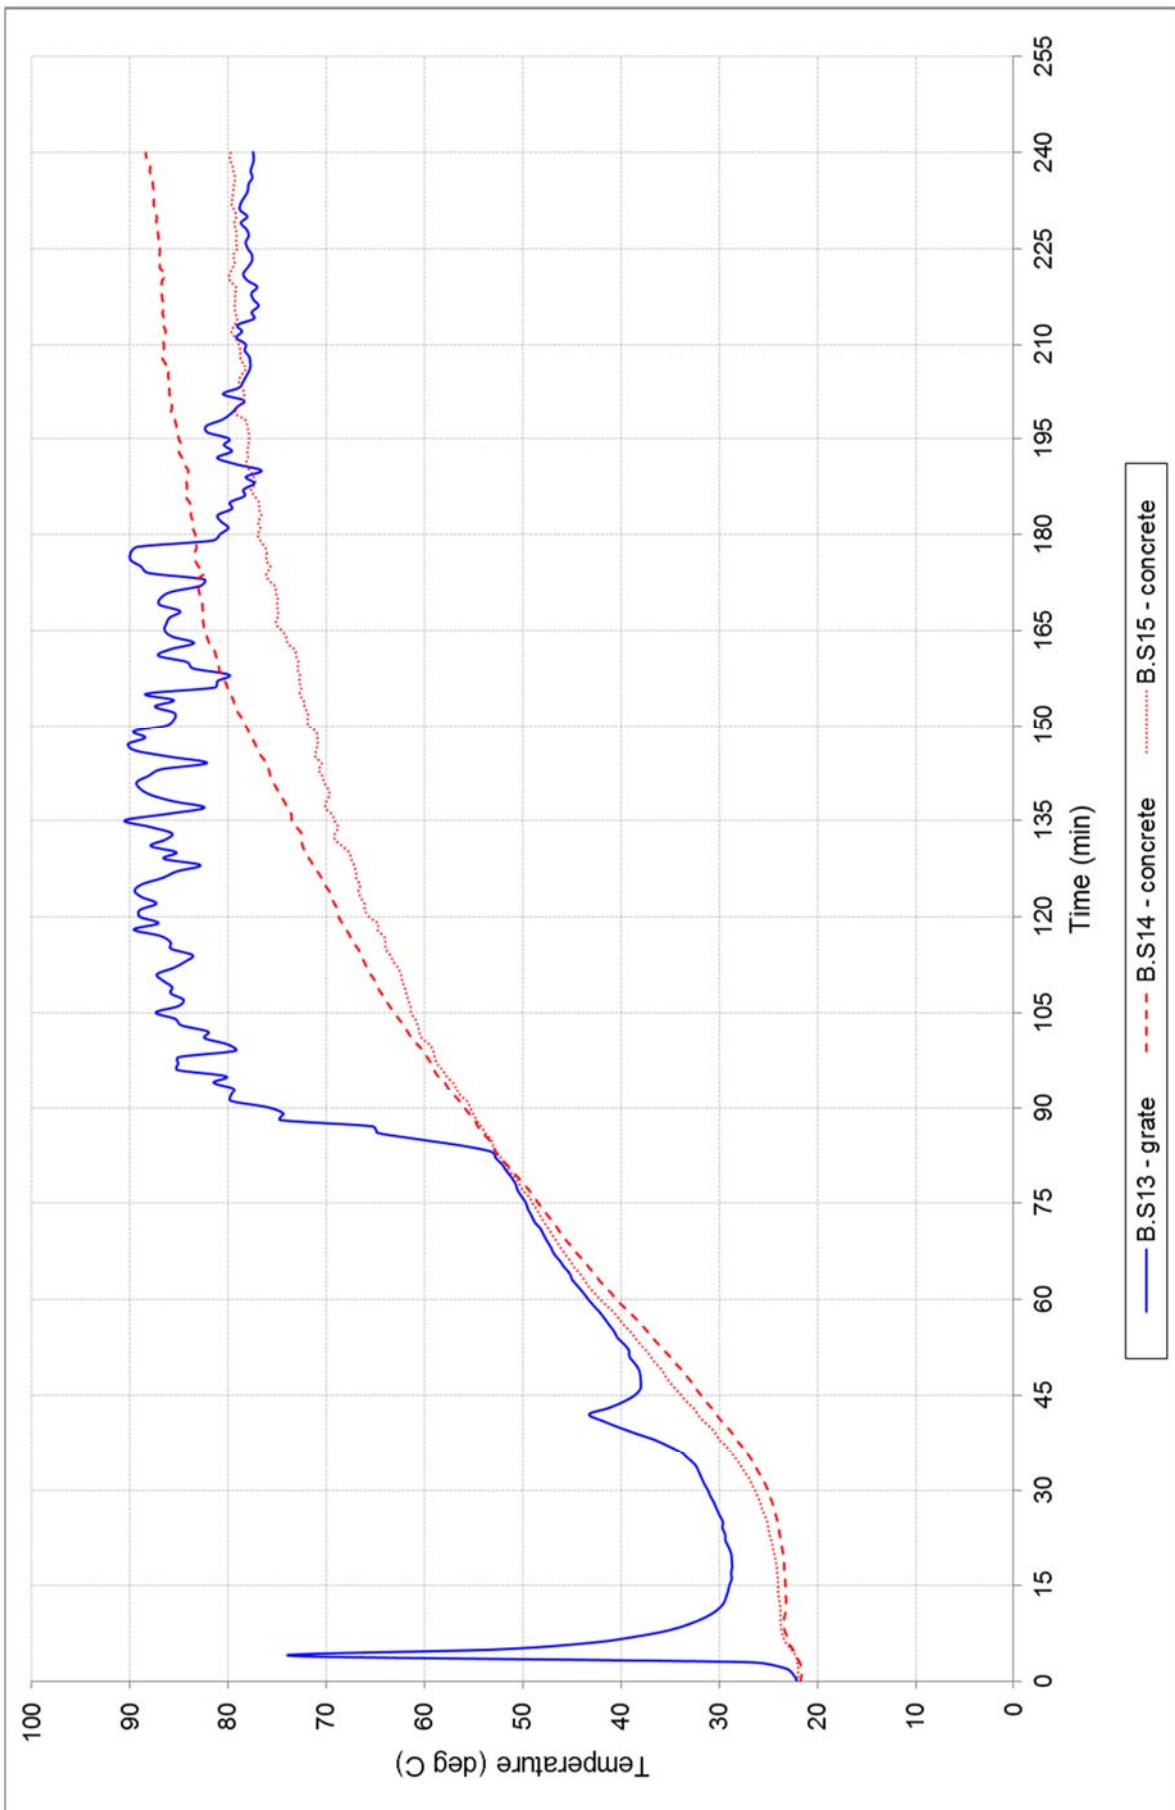
FIGURE 4 – SPECIMEN TEMPERATURE – ASSOCIATED WITH PENETRATION # 5

Figure 4 shows the curve of maximum temperature versus time associated with Penetration 5.

Integrity - no failure at 241 minutes

Insulation - no failure at 241 minutes
