**FIRE-RESISTANCE TEST ON
FIRE COLLARS PROTECTING A PLASTERBOARD
WALL PENETRATED BY SERVICES.**

**Report number FSP 1341
CSIRO job number SP3197
03 AUGUST 2009**

**Client
SNAP FIRE SYSTEMS PTY LTD**

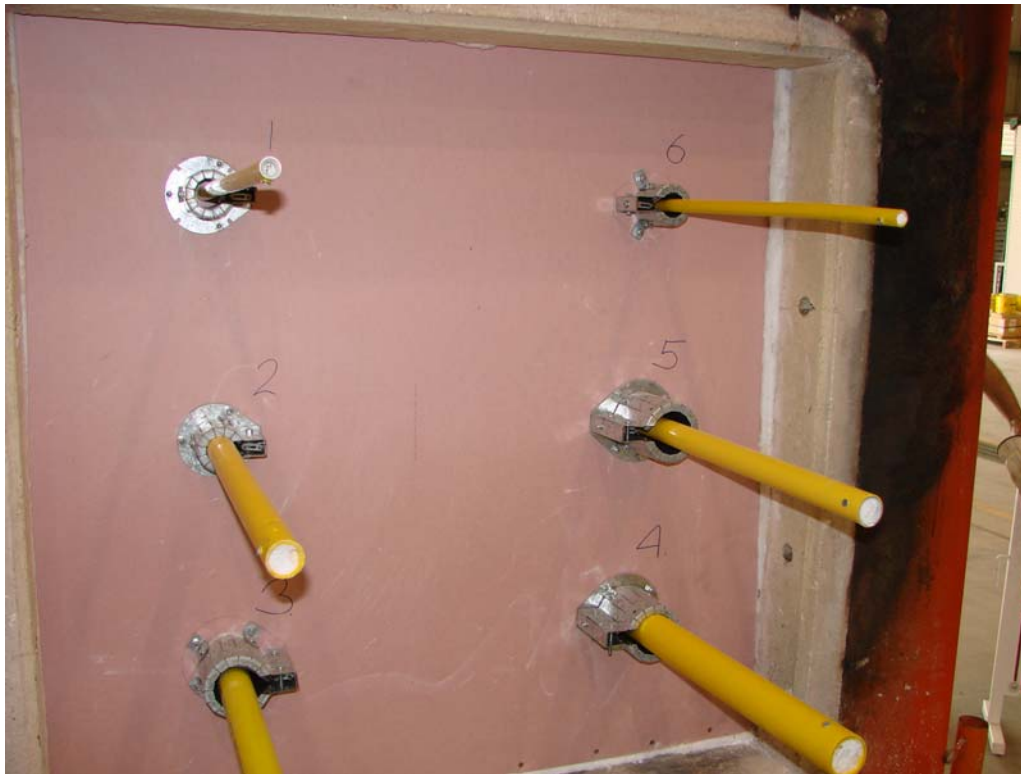
Photograph 1 – Exposed face of the specimen prior to testing

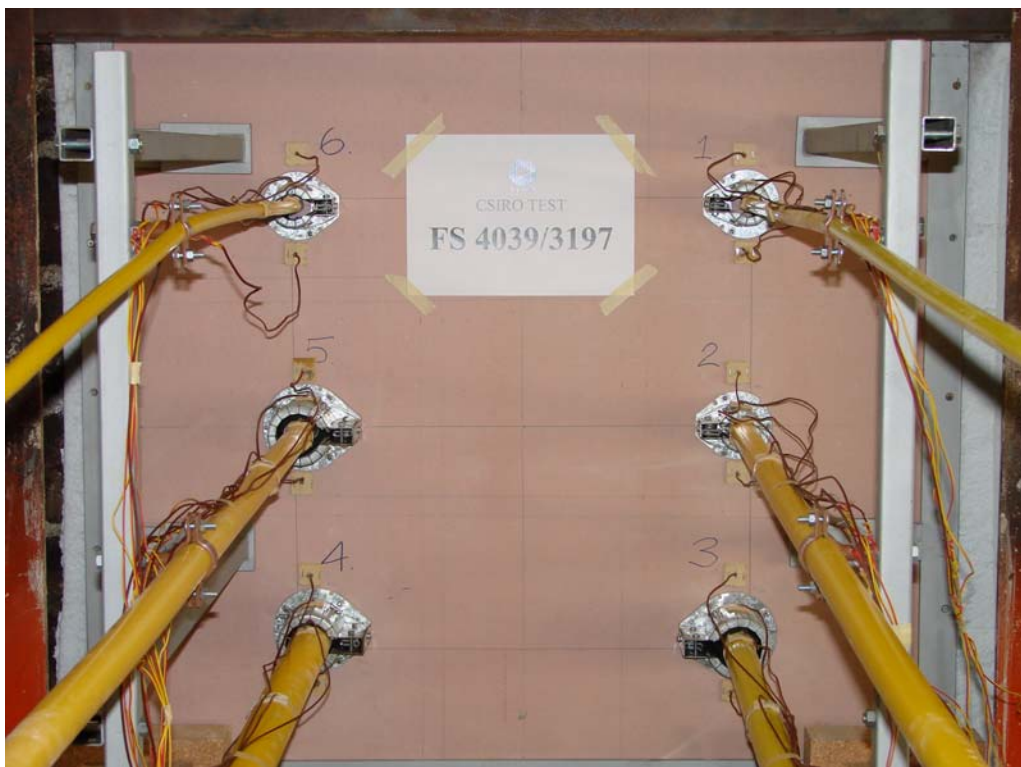
Photograph 2 – Unexposed face of the specimen prior to testing

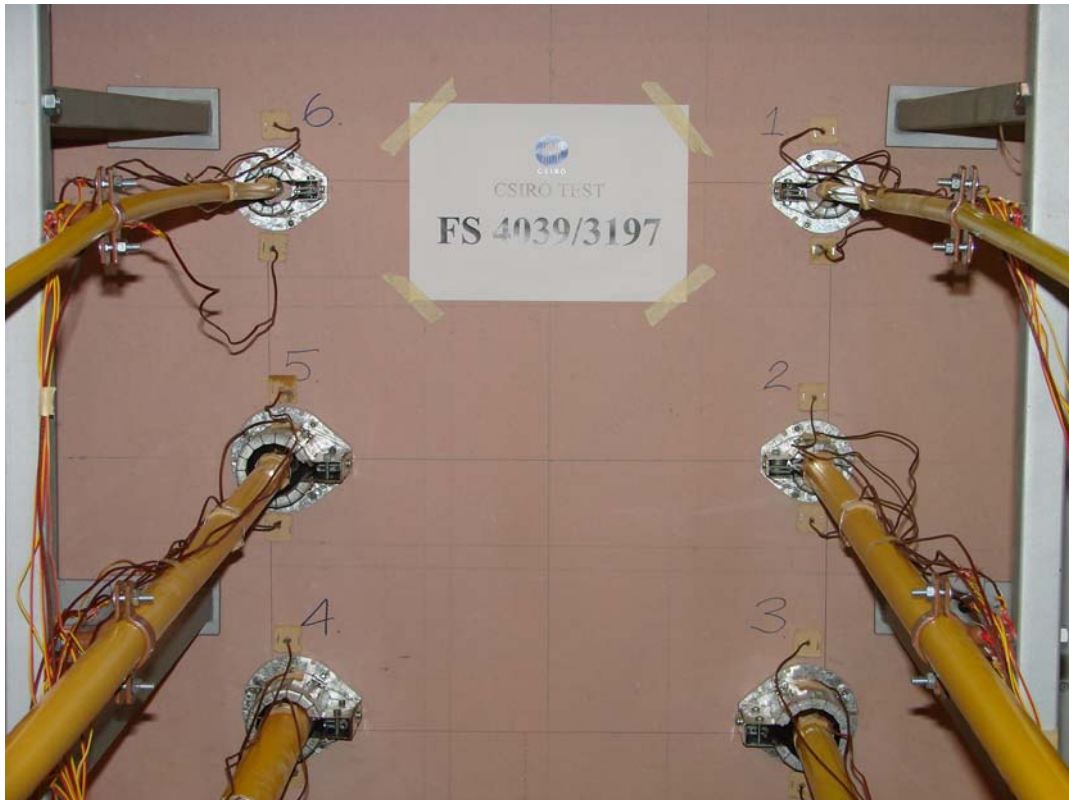
Photograph 3 – Specimen after 60 minutes of testing

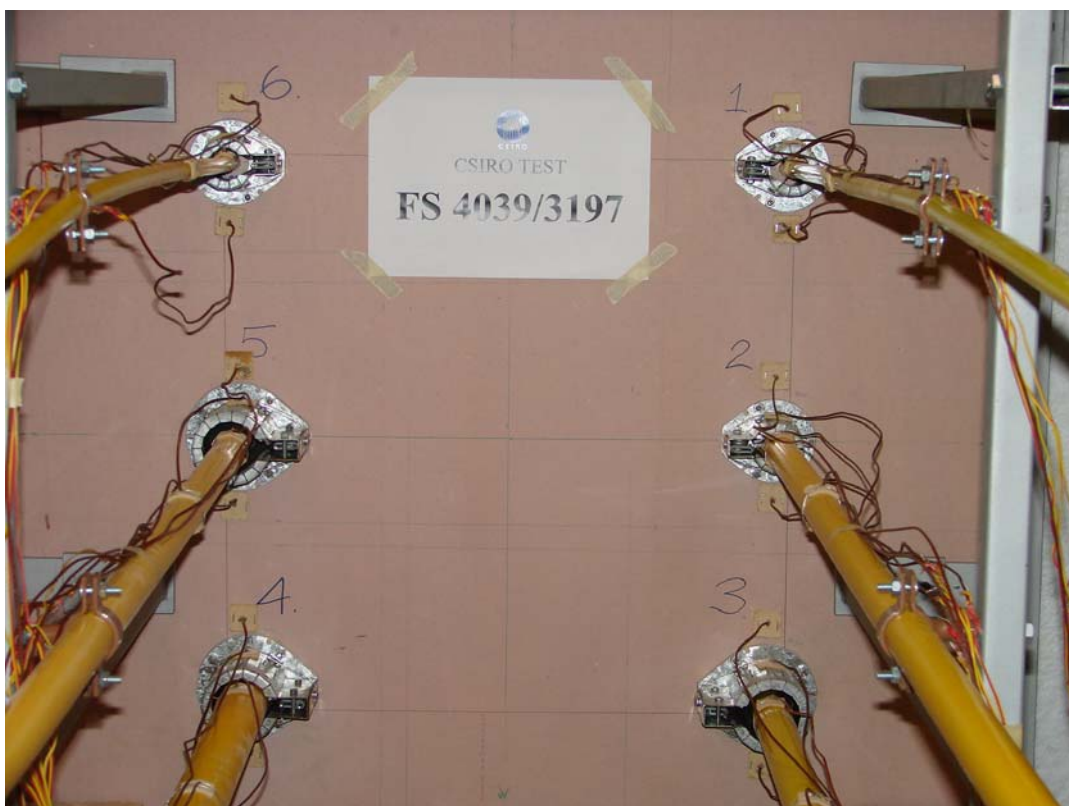
Photograph 4 – Specimen after 90 minutes of testing

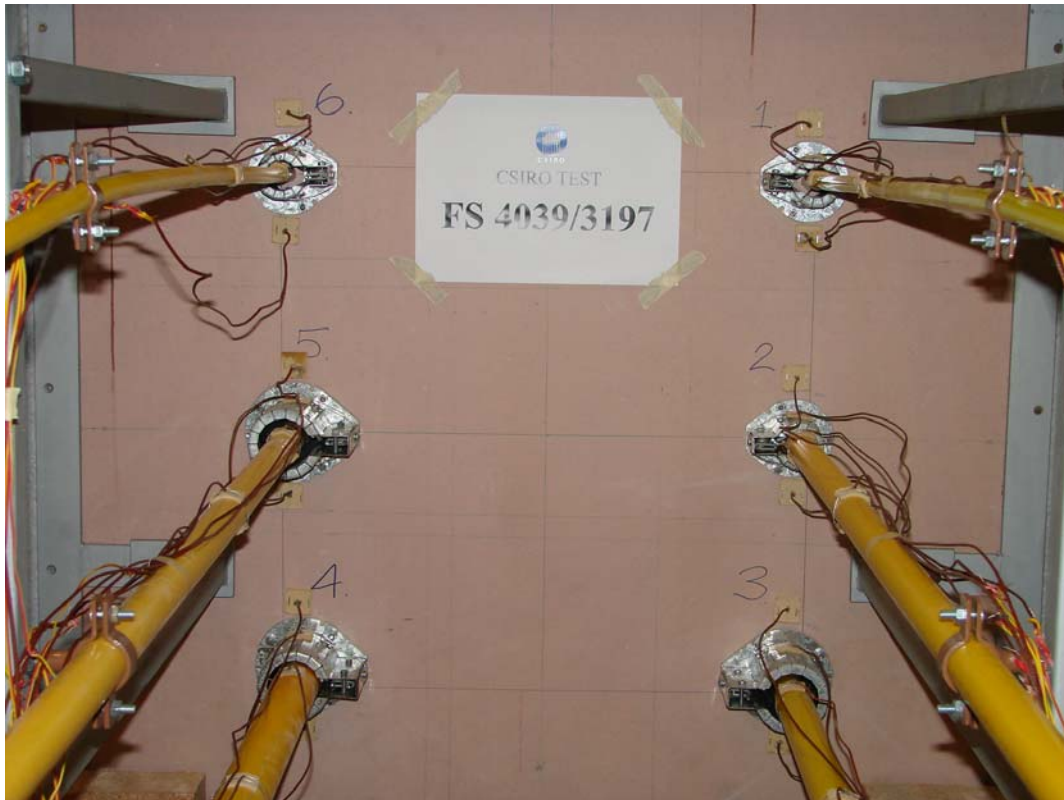
Photograph 5 – Specimen after 120 minutes of testing

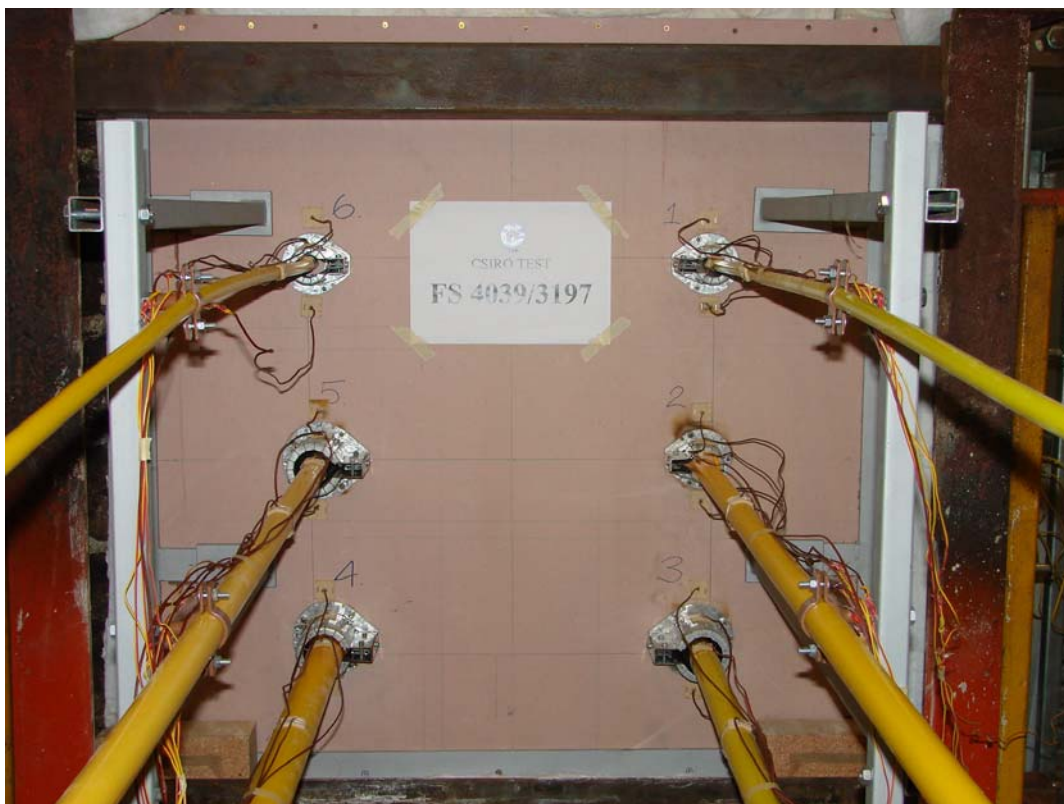
Photograph 6 – Specimen at the conclusion of testing

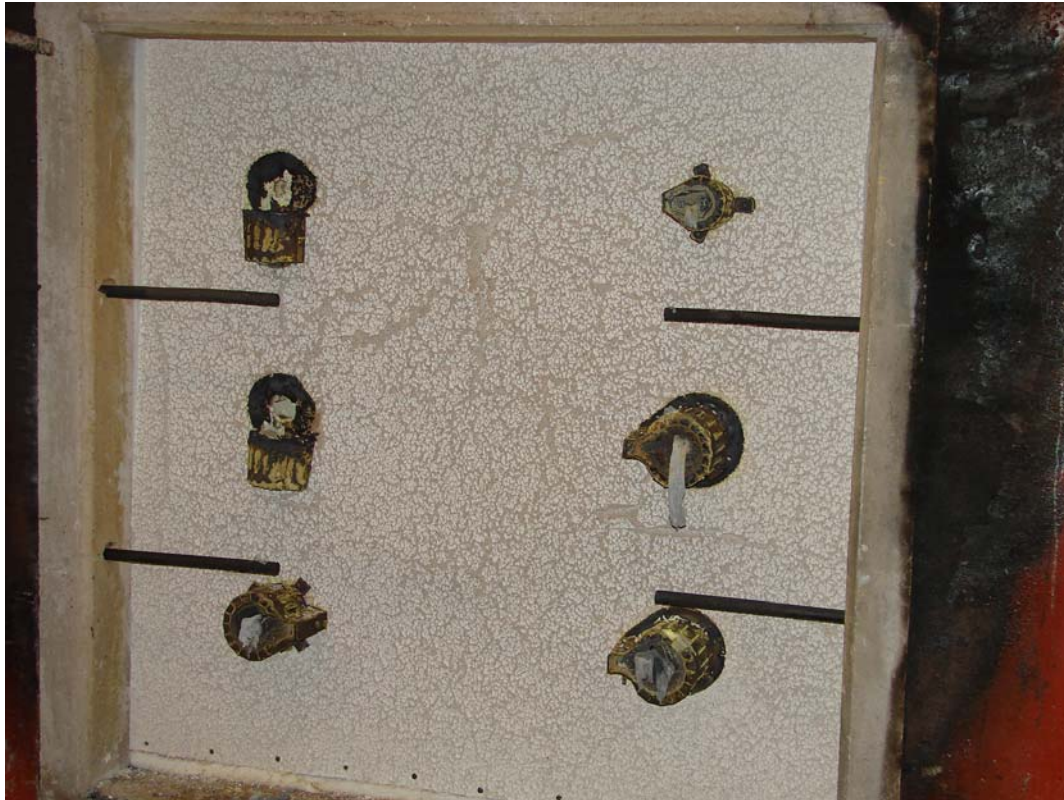
Photograph 7 – Exposed face after the conclusion of testing

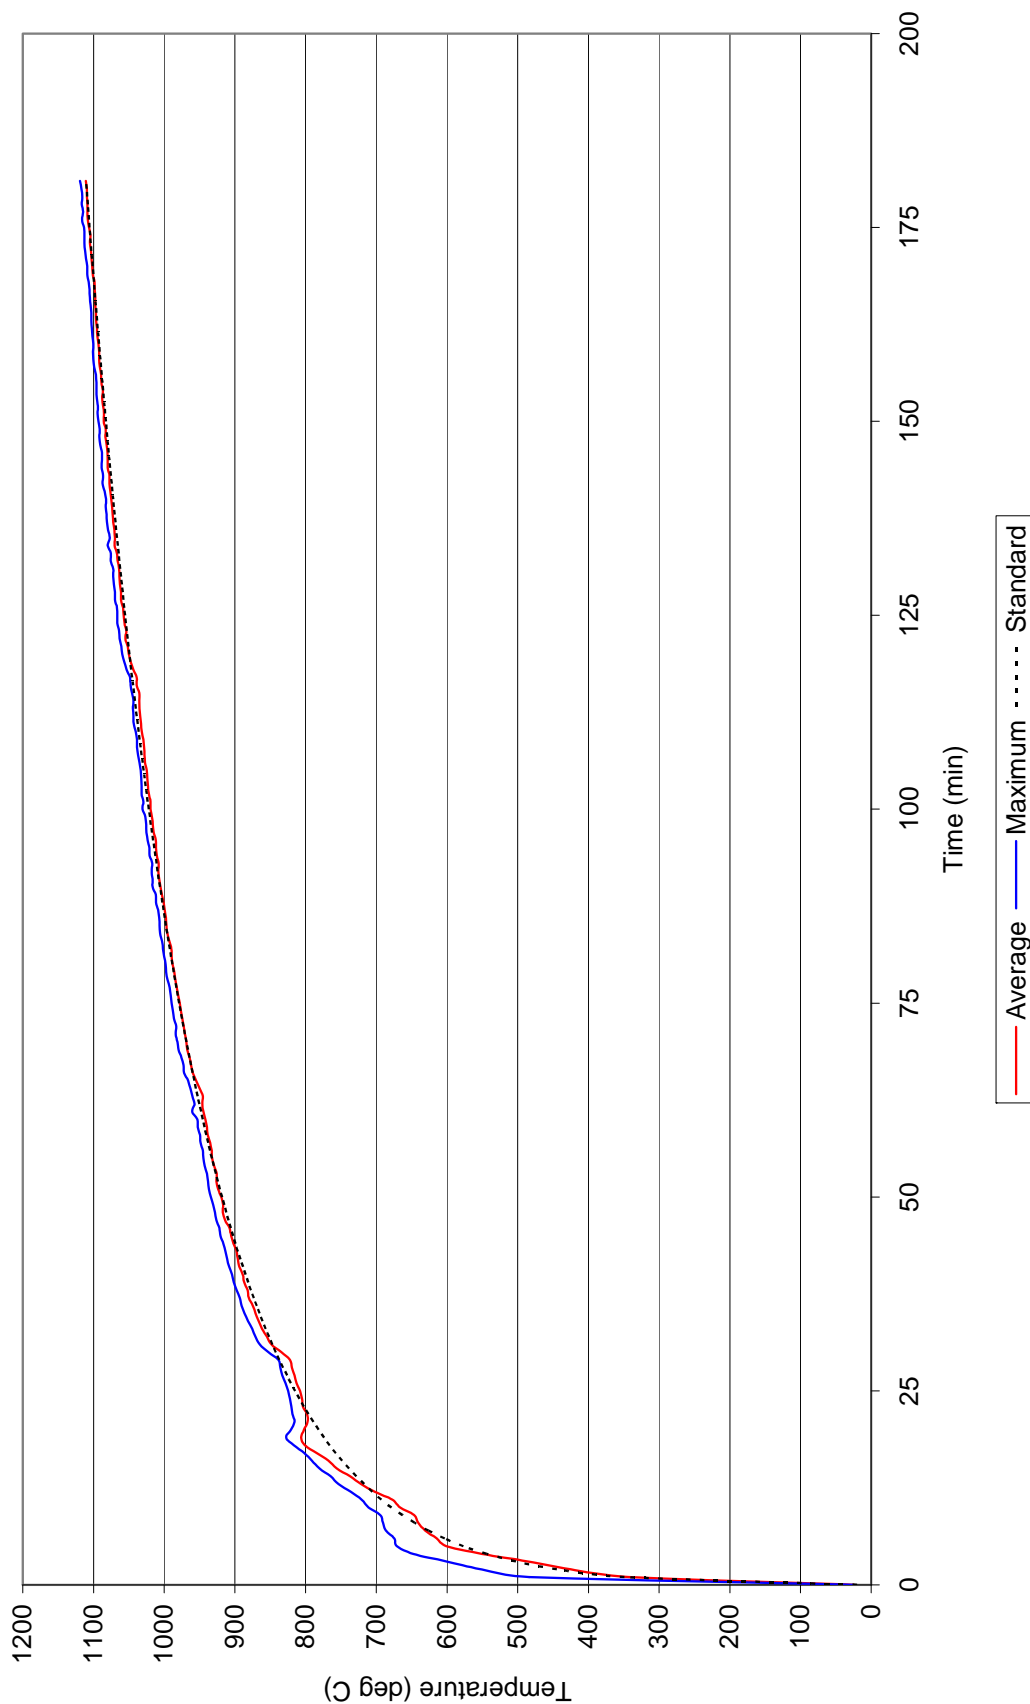
Figure 1 - Furnace temperature

Figure 1 shows the standard curves of temperature versus time for heating the furnace chamber and the actual curves of average and maximum temperature versus time recorded during the heating period.

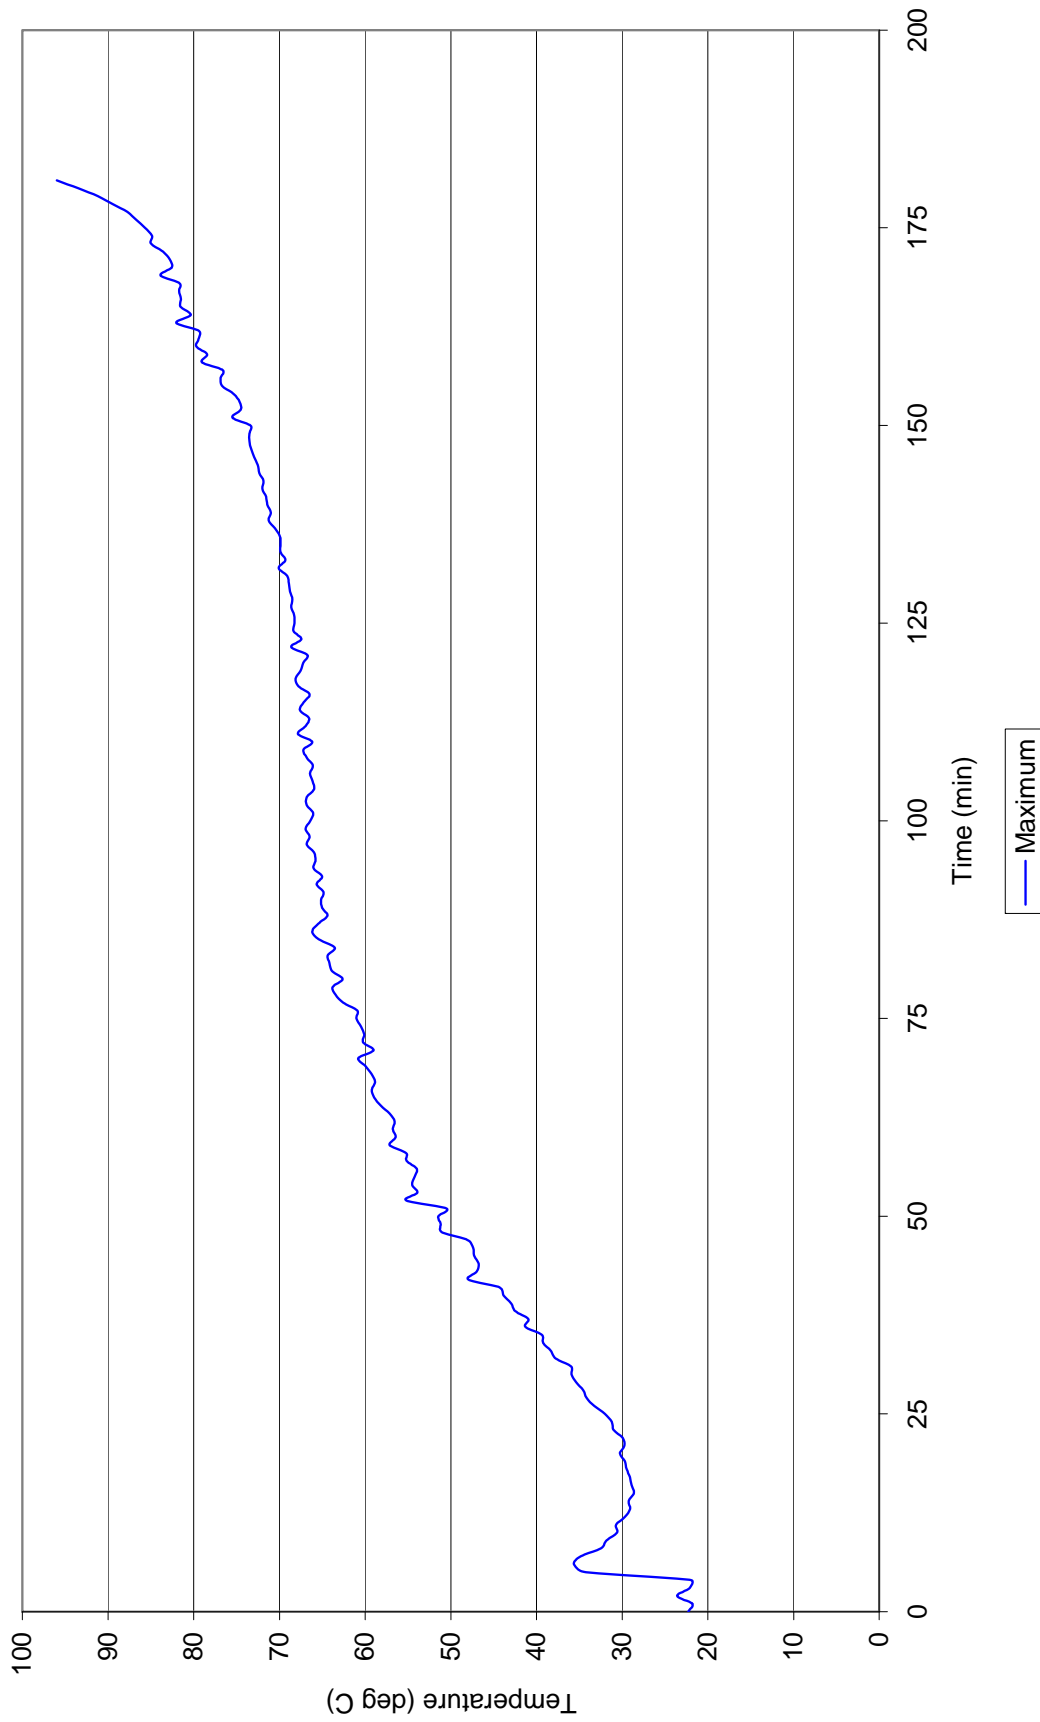
Figure 2 - Specimen temperature – Penetration 1

Figure 2 shows the curve of maximum temperature versus time associated with Penetration 1.

Structural adequacy	-	not applicable
Integrity	-	no failure at 181 minutes
Insulation	-	no failure at 181 minutes

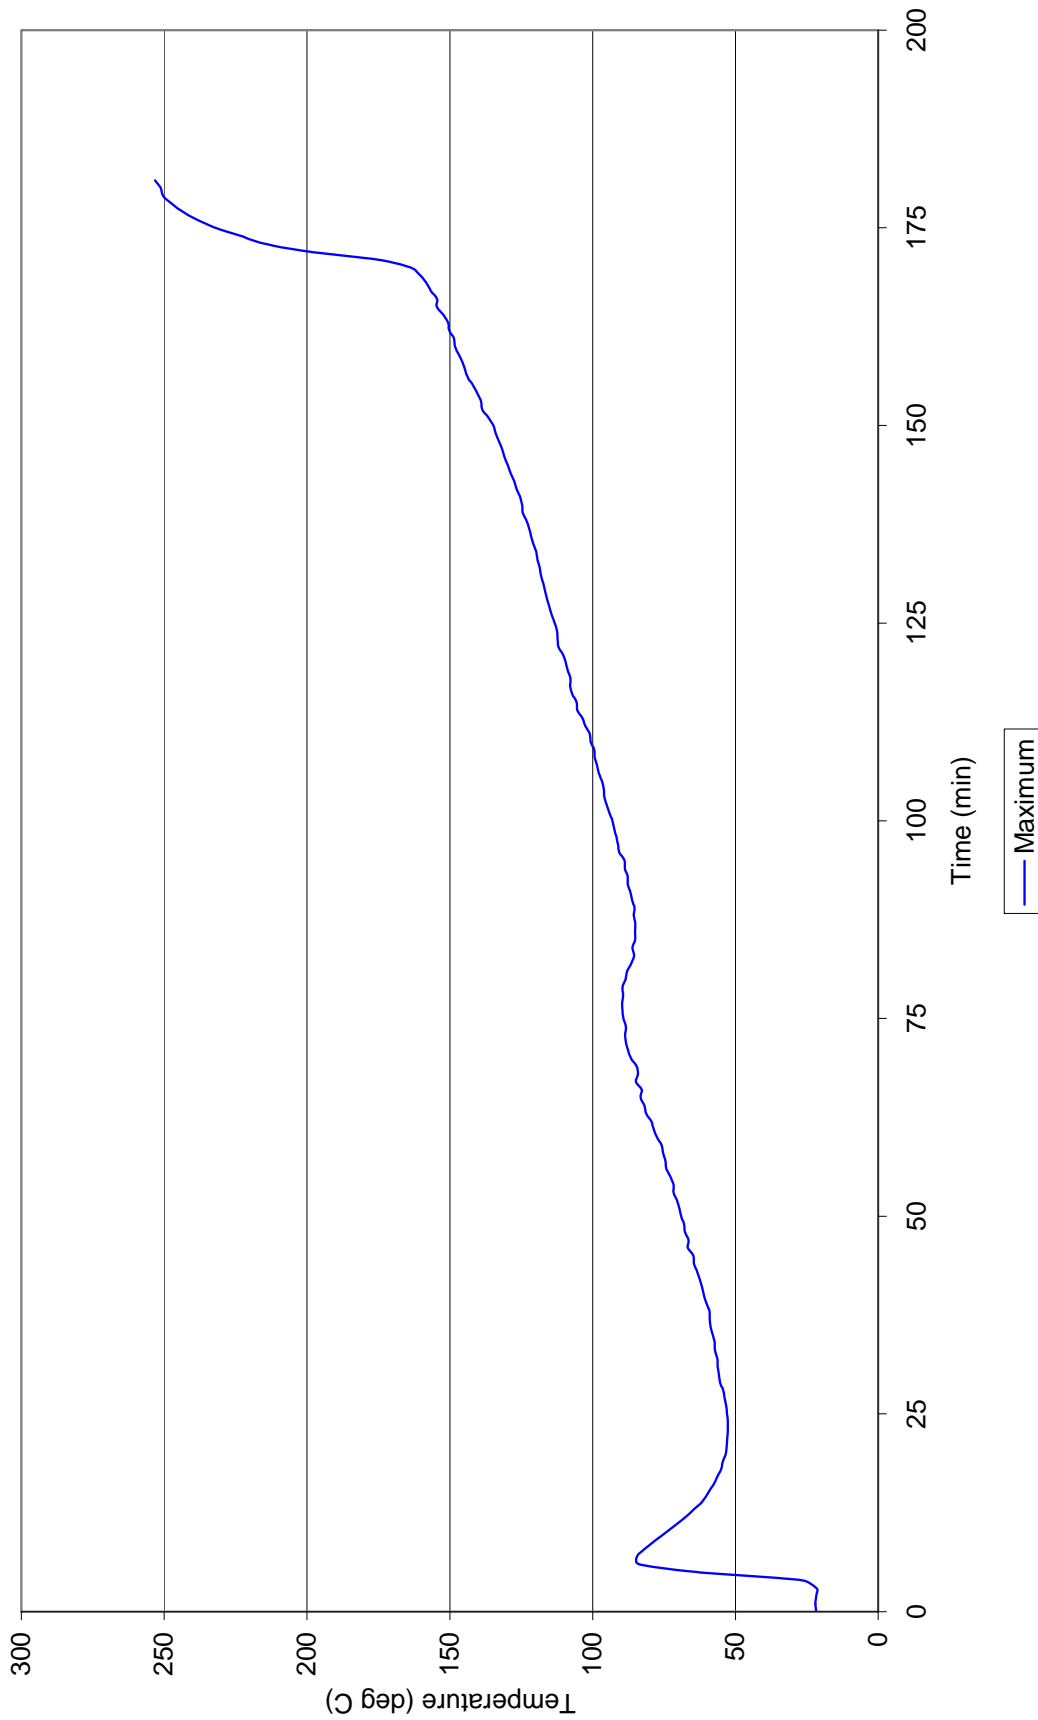
Figure 3 - Specimen temperature – Penetration 2

Figure 3 shows the curve of maximum temperature versus time associated with Penetration 2.

Structural adequacy	-	not applicable
Integrity	-	no failure at 181 minutes
Insulation	-	no failure at 172 minutes

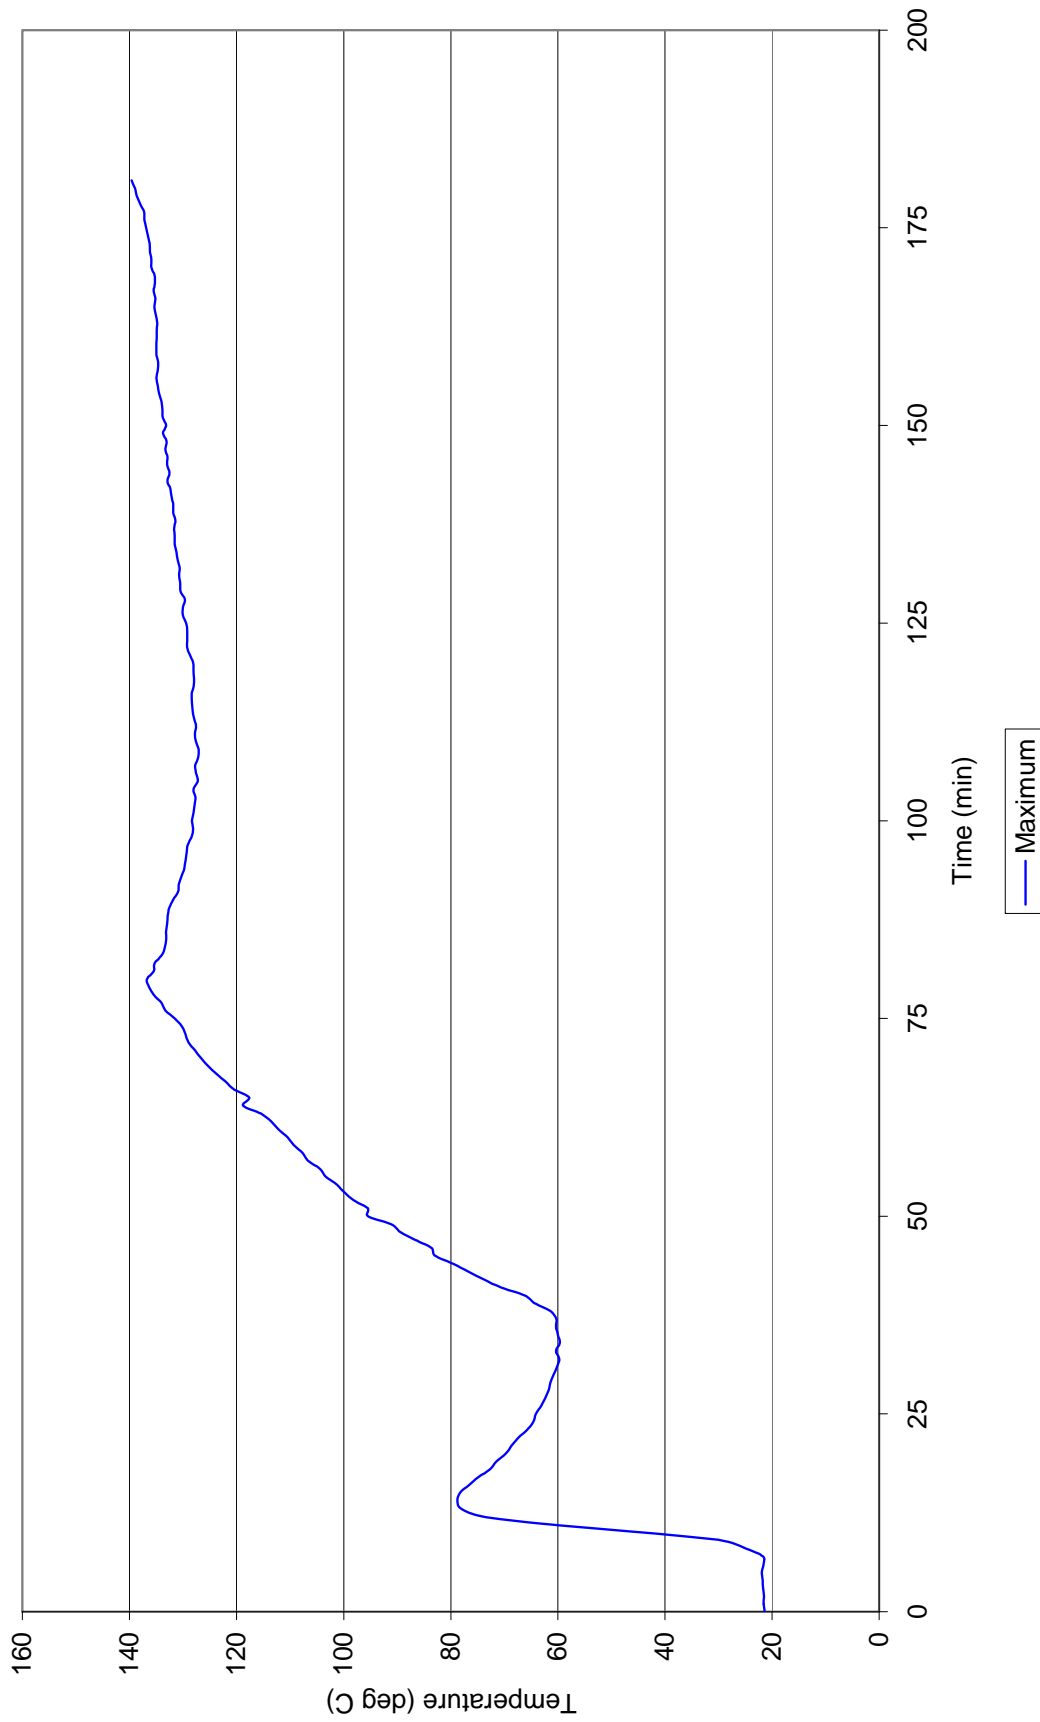
Figure 4 - Specimen temperature – Penetration 3

Figure 4 shows the curve of maximum temperature versus time associated with Penetration 3.

Structural adequacy	-	not applicable
Integrity	-	no failure at 181 minutes
Insulation	-	no failure at 181 minutes

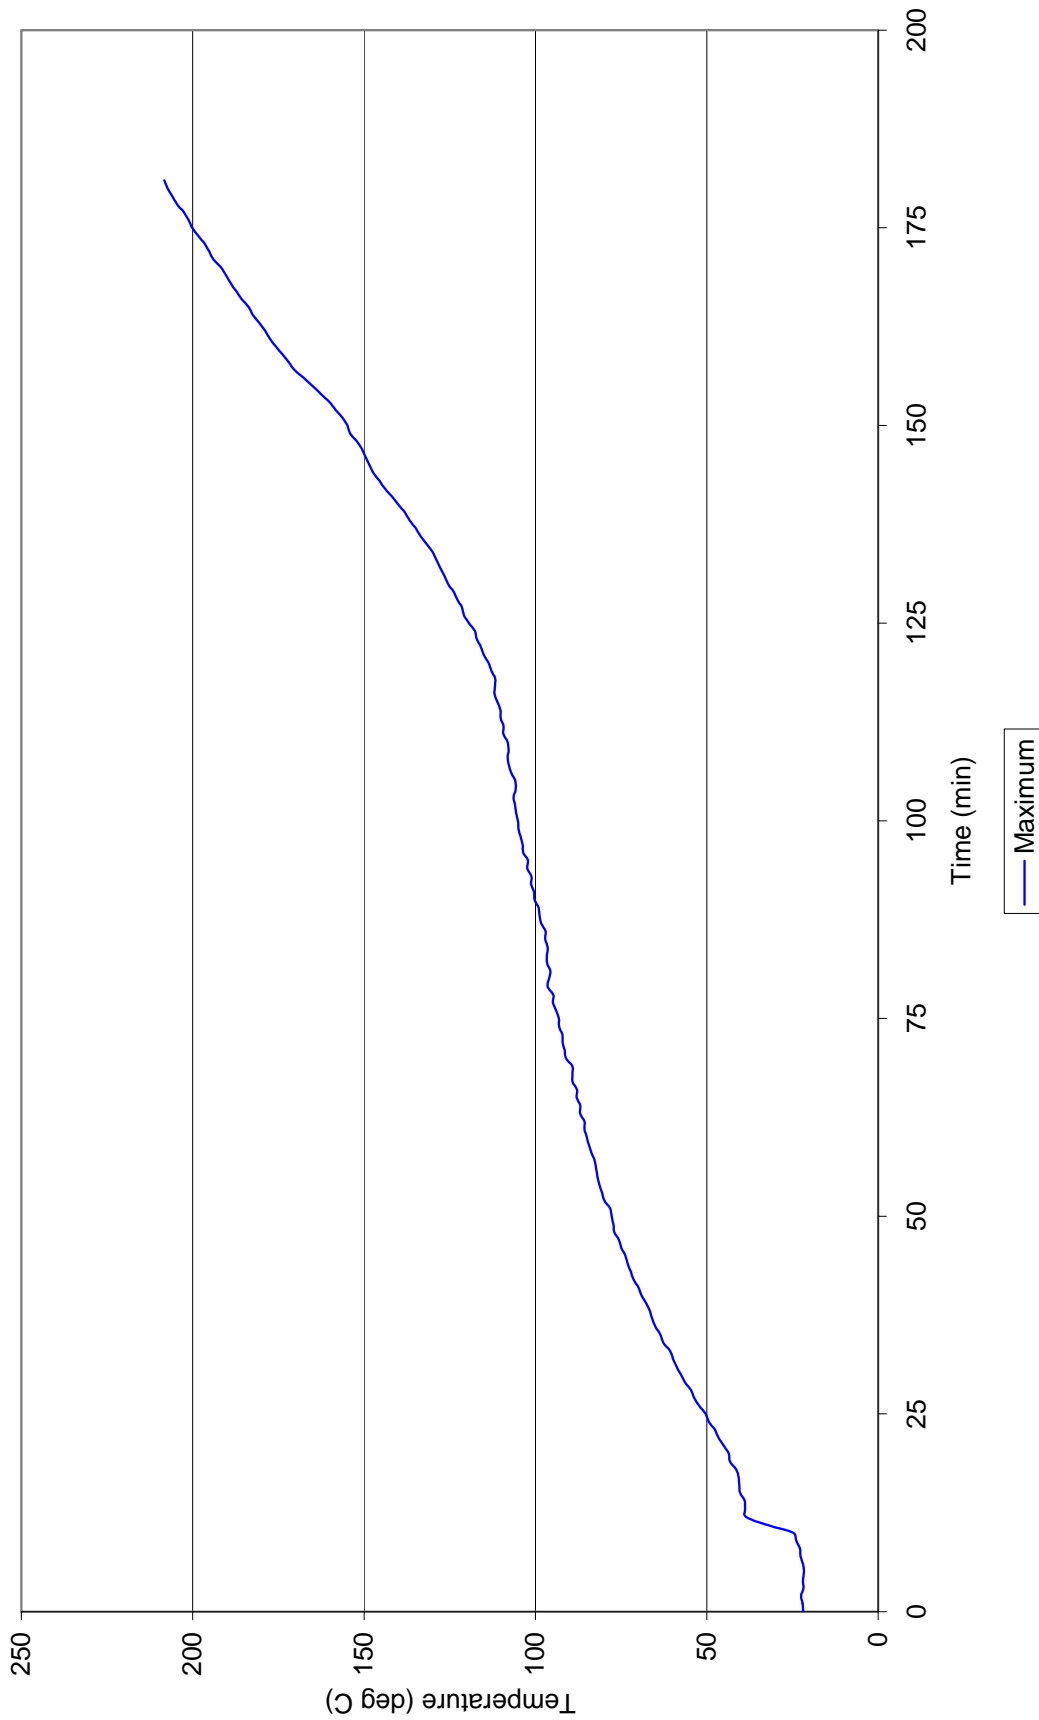
Figure 5 - Specimen temperature – Penetration 4

Figure 5 shows the curve of maximum temperature versus time associated with Penetration 4.

Structural adequacy	-	not applicable
Integrity	-	no failure at 181 minutes
Insulation	-	no failure at 177 minutes

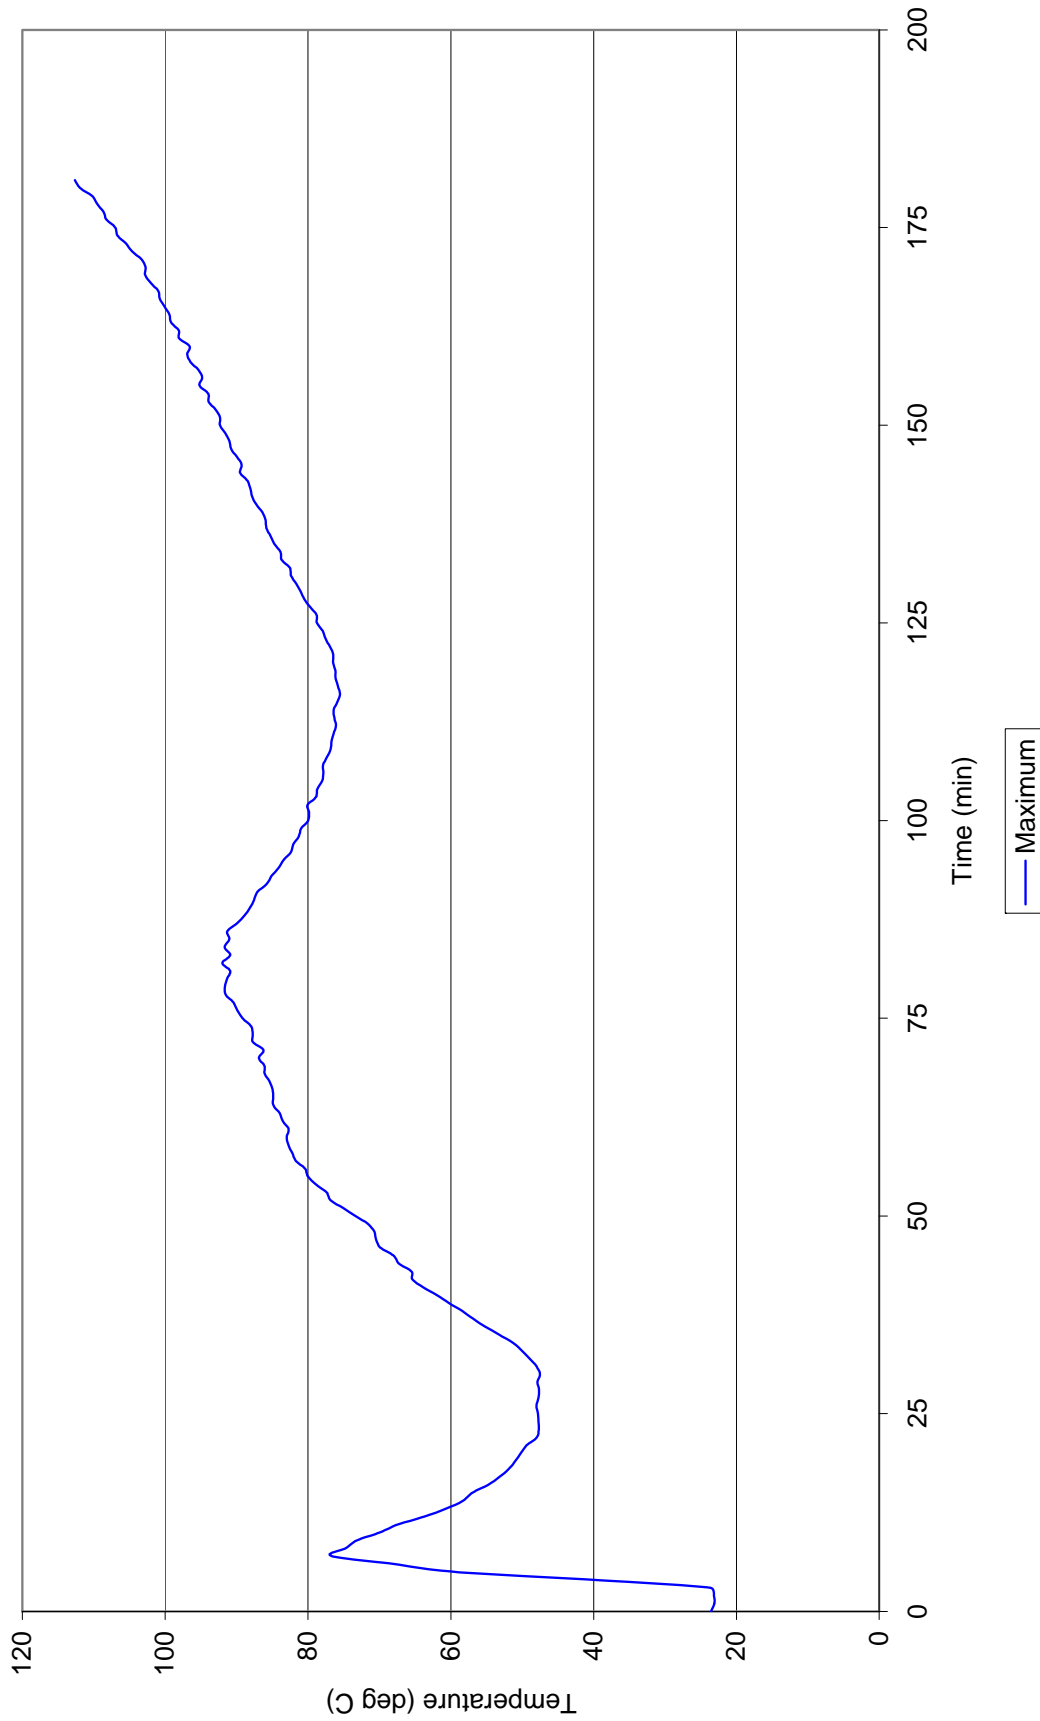
Figure 6 - Specimen temperature – Penetration 5

Figure 6 shows the curve of maximum temperature versus time associated with Penetration 5.

Structural adequacy	-	not applicable
Integrity	-	no failure at 181 minutes
Insulation	-	no failure at 181 minutes

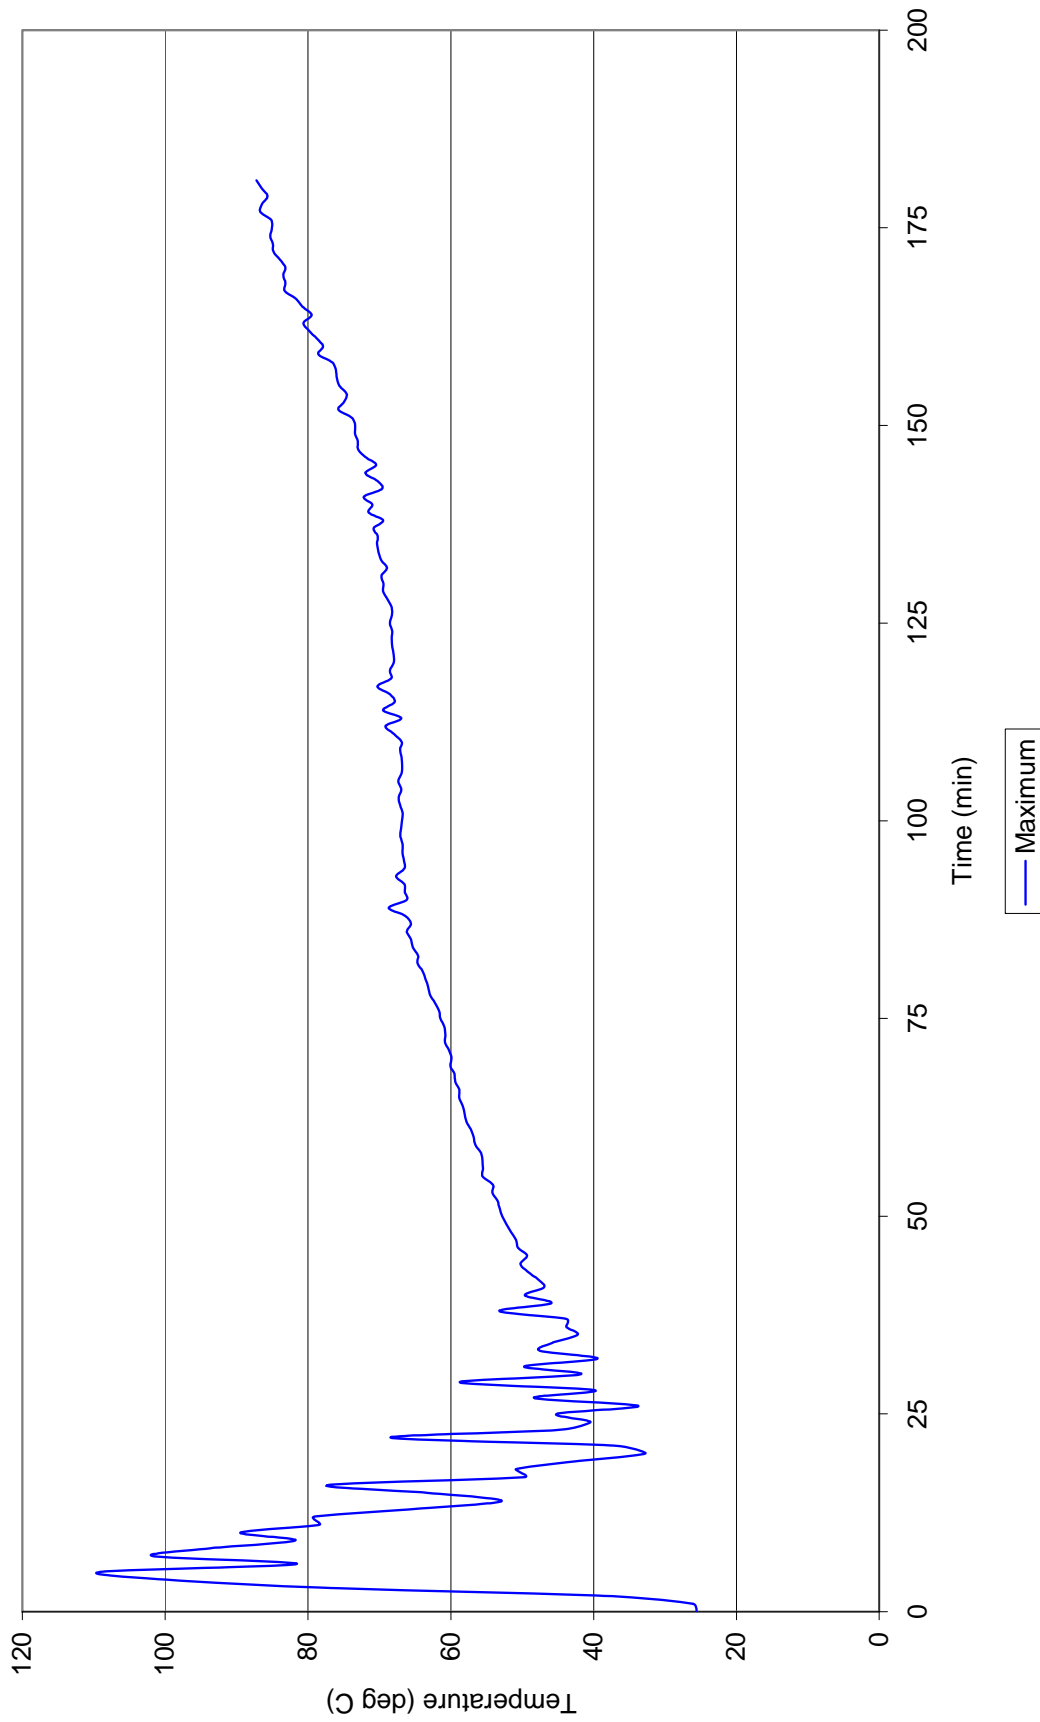
Figure 7 - Specimen temperature – Penetration 6

Figure 7 shows the curve of maximum temperature versus time associated with Penetration 6.

Structural adequacy	-	not applicable
Integrity	-	no failure at 181 minutes
Insulation	-	no failure at 181 minutes

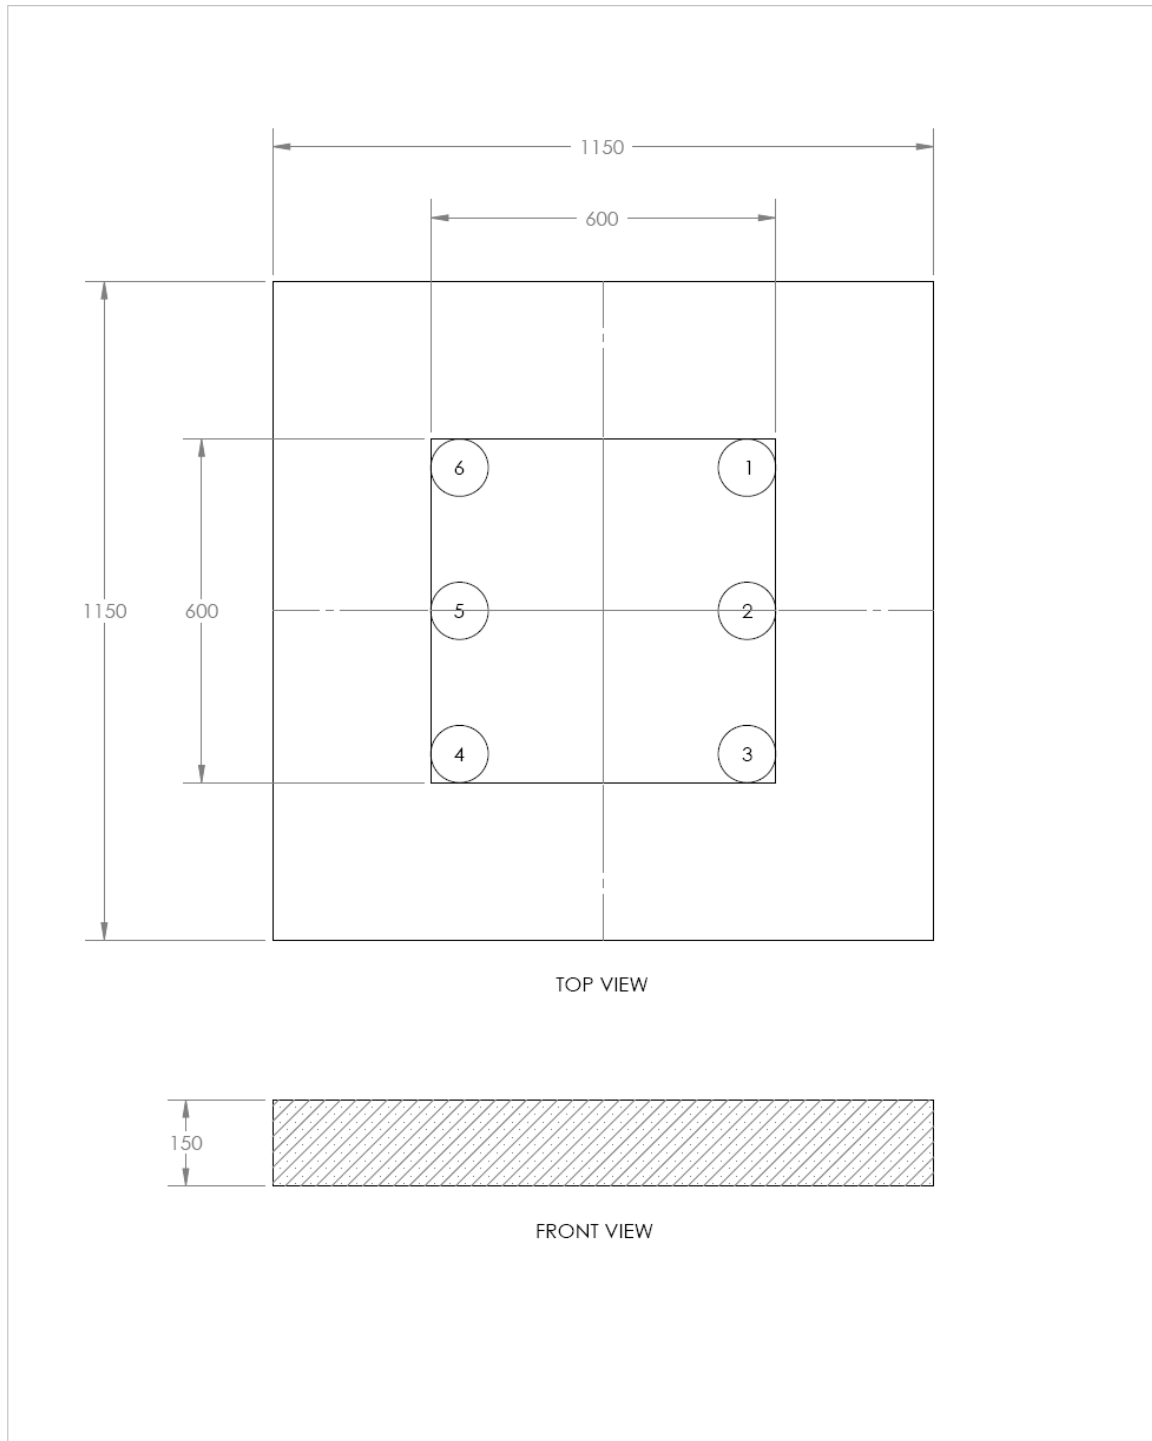
Specification numbered TESTWALL-1, dated November 2008 by Snap Fire Systems

BRAND	DESCRIPTION	DIAMETER	SLAB POSITION	COLLAR	TYPE	SNAP FIRE SYSTEMS	
REHAU	PE(X)-AL-PE	16	1	SNAP32GAS	RETRO

DWG.No. TESTWALL-1 COLLAR TEST LOCATIONS NOV 2008 SCALE 1:10	
IPEX	PE-AL-PE	32	2	SNAP32GAS	RETRO		
REHAU	PE(X)-AL-PE	40	3	SNAP50GAS	RETRO		
IPEX	PE-AL-PE	50	4	SNAP50GAS	RETRO		
GASPEX	PE(X)-AL-PE(X)	32	5	SNAP50GAS	RETRO		
IPEX	PE-AL-PE	16	6	SNAP32GAS	RETRO

Drawing numbered TESTWALL, dated November 2008, by Snap Fire Systems
