**FIRE-RESISTANCE TEST ON  
FIRE COLLARS PROTECTING A PLASTERBOARD  
WALL PENETRATED BY SERVICES**

**Report number FSP 1360  
CSIRO job number SP3241  
Date of issue 31 JULY 2009**

**Client  
SNAP FIRE SYSTEMS PTY LTD.**

The sponsor identified the specimen as Snap Retrofitted Fire Collars protecting a plasterboard wall penetrated by six PPR pipes.

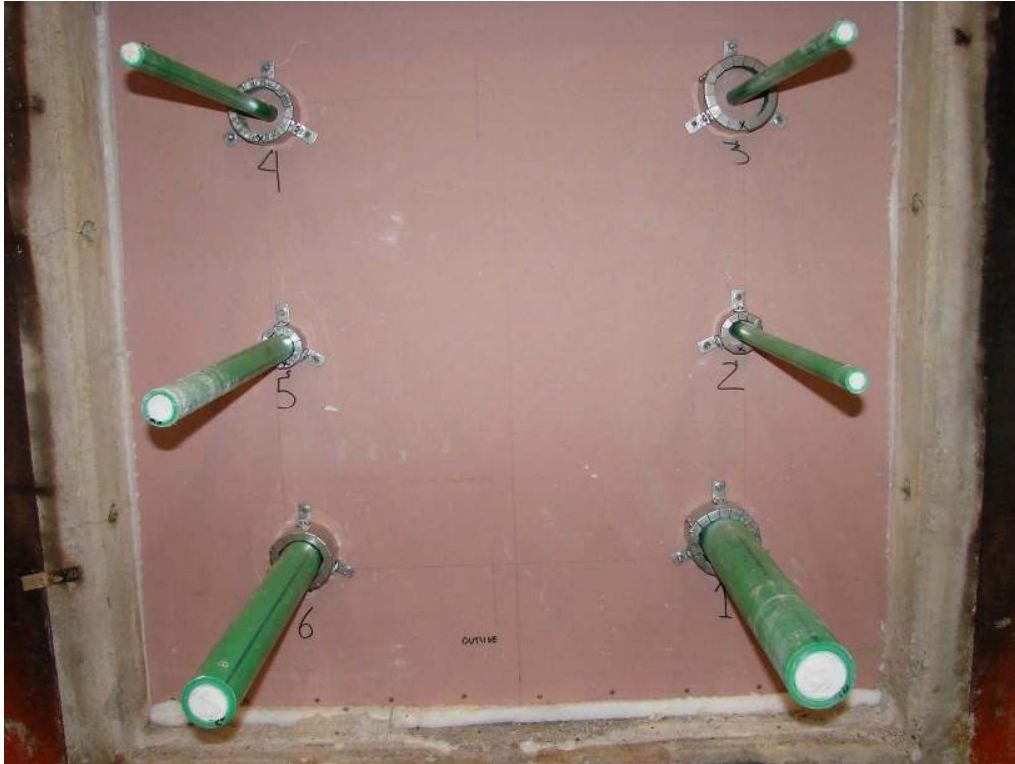
Photograph 1 – Exposed face of the specimen prior to testing

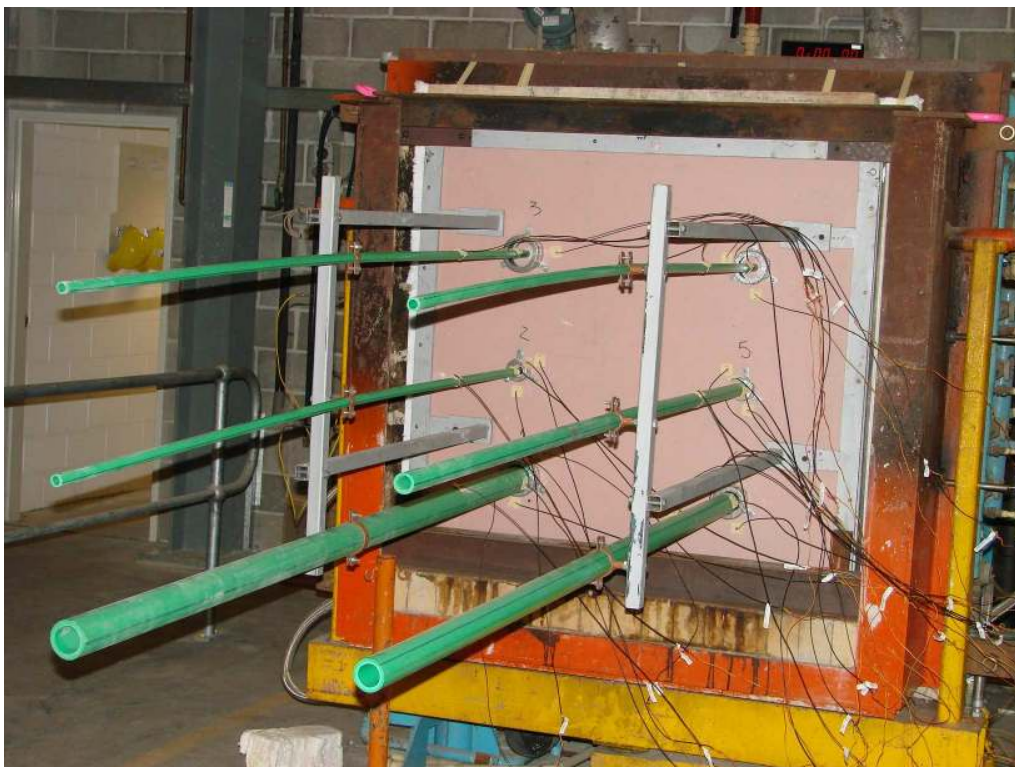
Photograph 2 – Unexposed face of the specimen prior to testing

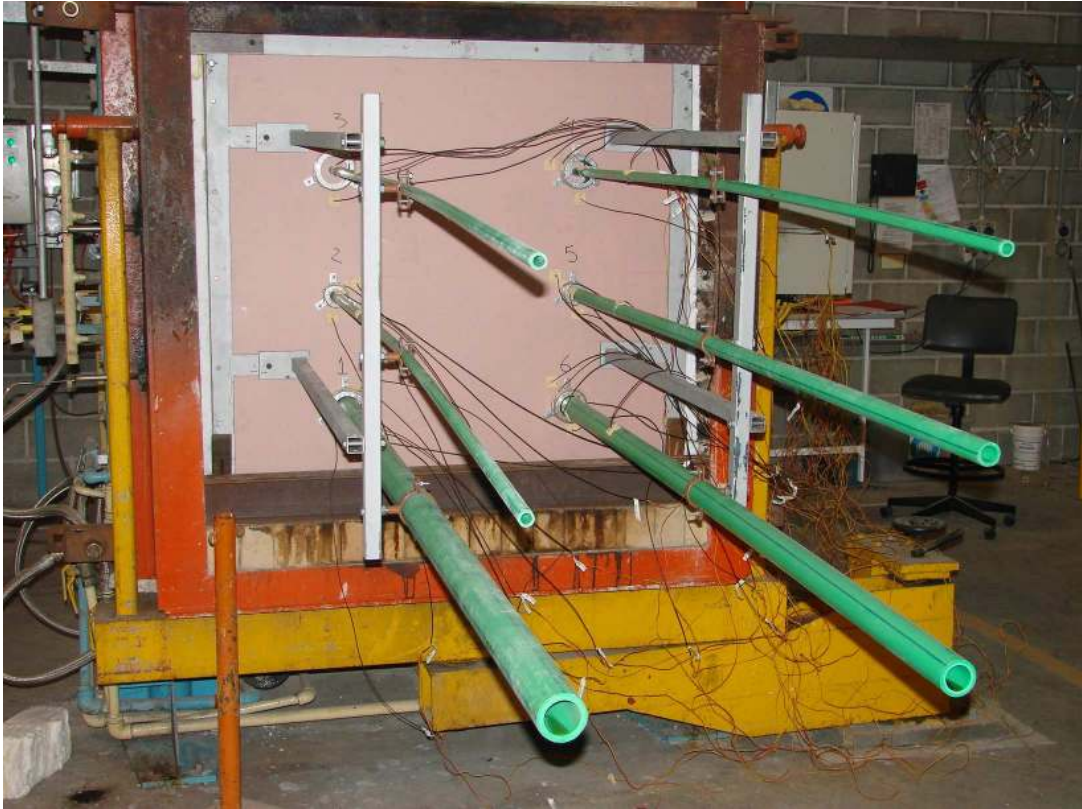
Photograph 3 – Specimen after 60 minutes of testing

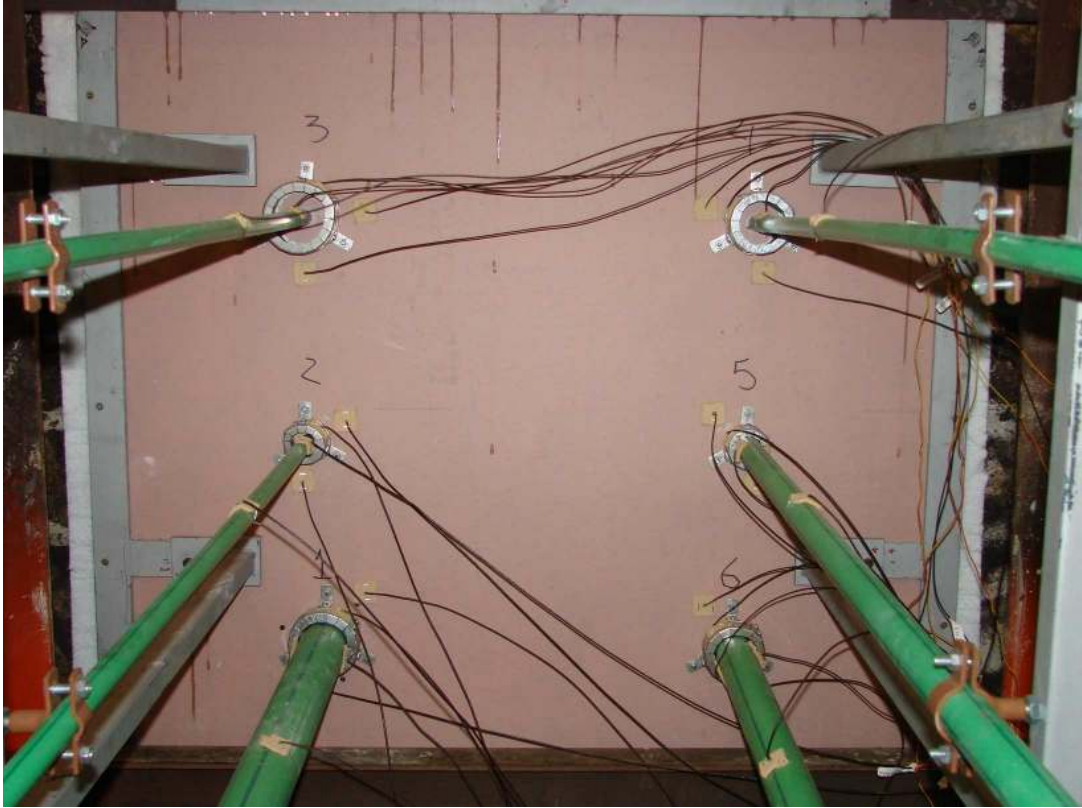
Photograph 4 – Specimen after 120 minutes of testing

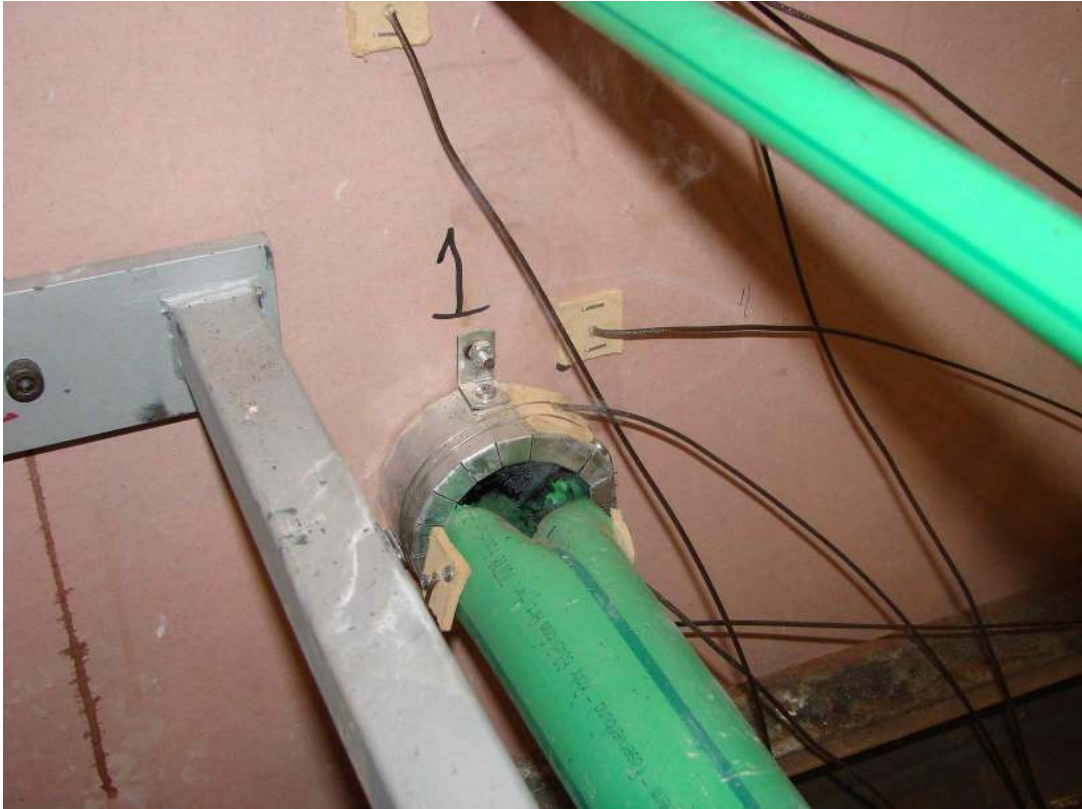
Photograph 5 – Pipe #1 after 170 minutes of testing

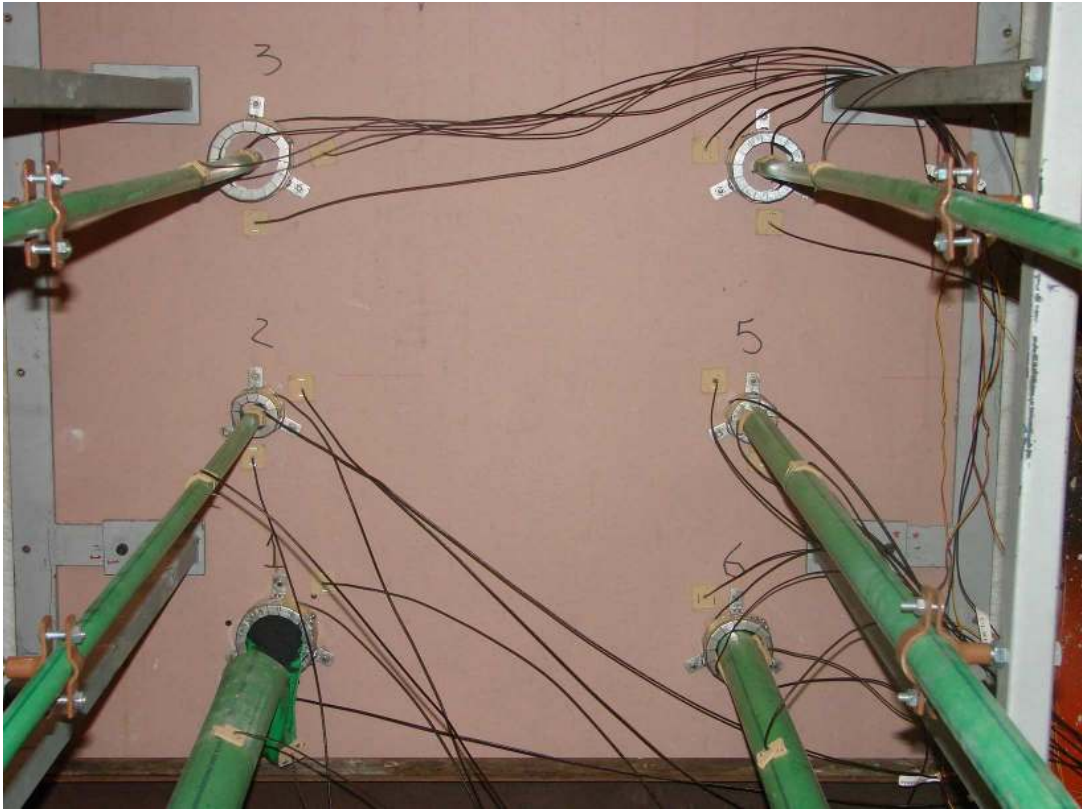
Photograph 6 – Specimen at the conclusion of testing

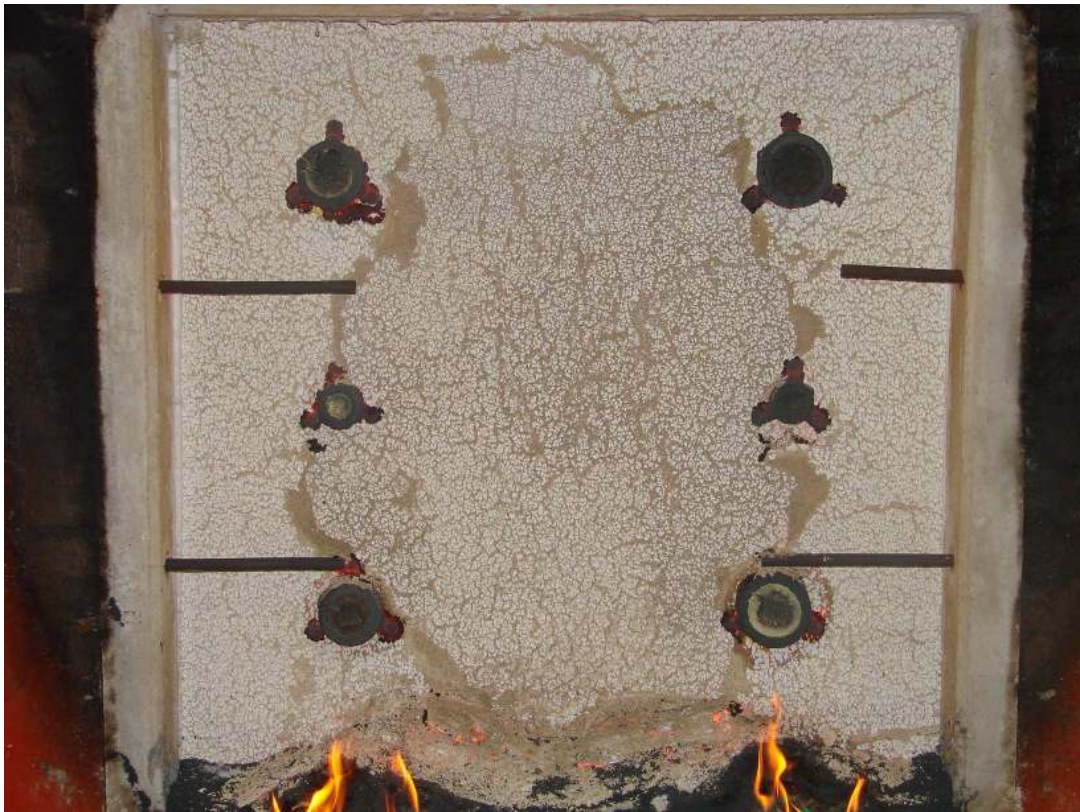
Photograph 7 – Exposed face of the specimen after the conclusion of testing

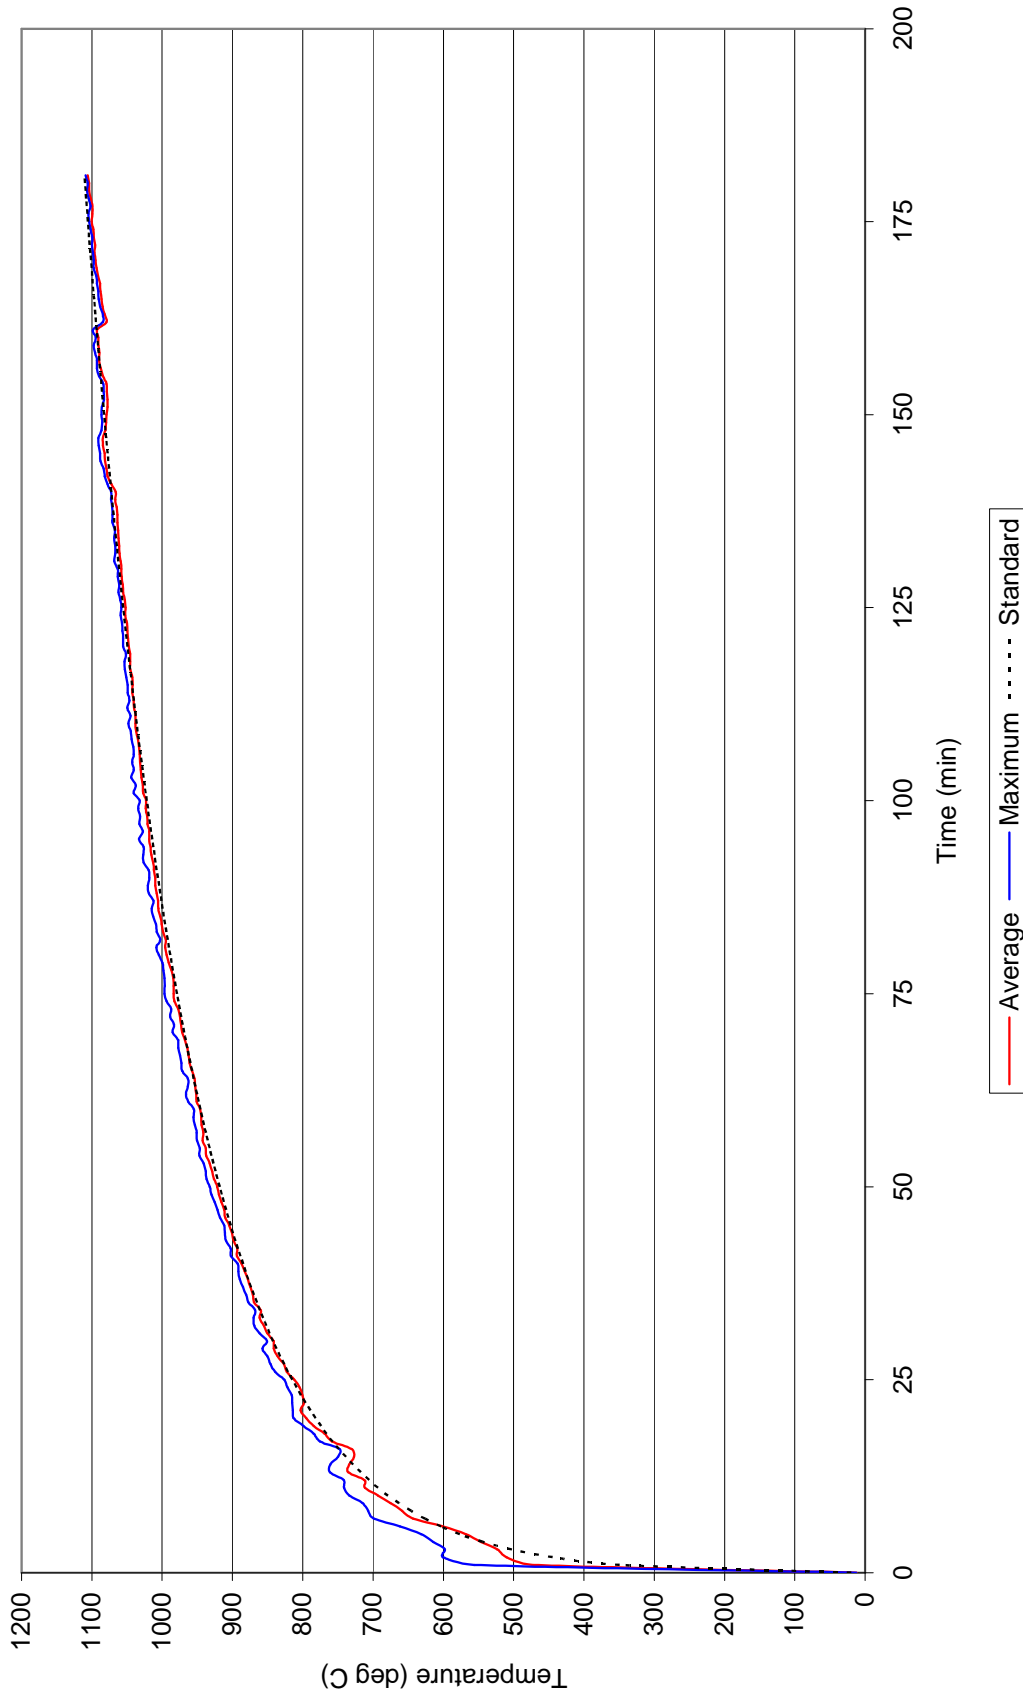
Figure 1 - Furnace temperature

Figure 1 shows the standard curves of temperature versus time for heating the furnace chamber and the actual curves of average and maximum temperature versus time recorded during the heating period.

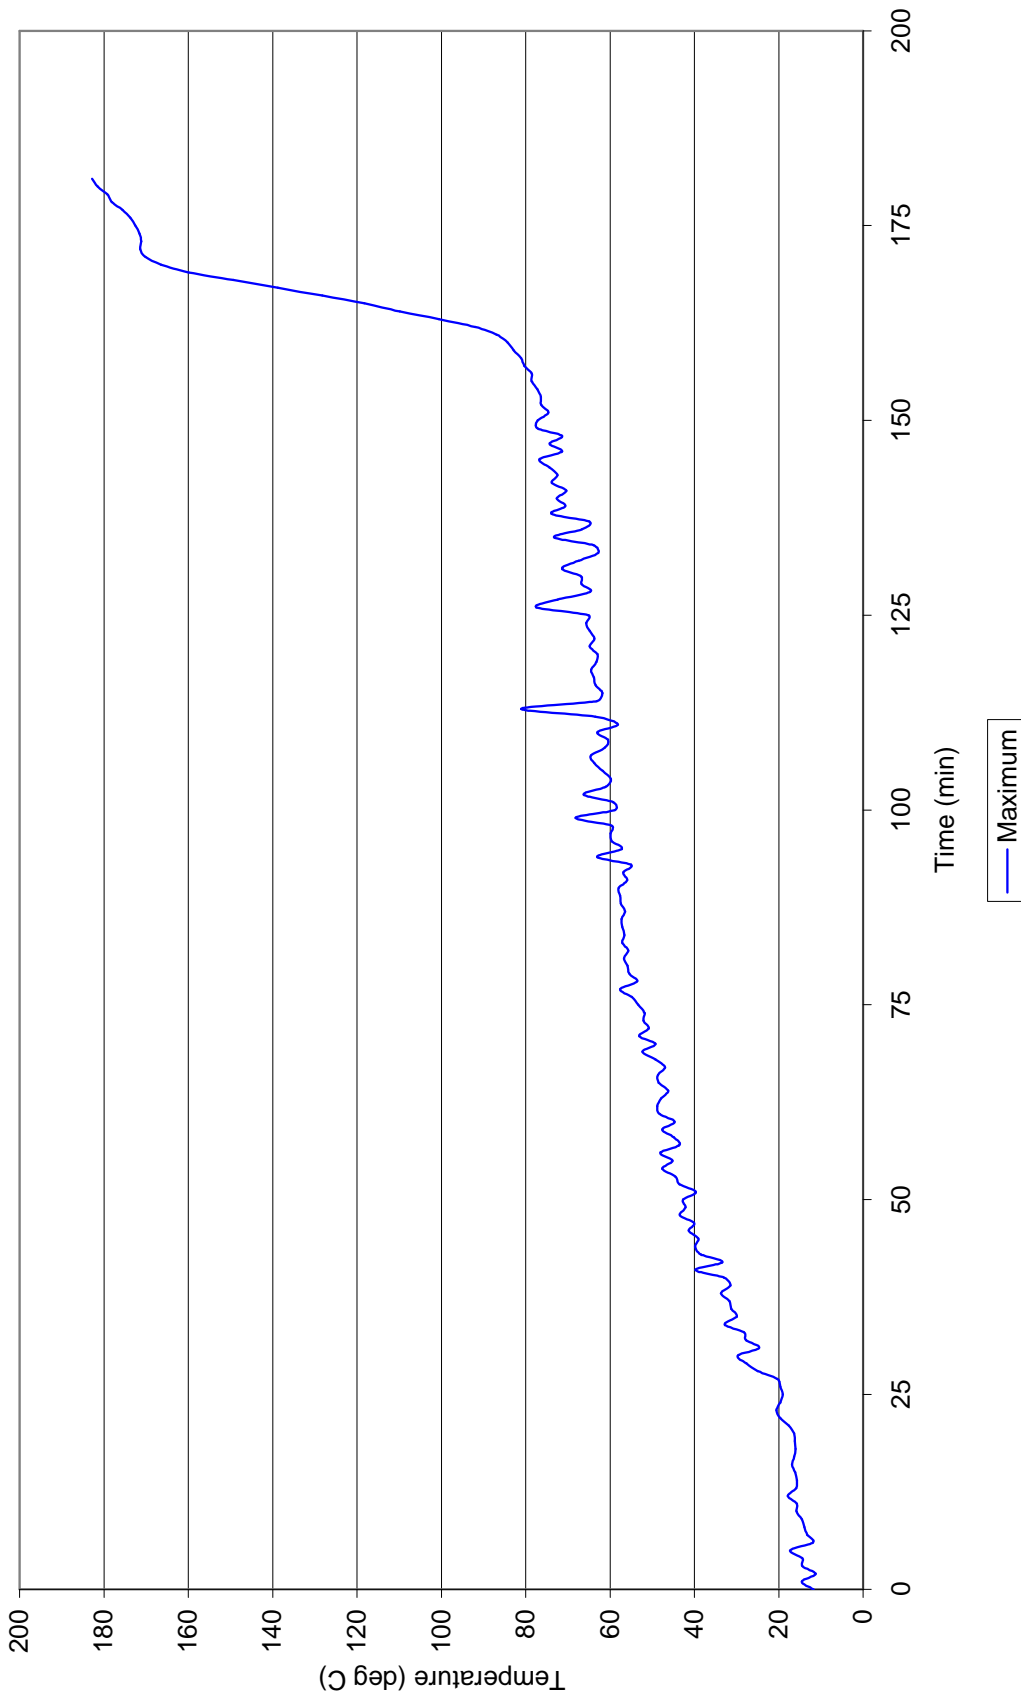
Figure 2 - Specimen temperature – Penetration 1

Figure 2 shows the curve of maximum temperature versus time associated with Penetration 1.

Structural adequacy	-	not applicable
Integrity	-	no failure at 181 minutes
Insulation	-	no failure at 181 minutes

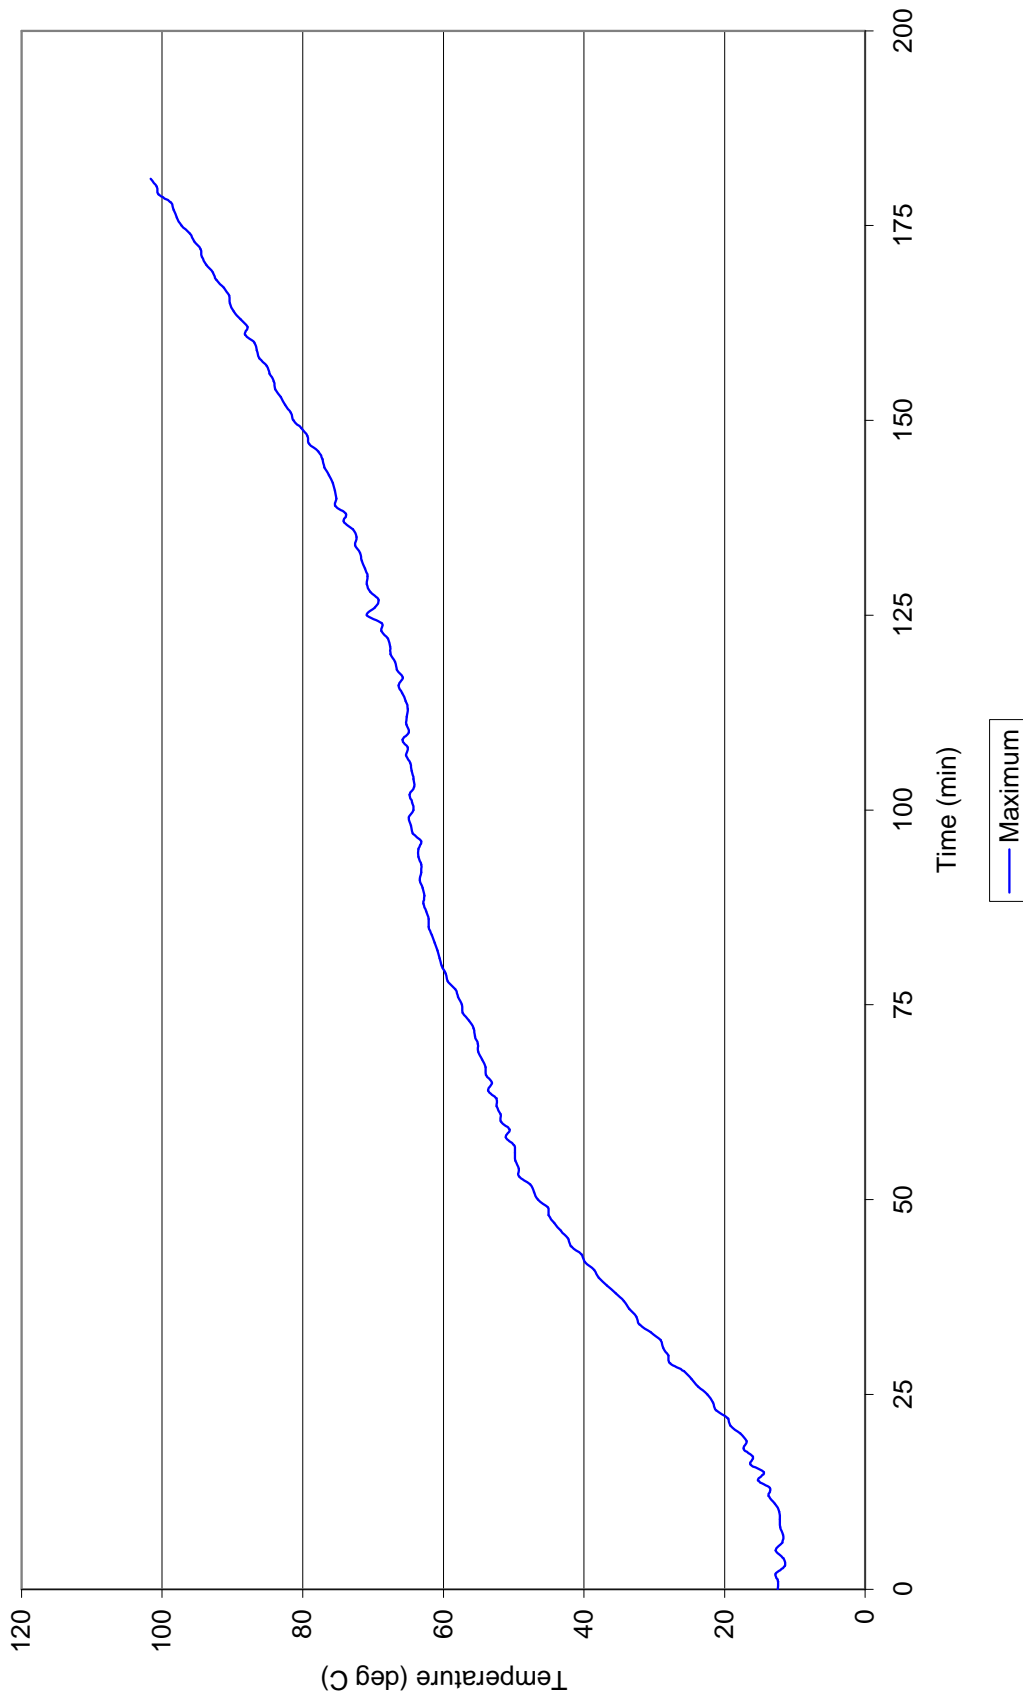
Figure 3 - Specimen temperature – Penetration 2

Figure 3 shows the curve of maximum temperature versus time associated with Penetration 2.

Structural adequacy	-	not applicable
Integrity	-	no failure at 181 minutes
Insulation	-	no failure at 181 minutes

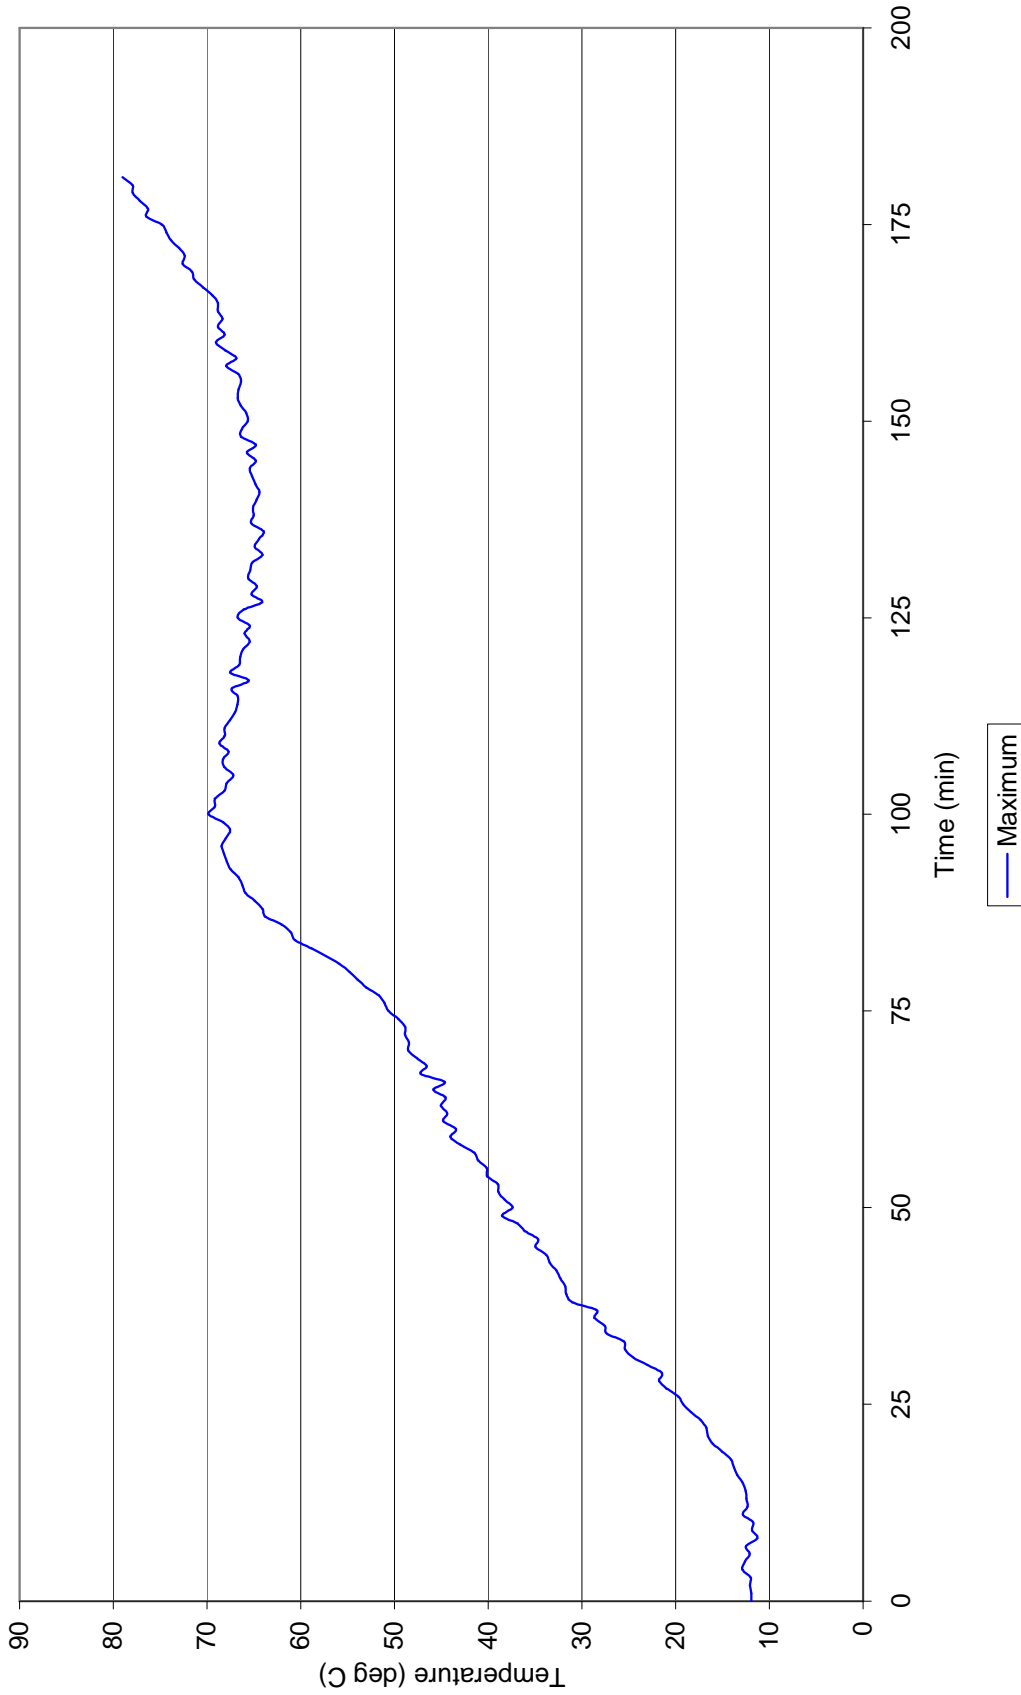
Figure 4 - Specimen temperature – Penetration 3

Figure 4 shows the curve of maximum temperature versus time associated with Penetration 3.

Structural adequacy	-	not applicable
Integrity	-	no failure at 181 minutes
Insulation	-	no failure at 181 minutes

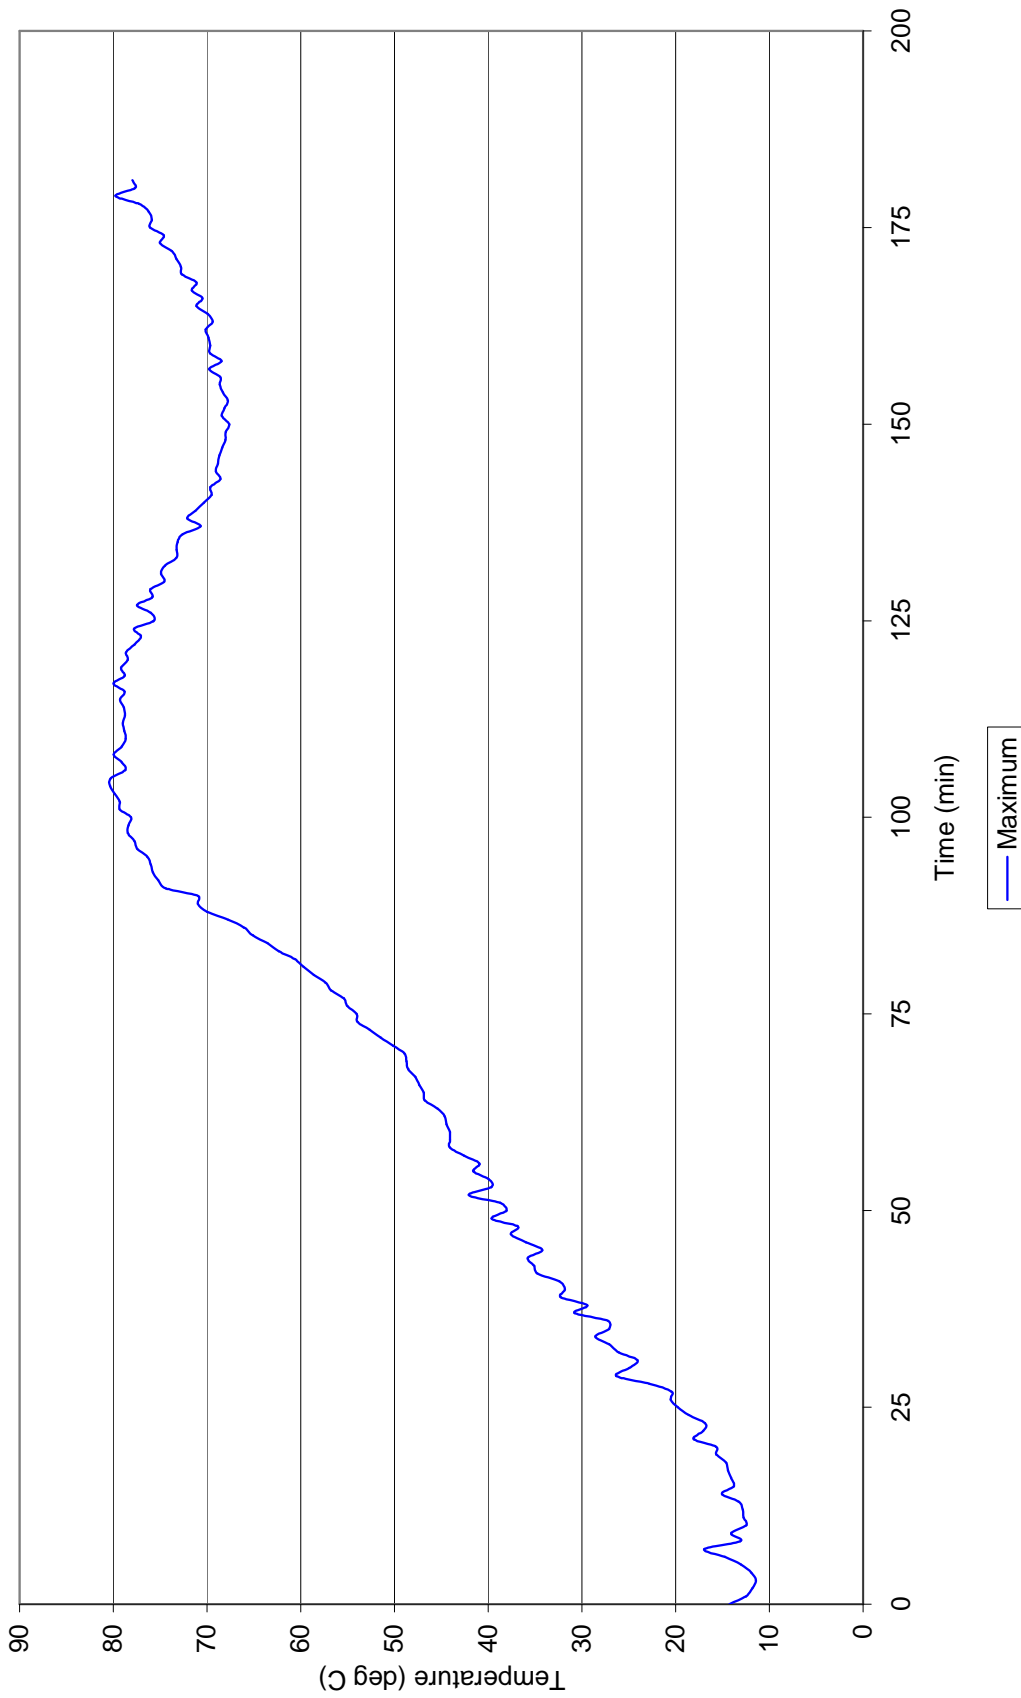
Figure 5 - Specimen temperature – Penetration 4

Figure 5 shows the curve of maximum temperature versus time associated with Penetration 4.

Structural adequacy	-	not applicable
Integrity	-	no failure at 181 minutes
Insulation	-	no failure at 181 minutes

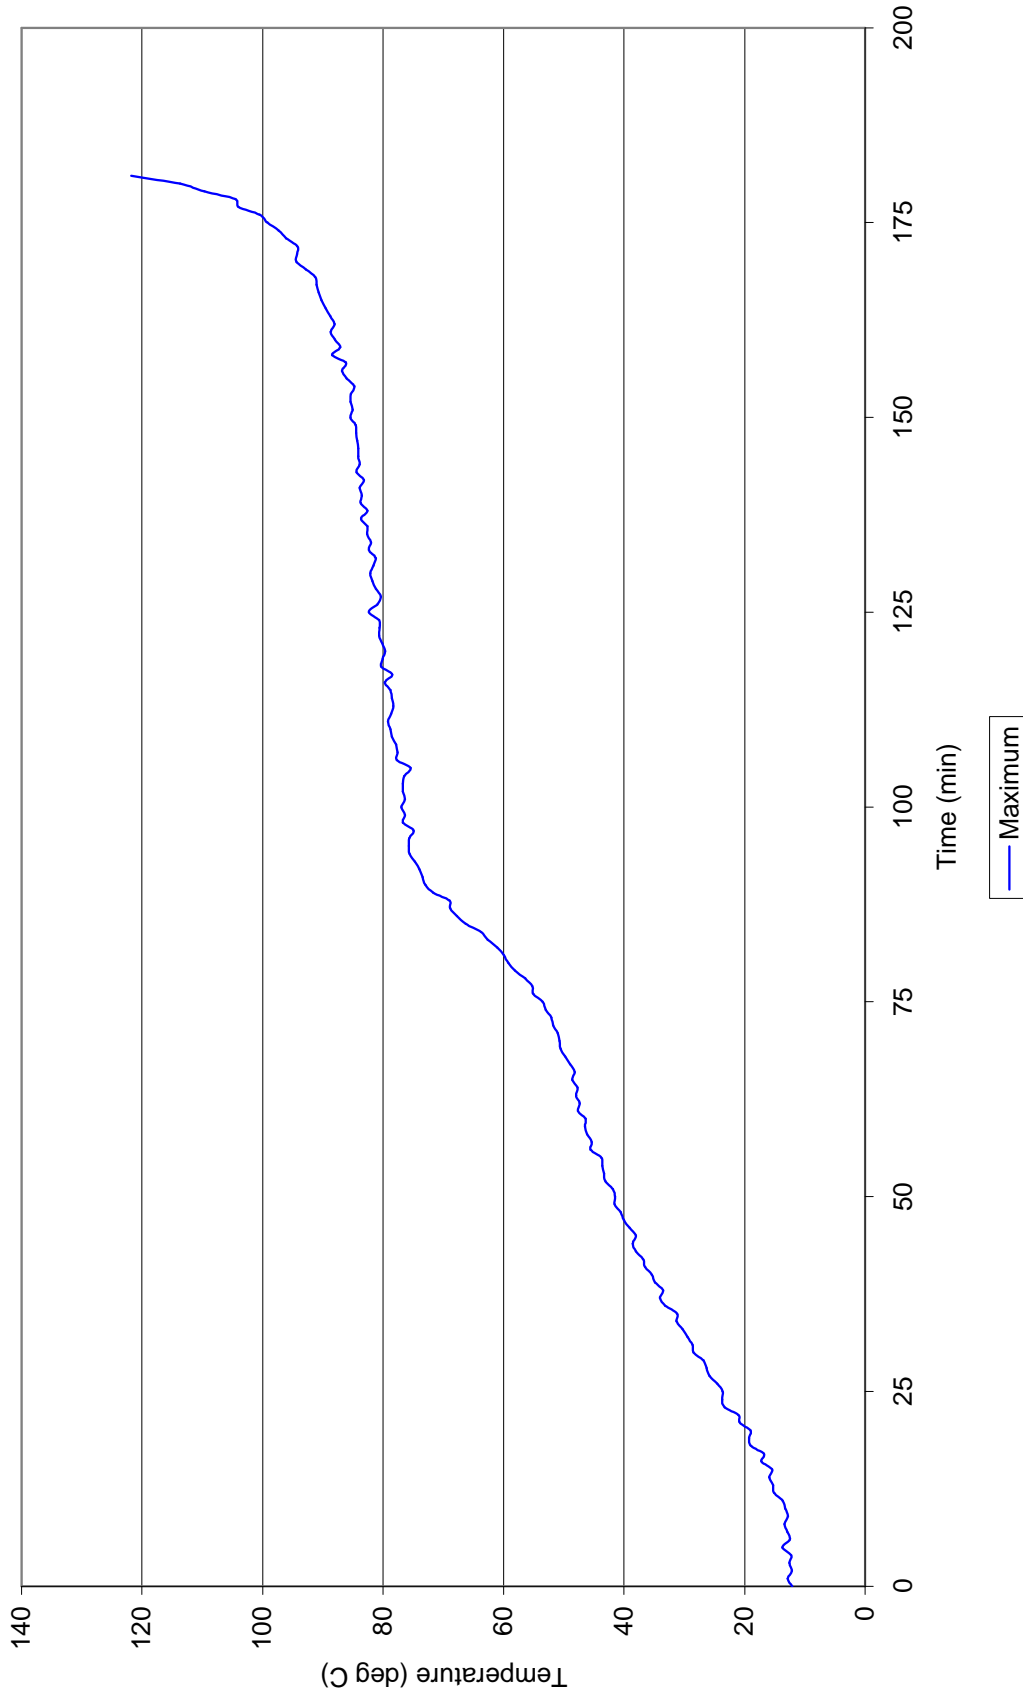
Figure 6 - Specimen temperature – Penetration 5

Figure 6 shows the curve of maximum temperature versus time associated with Penetration 5.

Structural adequacy	-	not applicable
Integrity	-	no failure at 181 minutes
Insulation	-	no failure at 181 minutes

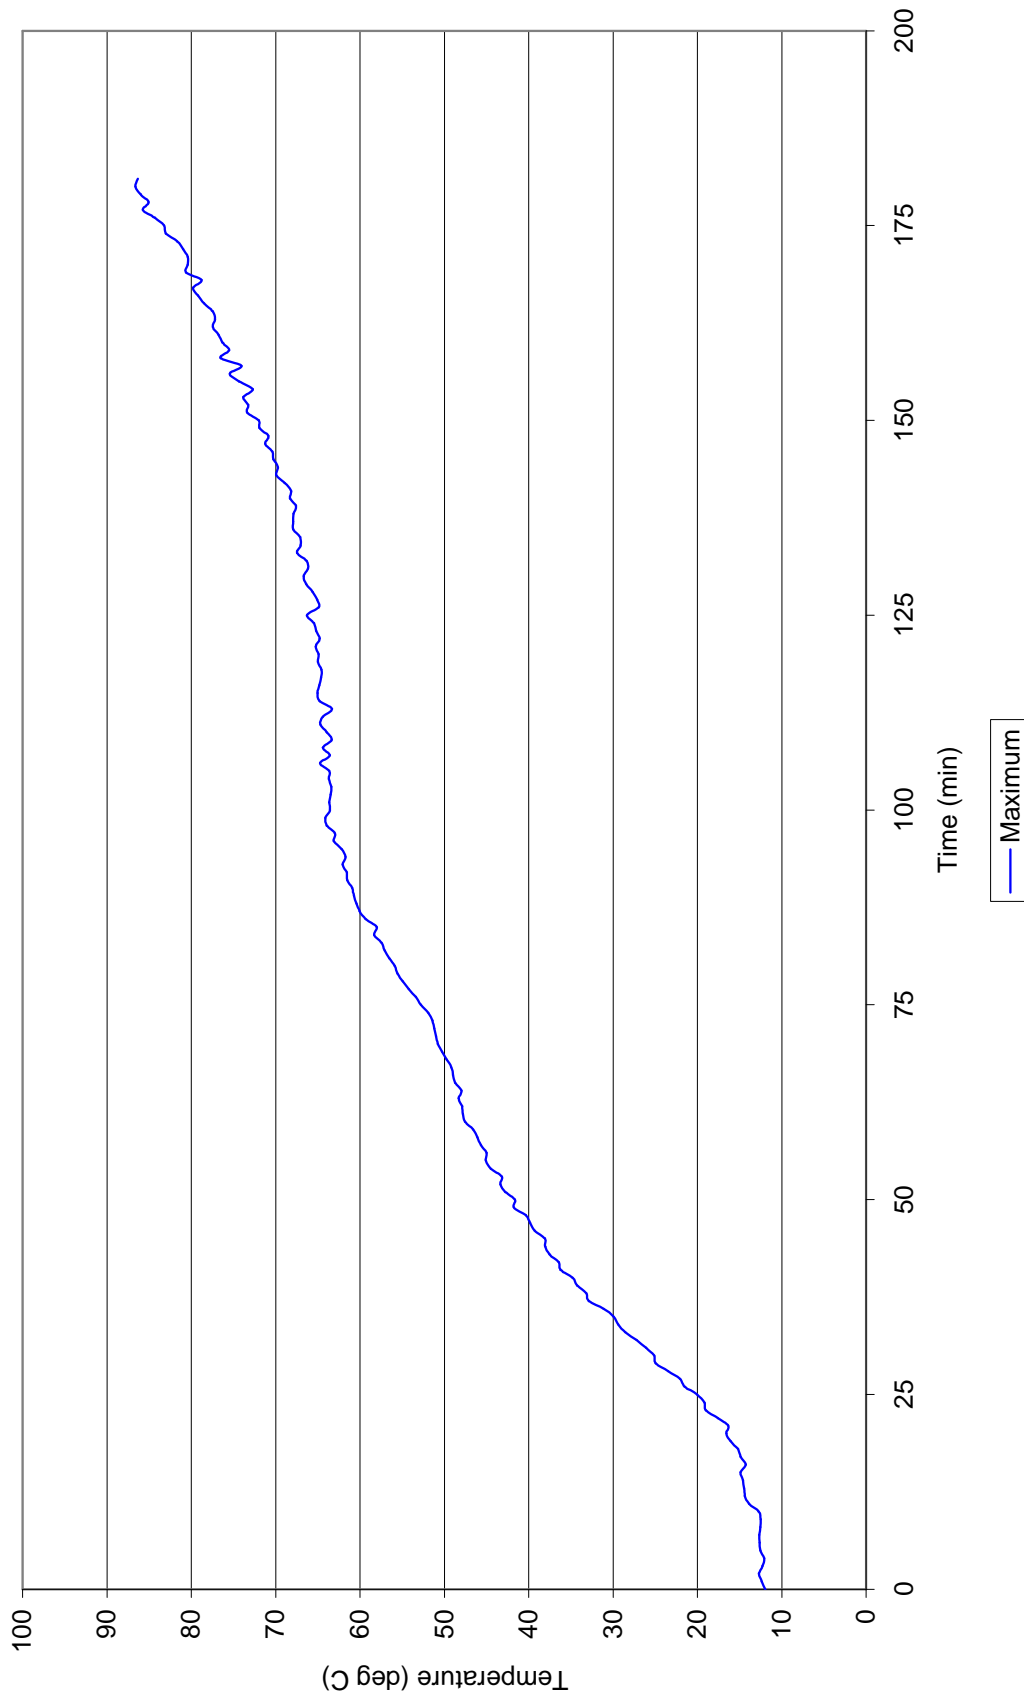
Figure 7 - Specimen temperature – Penetration 6

Figure 7 shows the curve of maximum temperature versus time associated with Penetration 6.

Structural adequacy	-	not applicable
Integrity	-	no failure at 181 minutes
Insulation	-	no failure at 181 minutes

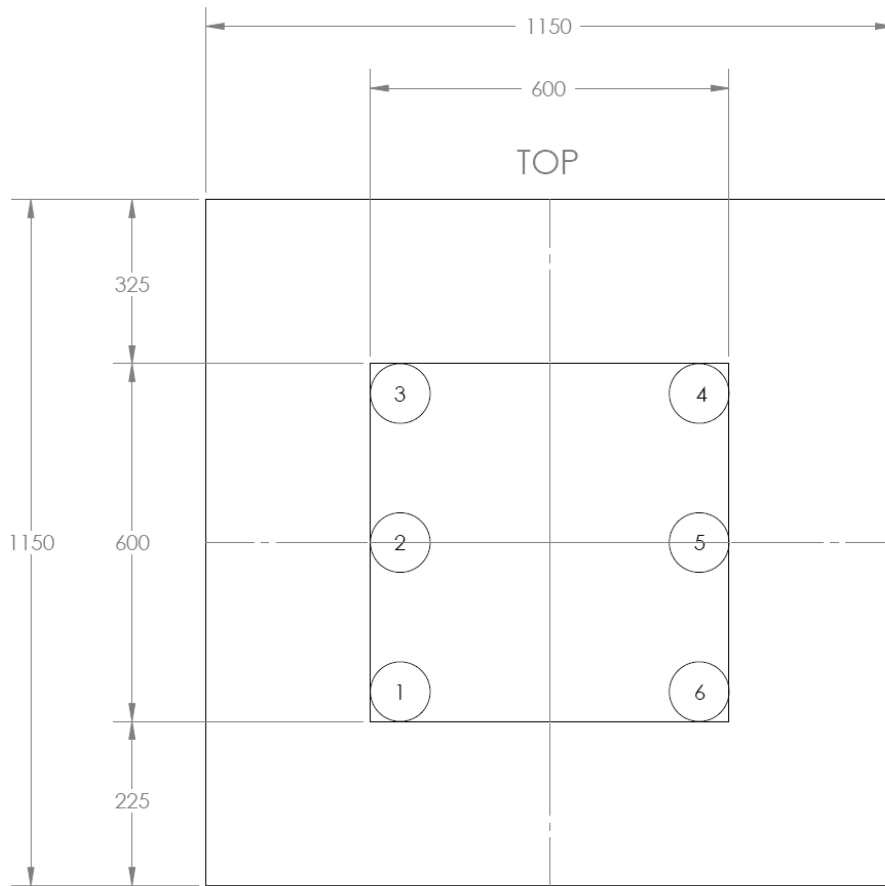
Drawing numbered PPRTTESTWALL-1, dated November 2008, by Snap Fire Systems

SDR	PIPE DESCRIPTION	PIPE DIAMETER	POSITION	COLLAR	TYPE
7.4	PPR	63	1	63 METAL	RETRO
7.4	PPR	20	2	32 METAL	RETRO
7.4	PPR	20	3	63 METAL	RETRO
7.4	PPR	20	4	50 METAL	RETRO
7.4	PPR	32	5	32 METAL	RETRO
7.4	PPR	50	6	50 METAL	RETRO

<b>SNAP FIRE SYSTEMS</b>	
 	DWG No. PPRTTESTWALL-1
	PPR TESTWALL COLLAR / PIPE LOCATIONS
	NOV 2008      SCALE 1:10

Drawings numbered PPRTESTWALL-1, dated November 2008; PPRWALLINSTALL, dated 8 June 2009; SNAP32R, SNAP50R and SNAP63R, all dated 8 May 2009 by Snap Fire System.
