Fire-resistance test on fire collars protecting a CSR Hebel AAC block wall penetrated by services

Test Report

Report number: FSP 1668

Date: 24 December 2014

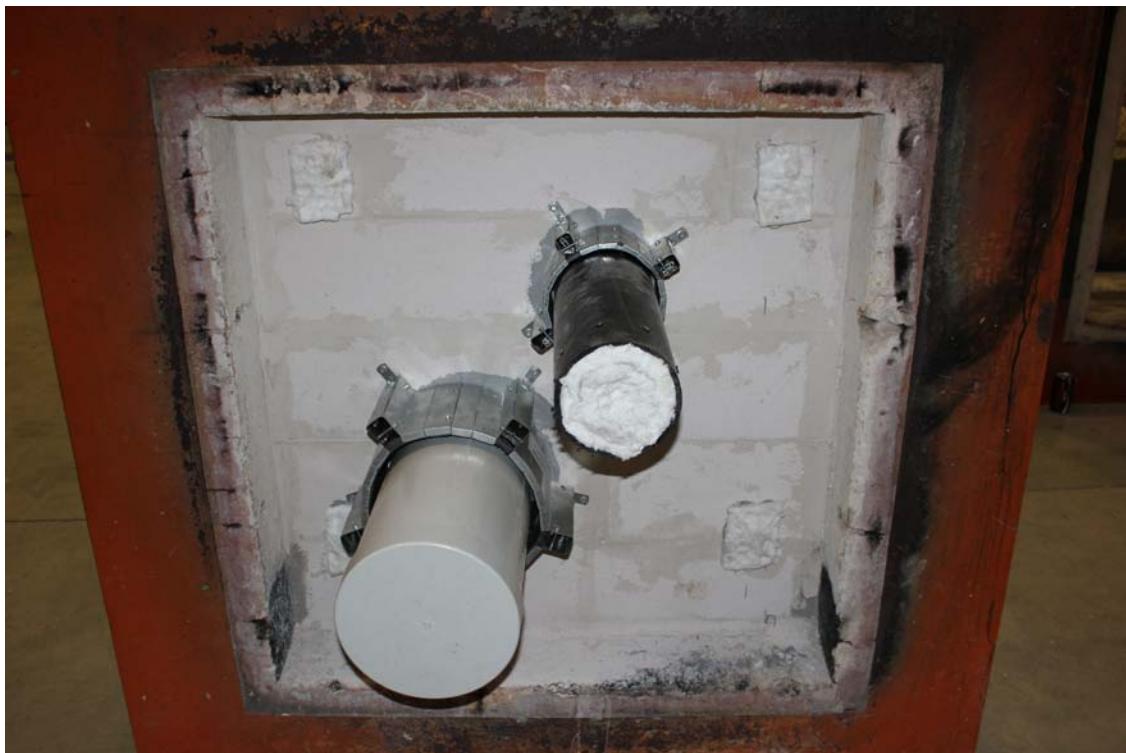
PHOTOGRAPH 1 – EXPOSED FACE OF SPECIMENS PRIOR TO TESTING

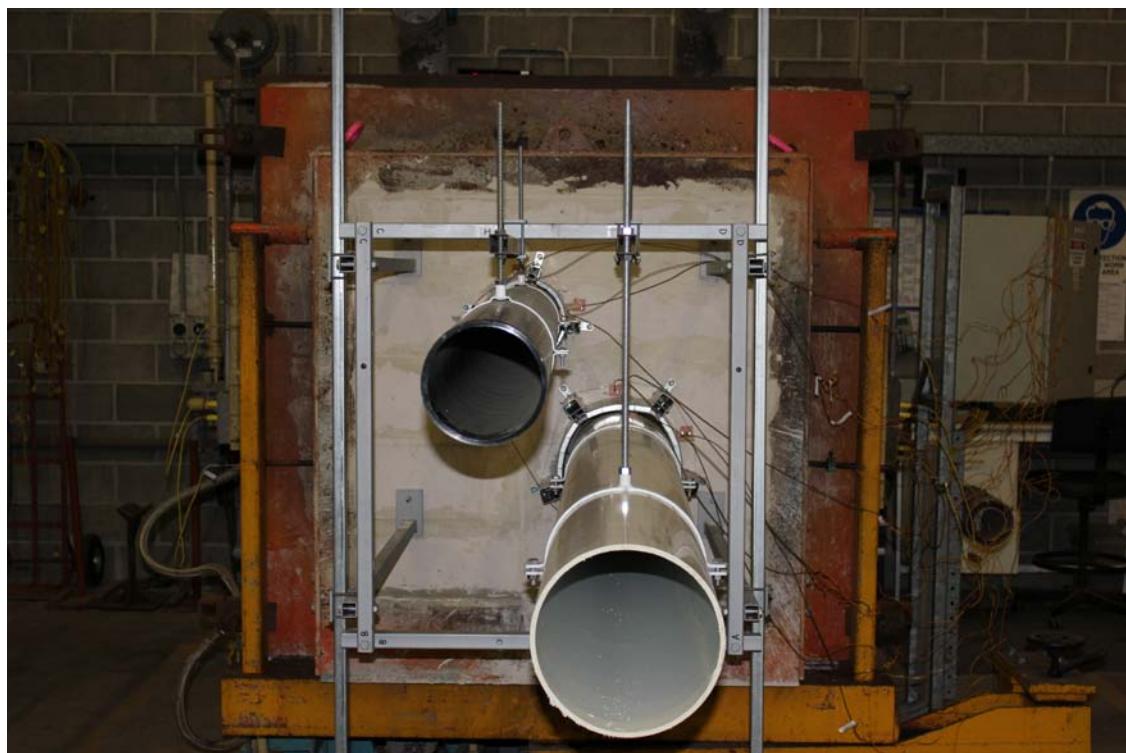
PHOTOGRAPH 2 – UNEXPOSED FACE OF SPECIMENS PRIOR TO TESTING

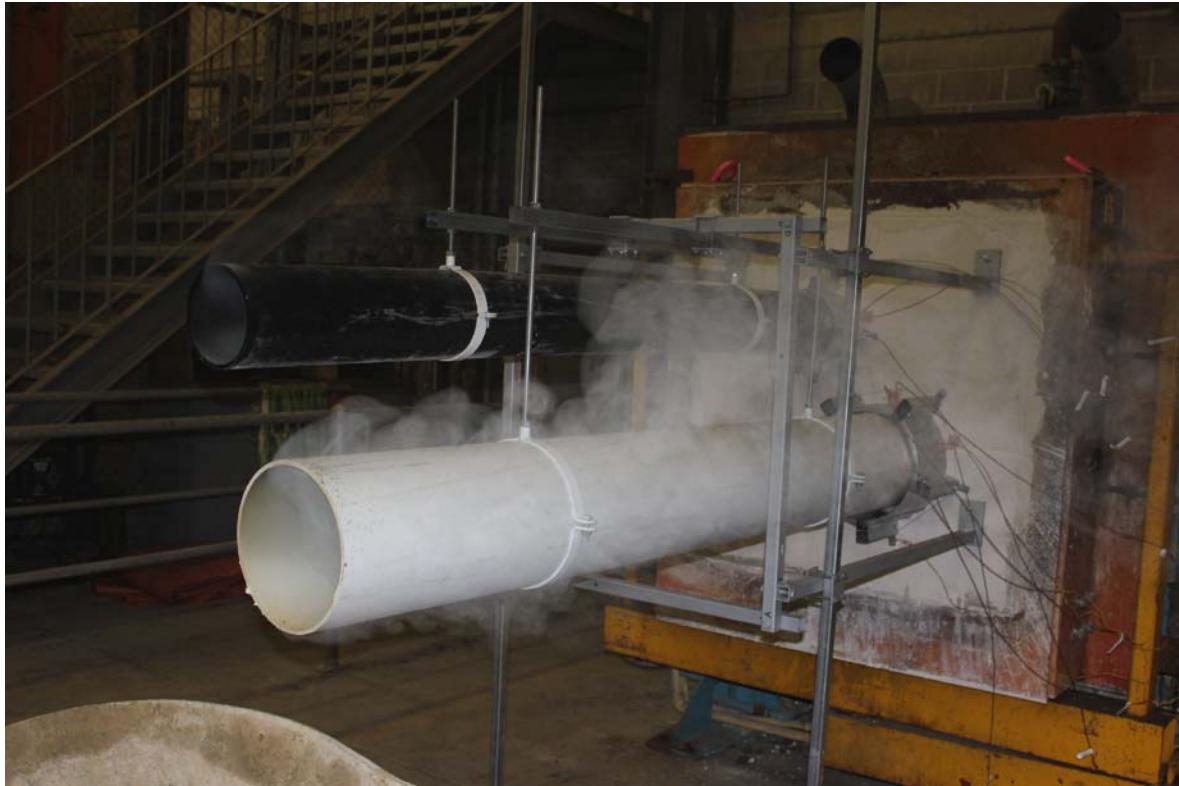
PHOTOGRAPH 3 – SPECIMENS AFTER 60 MINUTES OF TESTING

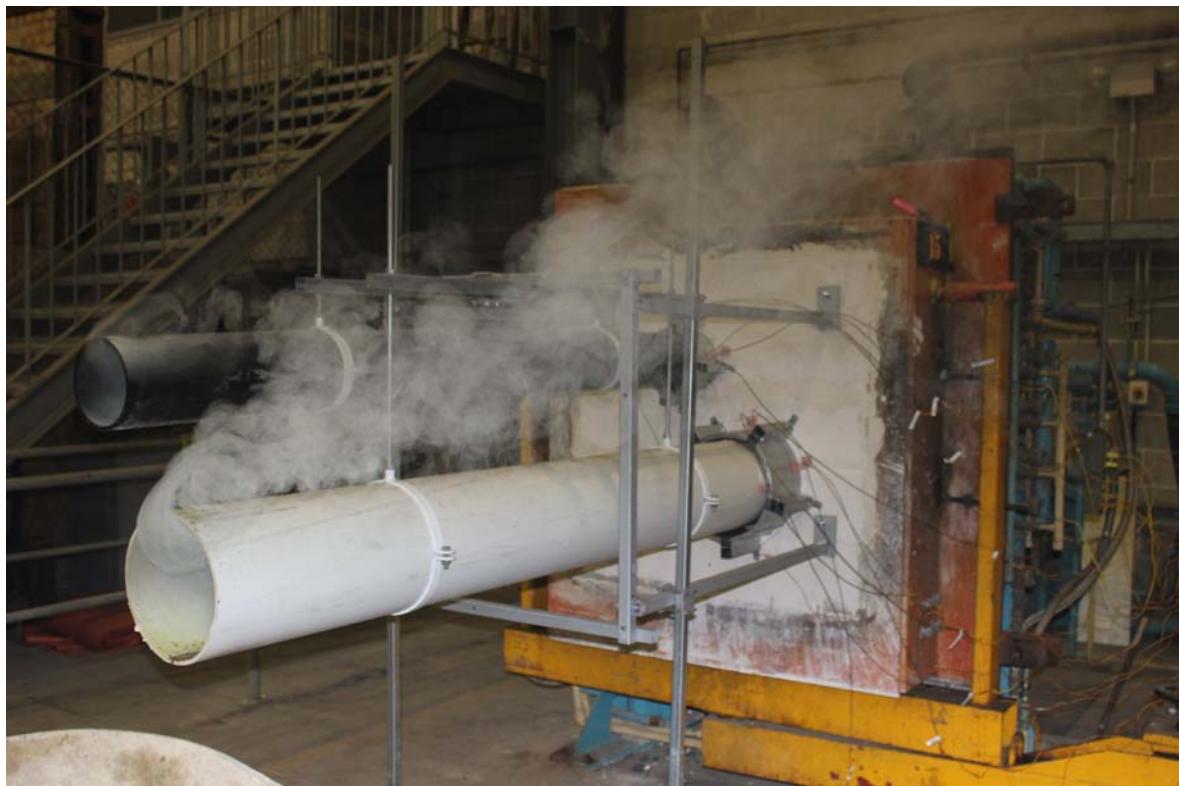
PHOTOGRAPH 4 – SPECIMENS AFTER 120 MINUTES OF TESTING

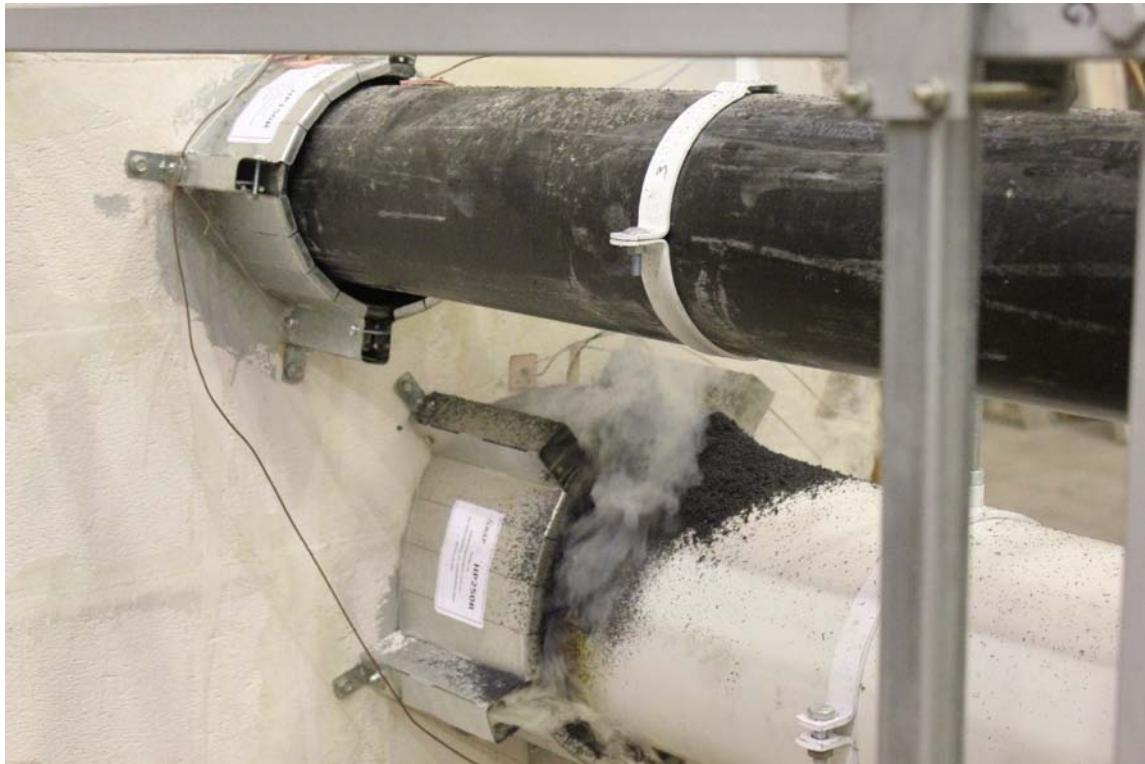
PHOTOGRAPH 5 – SPECIMENS AFTER 180 MINUTES OF TESTING

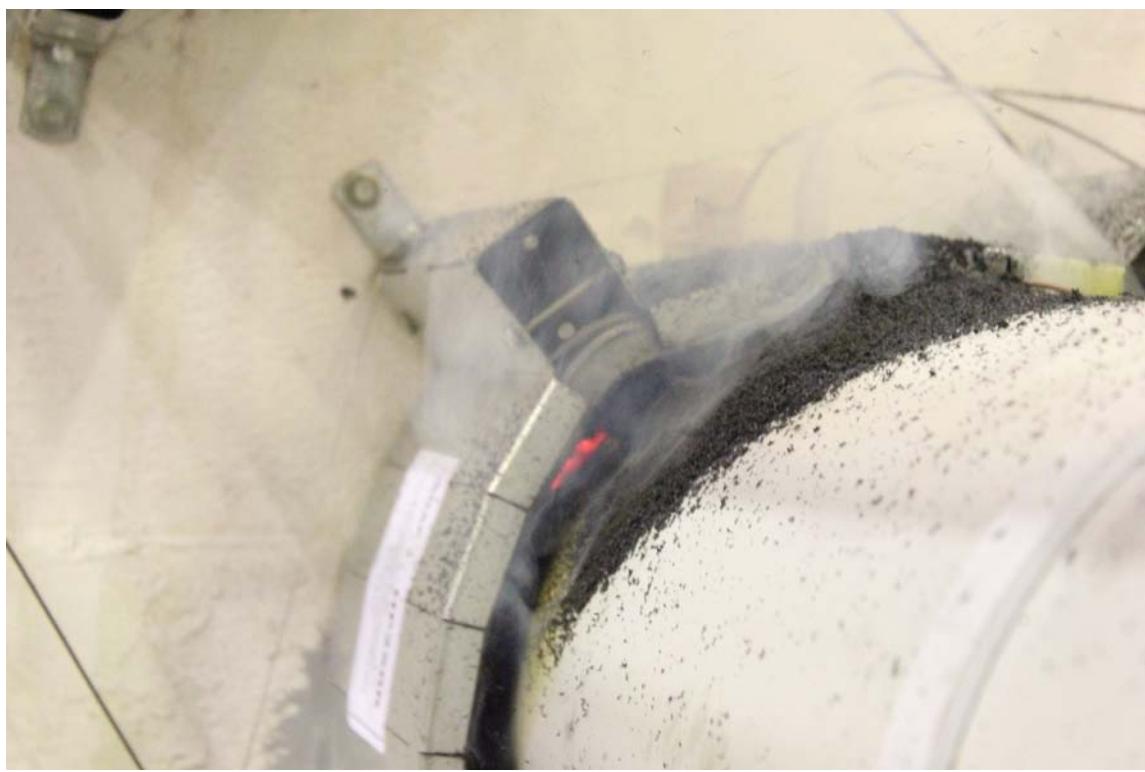
PHOTOGRAPH 6 – SPECIMEN #B AT 195 MINUTES OF TESTING

Integrity	-	195 minutes
-----------	---	-------------

Insulation	-	203 minutes
------------	---	-------------

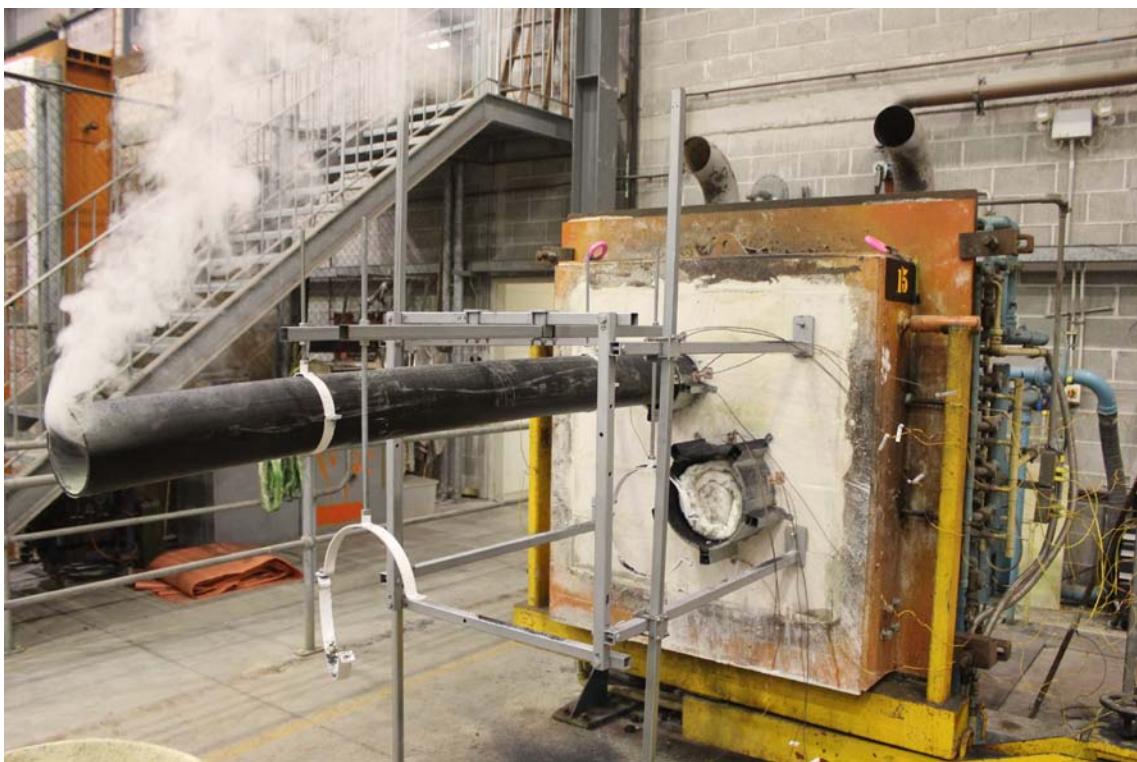
PHOTOGRAPH 8 – SPECIMENS AFTER 220 MINUTES OF TESTING
