# Fire-resistance test on fire collars protecting a concrete slab penetrated by services

## Test Report

**Author:** Mario Lara-Ledermann  
**Report number:** FSP 1692  
**Date:** 26 October 2015

## Sponsored Investigation No. FSP 1692

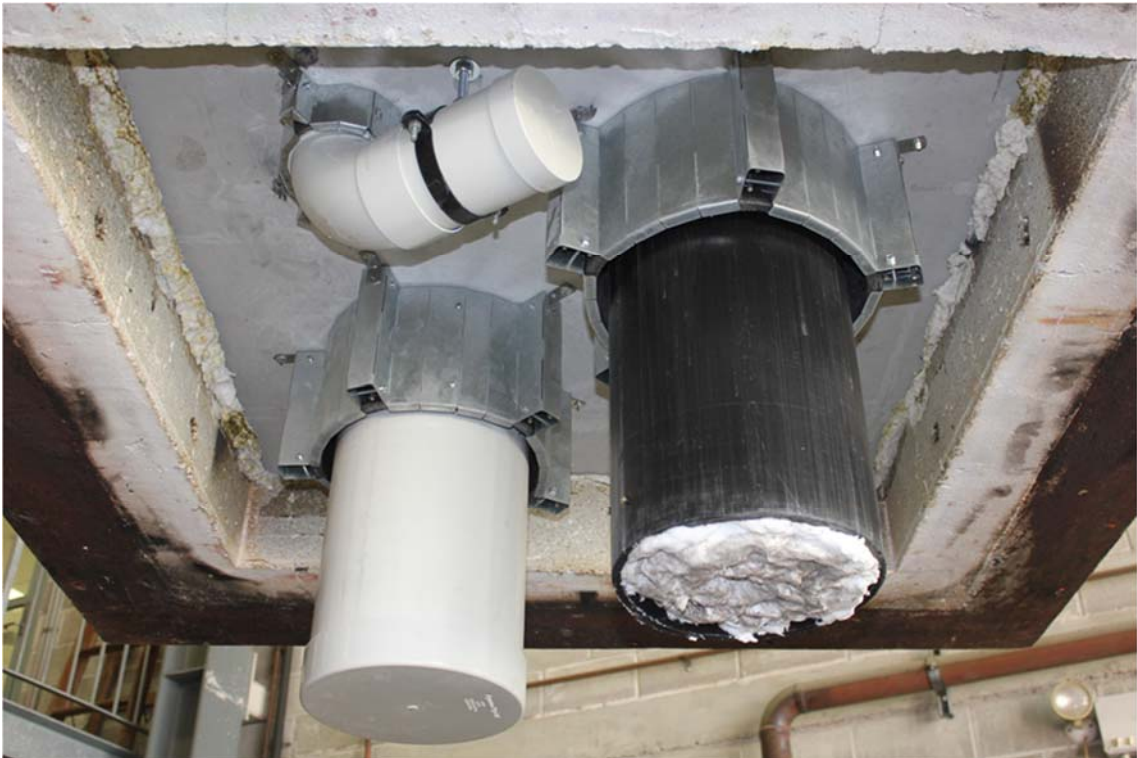
**PHOTOGRAPH 1 – EXPOSED FACE OF SPECIMENS PRIOR TO TESTING**

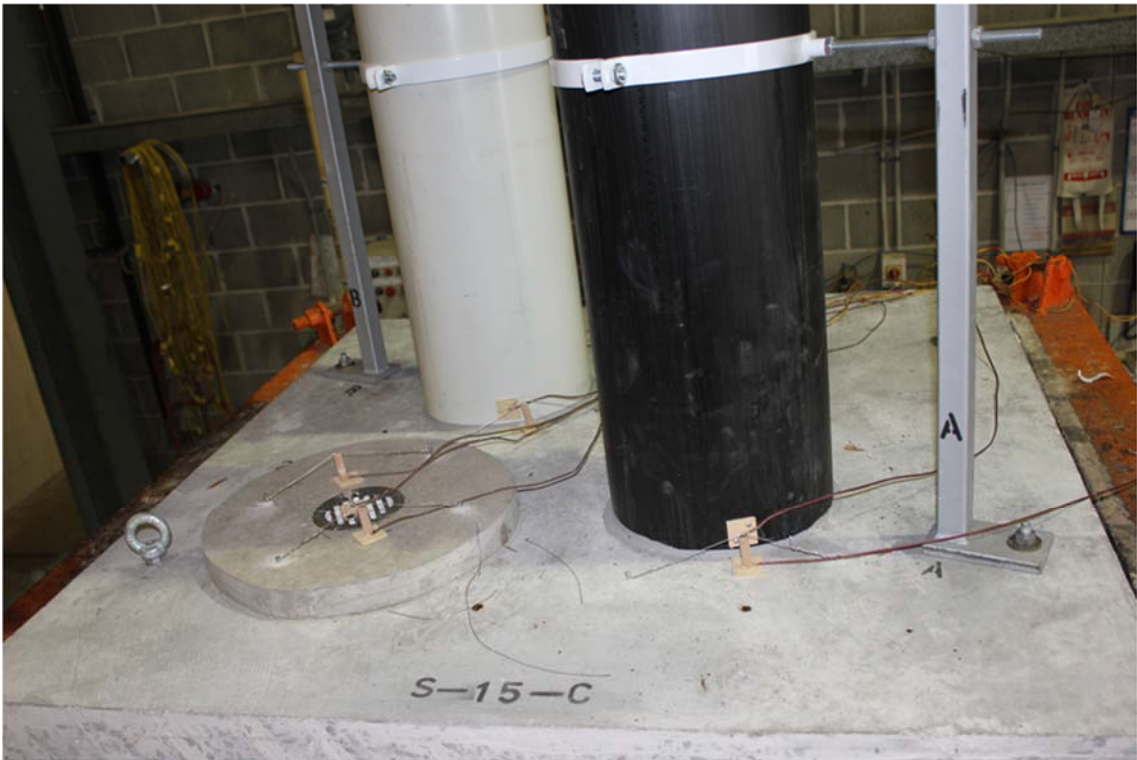
**PHOTOGRAPH 2 – UNEXPOSED FACE OF SPECIMENS PRIOR TO TESTING**

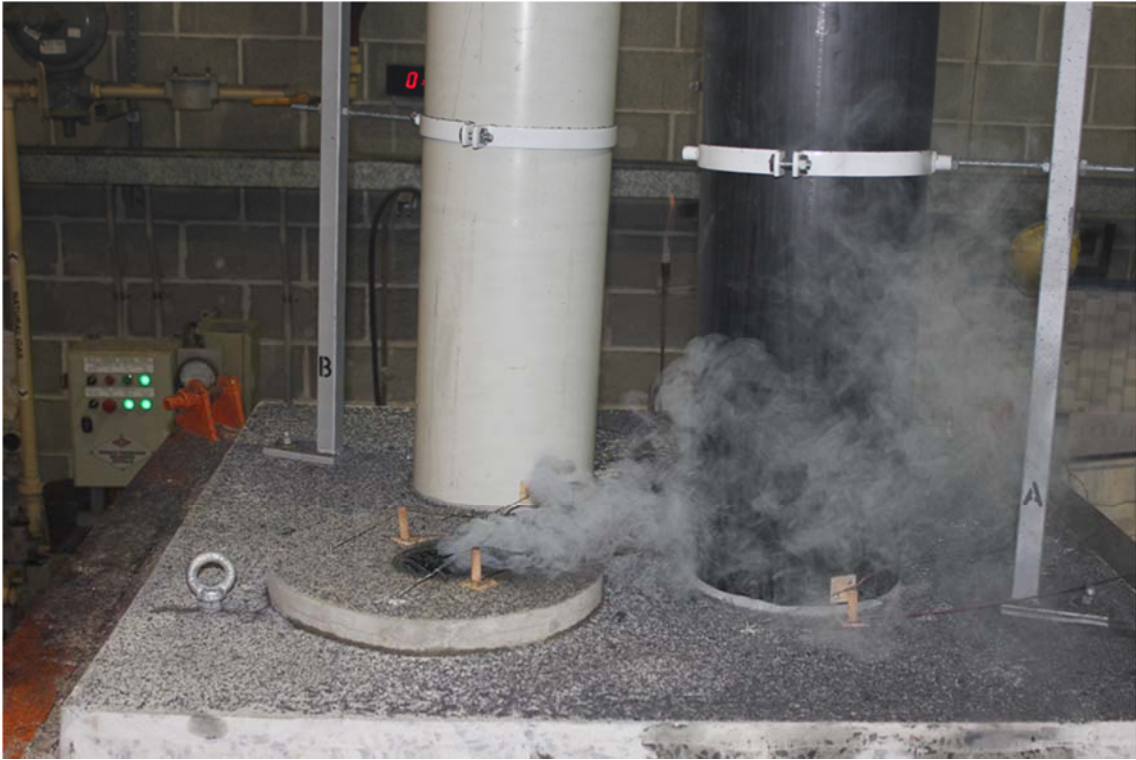
**PHOTOGRAPH 3 – SPECIMENS AFTER 60 MINUTES OF TESTING**

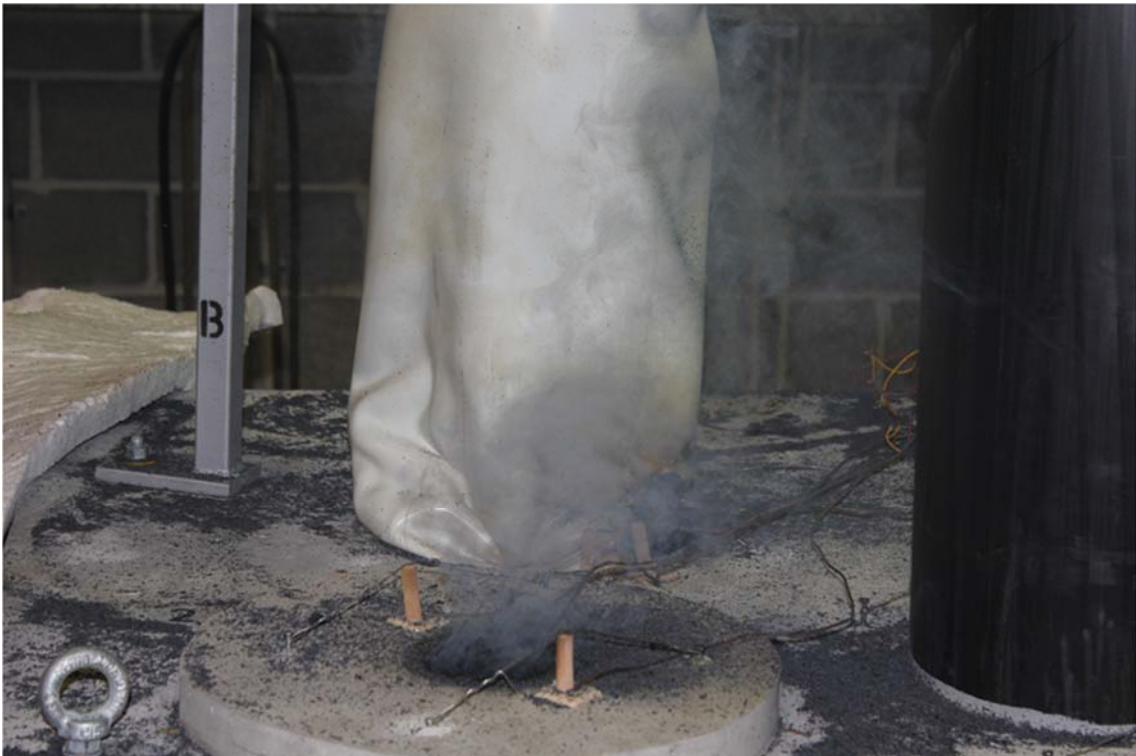
**PHOTOGRAPH 4 – SPECIMENS AFTER 120 MINUTES OF TESTING**

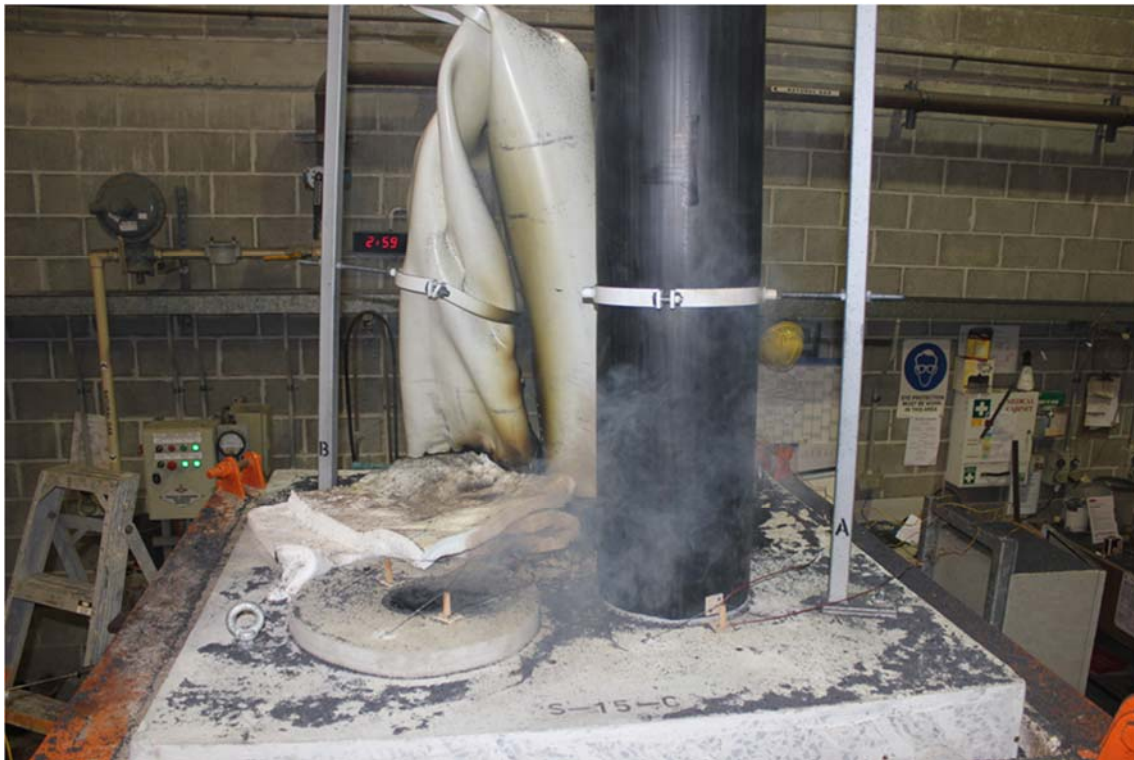
**PHOTOGRAPH 5 – SPECIMENS AFTER 180 MINUTES OF TESTING**

Time	Observation
5 minutes -	Smoke is fluing from Penetration 3.
8 minutes -	Smoke fluing from Penetration # 3 has decreased.
230 minutes -	Flaming is observed on the unexposed face of Penetration # 2. Flames have spread – affecting Penetration # 3. Test terminated.

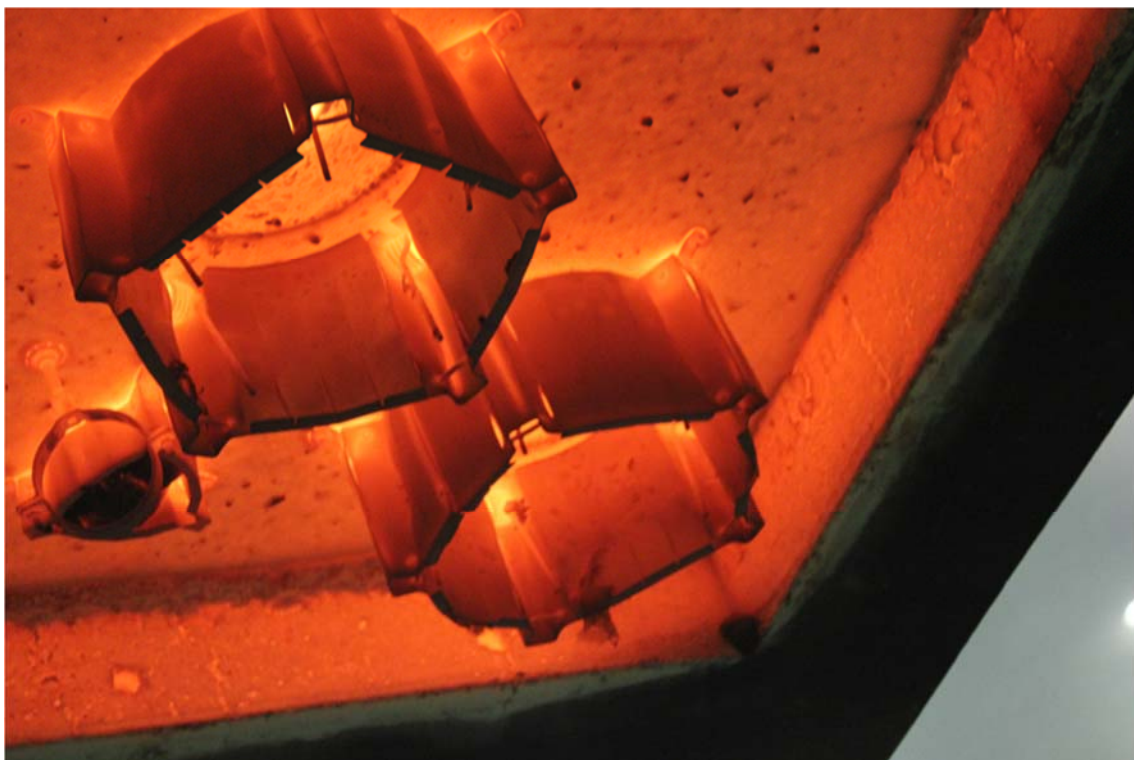
**PHOTOGRAPH 6 – EXPOSED FACE OF SPECIMENS AT CONCLUSION OF TESTING**

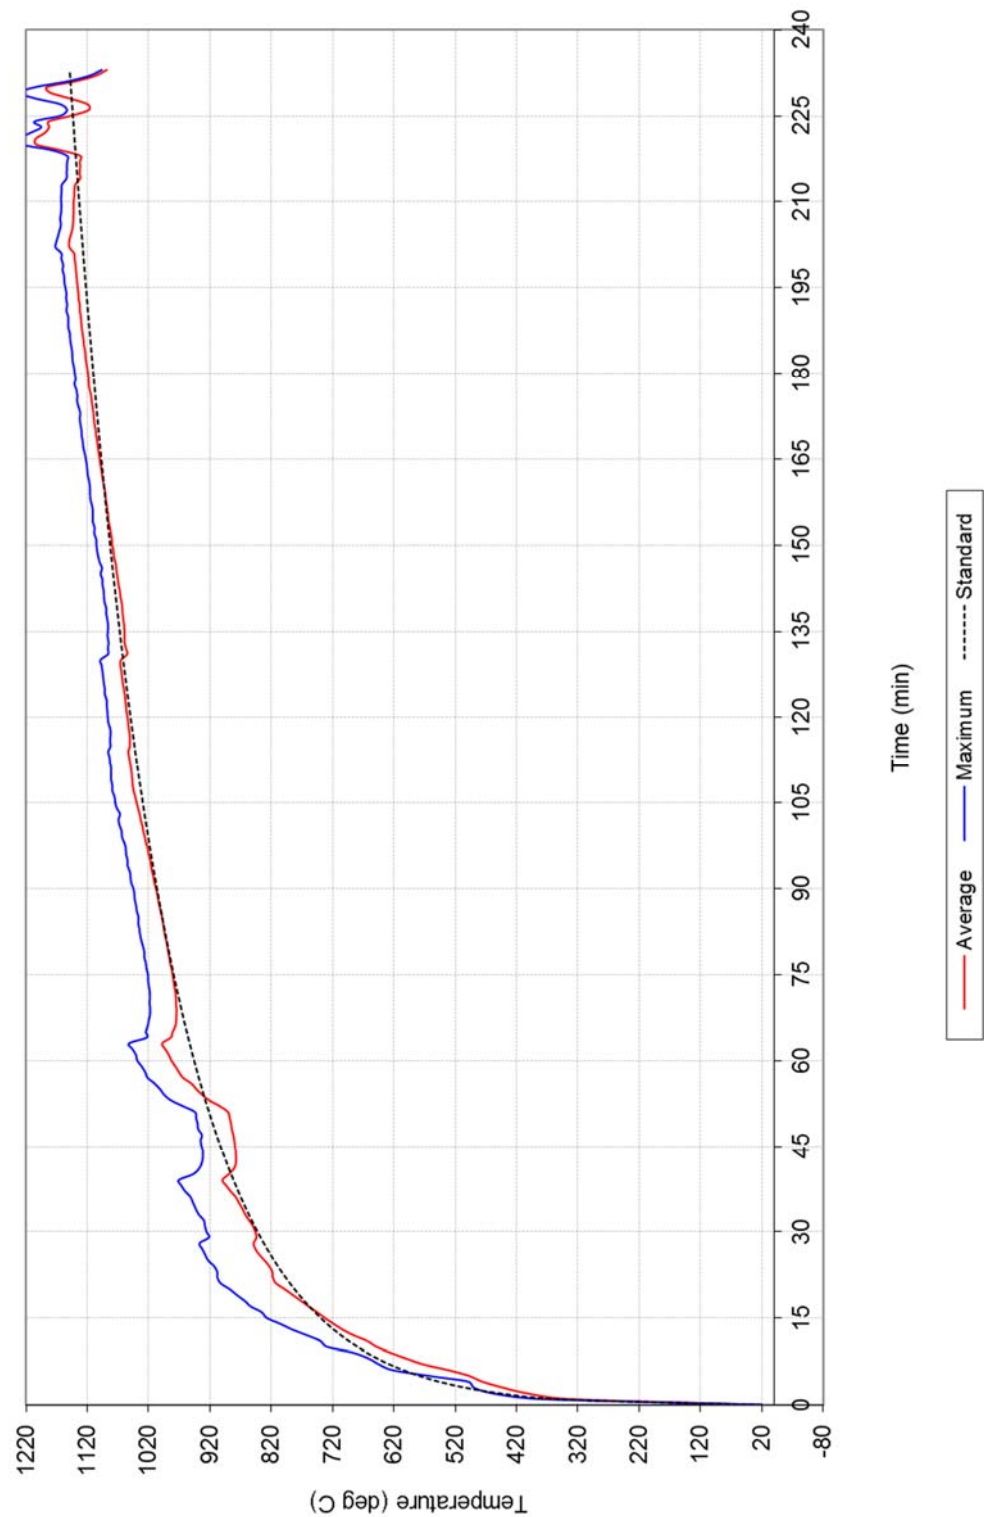
FIGURE 1 – FURNACE TEMPERATURE

Figure 1 shows the standard curves of temperature versus time for heating the furnace chamber and the actual curves of average and maximum temperature versus time recorded during the heating period.

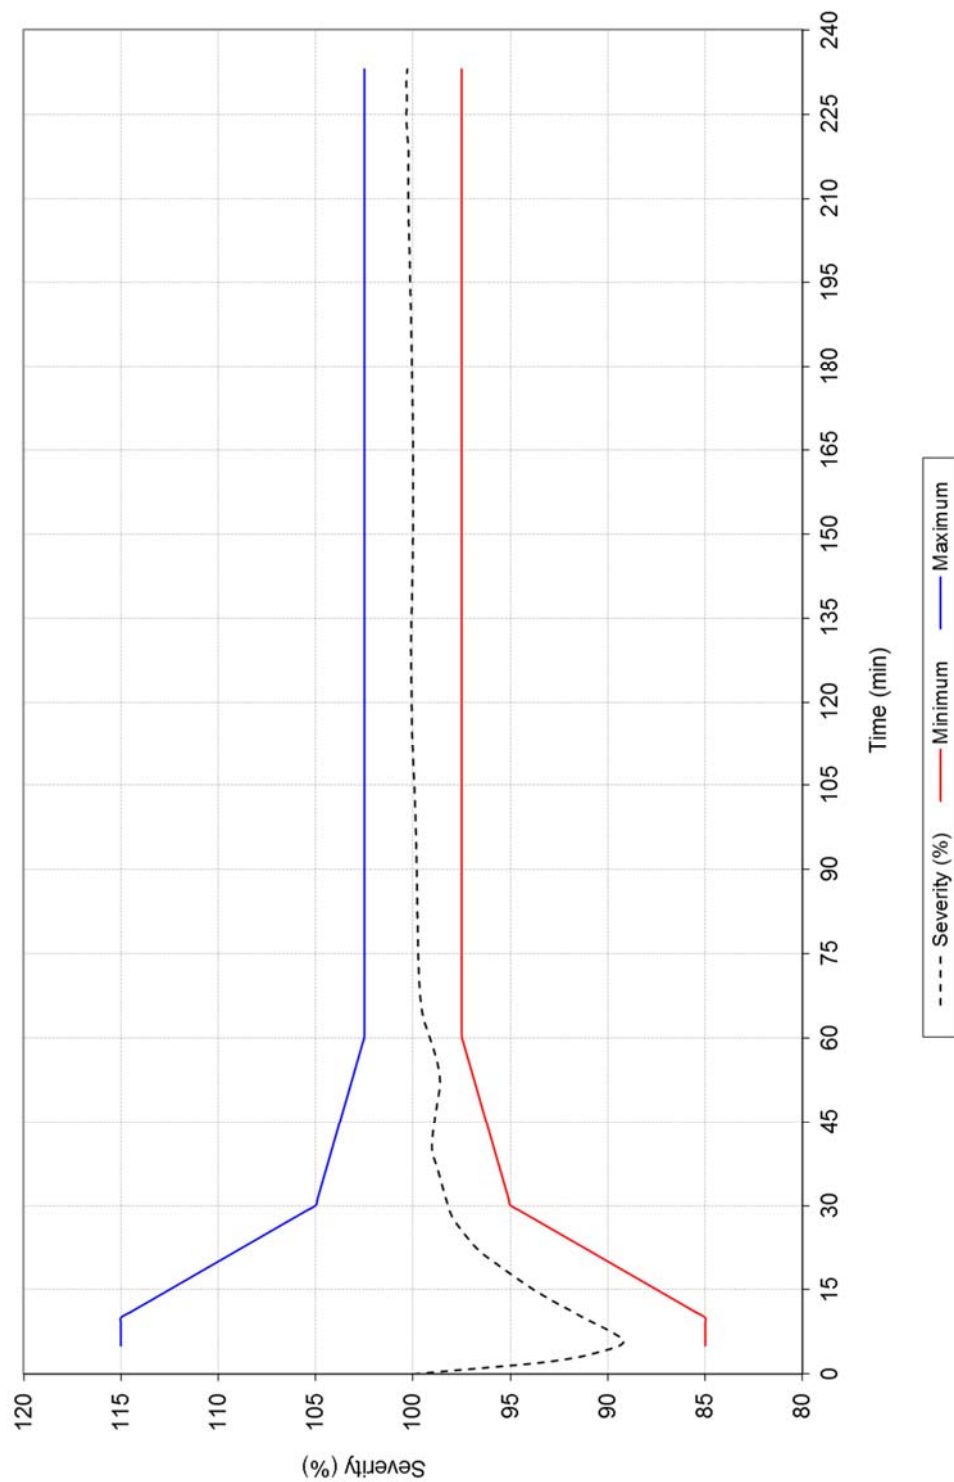
FIGURE 2 – FURNACE SEVERITY

Figure 2 shows the curve of furnace severity versus time during the heating period.

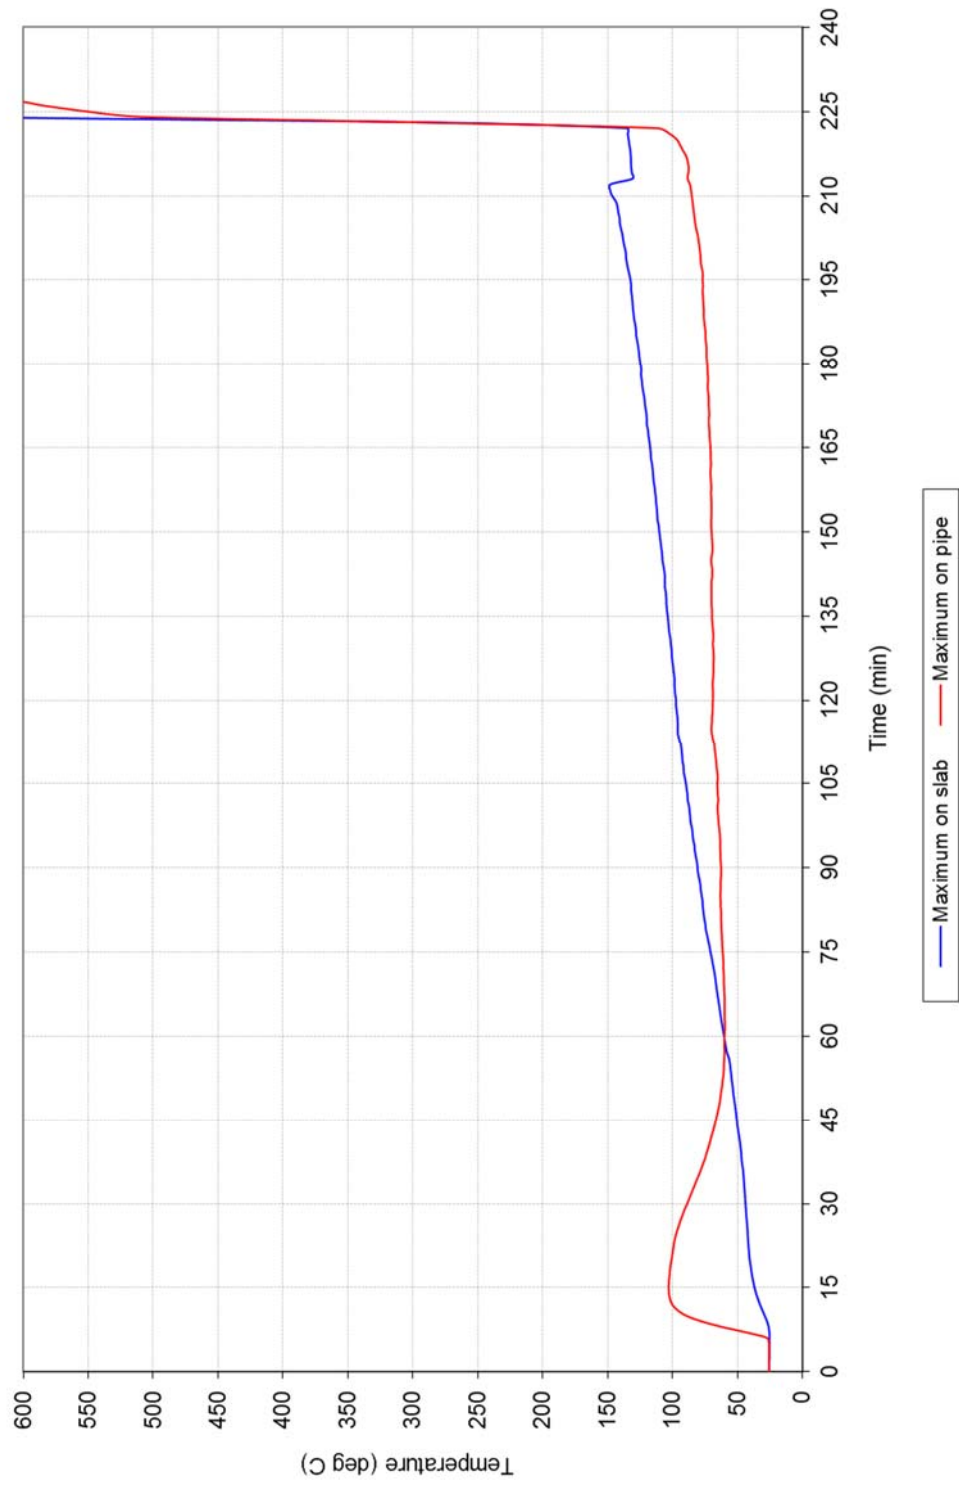
FIGURE 3 – SPECIMEN TEMPERATURE – ASSOCIATED WITH PENETRATION 3

Figure 3 shows the curve of maximum temperature versus time associated with Penetration 3.

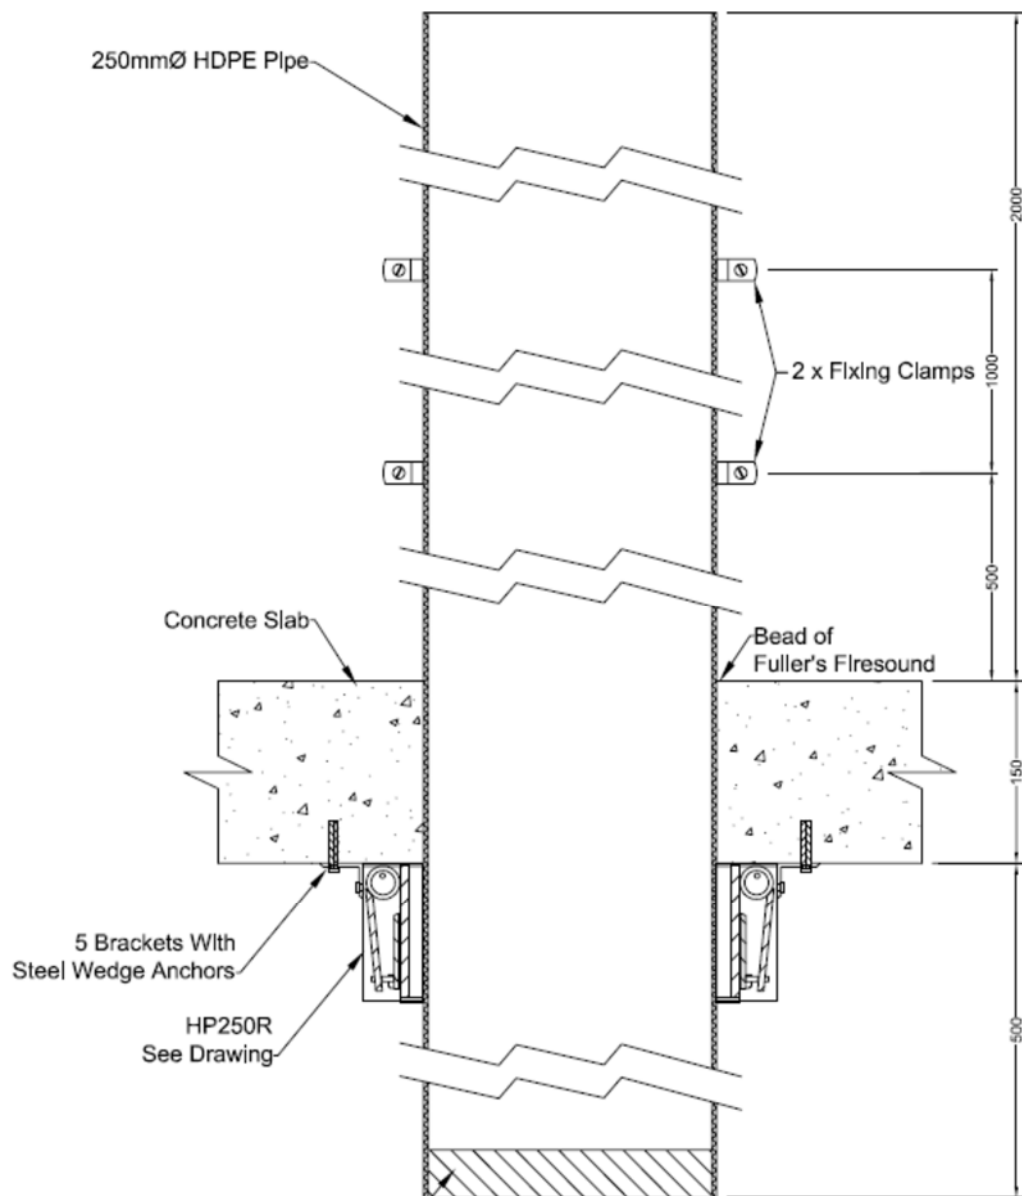
PENETRATION # 3  
HDPE 250-MM STACK  
13 APR 2015

DRAWING NUMBERED "PENETRATION #3 – HDPE 250-MM STACK", DATED 13 APRIL 2015, BY SNAP FIRE SYSTEMS PTY LTD.

The penetrating service comprised a 250-mm diameter High Density Polyethylene (HDPE) stack pipe, with a wall thickness of 7.25-mm fitted through the collar's sleeve. The pipe projected vertically, 2000-mm above the concrete slab. The pipe was supported at 500-mm and 1000-mm from the unexposed face of the concrete slab. On the exposed side of the slab, the penetrating pipe was supported by 5 brackets with Steel Wedge Anchors fixed to the concrete slab. On the exposed face, the pipe was capped using a Kaowool plug.

On the unexposed face, the gap between the pipe and the slab was filled with a bead of Fullers Firesound as show in drawing titled "Penetration #3 – HDPE 250-mm stack", dated 13 April 2015, by Snap Fire Systems Pty Ltd.

Drawing titled “Penetration #3 – HDPE 250-mm stack”, dated 13 April 2015, by Snap Fire Systems Pty Ltd.
