# Fire-resistance test on fire collars protecting a concrete slab penetrated by services

## Test Report

**Author:** Chris Wojcik  
**Report number:** FSP 1735  
**Date:** 8 September 2016

## Sponsored Investigation No. FSP 1735

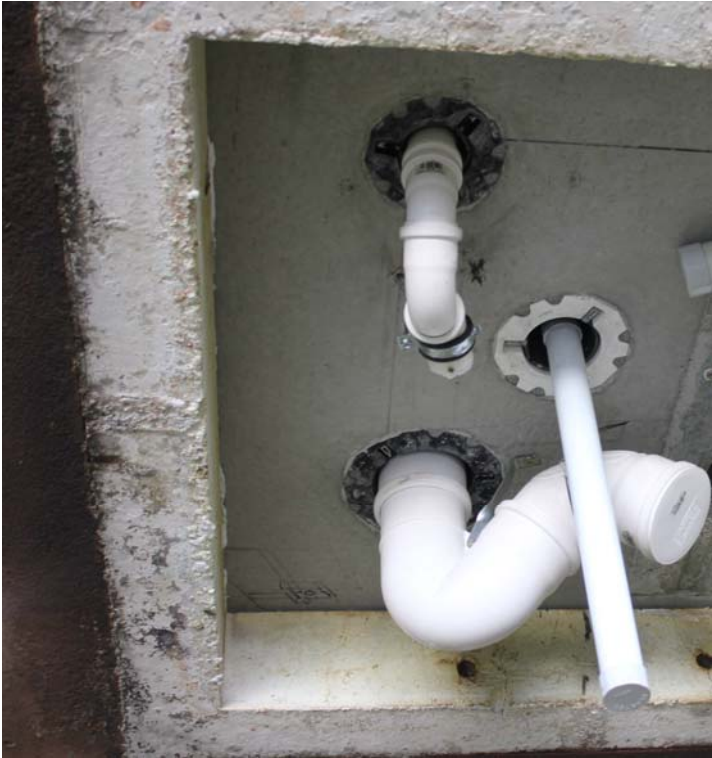
PHOTOGRAPH 1 – EXPOSED FACE OF SPECIMEN PRIOR TO TESTING

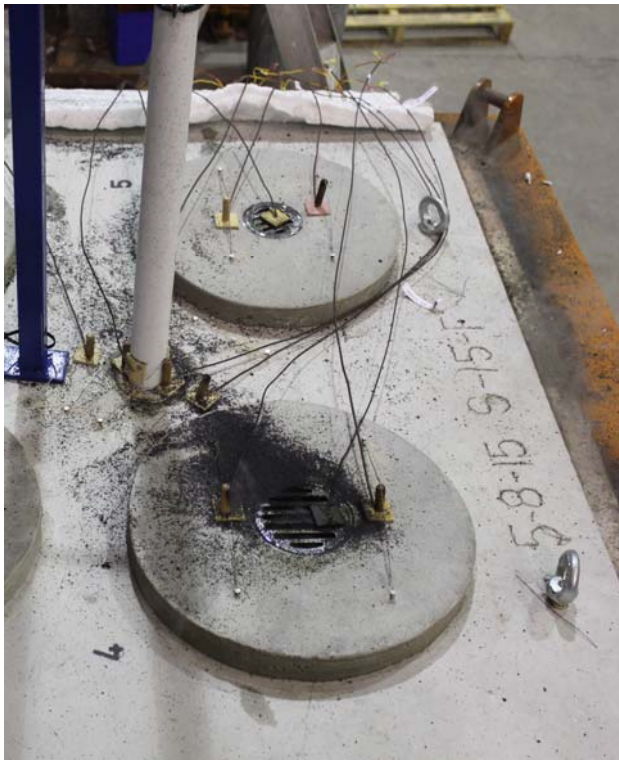
**PHOTOGRAPH 3 – SPECIMENS AFTER 60 MINUTES OF TESTING**

Time	Observation
60 minutes -	No apparent change to the specimen.
120 minutes -	No apparent change to the specimen.
180 minutes -	No apparent change to the specimen.
241 minutes -	No apparent change to the specimen. Test terminated

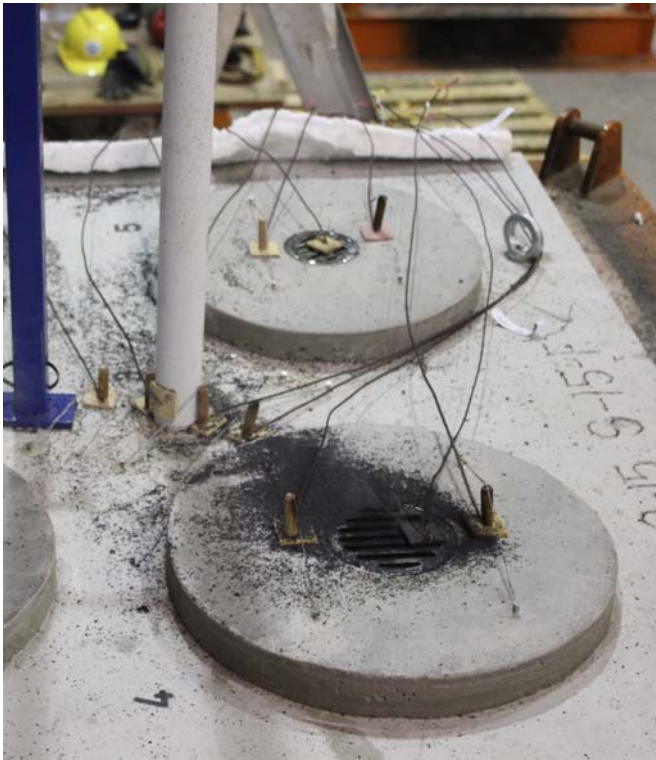
**PHOTOGRAPH 4 – SPECIMENS AFTER 120 MINUTES OF TESTING**

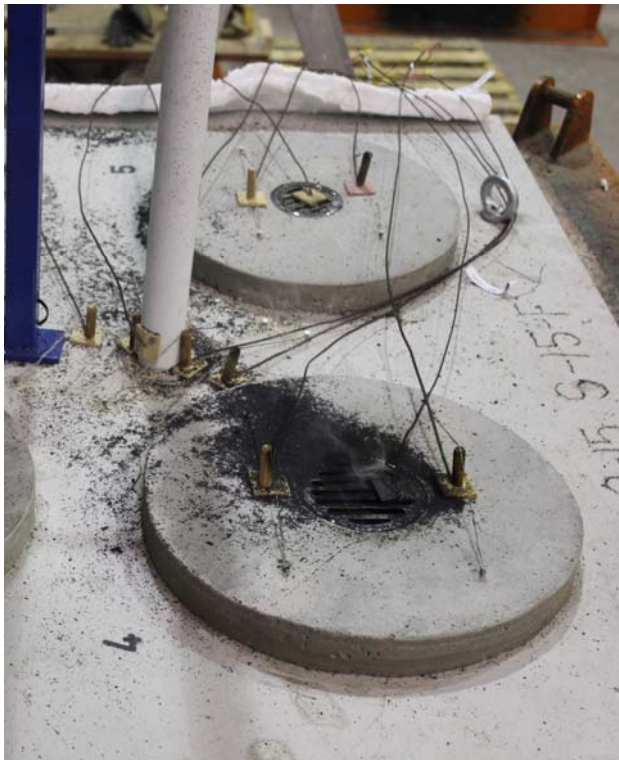
**PHOTOGRAPH 5 – SPECIMENS AFTER 180 MINUTES OF TESTING**

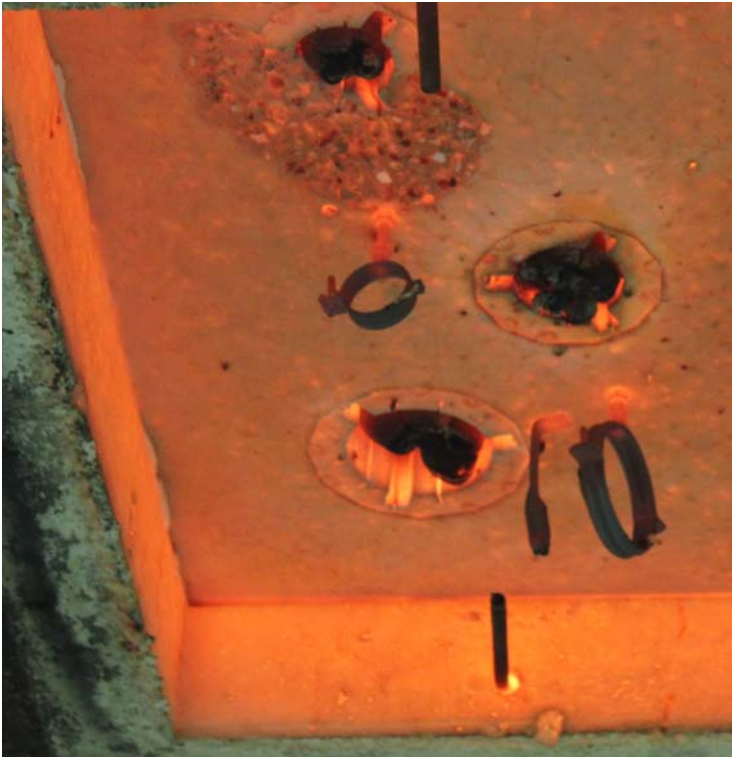
**PHOTOGRAPH 6 – EXPOSED FACE OF SPECIMENS AT CONCLUSION OF TESTING**
