Fire-resistance test on fire collars protecting a concrete slab penetrated by services

Test Report

Author: Mario Lara-Ledermann
Report number: FSP 1713
Date: 18 December 2015

Client: Snap Fire Systems Pty Ltd

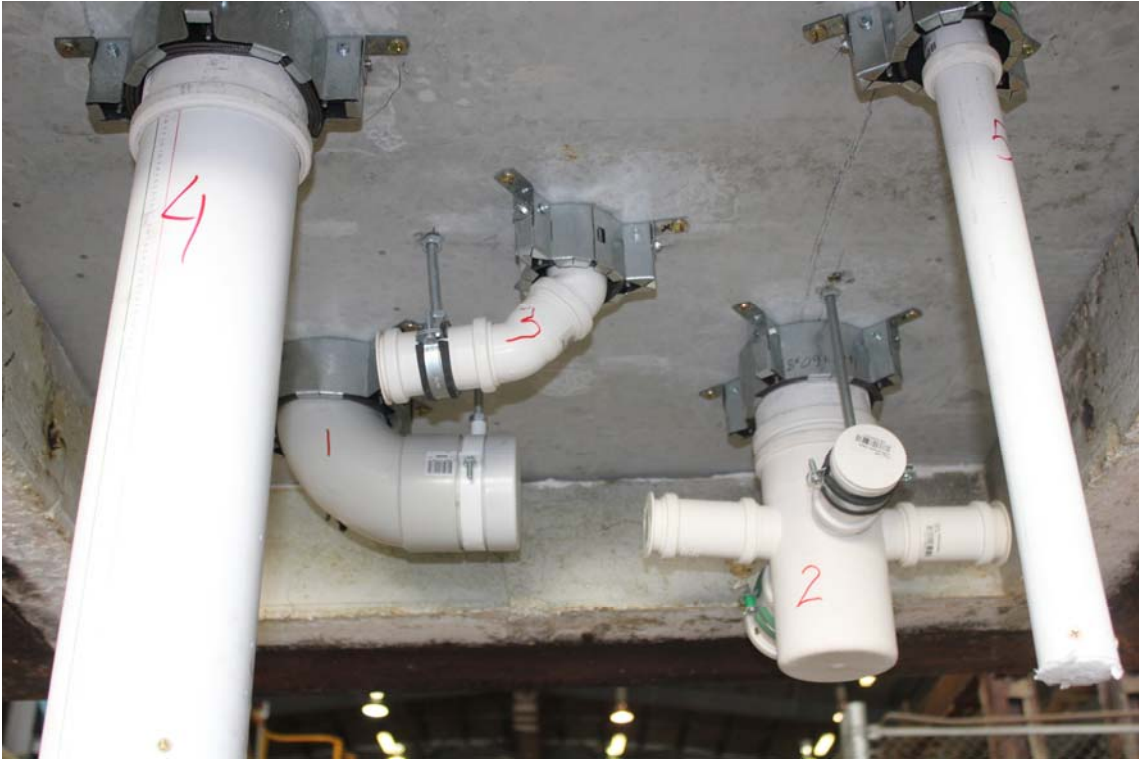
PHOTOGRAPH 1 – EXPOSED FACE OF SPECIMEN PRIOR TO TESTING

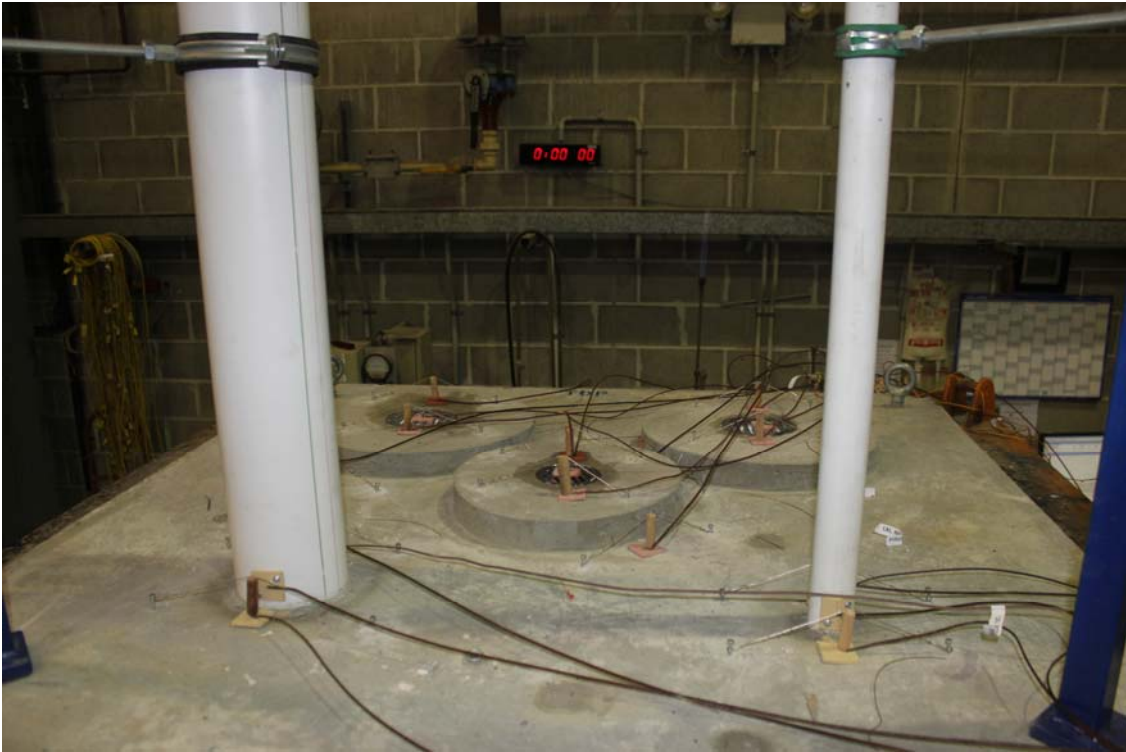
PHOTOGRAPH 2 – UNEXPOSED FACE OF SPECIMENS PRIOR TO TESTING

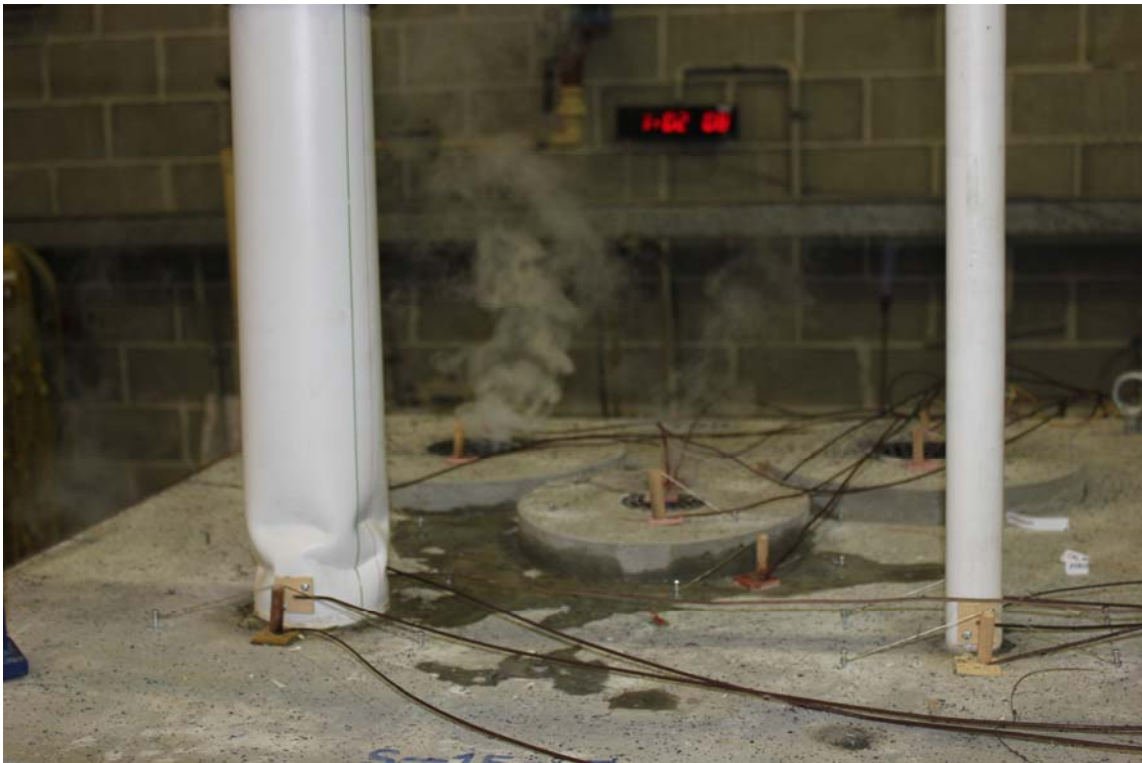
PHOTOGRAPH 3 – SPECIMENS AFTER 60 MINUTES OF TESTING

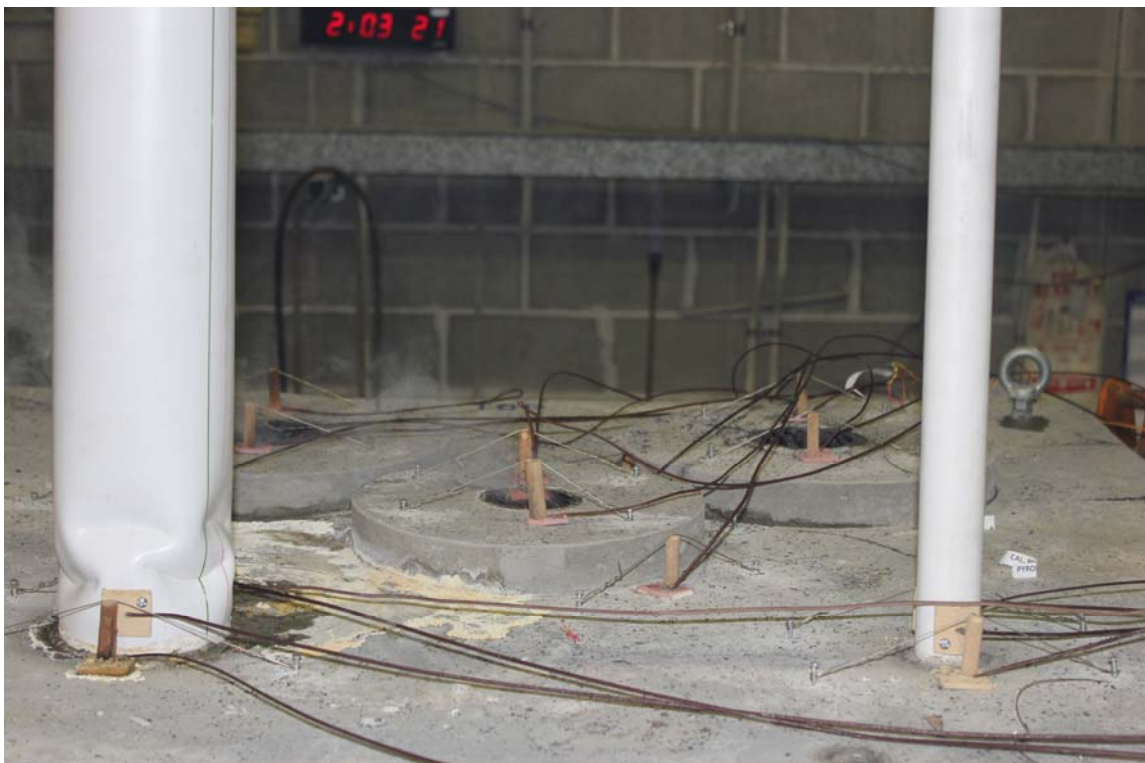
PHOTOGRAPH 4 – SPECIMENS AFTER 120 MINUTES OF TESTING

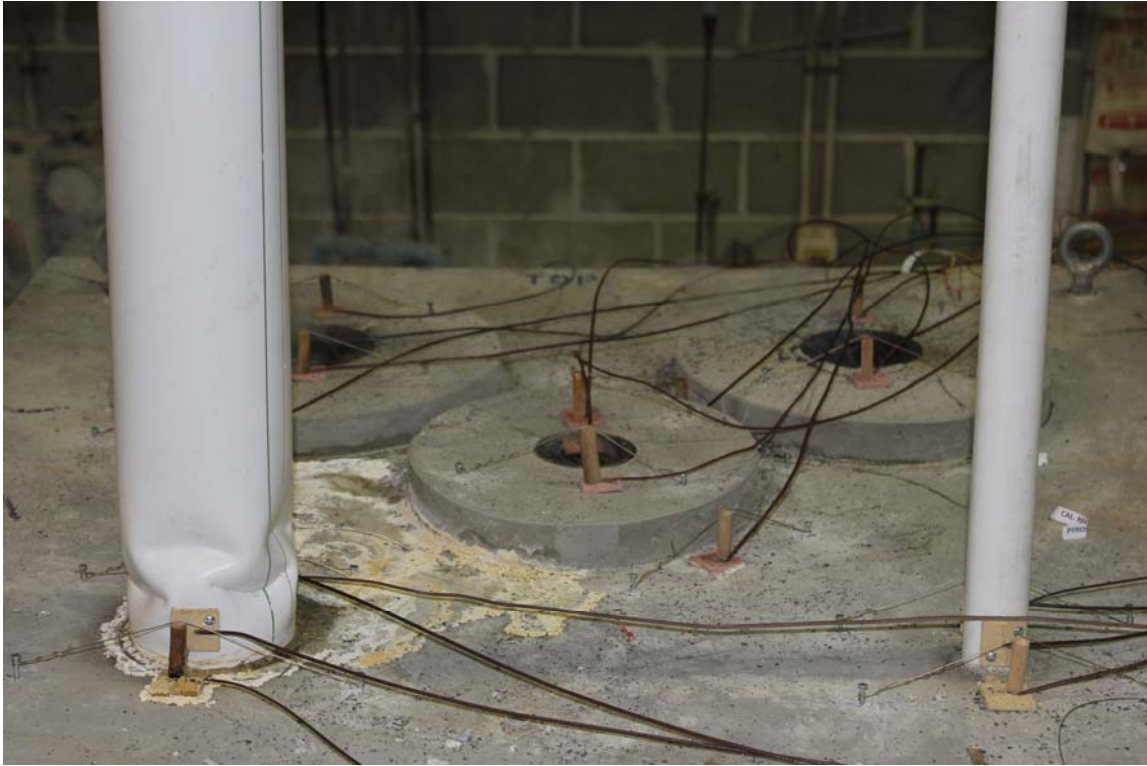
PHOTOGRAPH 5 – SPECIMENS AFTER 180 MINUTES OF TESTING

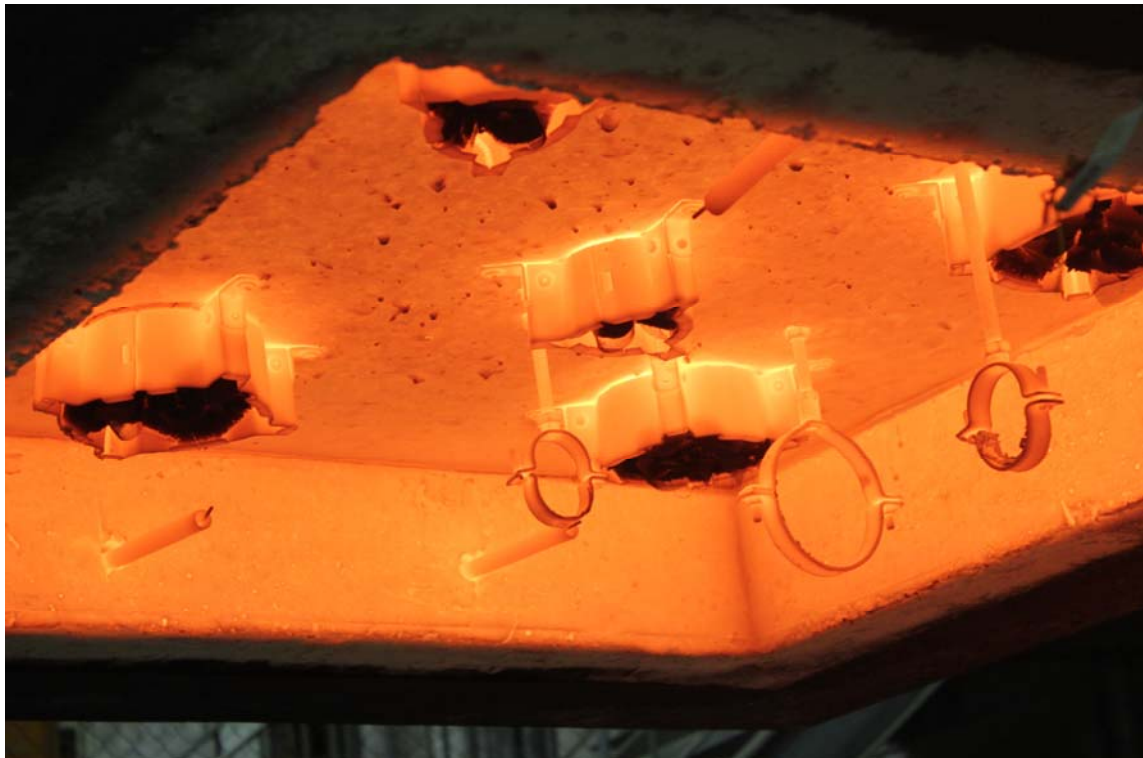
PHOTOGRAPH 6 – EXPOSED FACE OF SPECIMENS AT CONCLUSION OF TESTING

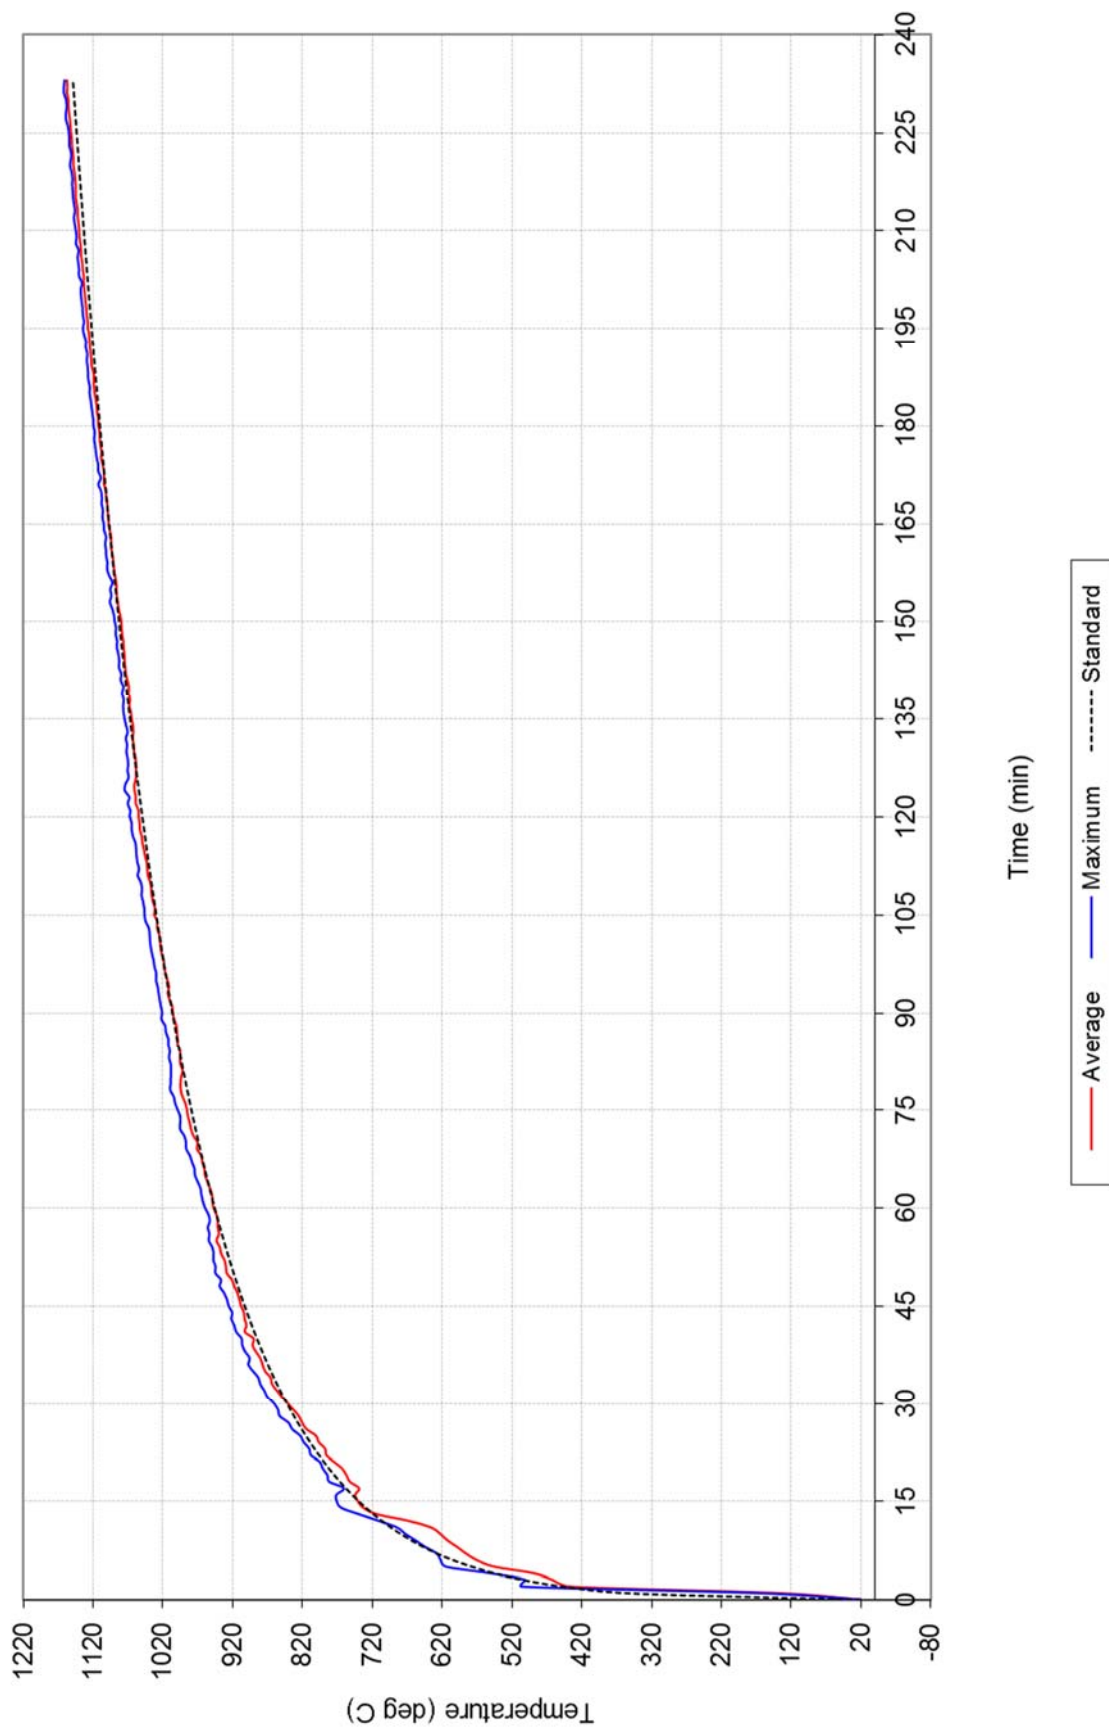
FIGURE 1 – FURNACE TEMPERATURE

Figure 1 shows the standard curves of temperature versus time for heating the furnace chamber and the actual curves of average and maximum temperature versus time recorded during the heating period.

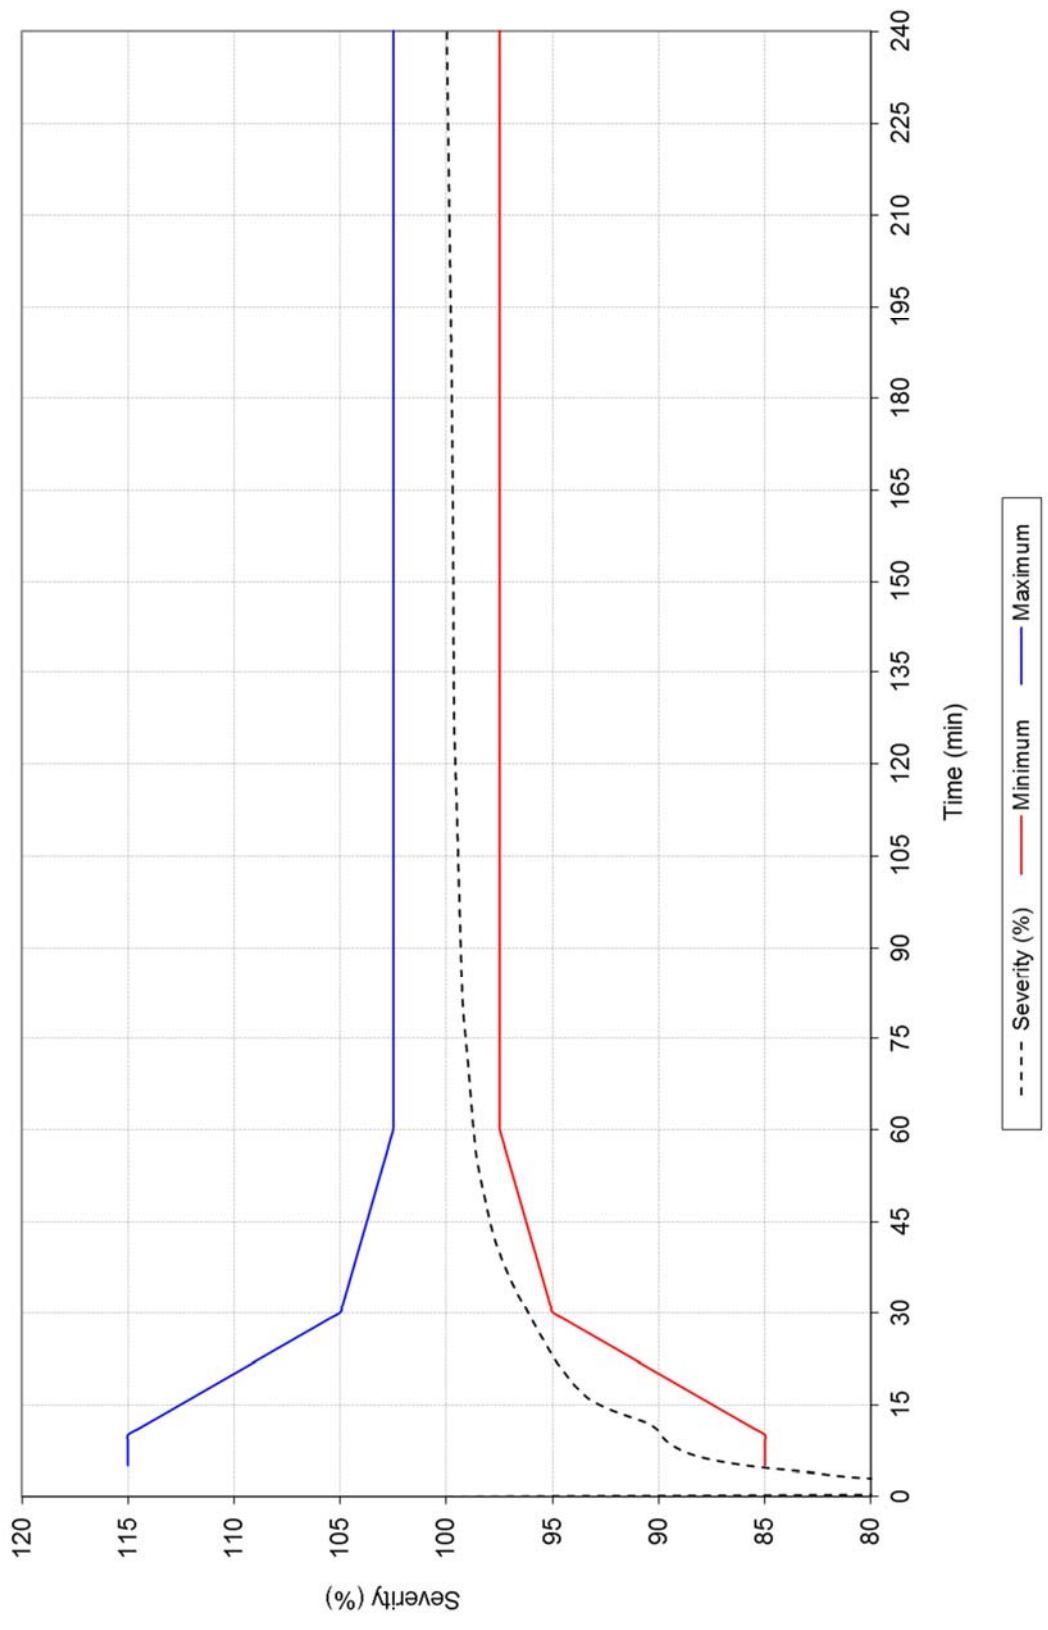
FIGURE 2 – FURNACE SEVERITY

Figure 2 shows the curve of furnace severity versus time during the heating period.

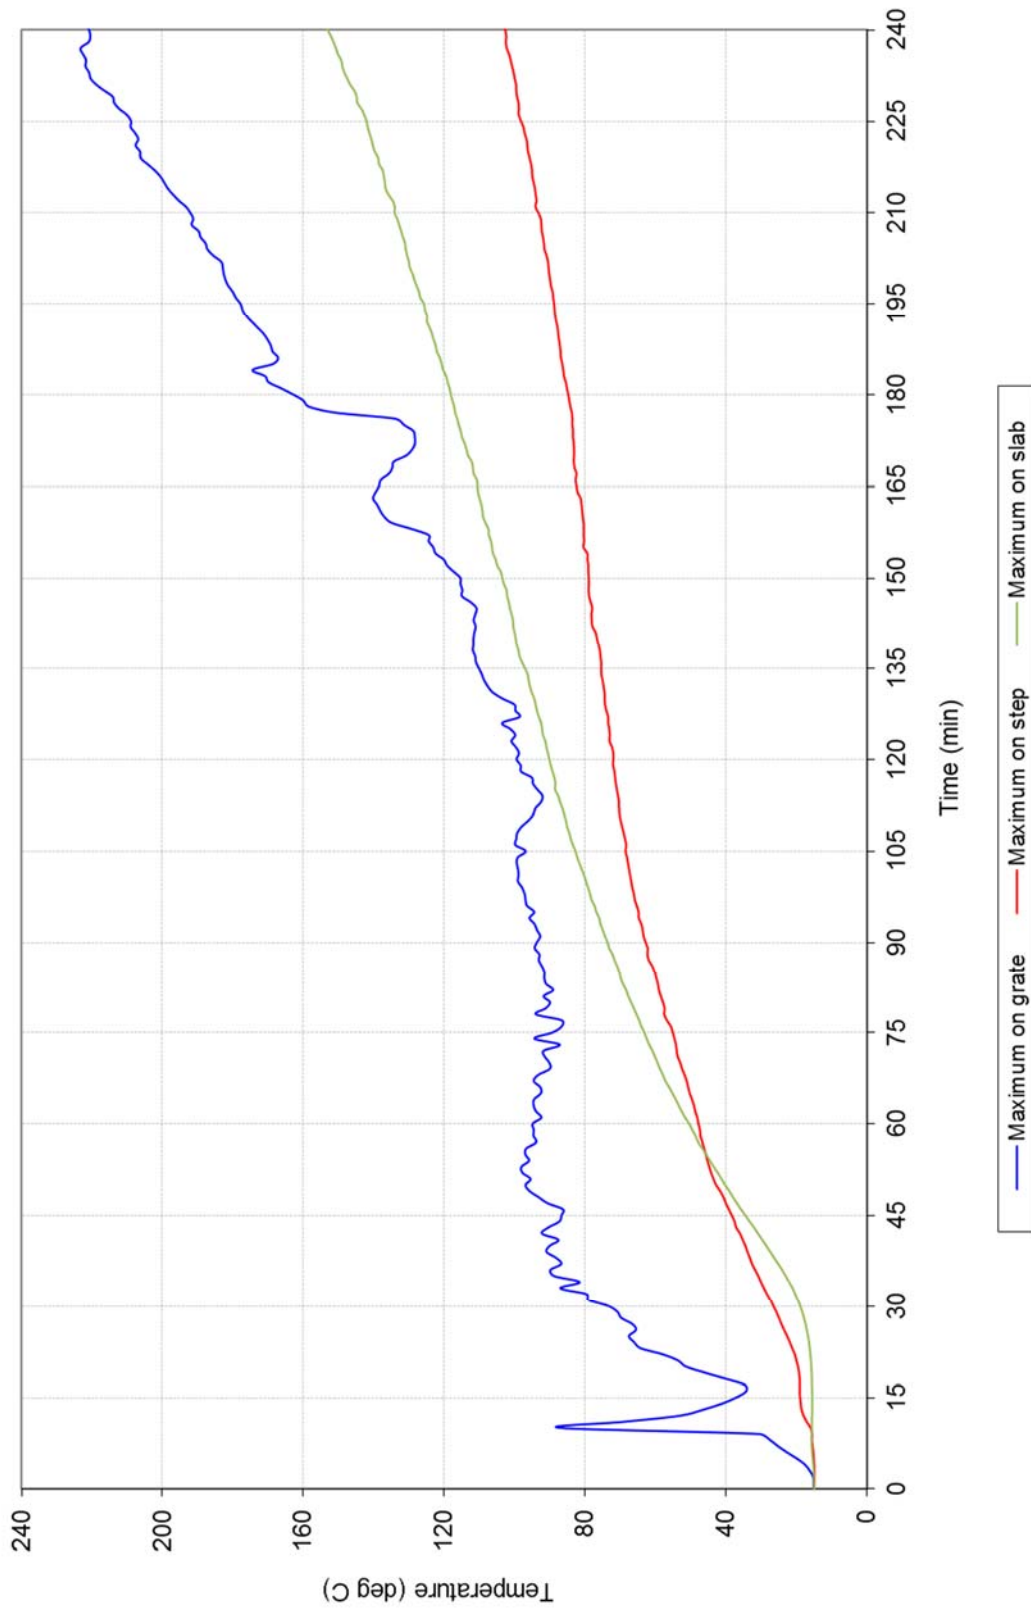
FIGURE 3 – SPECIMEN TEMPERATURE – ASSOCIATED WITH PENETRATION 1

Figure 3 shows the curve of maximum temperature versus time associated with Penetration 1.

Insulation - 213 minutes

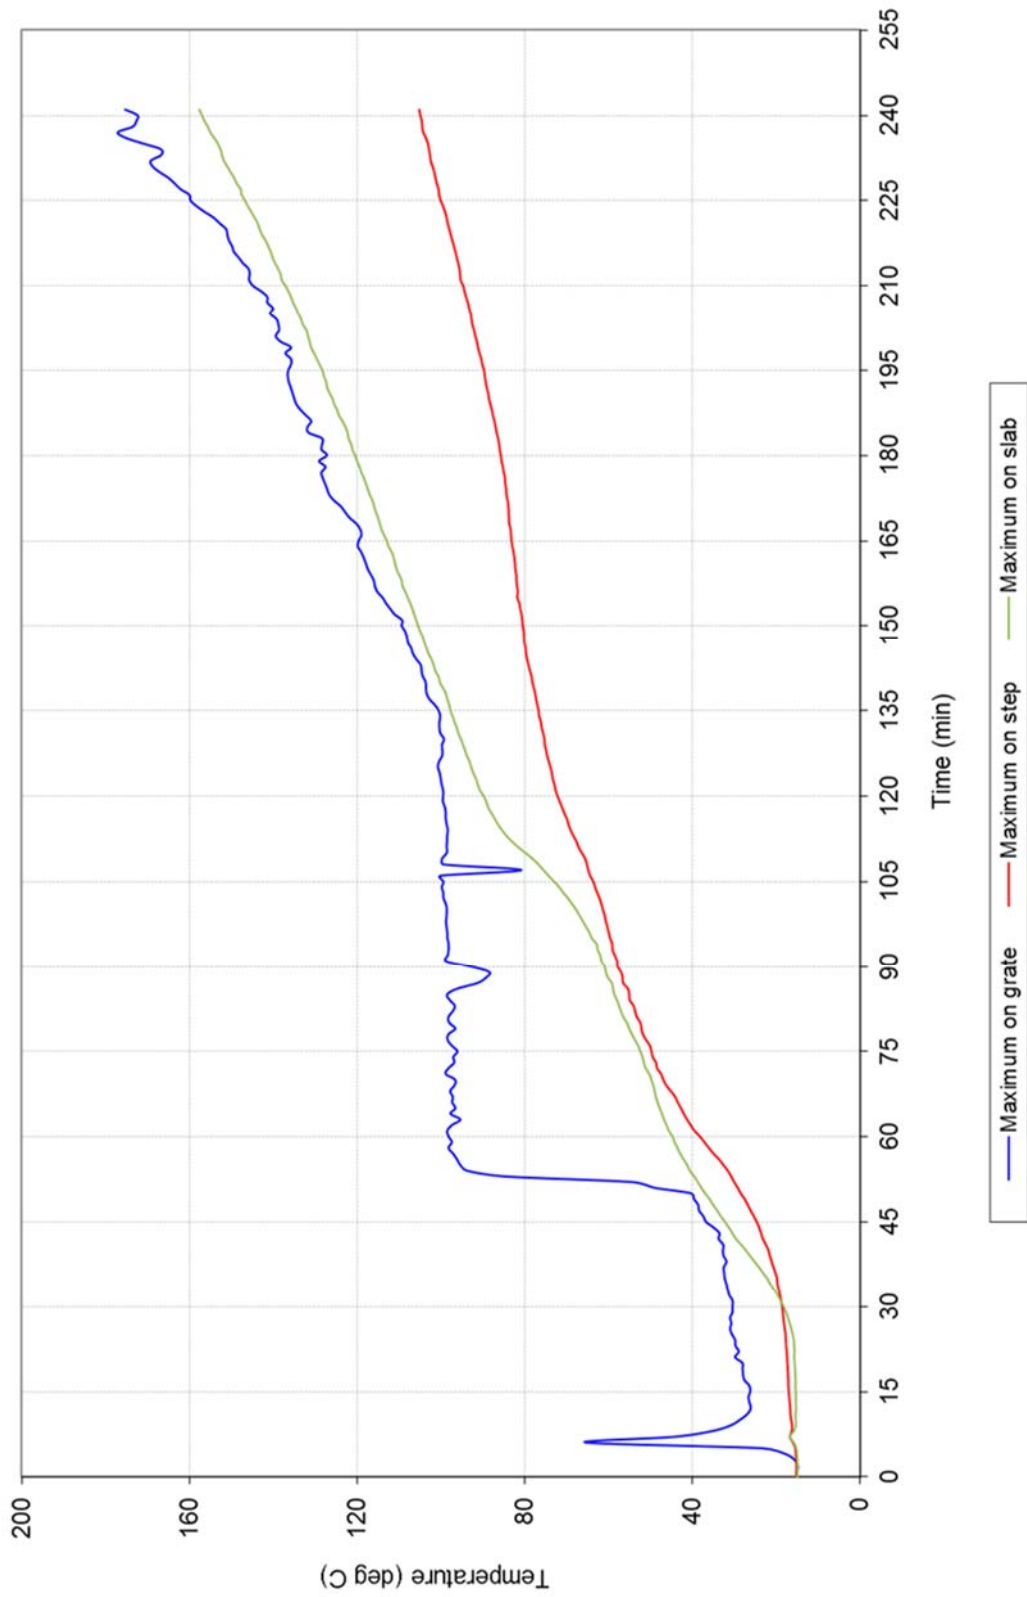
FIGURE 4 – SPECIMEN TEMPERATURE – ASSOCIATED WITH PENETRATION 3

Figure 4 shows the curve of maximum temperature versus time associated with Penetration 3.

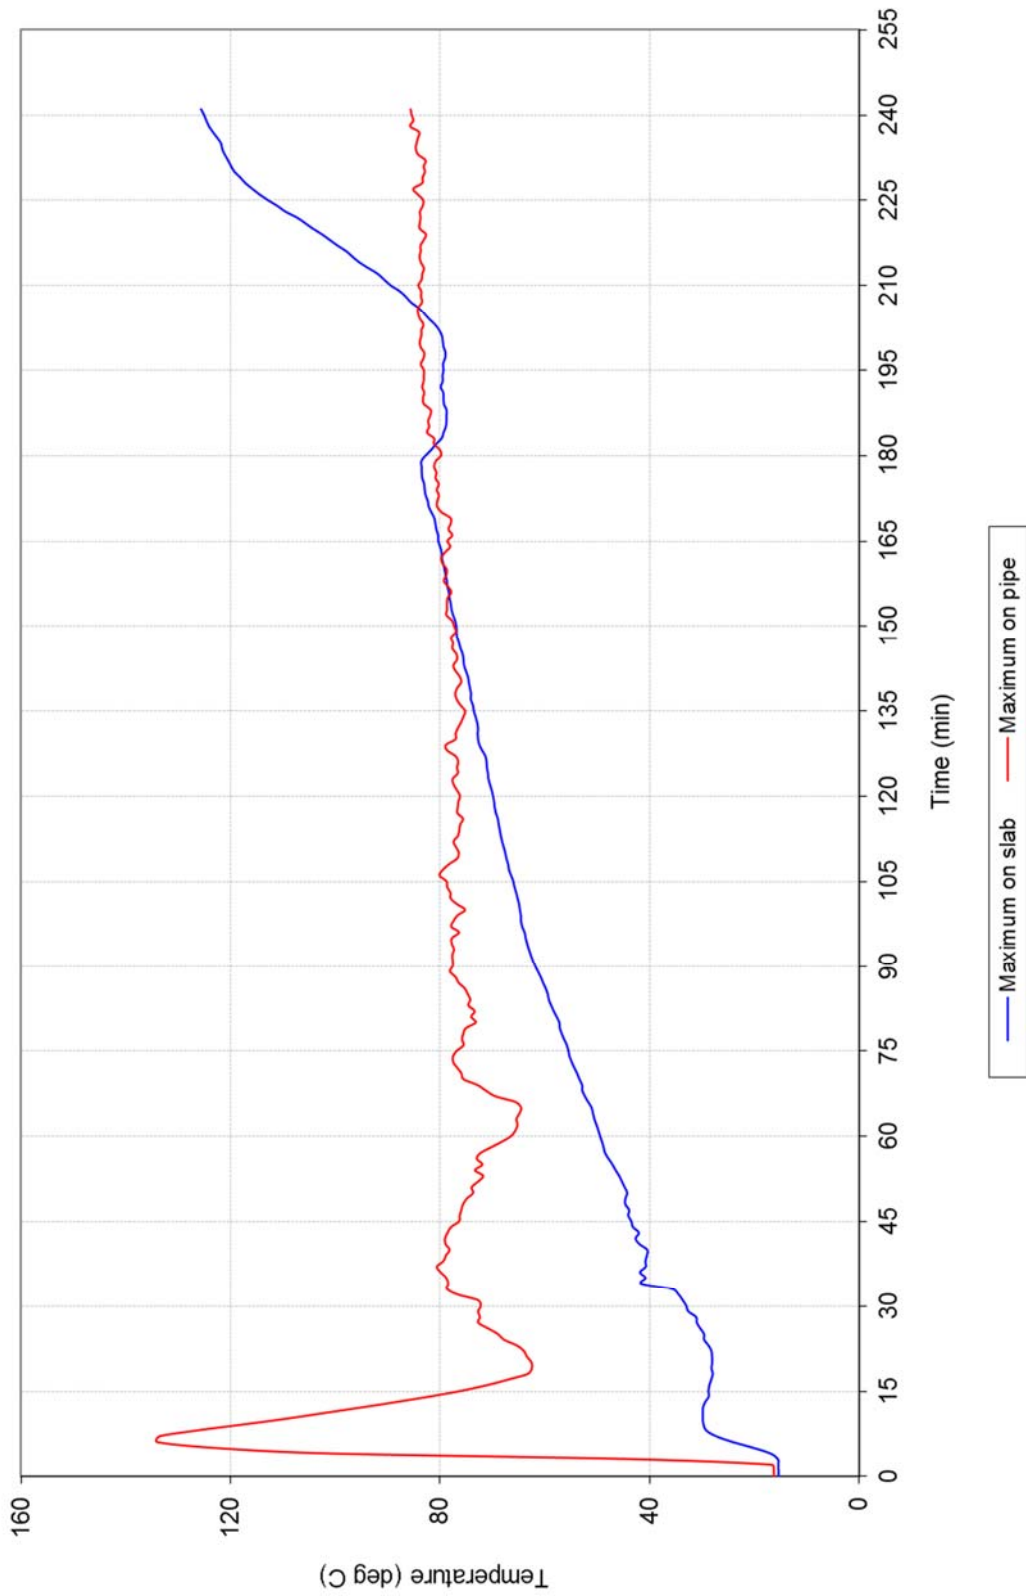
FIGURE 5 – SPECIMEN TEMPERATURE – ASSOCIATED WITH PENETRATION 4

Figure 5 shows the curve of maximum temperature versus time associated with Penetration 4.

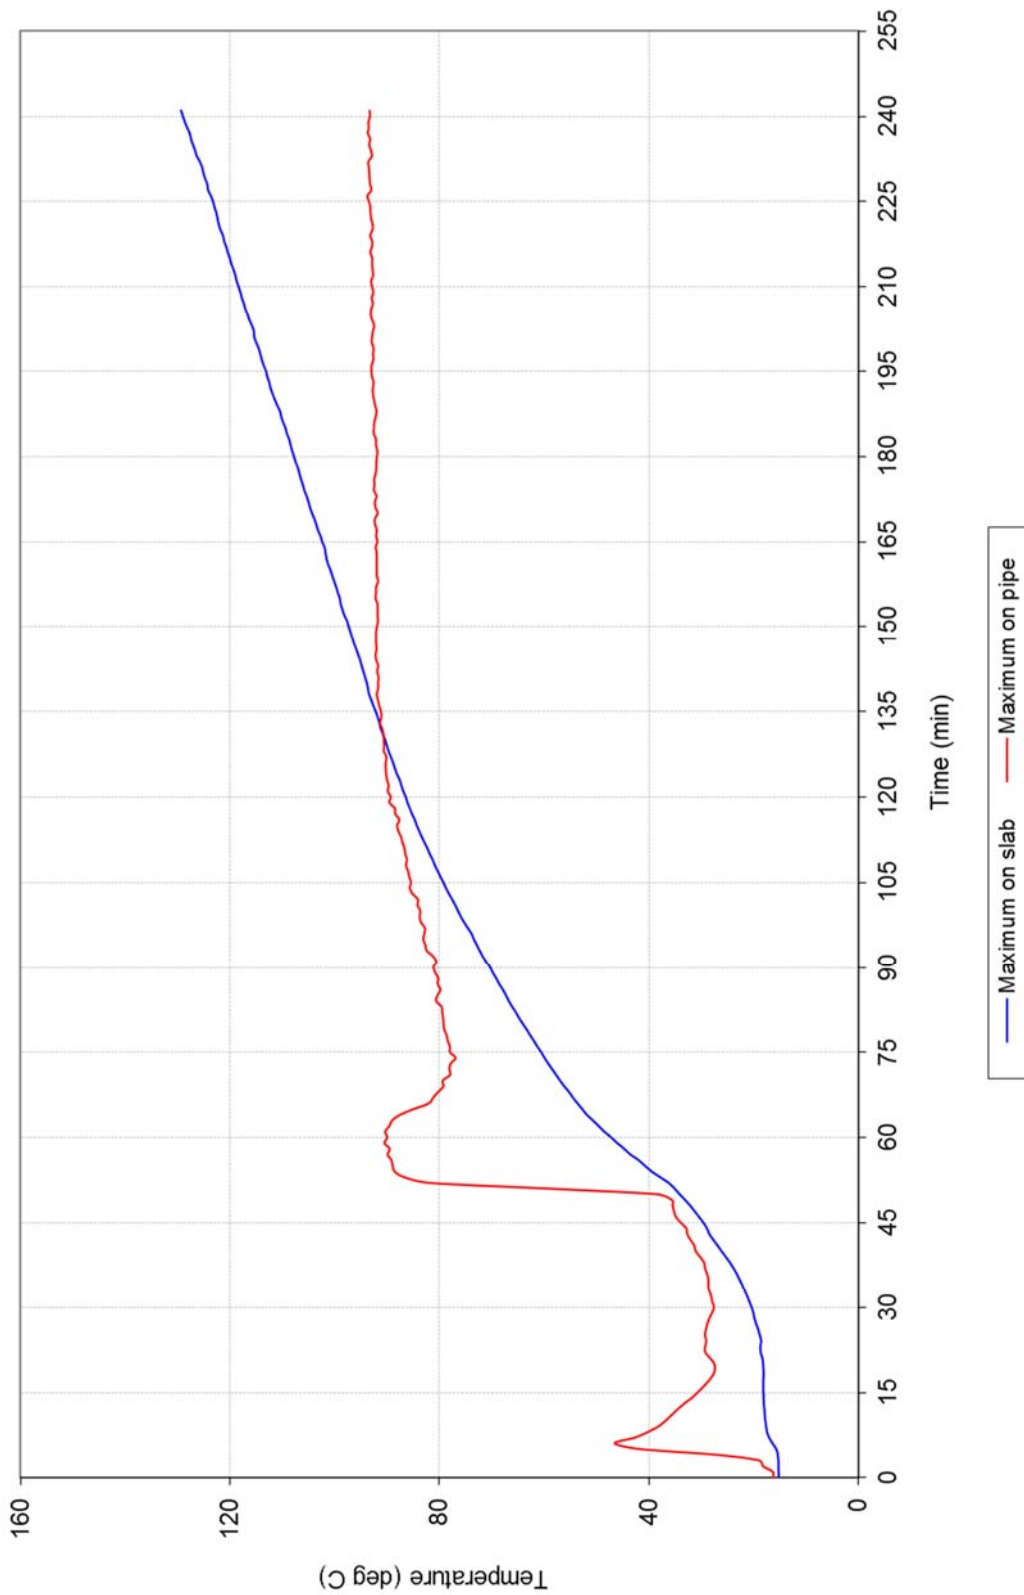
FIGURE 6 – SPECIMEN TEMPERATURE – ASSOCIATED WITH PENETRATION 5

Figure 6 shows the curve of maximum temperature versus time associated with Penetration 5.

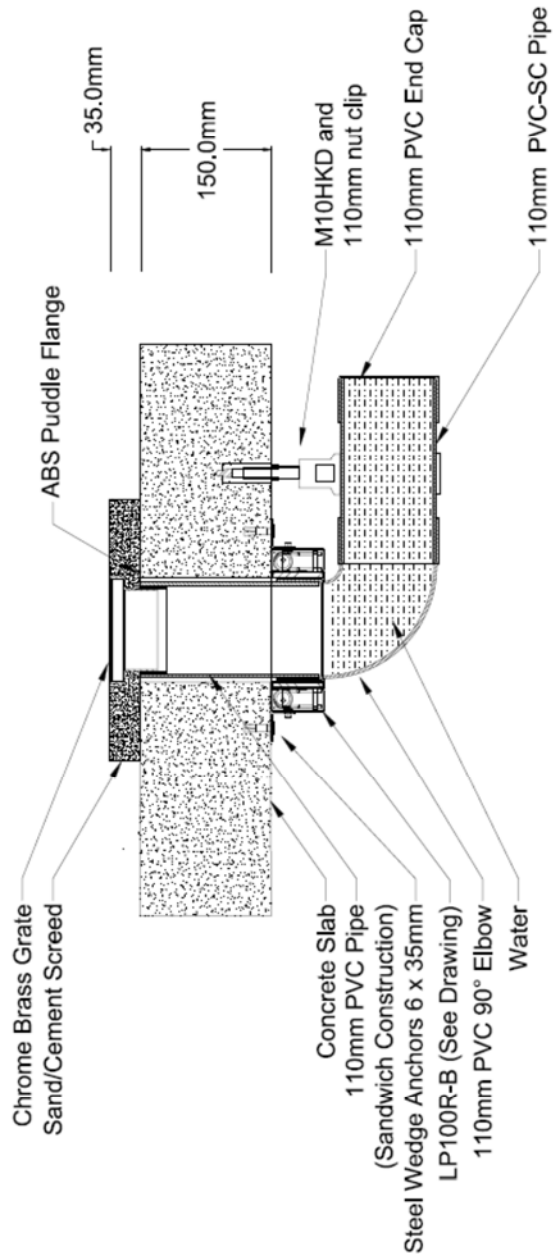
Test Slab S-15-E Penetration 1
 110mm PVC-SC Pipe – Floorwaste + Fitting Inside Collar – LP100R-B
 Date: 21 Sep 2015

DRAWING TITLED “TEST SLAB S-15-E PENETRATION # 1 110-MM PVC-SC PIPE – FLOORWASTE + FITTING INSIDE COLLAR – LP100R-B”, DATED 21 SEPTEMBER 2015, BY SNAP FIRE SYSTEMS PTY LTD

The collar was fixed to the underside of the slab with steel wedge anchors 6 x 35-mm as shown in drawing titled "Test Slab S-15-E Penetration # 1 110-mm PVC-SC Pipe – Floorwaste + Fitting inside Collar – LP100R-B", dated 21 September 2015, by Snap Fire Systems Pty Ltd.

The penetrating service comprised a 110-mm OD PVC-SC pipe, with a wall thickness of 3.6-mm fitted through the LP100R-B Snap fire collar. The floor waste system was fitted with a chromed brass floor waste grate. A 35-mm thick cement screed was laid on top of the concrete slab and finished flush with the floor grate. On the exposed side of the slab, a 110-mm OD PVC-SC 90° elbow was fitted to the pipe within the collar, supported by a M10 HKD clamp and 110-mm nut clip fixed to the concrete slab. On the exposed face, the penetration was capped using a PVC end cap.

The floor waste gully was charged with water to the level shown in drawing titled "Test Slab S-15-E Penetration # 1 110-mm PVC-SC Pipe – Floorwaste + Fitting inside Collar – LP100R-B", dated 21 September 2015, by Snap Fire Systems Pty Ltd.

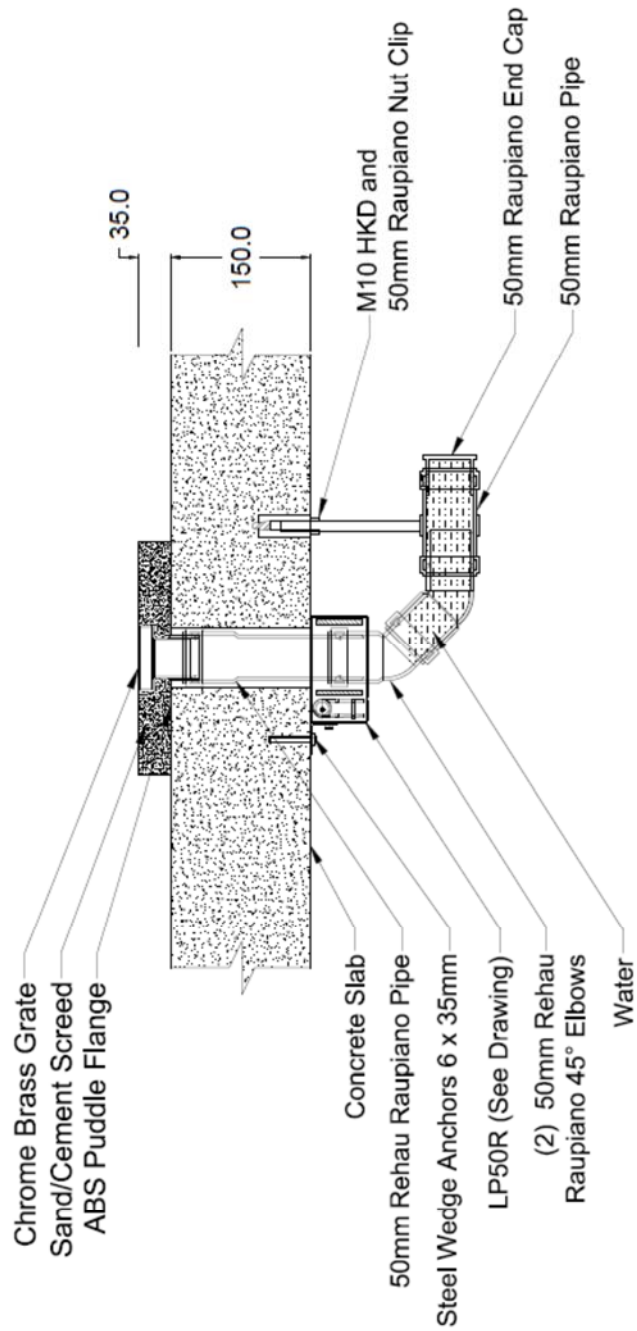
Test Slab S-15-E Penetration # 3
 50mm Raupiano Pipe – Floorwaste + Fitting Inside Collar – LP50R
 Date 21 Sept. 2015

DRAWING TITLED “TEST SLAB S-15-E PENETRATION # 3 50-MM RAUPIANO PIPE – FLOORWASTE + FITTING INSIDE COLLAR – LP50R”, DATED 21 SEPTEMBER 2015, BY SNAP FIRE SYSTEMS PTY LTD

The collar was fixed to the underside of the slab with steel wedge anchors 6 x 35-mm as shown in drawing titled “Test Slab S-15-E Penetration # 3 50-mm Raupiano Pipe – Floorwaste + Fitting inside Collar – LP100R-B”, dated 21 September 2015, by Snap Fire Systems Pty Ltd.

The penetrating service comprised a 50-mm Raupiano pipe, with a wall thickness of 2-mm fitted through the LP50R Snap fire collar. The floor waste system was fitted with a chromed brass floor waste grate. A 35-mm thick cement screed was laid on top of the concrete slab and finished flush with the floor grate. On the exposed side of the slab, two (2) 50-mm Rehau Raupiano 45° elbows were fitted to the pipe within the collar, supported by a M10 HKD clamp and 50-mm Raupiano nut clip fixed to the concrete slab. On the exposed face, the penetration was capped using a 50-mm Raupiano end cap.

The floor waste gully was charged with water to the level shown in drawing titled “Test Slab S-15-E Penetration # 3 50-mm Raupiano Pipe – Floorwaste + Fitting inside Collar – LP50R”, dated 21 September 2015, by Snap Fire Systems Pty Ltd.

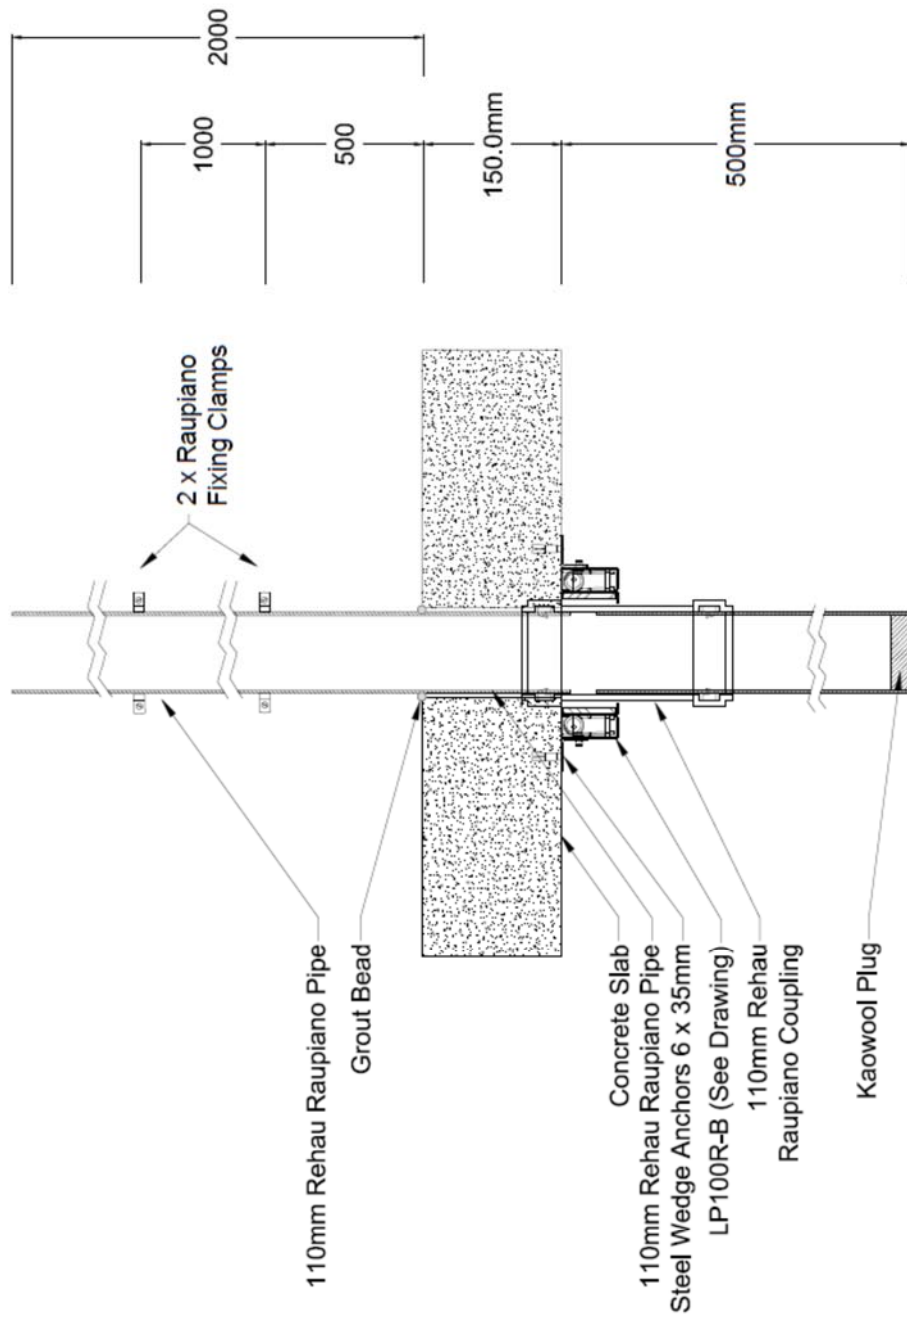
Test Slab S-15-E Penetration 4
 110mm Raupiano Pipe - Stack + Fitting Inside Collar - LP100R-B
 Date: 21 Sep 2015

DRAWING TITLED "TEST SLAB S-15-E PENETRATION # 4 110-MM RAUPIANO PIPE - STACK + FITTING INSIDE COLLAR - LP100R-B, DATED 21 SEPTEMBER 2015, BY SNAP FIRE SYSTEMS PTY LTD.

The collar was fixed to the underside of the slab with metal pin anchors 6 x 35-mm as shown in drawing titled “Test Slab S-15-E Penetration # 4 110-mm Raupiano Pipe – Stack + Fitting Inside Collar – LP100R-B, dated 21 September 2015, by Snap Fire Systems Pty Ltd.

The penetrating service comprised a 110-mm OD Rehau Raupiano PVC-SC pipe, with a wall thickness of 3-mm fitted through the LP100R-B Snap fire collar. The pipe projected vertically, 2000-mm above the concrete slab. The pipe was supported at 500-mm and 1000-mm from the unexposed face of the concrete slab. On the exposed face, 110-mm Rehau Raupiano Coupling was fitted to the penetration within the collar with the top lip recessed inside the slab. The penetration was capped using a Kaowool Plug.

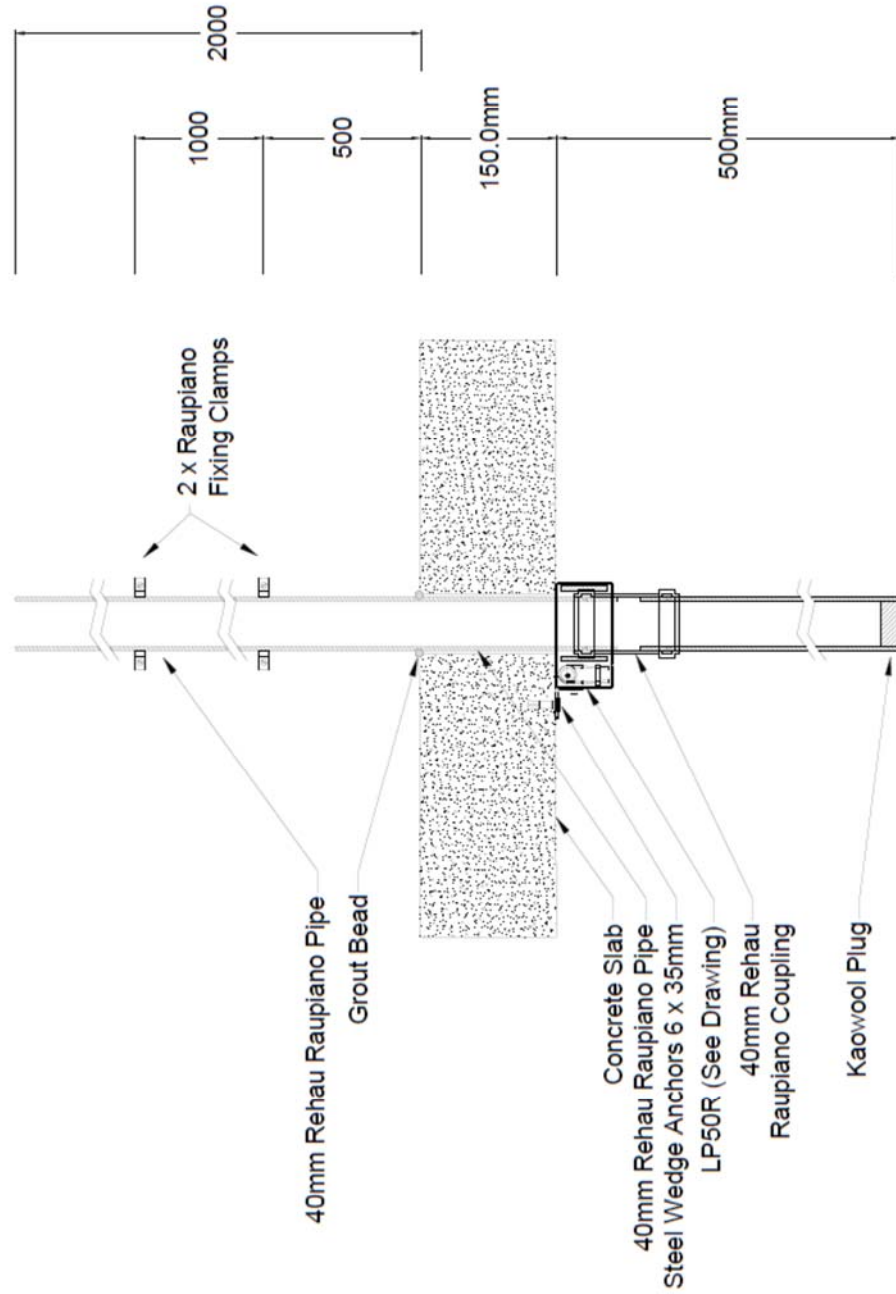
Test Slab S-15-E Penetration 5
 40mm Raupiano Pipe – Stack + Fitting Inside Collar – LP50R
 Date: 21Sep 2015

DRAWING TITLED “TEST SLAB S-15-E PENETRATION # 5 50-MM RAUPIANO PIPE – STACK + FITTING INSIDE COLLAR – LP50R”, DATED 21 SEPTEMBER 2015, BY SNAP FIRE SYSTEMS PTY LTD.

The collar was fixed to the underside of the slab with steel wedge anchors 6 x 35-mm as shown in drawing titled “Test Slab S-15-E Penetration # 5 40-mm Raupiano Pipe – Stack + Fitting inside Collar – LP50R”, dated 21 September 2015, by Snap Fire Systems Pty Ltd.

The penetrating service comprised a 40-mm OD Raupiano pipe stack, with a wall thickness of 2.1-mm fitted through the LP50R Snap fire collar. The pipe projected vertically, 2000-mm above the concrete slab. The pipe was supported at 500-mm and 1000-mm from the unexposed face of the concrete slab. On the exposed face a 40-mm Raupiano Coupling was fitted to the penetration within the collar. The penetration was capped using a Kaowool Plug.

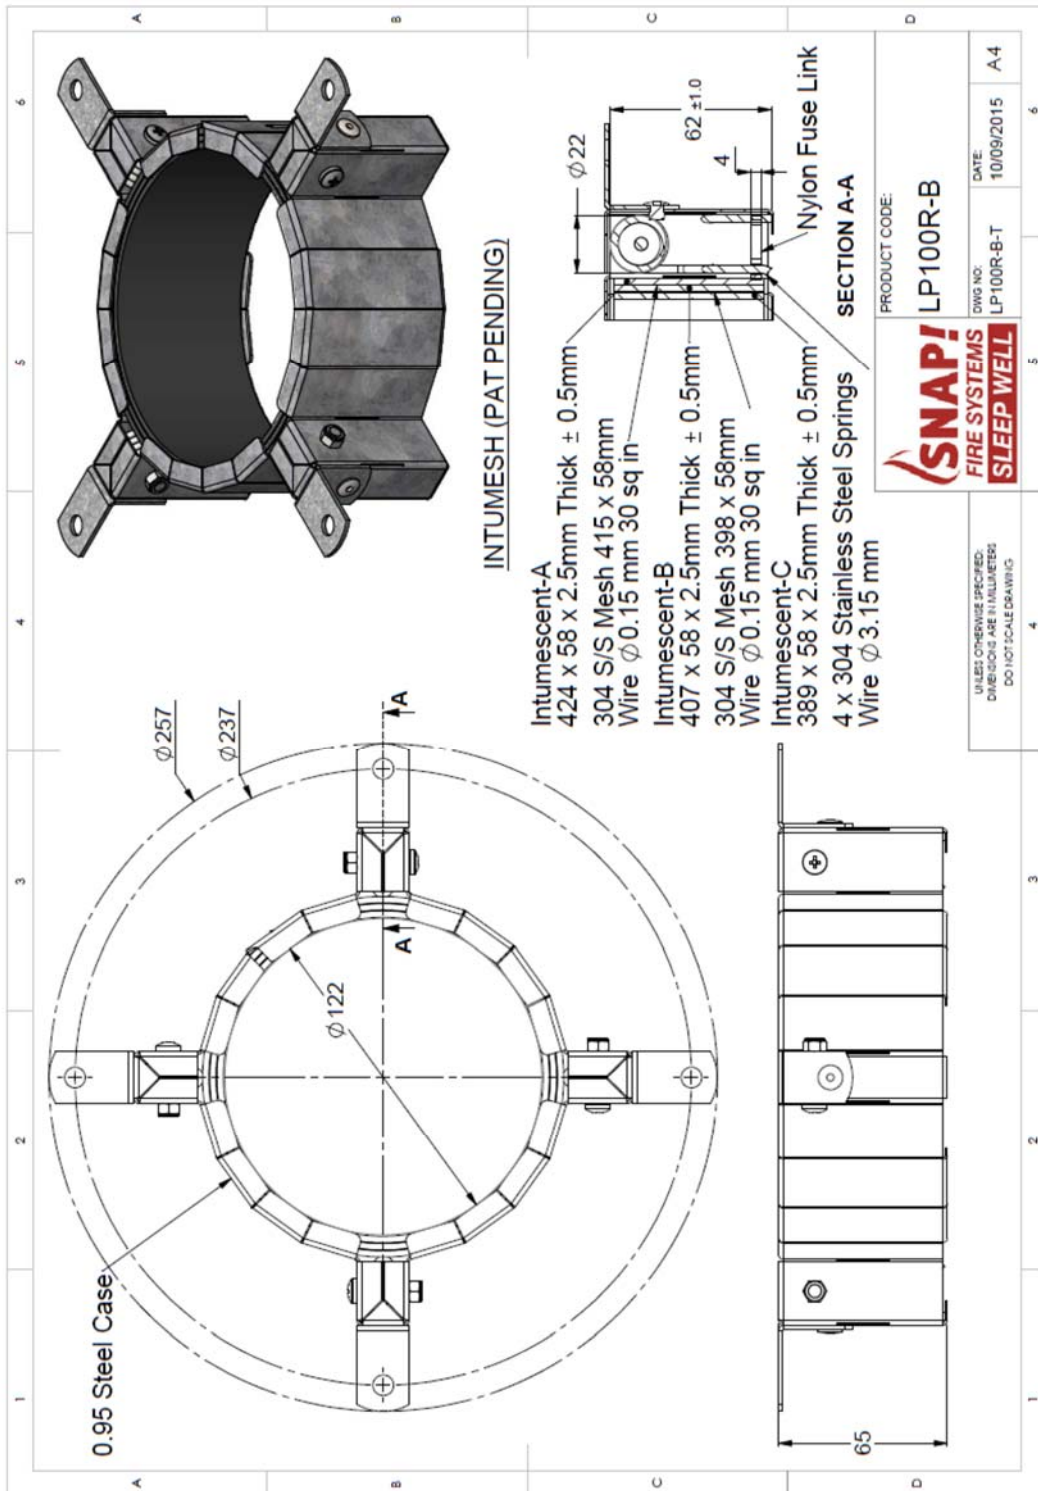
DRAWING NUMBERED LP100R-B, DATED 10 SEPTEMBER 2015, BY SNAP FIRE SYSTEMS PTY LTD.

The SNAP retrofitted LP100R-B fire collar comprised a 0.95 steel casing with a 122-mm inner diameter and a 257-mm diameter base flange. The 65-mm high collar casing incorporated:

- Intumesh Intumescent A - 424-mm x 58-mm x 2.5-mm thick intumescent material
- Intumesh Intumescent B – 407-mm x 58-mm x 2.5-mm thick intumescent material; and
- Intumesh Intumescent C – 389-mm x 58-mm x 2.5-mm thick intumescent material.

The closing mechanism comprised four stainless steel springs, nylon fuse links and a 304 stainless steel mesh measuring 415-mm x 58-mm, as shown in drawing numbered LP100R-B, dated 10 September 2015, by SNAP Fire Systems.
