Fire-resistance test on fire collars protecting a concrete slab penetrated by services

Test Report

Author: Mario Lara-Ledermann
Report number: FSP 1713
Date: 18 December 2015

Client: Snap Fire Systems Pty Ltd

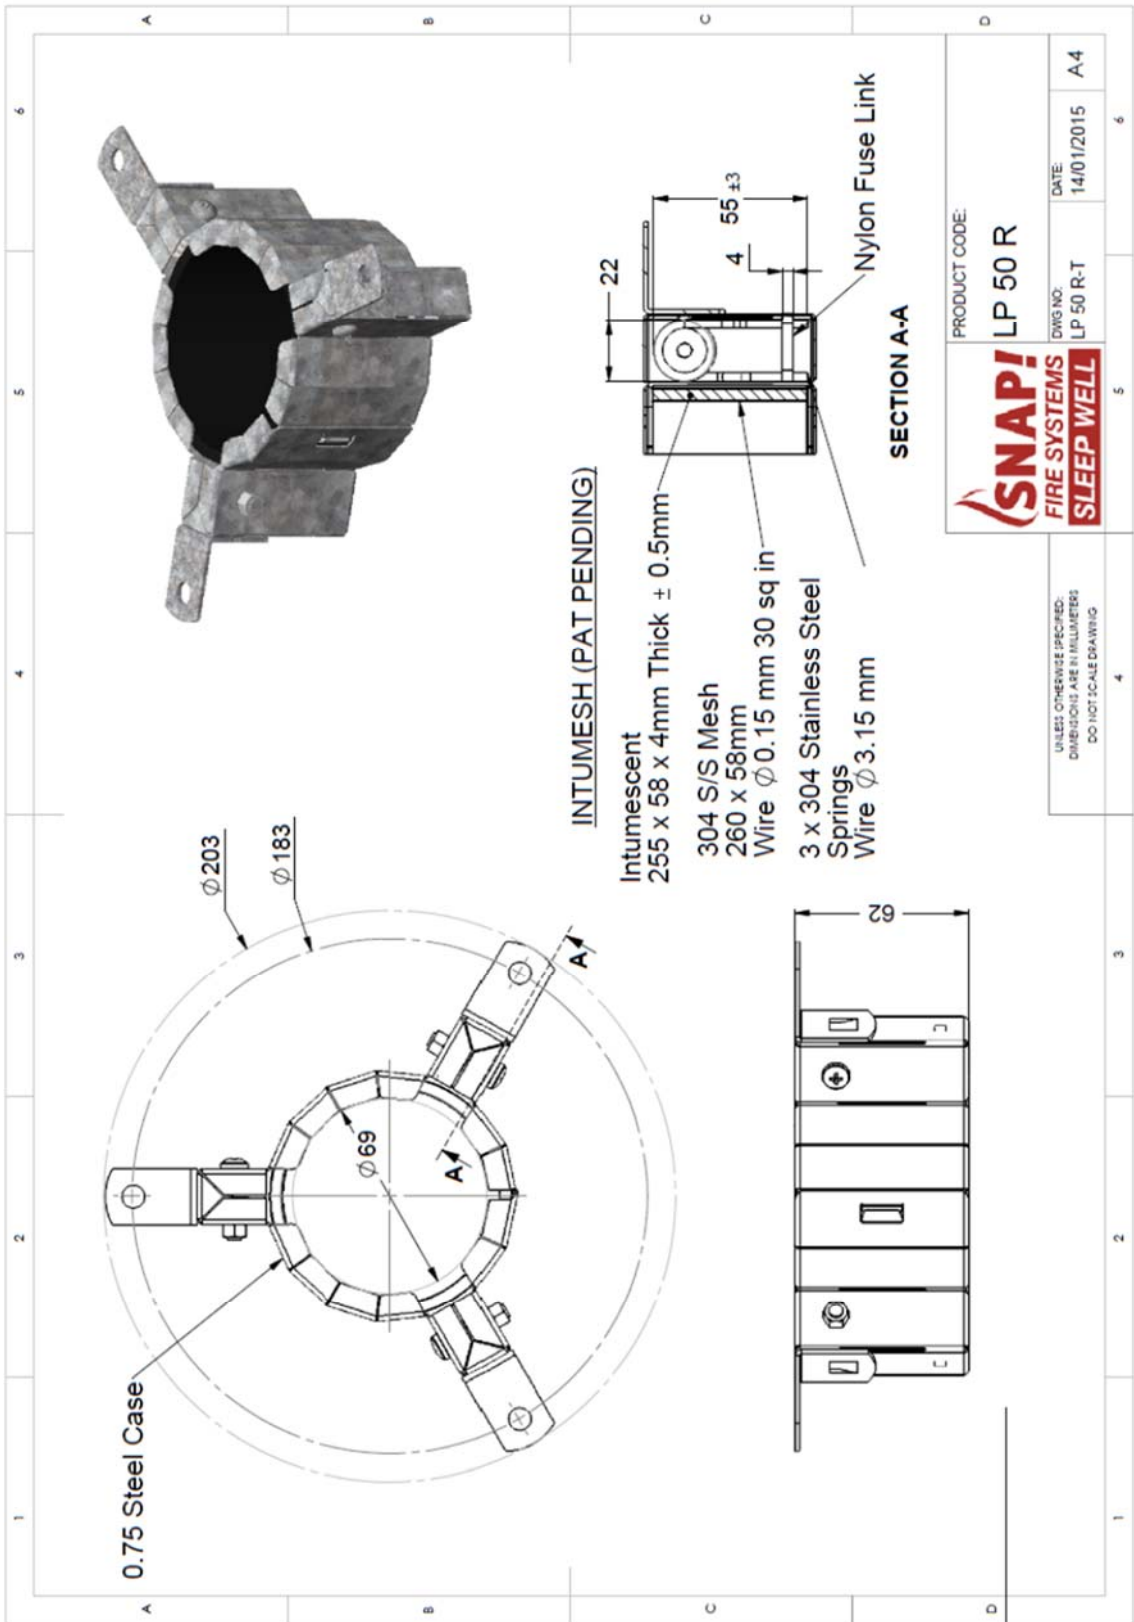
DRAWING NUMBERED LP50R-T, DATED 14 JANUARY 2015, BY SNAP FIRE SYSTEMS PTY LTD.

The SNAP retrofitted LP50R fire collar comprised a 0.75 steel casing with a 69-mm inner diameter and a 203-mm diameter base flange. The 62-mm high collar casing incorporated a 255 x 58 x 4-mm thick Intumesh Intumescent material.

The closing mechanism comprised three stainless steel springs, nylon fuse links and a 304 stainless steel mesh measuring 260-mm x 58-mm, as shown in drawing numbered LP50R-T, dated 14 January 2015, by Snap Fire Systems Pty Ltd.
