# Fire-resistance test on fire collars protecting a concrete floor slab penetrated by services

## Test Report

**Author:** Peter Gordon  
**Report number:** FSP 1872  
**Date:** 28 September 2018

## Sponsored Investigation No. FSP 1872

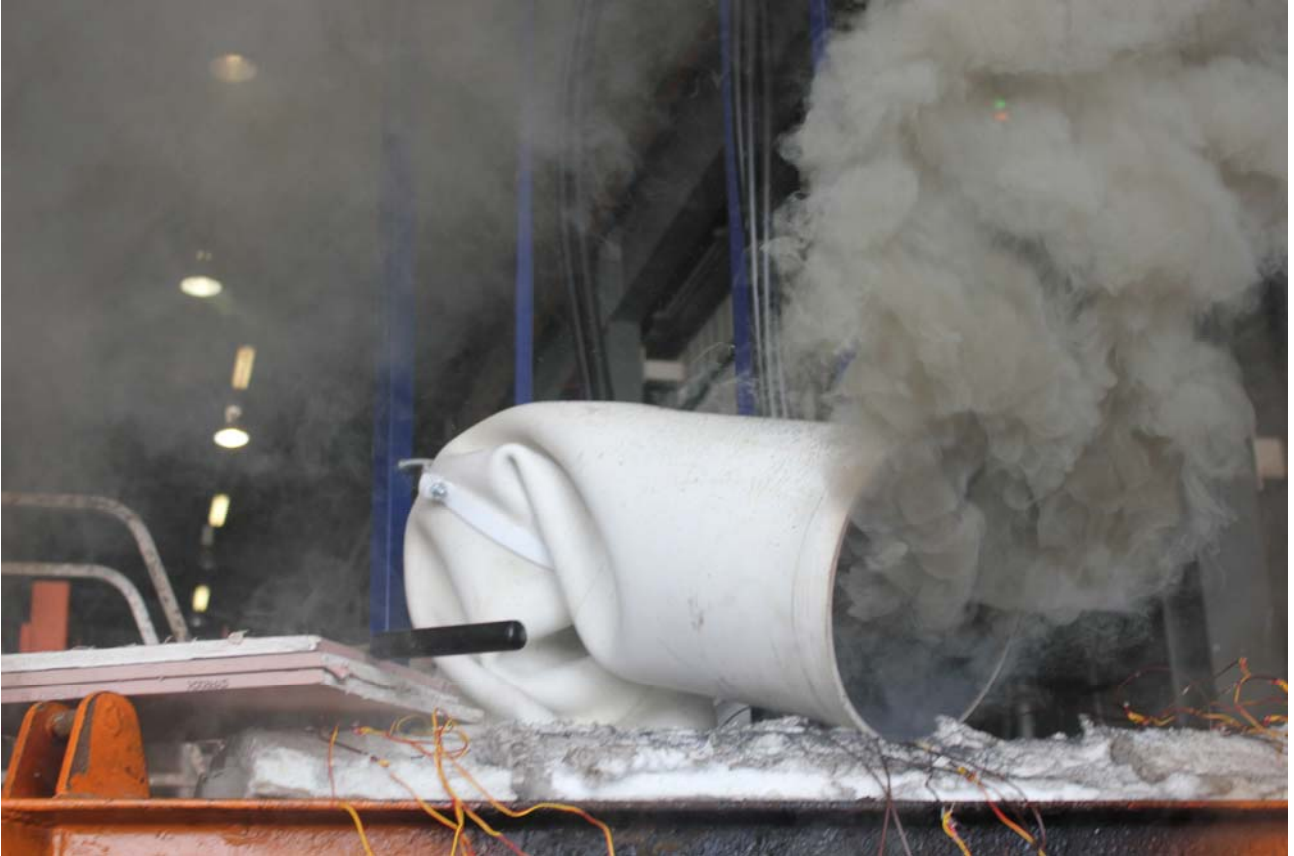
**PHOTOGRAPH 3 – PENETRATION 1 AFTER 7 MINUTES OF TESTING**

| Time | Observation |
|---|---|
| 7 minutes - | Base of Penetration 1 is starting to deform and collapse (photograph 3), Thermocouple 2 dislodged.. |

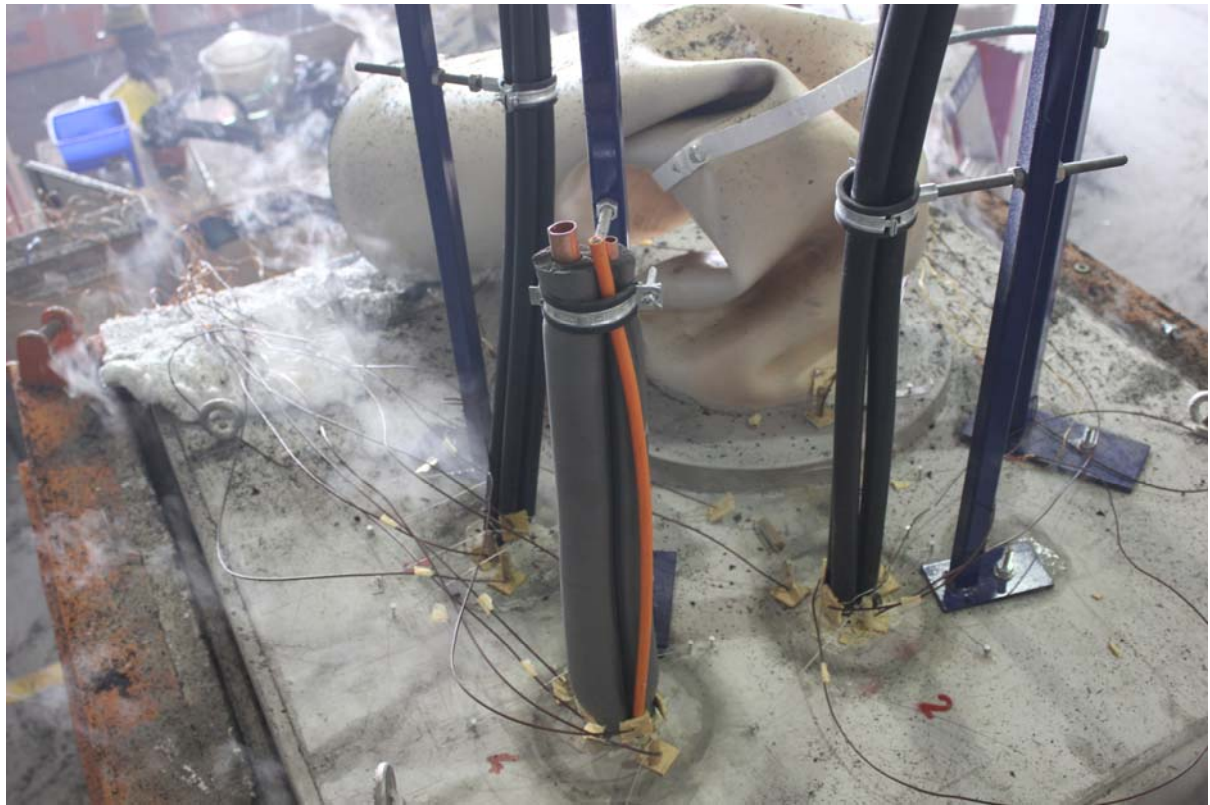
**PHOTOGRAPH 5 – PENETRATIONS AFTER 60 MINUTES OF TESTING**

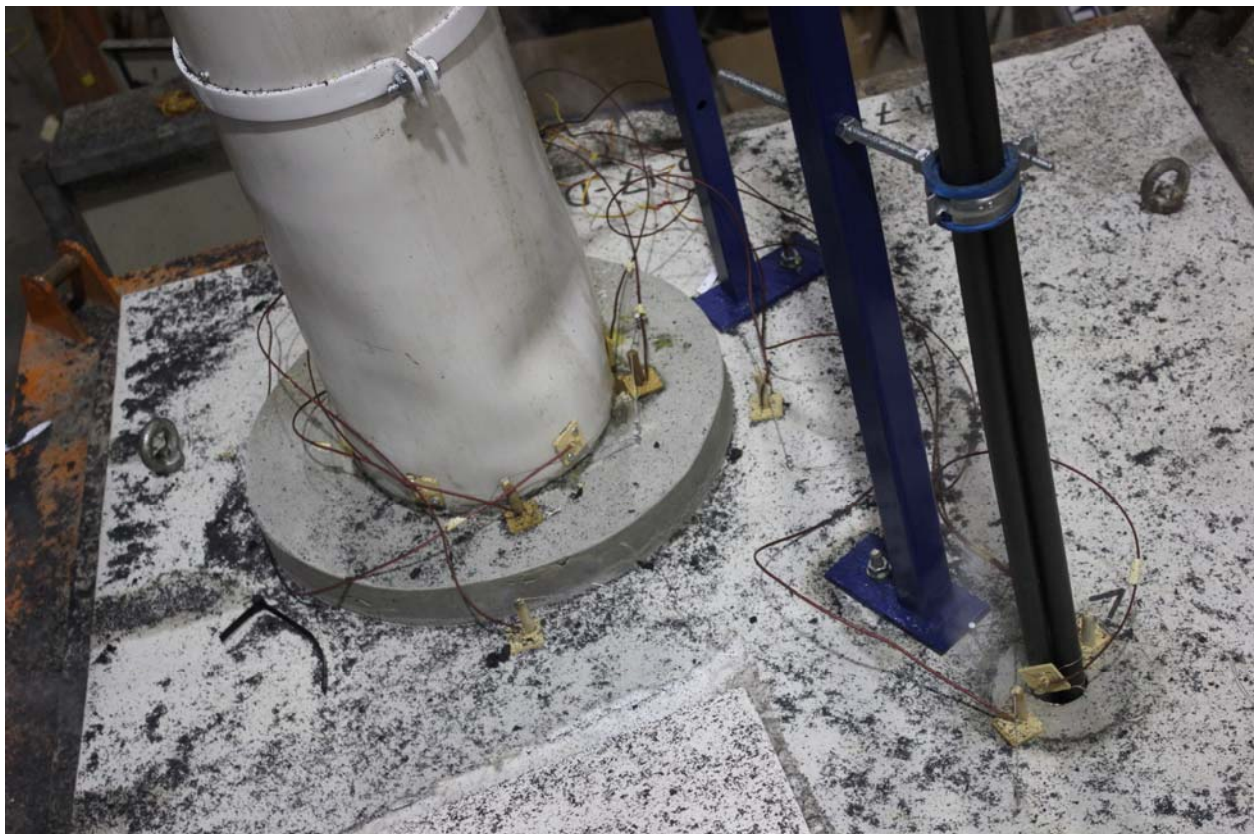
**PHOTOGRAPH 6 – PENETRATIONS AFTER 120 MINUTES OF TESTING**

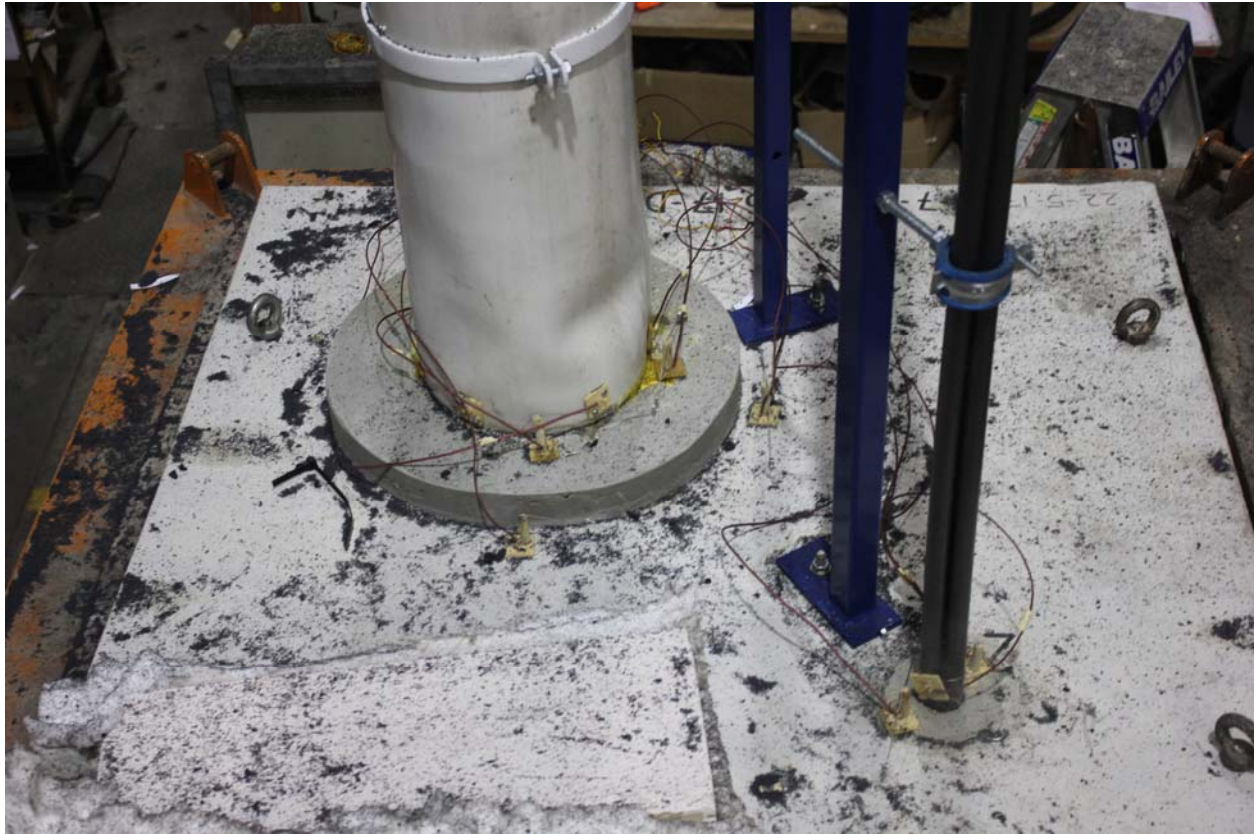
**PHOTOGRAPH 7 – PENETRATIONS AFTER 180 MINUTES OF TESTING**

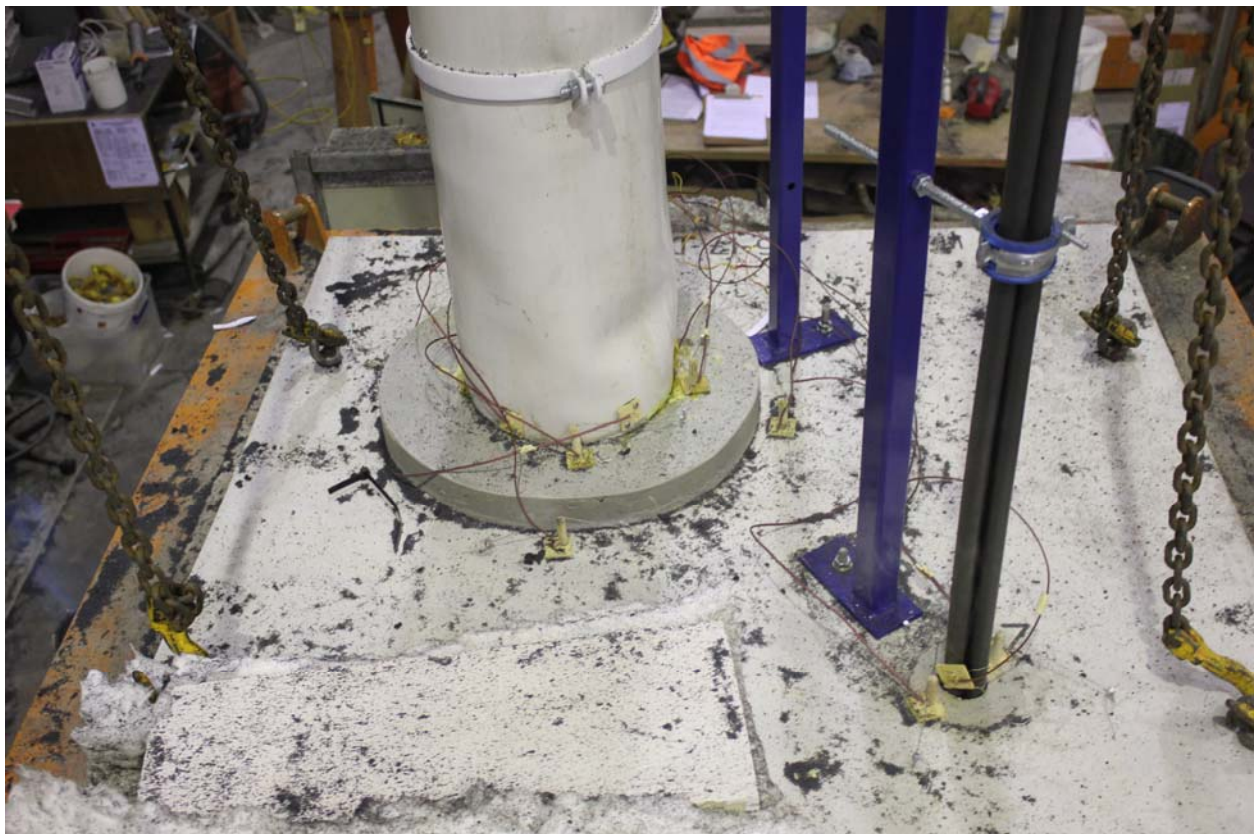
**PHOTOGRAPH 8 – UNEXPOSED FACED OF PENETRATION AT CONCLUSION OF TESTING**
