Fire-resistance test on fire collars protecting a concrete floor slab penetrated by services

Test Report

Author: Chris Wojcik
Report number: FSP 1883
Date: 14 August 2018

Sponsored Investigation No. FSP 1883

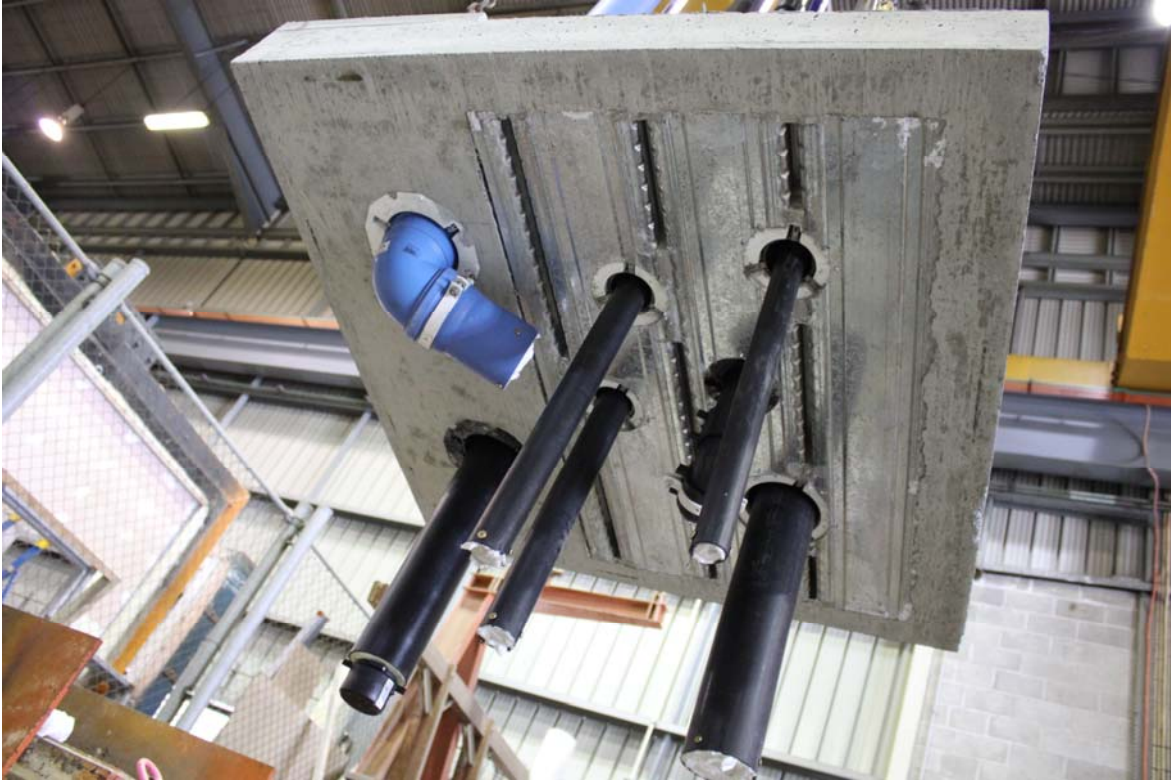
PHOTOGRAPH 1 – EXPOSED FACE OF SPECIMENS PRIOR TO TESTING

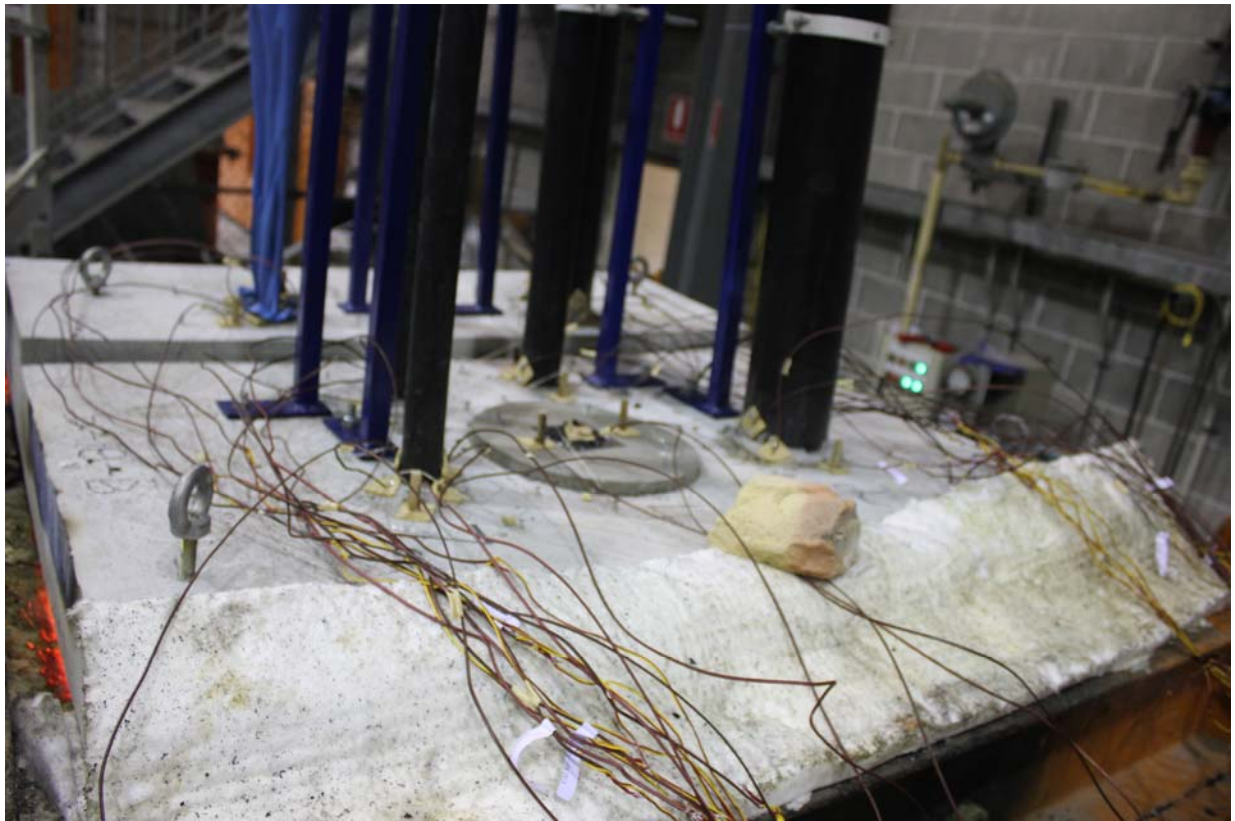
PHOTOGRAPH 5 – SPECIMENS AFTER 180 MINUTES OF TESTING

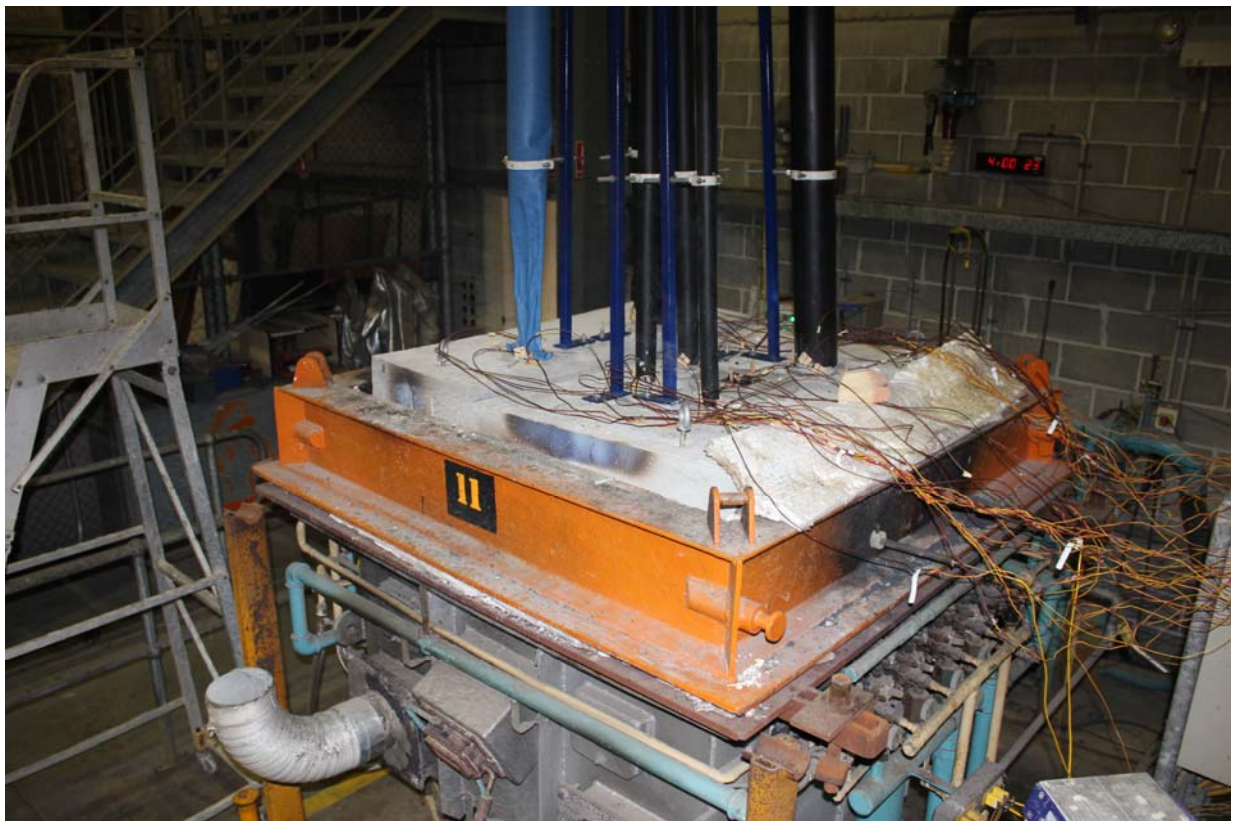
PHOTOGRAPH 6 – UNEXPOSED FACED OF SPECIMEN AT CONCLUSION OF TESTING

- 210 minutes - Smoke is being emitted from the grate on Penetration 4.
- 230 minutes - Smoke is being emitted from the intumescent seal on Penetration 7.
- 241 minutes - Test terminated

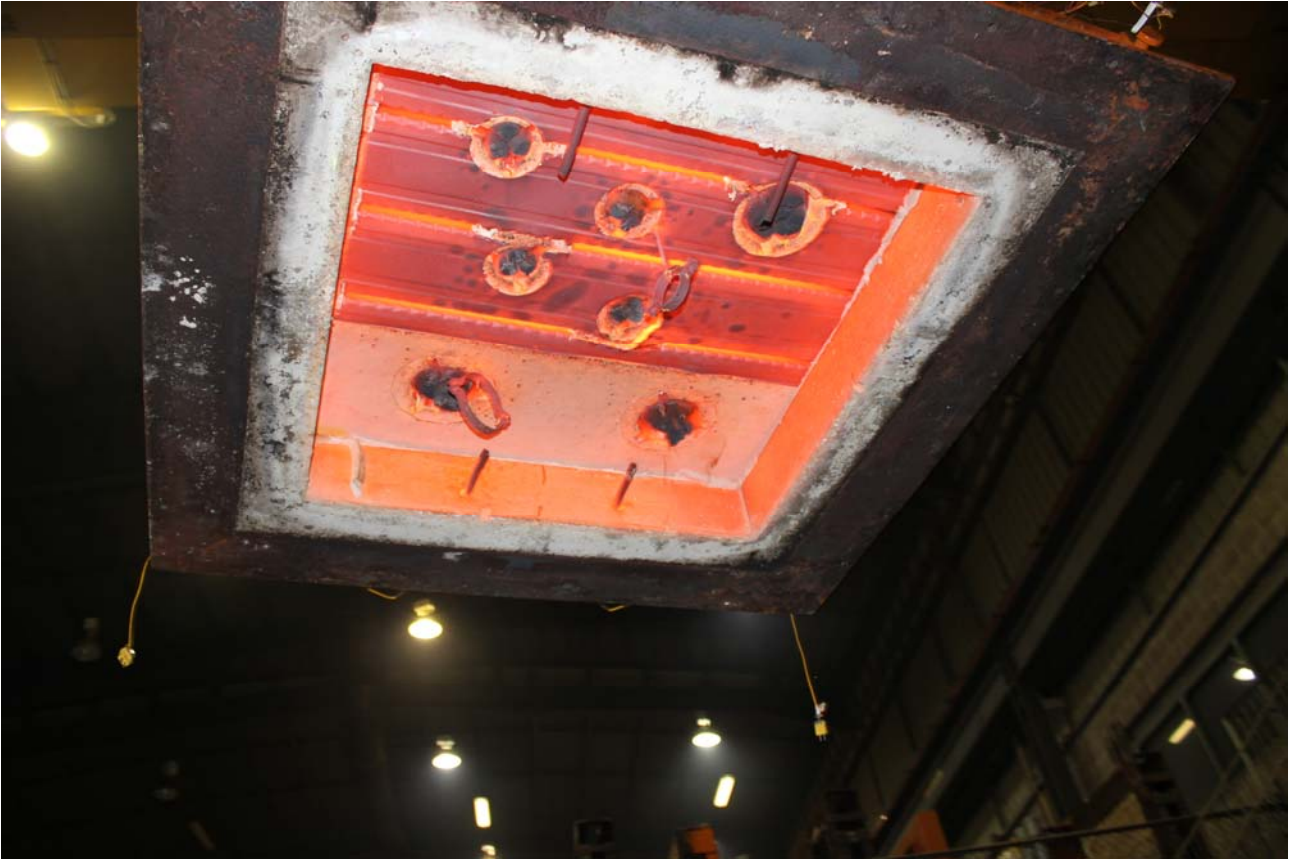
PHOTOGRAPH 7 – EXPOSED FACE OF SPECIMENS AT CONCLUSION OF TESTING
