Fire-resistance test on fire collars protecting a concrete floor slab penetrated by services

Test Report

Author: Chris Wojcik
Report number: FSP 1891
Date: 7 May 2018

Sponsored Investigation No. FSP 1891

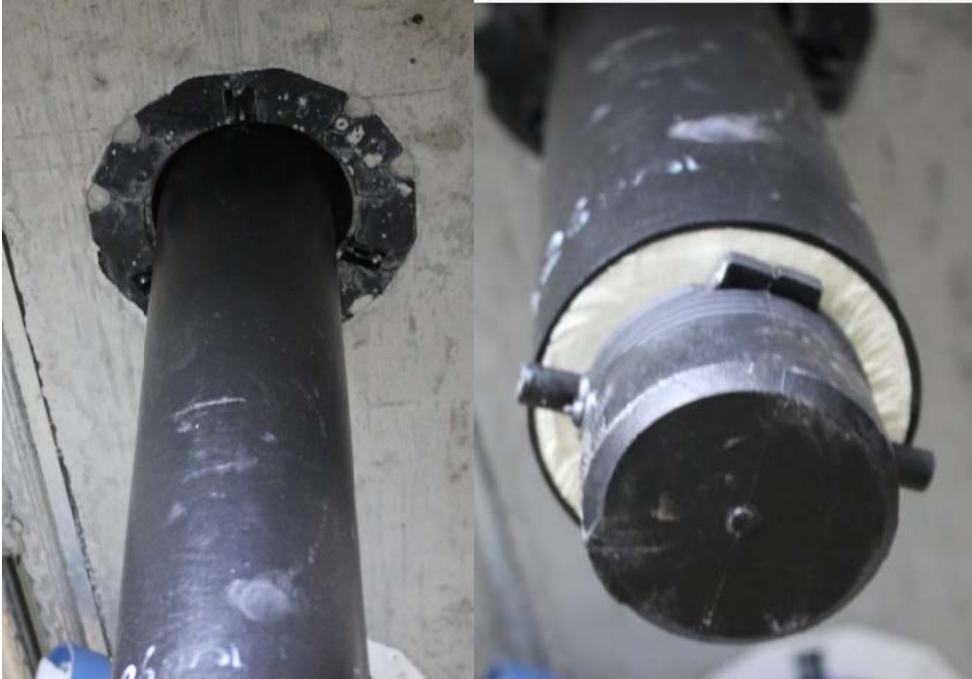
PHOTOGRAPH 1 – EXPOSED FACE OF SPECIMEN PRIOR TO TESTING

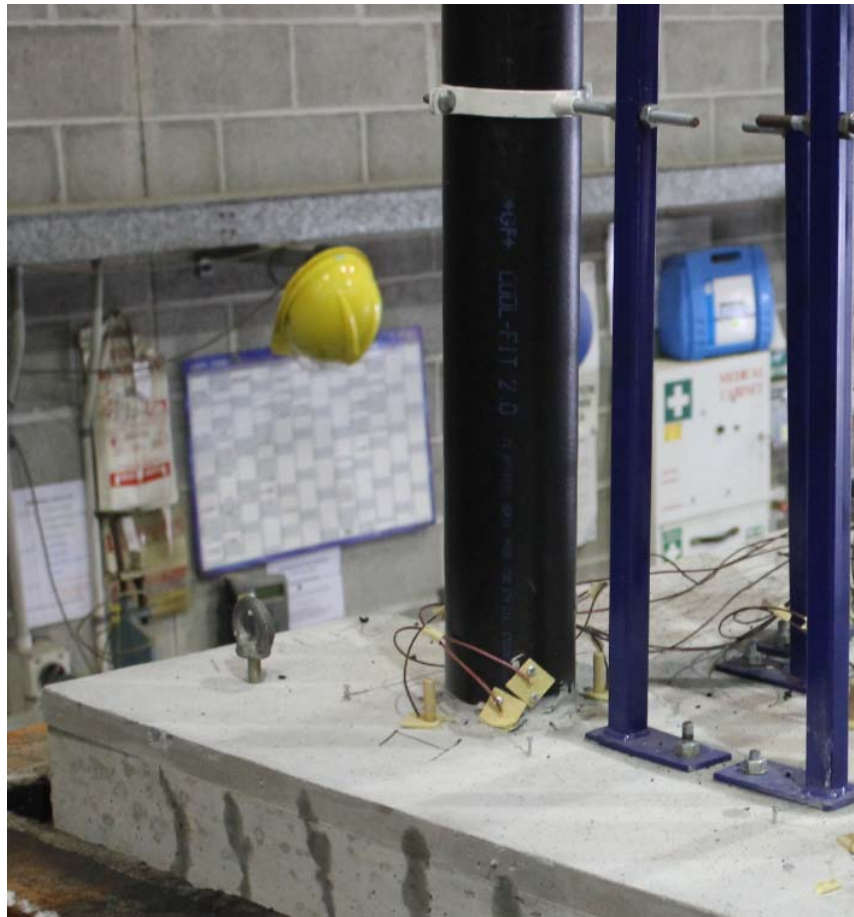
PHOTOGRAPH 3 – SPECIMENS AFTER 30 MINUTES OF TESTING

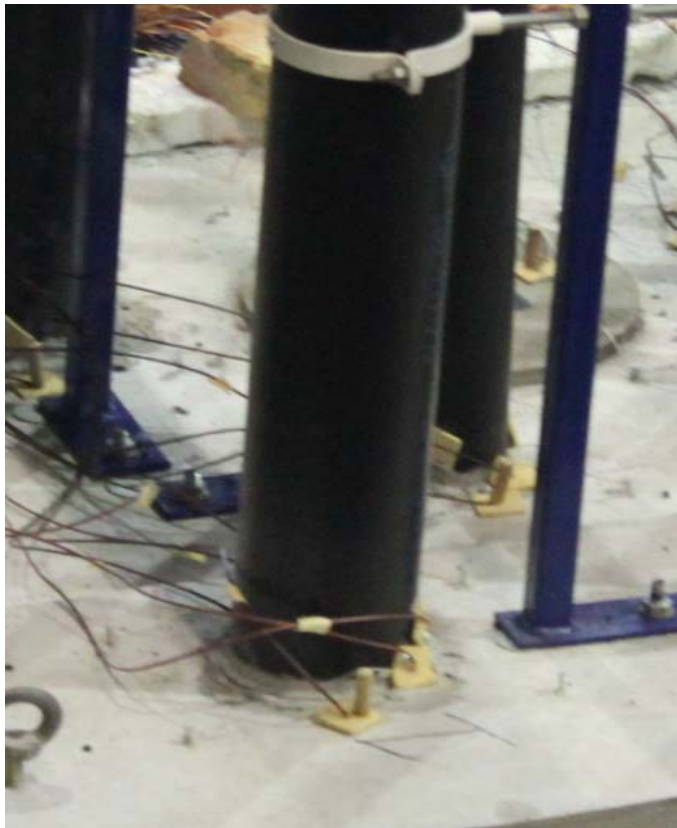
PHOTOGRAPH 5 – SPECIMENS AFTER 120 MINUTES OF TESTING

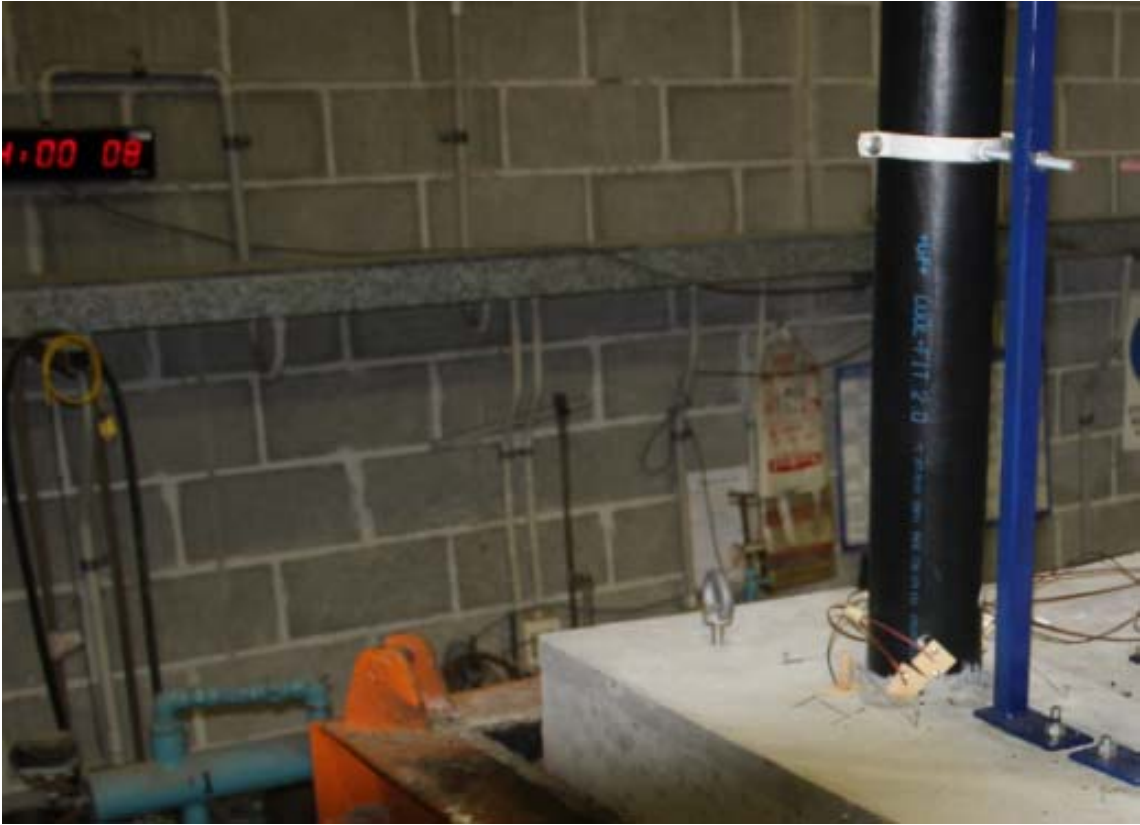
PHOTOGRAPH 7 – UNEXPOSED FACED OF SPECIMEN AT CONCLUSION OF TESTING

Time	Observation
9:30 minutes -	Penetration 1 is fluing smoke.
22 minutes -	Penetration 1 has ceased fluing smoke.
90 minutes -	No apparent change to unexposed face of specimen.
138 minutes -	Mastic is swelling at the base of Penetration 1.
241 minutes -	Test terminated.

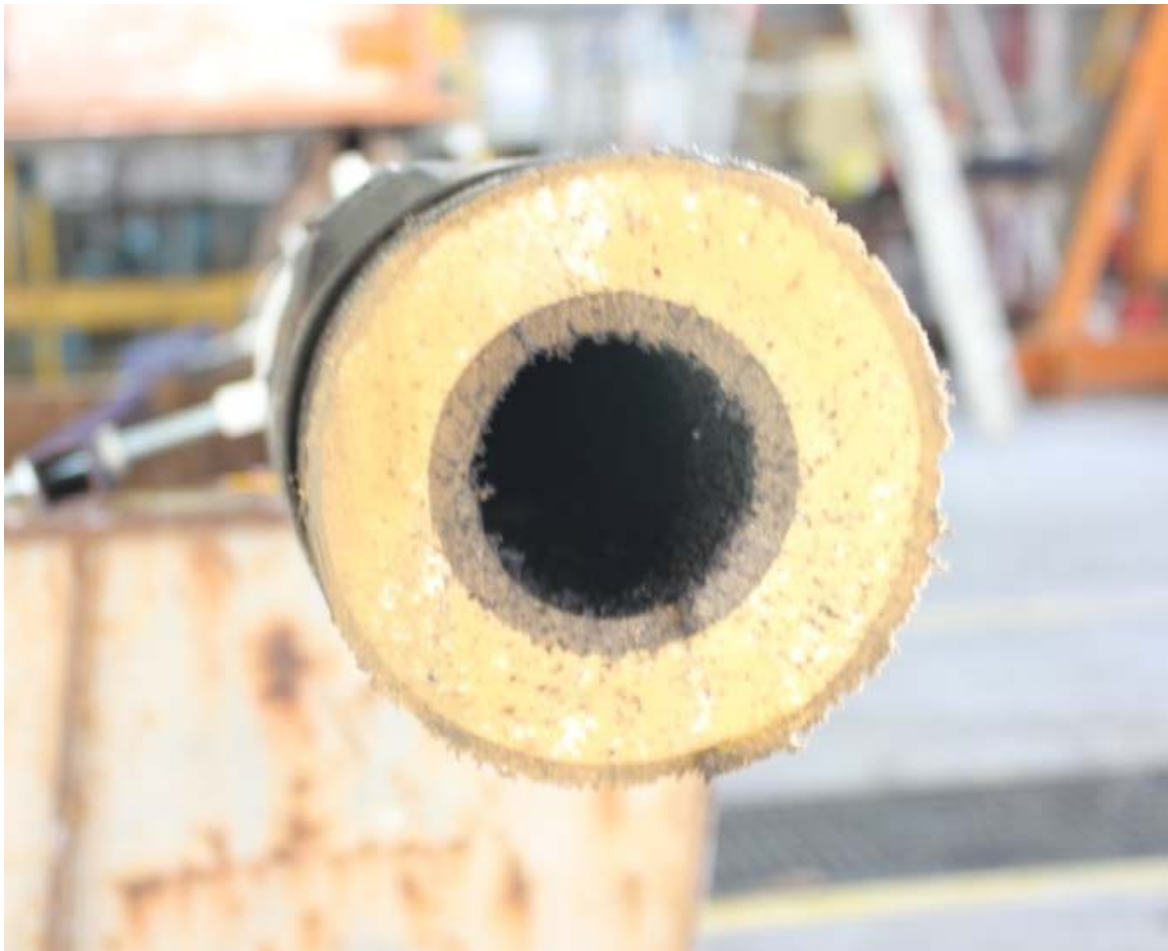
PHOTOGRAPH 9 – CROSS SECTION OF PIPE AT CONCLUSION OF TESTING
