Fire-resistance test on fire collars protecting a plasterboard wall penetrated by services

Test Report

Author: Peter Gordon
Report number: FSP 1932
Date: 13 December 2018

Sponsored Investigation No. FSP 1932

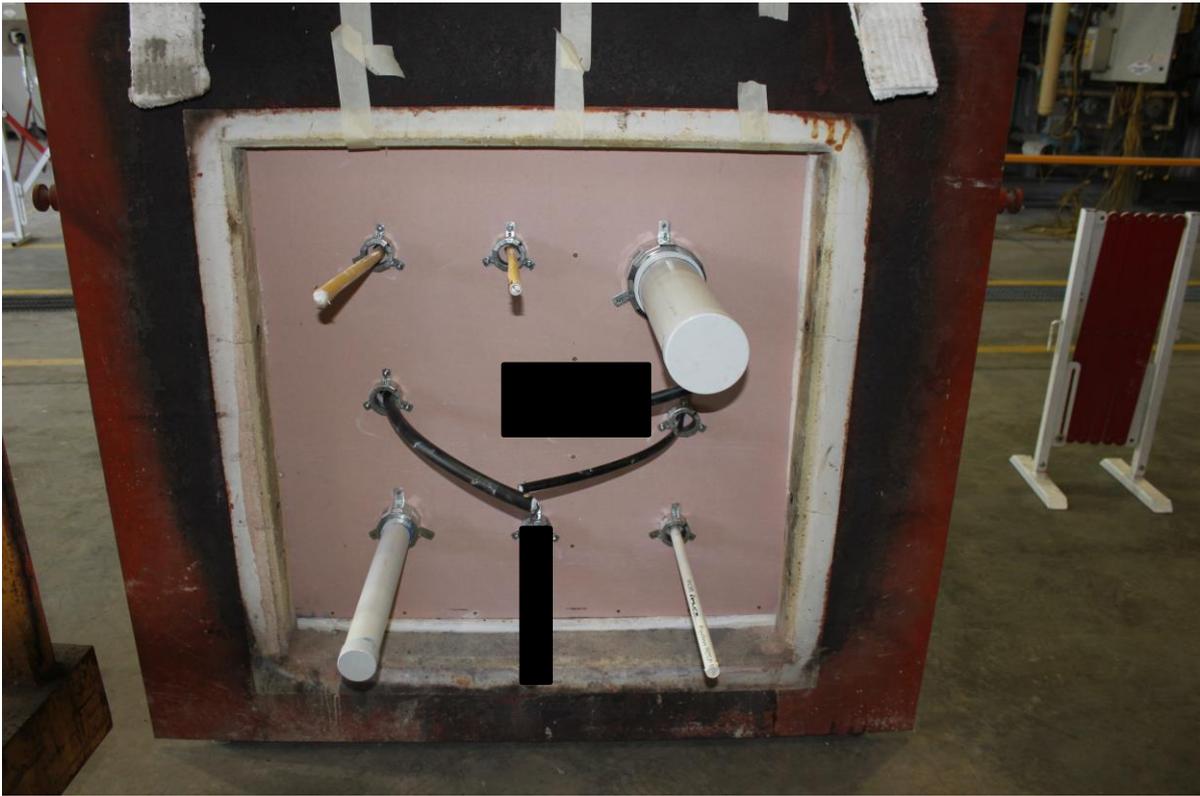
PHOTOGRAPH 1 – EXPOSED FACE OF SPECIMENS PRIOR TO TESTING

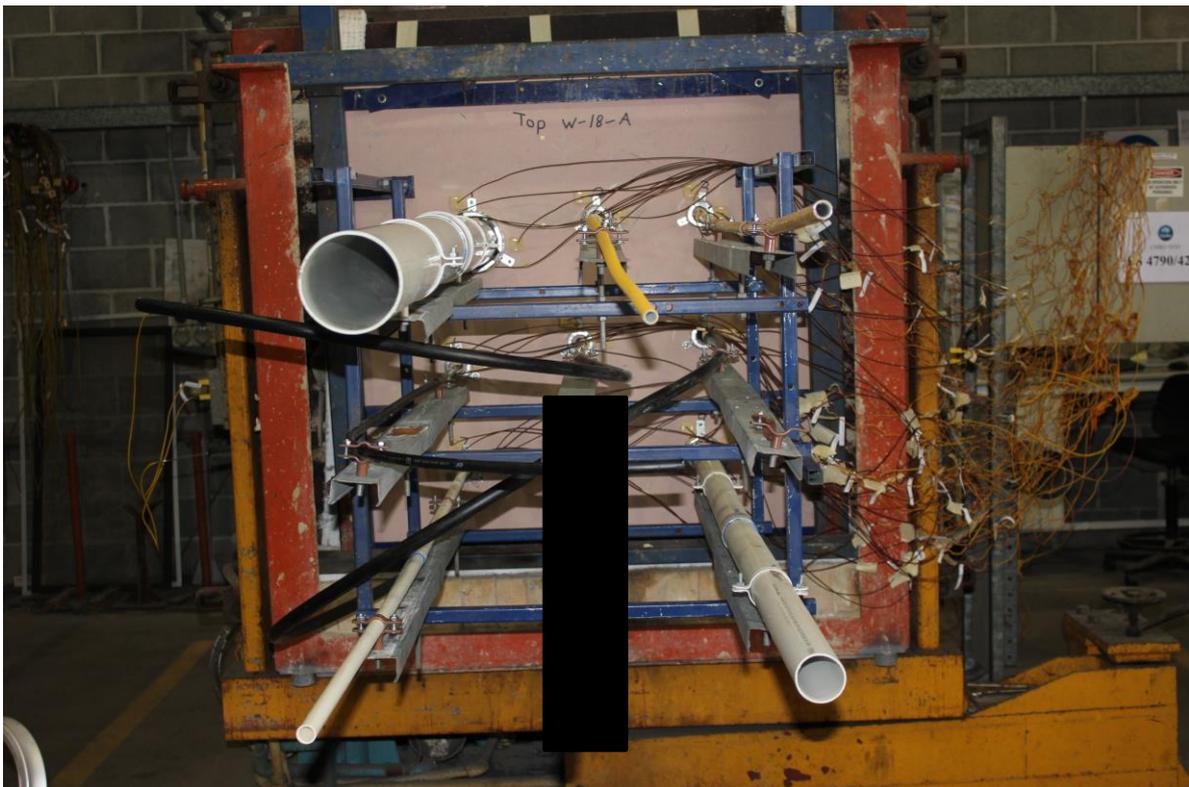
PHOTOGRAPH 2 – UNEXPOSED FACE OF SPECIMENS PRIOR TO TESTING

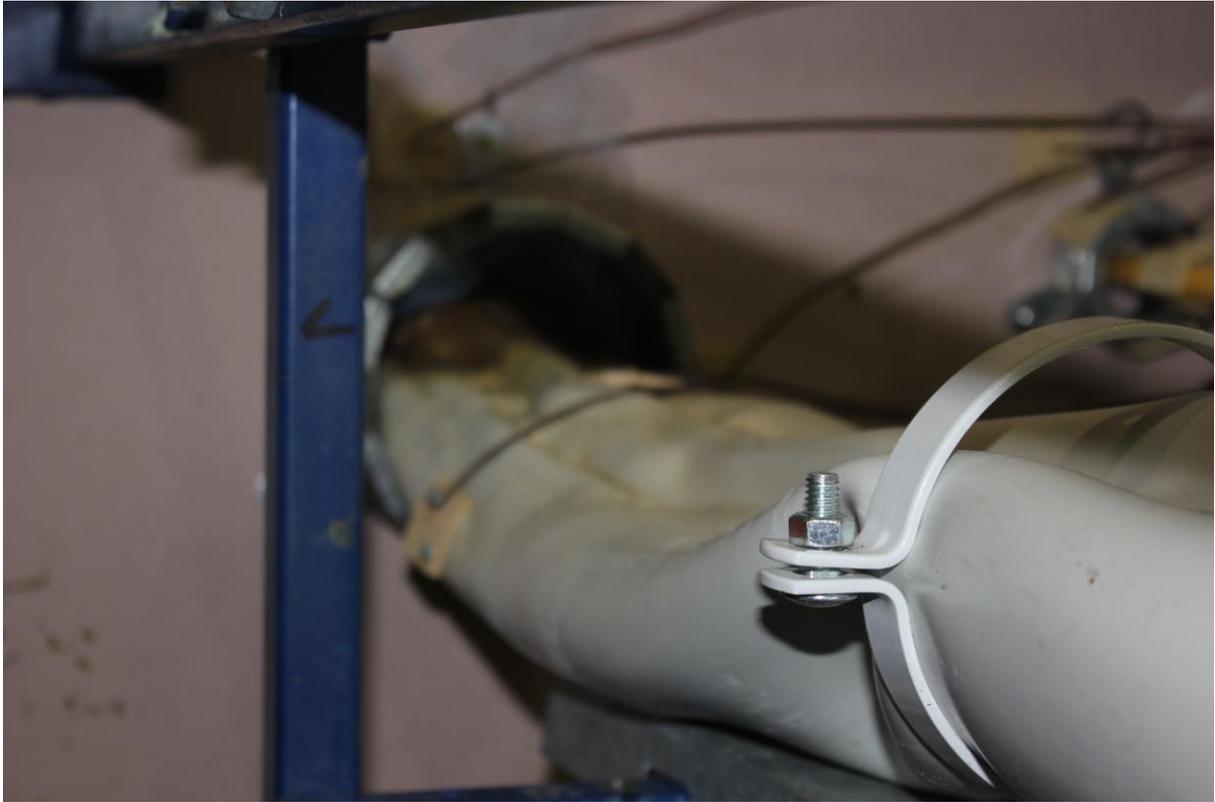
PHOTOGRAPH 3 – SPECIMEN 1 AFTER 4 MINUTES OF TESTING

Time	Observation
1 minute	- Smoke is being emitted from the collars of all 9 specimens.
2 minutes	- Smoke is fluing from Specimens 1.
4 minutes	- The pipe from Specimen 1 has distorted.
5 minutes	- Smoke is fluing from Specimen 9.
6 minutes	- Smoke has ceased fluing from Specimen 1.
11 minutes	- Smoke continues to be emitted from around the collar of Specimen 7, with no smoke fluing from the end of pipe.
17 minutes	- Smoke continues to be emitted from the collars of all 9 specimens.
30 minutes	- No further visible change to specimens.
37 minutes	- Smoke is fluing from the end of pipes of Specimens 4 and 6.
42 minutes	- Discolouration to the pipe of Specimen 9.
45 minutes	- Smoke is fluing from the end of pipes of Specimens 4 and 6.
49 minutes	- Smoke is fluing from the end of pipes of Specimen 6.
60 minutes	- <u>Insulation Failure - Specimens 1 and 6</u> – maximum temperature rise of 180K is exceeded on the plasterboard 25-mm from the collars of Specimens 1 and 6. Plasterboard starting to discolour.

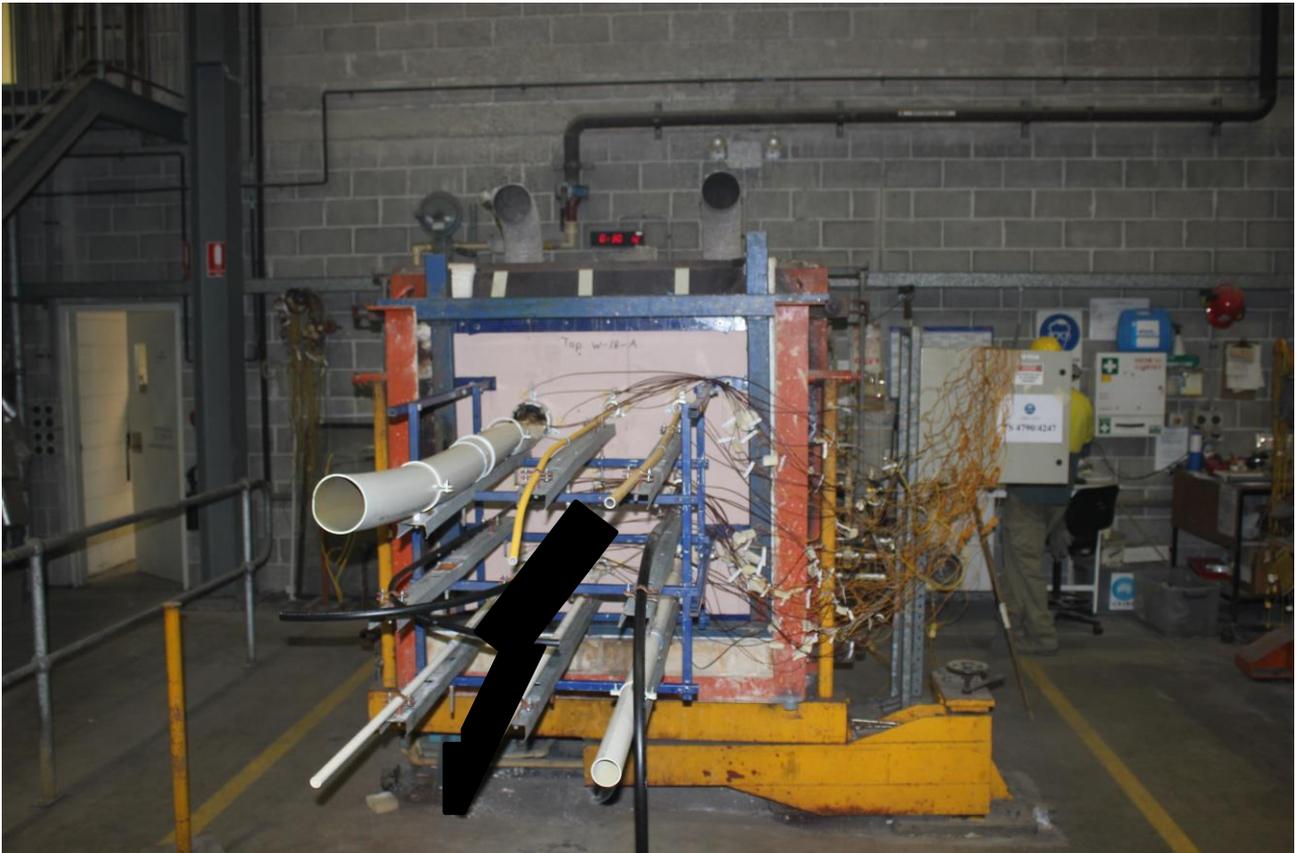
PHOTOGRAPH 4 – SPECIMENS AFTER 30 MINUTES OF TESTING

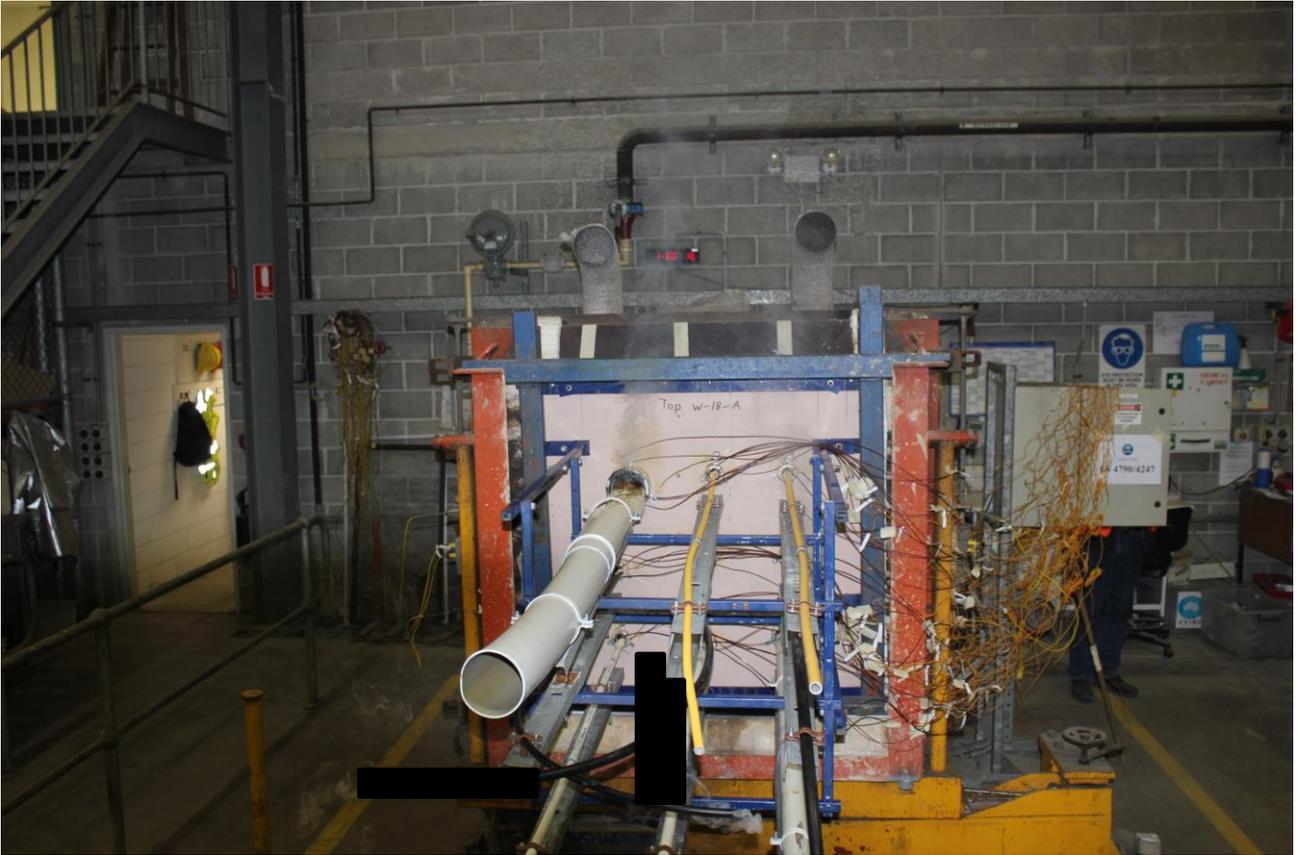
PHOTOGRAPH 5 – SPECIMENS AFTER 60 MINUTES OF TESTING

61 minutes	- <u>Insulation Failure - Specimen 4</u> – maximum temperature rise of 180K is exceeded on the plasterboard 25-mm from the collar of Specimen 4.
62 minutes	- <u>Insulation Failure Specimens 2 and 7</u> – maximum temperature rise of 180K is exceeded on the plasterboard 25-mm from the collars of Specimens 2 and 7. Test terminated.

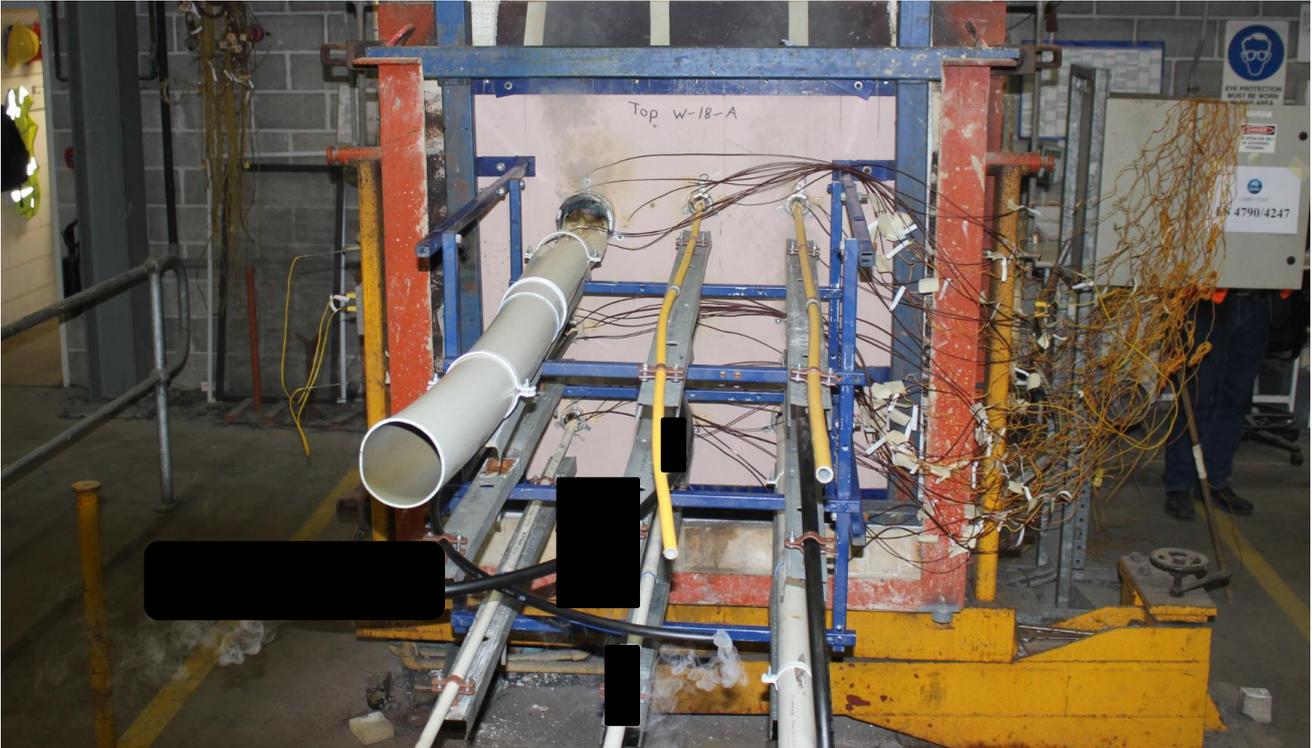
PHOTOGRAPH 6 – SPECIMENS AT CONCLUSION OF TESTING
