Fire-resistance test on fire collars protecting a plasterboard wall penetrated by services

Test Report

Report number: FSP 1985

Sponsored Investigation No. FSP 1985

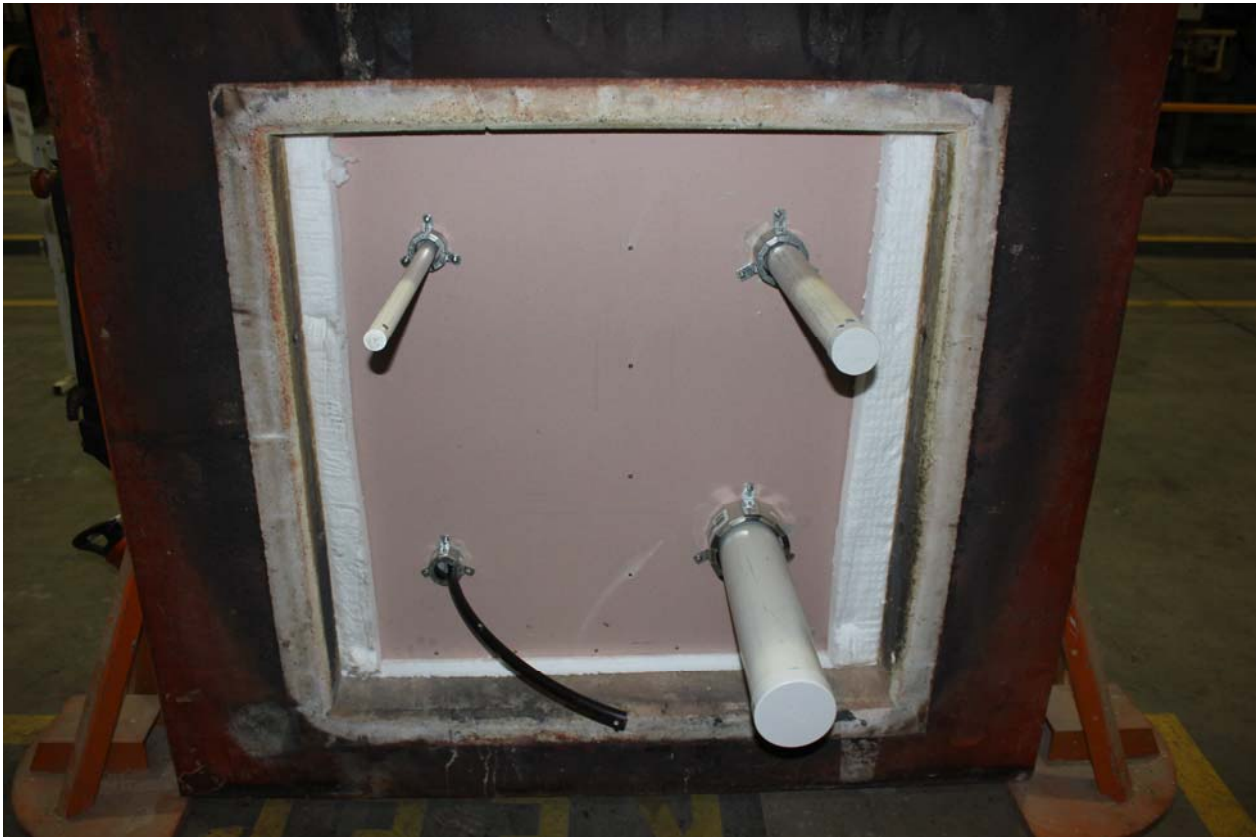
PHOTOGRAPH 1 – EXPOSED FACE OF SPECIMENS PRIOR TO TESTING

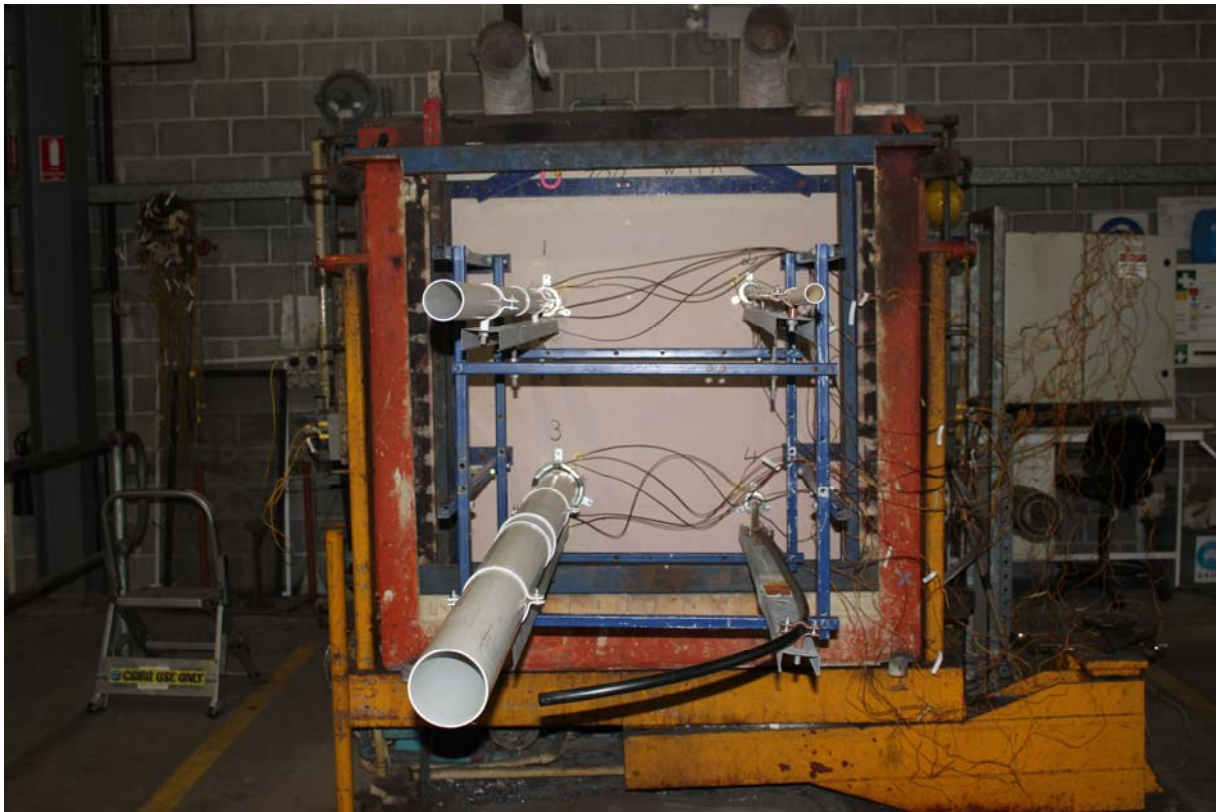
PHOTOGRAPH 2 – UNEXPOSED FACE OF SPECIMENS PRIOR TO TESTING

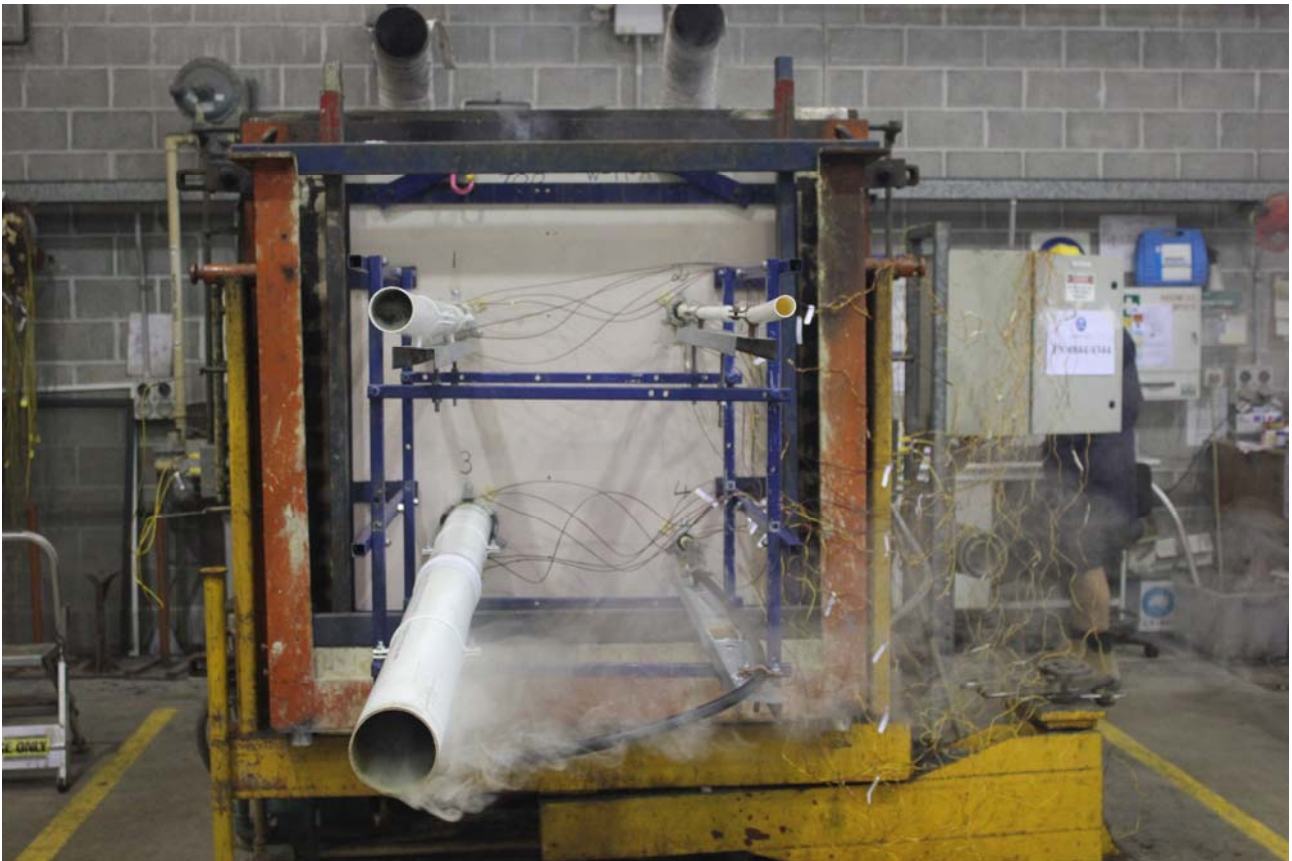
PHOTOGRAPH 3 – SPECIMENS AFTER 30 MINUTES OF TESTING

Time	Observation
2 minutes -	Smoke is fluing from Specimen 1.
3 minutes -	Smoke is being emitted from the collars of Specimens 3 and 4.
4 minutes -	Smoke is fluing from the end of Specimen 3.
5 minutes -	Smoke is fluing from the end of Specimen 4.
7 minutes -	Smoke has ceased fluing from the end of Specimens 1 and 4.
8 minutes -	Smoke is being emitted from the furnace flues.
9 minutes -	Smoke has ceased fluing from the end of Specimen 3.
10 minutes -	Smoke is being emitted from the furnace flues.
15 minutes -	A small amount of smoke is fluing from the collars of Specimens 2 and 3.
17 minutes -	A small amount of smoke is fluing from Specimen 3.
25 minutes -	A small amount of smoke is fluing from Specimens 1, 3 and 4.
31 minutes -	Discolouration at the base of pipe of Specimen 3.
39 minutes -	Smoke now fluing from the end of all specimens.
40 minutes -	Smoke fluing from the collars of all specimens.
53 minutes -	The pipe of Specimen 2 near collar has started charring.

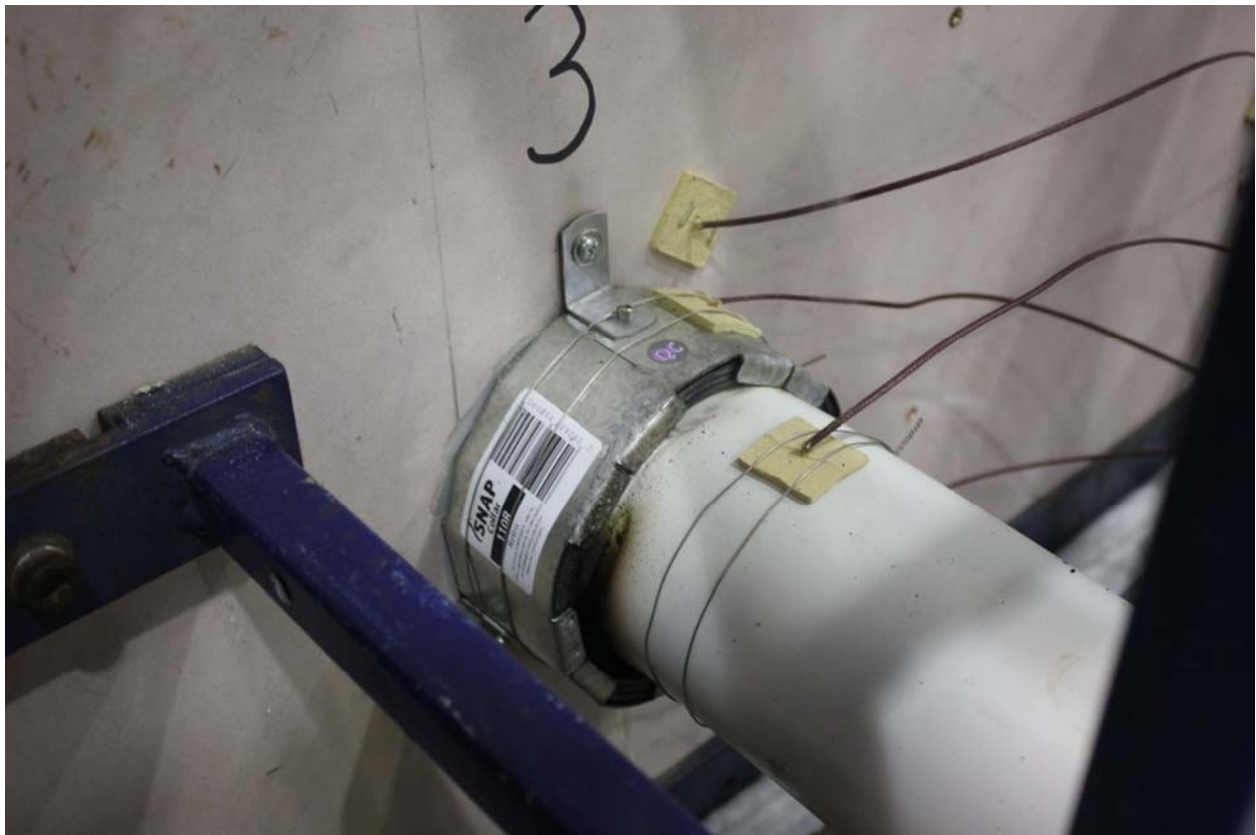
PHOTOGRAPH 4 – SPECIMEN 3 AFTER 31 MINUTES OF TESTING

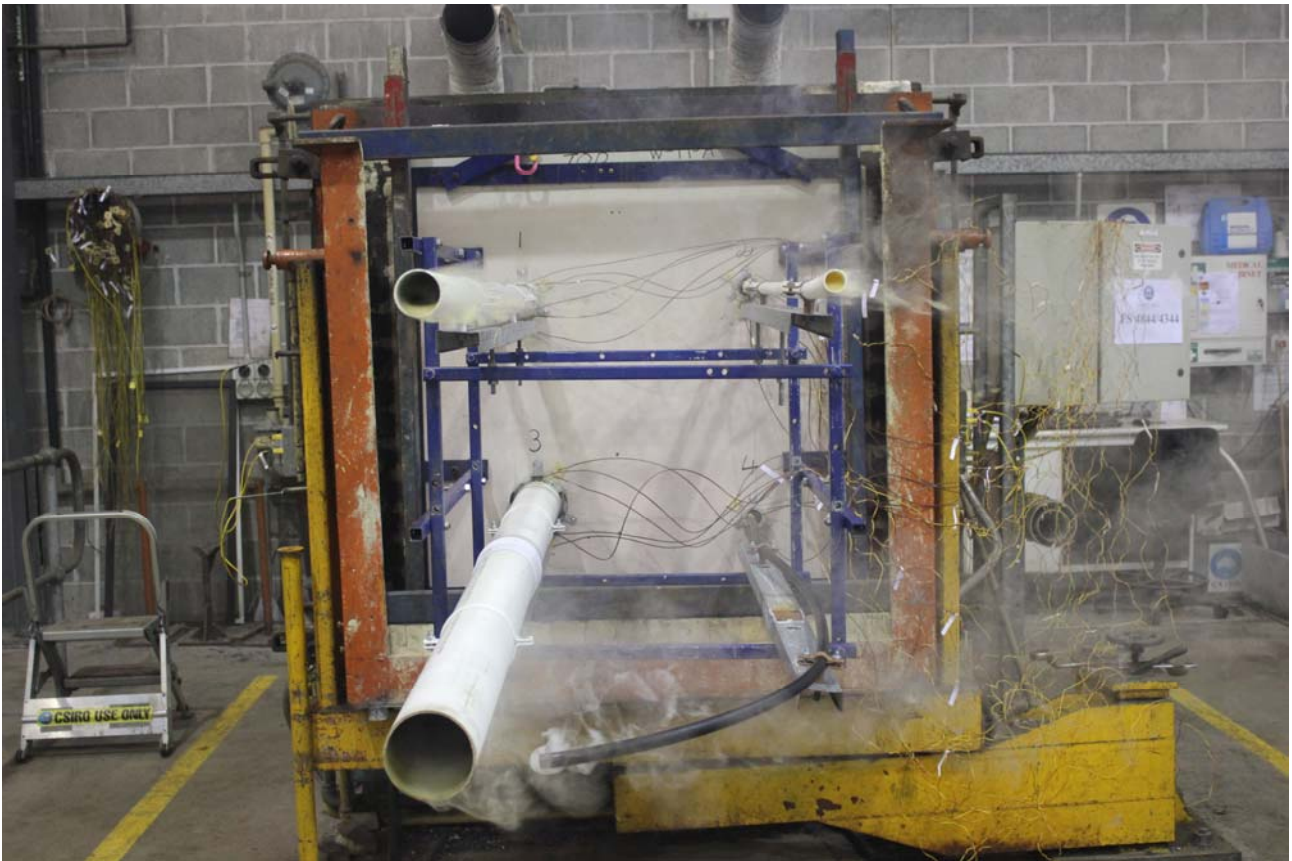
PHOTOGRAPH 5 – SPECIMENS AFTER 39 MINUTES OF TESTING

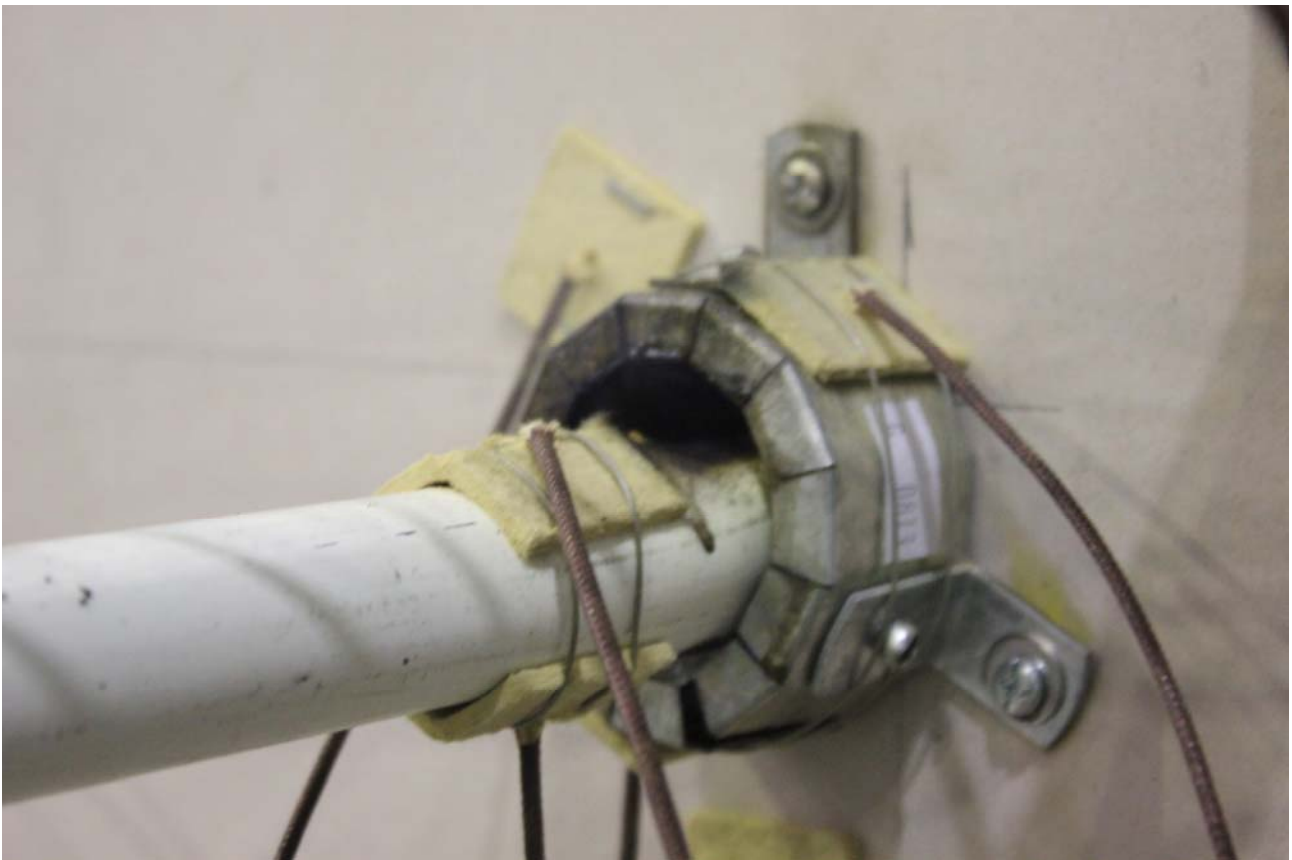
PHOTOGRAPH 6 – SPECIMEN 2 AFTER 54 MINUTES OF TESTING

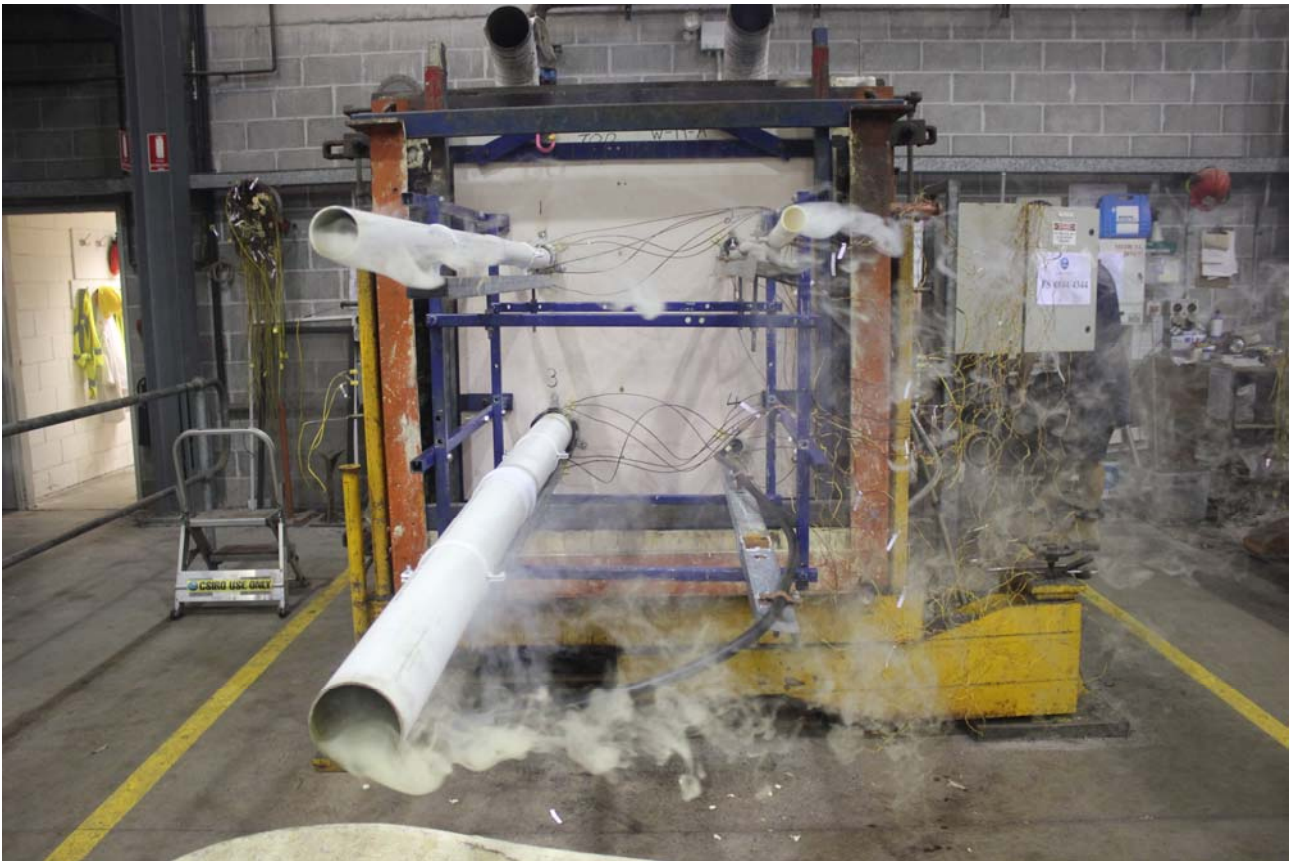
PHOTOGRAPH 7 – SPECIMENS AFTER 60 MINUTES OF TESTING

58 minutes -	The screw heads showing through plasterboard wall.
61 minutes -	<u>Insulation Failure of Specimen 4</u> – maximum temperature rise of 180K is exceeded on the top of pipe 25-mm away from collar on the unexposed face. Test terminated.

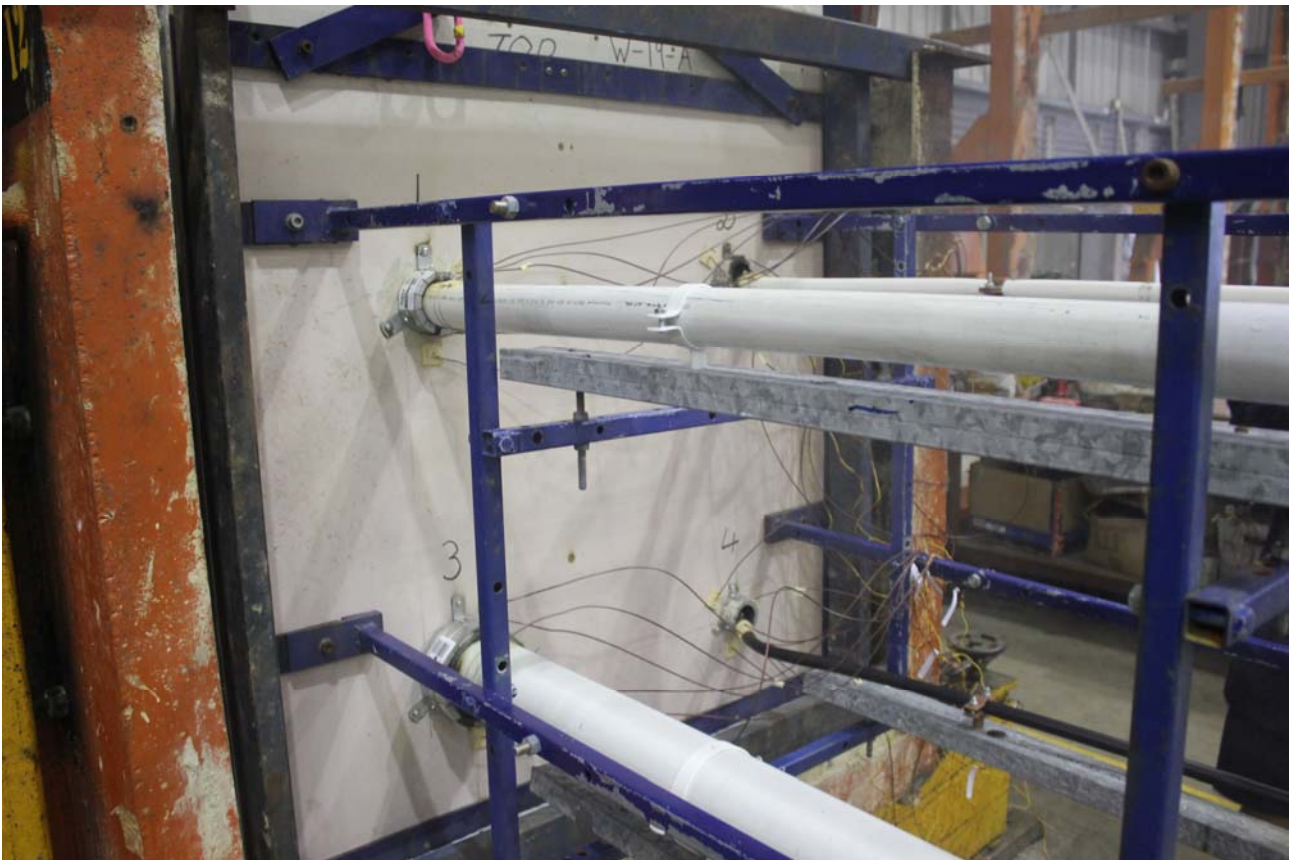
PHOTOGRAPH 8 – UNEXPOSED FACE OF SPECIMENS AT THE CONCLUSION OF TESTING

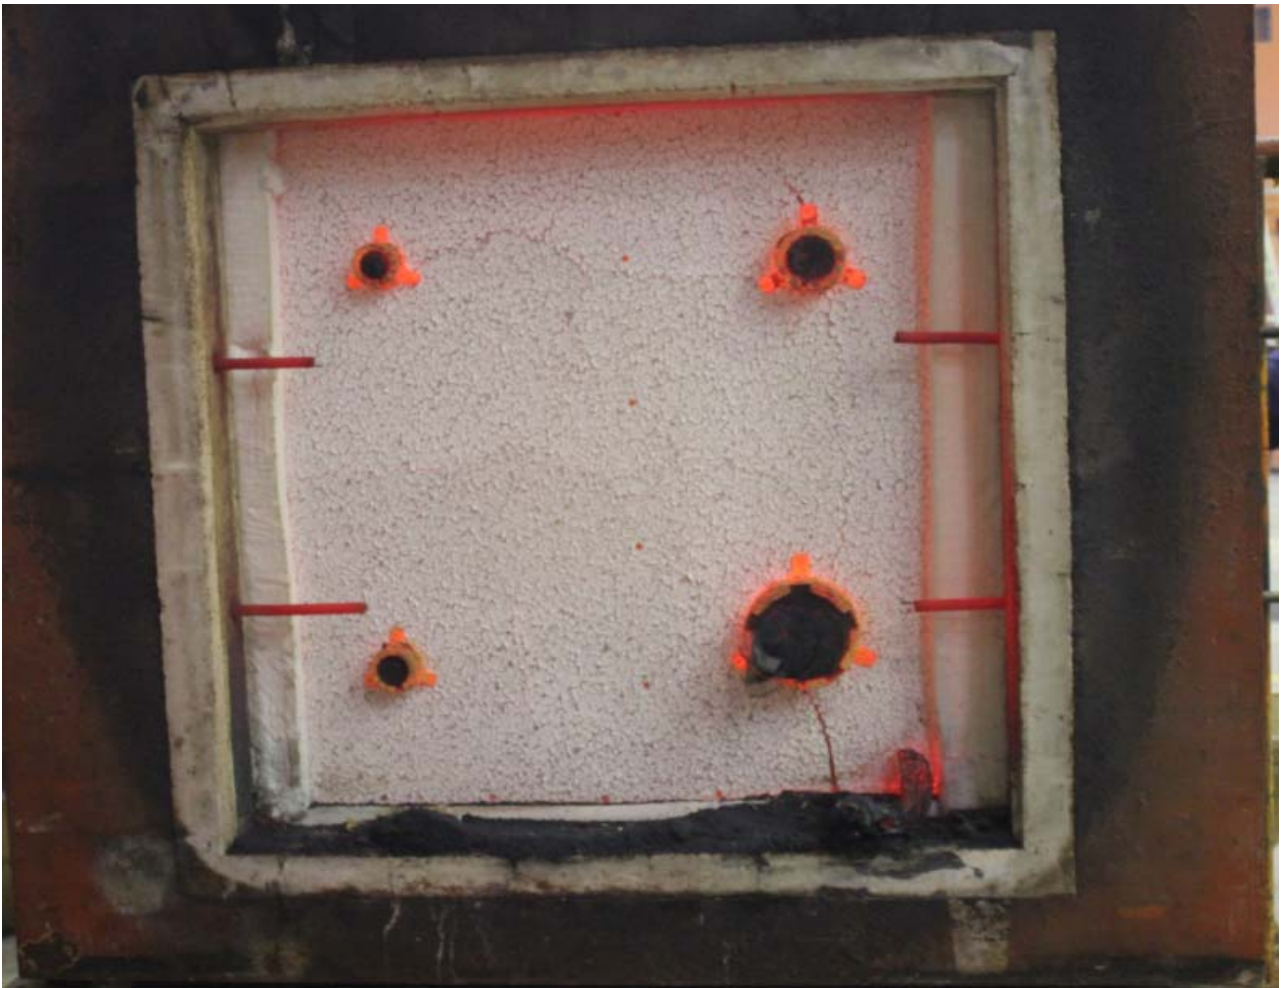
PHOTOGRAPH 9– EXPOSED FACE OF SPECIMENS AT CONCLUSION OF TESTING

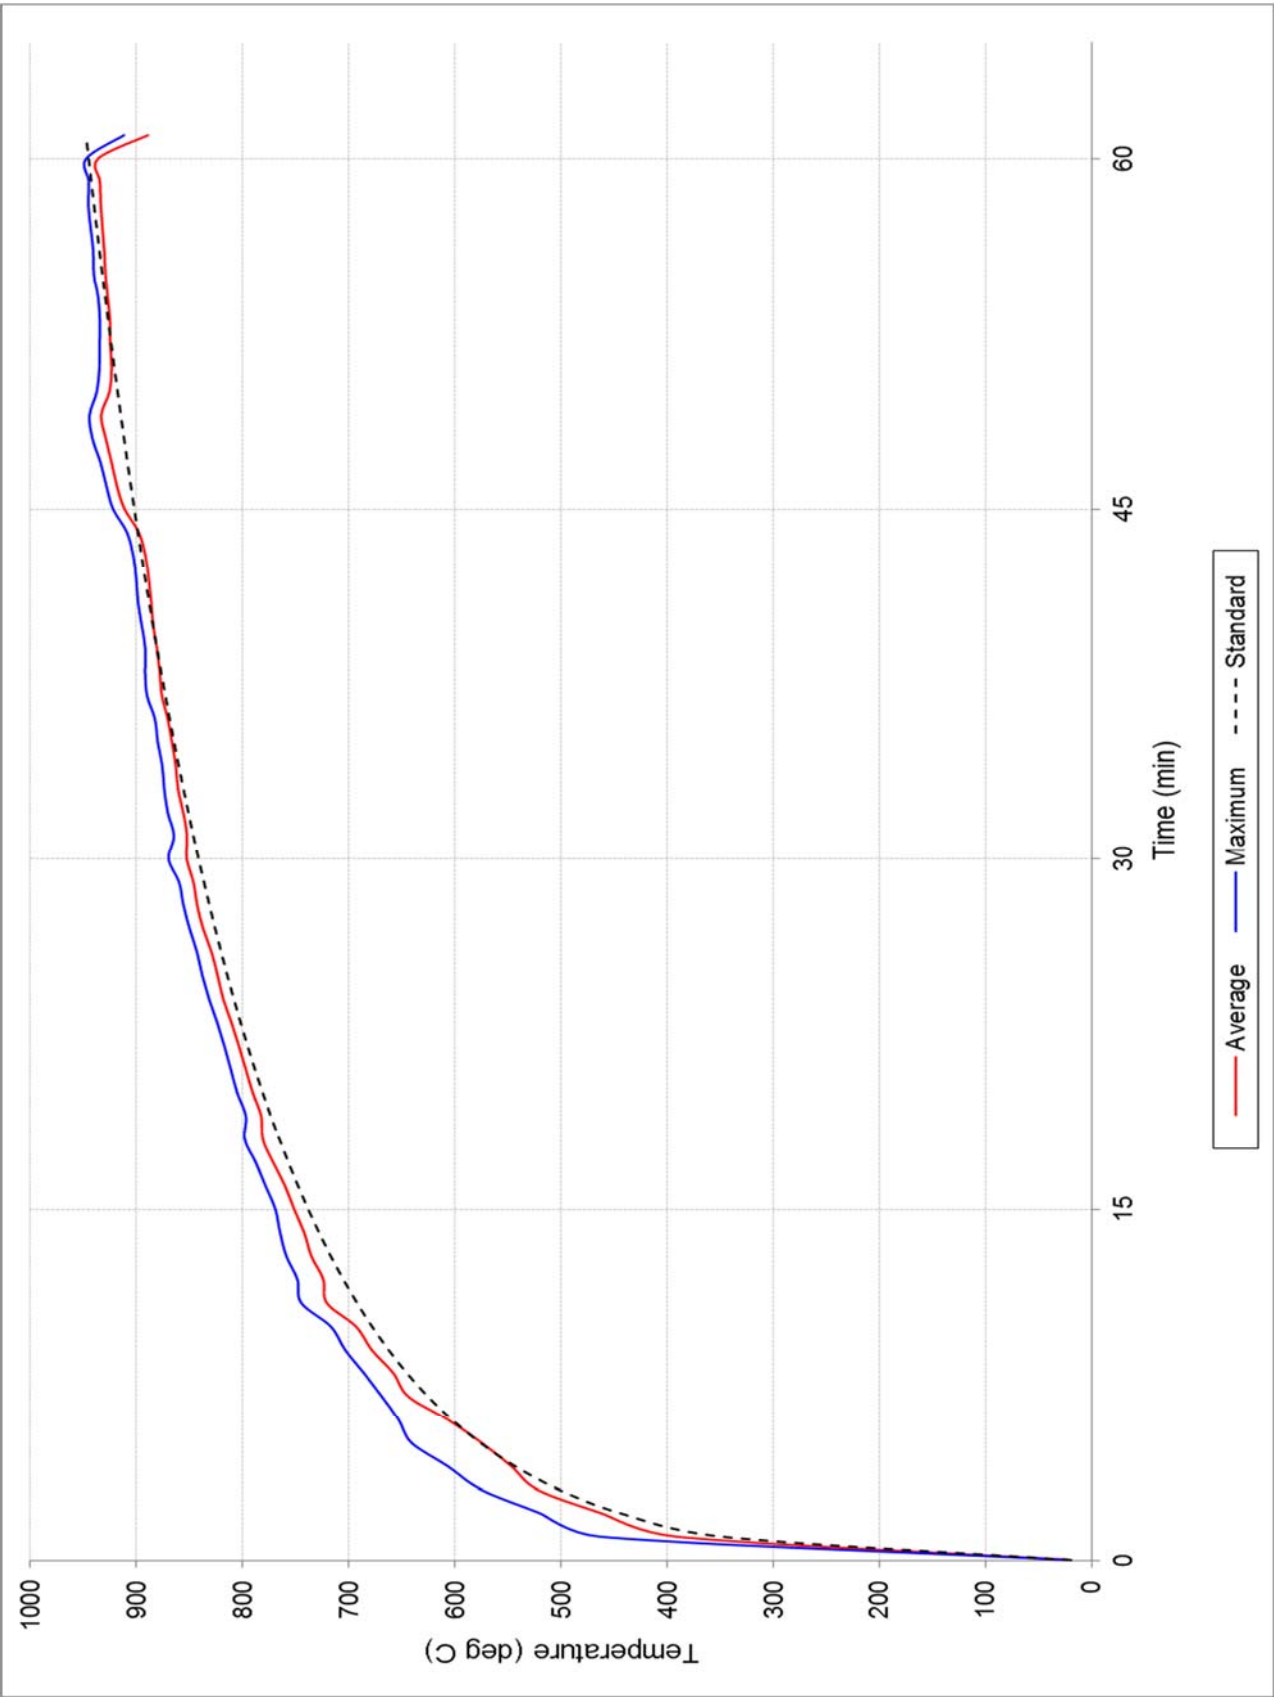
FIGURE 1 – FURNACE TEMPERATURE

Figure 1 shows the standard curves of temperature versus time for heating the furnace chamber and the actual curves of average and maximum temperature versus time recorded during the heating period.

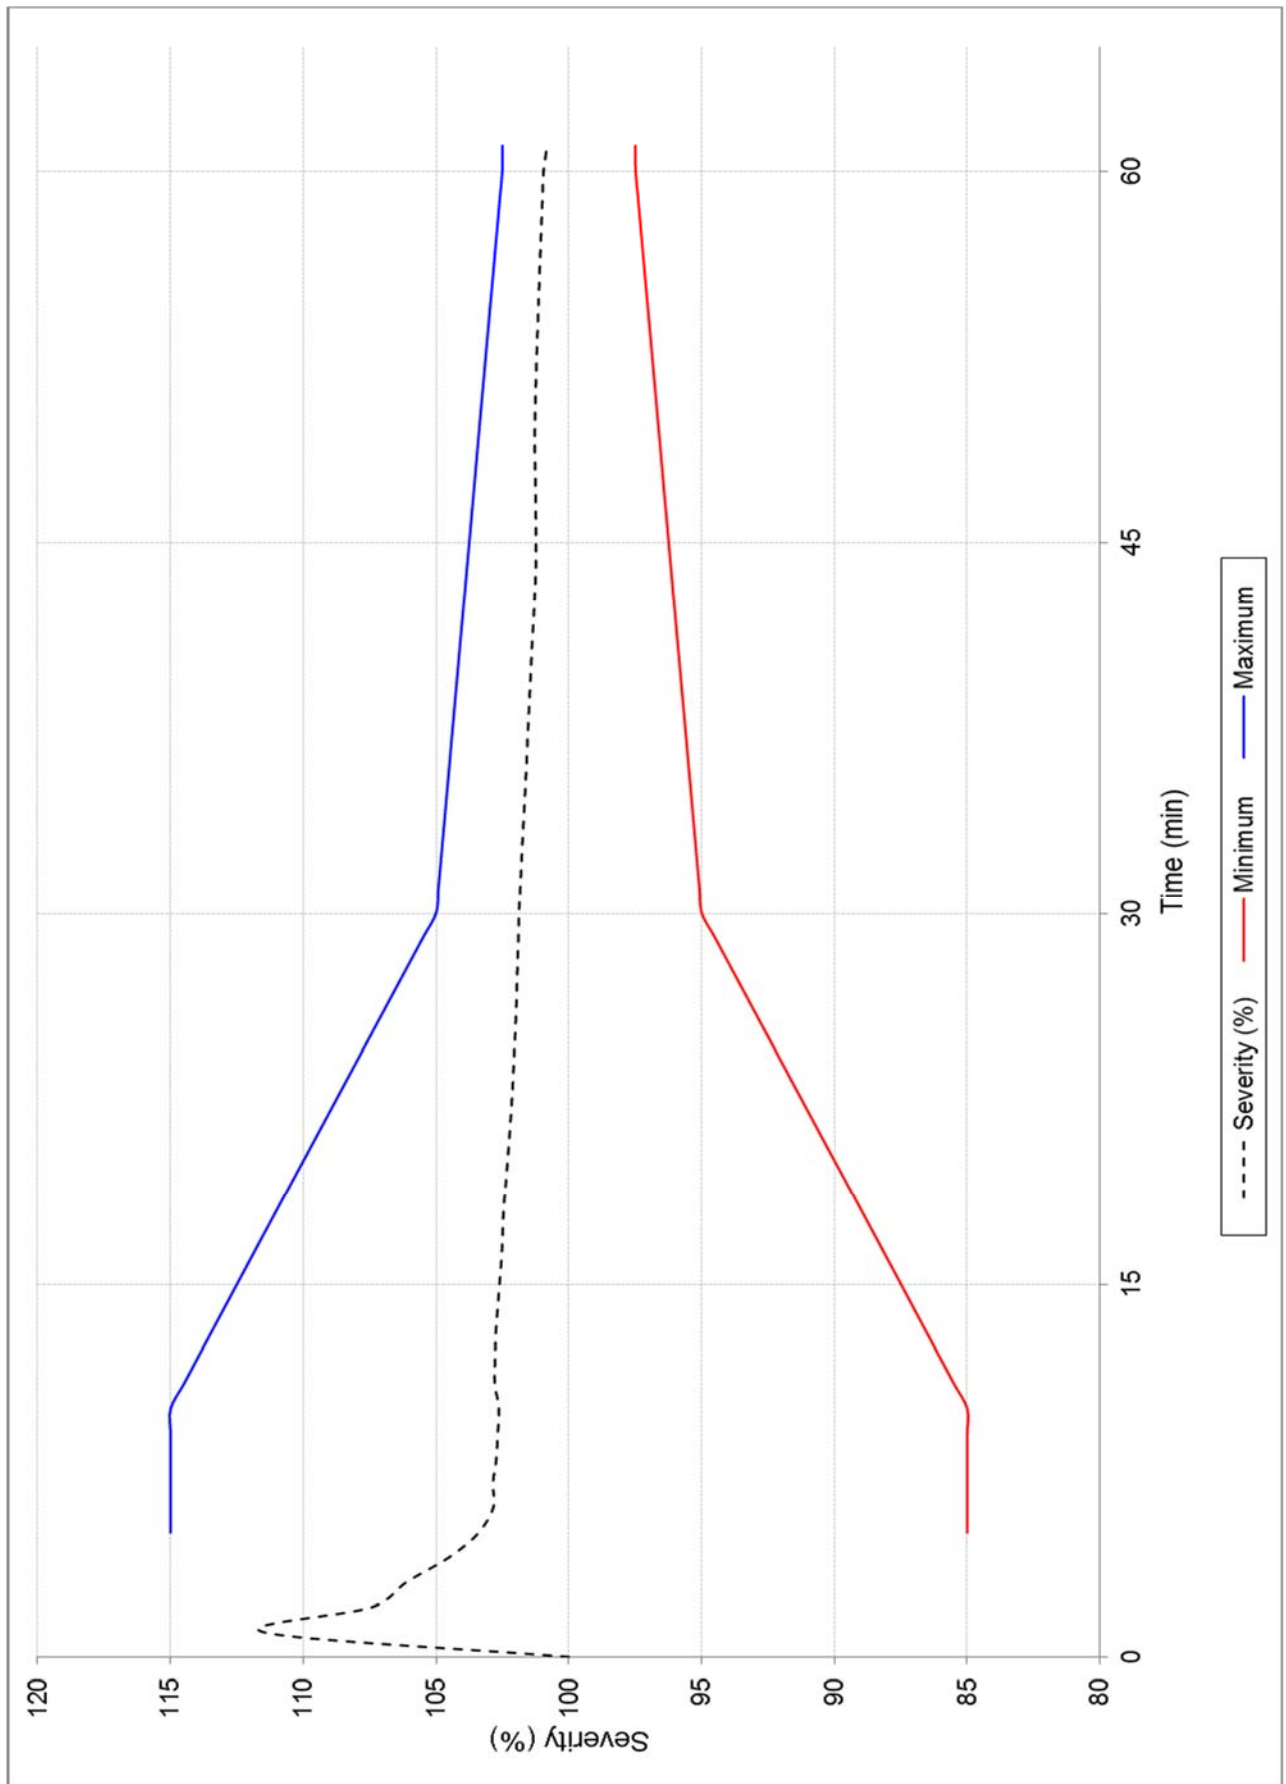
FIGURE 2 – FURNACE SEVERITY

Figure 2 shows the curve of furnace severity versus time during the heating period.

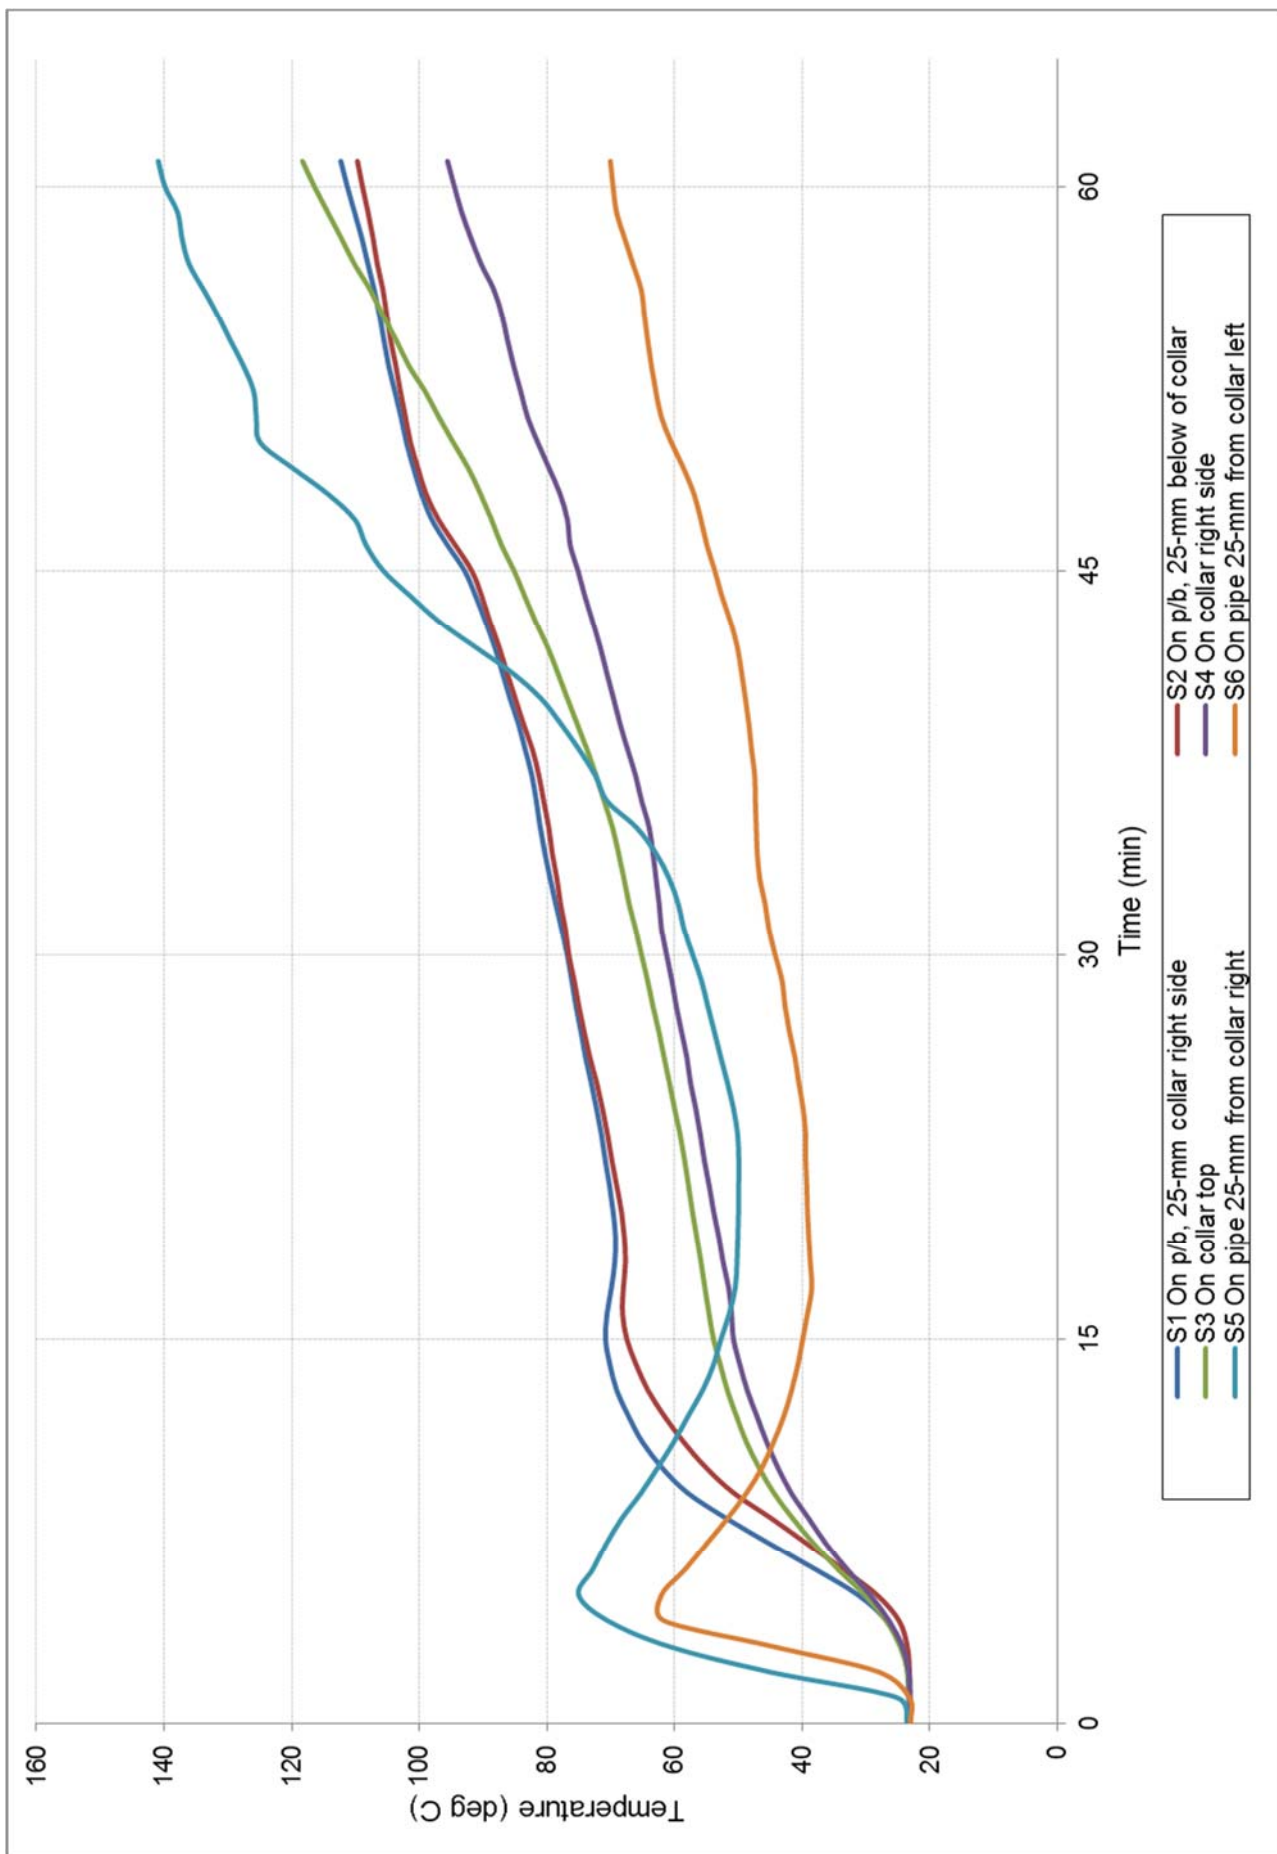
FIGURE 3 - SPECIMEN TEMPERATURE – ASSOCIATED WITH SPECIMEN # 1

Figure 3 shows the curve of temperature versus time associated with Specimen 1.

Structural adequacy	-	not applicable
Integrity	-	no failure at 61 minutes
Insulation	-	no failure at 61 minutes

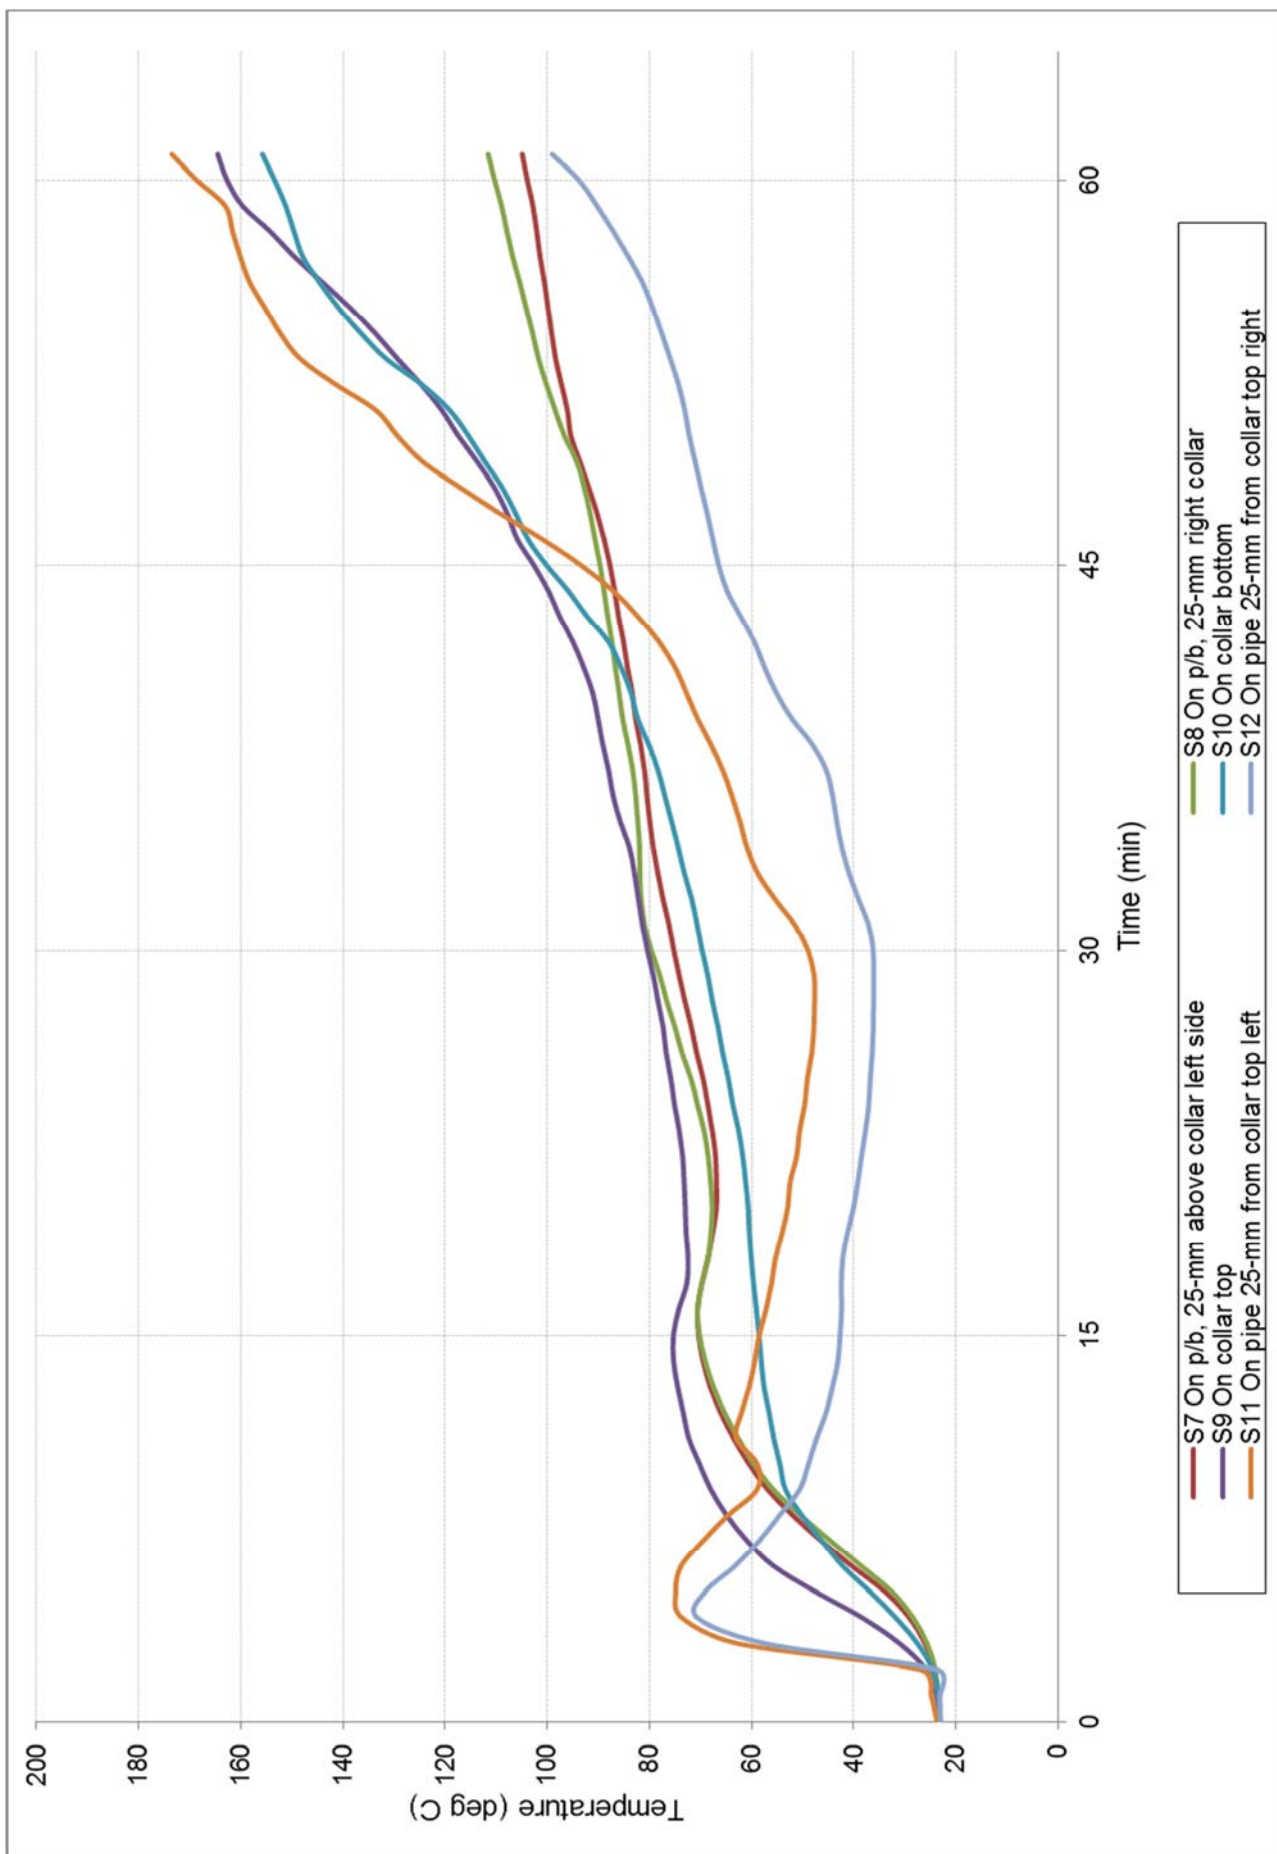
FIGURE 4 - SPECIMEN TEMPERATURE – ASSOCIATED WITH SPECIMEN # 2

Figure 4 shows the curve of temperature versus time associated with Specimen 2.

Structural adequacy	-	not applicable
Integrity	-	no failure at 61 minutes
Insulation	-	no failure at 61 minutes

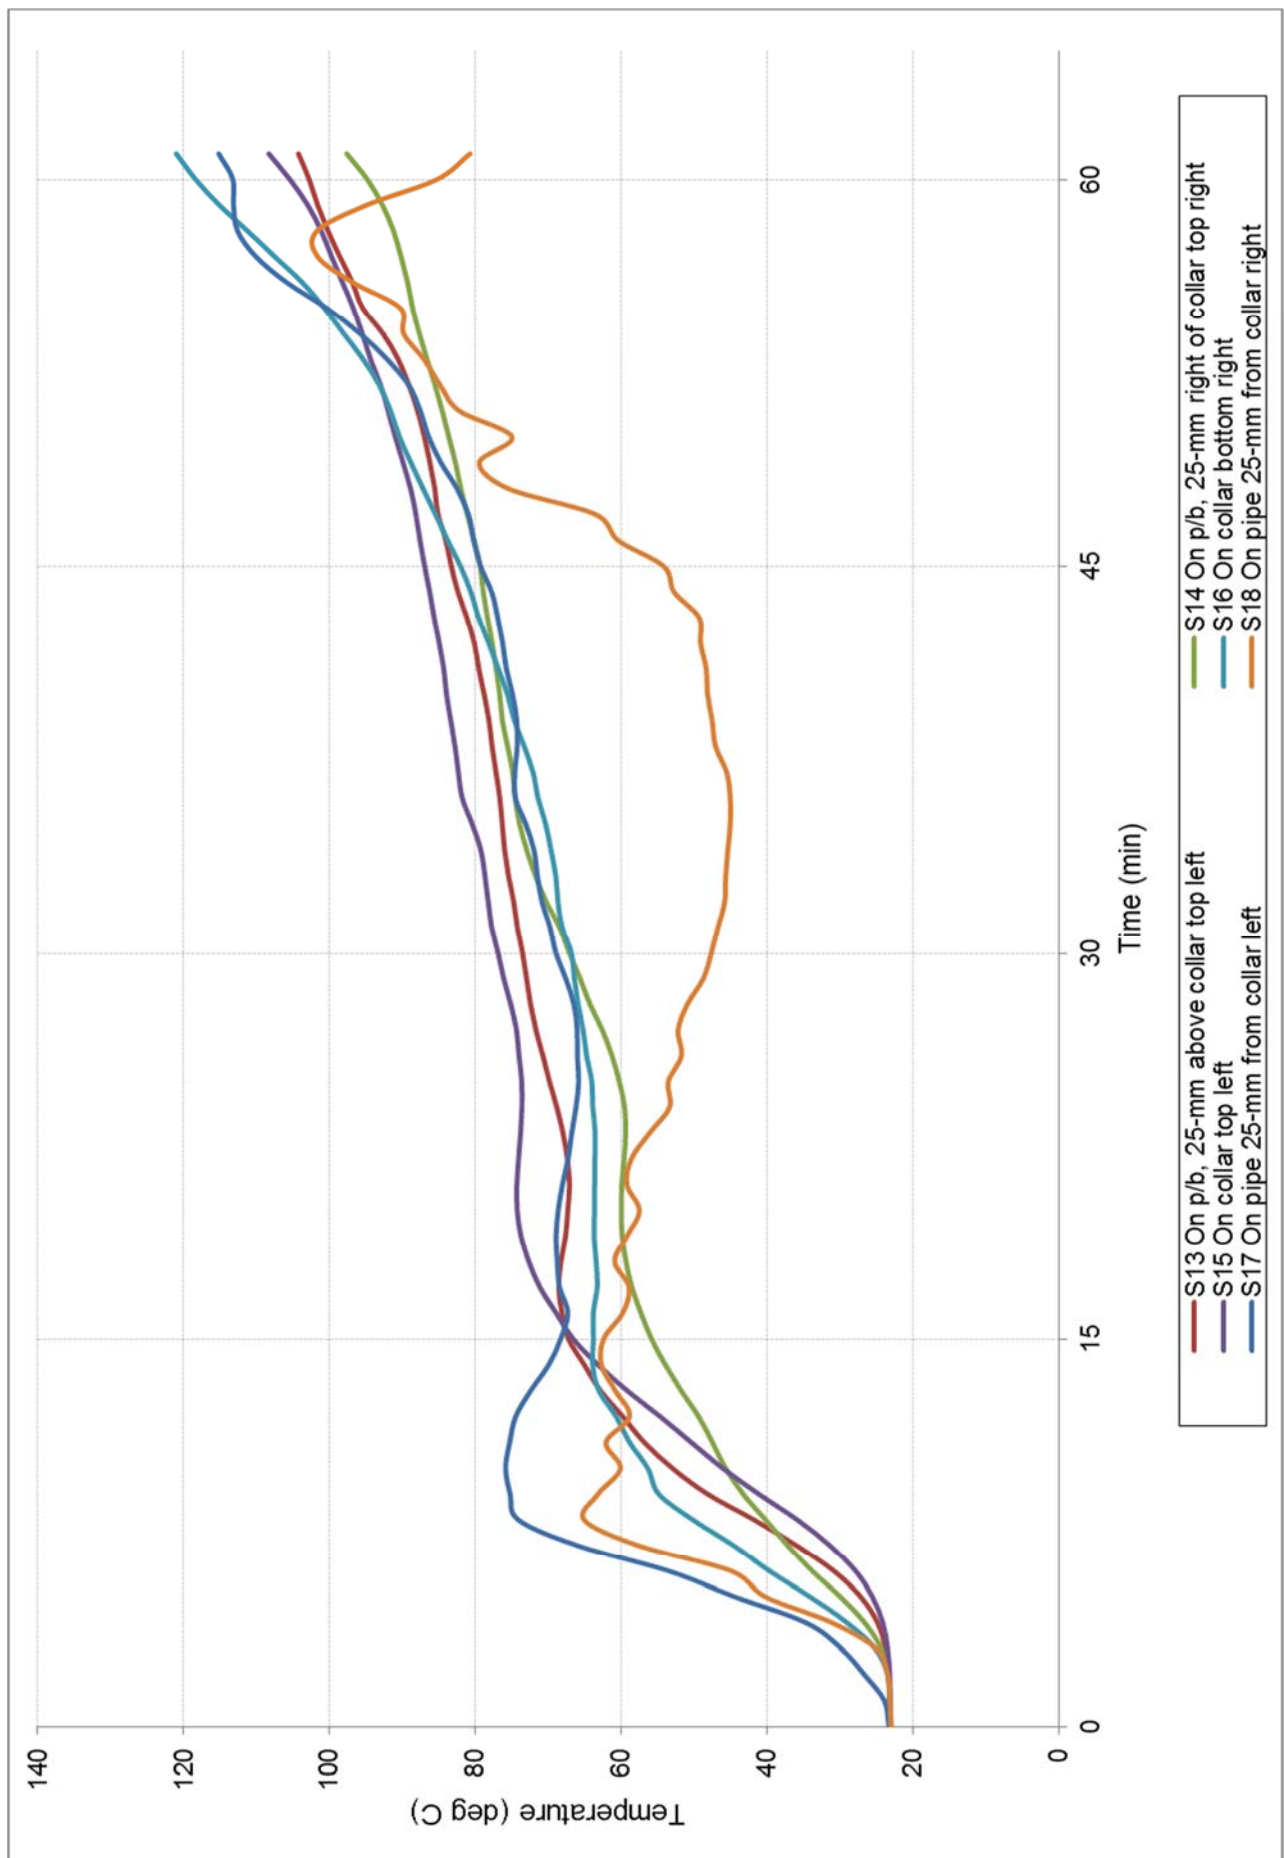
FIGURE 5 - SPECIMEN TEMPERATURE – ASSOCIATED WITH SPECIMEN # 3

Figure 5 shows the curve of temperature versus time associated with Specimen 3.

Structural adequacy	-	not applicable
Integrity	-	no failure at 61 minutes
Insulation	-	no failure at 61 minutes
