Fire-resistance test on fire collars protecting a plasterboard wall penetrated by services

Test Report

Report number: FSP 1985

Sponsored Investigation No. FSP 1985

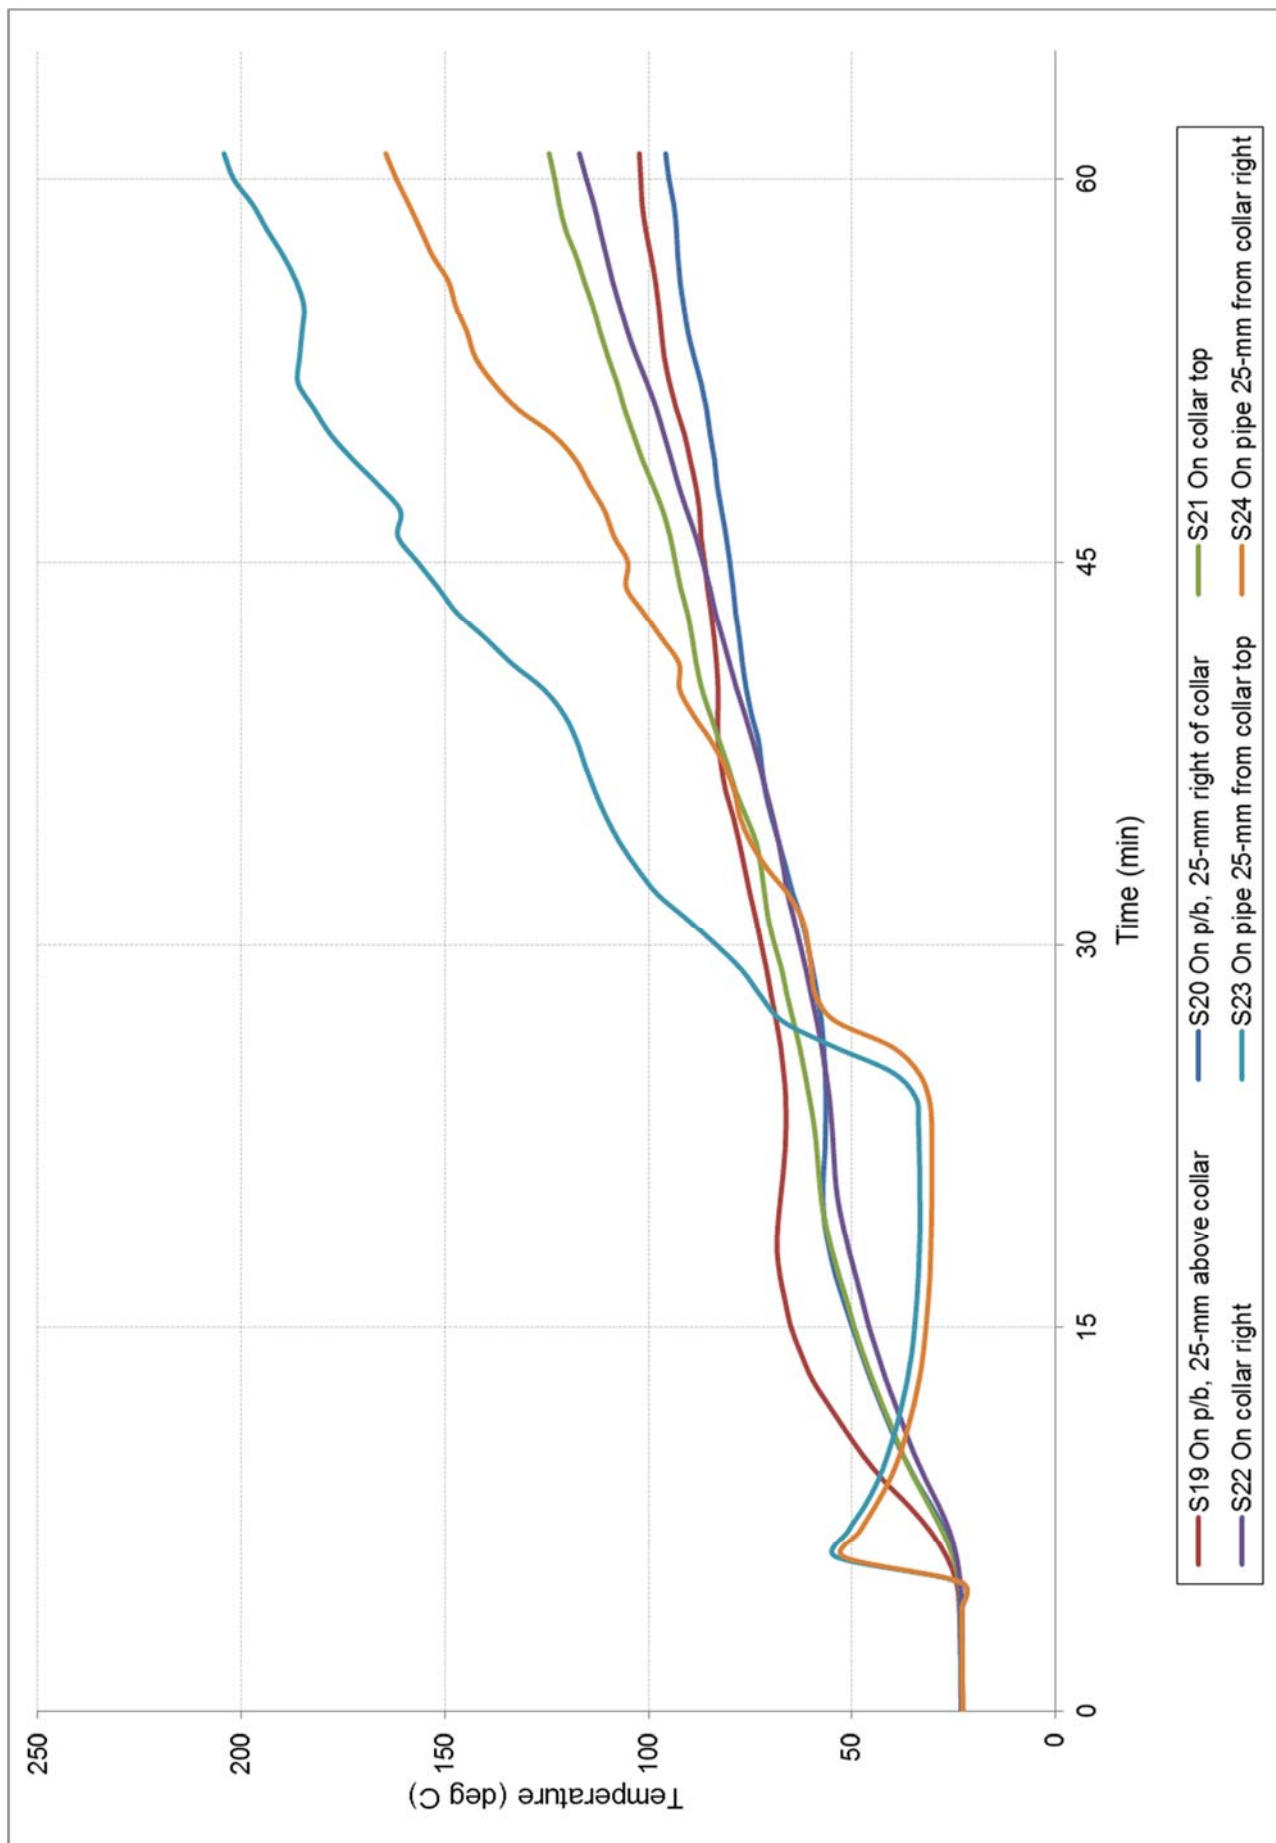
FIGURE 6 - SPECIMEN TEMPERATURE – ASSOCIATED WITH SPECIMEN # 4

58 minutes -	The screw heads showing through plasterboard wall.
61 minutes -	<u>Insulation Failure of Specimen 4</u> – maximum temperature rise of 180K is exceeded on the top of pipe 25-mm away from collar on the unexposed face. Test terminated.

Figure 6 shows the curve of temperature versus time associated with Specimen 4.

Structural adequacy	-	not applicable
Integrity	-	no failure at 61 minutes
Insulation	-	61 minutes

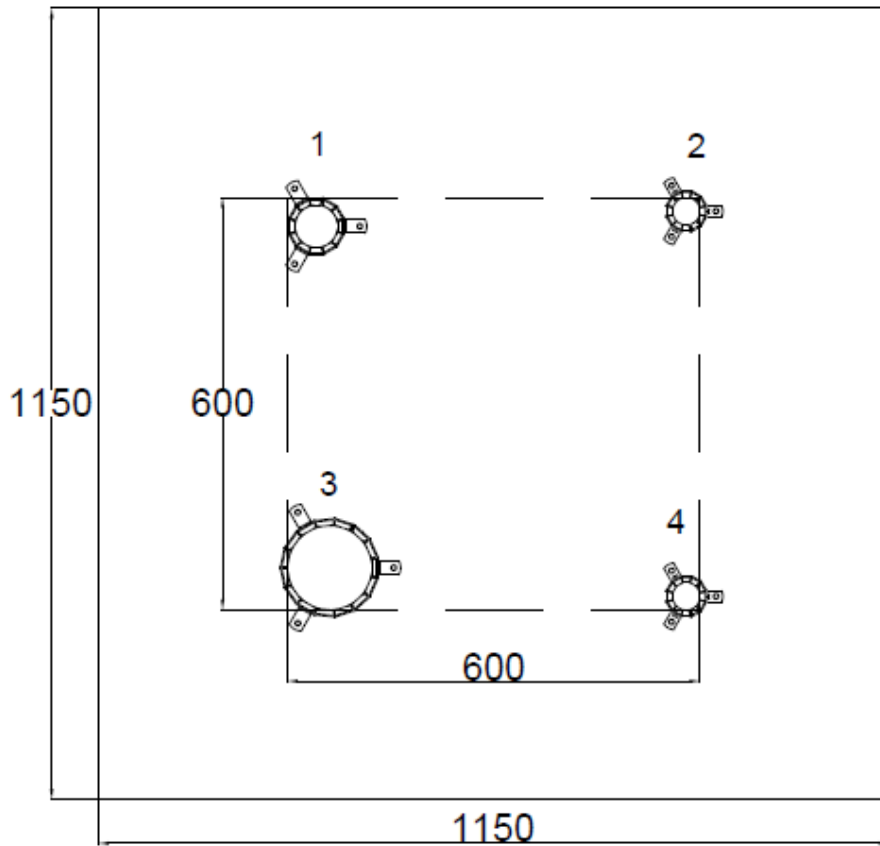
Test Wall W-19-A Layout

Penetration	Collar Code	Pipe Type	Pipe Diameter (mm)	Sealant
1	50R	PVC	56	Fireban One
2	32R	P-PVC	27	N/A
3	110R	PVC-SC	110	Firesound
4	32R	Pex-B	20	Firesound

DRAWING TITLED “TEST WALL W-19-A LAYOUT” DATED 25 FEBRUARY 2019, BY SNAP FIRE SYSTEMS PTY LTD.

The specimen comprised an 1150-mm x 1150-mm x 90-mm thick wall penetrated by four (4) pipes protected by retrofitted Snap Fire Systems fire collars.

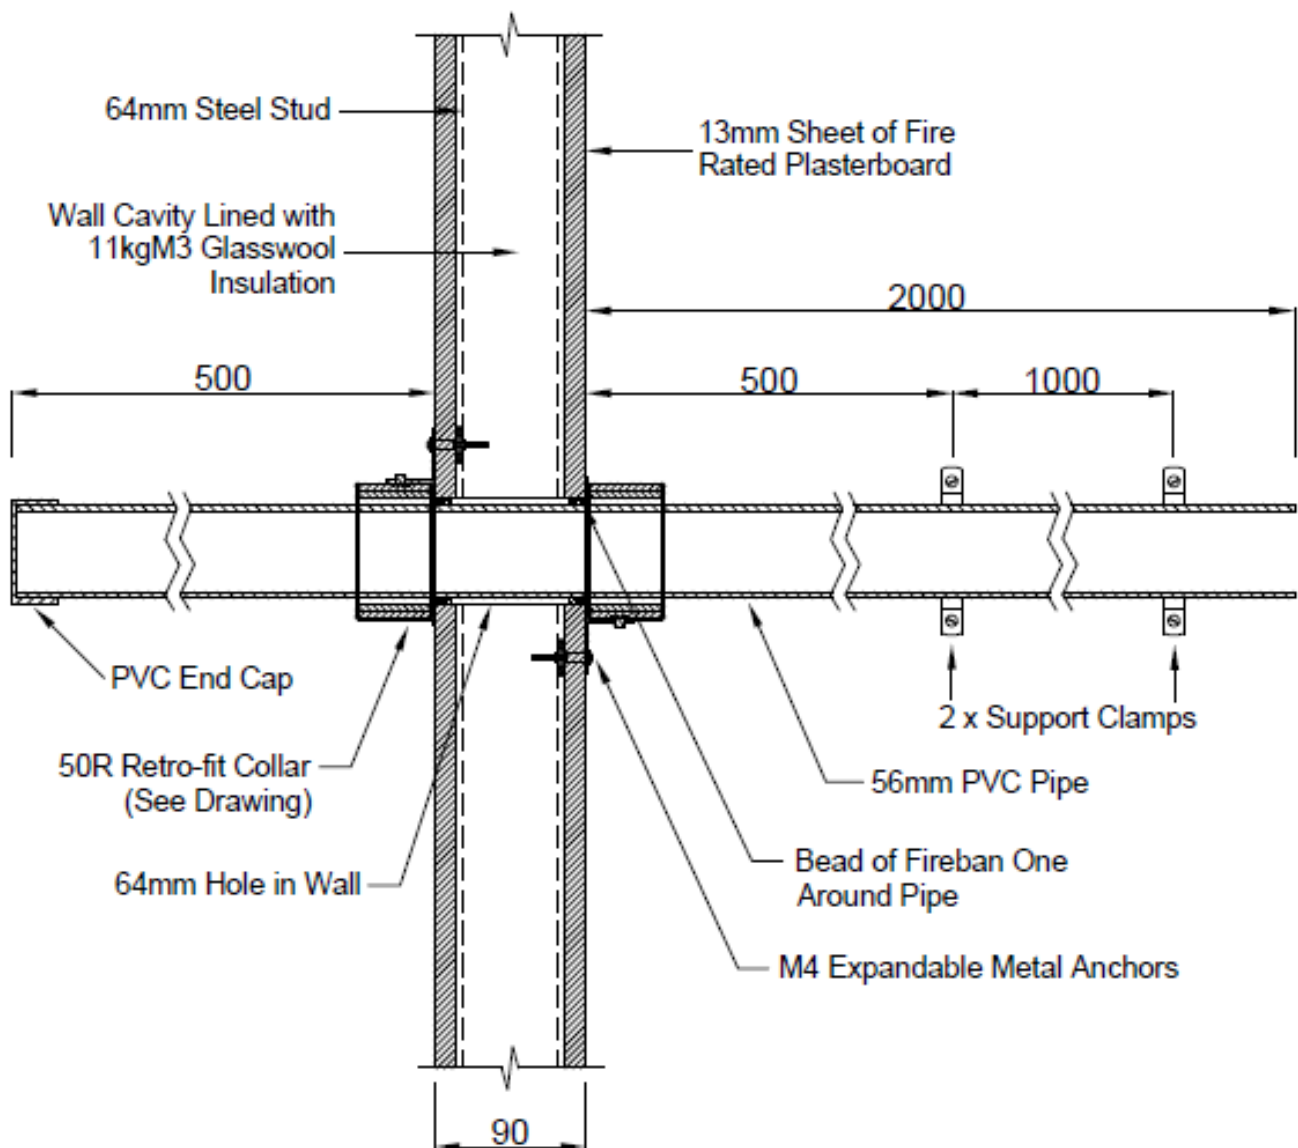
50 PVC Stack & 50R

DRAWING TITLED "SPECIMEN #1 50 PVC STACK & 50R" DATED 6 FEBRUARY 2019, BY SNAP FIRE SYSTEMS PTY LTD.

The SNAP Retrofit 50R fire collar comprised a 0.75-mm steel casing with a 62-mm inner diameter and a 147-mm diameter base flange. The 47-mm high collar casing incorporated a closing mechanism which comprised two soft Intumescent intumescent wraps lined within the internal circumference of the collar. Intumescent A was 4-mm thick x 43-mm wide x 220-mm long, and Intumescent B was 4-mm thick x 43-mm wide x 200-mm long. Between the strips was a layer of 316 grade stainless steel mesh 210-mm long x 42-mm wide with wire mesh diameter of 0.15-mm, as shown in drawing titled "SNAP 50 Retro", dated 18 January 2019, by Snap Fire Systems Pty Ltd. The Snap collars were surface mounted around the pipe on both the exposed and unexposed face of the wall and fixed through 3 mounting brackets using M4 expandable steel anchors.

The penetrating service comprised a 56-mm diameter PVC pipe, with a wall thickness of 2.45-mm which penetrated the wall through a 64-mm diameter cut-out hole as shown in drawing titled "Specimen #1, 50 PVC Stack & 50R", dated 6 January 2019, provided by Snap Fire Systems Pty Ltd. The pipe projected horizontally, 2000-mm away from the unexposed face of the wall and approximately 500-mm into the furnace chamber. The pipe was supported at nominally 500-mm and 1500-mm from the unexposed face of the plasterboard wall. The pipe was open at the unexposed end and capped with PVC end cap on the exposed end.

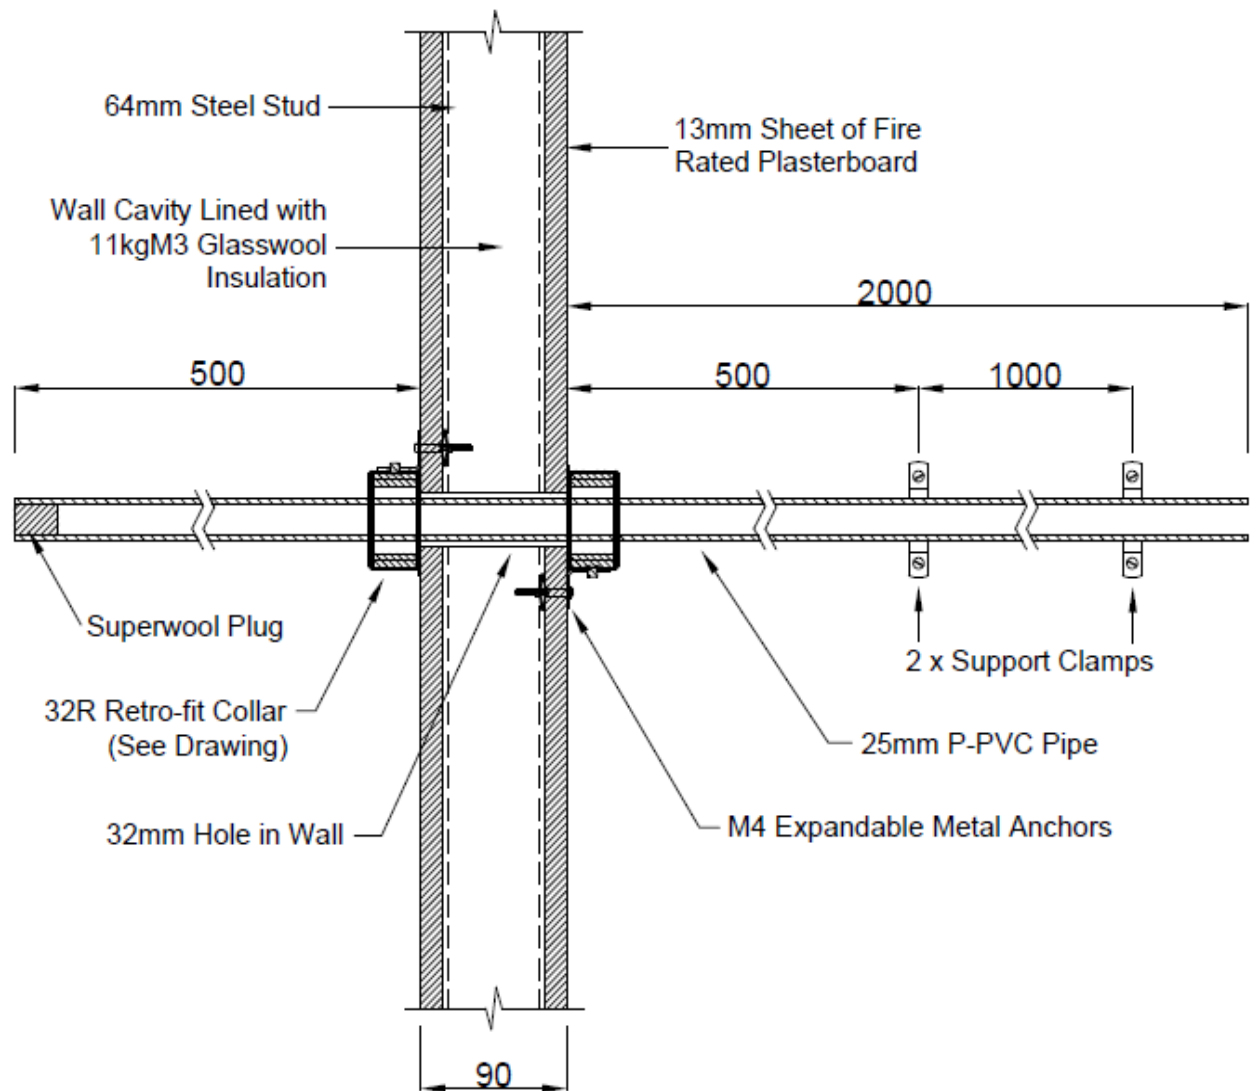
25 P-PVC Stack & 32R

DRAWING TITLED "SPECIMEN #2 25 P-PVC STACK & 32R", DATED 6 FEBRUARY 2019, PROVIDED BY SNAP FIRE SYSTEMS PTY LTD.

The 32R Retrofit collar comprised a 0.75-mm steel casing with a 40-mm inner diameter and a 106-mm diameter base flange. The 32-mm high collar casing incorporated a closing mechanism that was comprised of two soft Intumesh intumescent strips lined within the internal circumference of the collar. The inner and outer strips were 4-mm thick x 26-mm wide x 135-mm long, and 4-mm thick x 26-mm wide x 154-mm long, respectively. Between the strips was a layer of 316 stainless steel mesh 135 mm long x 25-mm wide with wire mesh diameter of 0.15-mm, as shown in drawing titled “SNAP 32 Retro”, dated 5 October 2017, by Snap Fire Systems Pty Ltd. The Snap collars were surface mounted around the pipe on both the exposed and unexposed face of the wall and fixed through 3 mounting brackets using M4 expandable steel anchors.

The penetrating service comprised a 27-mm P-PVC pipe, with a wall thickness of 1.7-mm, penetrating the wall through a 32-mm diameter cut-out hole as shown in drawing titled “Specimen #2, 25 P-PVC Pipe & 32R” dated 6 February 2019, provided by Snap Fire Systems Pty Ltd. The pipes projected horizontally, 2000-mm away from the unexposed face of the wall and approximately 500-mm into the furnace chamber. The pipes were supported at nominally 500-mm and 1500-mm from the unexposed face of the plasterboard wall. The pipes were open at the unexposed and capped with a Superwool plug on the exposed end.

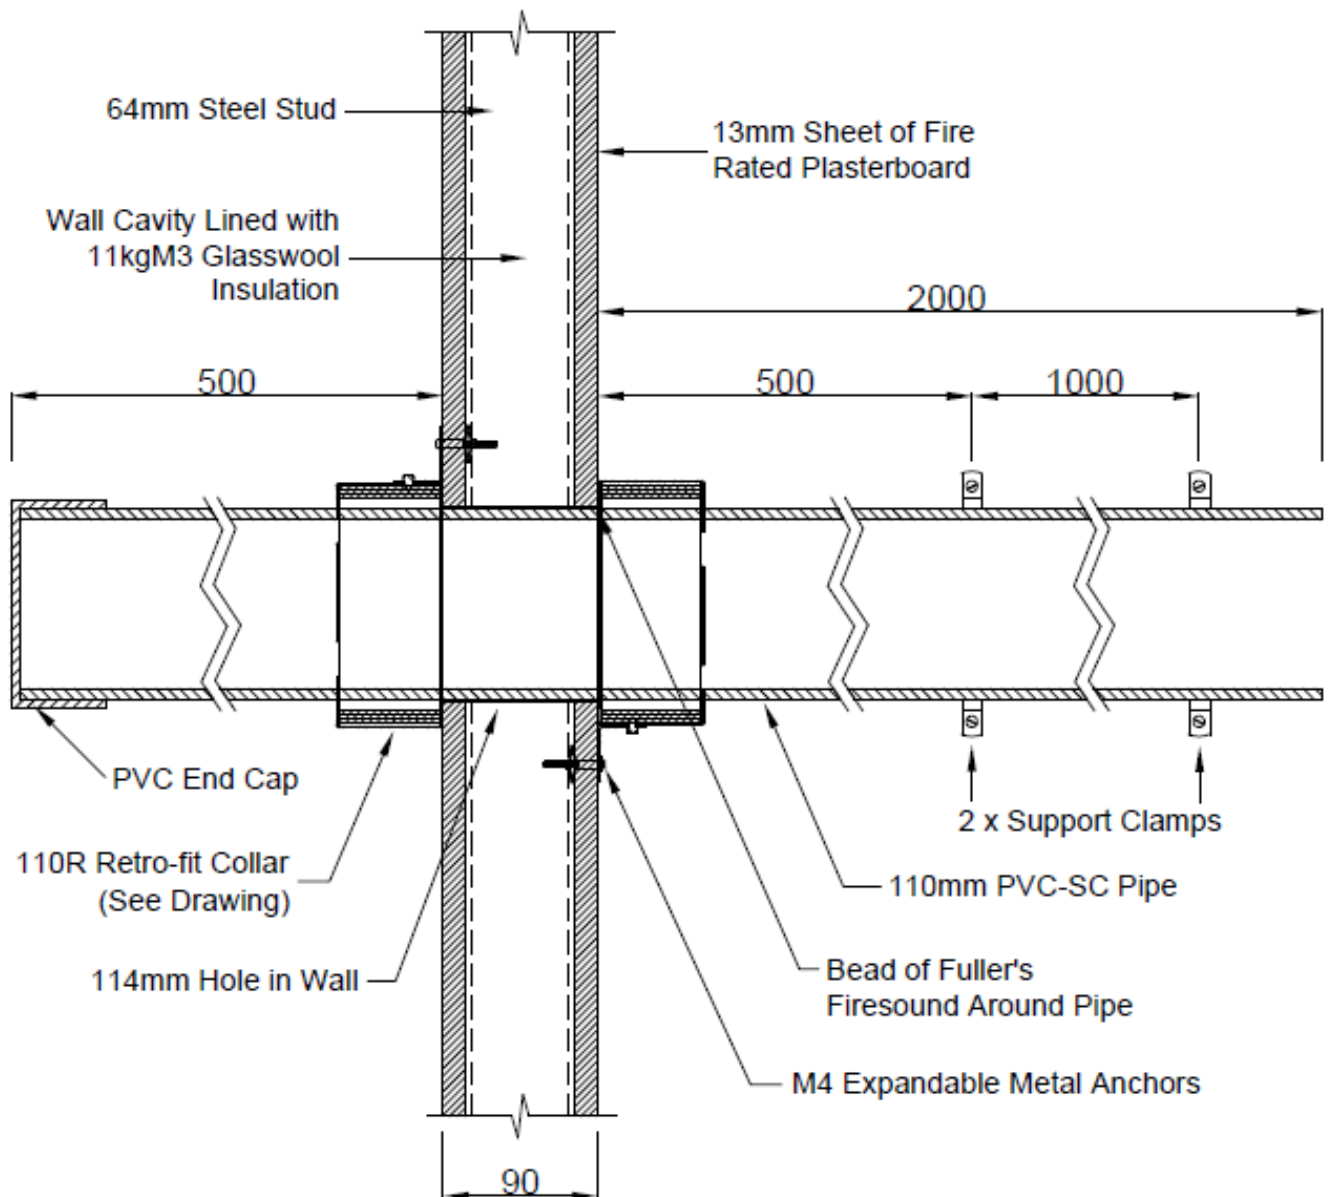
100 PVC-SC Stack & 110R

DRAWING TITLED "SPECIMEN #3 100 PVC-SC STACK & 110R", DATED 6 FEBRUARY 2019, PROVIDED BY SNAP FIRE SYSTEMS PTY LTD.

The SNAP Retrofit 110R fire collar comprised a 0.75-mm steel casing with a 122-mm inner diameter and a 206-mm diameter base flange. The 62-mm high collar casing incorporated a closing mechanism that was comprised of three soft Intumesh intumescent wraps and wire meshes lined within the internal circumference of the collar. Intumescent A was 2.5-mm thick x 58-mm wide x 424-mm long, Intumescent B was 2.5-mm thick x 58-mm wide x 407-mm long and Intumescent C was 2.5-mm thick x 58-mm wide x 389-mm long. Between intumescent strips A and B was a layer of 304 stainless steel mesh 415-mm long x 58-mm wide and between intumescent strips B and C was a layer of 316 stainless steel mesh 398-mm long x 58-mm wide both had wire mesh diameters of 0.15-mm, as shown in drawing titled “SNAP 110 Retro”, dated 16 January 2019, by Snap Fire Systems Pty Ltd. The Snap collars were surface mounted around the pipe on both the exposed and unexposed face of the wall and fixed through 3 mounting brackets using M4 expandable steel anchors.

The penetrating service comprised a 110-mm PVC-SC pipe, with a wall thickness of 3.46-mm fitted through the collar’s sleeve. The pipe penetrated the wall through a 114-mm diameter opening and projected horizontally 2000-mm away from the unexposed face of the wall and approximately 500 mm into the furnace chamber. The pipe was supported at nominally 500-mm, and 1500-mm from the unexposed face of the plasterboard wall, as shown in drawing titled “Specimen #3, 100 PVC-SC Stack & 110R”, dated 6 February 2019, provided by Snap Fire Systems Pty Ltd. The pipe was open on the unexposed end and capped on the exposed end with a PVC end cap.

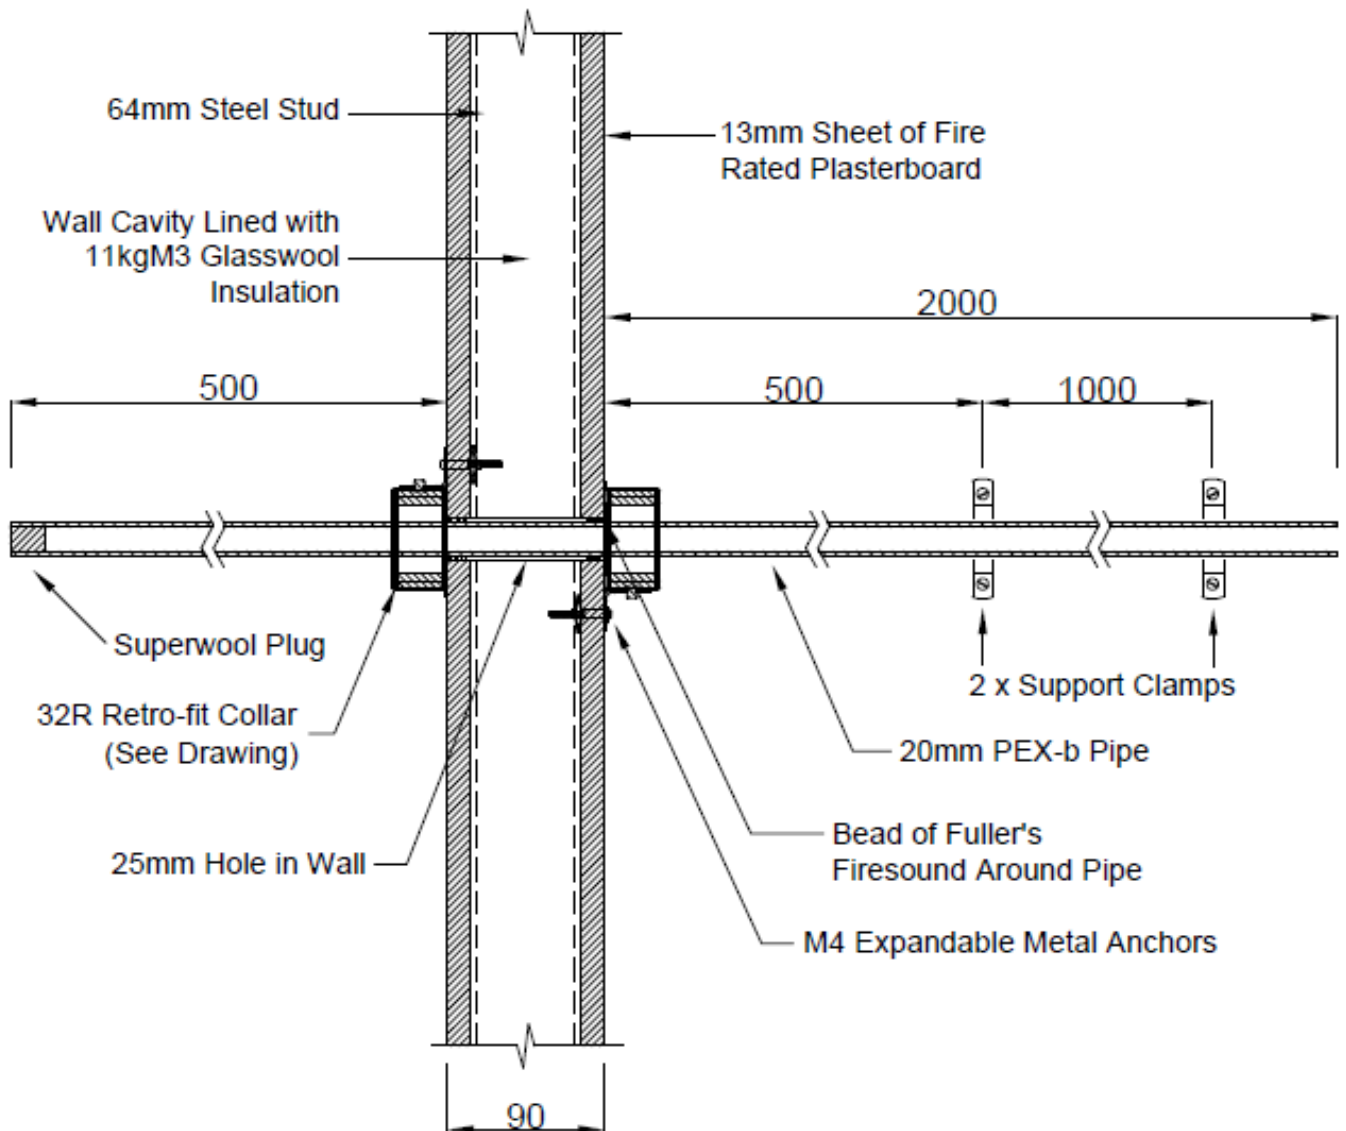
20 PEX-b Stack & 32R

DRAWING TITLED "SPECIMEN #4 20 PEX-B STACK & 32R", DATED 6 FEBRUARY 2019, PROVIDED BY SNAP FIRE SYSTEMS PTY LTD.

The 32R Retrofit collar comprised a 0.75-mm steel casing with a 40-mm inner diameter and a 106-mm diameter base flange. The 32-mm high collar casing incorporated a closing mechanism that was comprised of two soft Intumesh intumescent strips lined within the internal circumference of the collar. The inner and outer strips were 4-mm thick x 26-mm wide x 135-mm long, and 4-mm thick x 26-mm wide x 154-mm long, respectively. Between the strips was a layer of 316 stainless steel mesh 135 mm long x 25-mm wide with wire mesh diameter of 0.15-mm, as shown in drawing titled “SNAP 32 Retro”, dated 12 January 2017, by Snap Fire Systems Pty Ltd. The Snap collars were surface mounted around the pipe on both the exposed and unexposed face of the wall and fixed through 3 mounting brackets using M4 expandable steel anchors.

The penetrating service comprised a 20-mm PEX-b pipe, with a wall thickness of 2.46-mm, penetrating the wall through a 25-mm diameter cut-out hole as shown in drawing titled “Specimen #4, 20 PEX-b Stack & 32R”, dated 6 February 2019, provided by Snap Fire Systems Pty Ltd. The pipes projected horizontally, 2000-mm away from the unexposed face of the wall and approximately 500-mm into the furnace chamber. The pipes were supported at nominally 500-mm and 1500-mm from the unexposed face of the plasterboard wall. The pipes were open at the unexposed and capped with a Superwool plug on the exposed end.

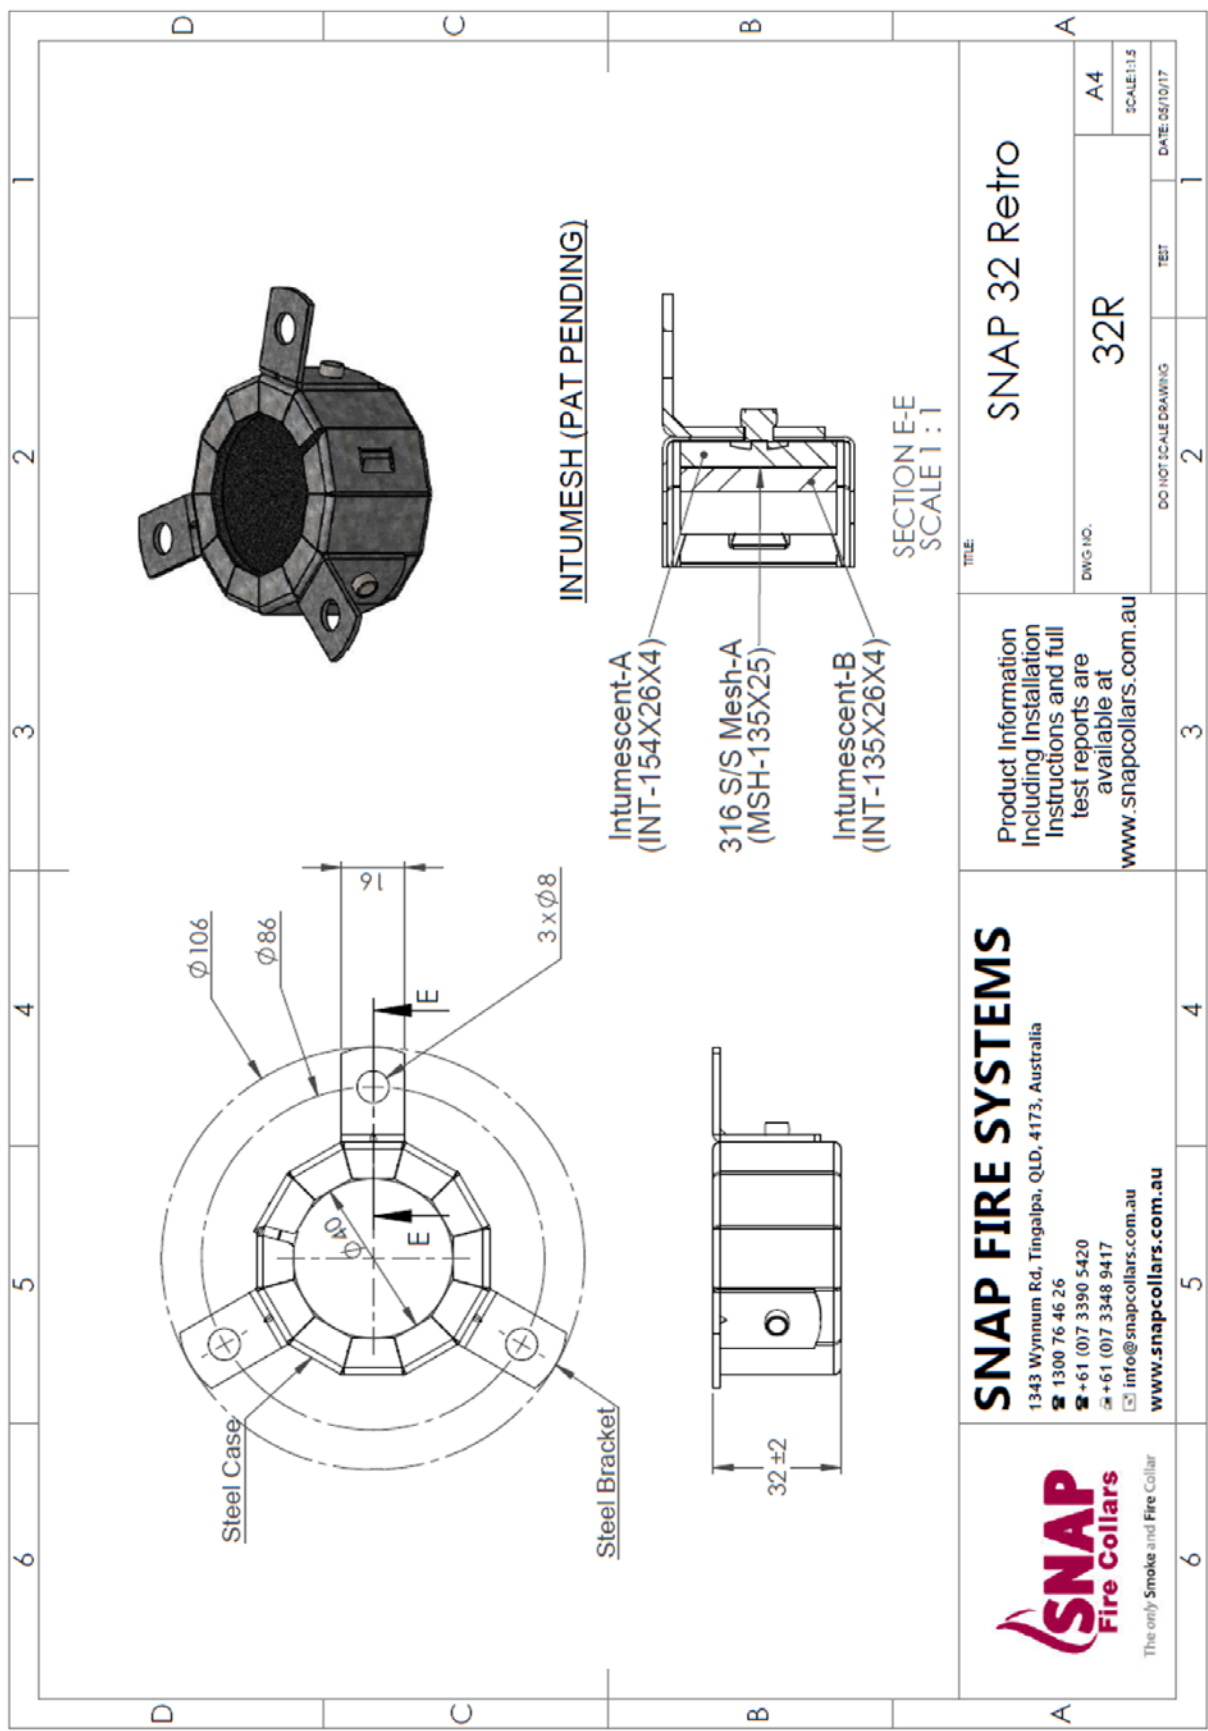
DRAWING NUMBERED 32R, TITLED “SNAP 32 RETRO”, DATED 5 OCTOBER 2017, BY SNAP FIRE SYSTEMS PTY LTD.

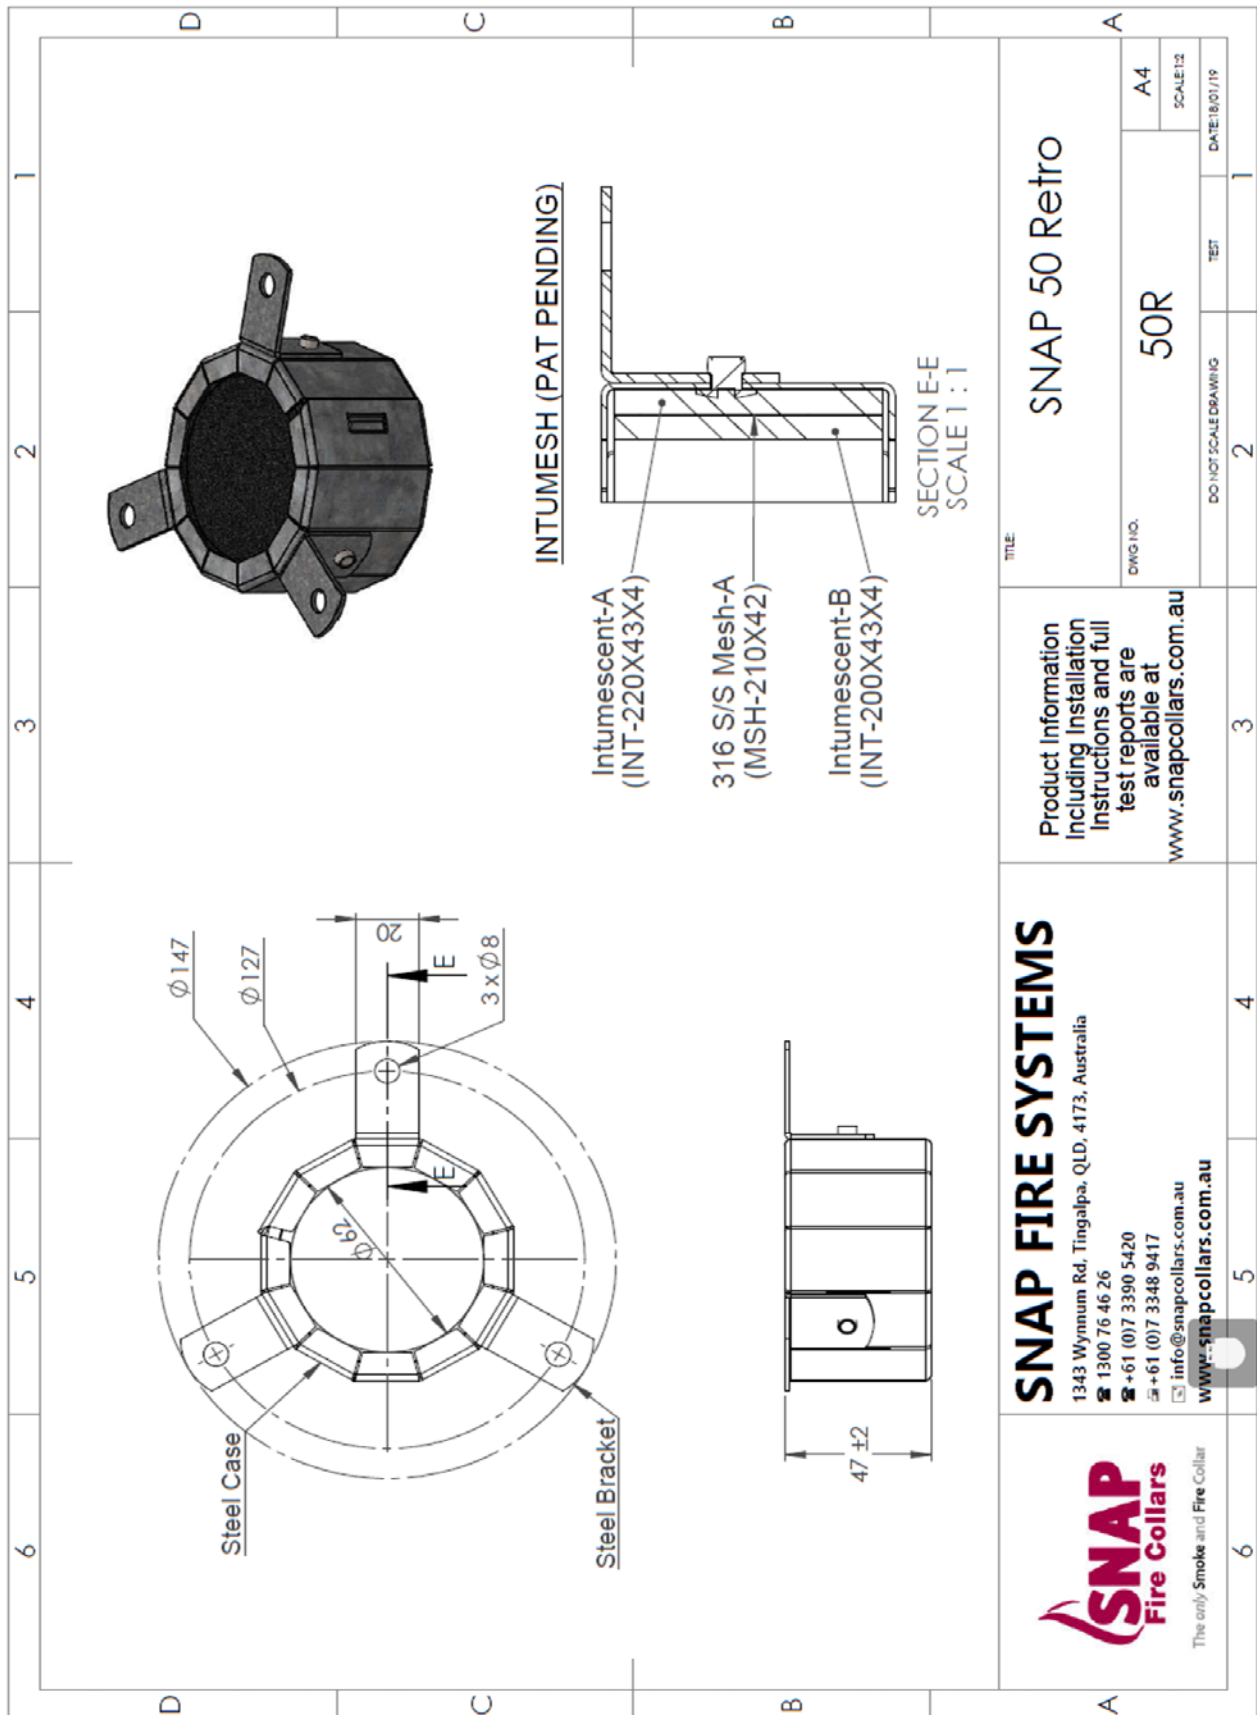
DRAWING NUMBERED 50R, TITLED "SNAP 50 RETRO", DATED 12 JANUARY 2019, BY SNAP FIRE SYSTEMS PTY LTD.

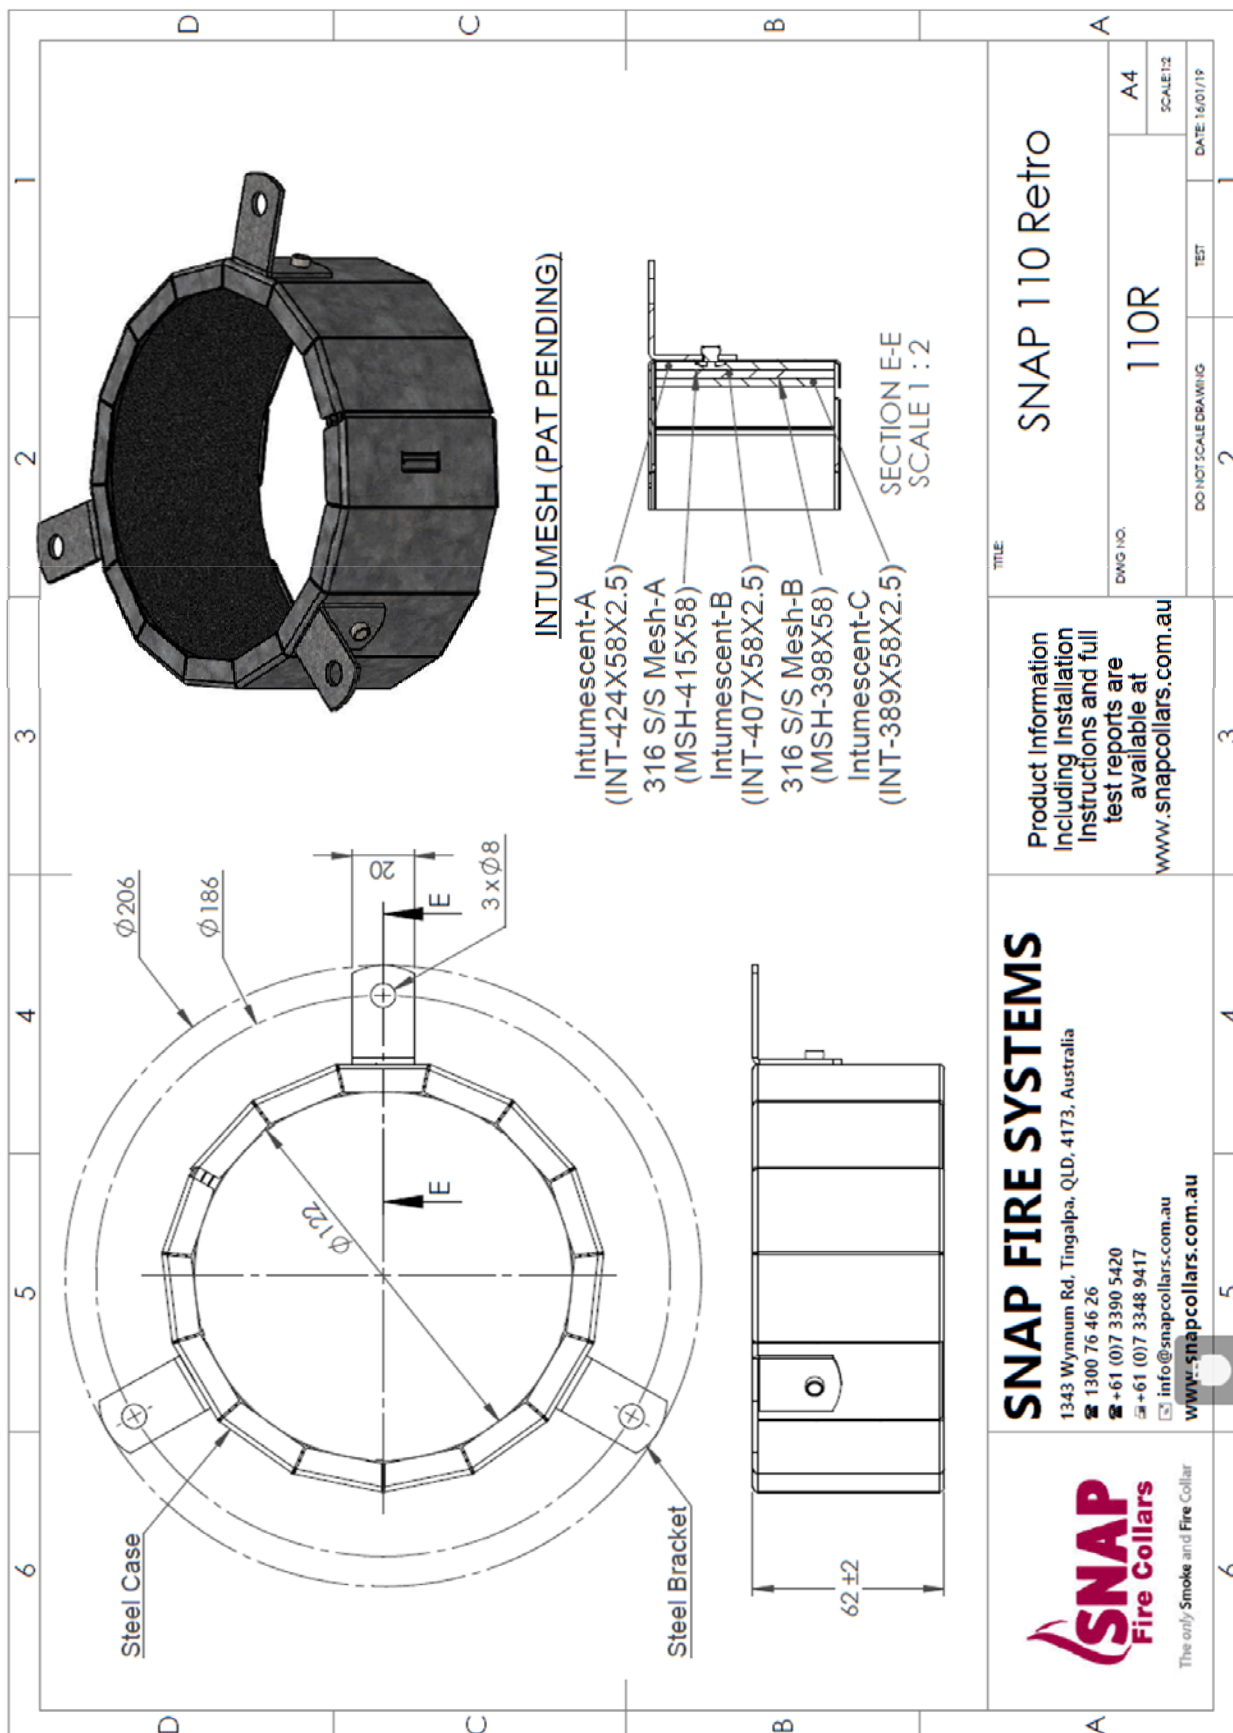
DRAWING NUMBERED 110R, TITLED "SNAP 110 RETRO", DATED 16 JANUARY 2019, BY SNAP FIRE SYSTEMS PTY LTD.
