Fire-resistance test on fire collars protecting a concrete floor slab penetrated by services

Test Report

Author: Peter Gordon
Report number: FSP 1986
Date: 7 May 2019

Client: IG6 Pty Ltd as trustee for the IG6 IP Trust

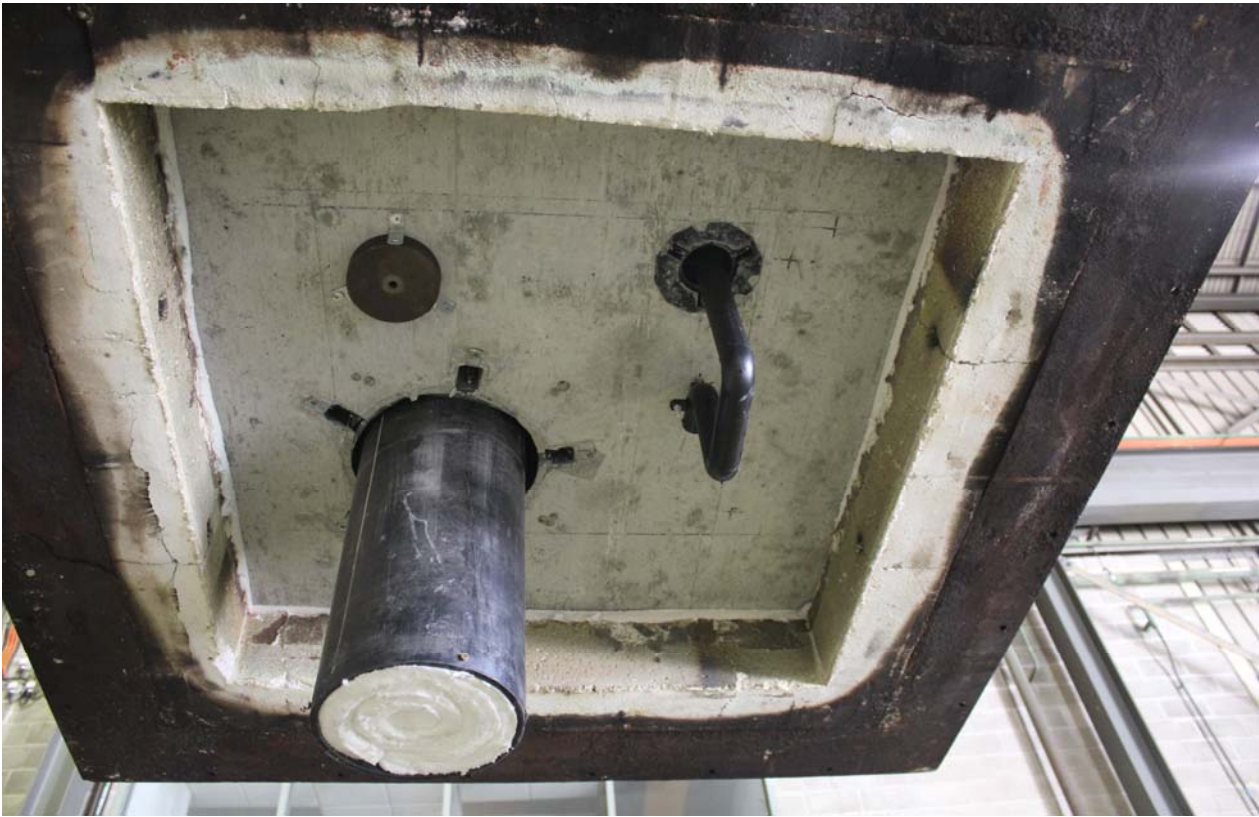
PHOTOGRAPH 1 – EXPOSED FACE OF SPECIMENS PRIOR TO TESTING

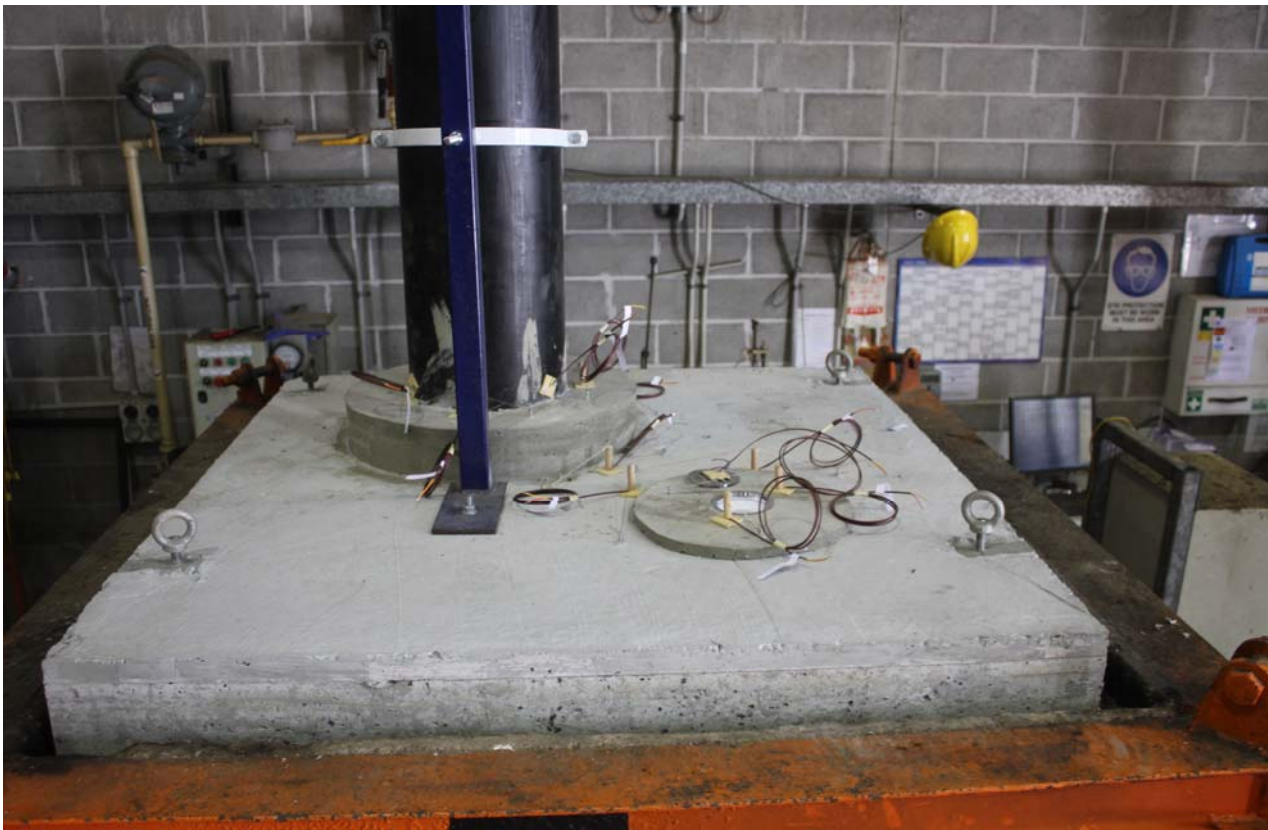
PHOTOGRAPH 2 – UNEXPOSED FACE OF SPECIMENS PRIOR TO TESTING

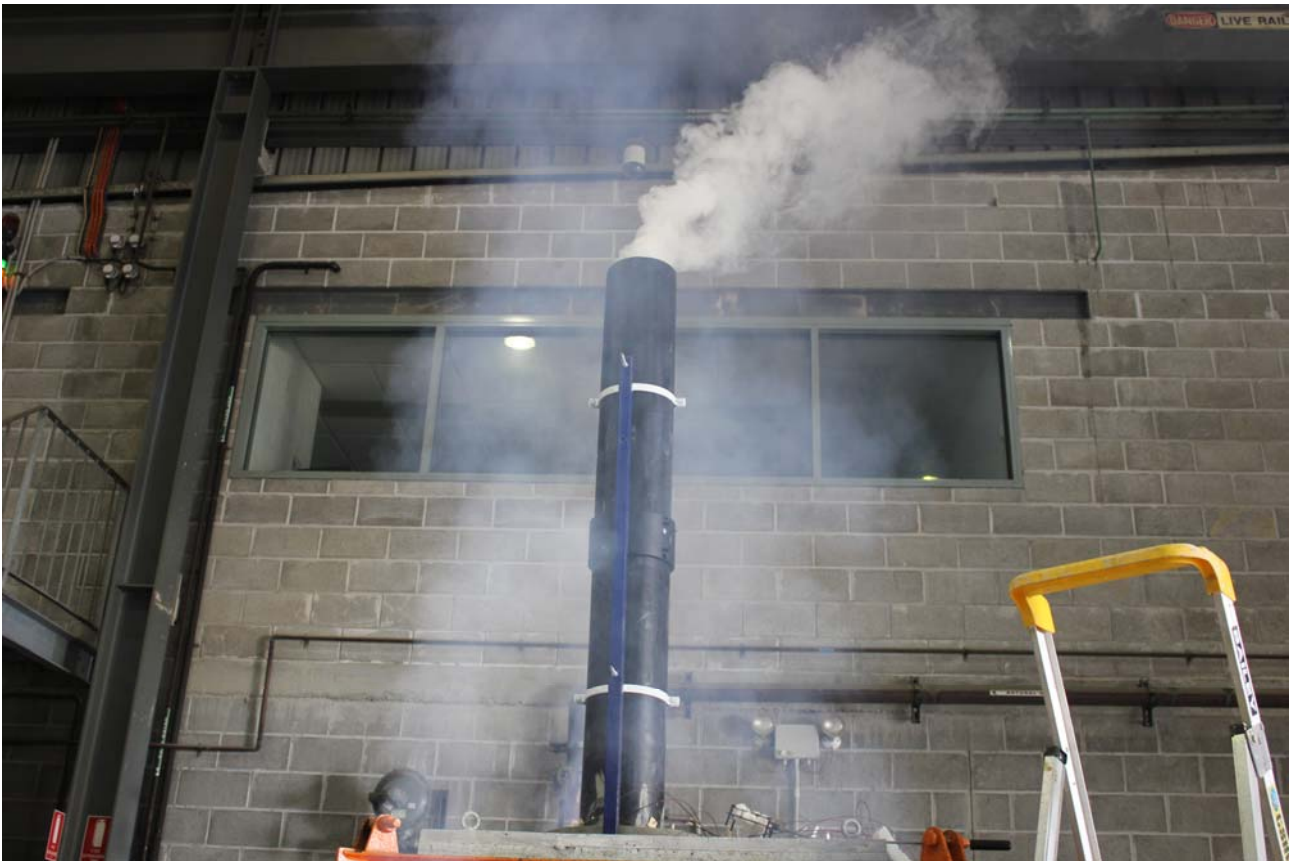
PHOTOGRAPH 3 – SPECIMEN 1 AFTER 6 MINUTES OF TESTING

| Time | Observation |
|---|--|
| 6 minutes - | The smoke level being emitted from the furnace flues has increased. Smoke has started fluing from the pipe of Specimen 1. |

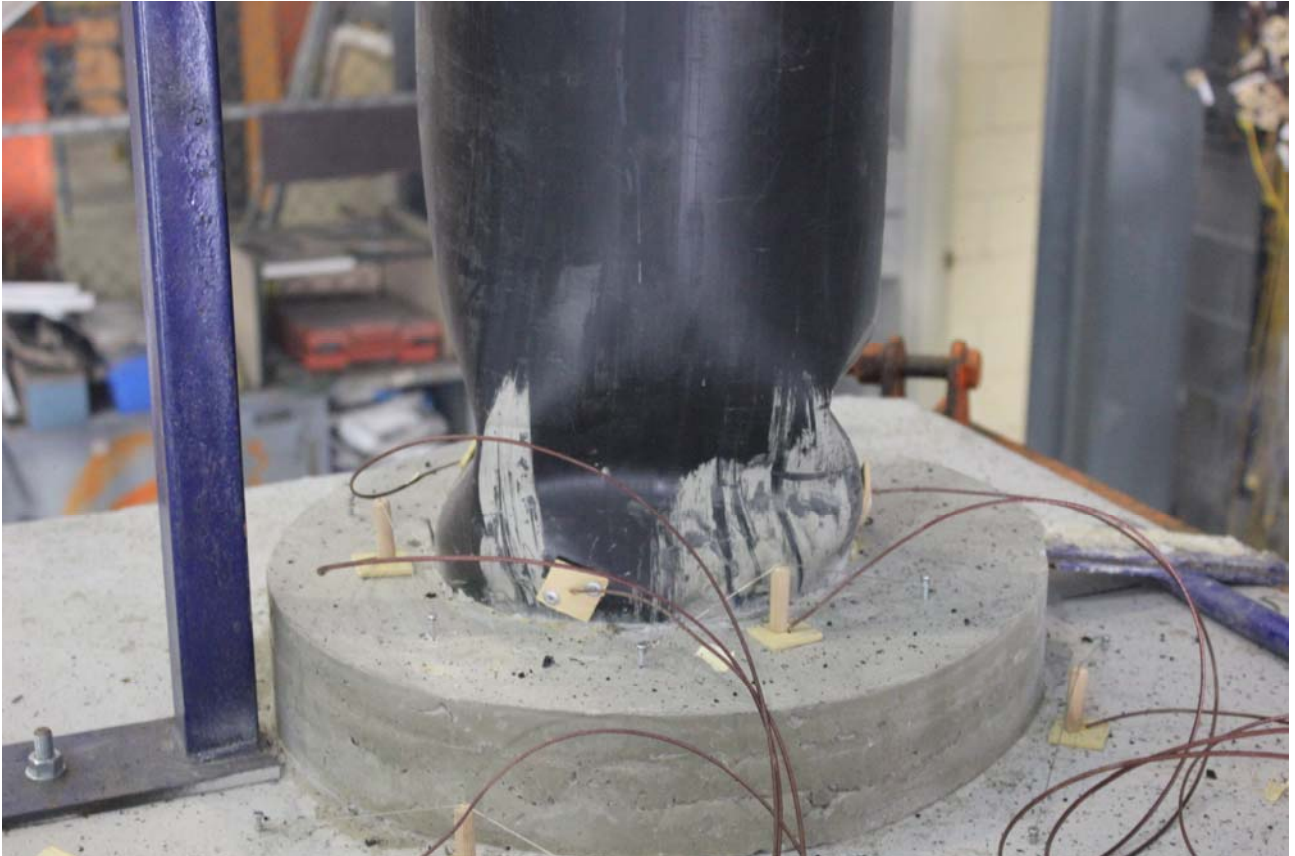
PHOTOGRAPH 4 – BASE OF SPECIMEN 1 AFTER 14 MINUTES OF TESTING

| Time | Observation |
|---|--|
| 14 minutes - | The black pipe above the collar in Specimen 1 has deformed. |

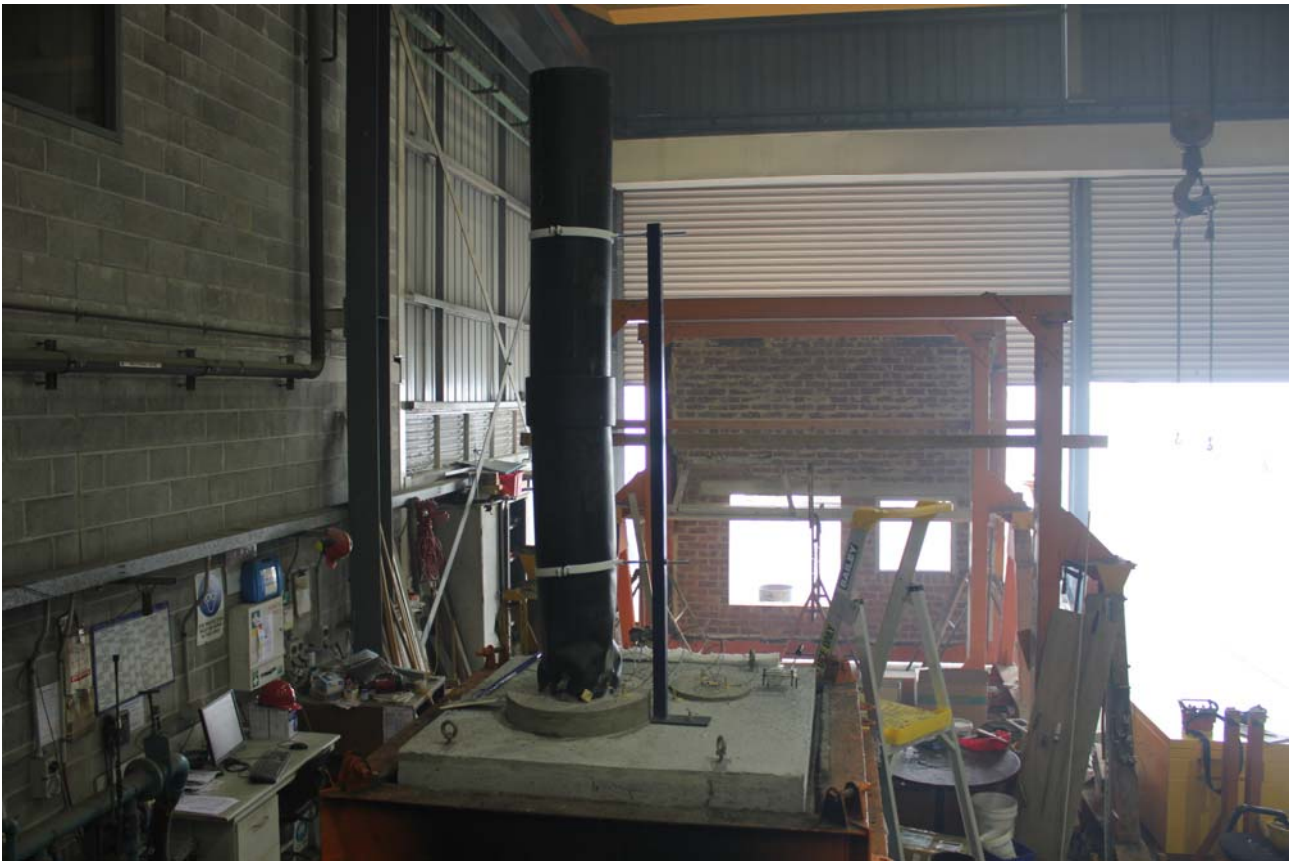
PHOTOGRAPH 5 – SPECIMENS AFTER 30 MINUTES OF TESTING

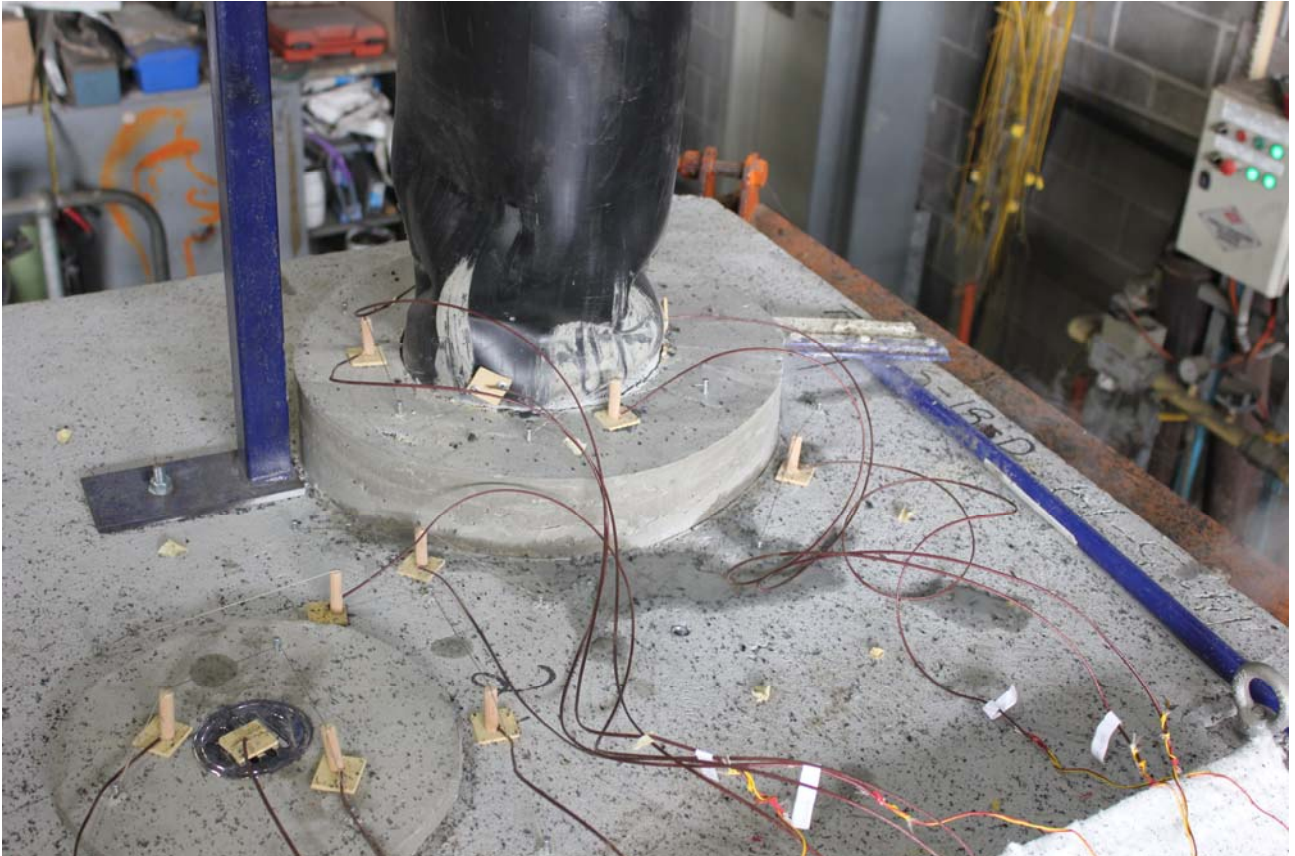
PHOTOGRAPH 6 – SPECIMENS AFTER 60 MINUTES OF TESTING

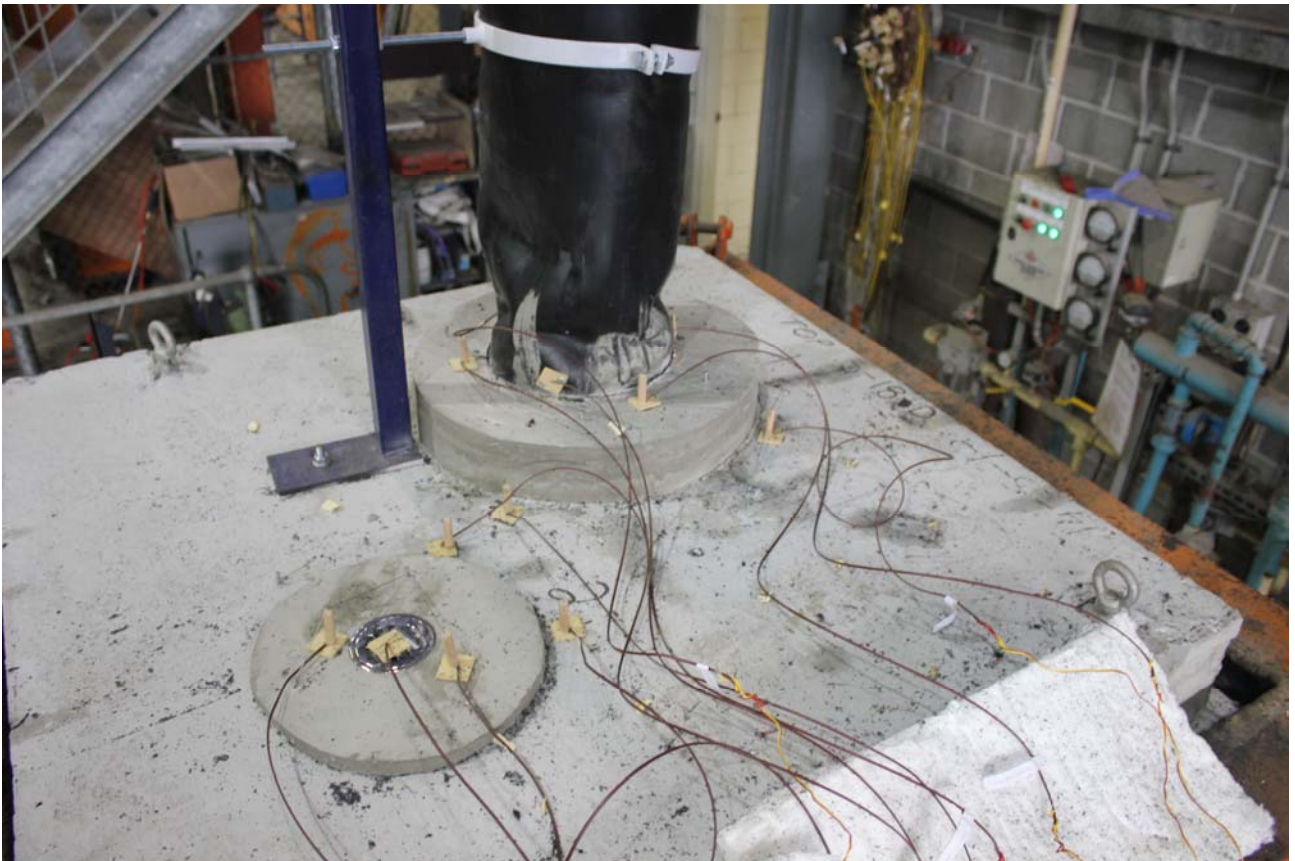
PHOTOGRAPH 7 – SPECIMENS AFTER 120 MINUTES OF TESTING

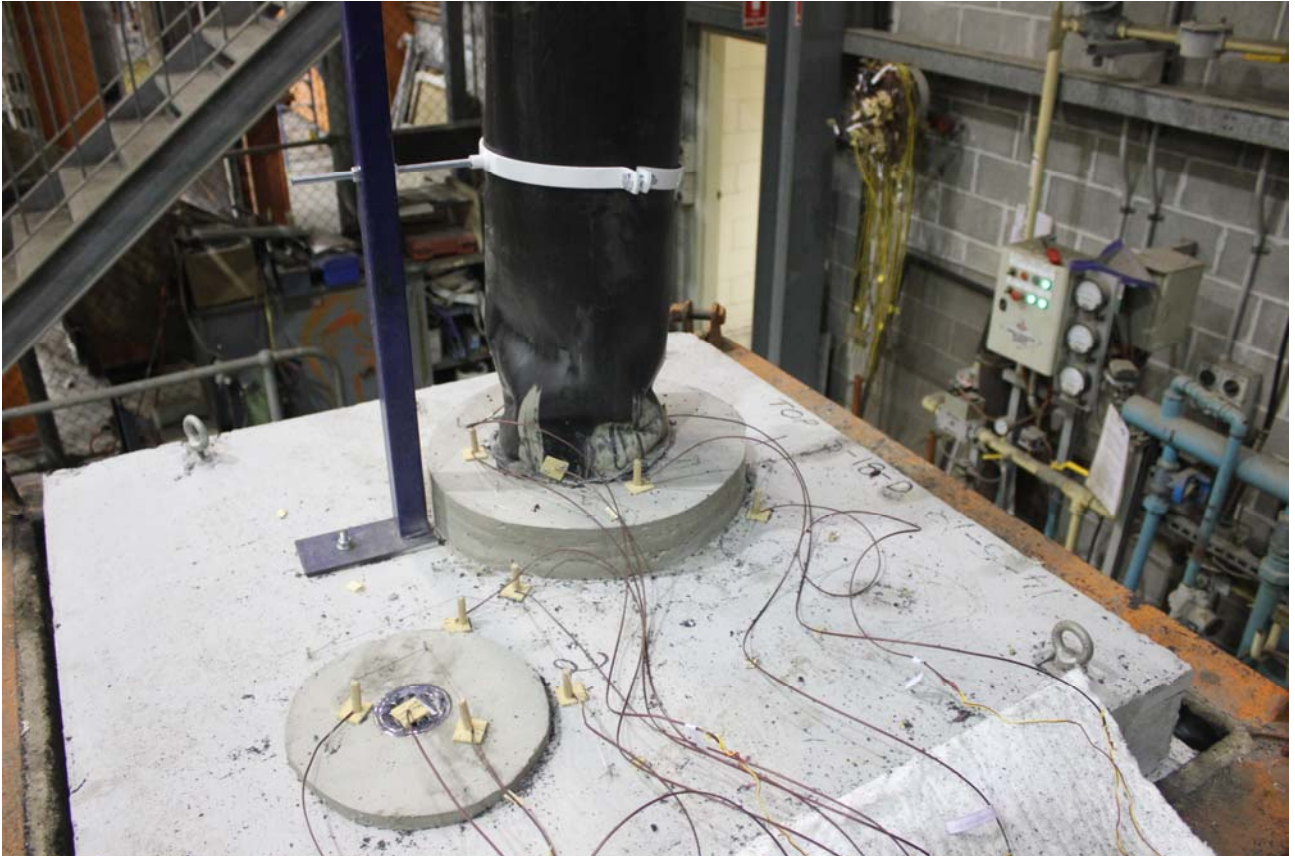
PHOTOGRAPH 8 – SPECIMENS AFTER 180 MINUTES OF TESTING

| Time | Observation |
|---|--|
| 180 minutes - | No further visible change from both specimens. |

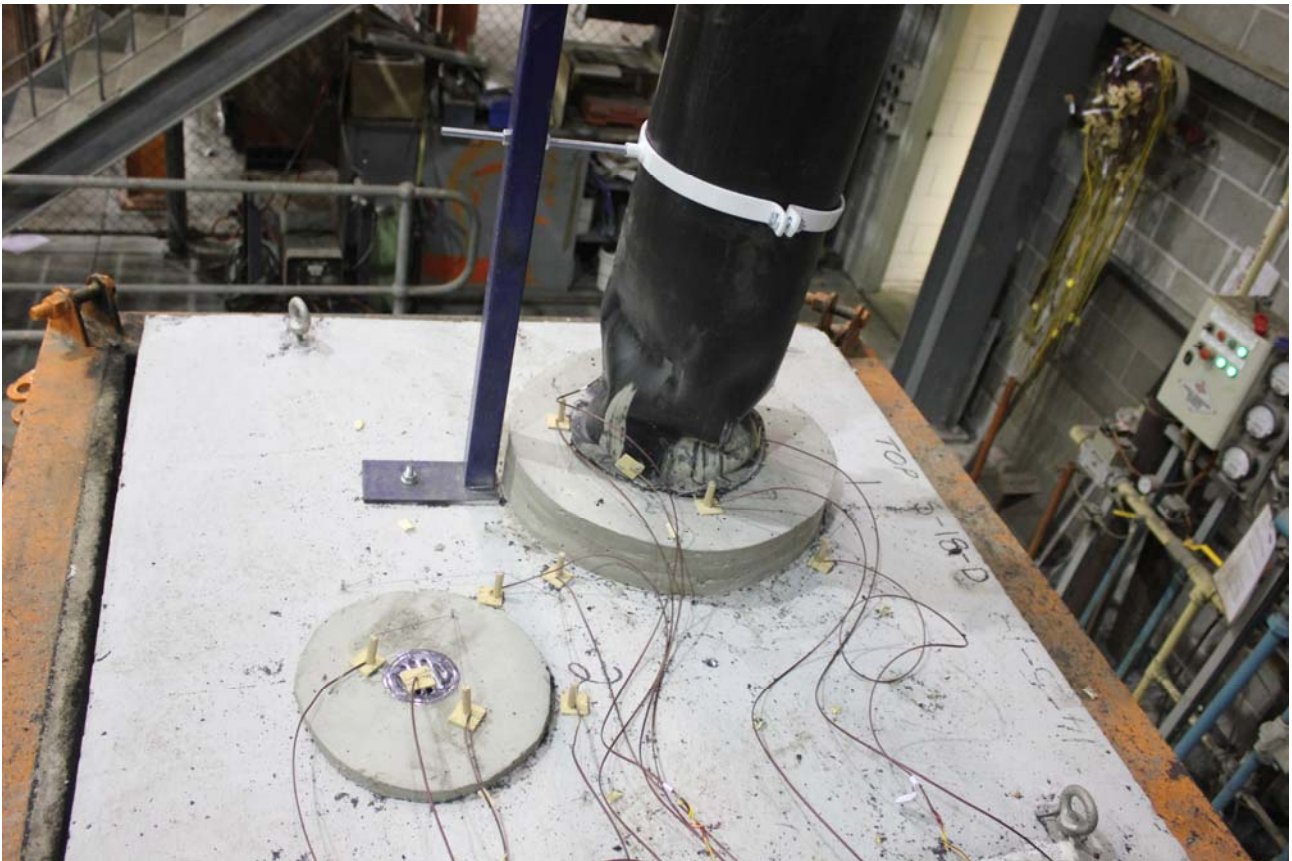
PHOTOGRAPH 9 – SPECIMENS 1 AFTER 240 MINUTES OF TESTING

| Time | Observation |
|---|--|
| 241 minutes - | <u>Insulation Failure Specimen 1</u> – maximum temperature rise of 180K is exceeded on the hob. |

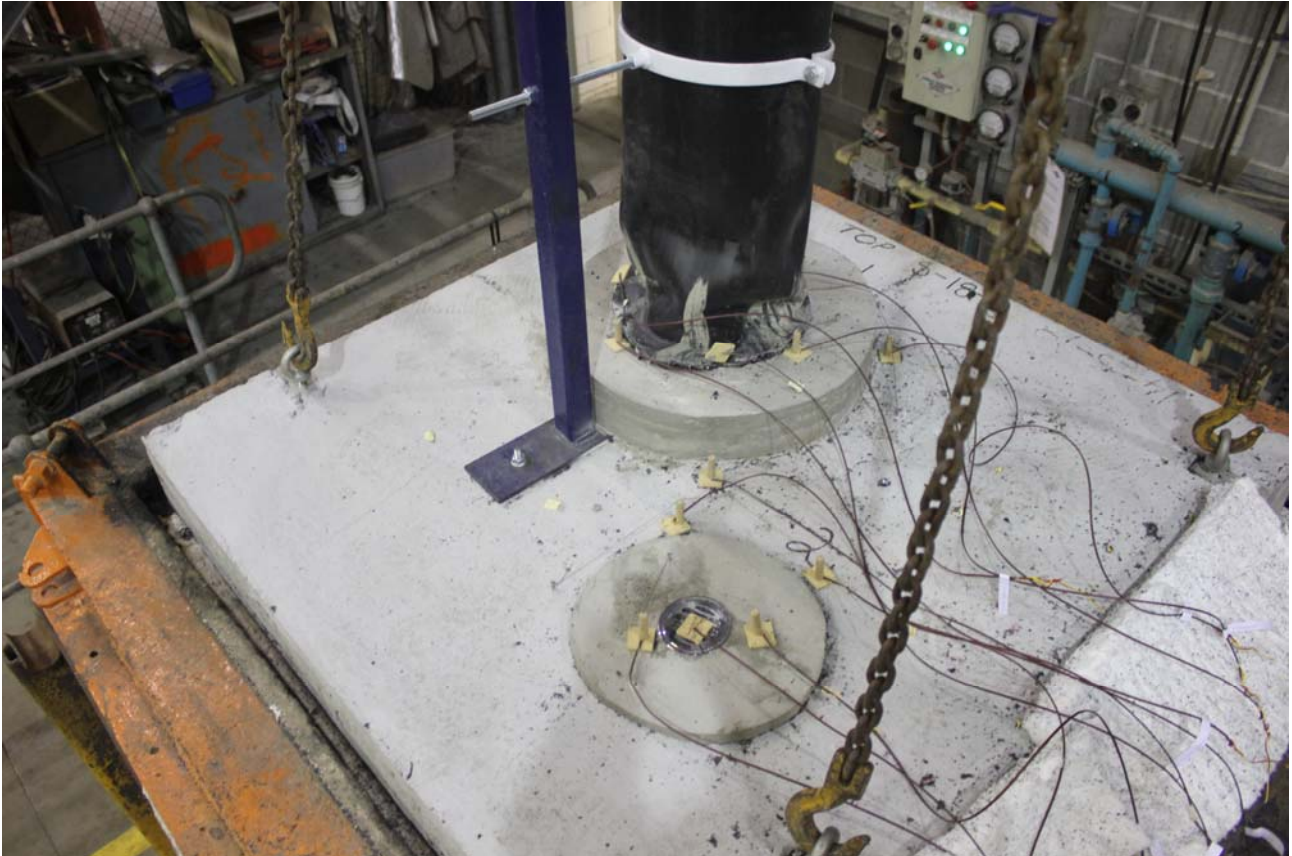
PHOTOGRAPH 10 – UNEXPOSED FACE OF SPECIMEN AT CONCLUSION OF TESTING

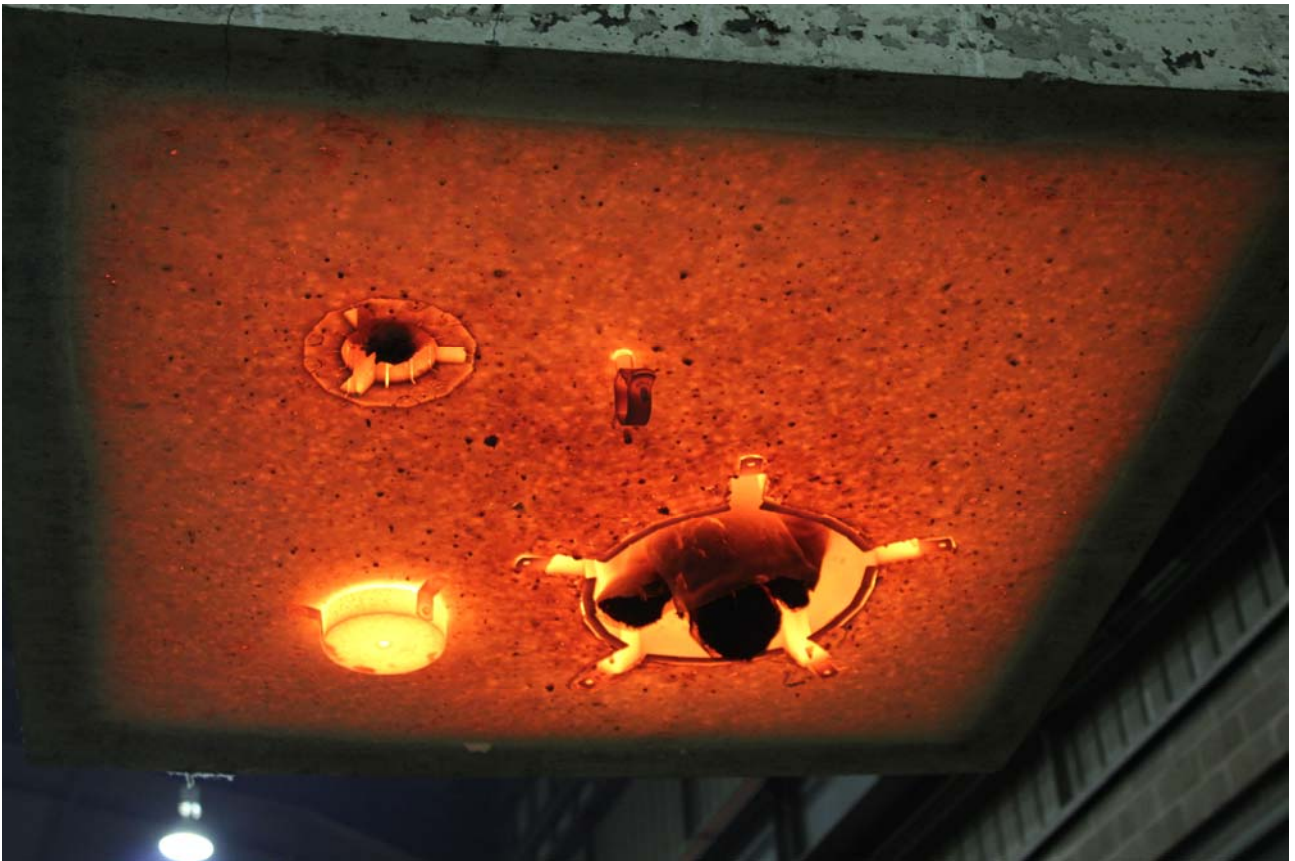
PHOTOGRAPH 11 – EXPOSED FACE OF SPECIMENS AT CONCLUSION OF TESTING

Post Test Observations - The 2.65-Kg steel weight from Specimen 3 had remained attached to the underside of the slab for the duration of the test. Refer Photograph 11.

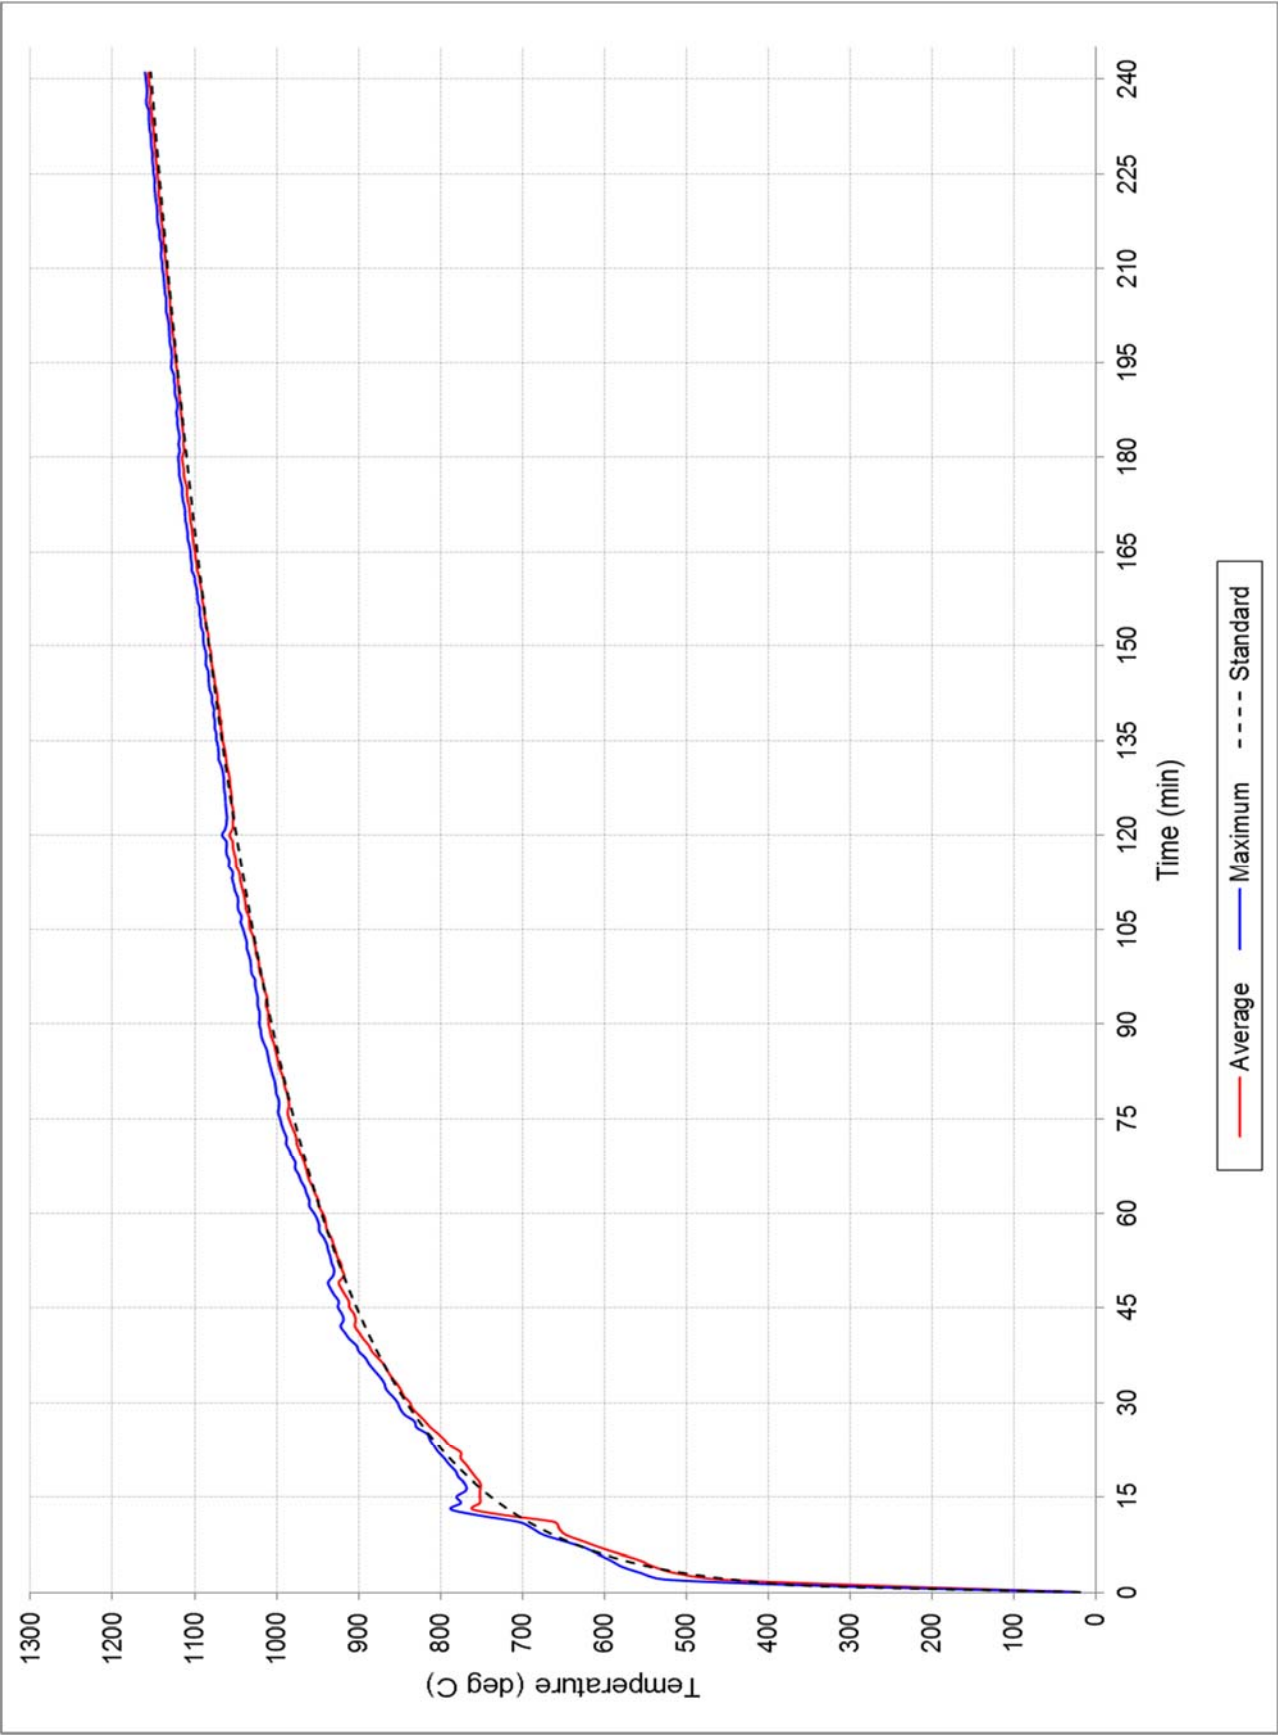
FIGURE 1 – FURNACE TEMPERATURE

Figure 1 shows the standard curves of temperature versus time for heating the furnace chamber and the actual curves of average and maximum temperature versus time recorded during the heating period.

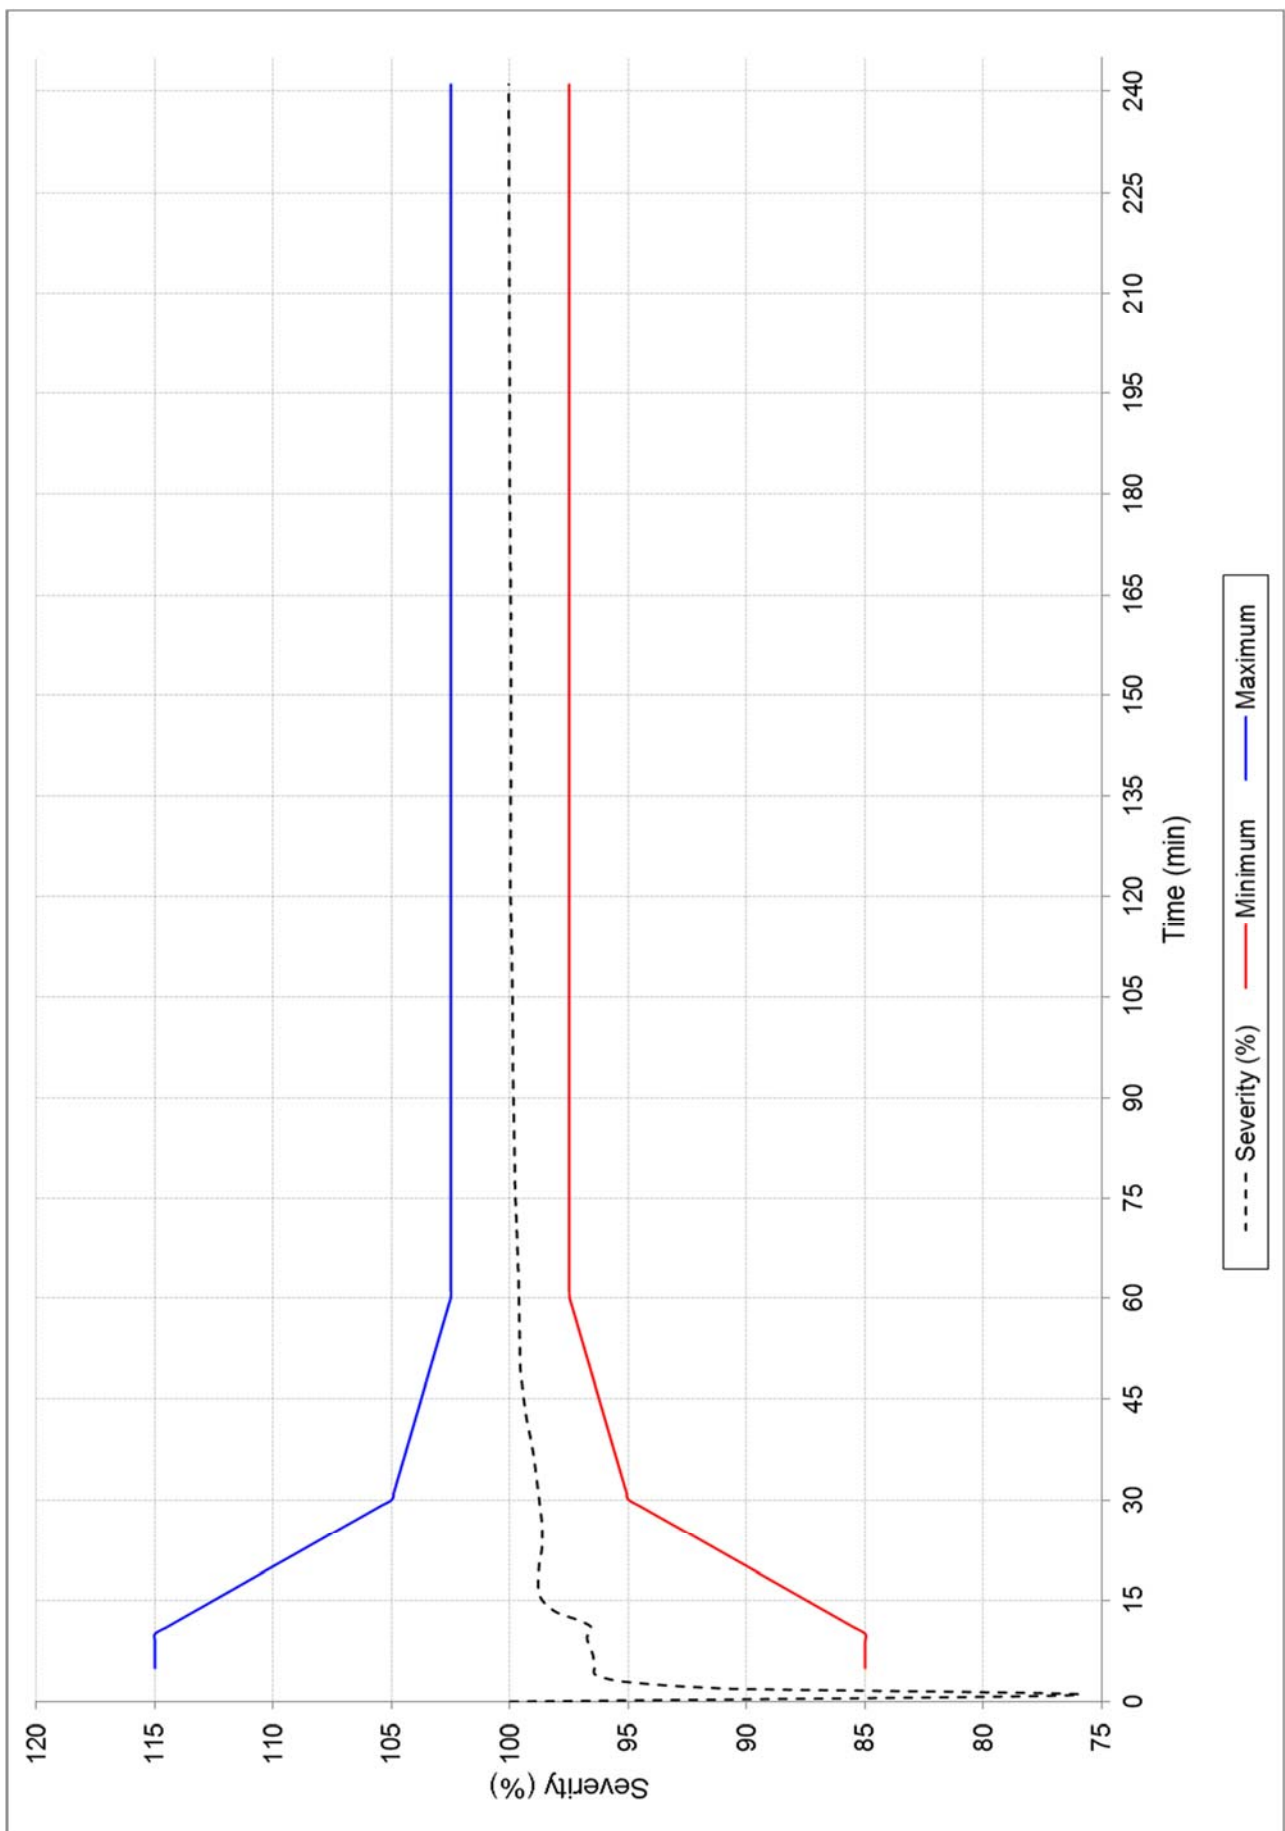
FIGURE 2 – FURNACE SEVERITY

Figure 2 shows the curve of furnace severity versus time during the heating period.

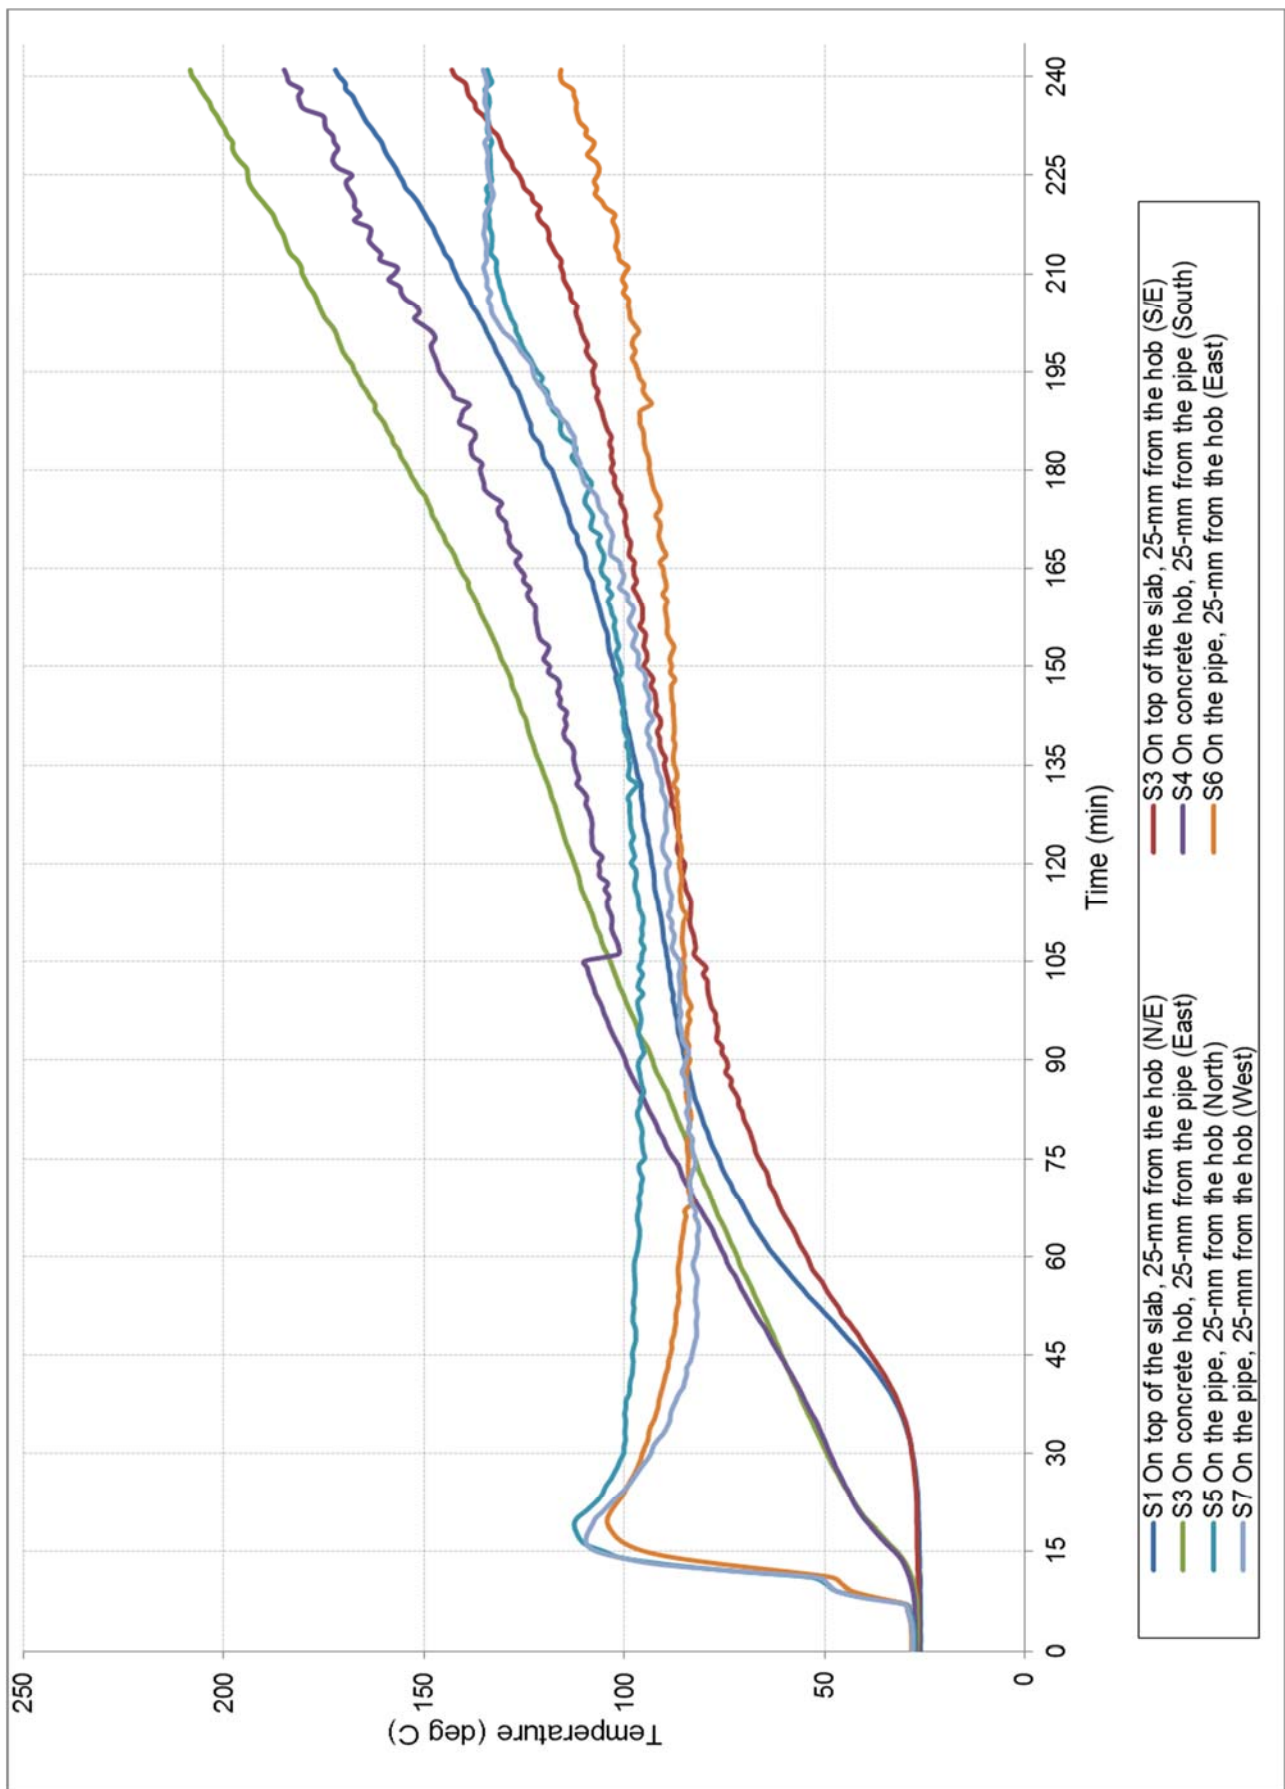
FIGURE 3 – SPECIMEN TEMPERATURE – ASSOCIATED WITH SPECIMEN # 1

Figure 3 shows the curve of temperature versus time associated with Specimen 1.

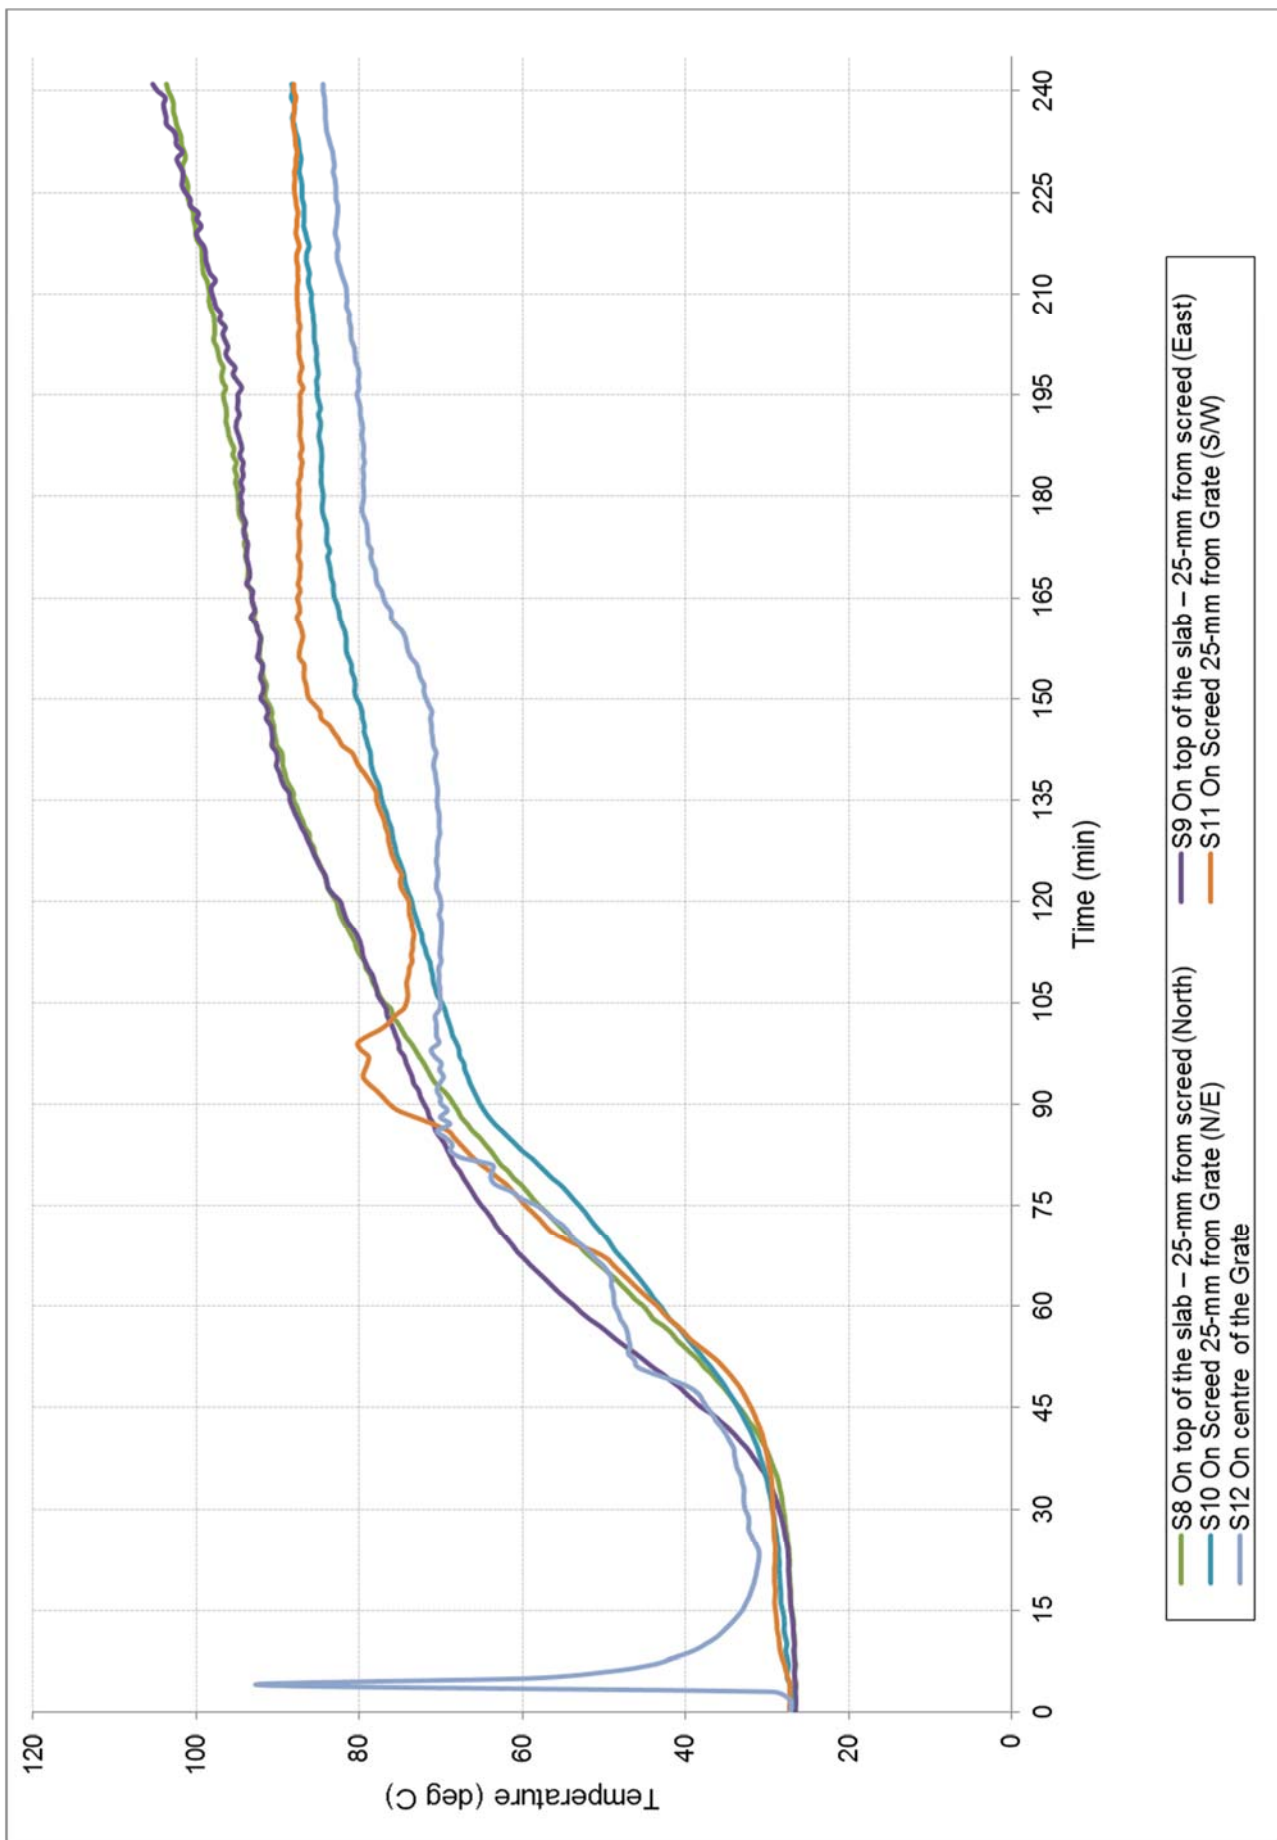
FIGURE 4 – SPECIMEN TEMPERATURE – ASSOCIATED WITH SPECIMEN # 2

Figure 4 shows the curve of temperature versus time associated with Specimen 2.

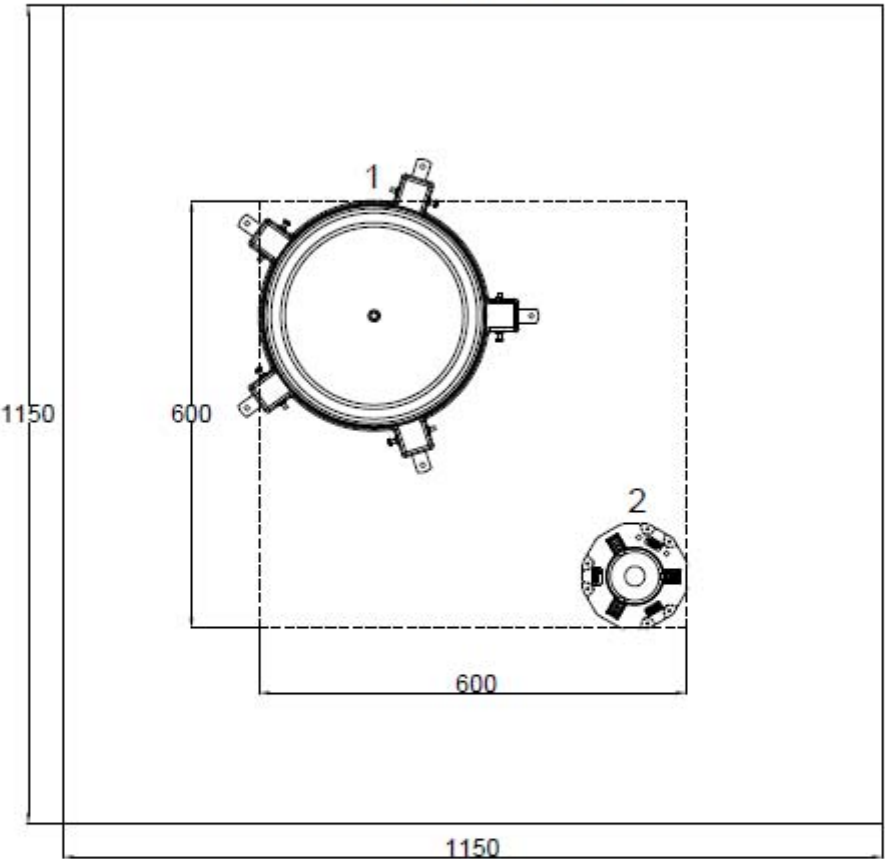
Snap Fire Systems Pty Ltd
Test Slab S-18-D Layout
Date: 10 DEC 2018

| Penetration | Collar Code | Pipe Type | Pipe Diameter (mm) | Fitting |
| 1 | 250C | HDPE | 250 | N/A |
| 2 | H50FWS | HDPE | 40 | N/A |

DRAWING TITLED “TEST SLAB S-18-D LAYOUT”, DATED 10 DECEMBER 2018, BY SNAP FIRE SYSTEMS PTY LTD.

Drawing titled “Test Slab S-18-D Layout”, dated 10 December 2018, by Snap Fire Systems Pty Ltd.
