Fire-resistance test on fire collars protecting a concrete floor slab penetrated by services

Test Report

Author: Peter Gordon
Report number: FSP 1986
Date: 7 May 2019

Client: IG6 Pty Ltd as trustee for the IG6 IP Trust

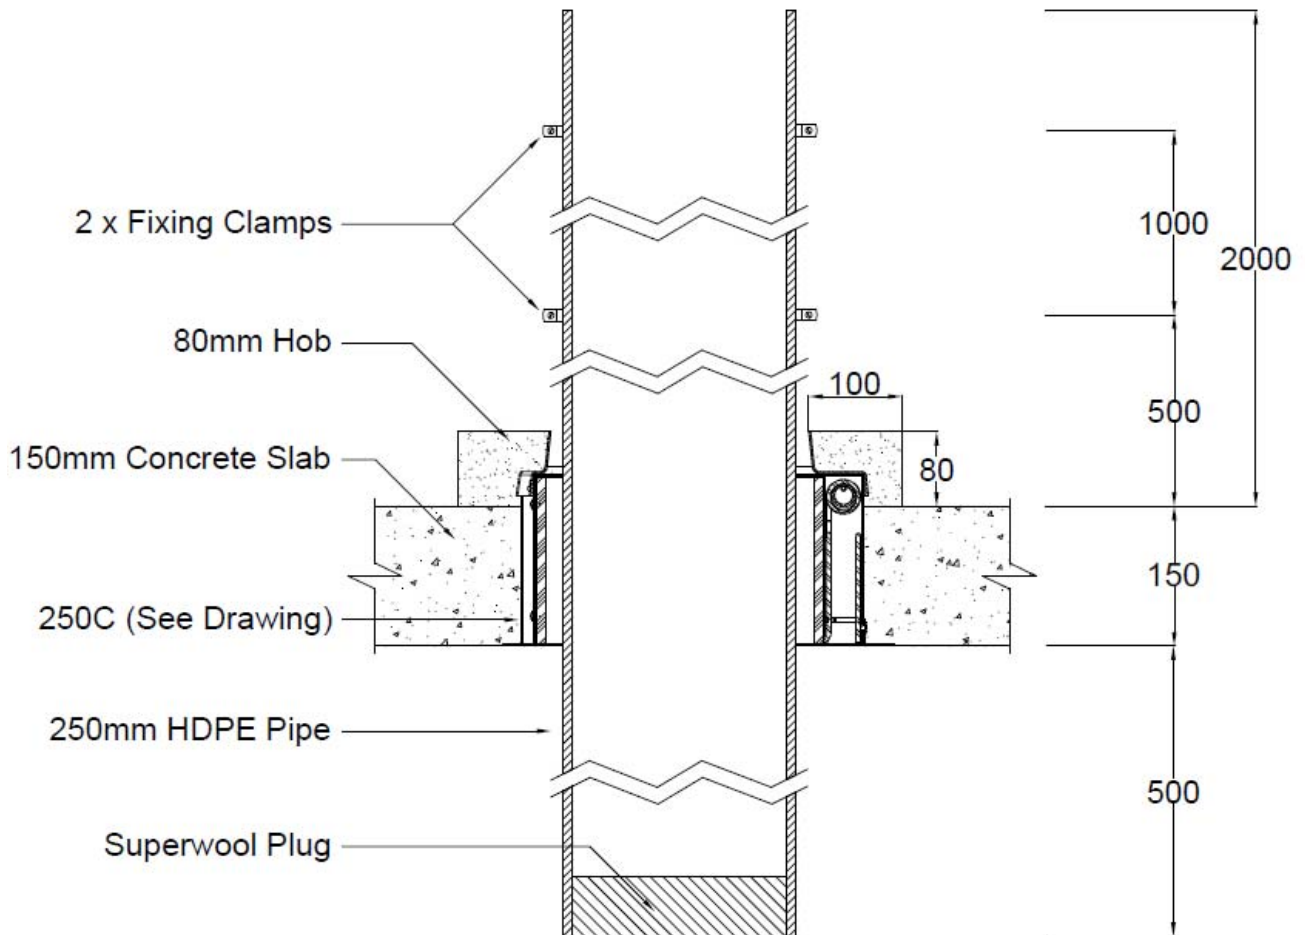
250 HDPE Stack & 250C

**DRAWING TITLED "SPECIMEN #1, 250 HDPE STACK & 250C", DATED 10 DECEMBERR 2018, PROVIDED BY
SNAP FIRE SYSTEMS PTY LTD.**

The SNAP 250C cast-in fire collar comprised of a 3-mm ABS cover attached to a 0.75-mm thick steel casing with a 288-mm inner diameter and a 460-mm diameter base flange. The 187-mm high casing incorporated a 930-mm x 179-mm x 10-mm thick Intumesh intumescent material. The closing mechanism comprised five stainless steel springs, black nylon fuse links and a 1020-mm x 174-mm 316 stainless steel mesh, as shown in drawing number 250C, titled "SNAP 250 Cast-In", dated 22 October 2018, by Snap Fire Systems Pty Ltd.

The penetrating service comprised a 250-mm HDPE stack pipe with a wall thicknesses of 8.3-mm. An 80-mm high x 100-mm wide concrete hob was formed over the collar on the unexposed face. The pipe projected vertically 2000-mm above the concrete and 500-mm into the furnace chamber. The pipe was supported at 500-mm and 1500-mm from the unexposed face of the concrete slab as shown in Drawing titled "Specimen #1, 250 HDPE stack and 250C", dated 10 December 2018, provided by Snap Fire Systems Pty Ltd. The exposed end of the pipe was plugged with Superwool ceramic fibre.

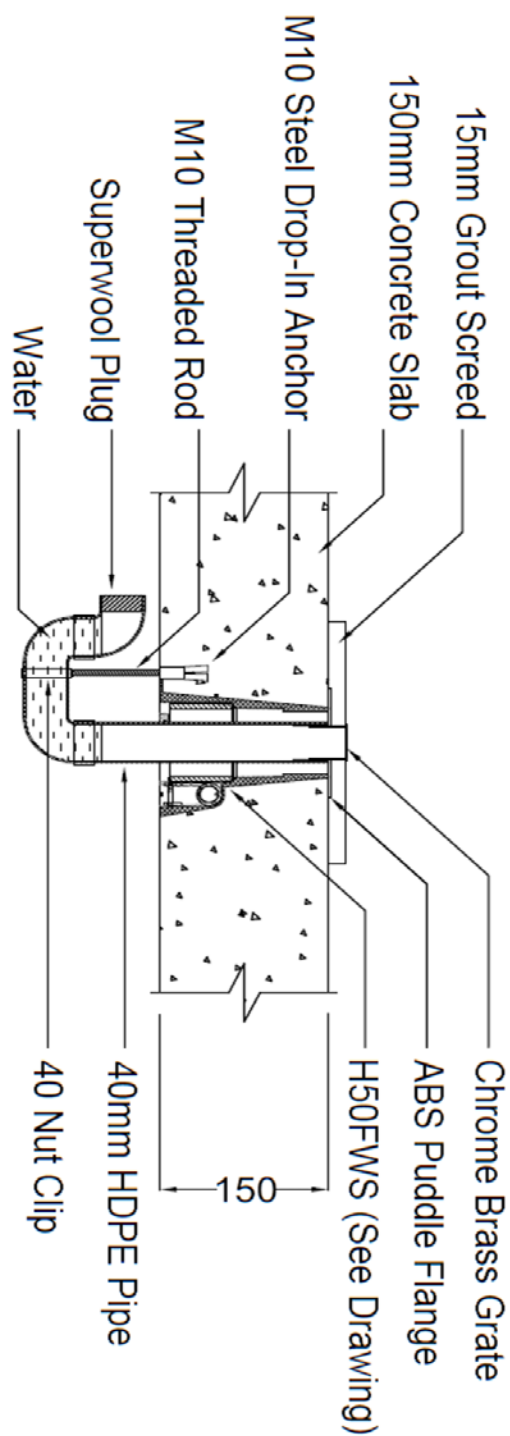
40 HDPE Floorwaste & H50FWS

DRAWING TITLED "SPECIMEN #2, 40 HDPE FLOORWASTE & H50FWS", DATED 28 FEBRUARY 2019,
PROVIDED BY SNAP FIRE SYSTEMS PTY LTD.

The SNAP 50 High-Top Floor Waste Shower cast in fire collar comprised a 1.6-mm thick polypropylene casing with a 67-mm inner diameter and a 150-mm diameter base flange. The 250-mm high collar casing incorporated a 230-mm x 55-mm x 5-mm thick intumescent material. The closing mechanism incorporated three stainless steel springs, with nylon fuse links and a 268-mm x 53-mm 316 stainless steel mesh as shown in drawing number H50FWF-RR, titled “SNAP 50 High-Top Floor Waste Shower”, dated 29 September 2017, by Snap Fire Systems Pty Ltd.

The penetrating service comprised a 40-mm diameter HDPE pipe, with a wall thickness of 3.8-mm. The floor waste system was fitted with a chrome brass grate and an ABS Puddle Flange. A 15-mm thick grout screed was laid on top of the concrete slab and finished flush with the floor grate. On the exposed side of the slab, an M10 threaded rod was connected to the penetrating pipe, fixed to the concrete slab with M10 Steel Drop-In Anchor. The exposed end of the pipe was plugged with Superwool ceramic fibre.

The floor waste was charged with water to the level shown in drawing titled “Specimen #2, 40 HDPE Floor waste & H50FWS”, dated 28 February 2019, provided by Snap Fire Systems Pty Ltd.

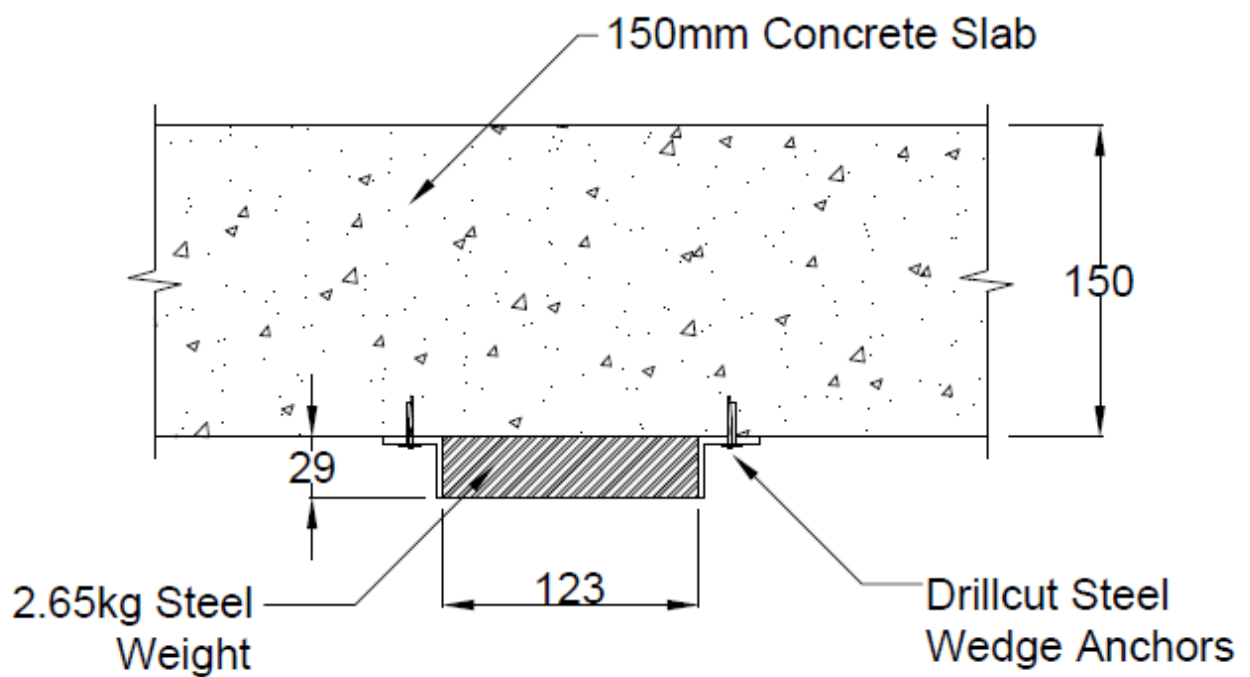
W-18-D Specimen 3

DRAWING TITLED "W-18-D SPECIMEN 3", RECEIVED 13 MARCH 2019 BY SNAP FIRE SYSTEMS PTY LTD.

A 2.65-kg weight was attached to the exposed face of the concrete slab with three 6-mm x 35-mm Drillcut Steel Wedge Anchors as shown in drawing titled “W-18-D Specimen 3”, received 13 March 2019 from Snap Fire Systems Pty Ltd.

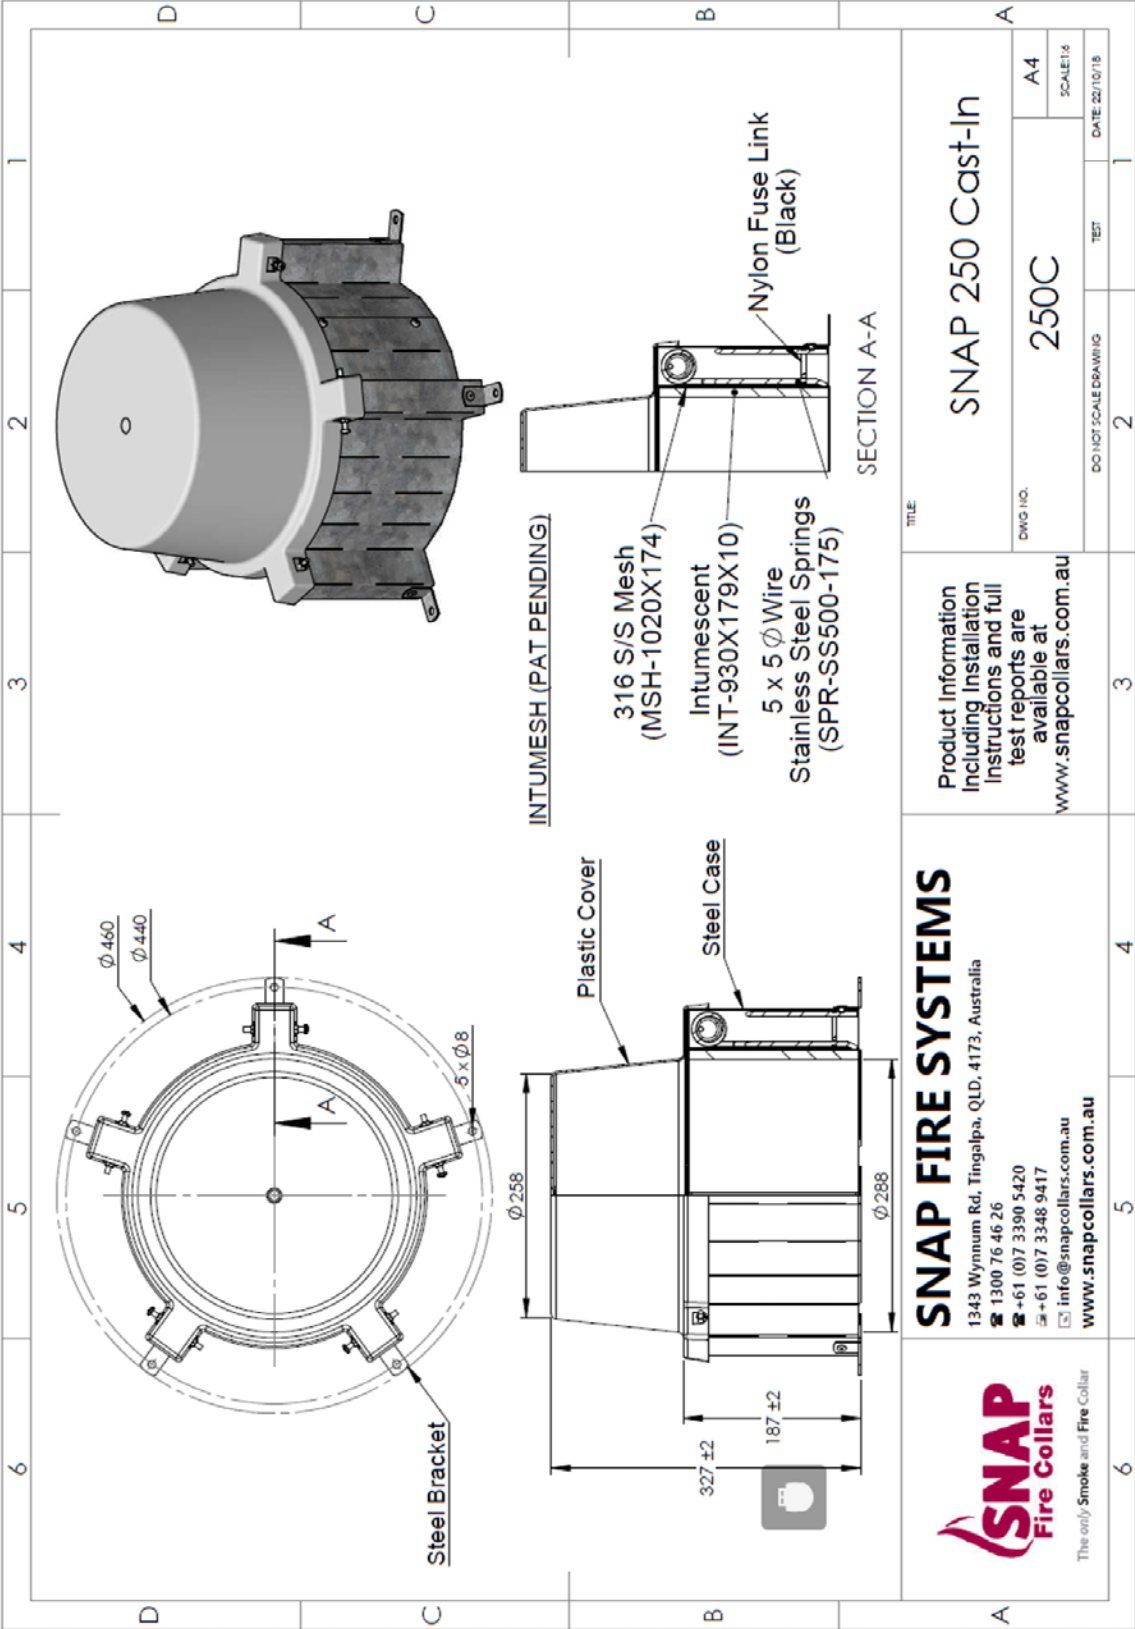
DRAWING NUMBERED 250C, TITLE “SNAP 250 CAST-IN” DATED 10 DECEMBER 2018, BY SNAP FIRE SYSTEMS PTY LTD

Drawing number 250C, titled “SNAP 250 Cast-In”, dated 22 October 2018, by Snap Fire Systems Pty Ltd.

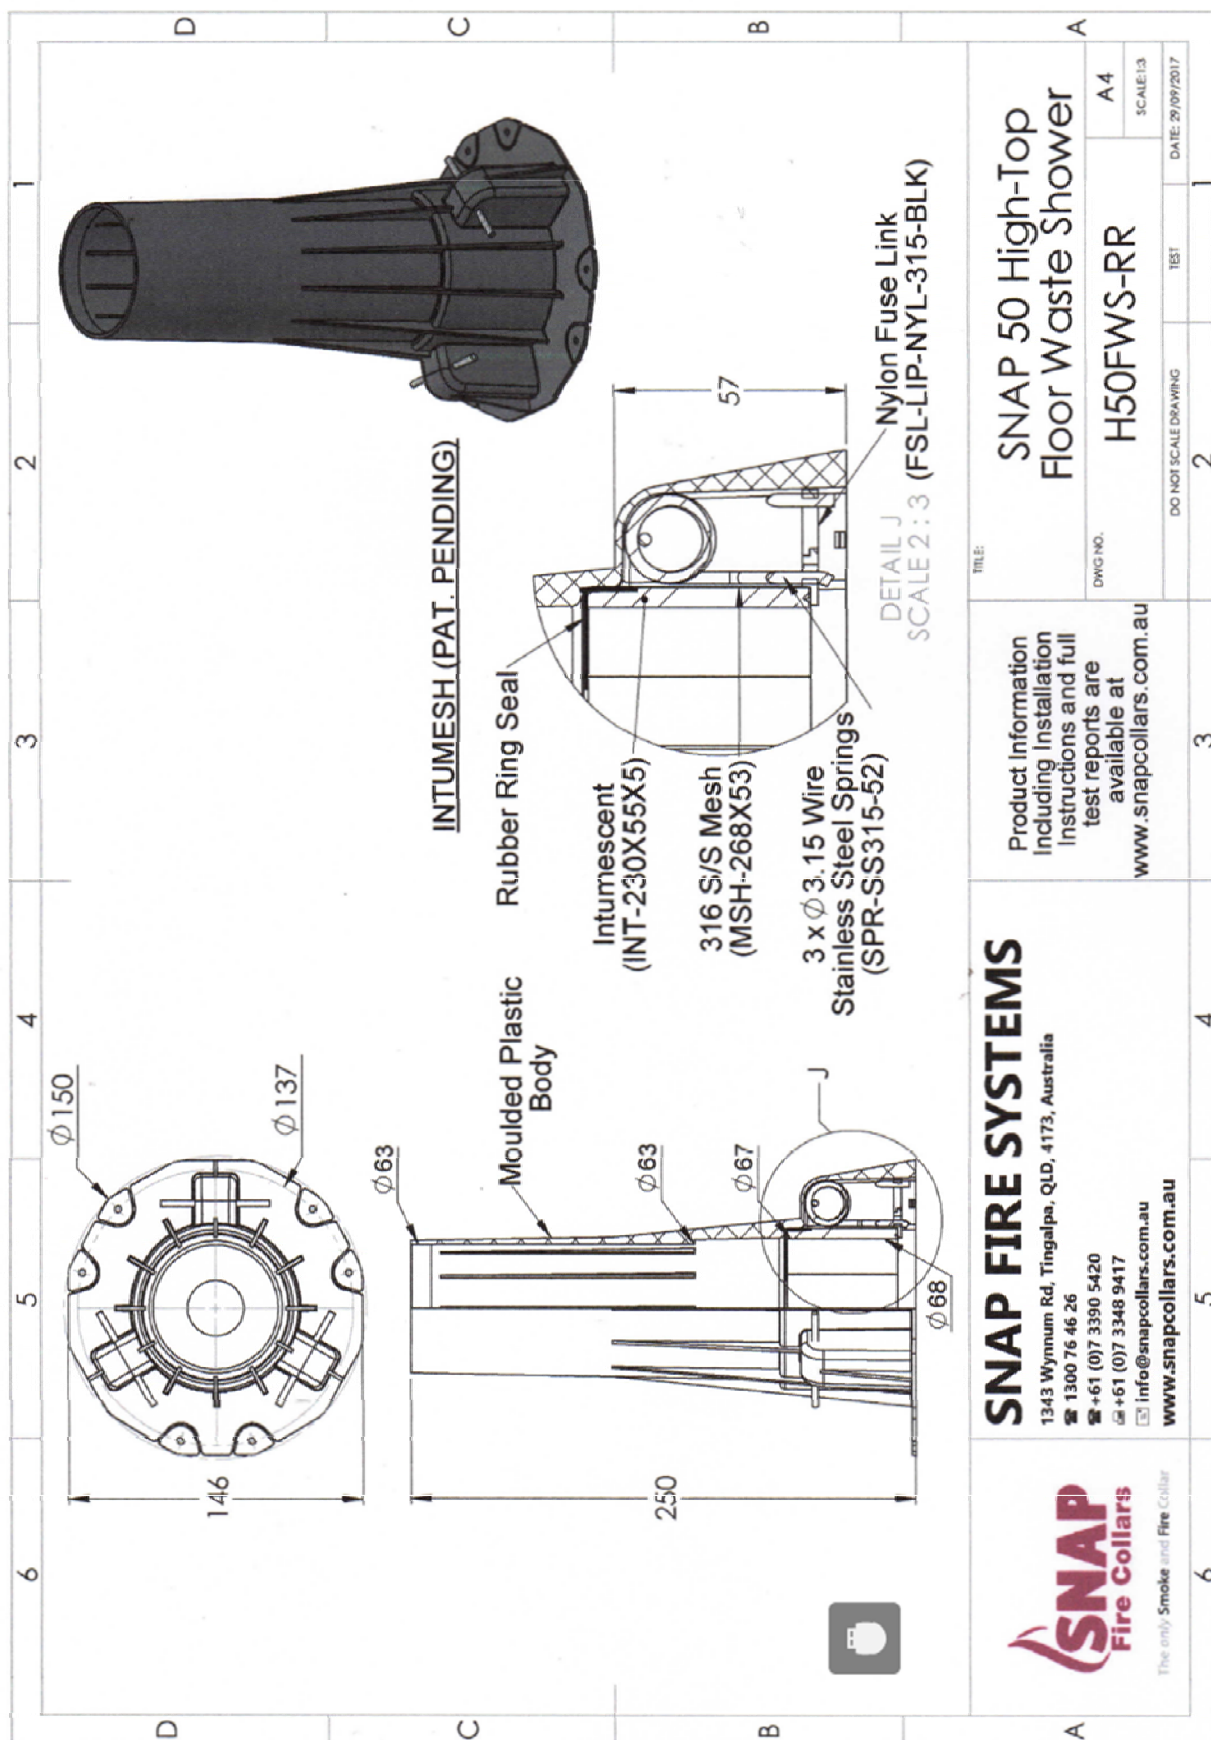
DRAWING NUMBERED H50FWS-RR, TITLE "SNAP 50 HIGH-TOP FLOOR WASTE SHOWER" DATED 10 DECEMBER 2018, BY SNAP FIRE SYSTEMS PTY LTD

Drawing number H50FWF-RR, titled “SNAP 50 High-Top Floor Waster Shower”, dated 29 September 2017, by Snap Fire Systems Pty Ltd.
