Fire-resistance test on fire collars protecting a concrete floor slab penetrated by services

Test Report

Author: Peter Gordon
Report number: FSP 2016
Date: 19 August 2019

Sponsored Investigation No. FSP 2016

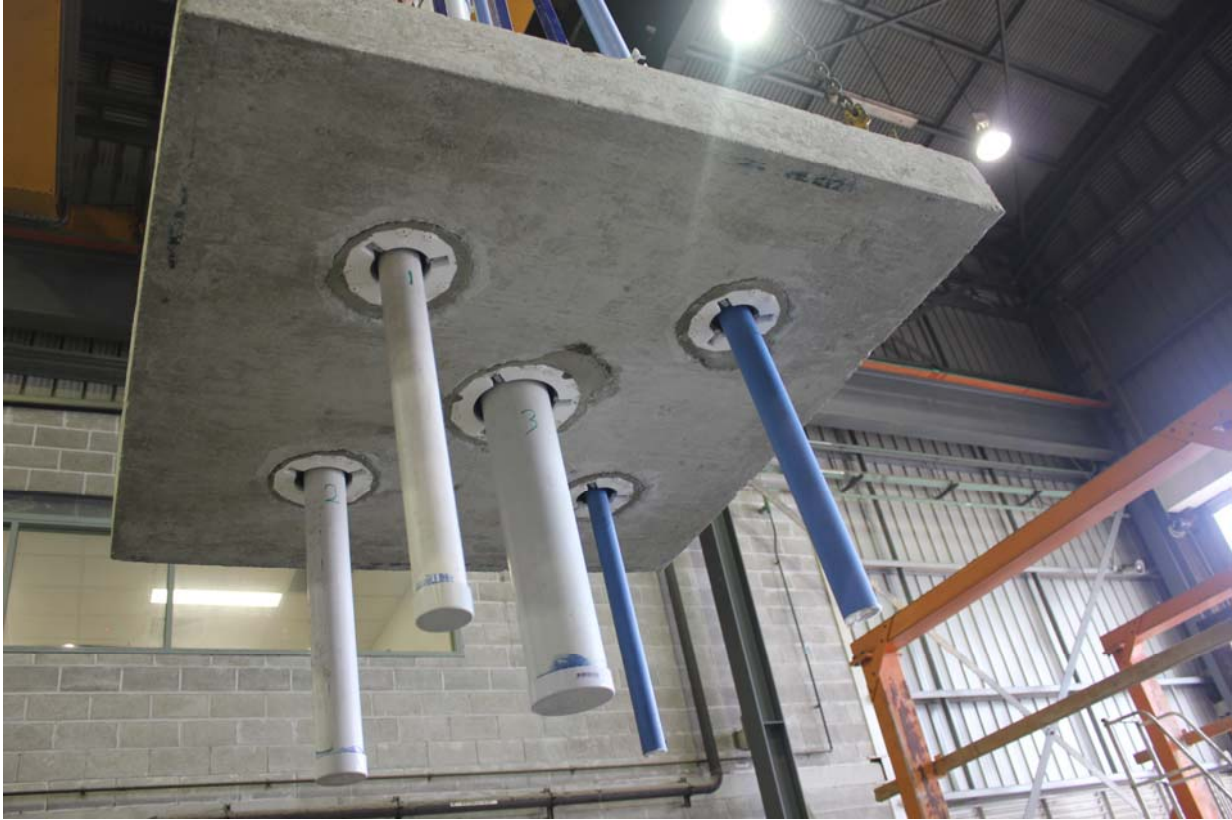
PHOTOGRAPH 1 – EXPOSED FACE OF SPECIMENS PRIOR TO TESTING

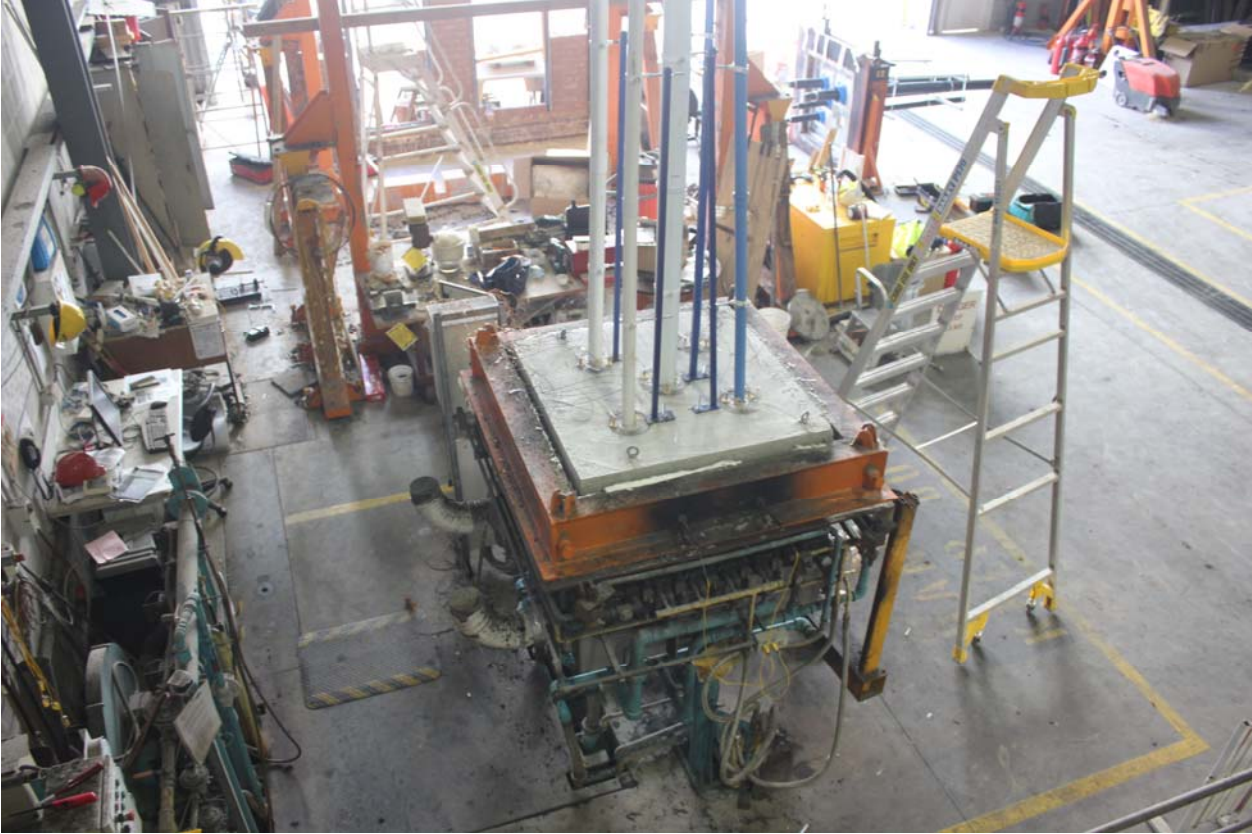
PHOTOGRAPH 2 – UNEXPOSED FACE OF SPECIMENS PRIOR TO TESTING

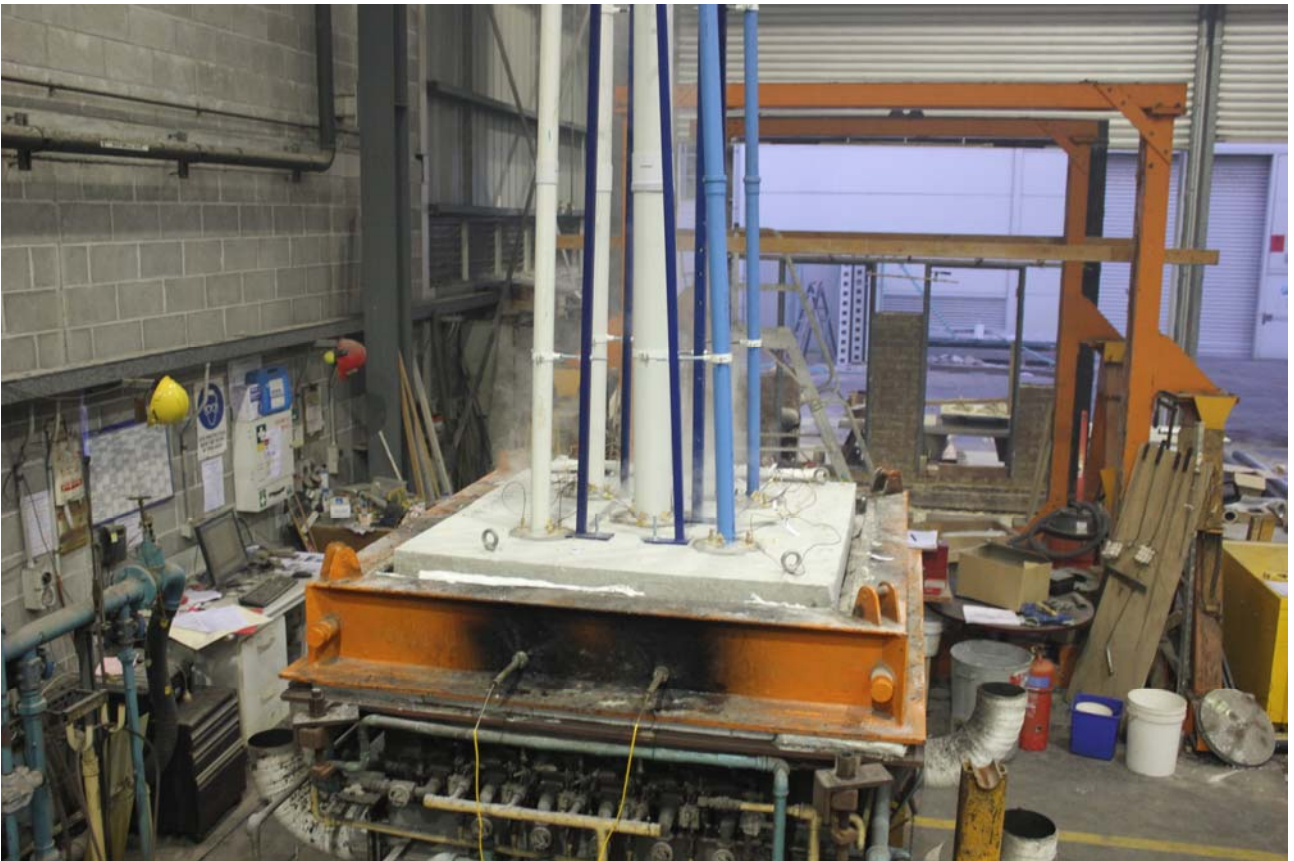
PHOTOGRAPH 3 – SPECIMENS AFTER 35 MINUTES OF TESTING

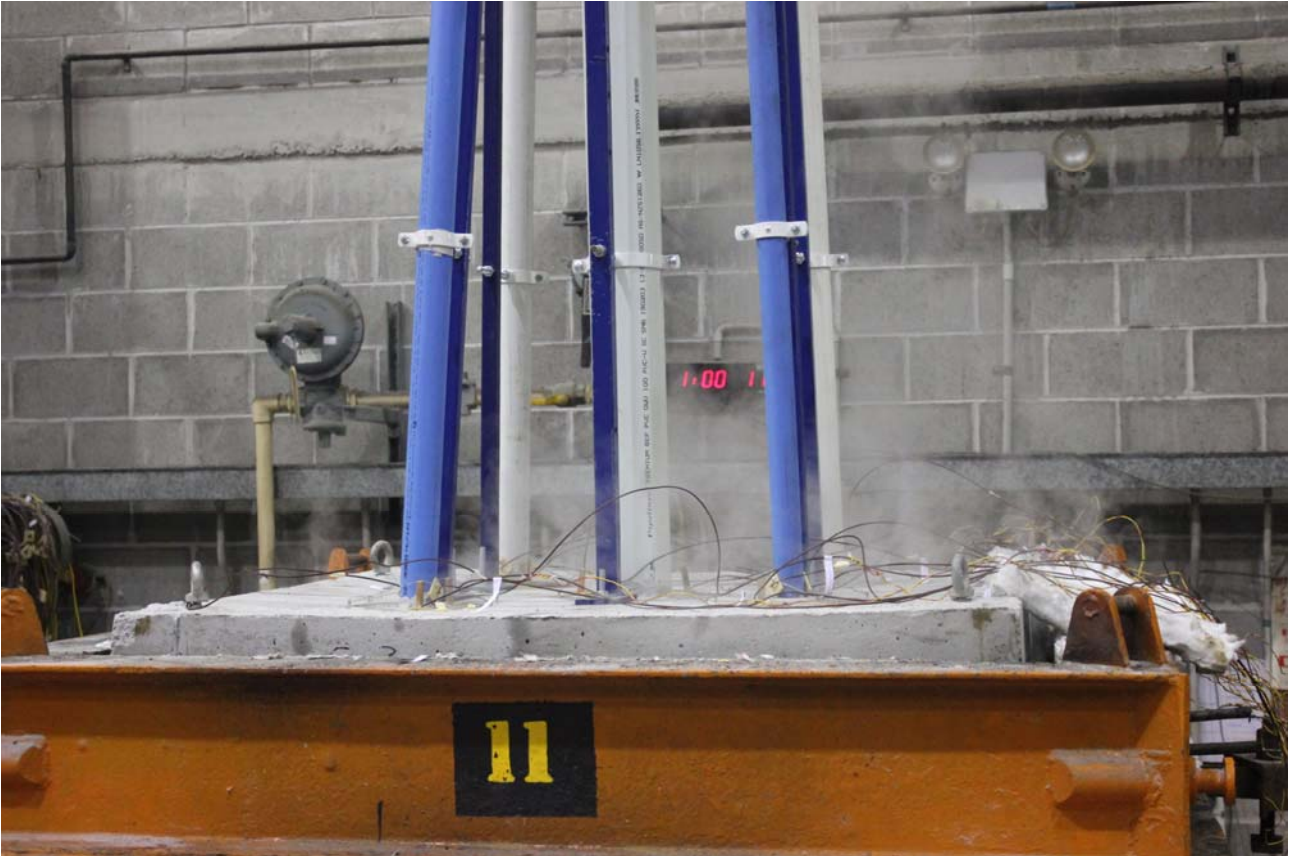
PHOTOGRAPH 4 – SPECIMENS AFTER 60 MINUTES OF TESTING

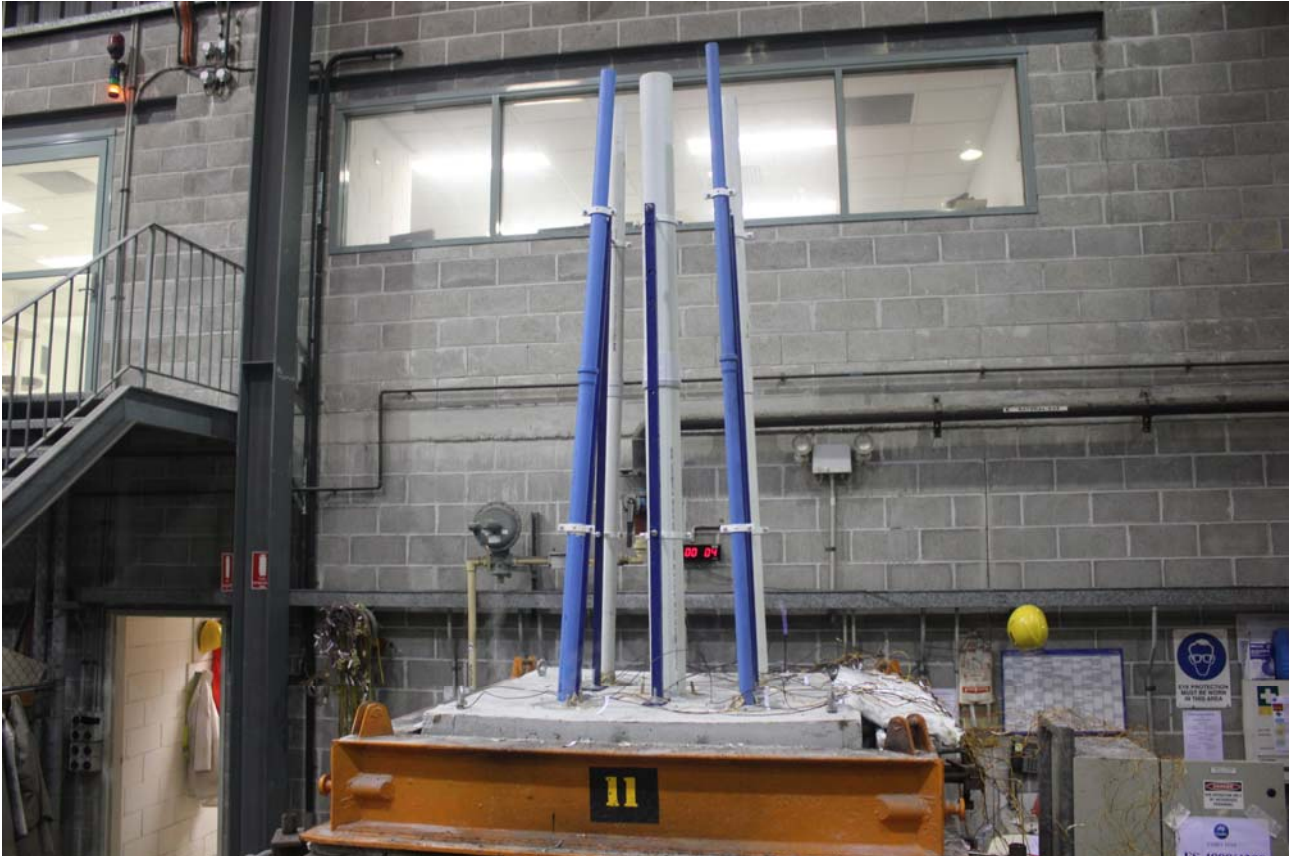
PHOTOGRAPH 6 – SPECIMENS AFTER 120 MINUTES OF TESTING

- 120 minutes - Intumescent sealant around the base of Specimens 2, 3, 4 and 5 has swollen.
- 148 minutes - Insulation failure of Specimen 3 - maximum temperature rise of 180K is exceeded on the slab 25-mm from mastic on the unexposed face.

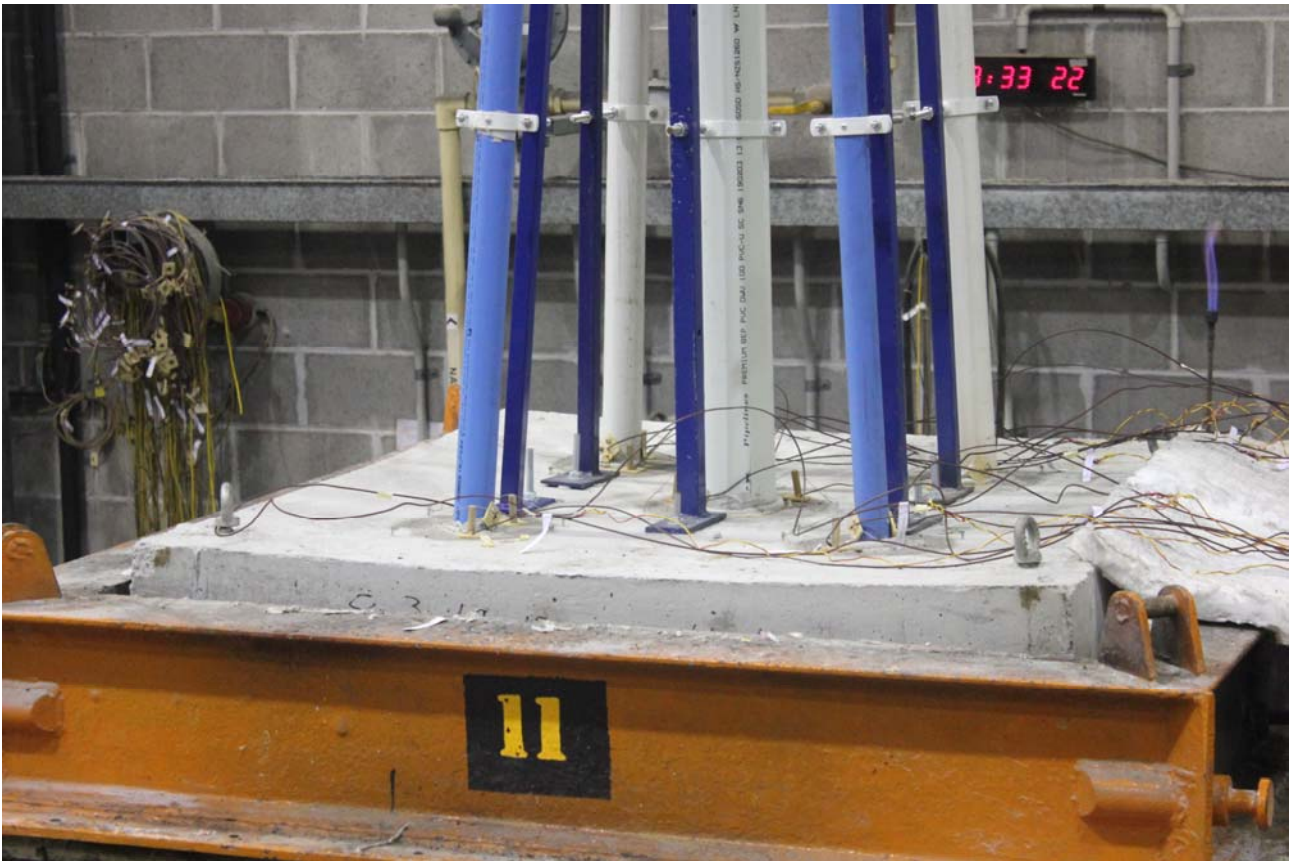
PHOTOGRAPH 9 – SPECIMENS AFTER 210 MINUTES OF TESTING

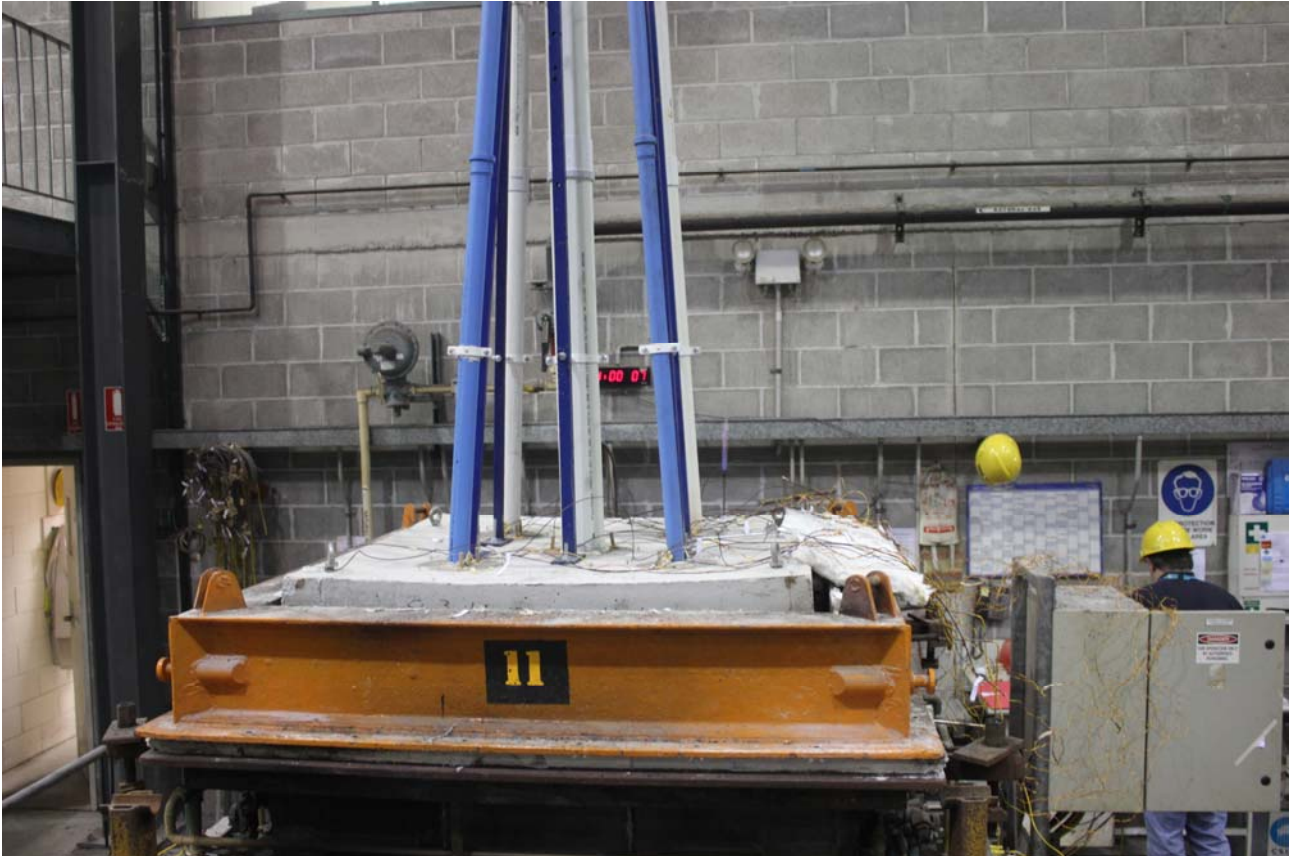
PHOTOGRAPH 10 – SPECIMENS AFTER 240 MINUTES OF TESTING

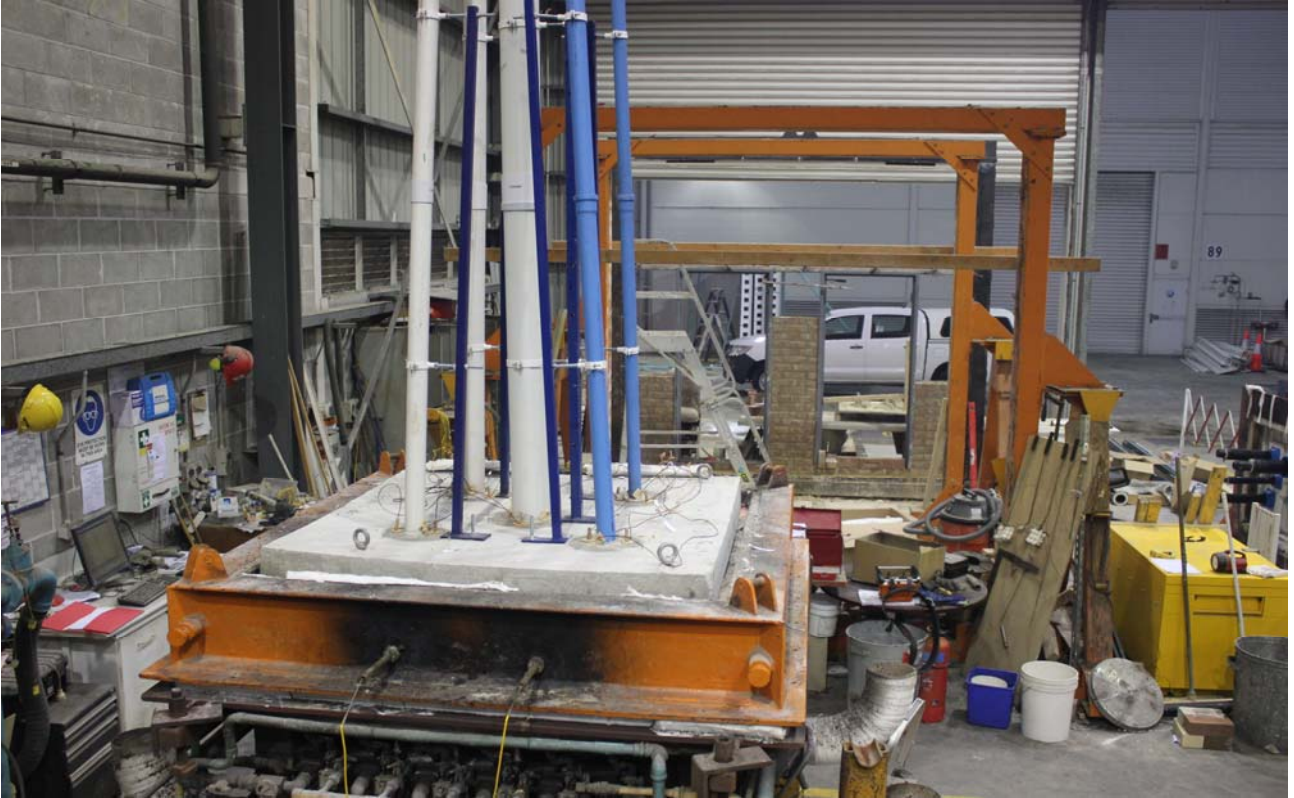
PHOTOGRAPH 11 – UNEXPOSED FACED OF SPECIMENS AT THE CONCLUSION OF TESTING

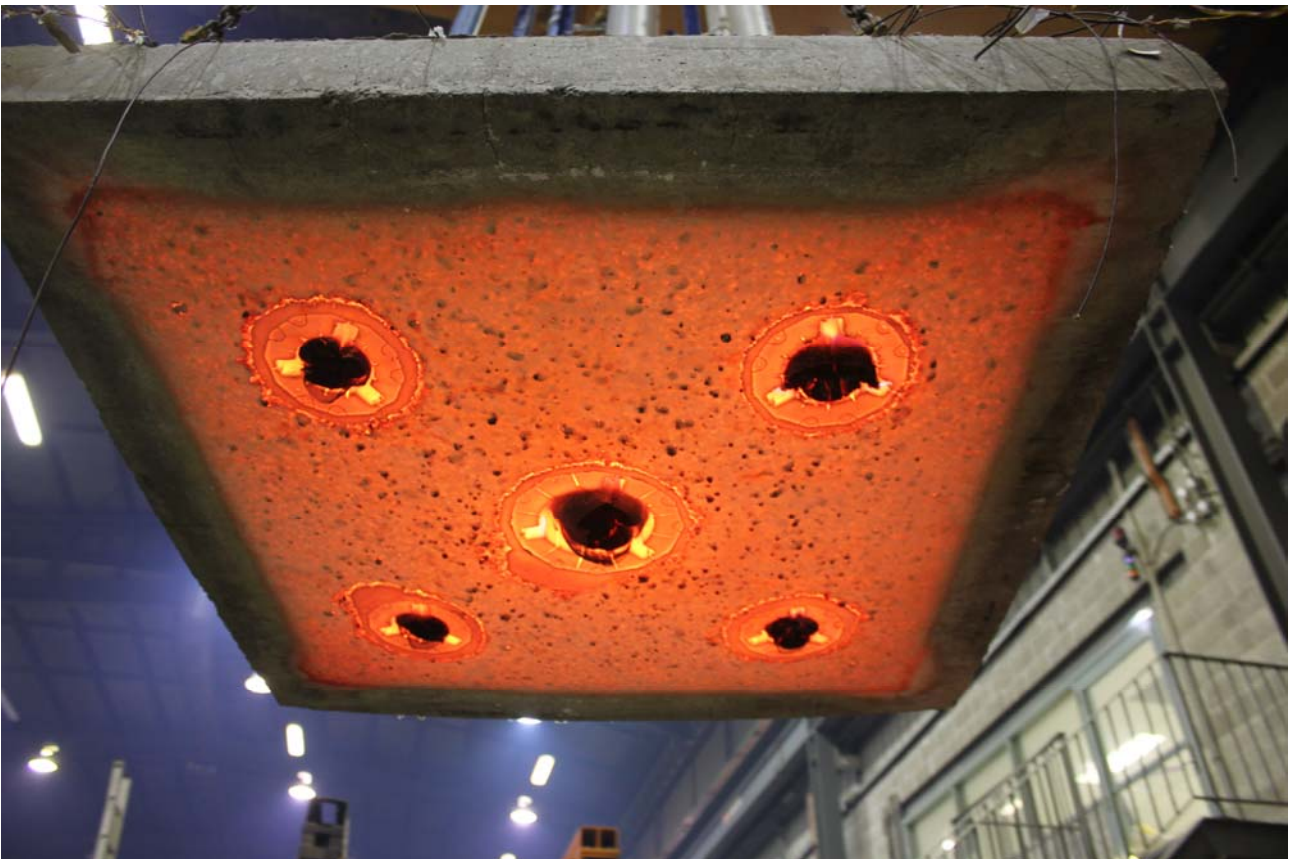
PHOTOGRAPH 12 – EXPOSED FACE OF SPECIMENS AFTER THE CONCLUSION OF TESTING
