# Fire-resistance test on fire collars protecting a concrete slab penetrated by services

## Test Report

**Author:** Peter Gordon  
**Report number:** FSP 2050  
**Date:** 29 November 2019

## Sponsored Investigation No. FSP 2050

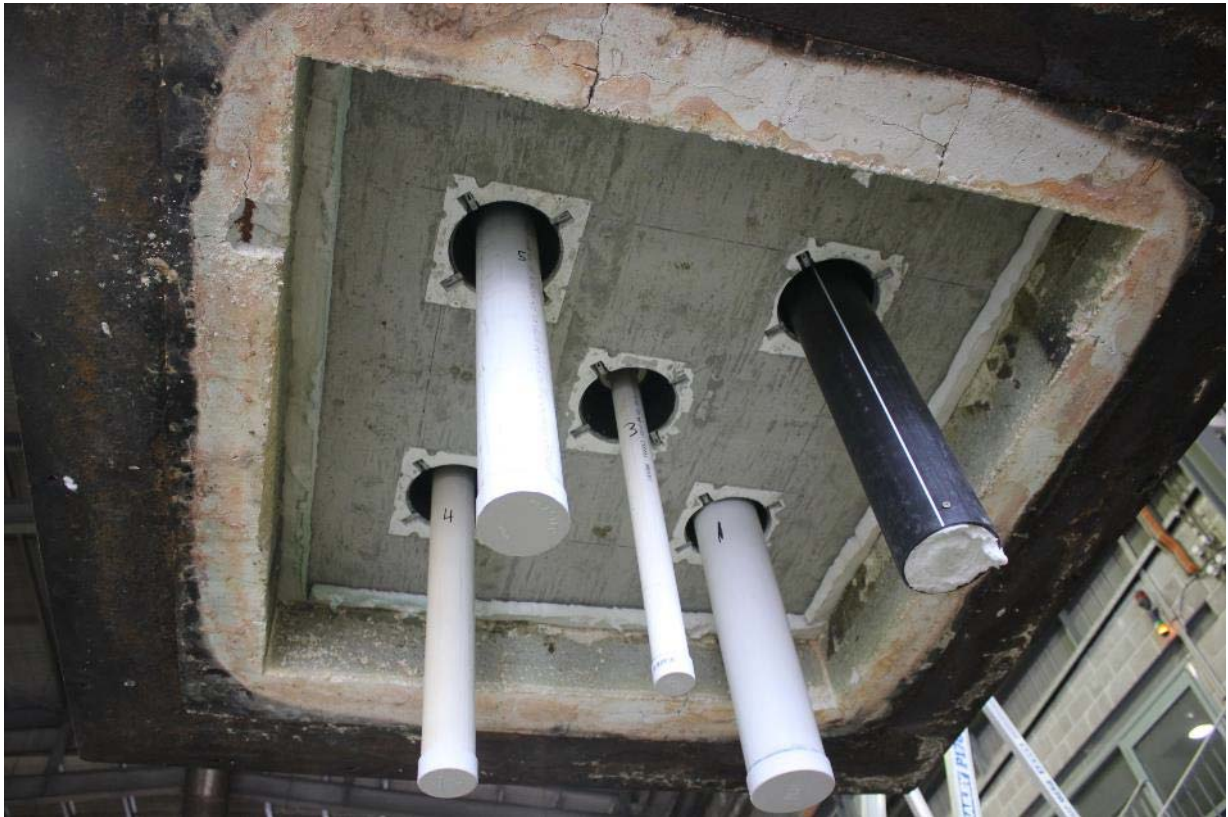
PHOTOGRAPH 1 – EXPOSED FACE OF SPECIMENS PRIOR TO TESTING

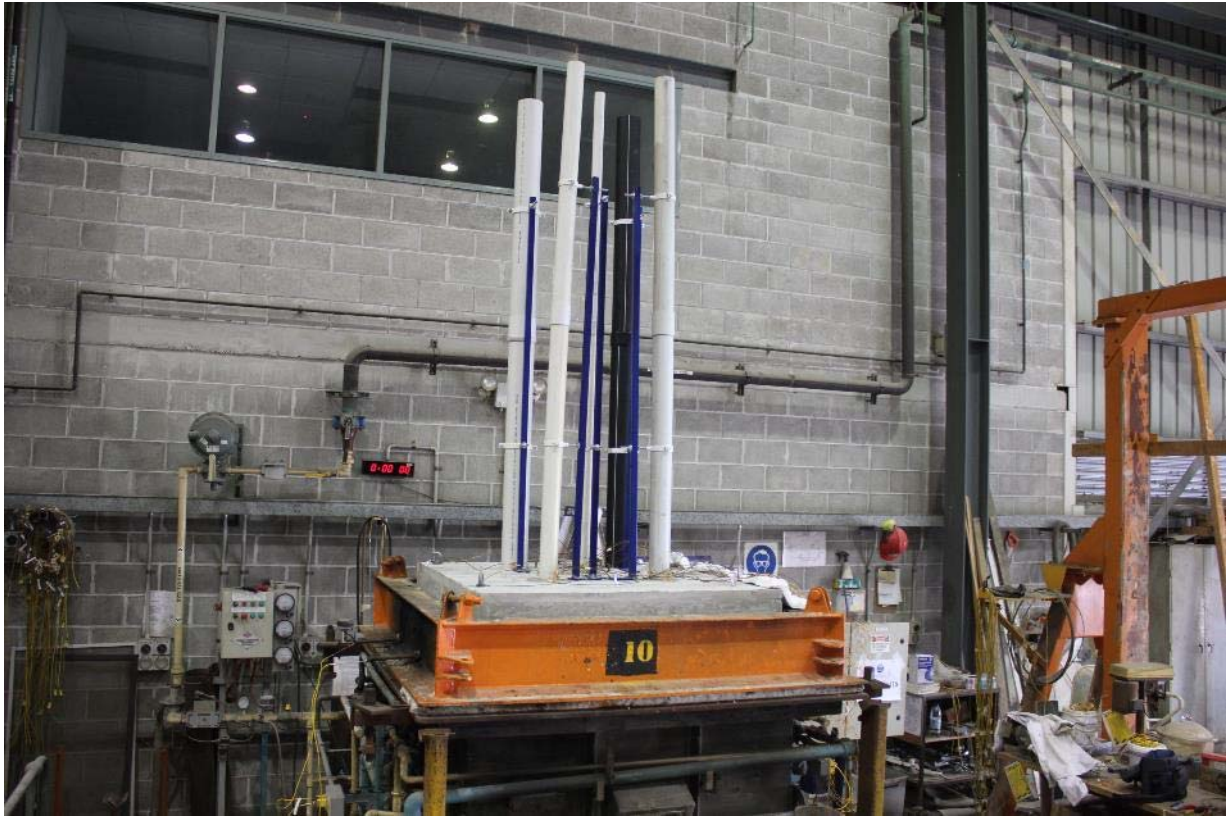
PHOTOGRAPH 2 – UNEXPOSED FACE OF SPECIMENS PRIOR TO TESTING

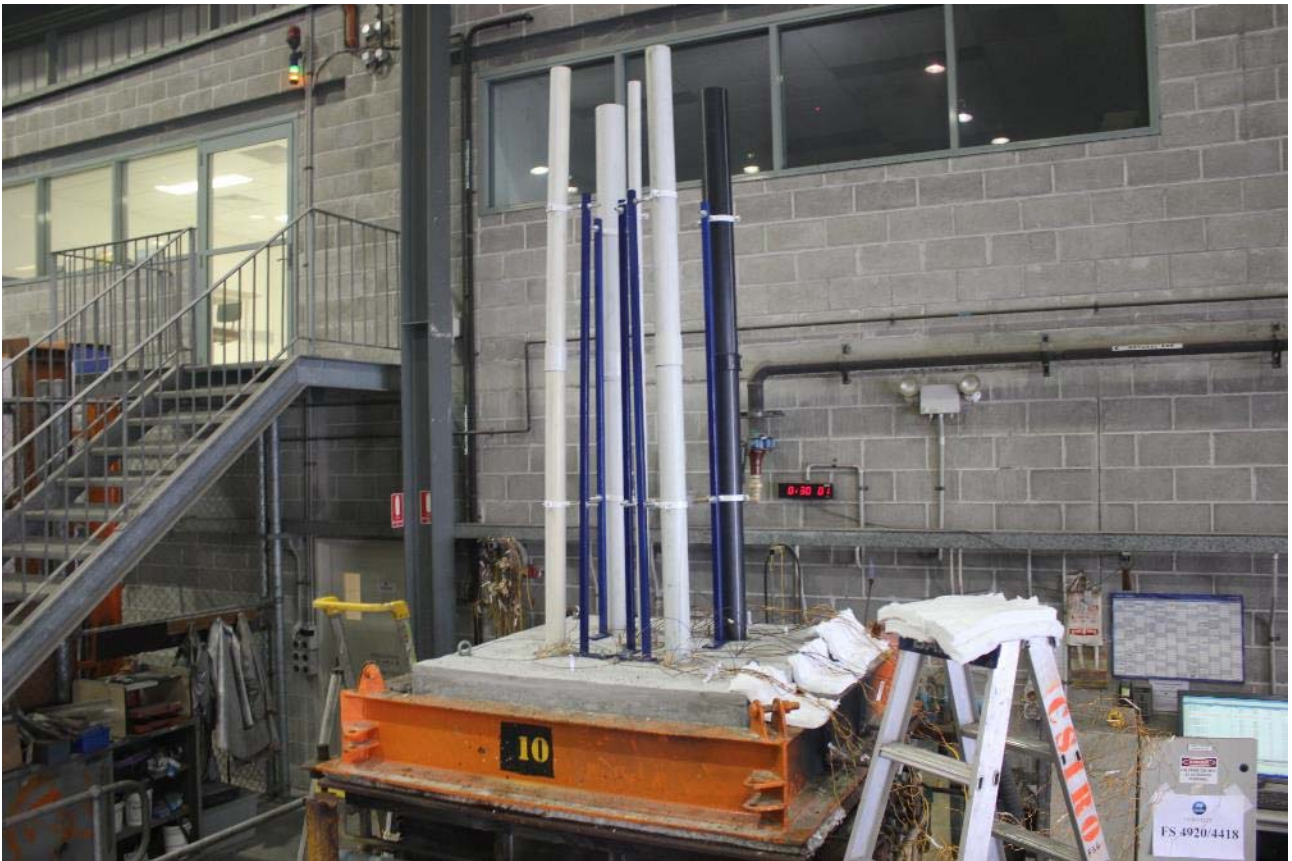
**PHOTOGRAPH 3 – SPECIMENS AFTER 30 MINUTES OF TESTING**

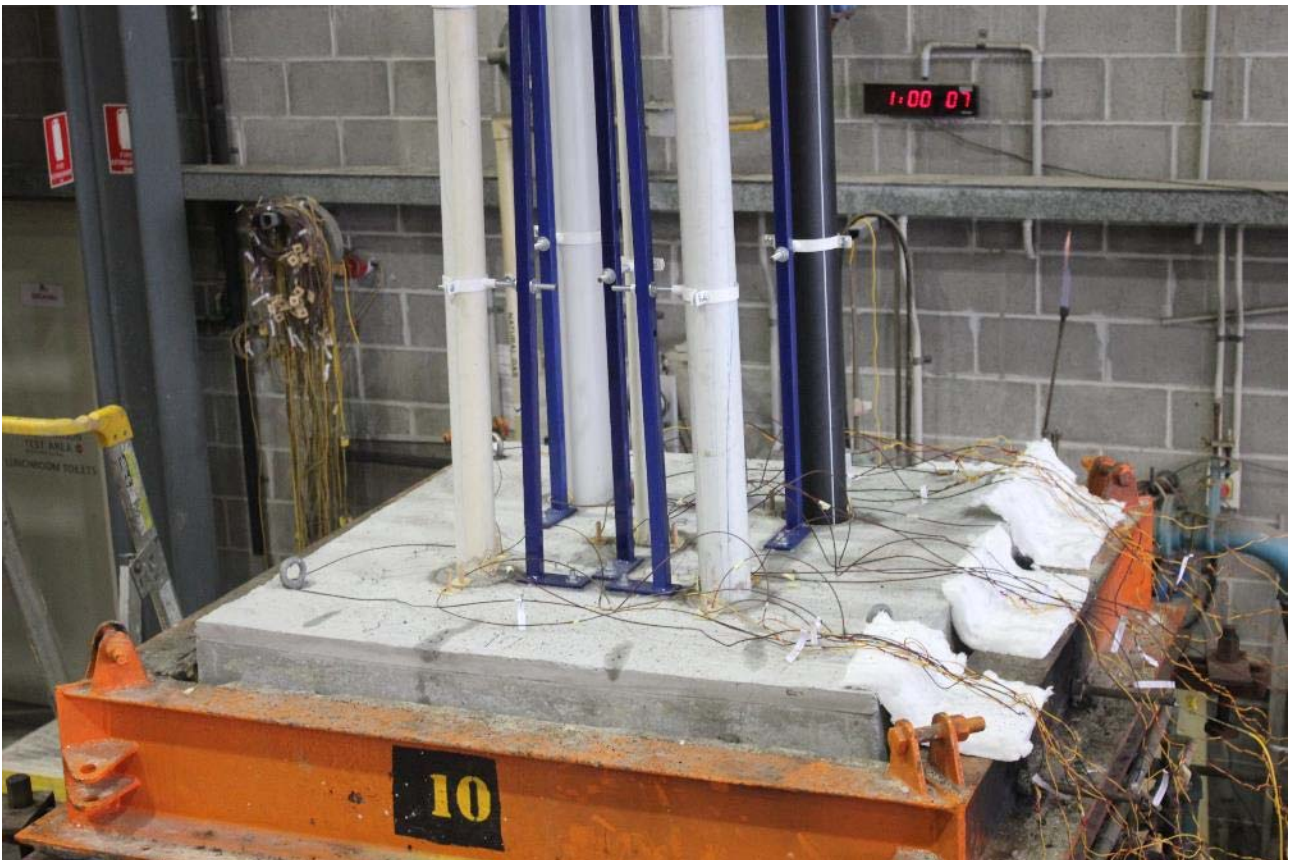
**PHOTOGRAPH 4 – SPECIMENS AFTER 60 MINUTES OF TESTING**

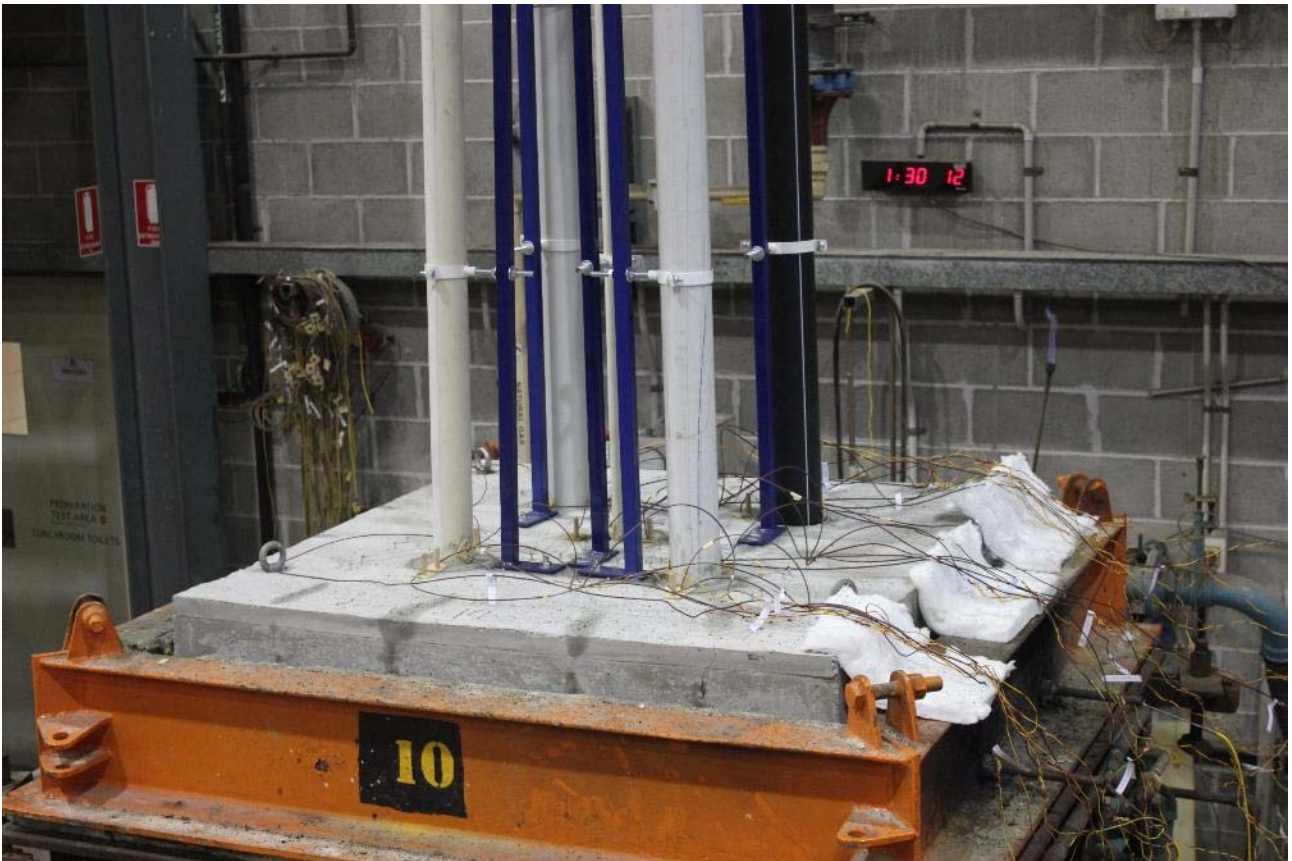
**PHOTOGRAPH 5 – SPECIMENS AFTER 90 MINUTES OF TESTING**

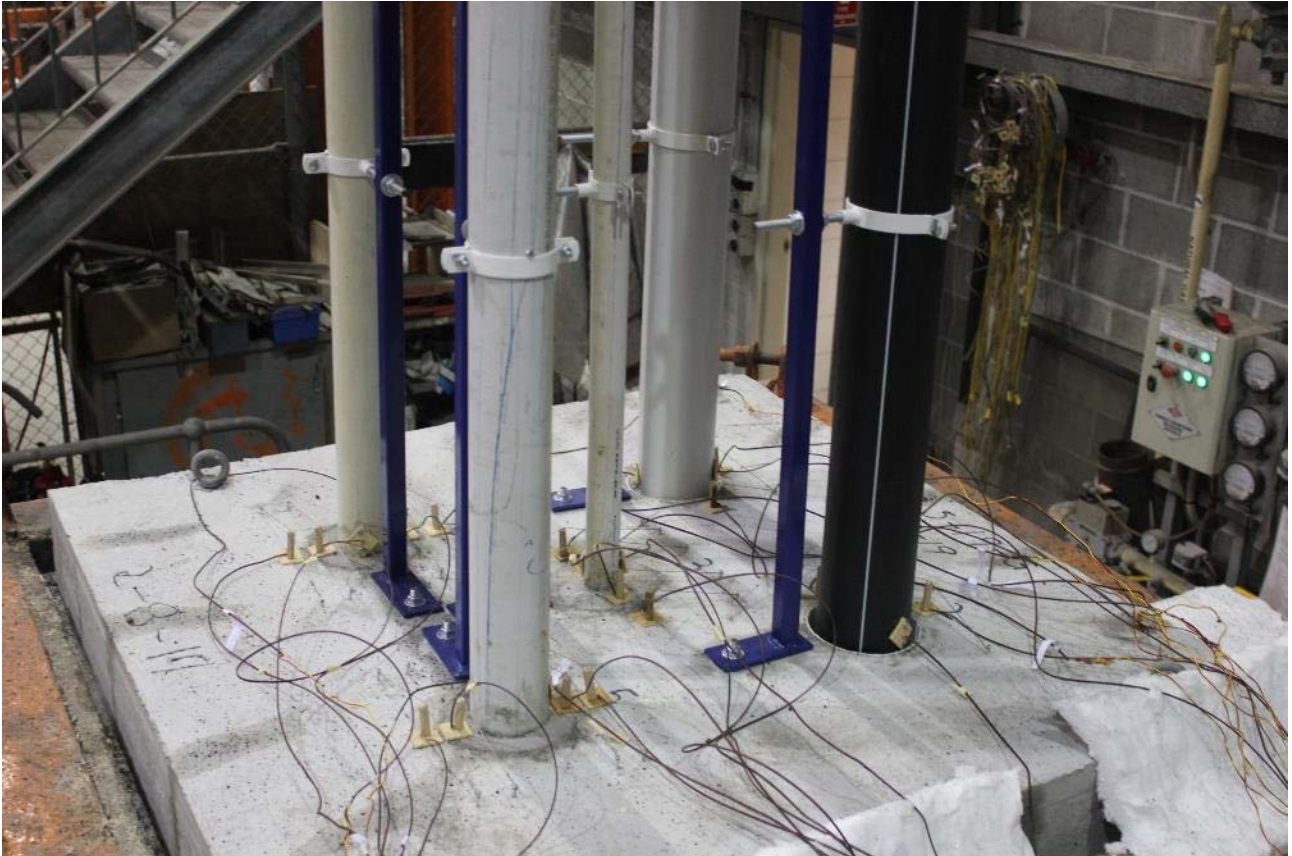
**PHOTOGRAPH 6 – SPECIMENS AFTER 120 MINUTES OF TESTING**

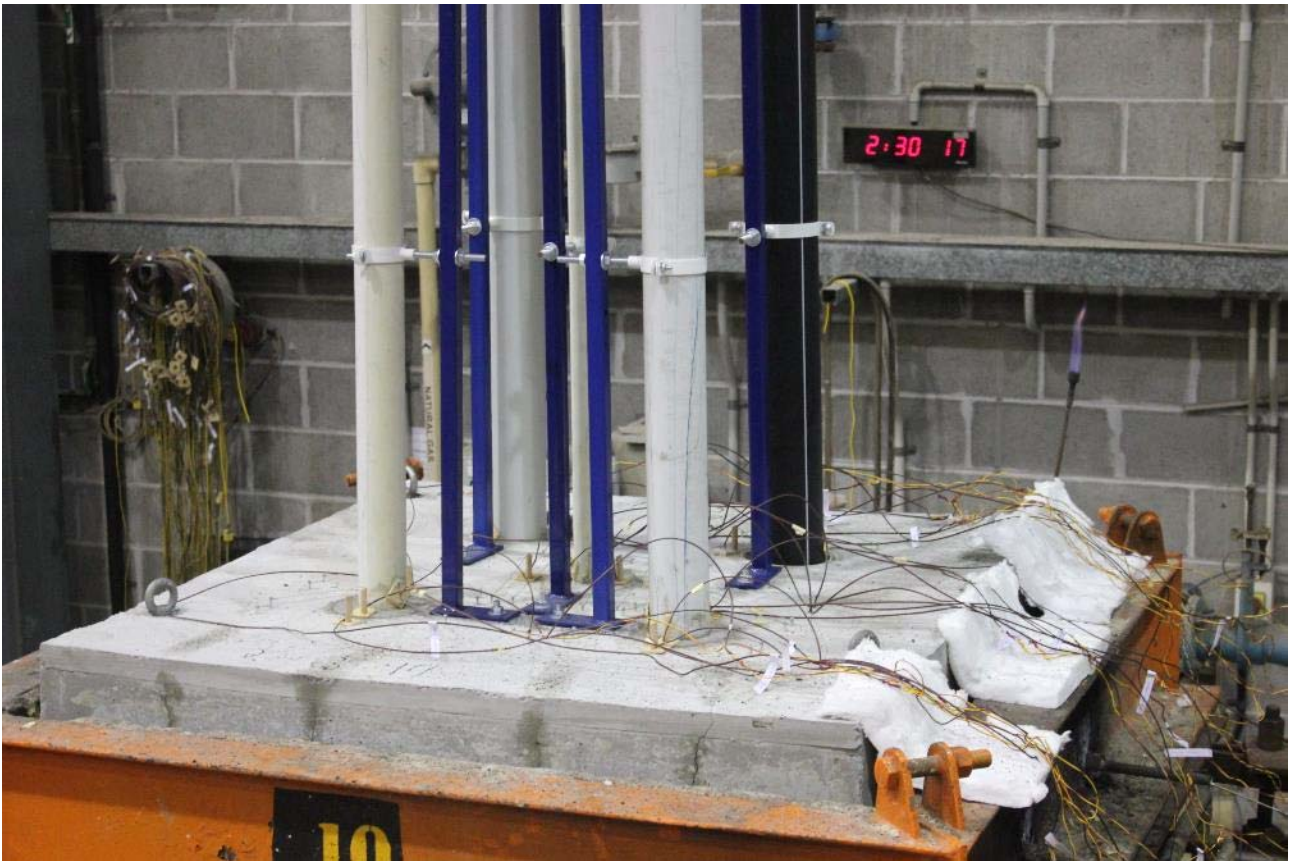
**PHOTOGRAPH 7 – SPECIMENS AFTER 150 MINUTES OF TESTING**

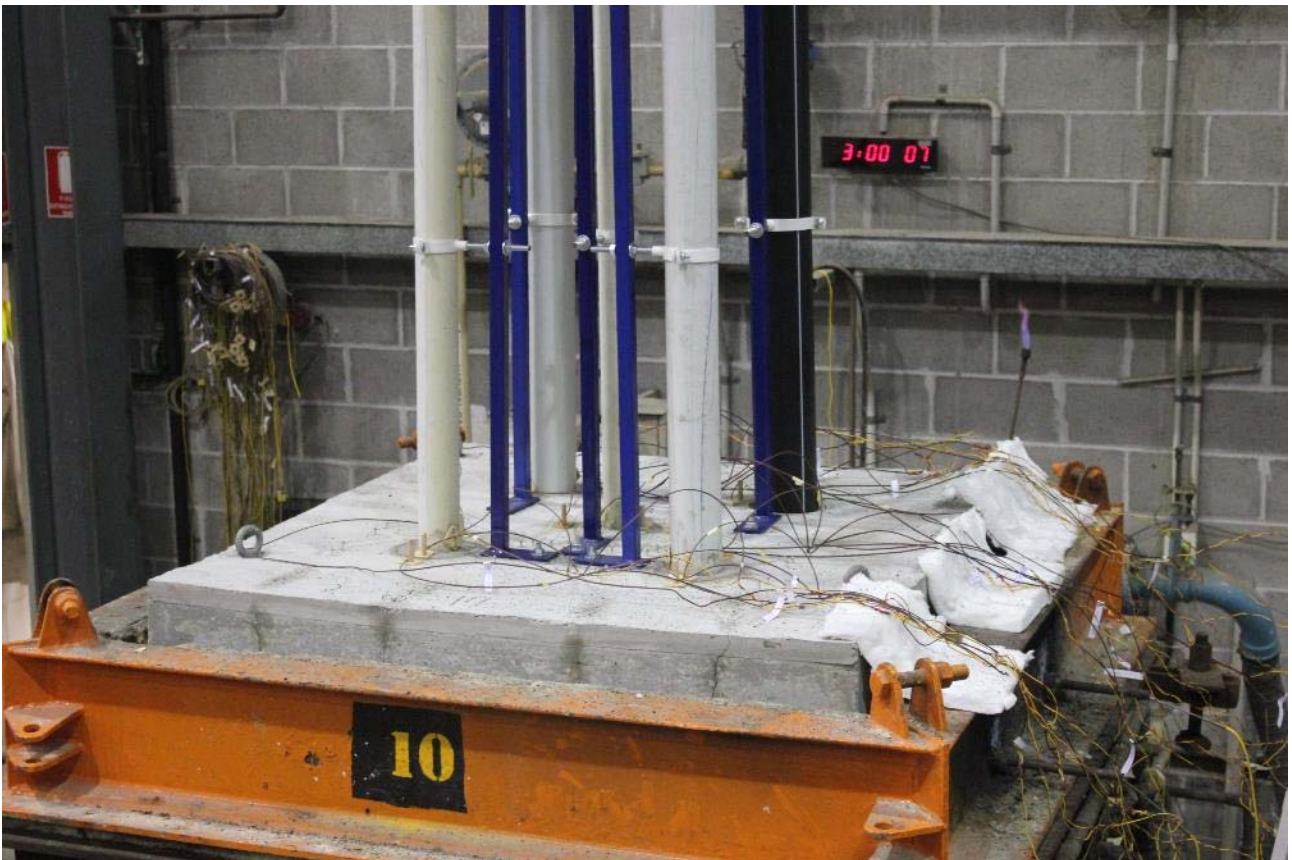
**PHOTOGRAPH 8 – SPECIMENS AFTER 180 MINUTES OF TESTING**

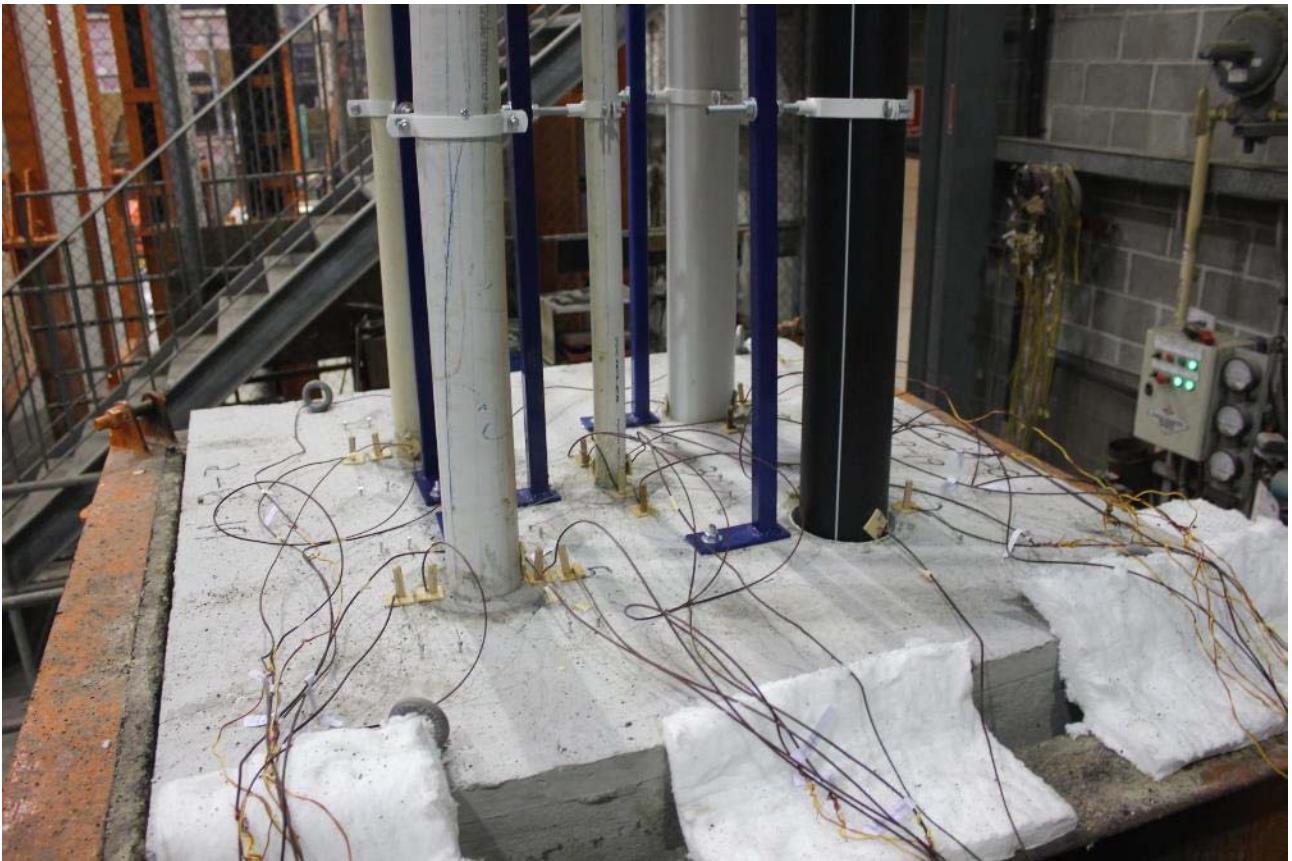
**PHOTOGRAPH 9 – SPECIMENS AFTER 210 MINUTES OF TESTING**

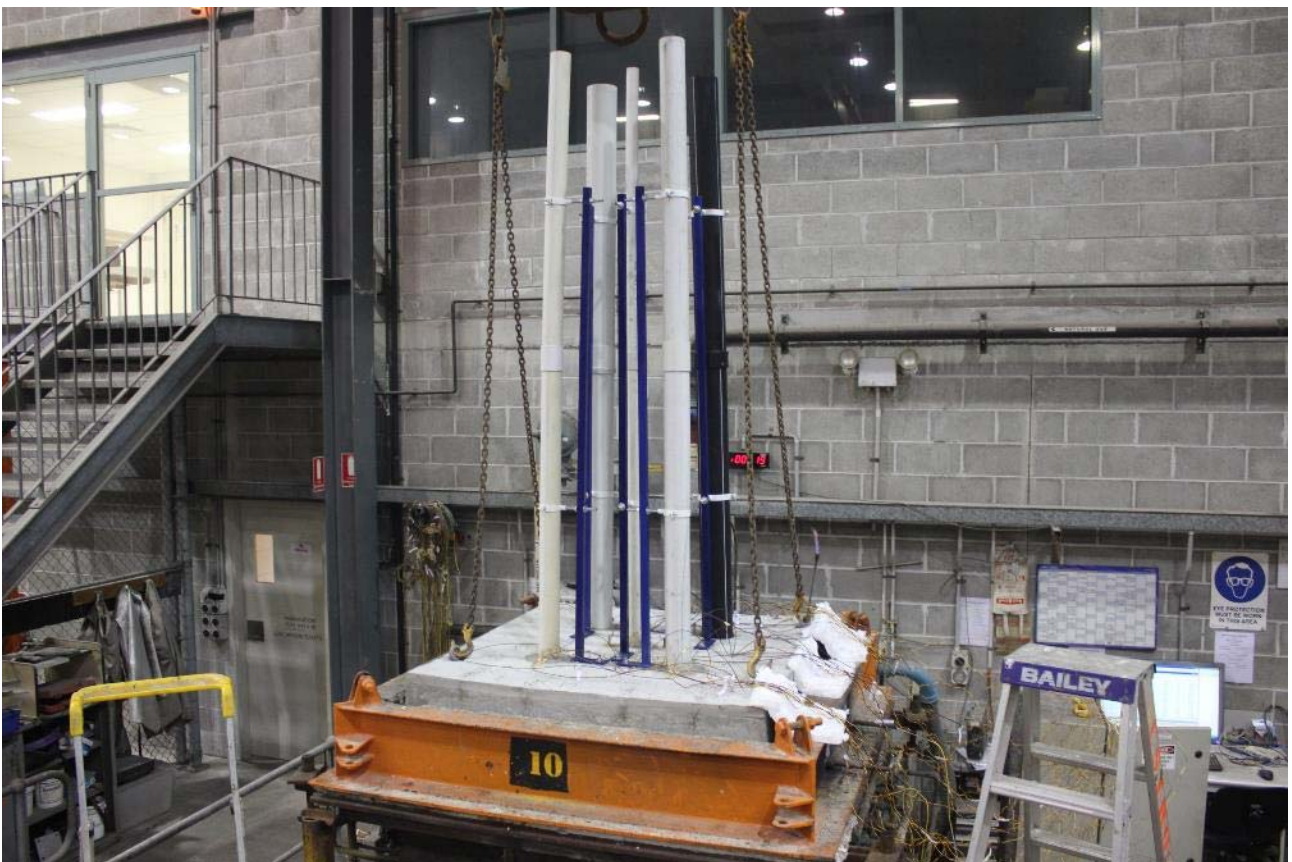
**PHOTOGRAPH 10 – SPECIMENS AFTER 240 MINUTES OF TESTING**

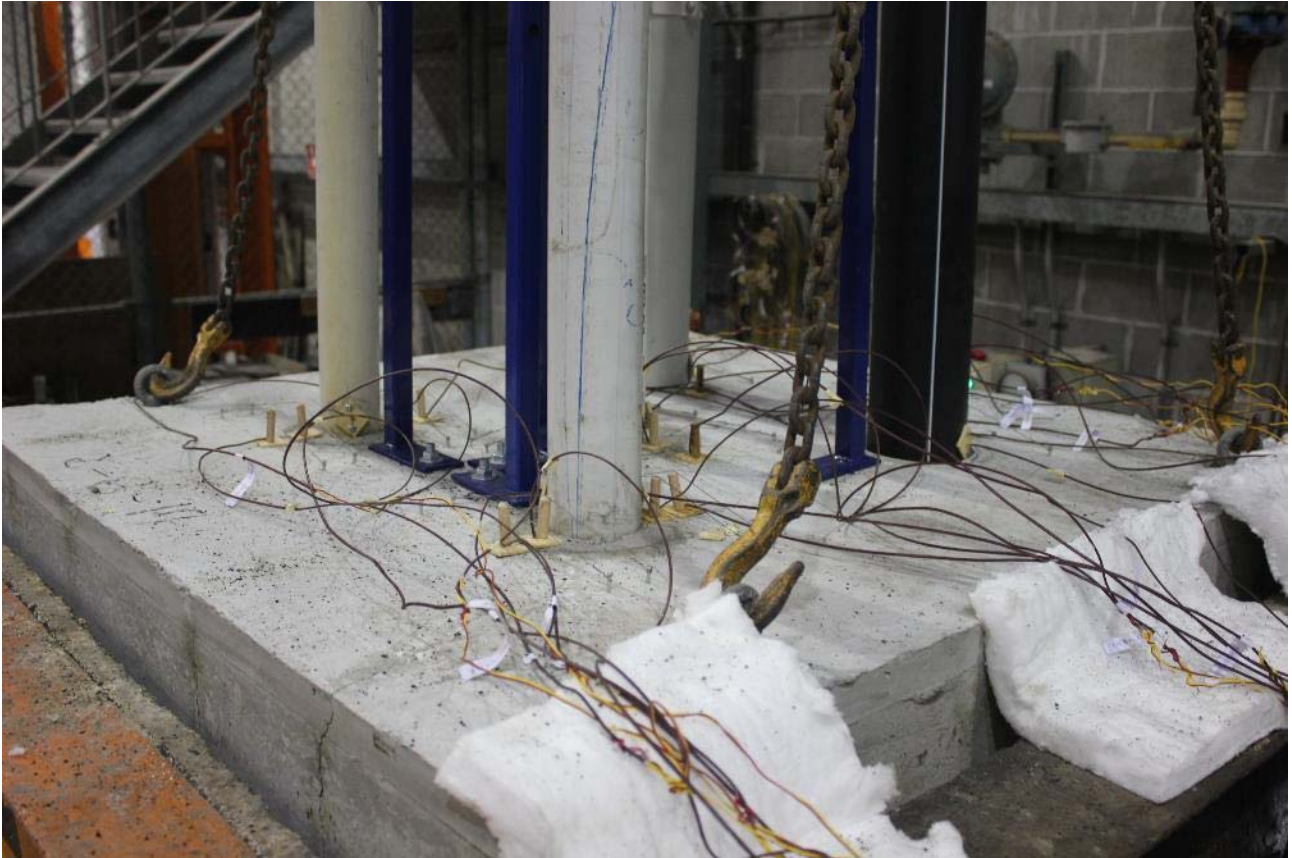
**PHOTOGRAPH 11 – UNEXPOSED FACE OF SPECIMENS AT THE CONCLUSION OF TESTING**

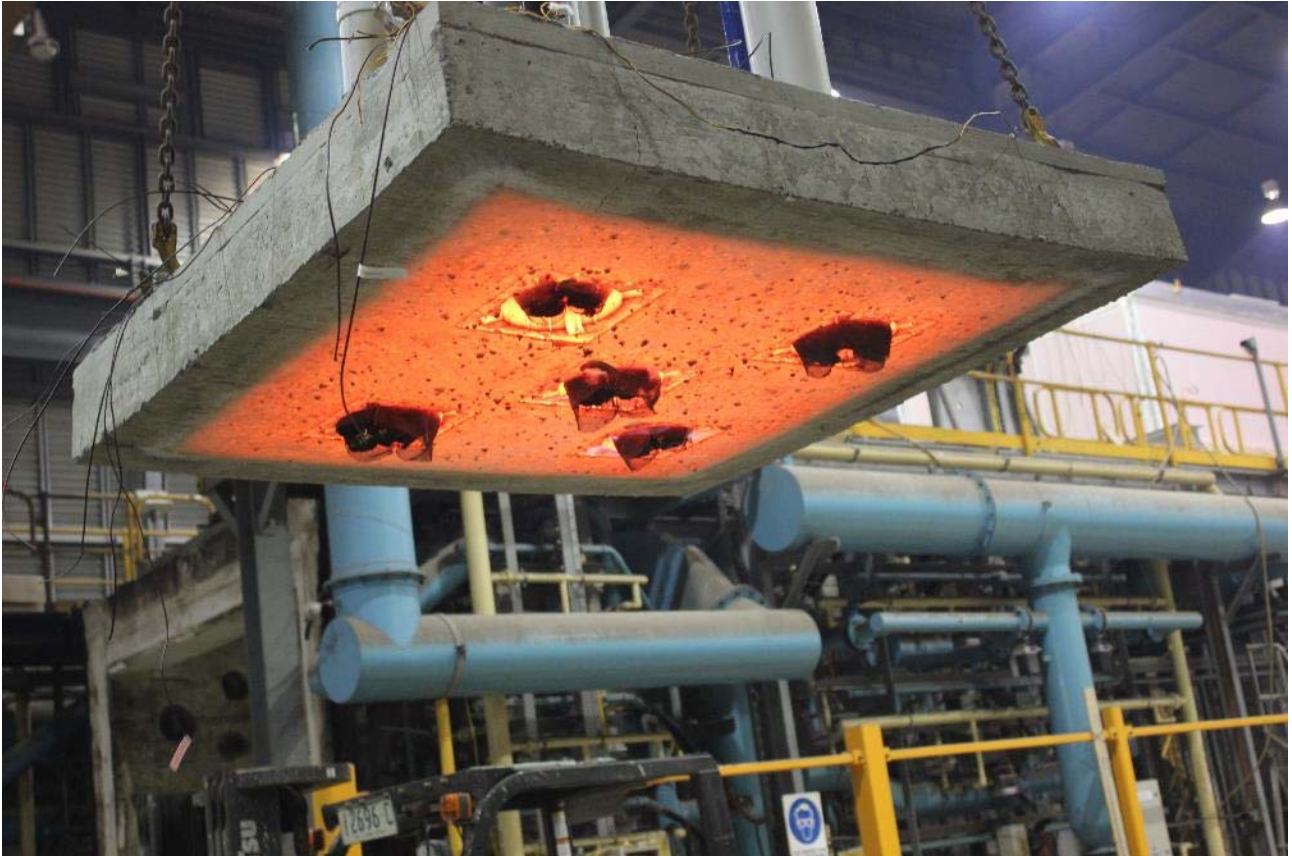
**PHOTOGRAPH 12 – EXPOSED FACE OF SPECIMENS AFTER THE CONCLUSION OF TESTING**
