Fire-resistance test on a fire collar protecting a concrete slab penetrated by a single service

Test Report

Author: Peter Gordon
Report number: FSP 2074
Date: 11 May 2020

Sponsored Investigation No. FSP 2074

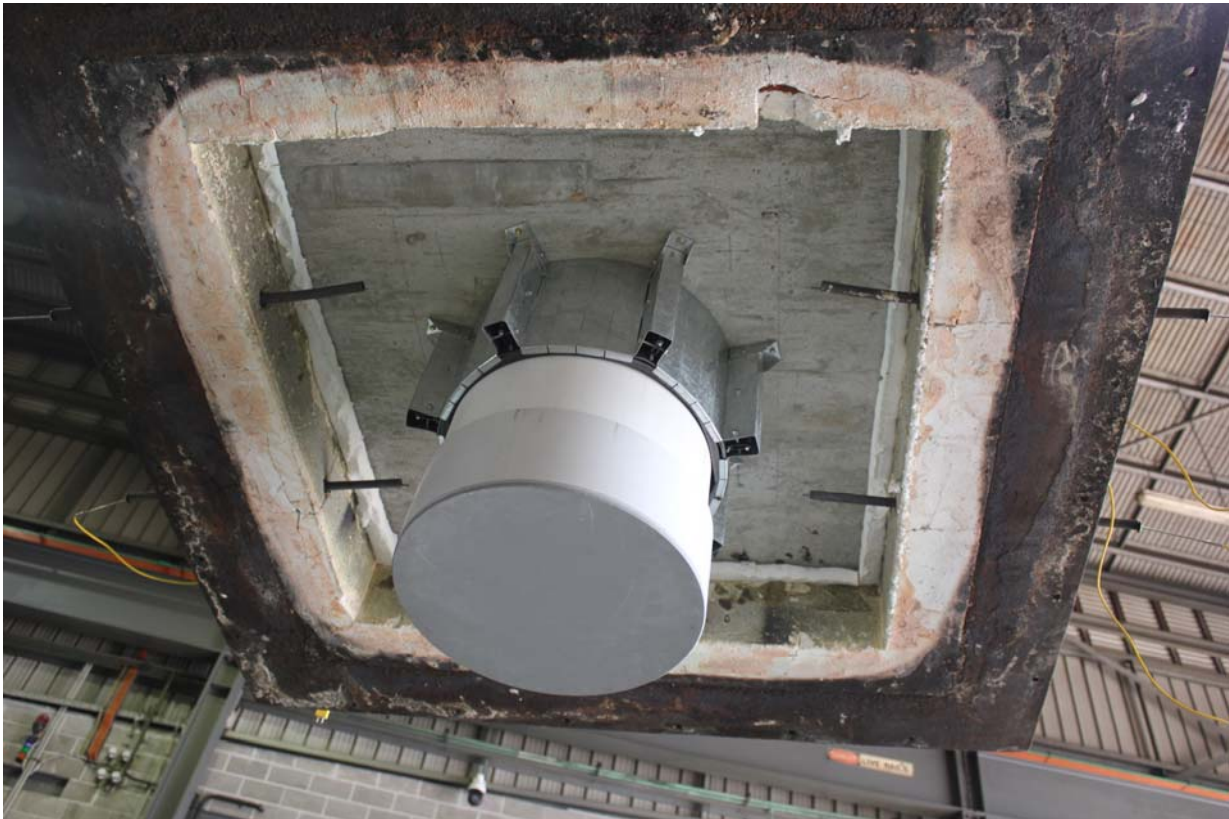
PHOTOGRAPH 1 – EXPOSED FACE OF SPECIMEN PRIOR TO TESTING

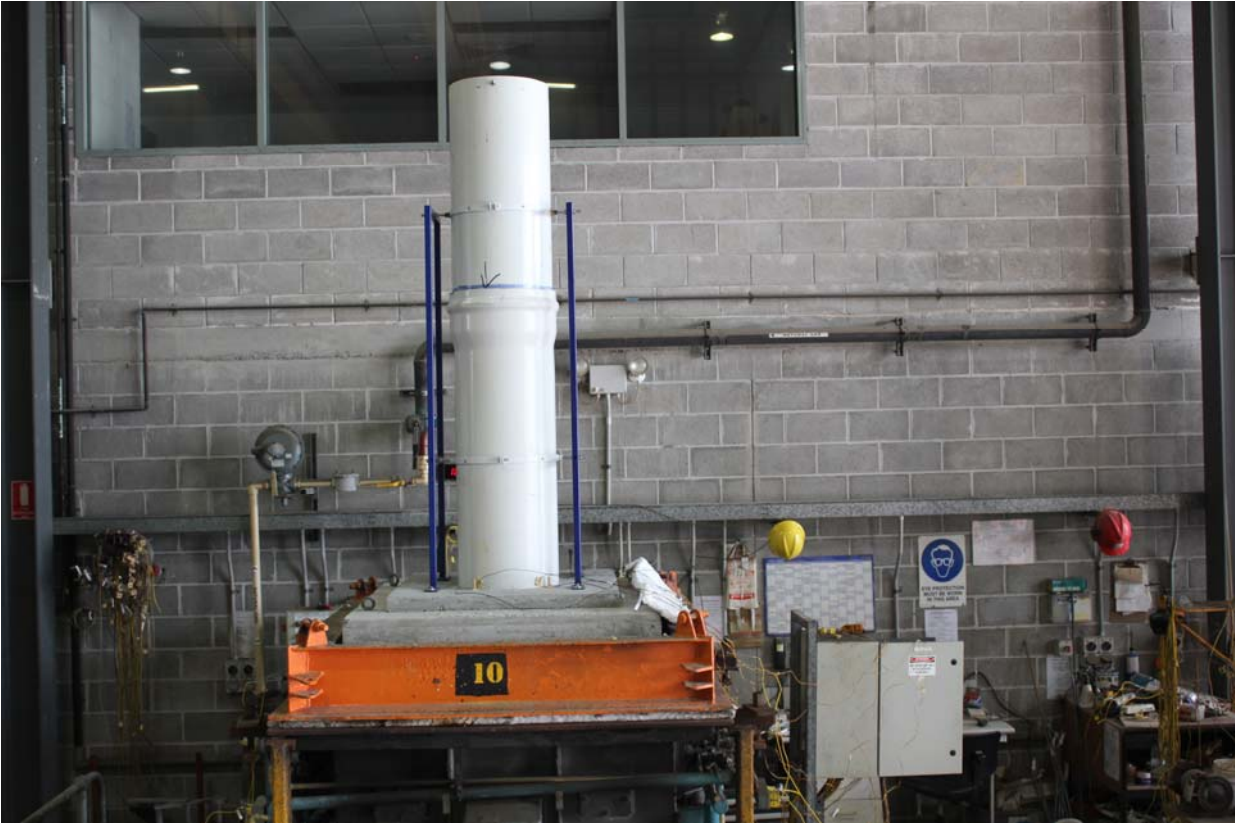
PHOTOGRAPH 2 – UNEXPOSED FACE OF SPECIMEN PRIOR TO TESTING

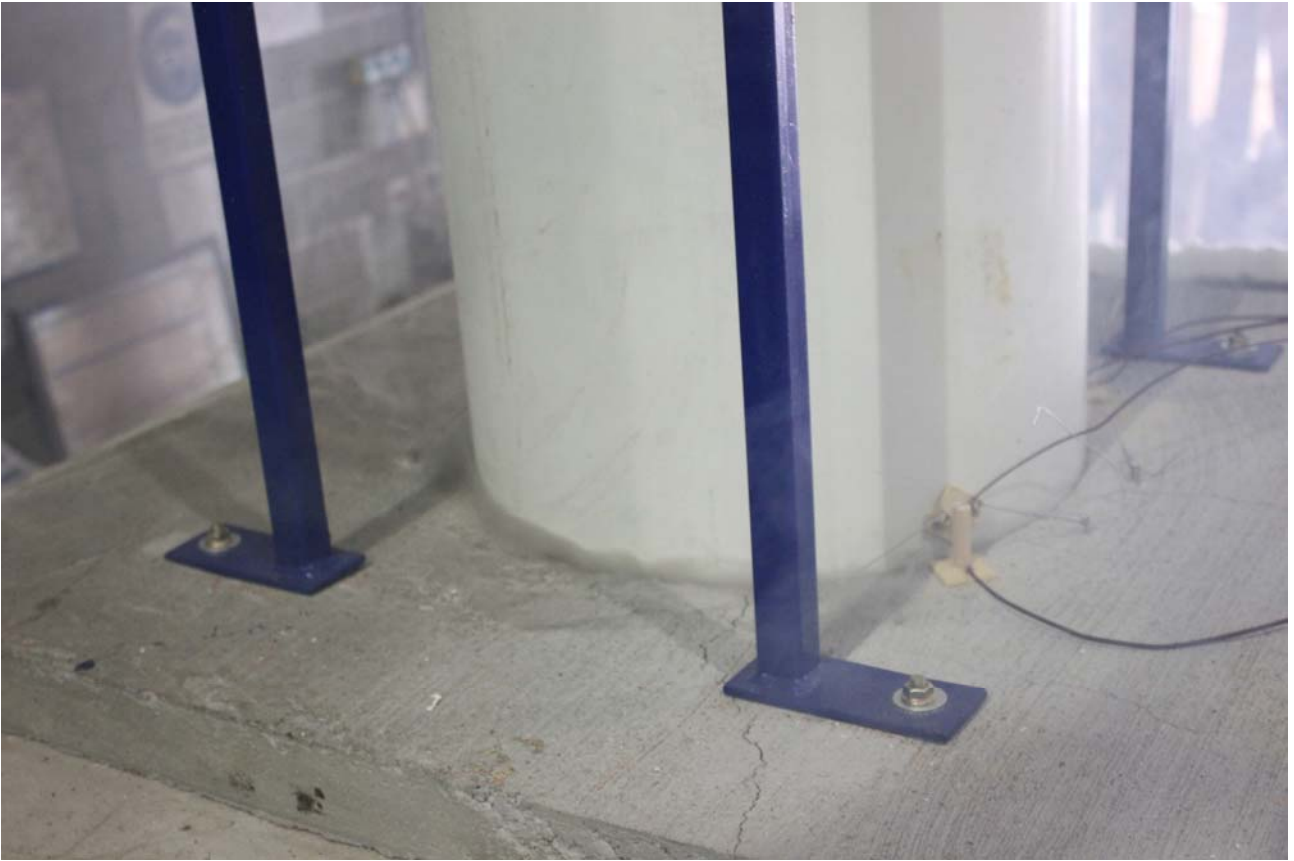
PHOTOGRAPH 3 – SPECIMEN AFTER 3 MINUTES OF TESTING

Time	Observation
3 minutes -	Black smoke is being emitted from furnace flues.
4 minutes -	Smoke is being emitted from the base of pipe.
6 minutes -	Black smoke and flames are being emitted from the end of pipe.
8 minutes -	Flaming at the top of pipe has now ceased.
9 minutes -	The level of smoke being emitted from the end of the pipe has reduced.
10 minutes -	The colour of the smoke has now changed to grey and the quantity of smoke fluing has further reduced.
12 minutes -	The quantity of smoke being emitted from the end of pipe continues to reduce.
15 minutes -	Light smoke continues to vent at the base of pipe.
23 minutes -	The quantity of smoke being emitted has further reduced.
50 minutes -	The light smoke continues fluing from the end of pipe. The smoke venting from the base of pipe has almost ceased.
60 minutes -	Little visible change to specimen.
120 minutes -	Little visible change to specimen.
150 minutes -	The level of smoke fluing for the end of pipe has begun to increase and change in colour from light grey to yellow greenish.

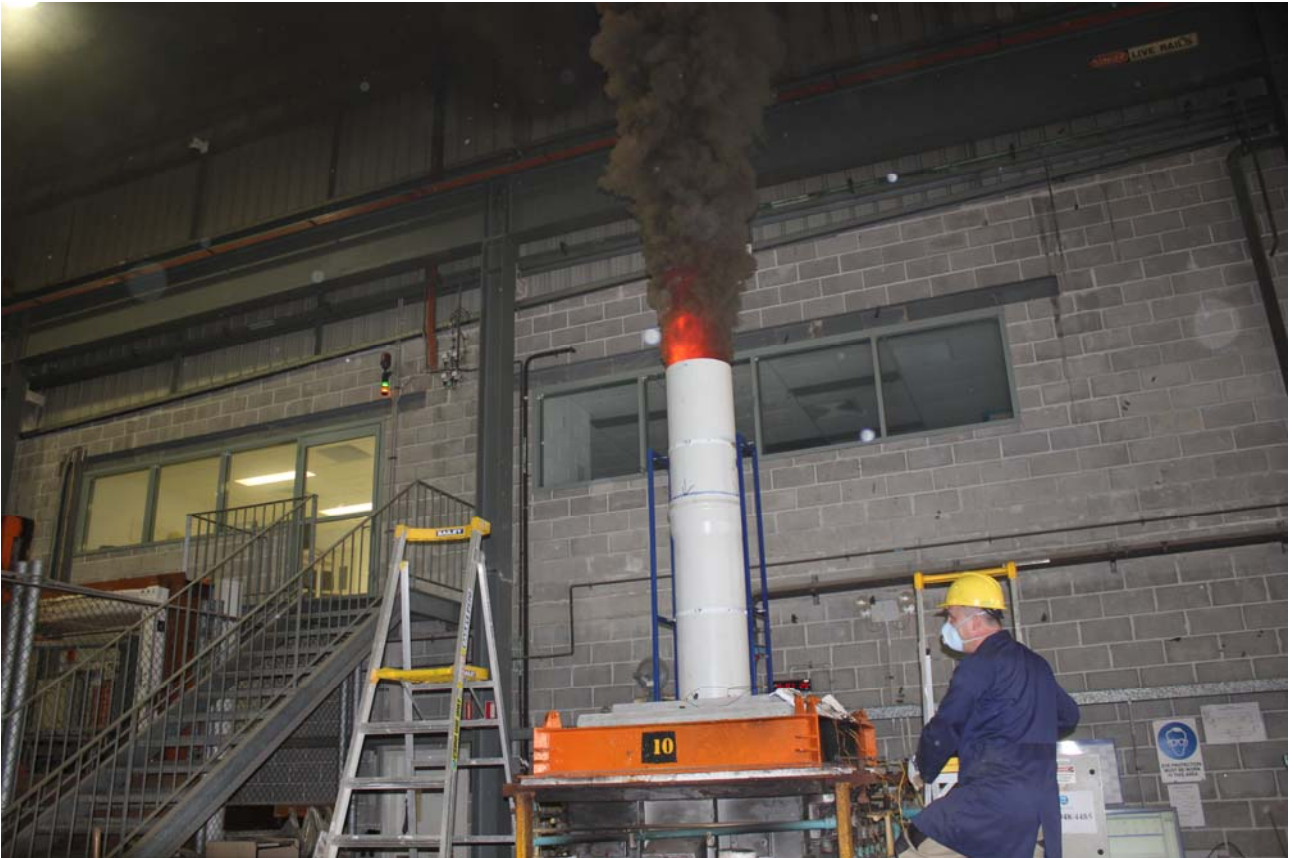
PHOTOGRAPH 4 – SPECIMEN AFTER 7 MINUTES OF TESTING

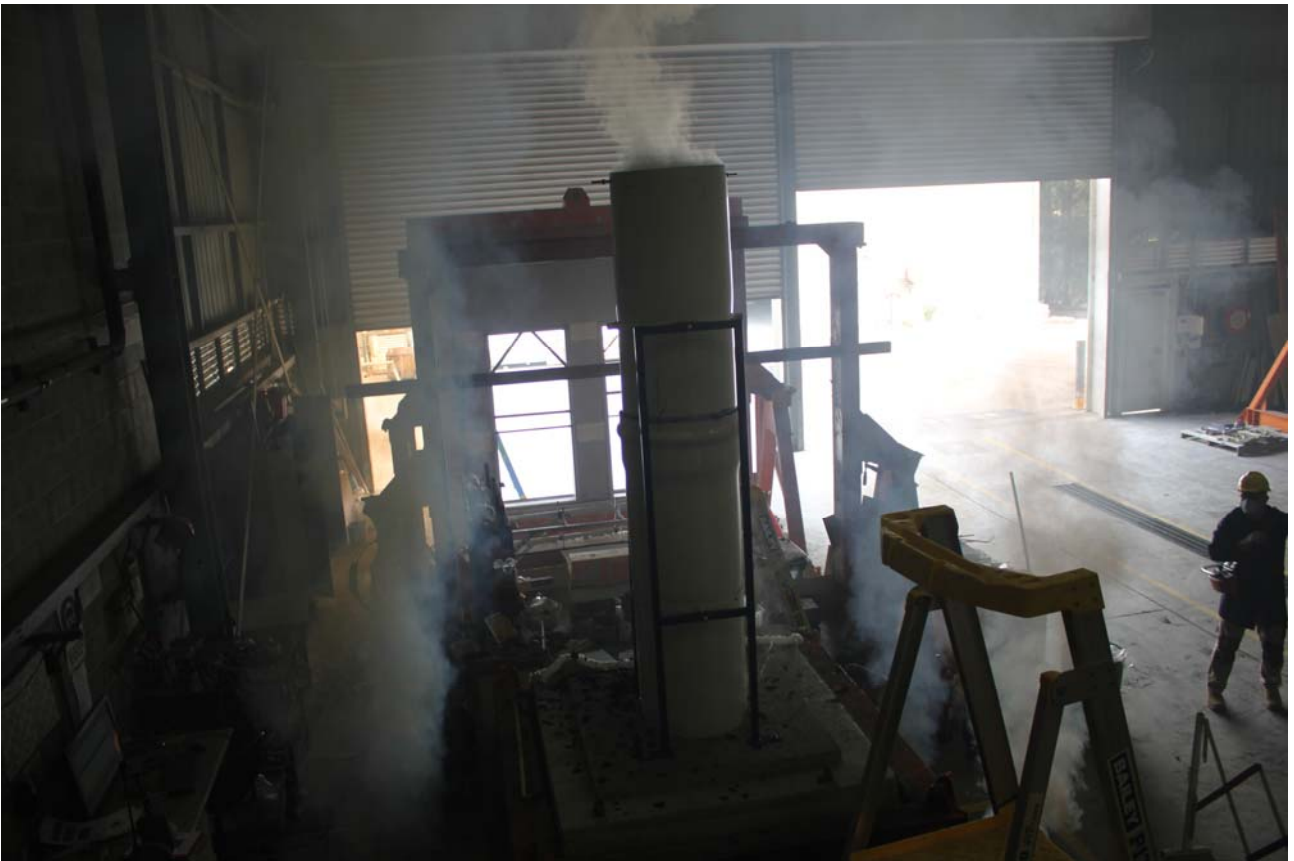
PHOTOGRAPH 5 – SPECIMEN AFTER 15 MINUTES OF TESTING

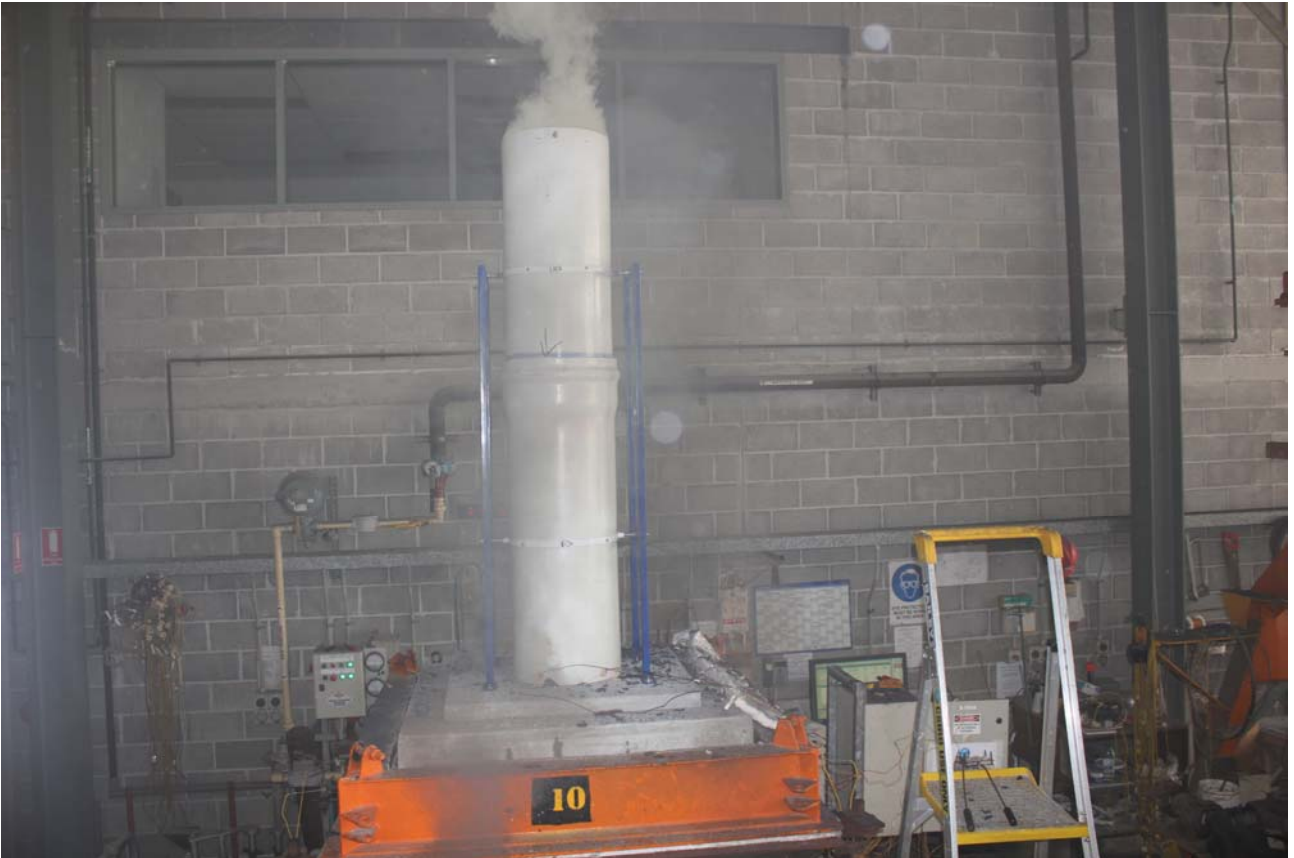
PHOTOGRAPH 6 – SPECIMEN AFTER 30 MINUTES OF TESTING

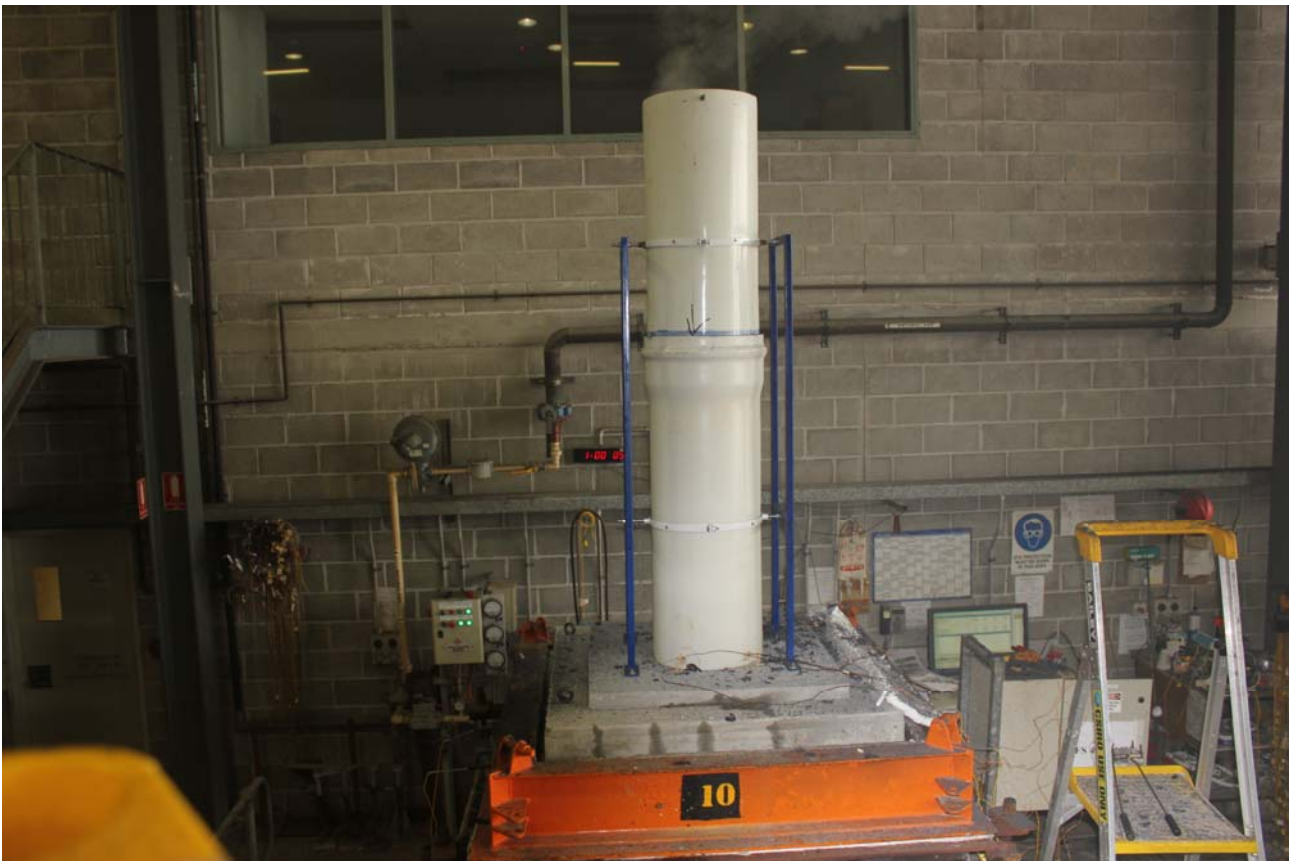
PHOTOGRAPH 7 – SPECIMEN AFTER 60 MINUTES OF TESTING

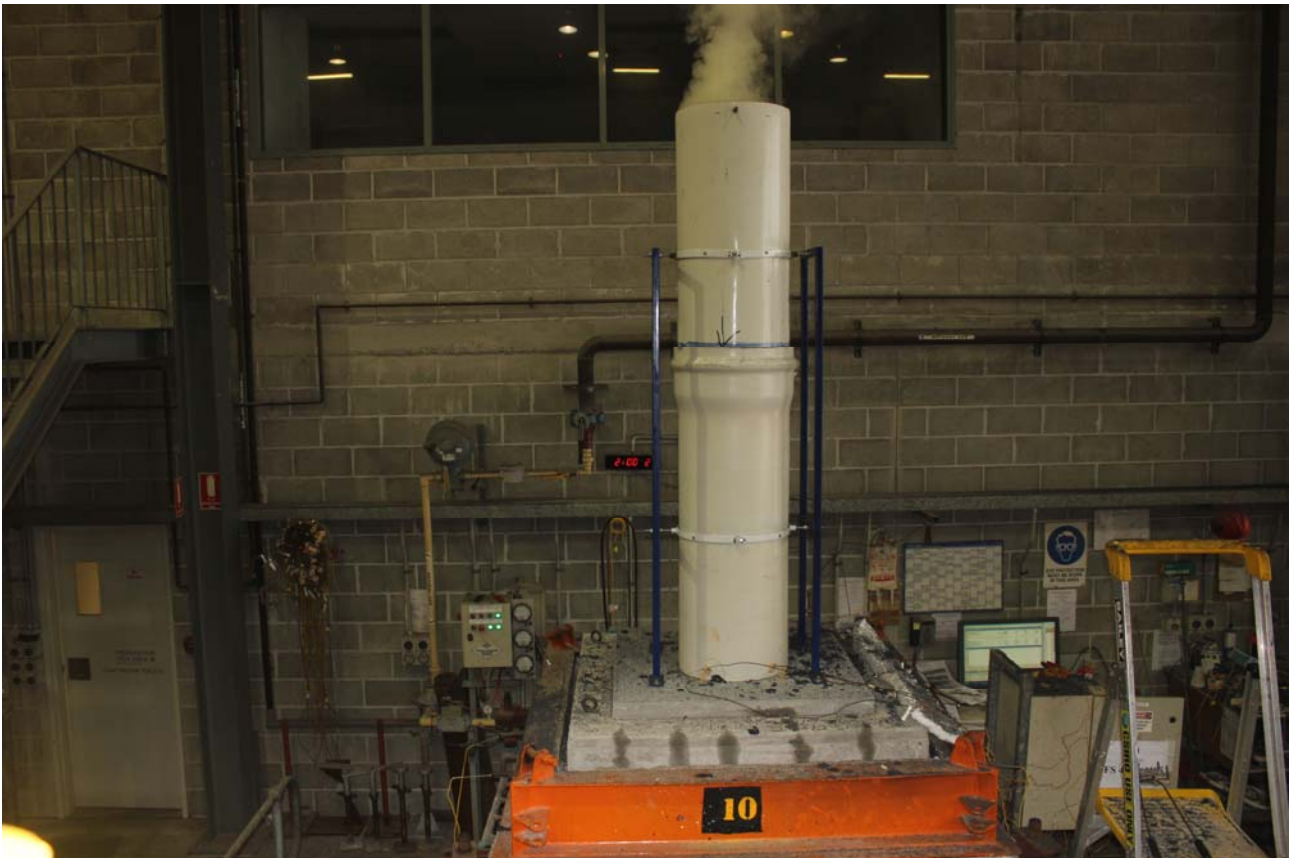
PHOTOGRAPH 8 – SPECIMEN AFTER 120 MINUTES OF TESTING

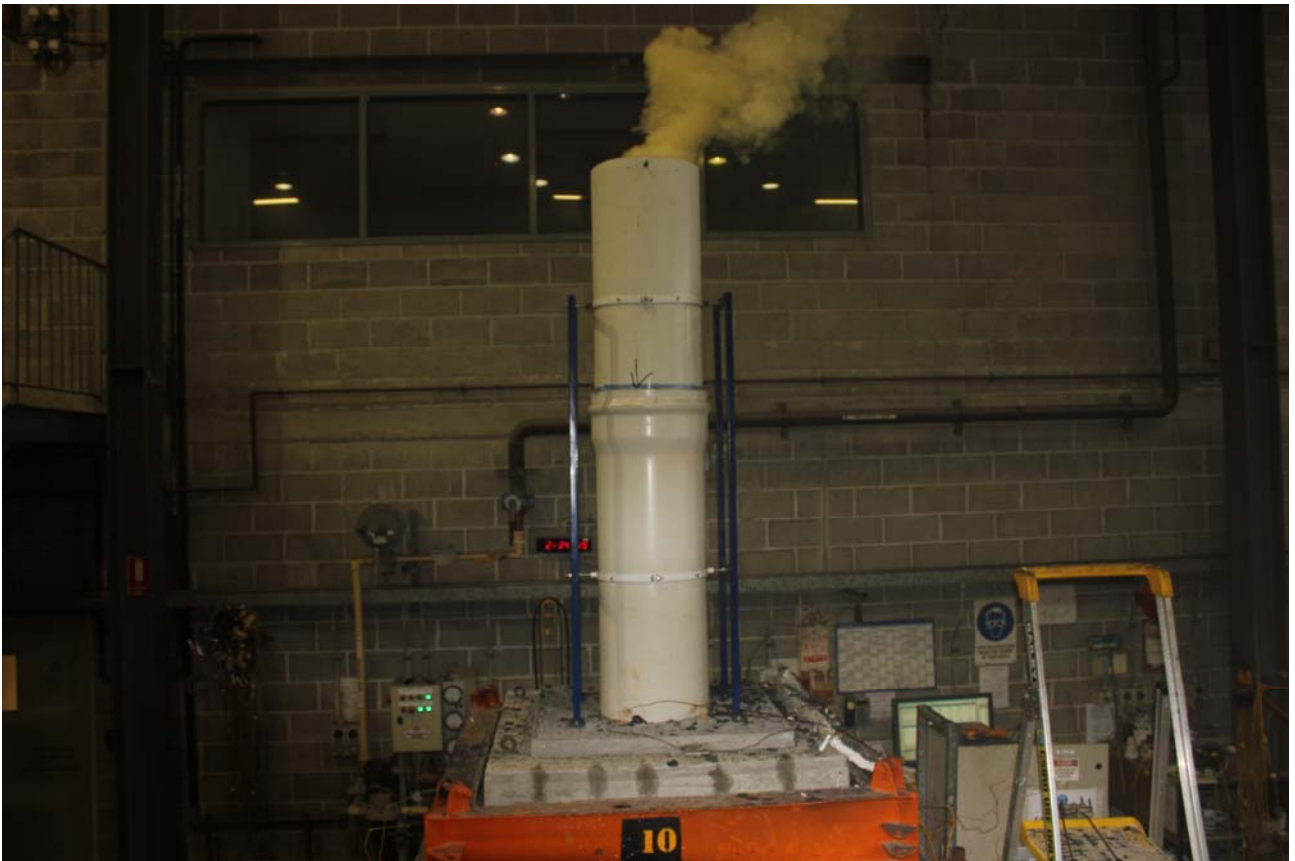
PHOTOGRAPH 9 – SPECIMEN AFTER 154 MINUTES OF TESTING

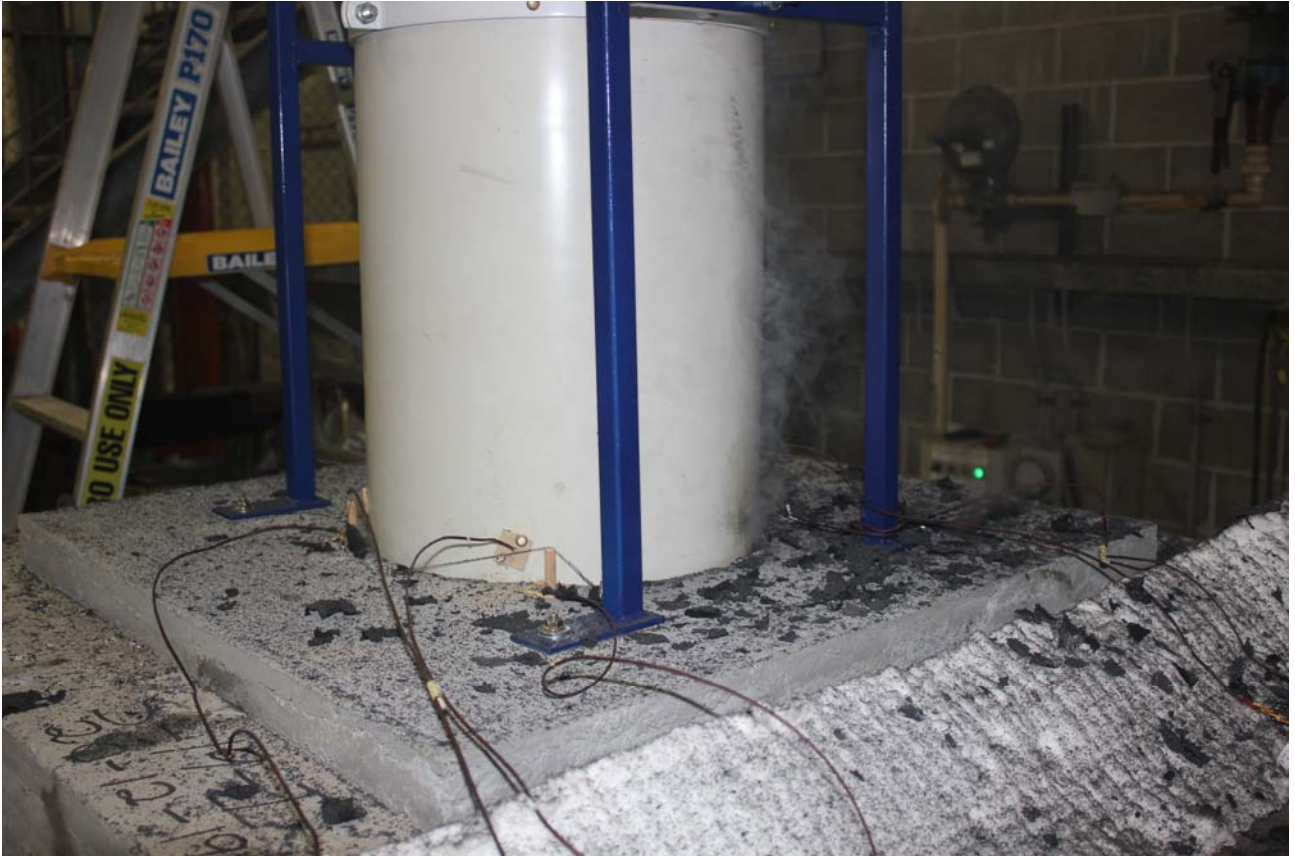
PHOTOGRAPH 10 – SPECIMEN AFTER 155MINUTES OF TESTING

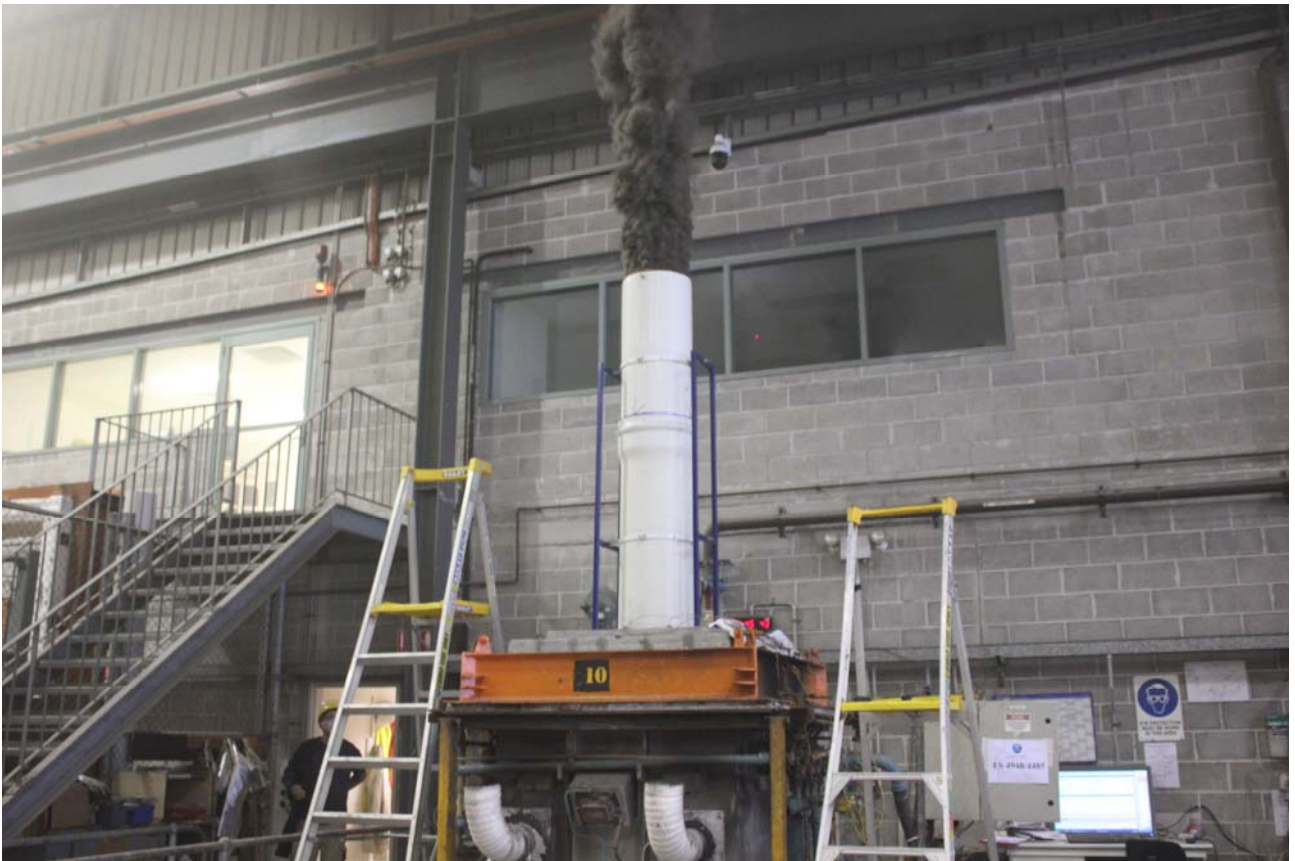
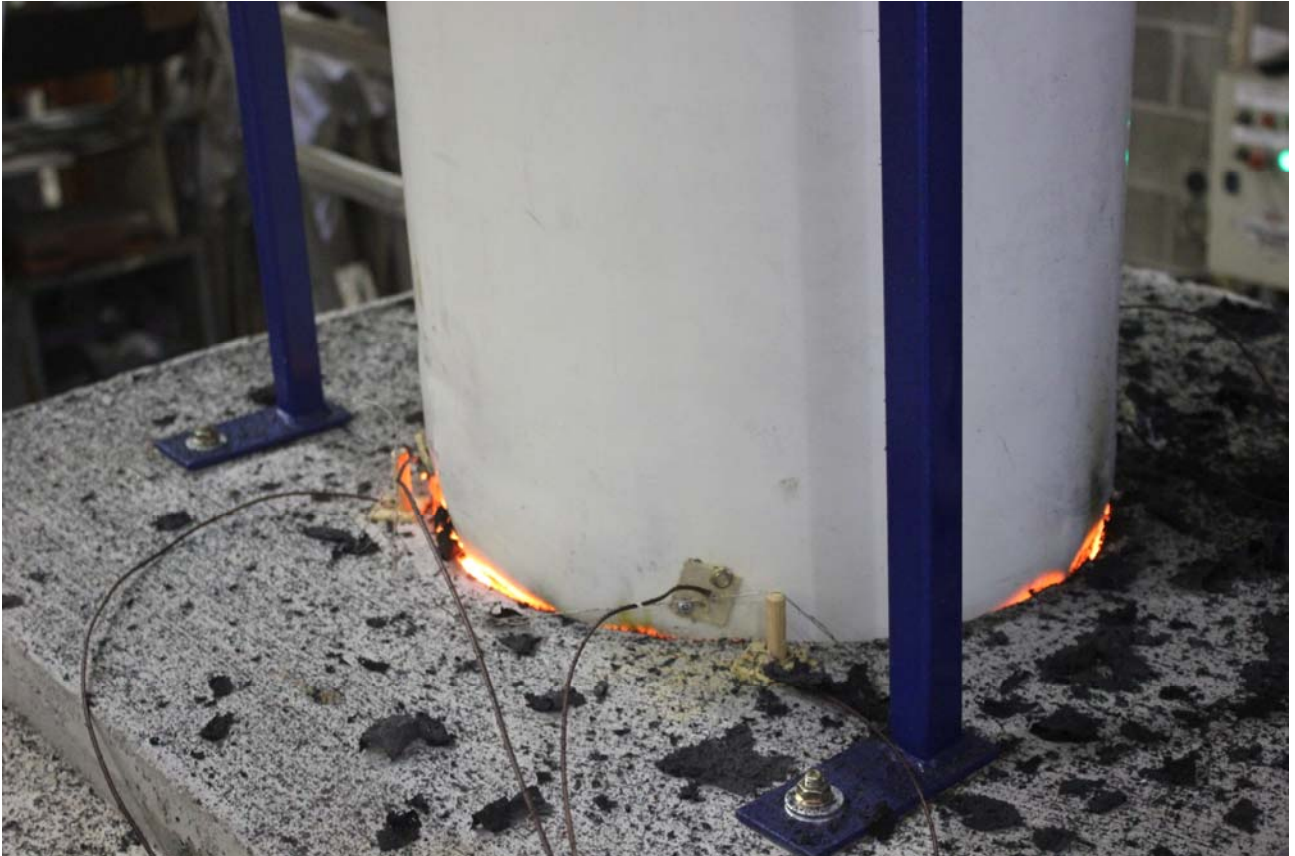
PHOTOGRAPH 11 – SPECIMEN AFTER 165 MINUTES OF TESTING

PHOTOGRAPH 12 – SPECIMEN AFTER 165 MINUTES OF TESTING

- 162 minutes - The quantity of smoke venting from the base of pipe has begun to increase, with visible smoke staining at the of the pipe.
- 165 minutes - Black smoke and flames are being emitted from the end of the pipe. The glow of the furnace can be seen through a large gap around the base of the pipe. Cotton pad test applied over the gap at the base of pipe – no ignition noted at this time
- 167 minutes - Integrity failure – Sustained flaming at the base of pipe greater than 10 seconds observed
- 168 minutes - Insulation failure- maximum temperature rise of 180K is exceeded at the base of pipe 25-mm away from the concrete slab.
- 168 minutes - Test terminated.

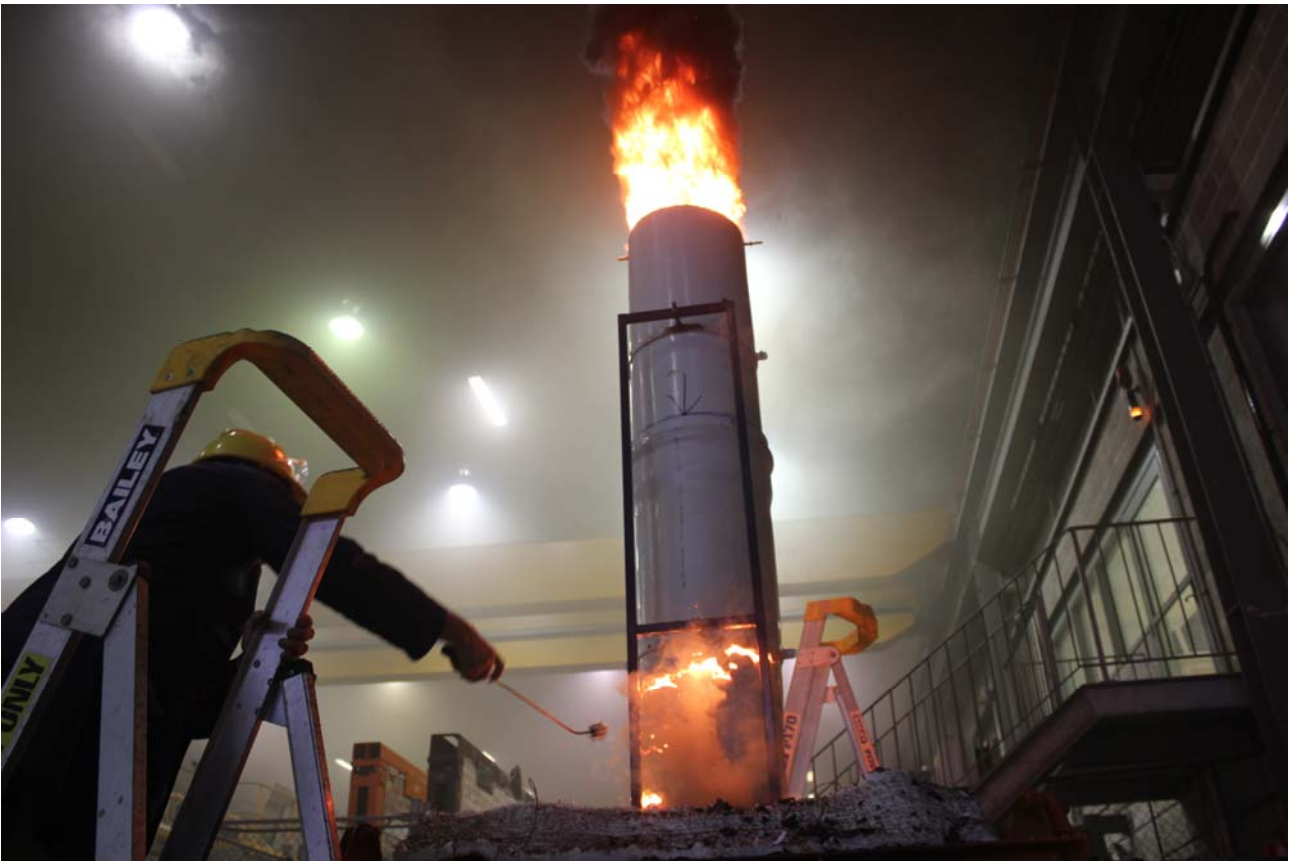
PHOTOGRAPH 13 – SPECIMEN AFTER 167 MINUTES OF TESTING

Structural adequacy	-	not applicable
Integrity	-	167 minutes
Insulation	-	168 minutes

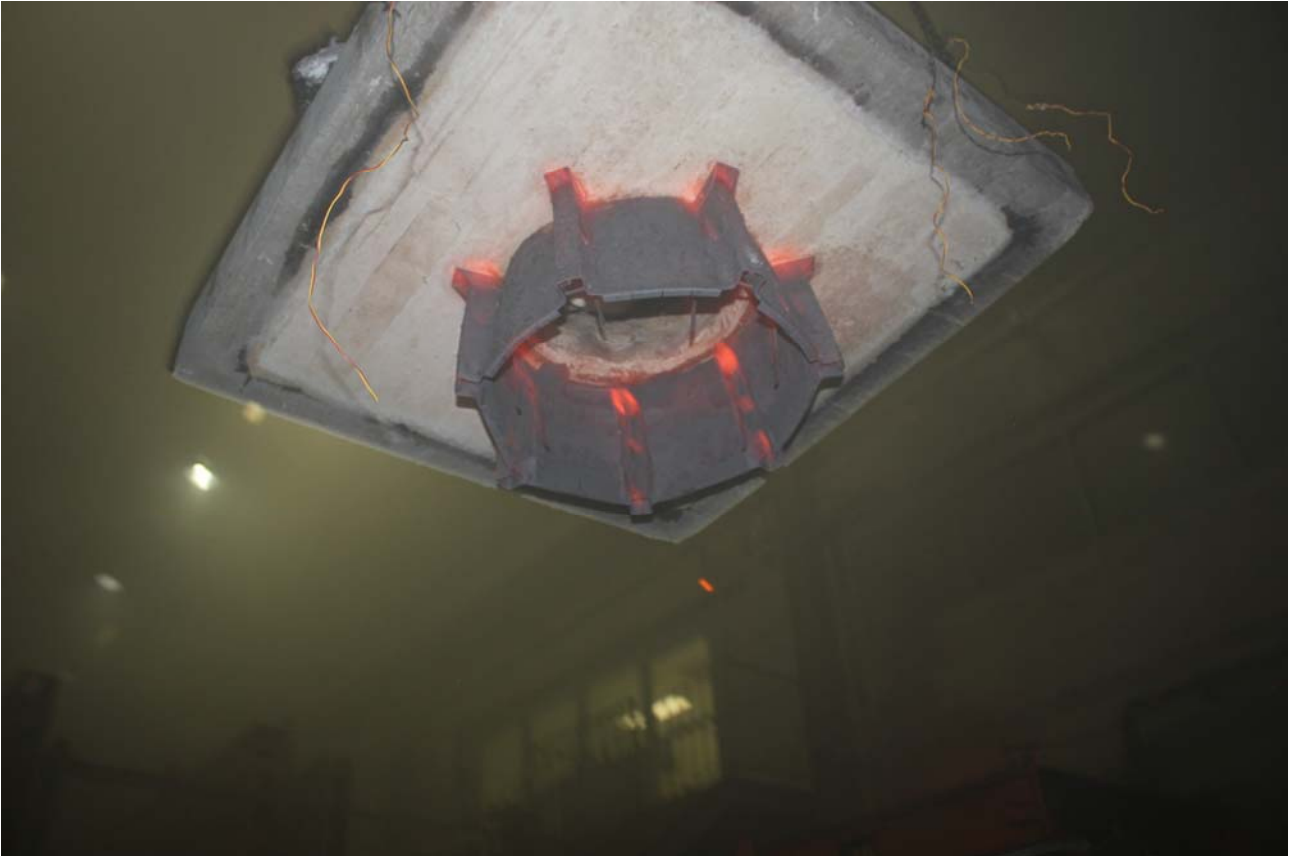
PHOTOGRAPH 14 – EXPOSED FACE OF SPECIMEN AT THE CONCLUSION OF TESTING

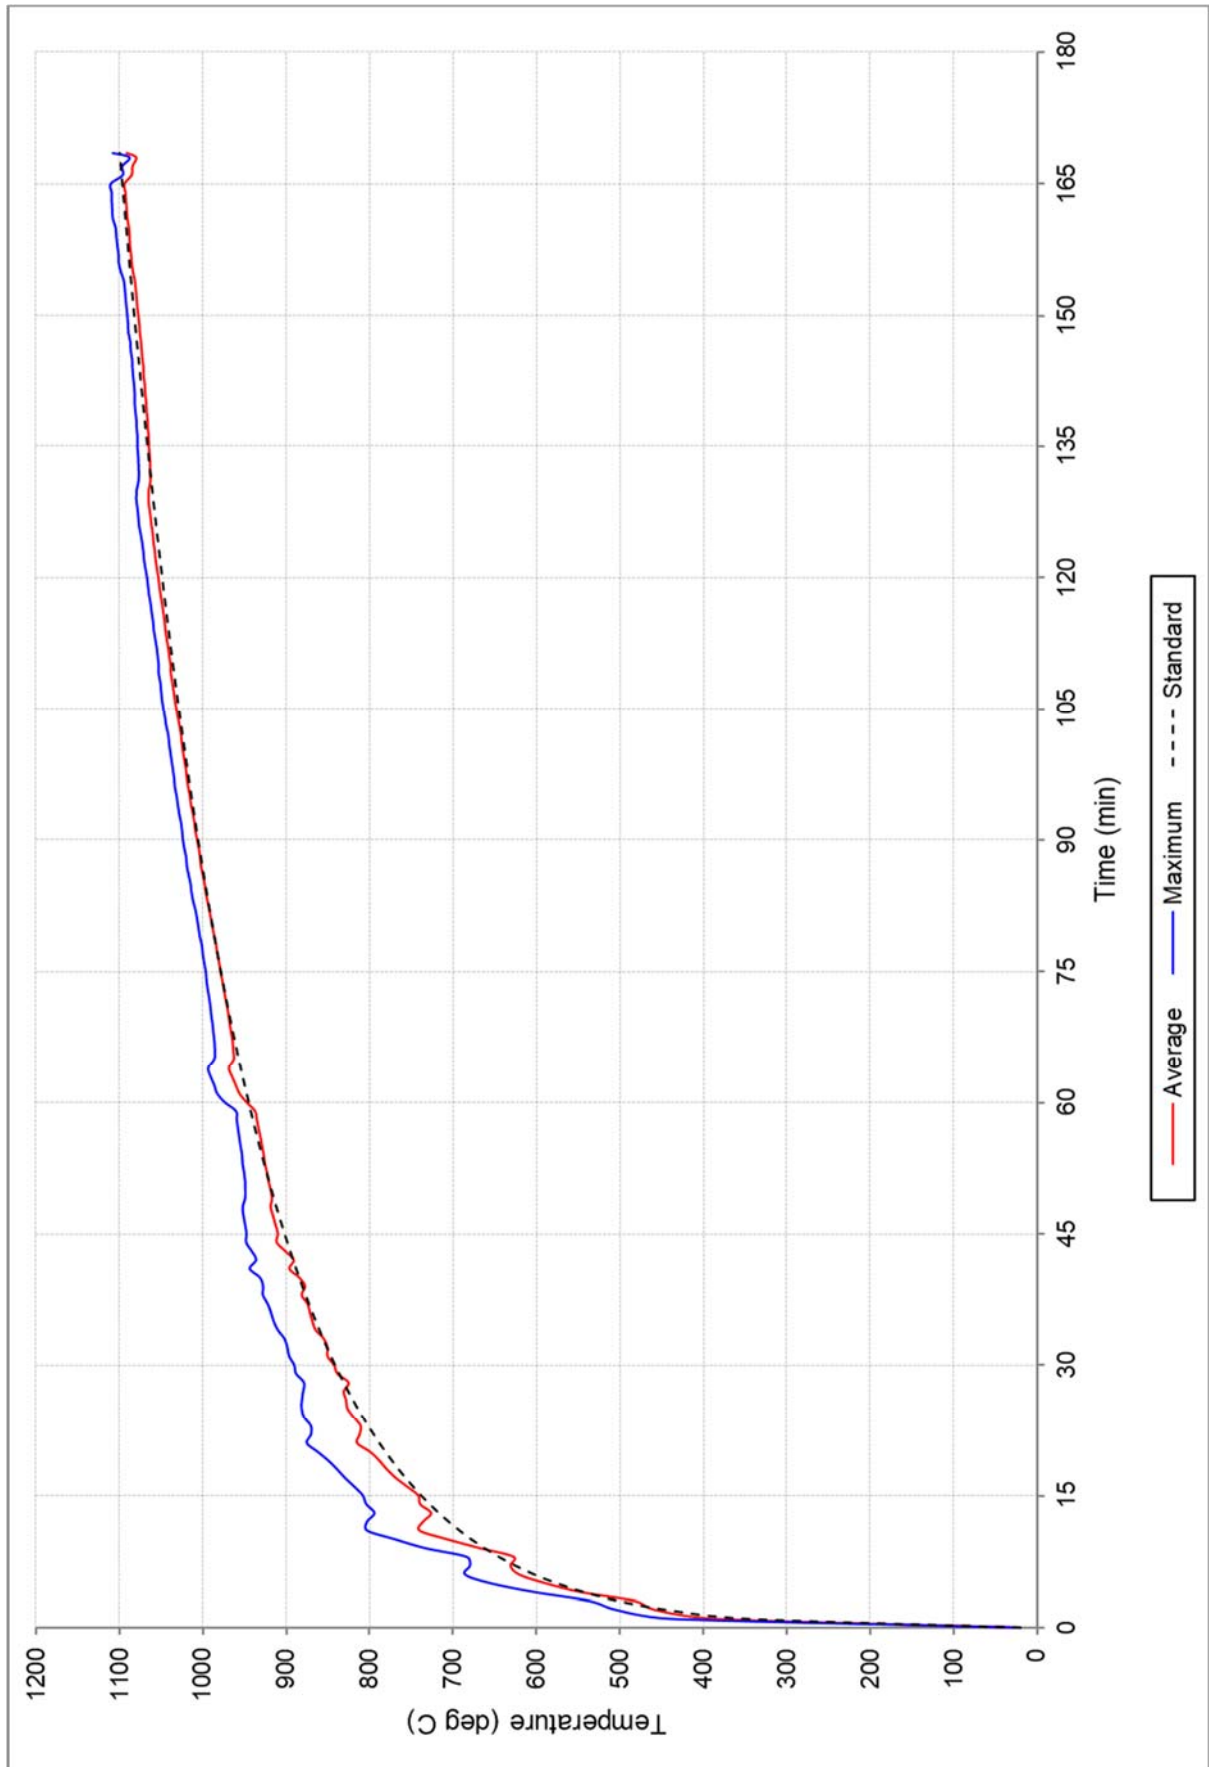
FIGURE 1 – FURNACE TEMPERATURE

Figure 1 shows the standard curves of temperature versus time for heating the furnace chamber and the actual curves of average and maximum temperature versus time recorded during the heating period.

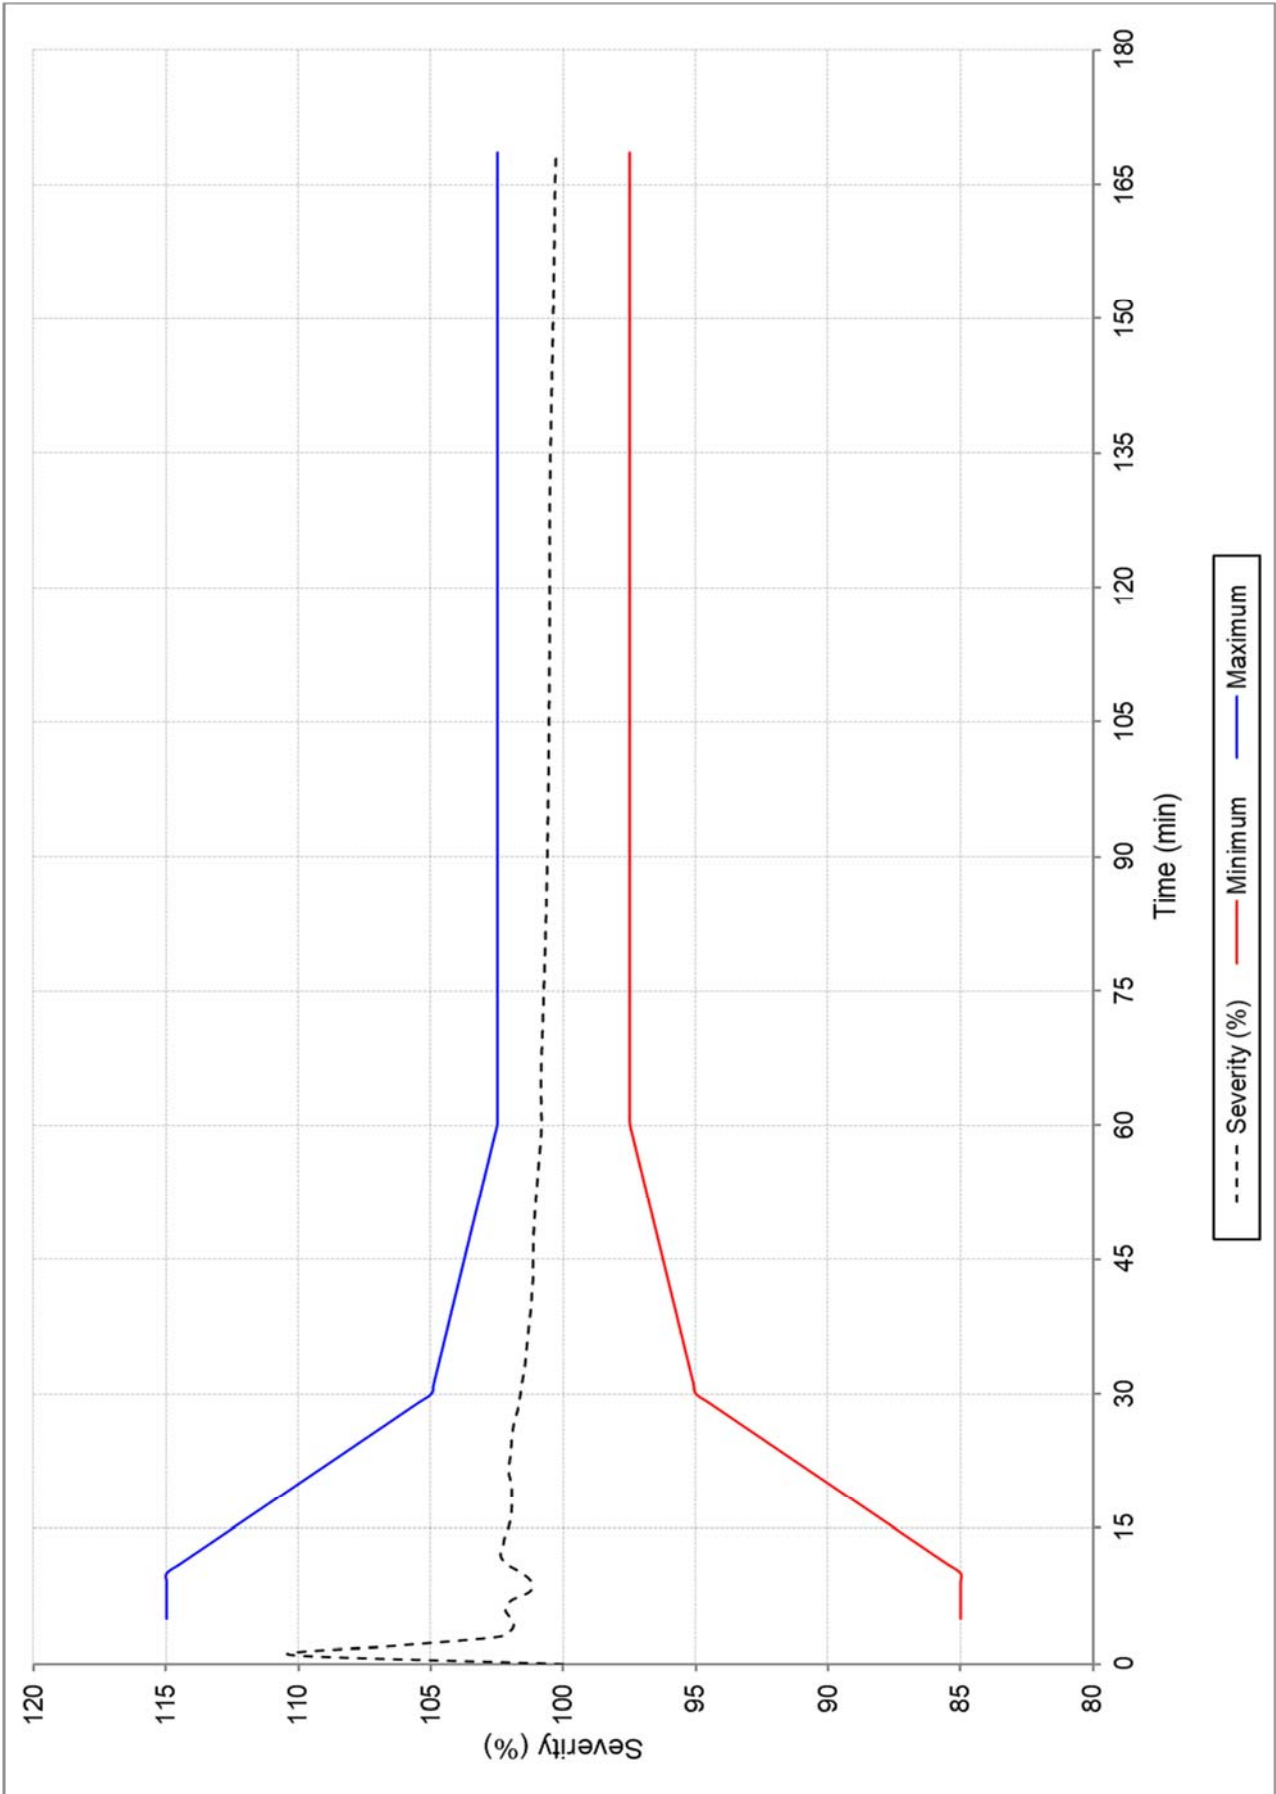
FIGURE 2 – FURNACE SEVERITY

Figure 2 shows the curve of furnace severity versus time during the heating period.

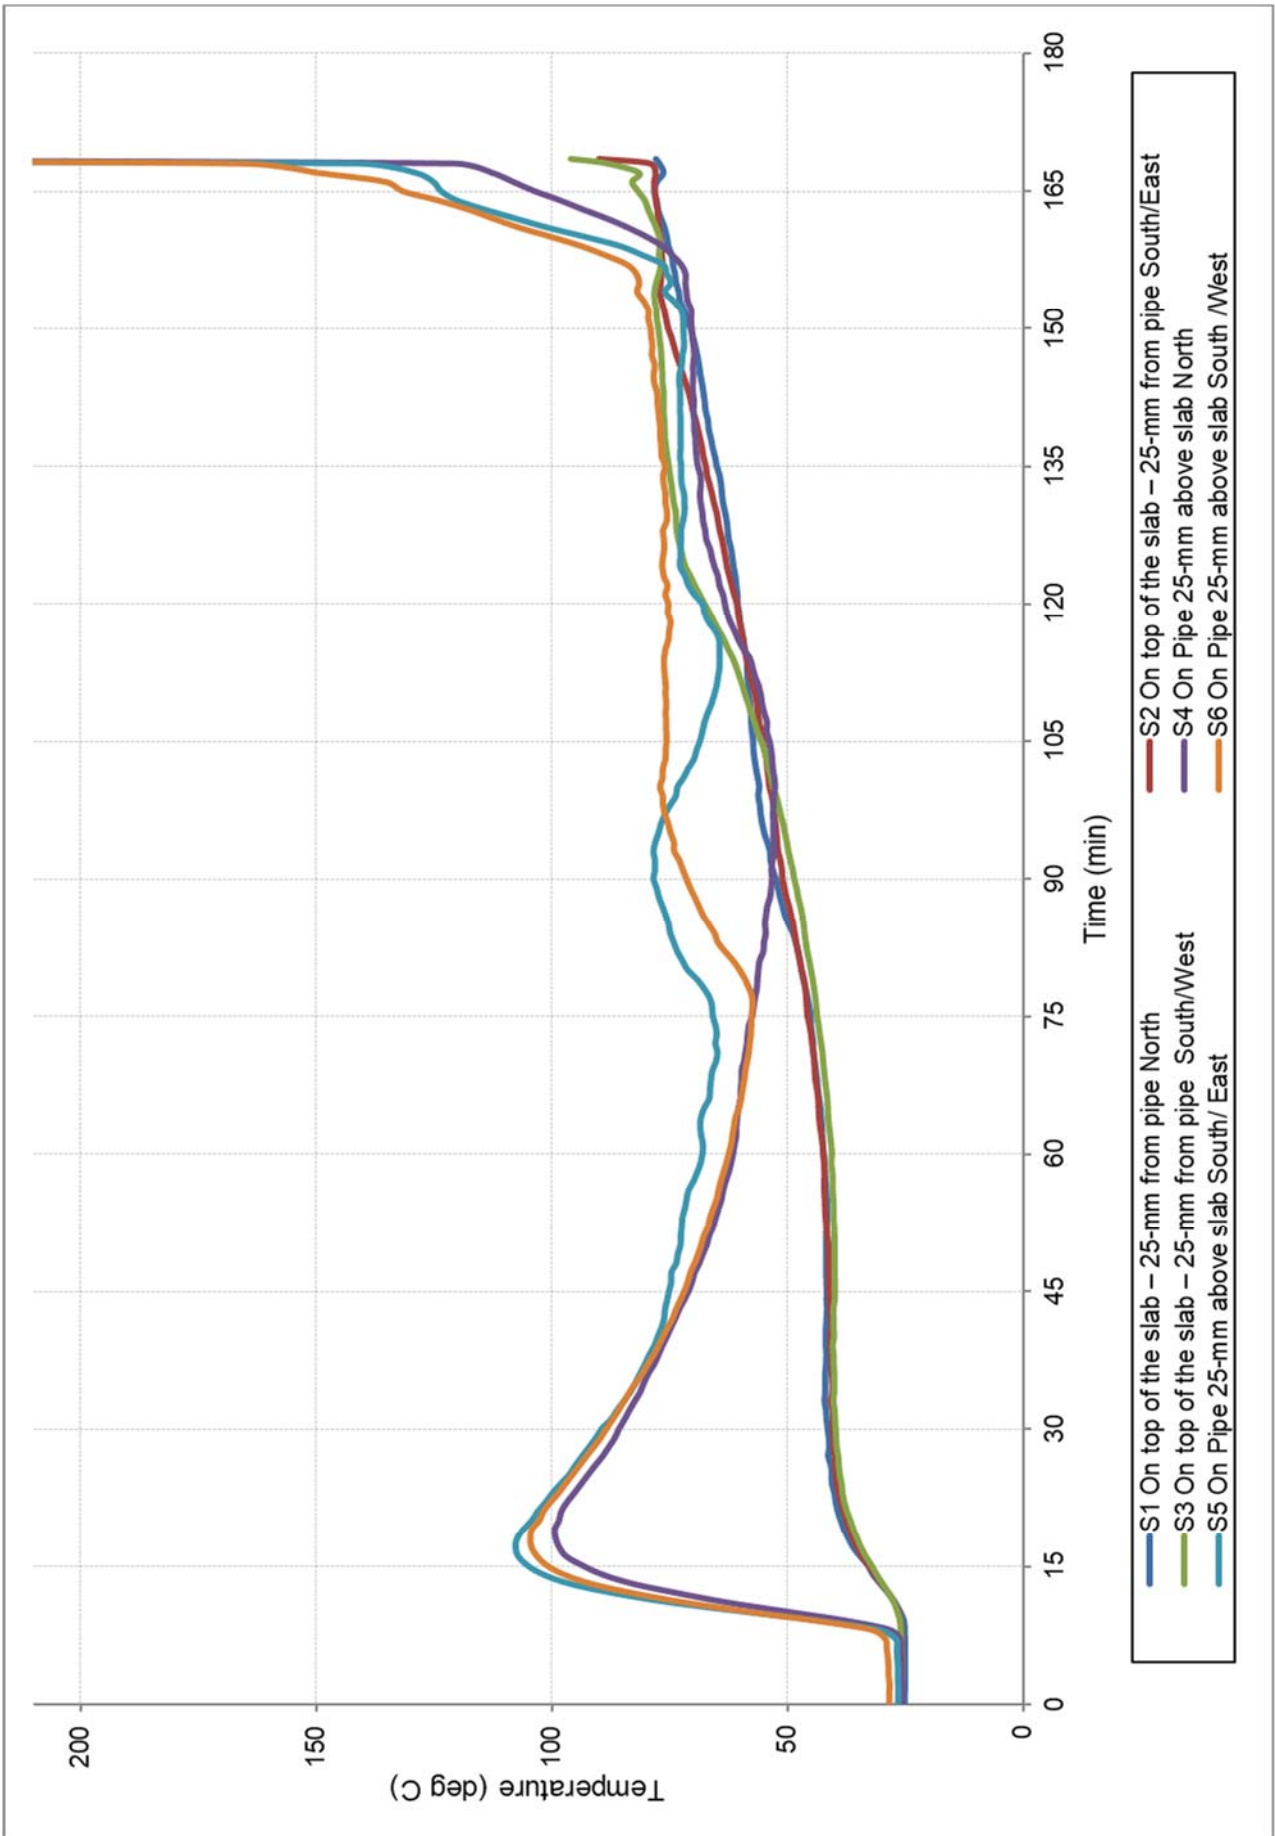
FIGURE 3 – SPECIMEN TEMPERATURE – ASSOCIATED WITH SPECIMEN 1

Figure 3 shows the curve of temperature versus time associated with Specimen 1.
