Fire-resistance test on a fire collar protecting a concrete slab penetrated by a single service

Test Report

Author: Peter Gordon
Report number: FSP 2074
Date: 11 May 2020

Sponsored Investigation No. FSP 2074

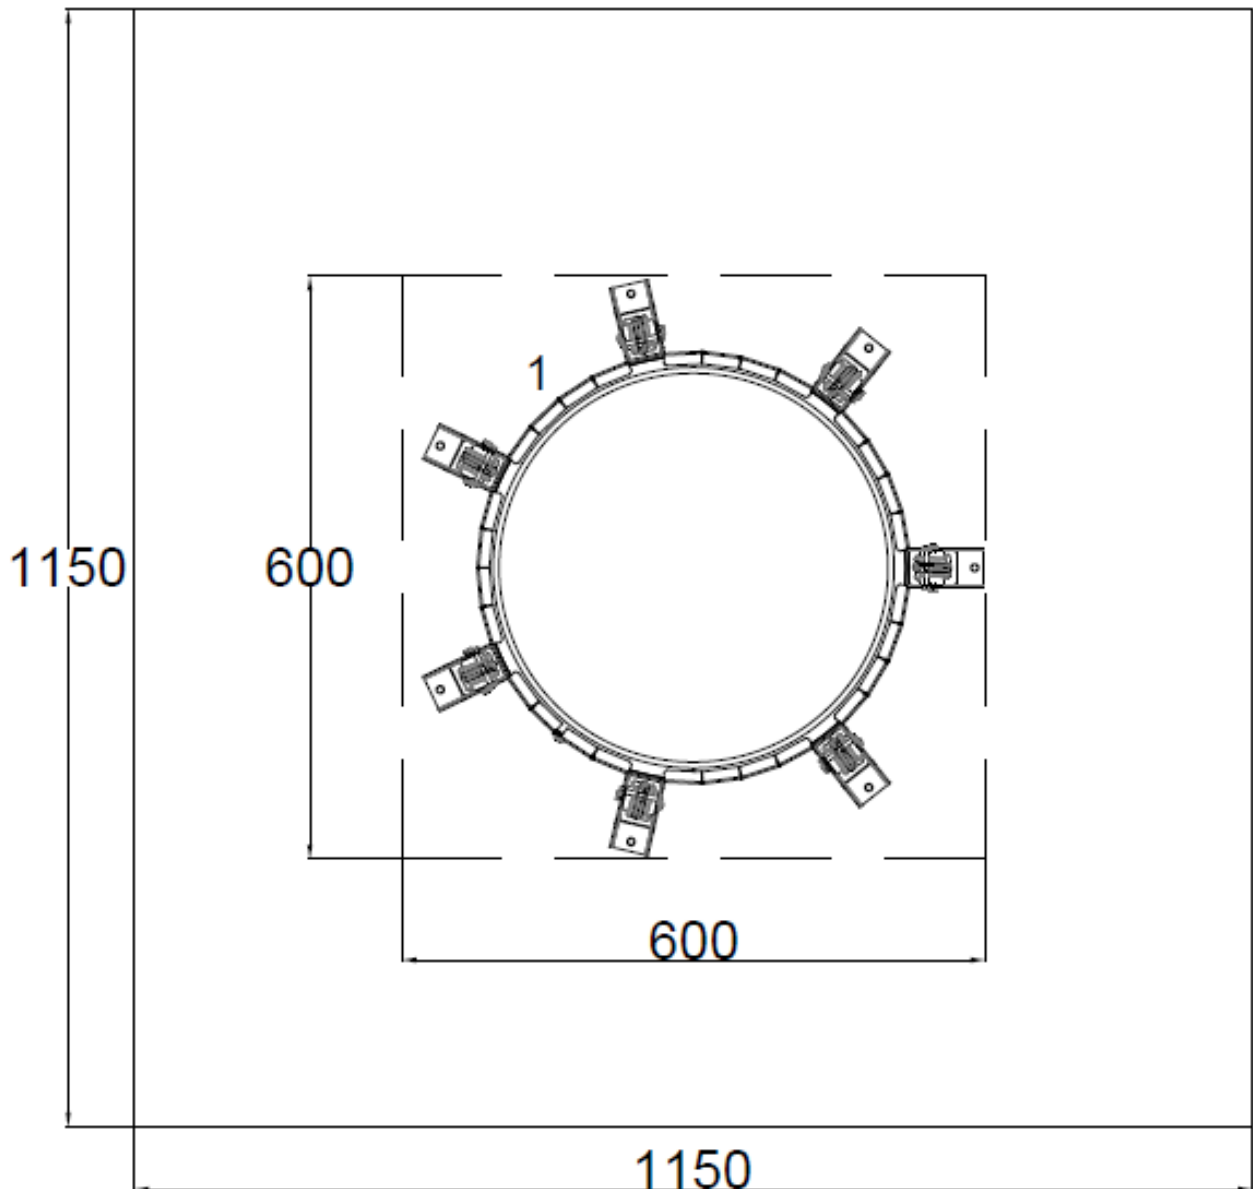
Test Slab S-19-I Layout

Penetration	Collar Code	Pipe Type	Pipe Diameter (mm)	Sealant
1	HP400R	PVC	375	n/a

DRAWING TITLED "TEST SLAB S-19-I LAYOUT", PROVIDED BY SNAP FIRE SYSTEMS PTY LTD

- Drawing titled “Test Slab S-19-I Layout”, dated 12 December 2019 provided by Snap Fire Systems Pty Ltd.
- Drawing titled “Specimen #1 375mm PVC stack & HP400R”, dated 12 December 2019, provided by Snap Fire Systems Pty Ltd.
- Drawing titled “SNAP 400 High Profile Retro”, dated 6 January 2020, by Snap Fire Systems.

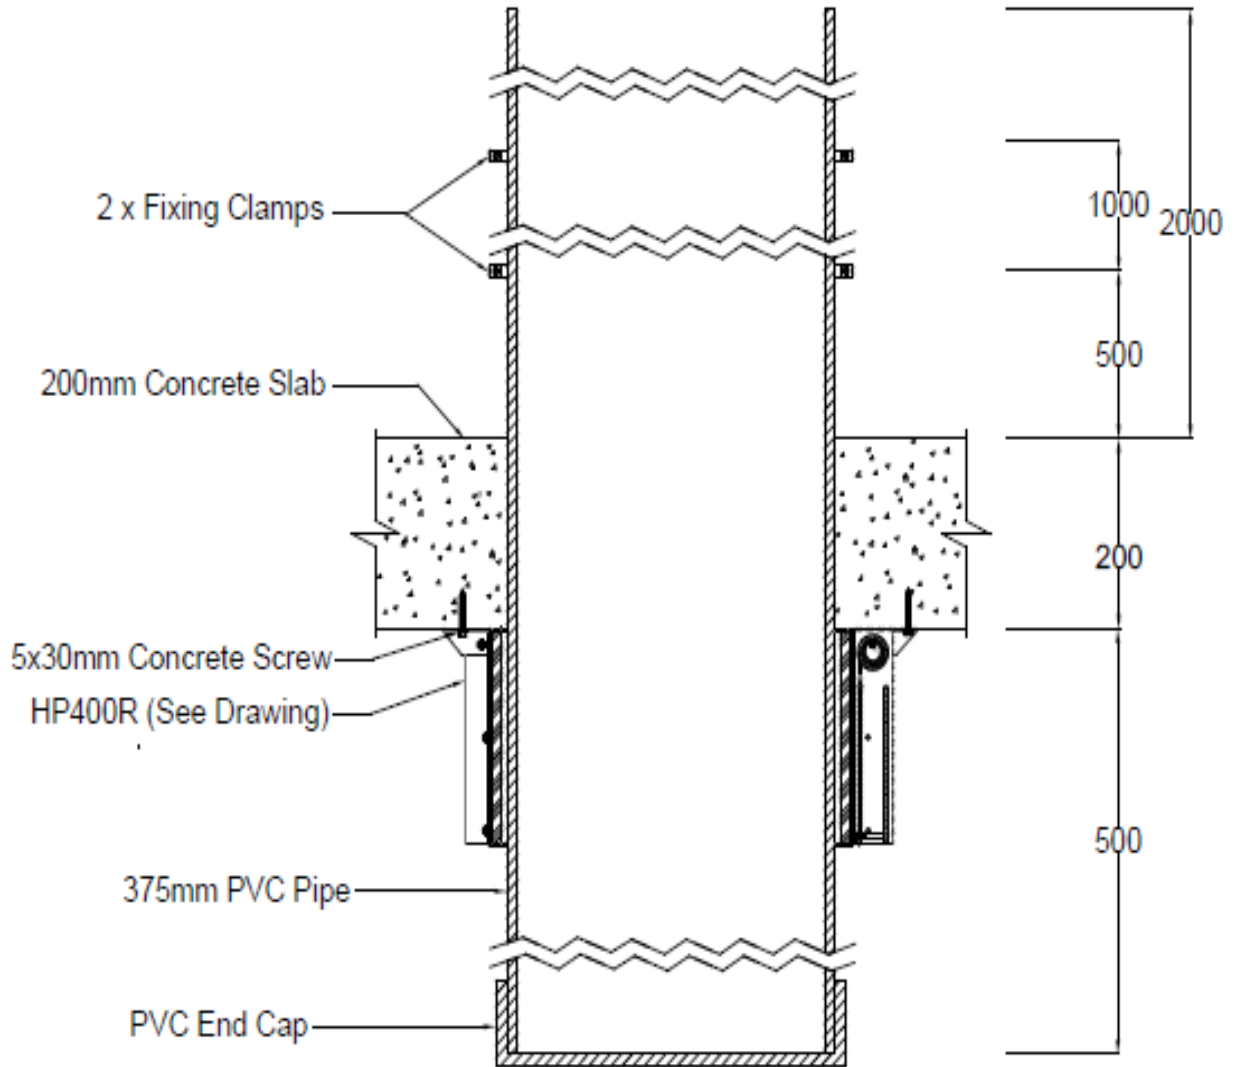
375mm PVC Stack & HP400R

Specimen #1

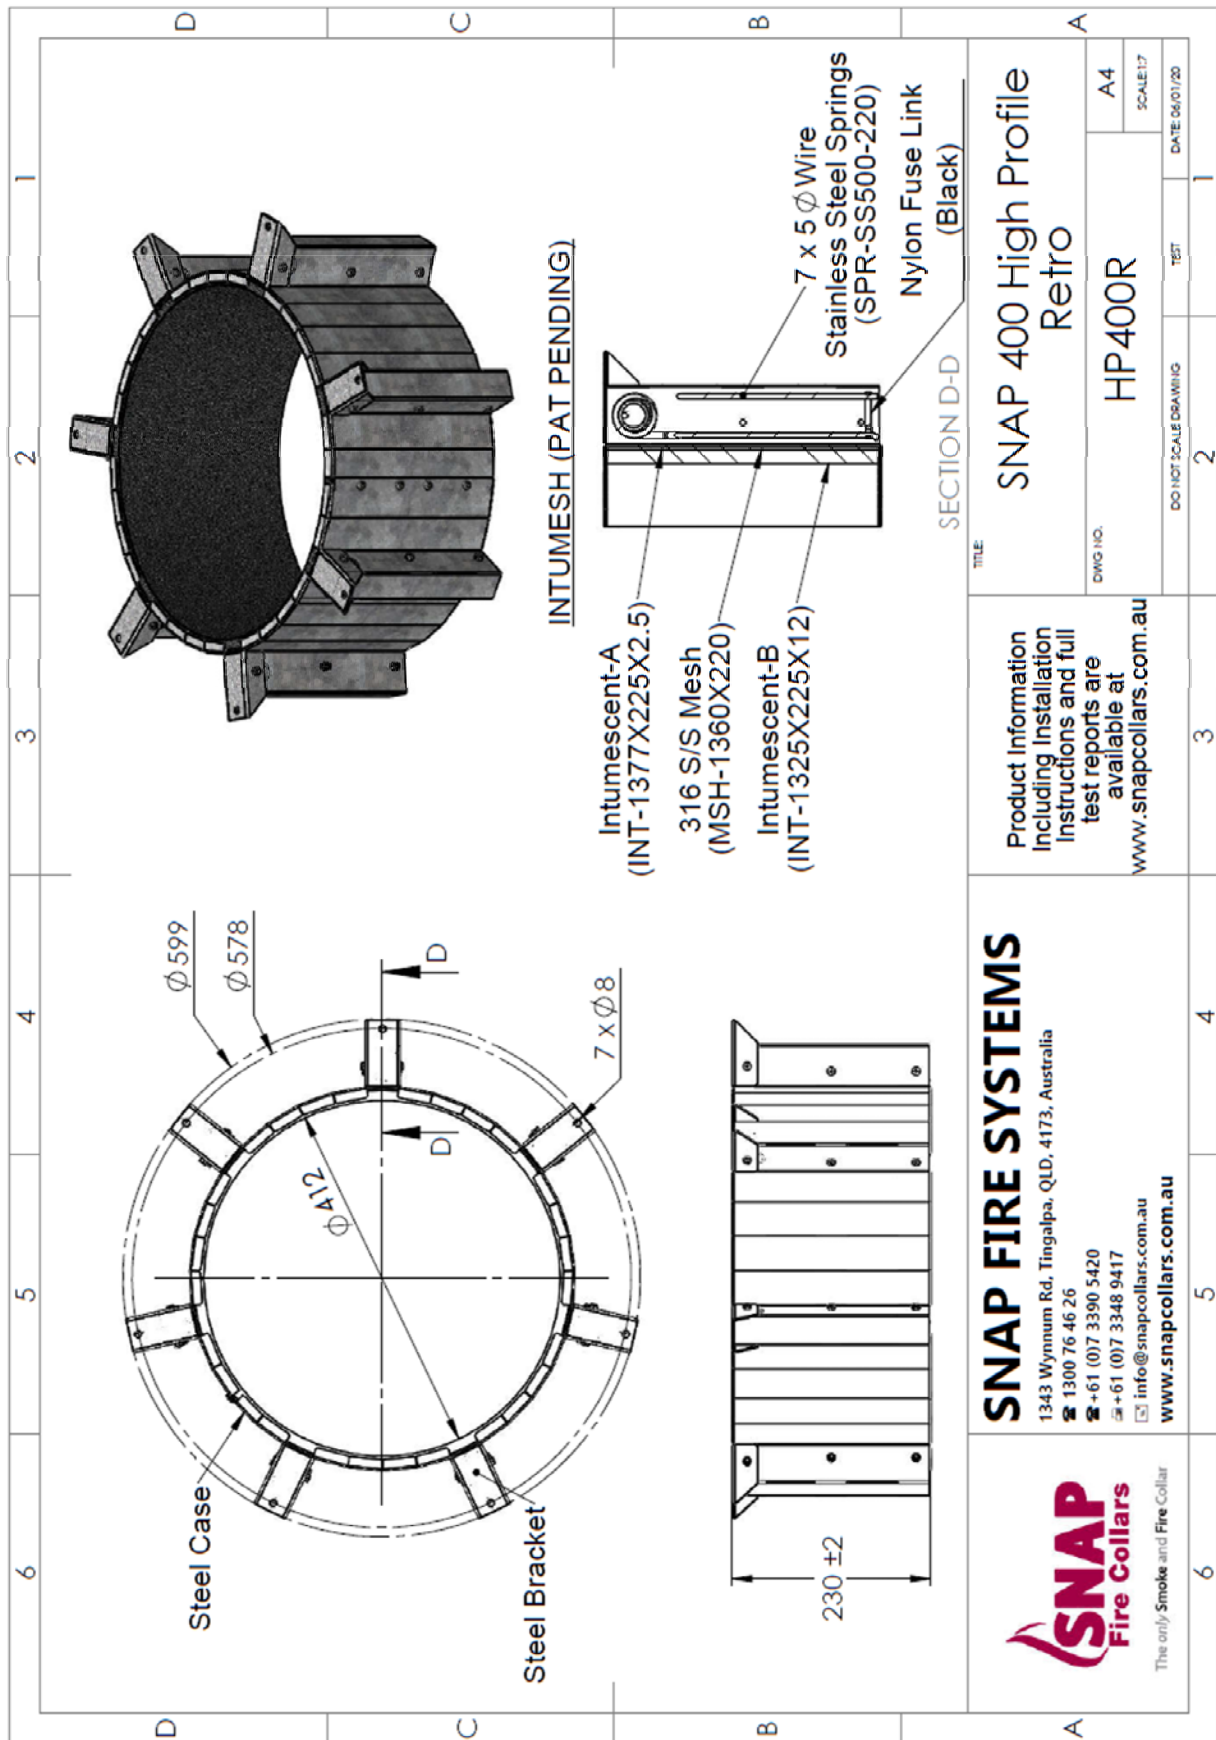
DRAWING TITLED "SNAP 400 HIGH PROFILE RETRO", 6 JANUARY 2020, BY SNAP FIRE SYSTEMS

The SNAP HP400R High Profile Retro fire collar comprised a 0.95-mm steel casing with a 412-mm inner diameter and a 599-mm diameter base flange. The 230-mm high collar casing incorporated two strips of Intumesh intumescent material, Intumescent-A 1377-mm x 225-mm x 2.5-mm thick and Intumescent-B 1325-mm x 225-mm x 12-mm thick. The closing mechanism comprised seven equally spaced steel springs (fabricated using SPR-SS500-20 grade stainless steel wire having a diameter of 5-mm) held with nylon fuse links and a 1360-mm x 220-mm 316 stainless steel mesh located in between the two intumescent strips as shown in drawing title "SNAP 400 High Profile Retro", dated 6 January 2020, by Snap Fire Systems. The SNAP HP400R High profile Retro fire collar was fixed to the underside of the slab using seven 30-mm x 5-mm concrete screws.
