# Fire-resistance test on fire collars protecting a Hebel PowerPanel wall penetrated by services

## Test Report

**Author:** Peter Gordon  
**Report number:** FSP 2058 (Revision C)  
**Date:** 21 September 2020

## Sponsored Investigation No. FSP 2058

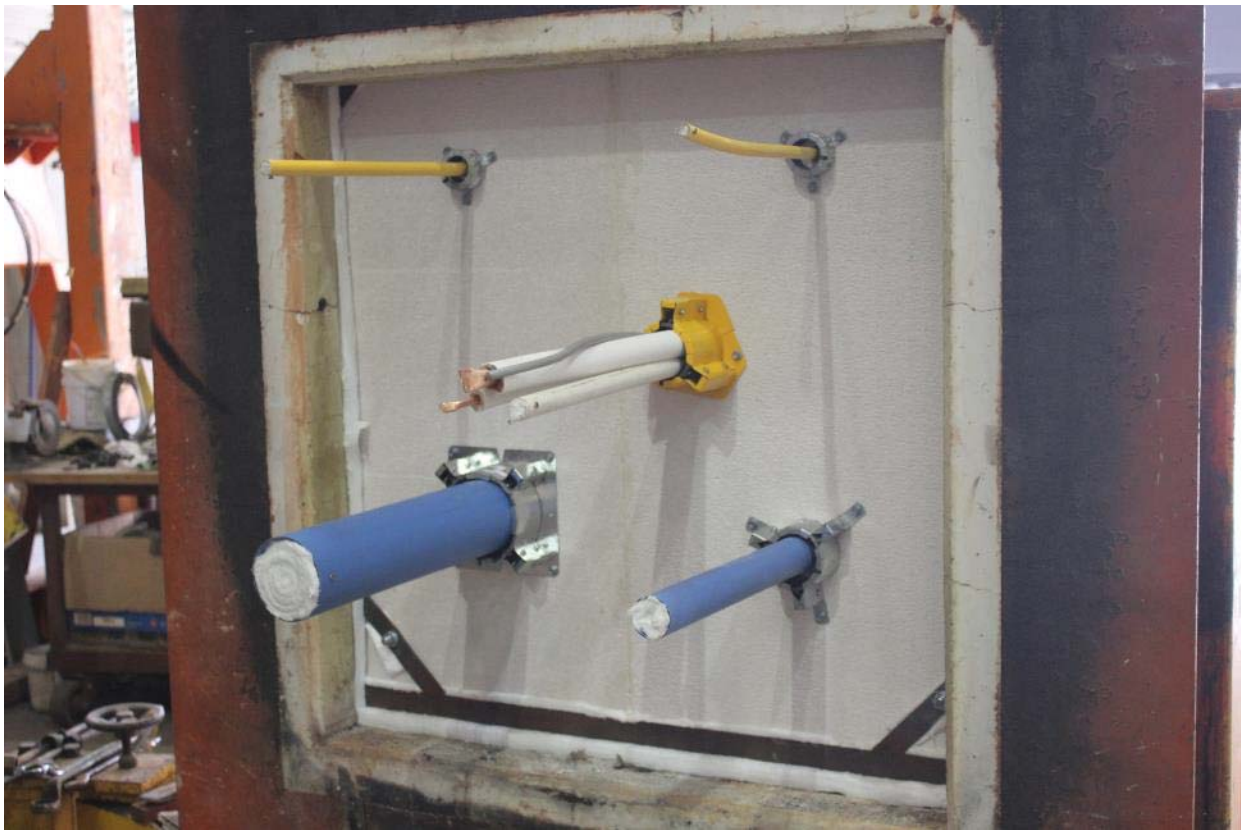
**PHOTOGRAPH 1 – EXPOSED FACE OF SPECIMENS PRIOR TO TESTING**

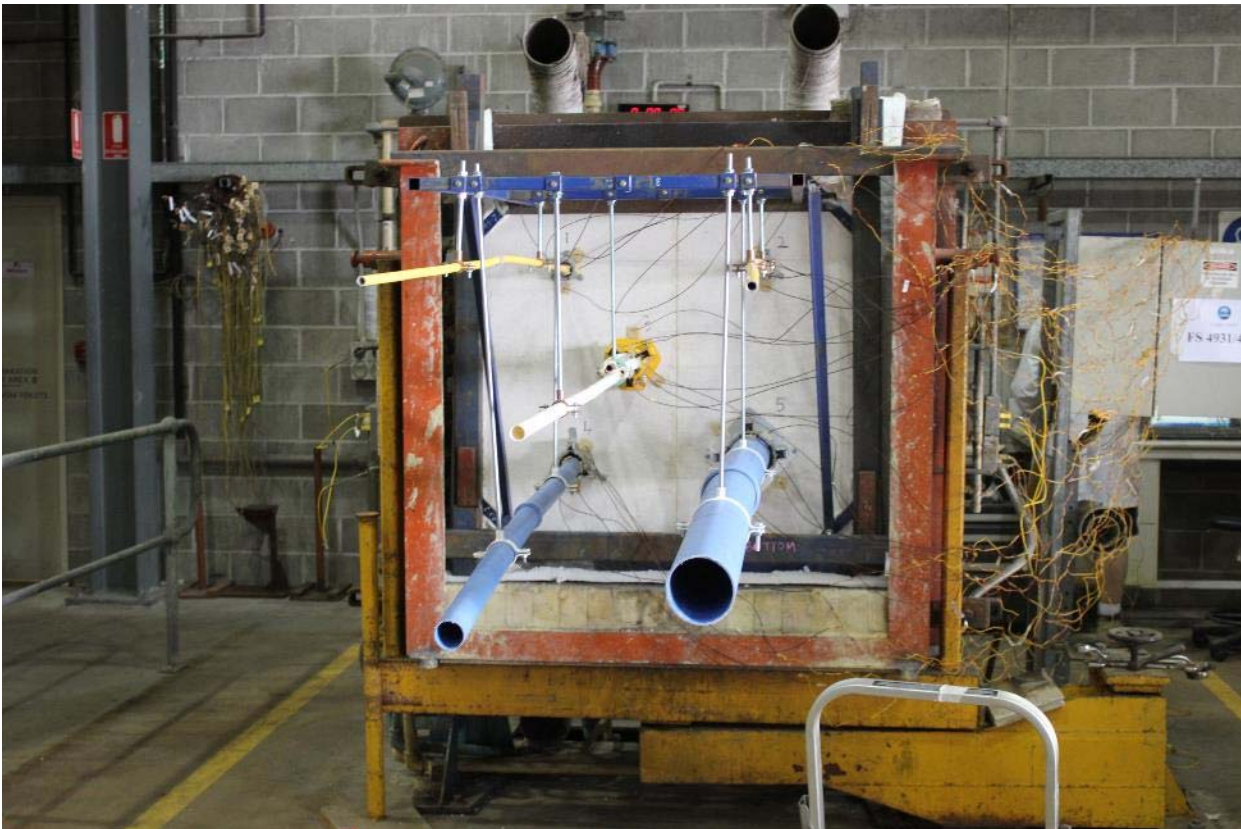
**PHOTOGRAPH 2 – UNEXPOSED FACE OF SPECIMENS PRIOR TO TESTING**

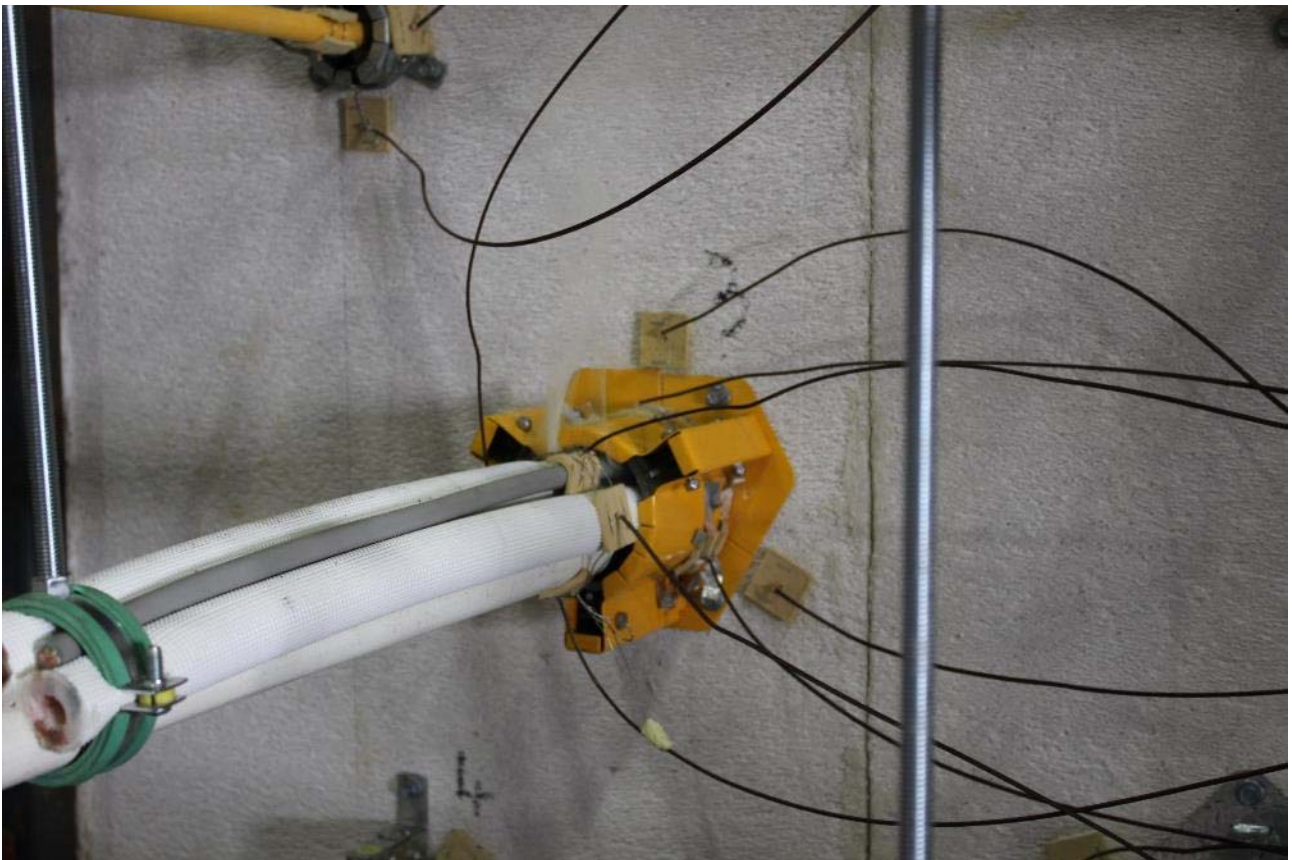
**PHOTOGRAPH 4 – SPECIMEN 3 AFTER 20 MINUTES OF TESTING**

- 21 minutes - Smoke resumes fluing from the insulation at the end of the ¾-inch copper pair coil pipes of Specimen 3.
- 22 minutes - The insulation at the base of the ¾-inch and a ⅝-inch insulated copper pair coil pipes of Specimen 3 has begun to melt and shrink. Thermocouple #20 measuring the temperature of the ¾-inch insulated copper pair coil has detached from the pipe lagging.

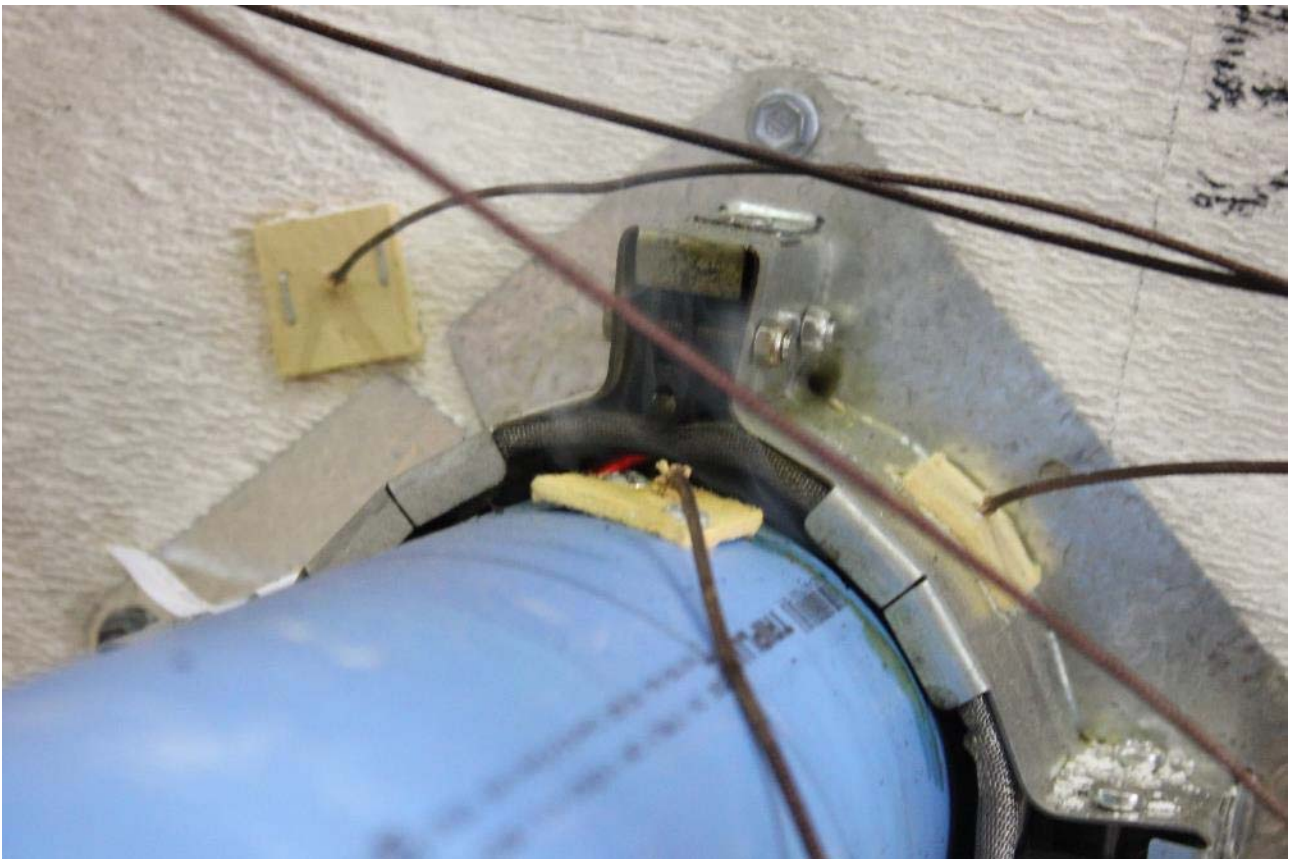
**PHOTOGRAPH 10 – SPECIMEN 5 AFTER 119 MINUTES OF TESTING**
