# Fire-resistance test on fire collars protecting a concrete slab penetrated by services

## Test Report

**Report number:** FSP 2088

## Sponsored Investigation No. FSP 2088

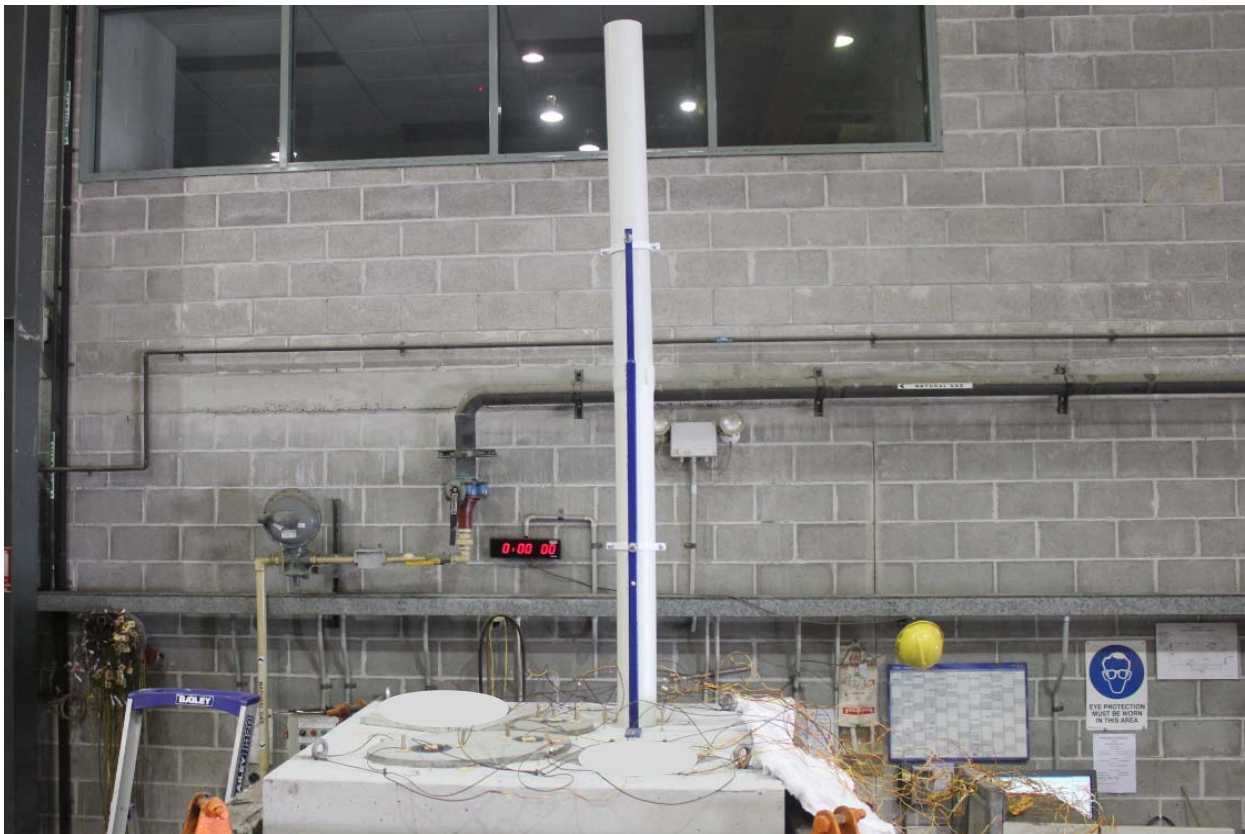
**PHOTOGRAPH 2 – UNEXPOSED FACE OF SPECIMENS PRIOR TO TESTING**

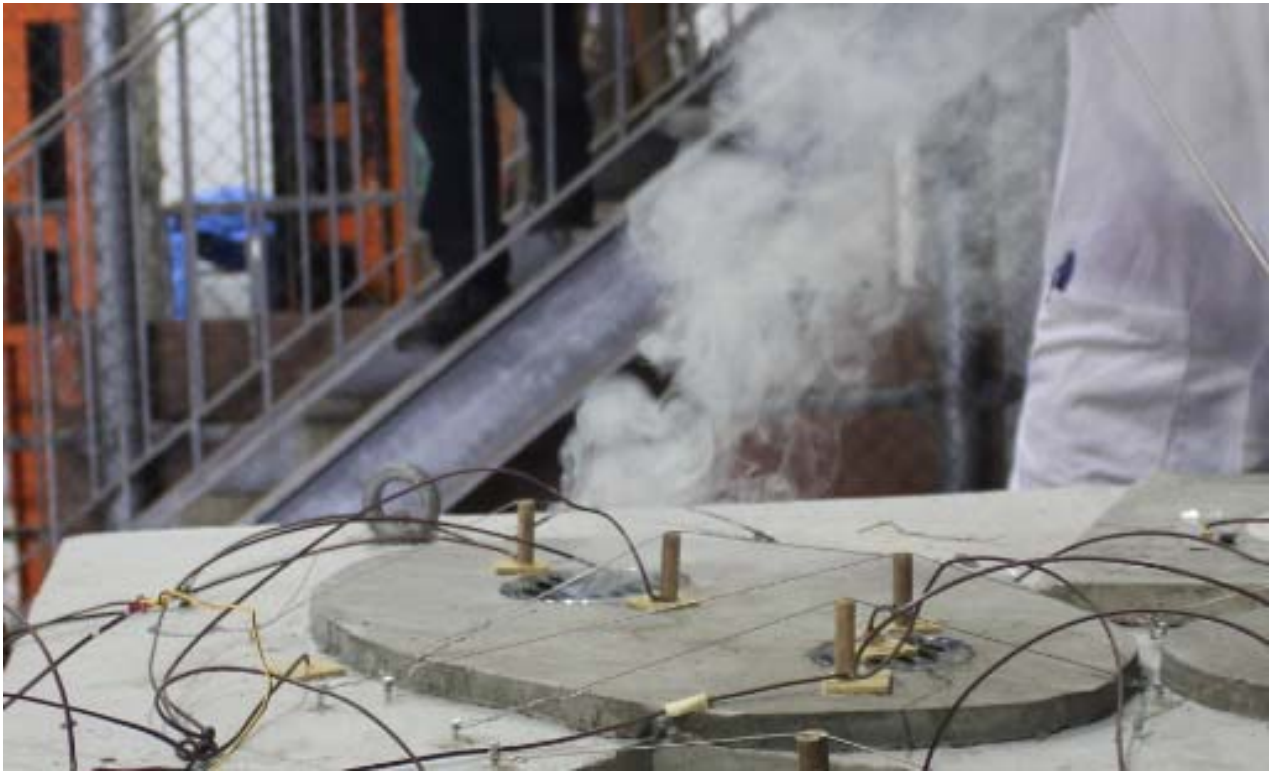
**PHOTOGRAPH 3 – SPECIMEN 3 AFTER 3 MINUTES OF TESTING**

Time	Observation
3 minutes -	Smoke has begun fluing from the grate of the Specimen 3 floor waste.
3 ½ minutes -	Smoke has begun fluing from the end of the PVC pipe of Specimen 2.
4 minutes -	Smoke has begun fluing from the small grate of the Specimen 2 floor waste.
5 minutes -	Cotton pad test applied above the large grate of Specimen 3 – no ignition noted at this time.
7 minutes -	Smoke has ceased fluing from the grate of the Specimen 2 floor waste.
8 minutes -	Cotton pad test applied above the large grate of Specimen 3 – no ignition noted at this time.
15 minutes -	Loud popping noises are emitted from the specimens, indicating possible spalling of the concrete slab.
24 minutes -	Smoke has almost ceased fluing from the end of the pipes of Specimen 2. Loud popping noises indicating possible spalling of the slab are again heard.
26 minutes -	Smoke has ceased fluing from the large grate of the Specimen 3 floor waste.
