Fire-resistance test on fire collars protecting a concrete slab penetrated by services

Test Report

Author: Peter Gordon
Report number: FSP 2224
Date: 21 September 2021

Sponsored Investigation No. FSP 2224

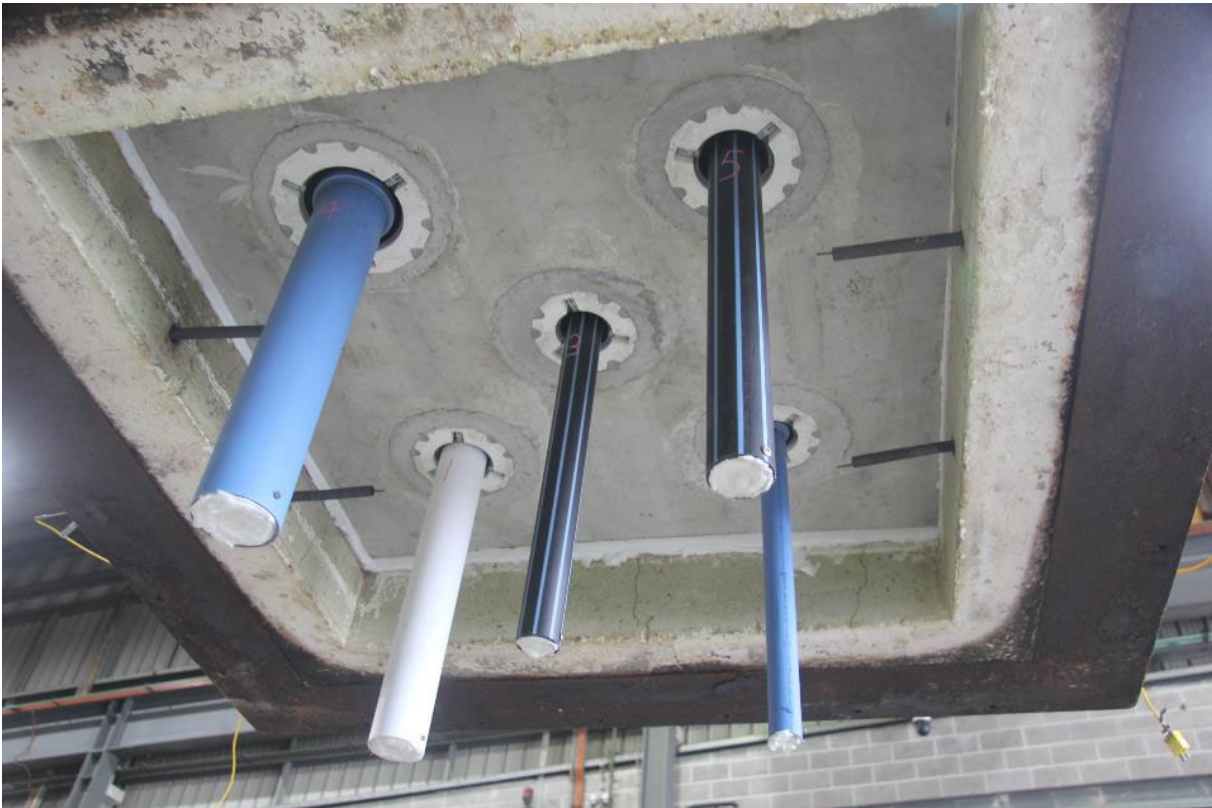
PHOTOGRAPH 1 – EXPOSED FACE OF SPECIMEN PRIOR TO TESTING

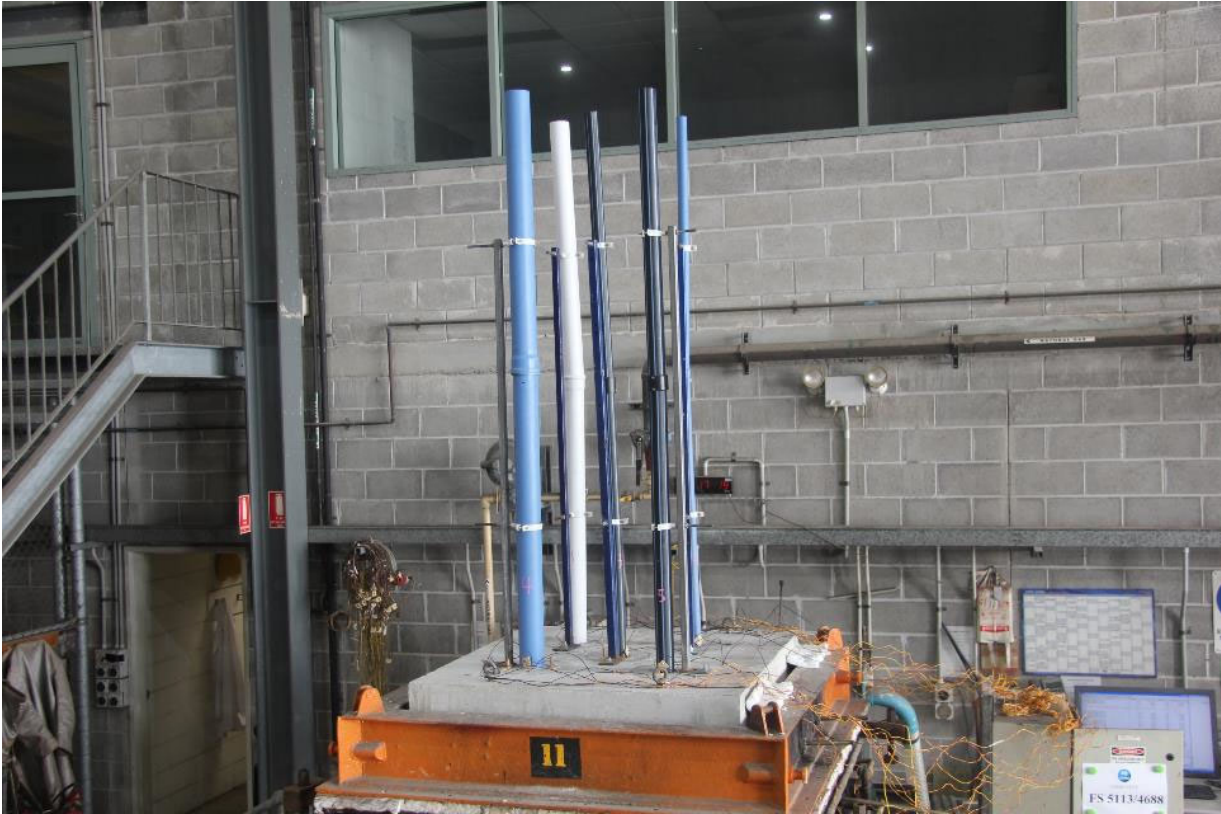
PHOTOGRAPH 2 – UNEXPOSED FACE OF SPECIMEN PRIOR TO TESTING

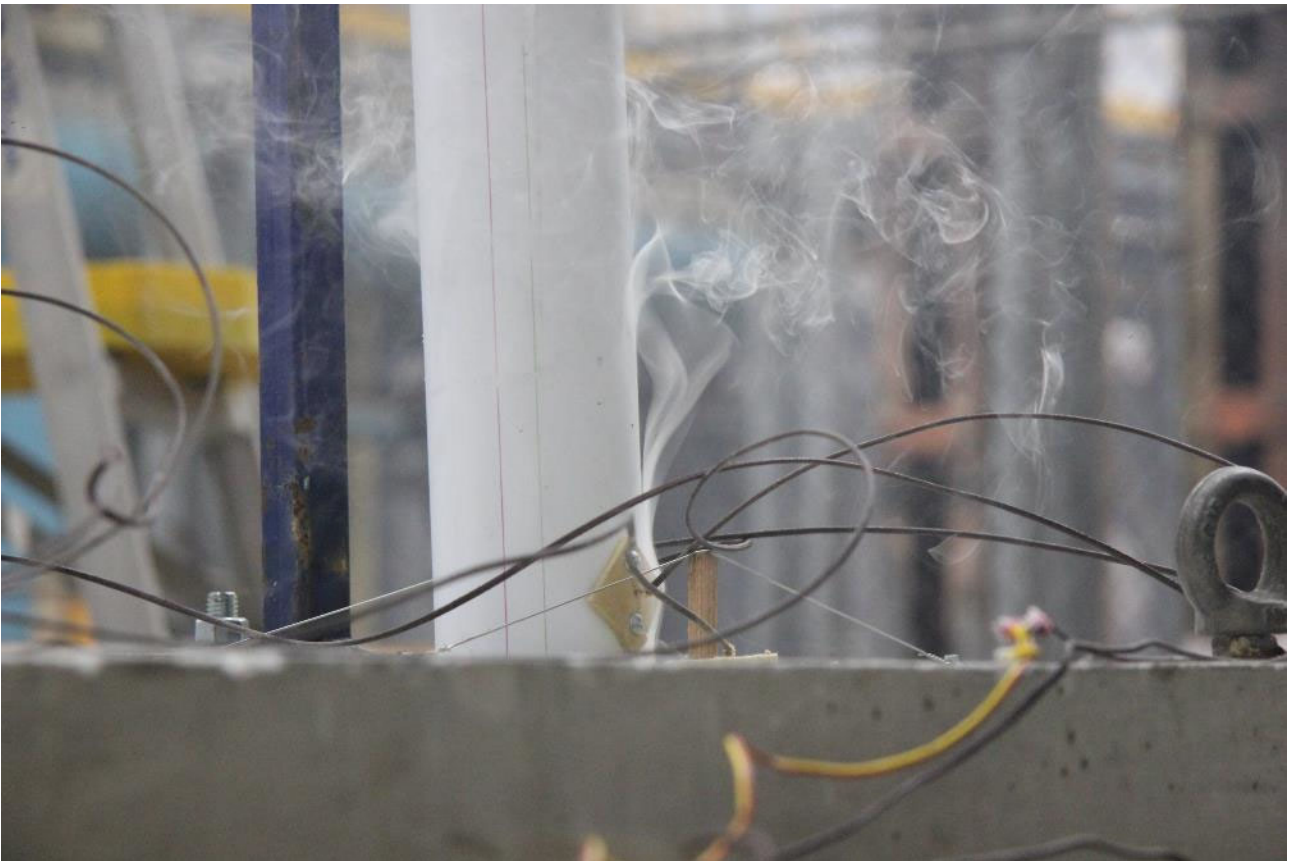
PHOTOGRAPH 3 – SPECIMEN 1 AT 15 MINUTES INTO THE TEST

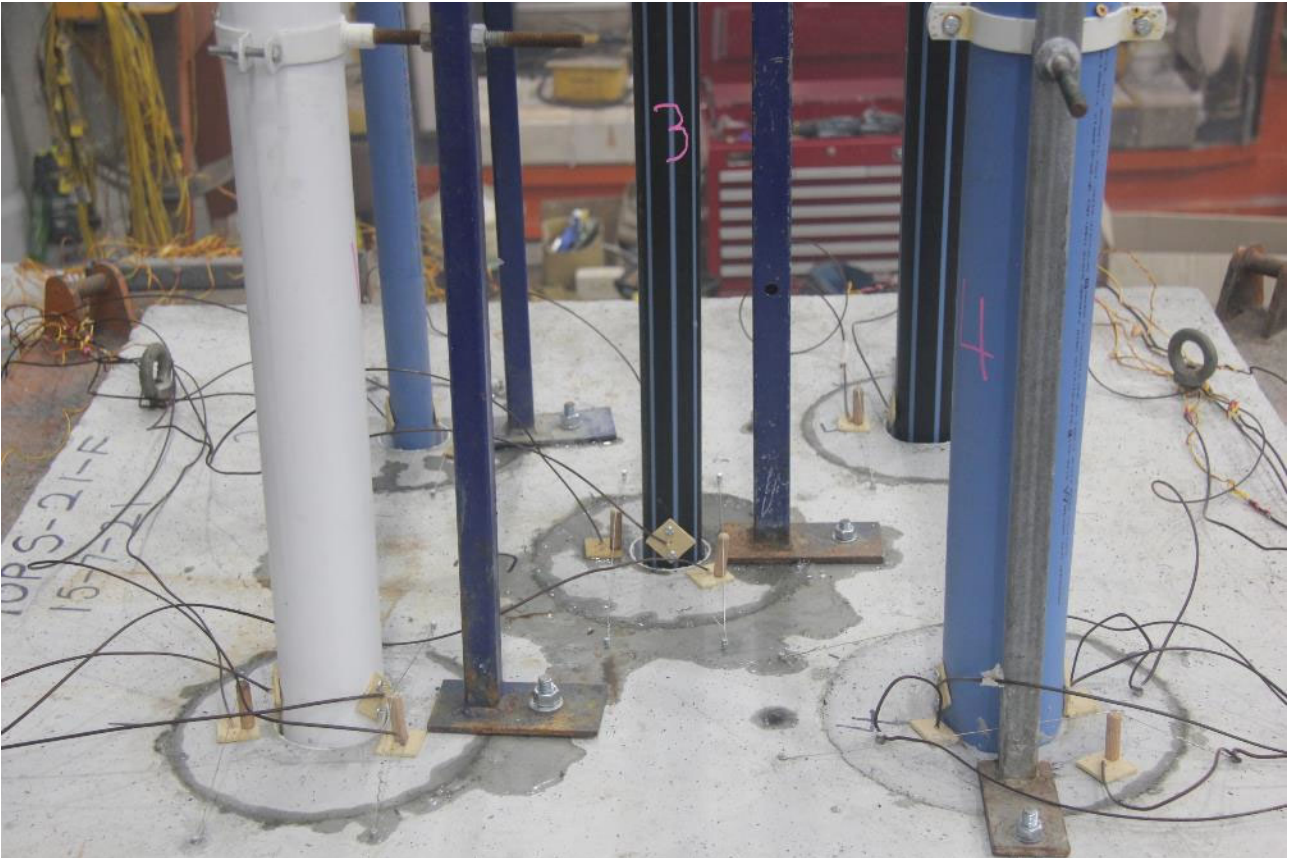
PHOTOGRAPH 4 – SPECIMENS AT 25 MINUTES INTO THE TEST

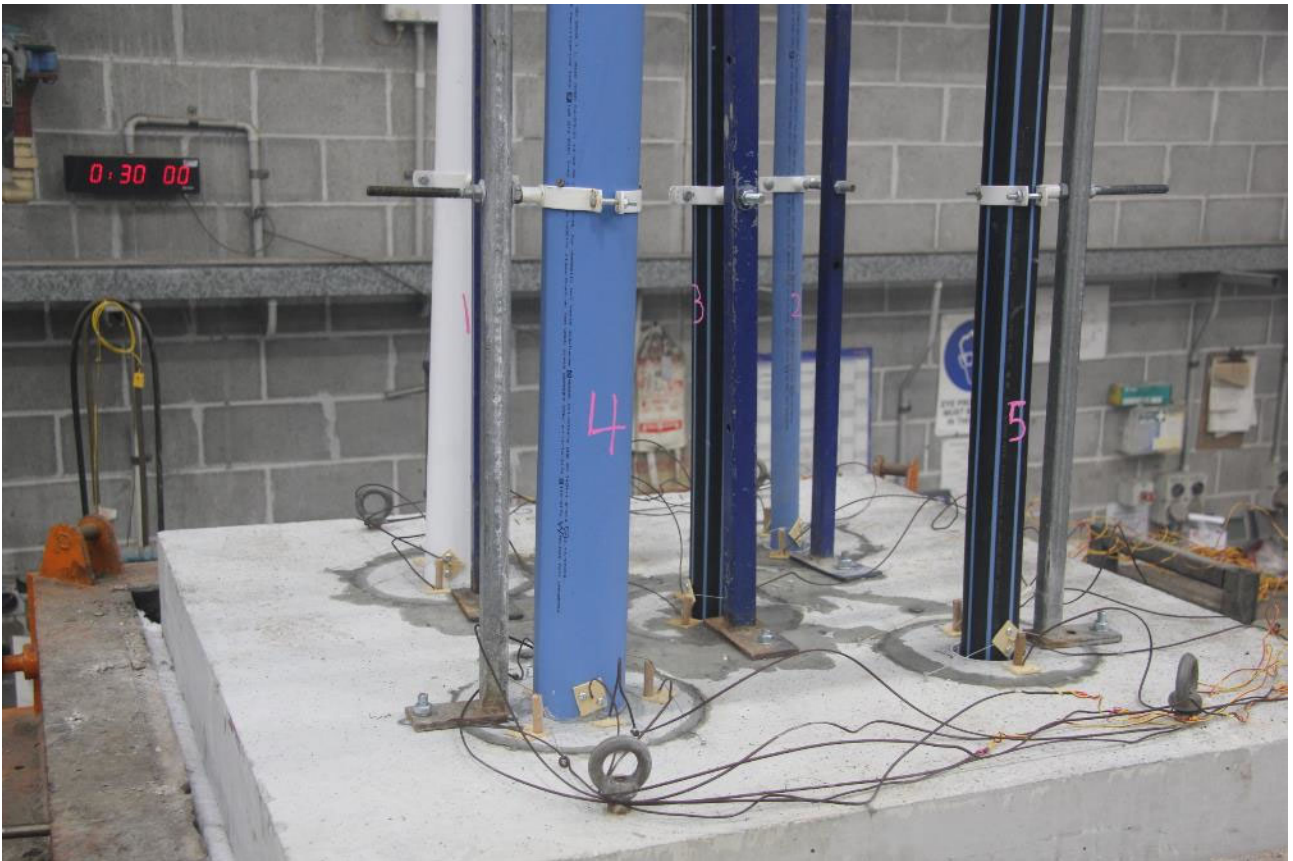
PHOTOGRAPH 5 – UNEXPOSED FACE OF SPECIMENS AT 30 MINUTES INTO THE TEST

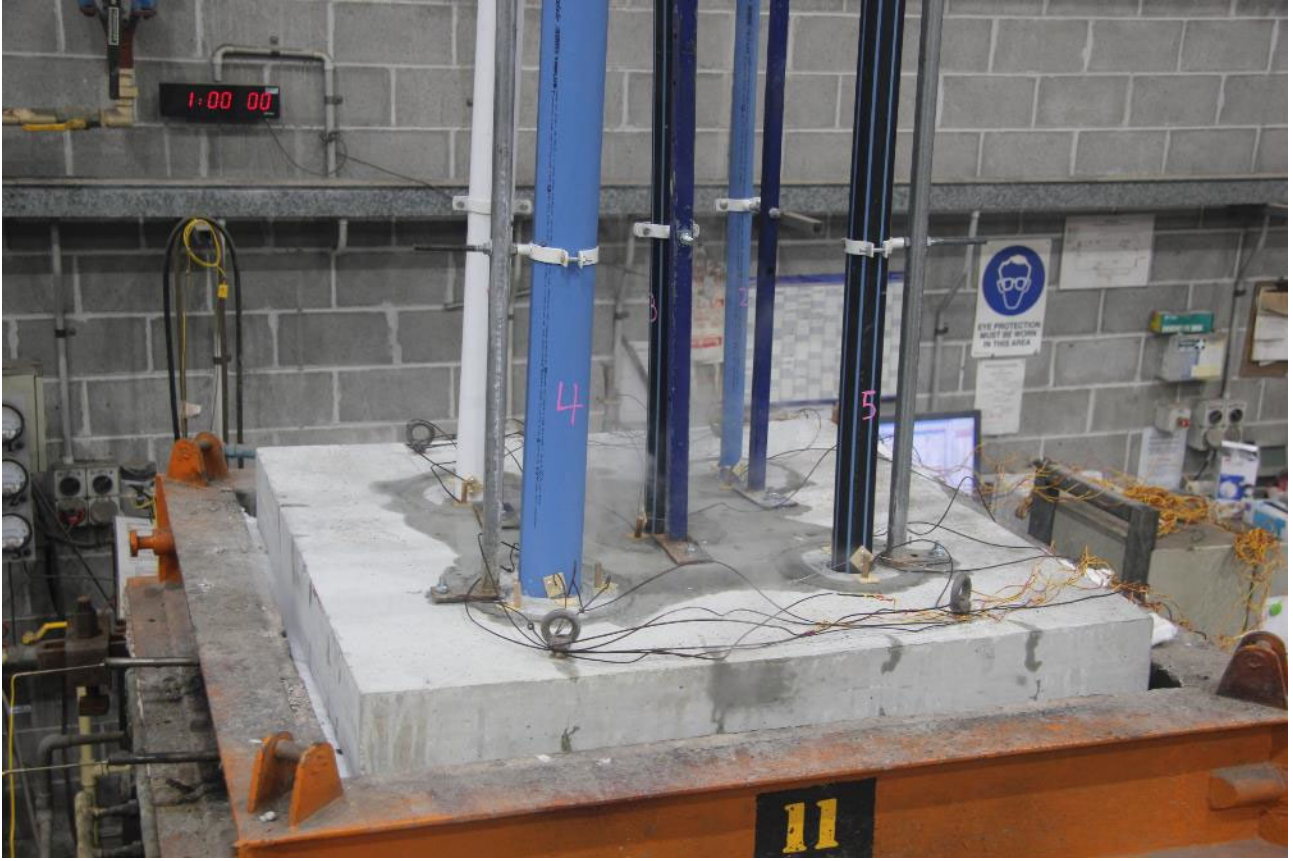
PHOTOGRAPH 6 –SPECIMENS AT 60 MINUTES INTO THE TEST

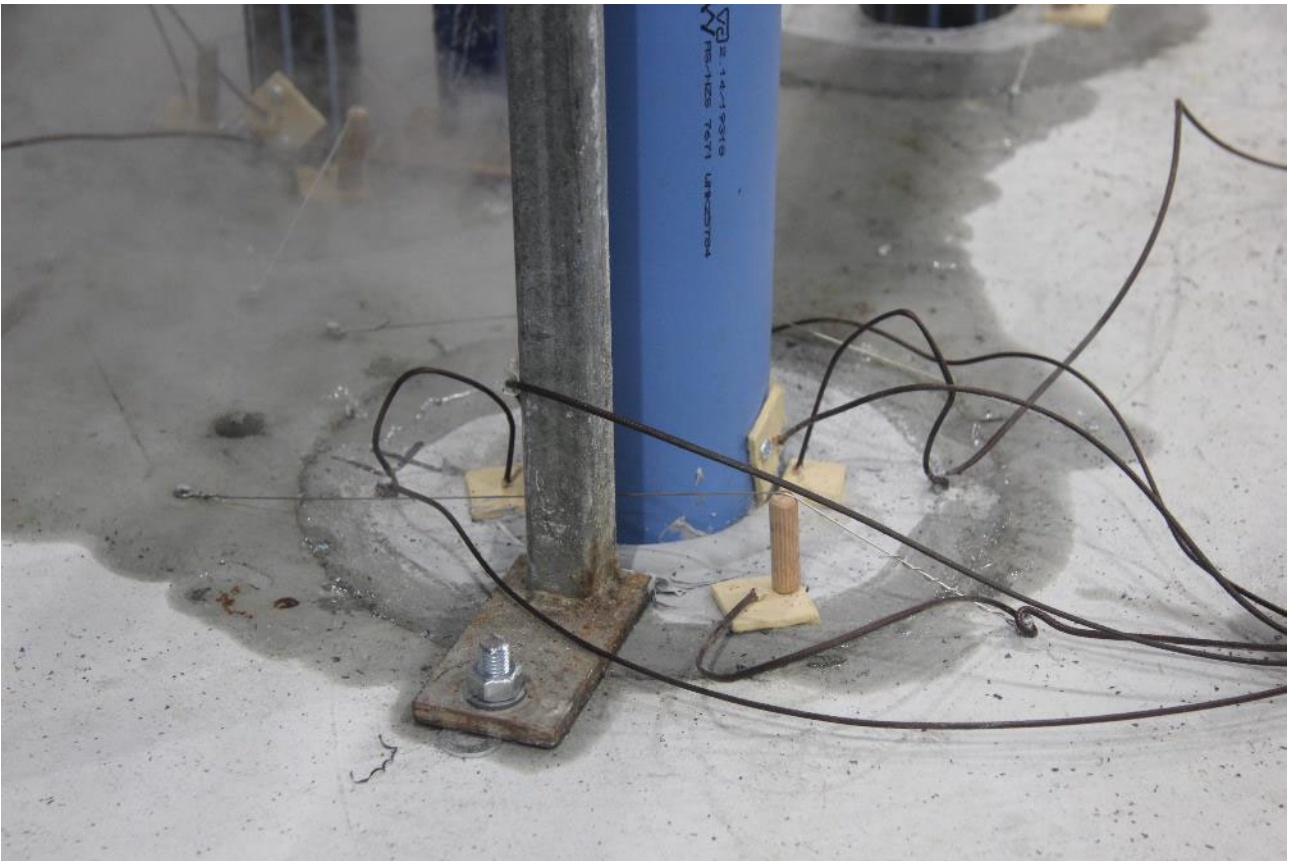
PHOTOGRAPH 7 – SPECIMEN 4 AT 60 MINUTES INTO THE TEST

38 minutes -	Moisture has pooled on the top of the concrete slab.
62 minutes -	The sealant has begun to swell at the base of Specimen 4. The moisture on the concrete slab at the base of Specimens 1, 2, 4 and 5 has begun to dry. Moisture has pooled around Specimen 3 due to the buckling of the concrete slab.
135 minutes -	Moisture has evaporated on the unexposed face of the slab.
155 minutes -	The base of the pipes inside collar sleeves of Specimen 2, 3 and 5 have begun to melt.
180 minutes -	Little to no visible changes to all specimens.
241 minutes -	Test terminated.

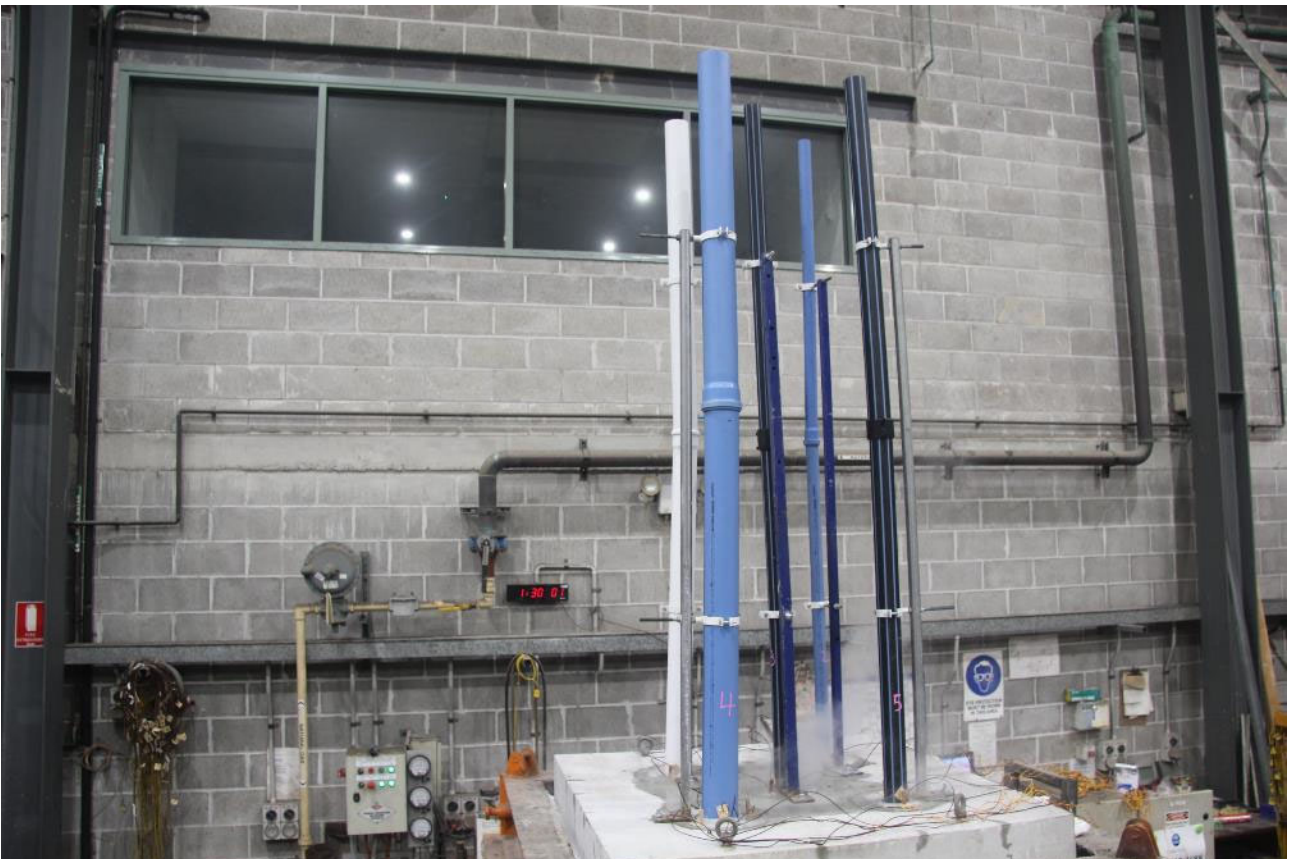
PHOTOGRAPH 8 – SPECIMENS AT 90 MINUTES INTO THE TEST

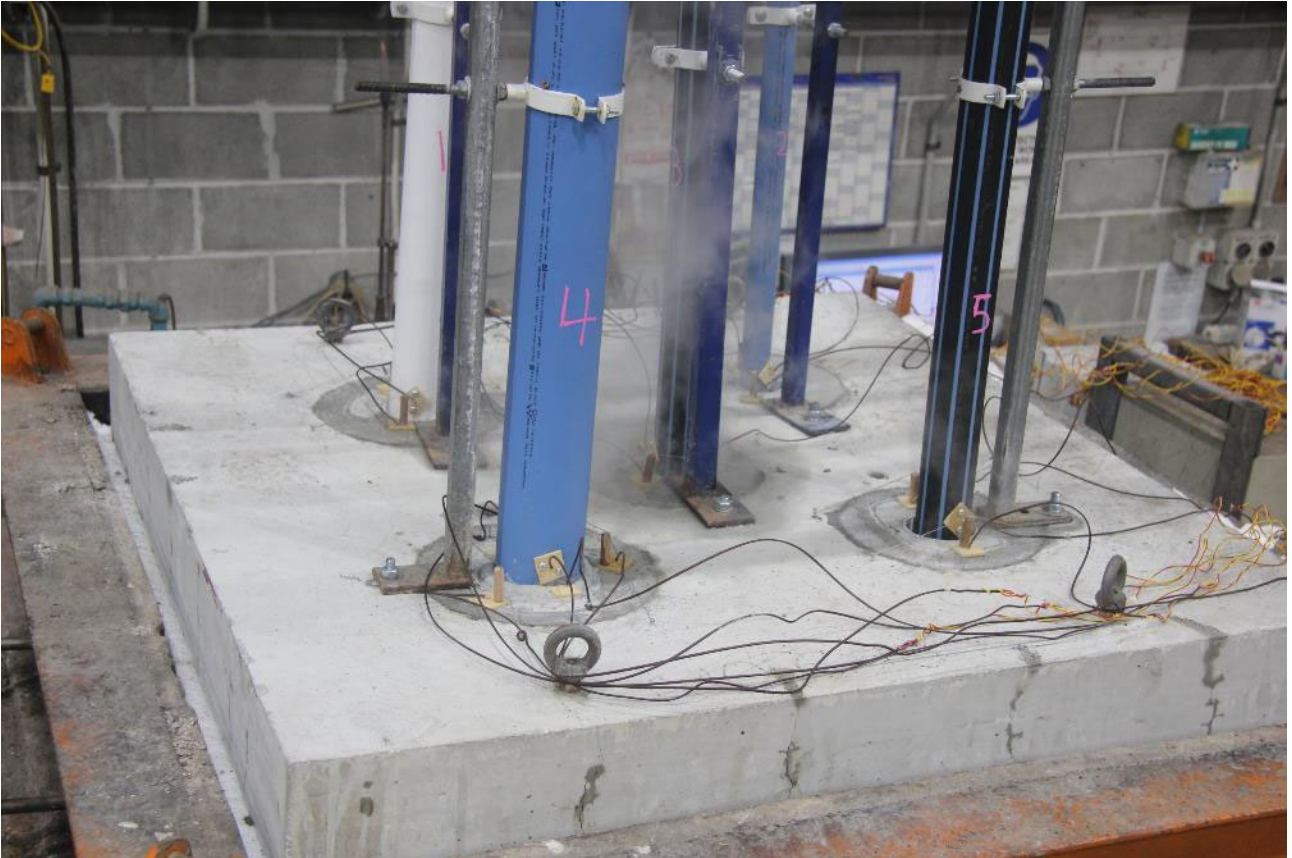
PHOTOGRAPH 9 – SPECIMENS AT 120 MINUTES INTO THE TEST

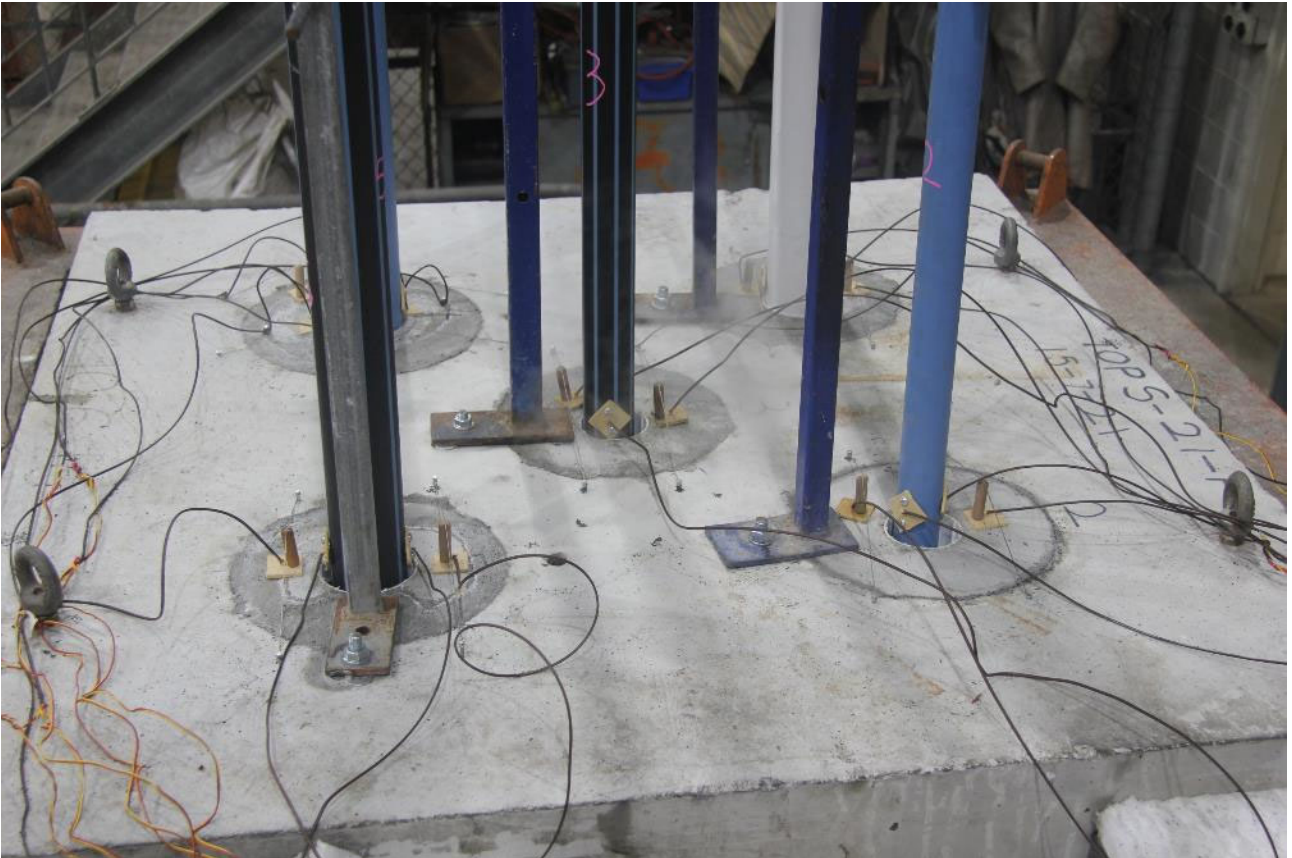
PHOTOGRAPH 10 – SPECIMENS AT 135 MINUTES INTO THE TEST

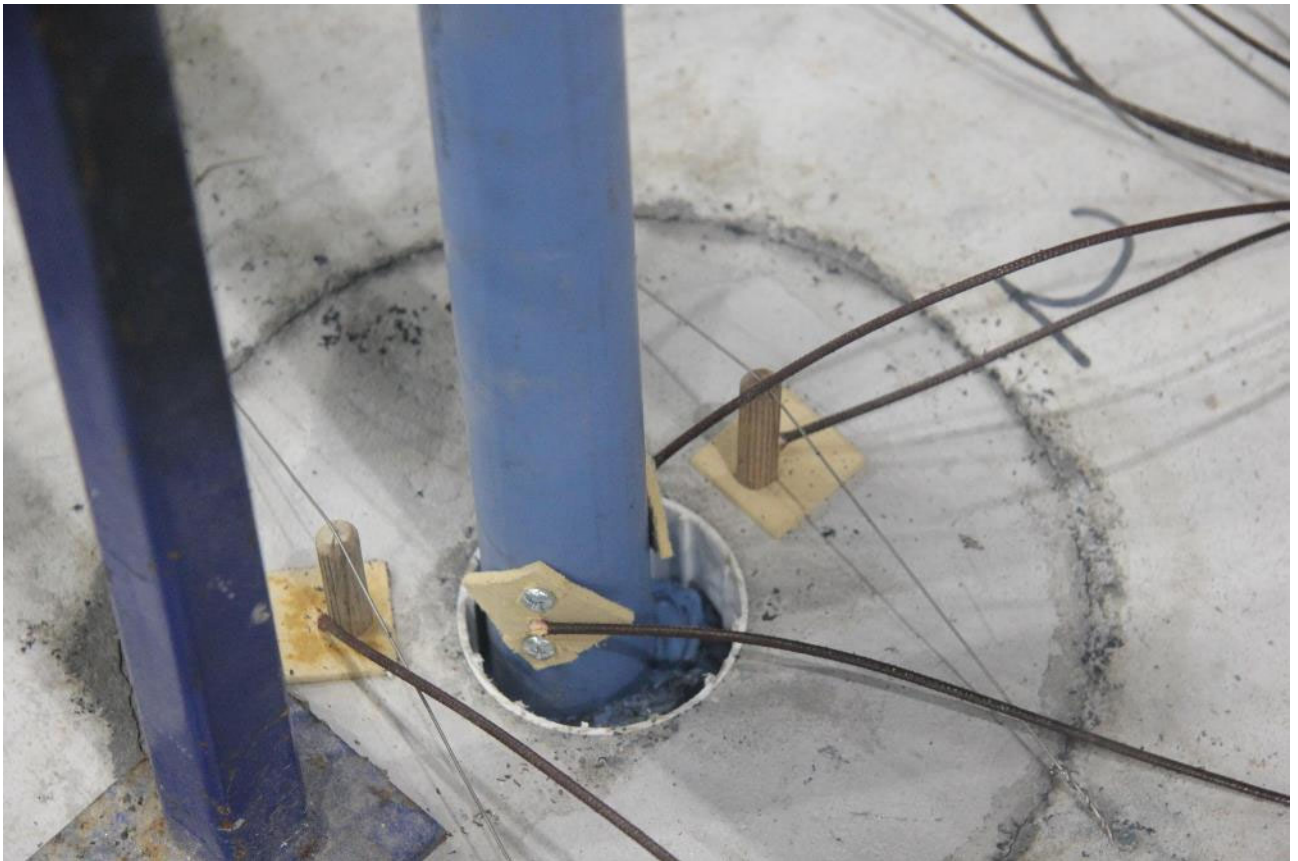
PHOTOGRAPH 11 – SPECIMEN 2 AT 155 MINUTES INTO THE TEST

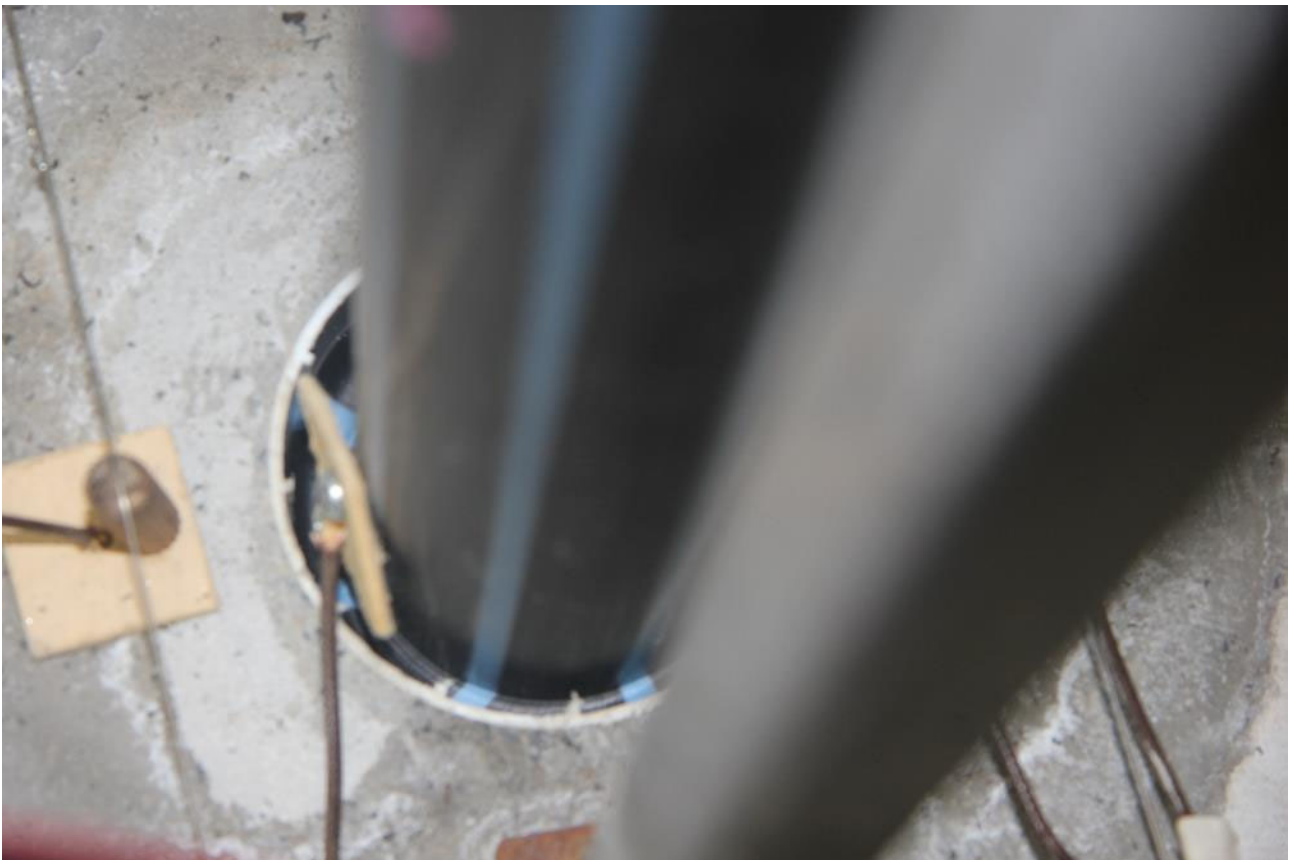
PHOTOGRAPH 12 – SPECIMEN 5 AT 155 MINUTES INTO THE TEST

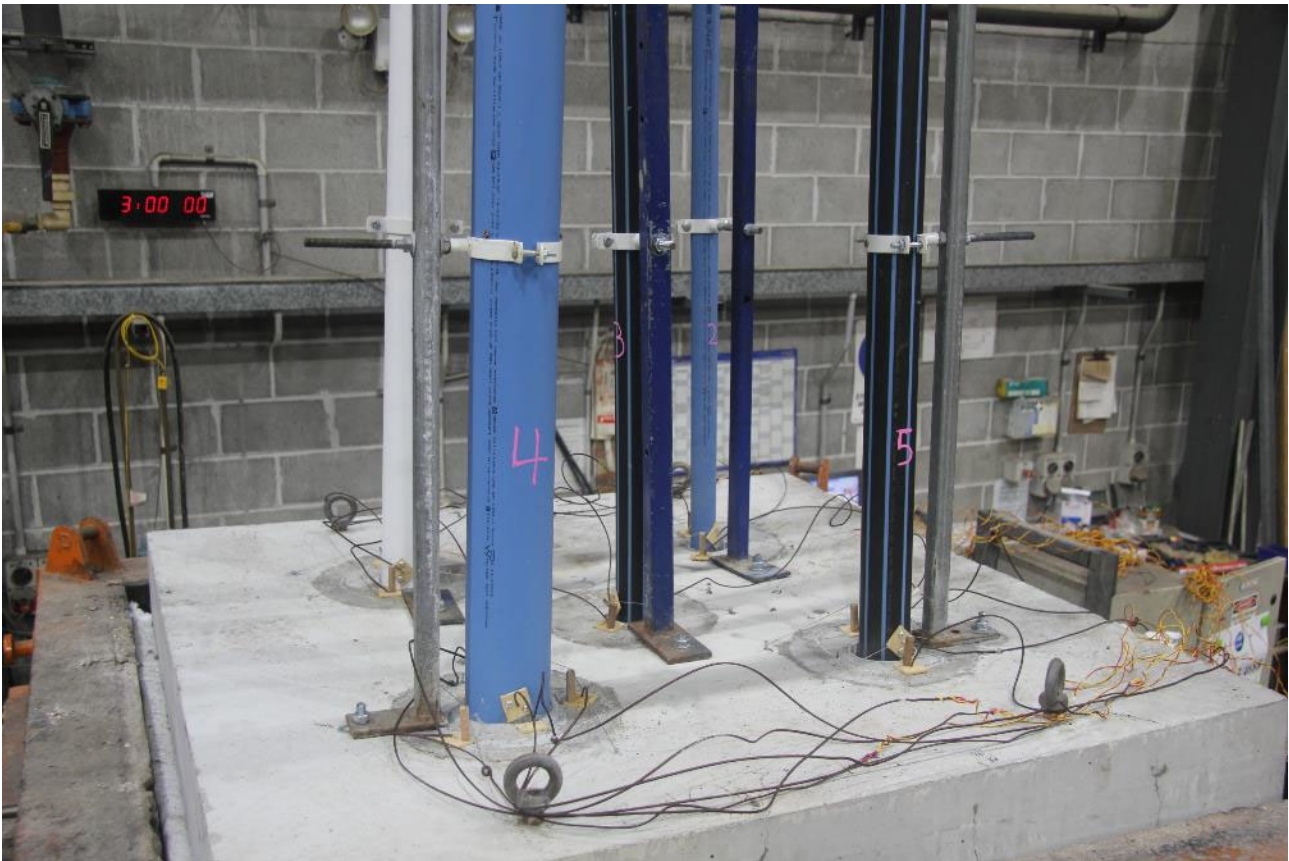
PHOTOGRAPH 13 – SPECIMENS AT 180 MINUTES INTO THE TEST

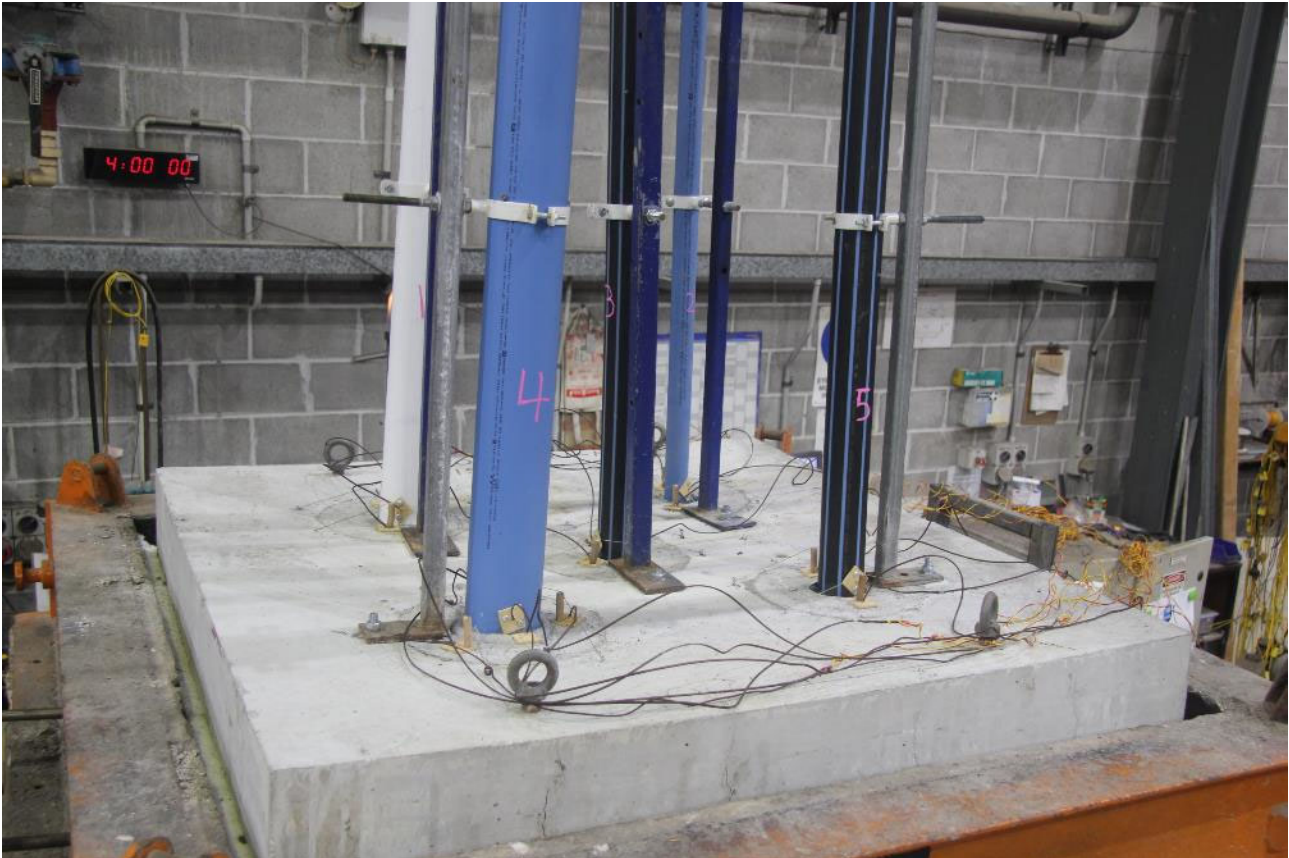
PHOTOGRAPH 14 – SPECIMENS AT 240 MINUTES INTO THE TEST

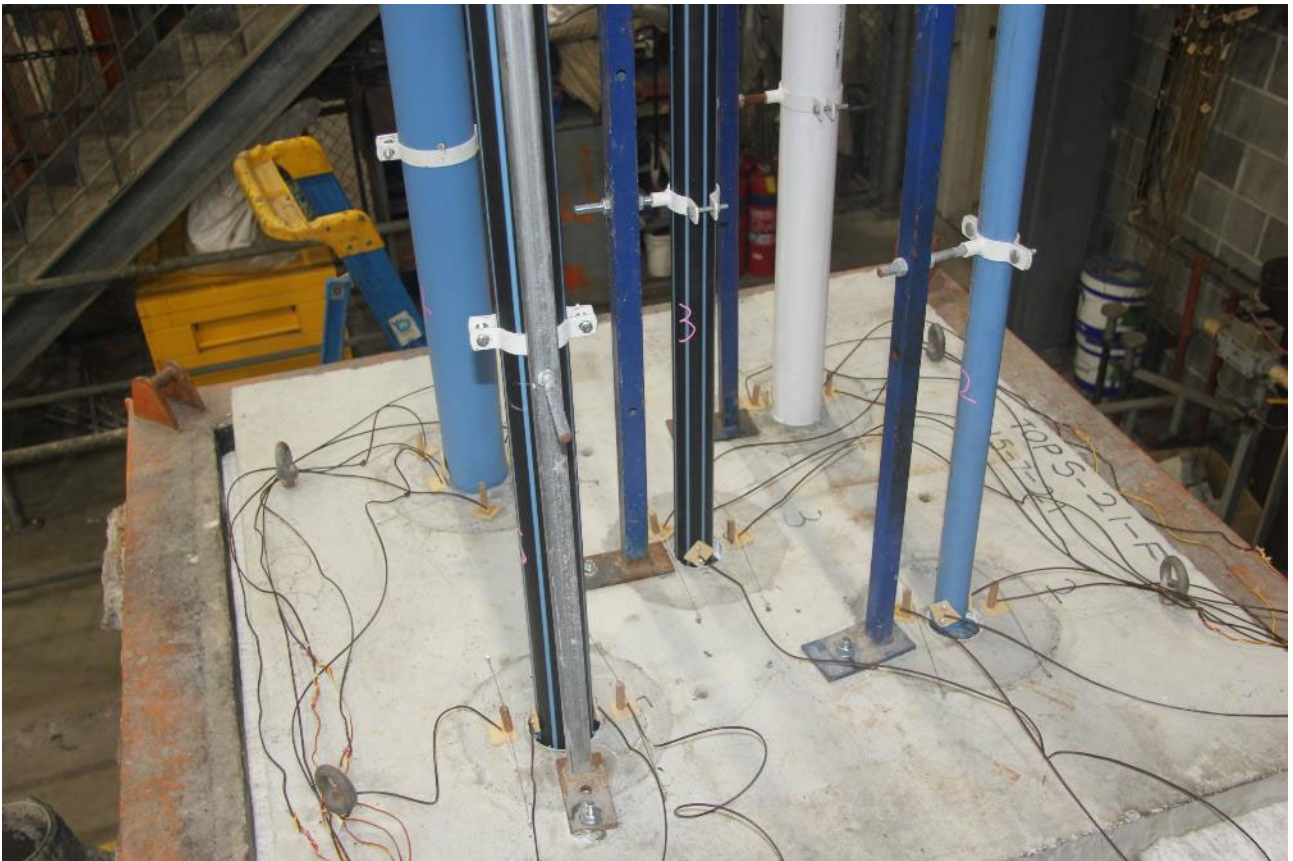
PHOTOGRAPH 15 – SPECIMENS AT THE CONCLUSION OF TESTING

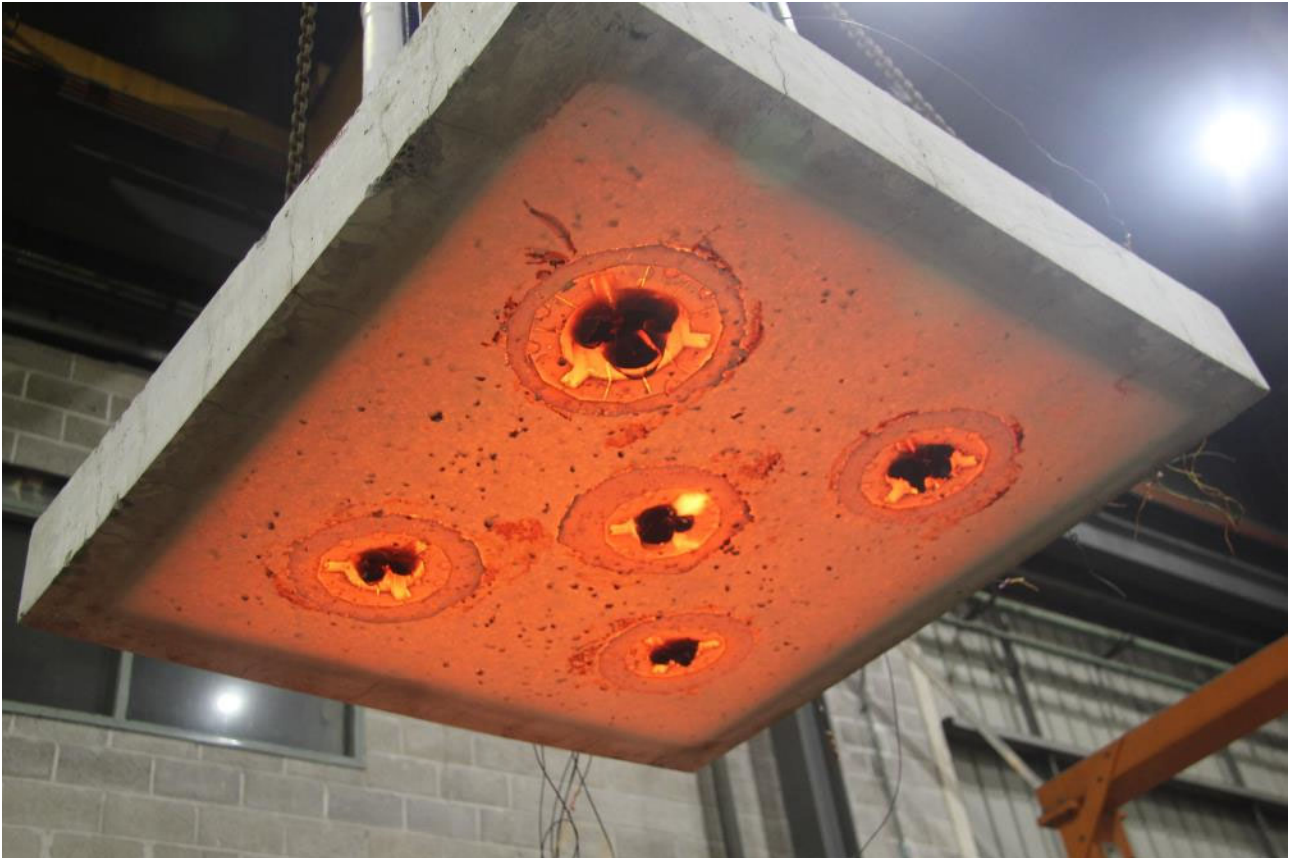
PHOTOGRAPH 16 – EXPOSED FACE OF SPECIMENS AT THE CONCLUSION OF TESTING
