Fire-resistance test on retrofit fire collars protecting a plasterboard wall penetrated by services

Test Report

Author: Peter Gordon
Report number: FSP 2237
Date: 14 December 2021
Client: IG6 Pty Ltd

Sponsored Investigation No. FSP 2237

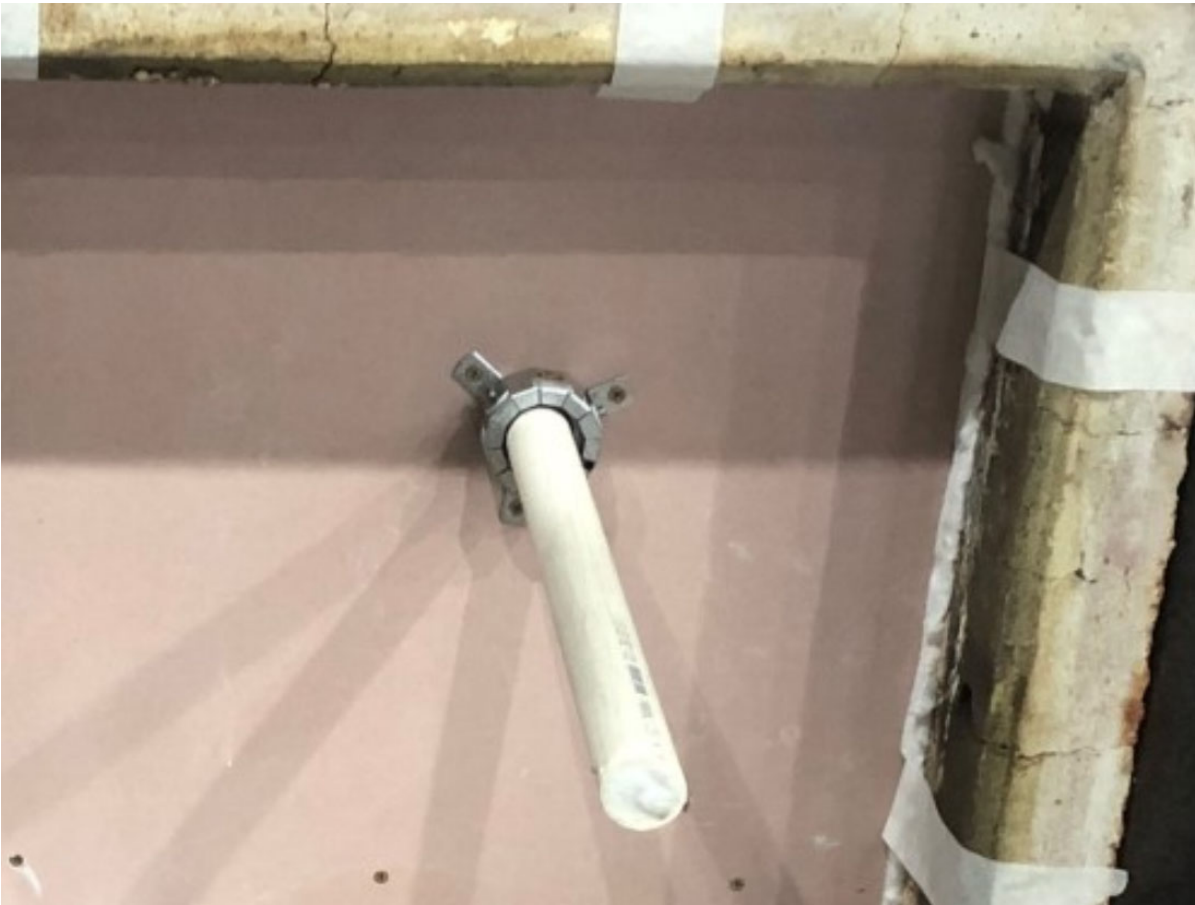
PHOTOGRAPH 1 – EXPOSED FACE OF SPECIMEN 1 PRIOR TO TESTING

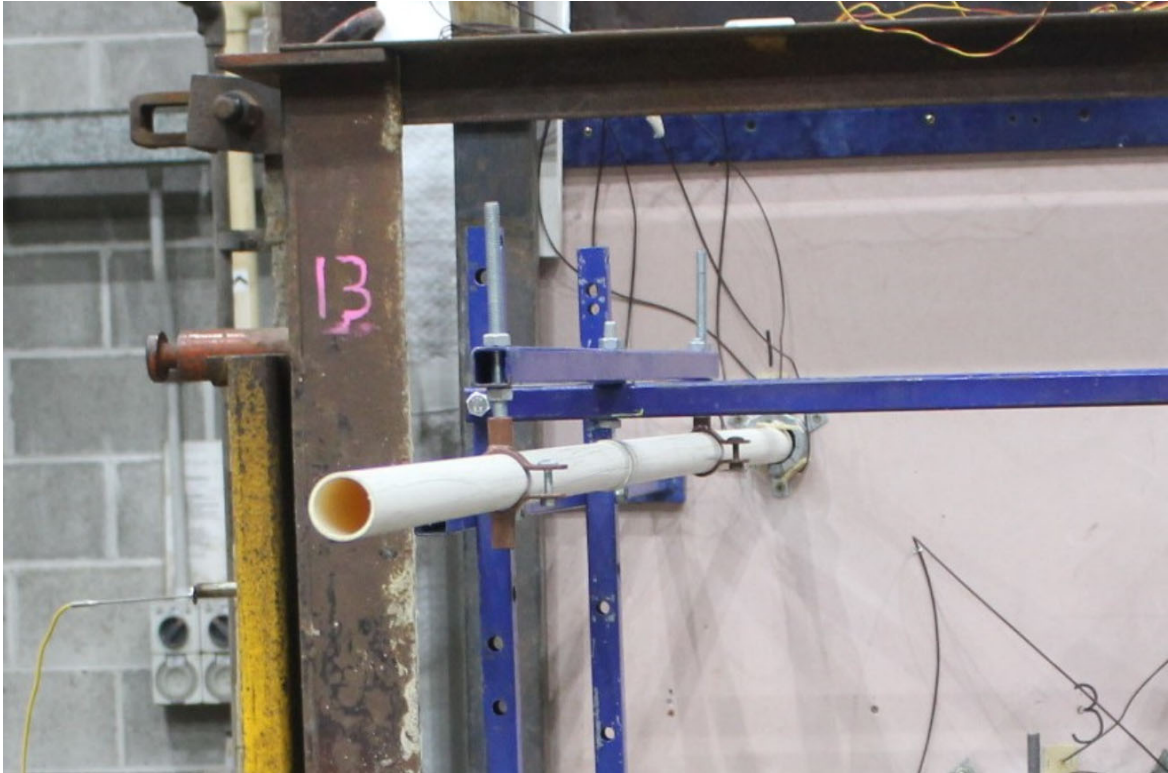
PHOTOGRAPH 2 – UNEXPOSED FACE OF SPECIMEN 1 PRIOR TO TESTING

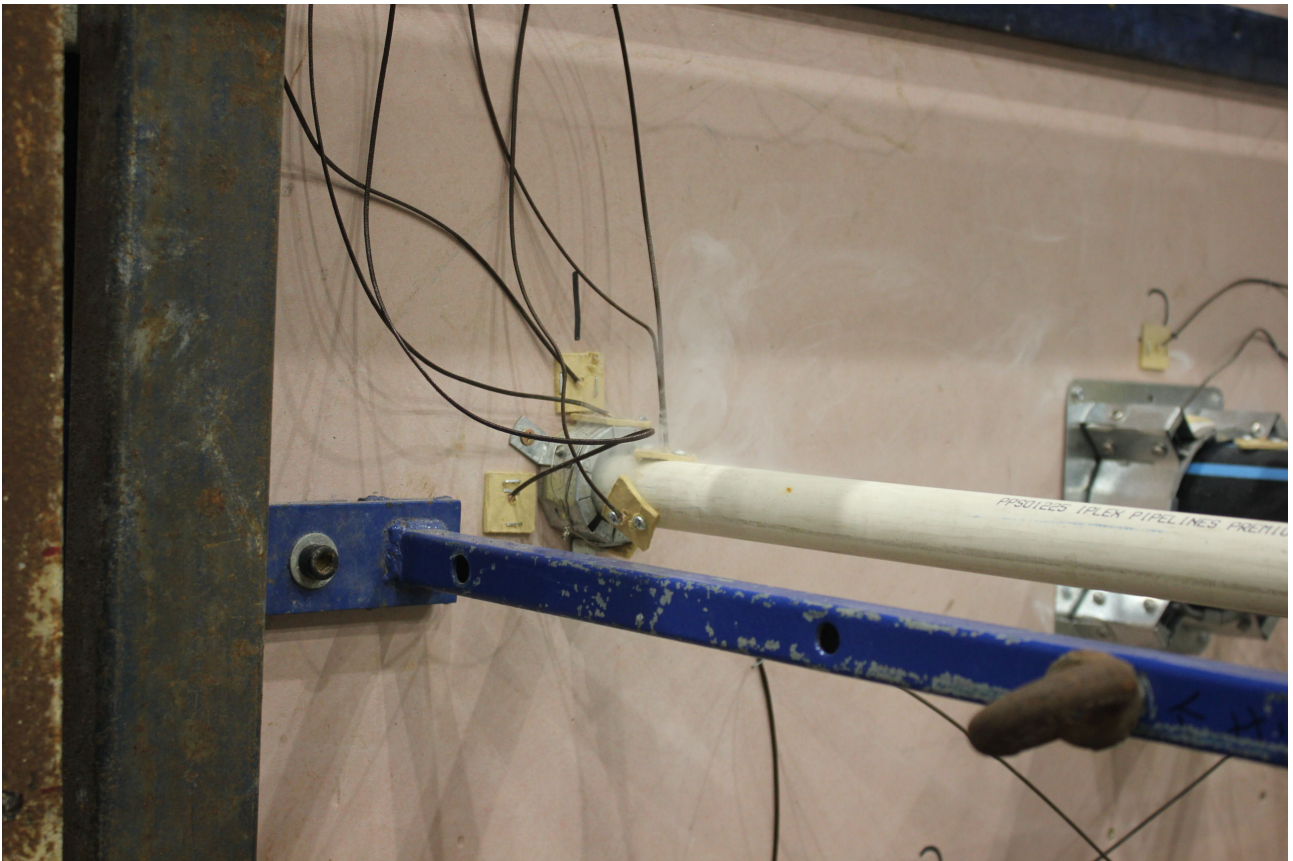
PHOTOGRAPH 3 – BASE OF SPECIMEN 1 AFTER 1 MINUTE OF TESTING

Time	Observation
0:40 minute	- Smoke is being emitted between the collar and the pipe at the base of Specimen 1.
2 minutes	- Smoke has started to flue from the end of the pipe of Specimen 1.
4 minutes	- Smoke has ceased fluing from the end of the pipe of Specimen 1.
11 minutes	- Smoke has ceased being emitted from between the pipe and collar at the base of Specimen 1.
55 minutes	- Light smoke has resumed fluing at the end of the pipe of Specimen 1.
61 minutes	- Smoke has ceased fluing from the end of the pipe of Specimen 1.
84 minutes	- Smoke has resumed fluing at the end of the pipe of Specimen 1.
121 minutes	- Test terminated.

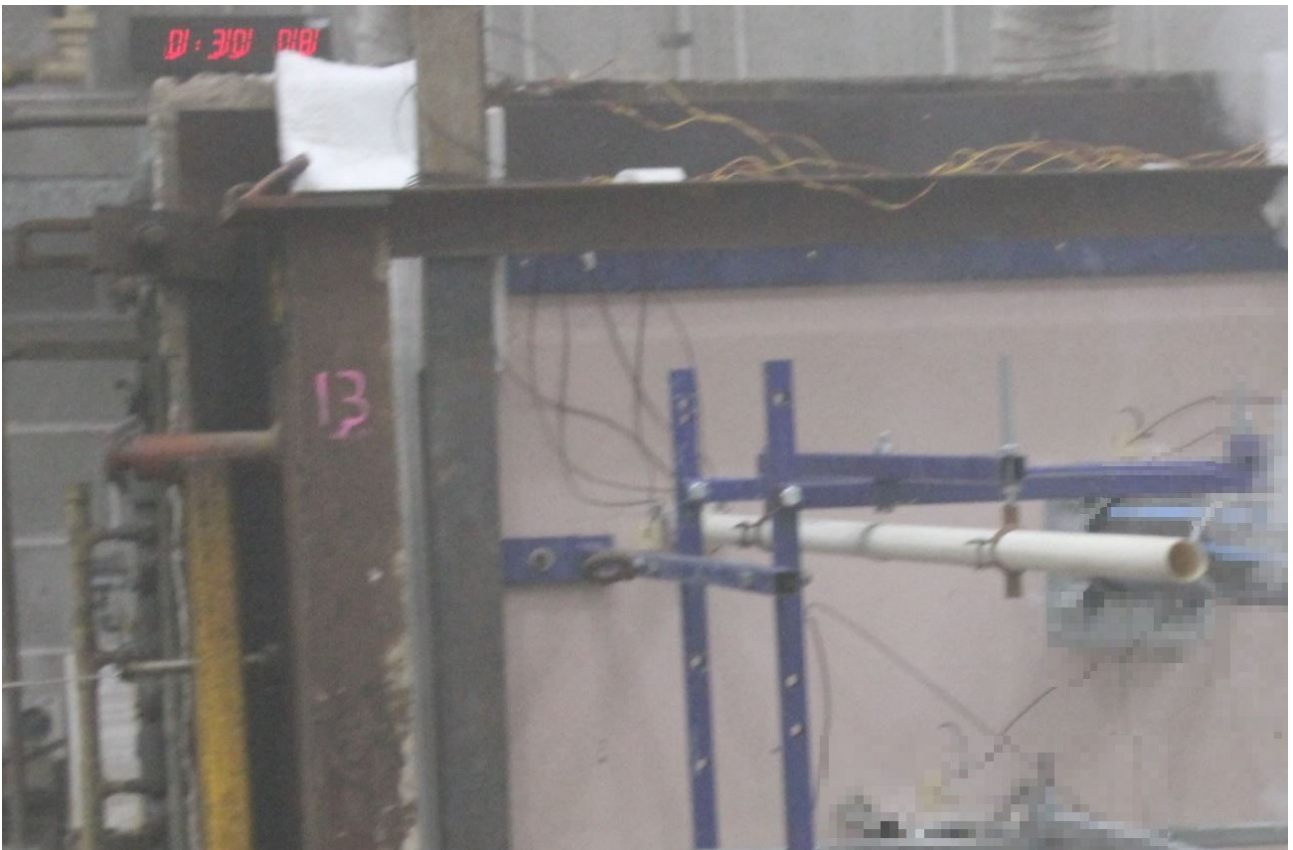
PHOTOGRAPH 4 – SPECIMEN 1 AFTER 30 MINUTES OF TESTING

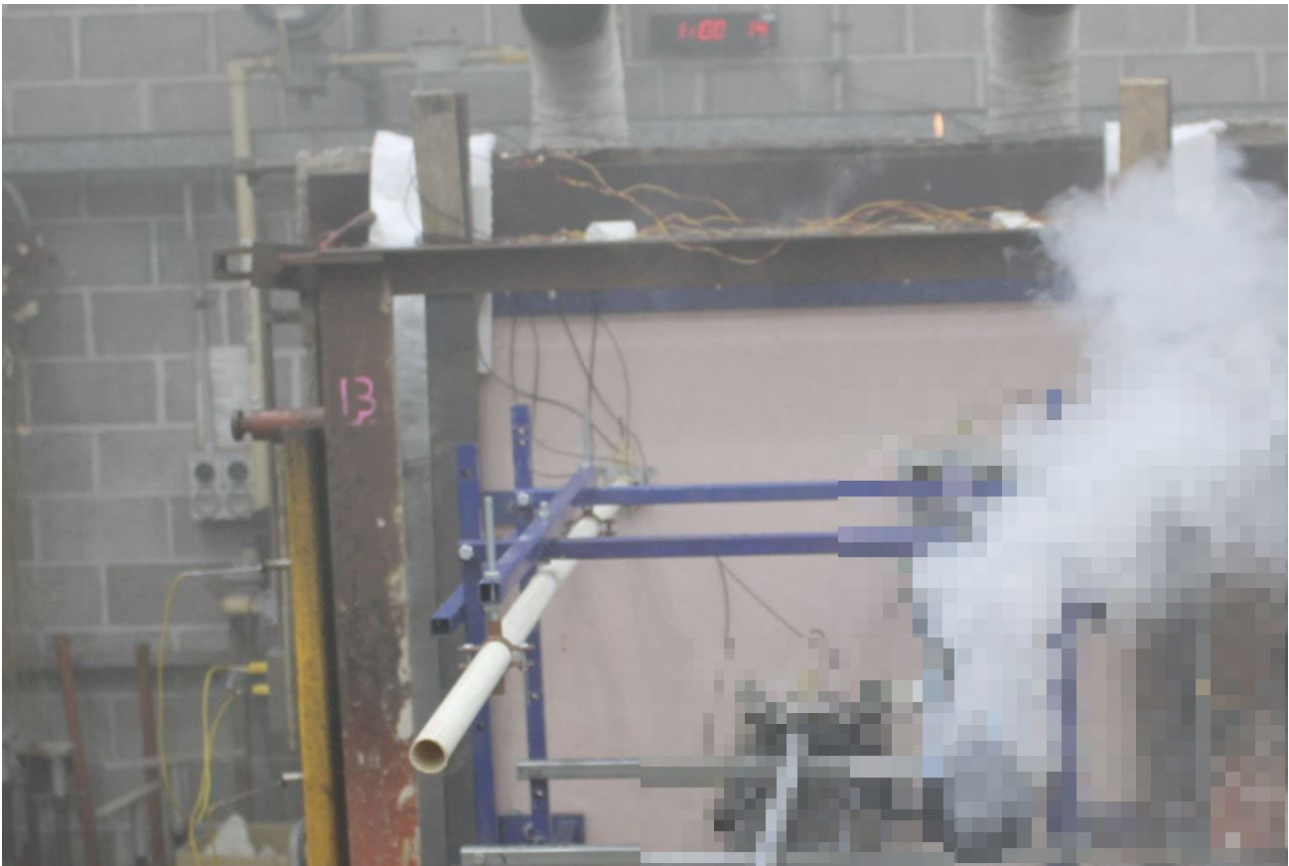
PHOTOGRAPH 5 – SPECIMEN 1 AFTER 60 MINUTES OF TESTING

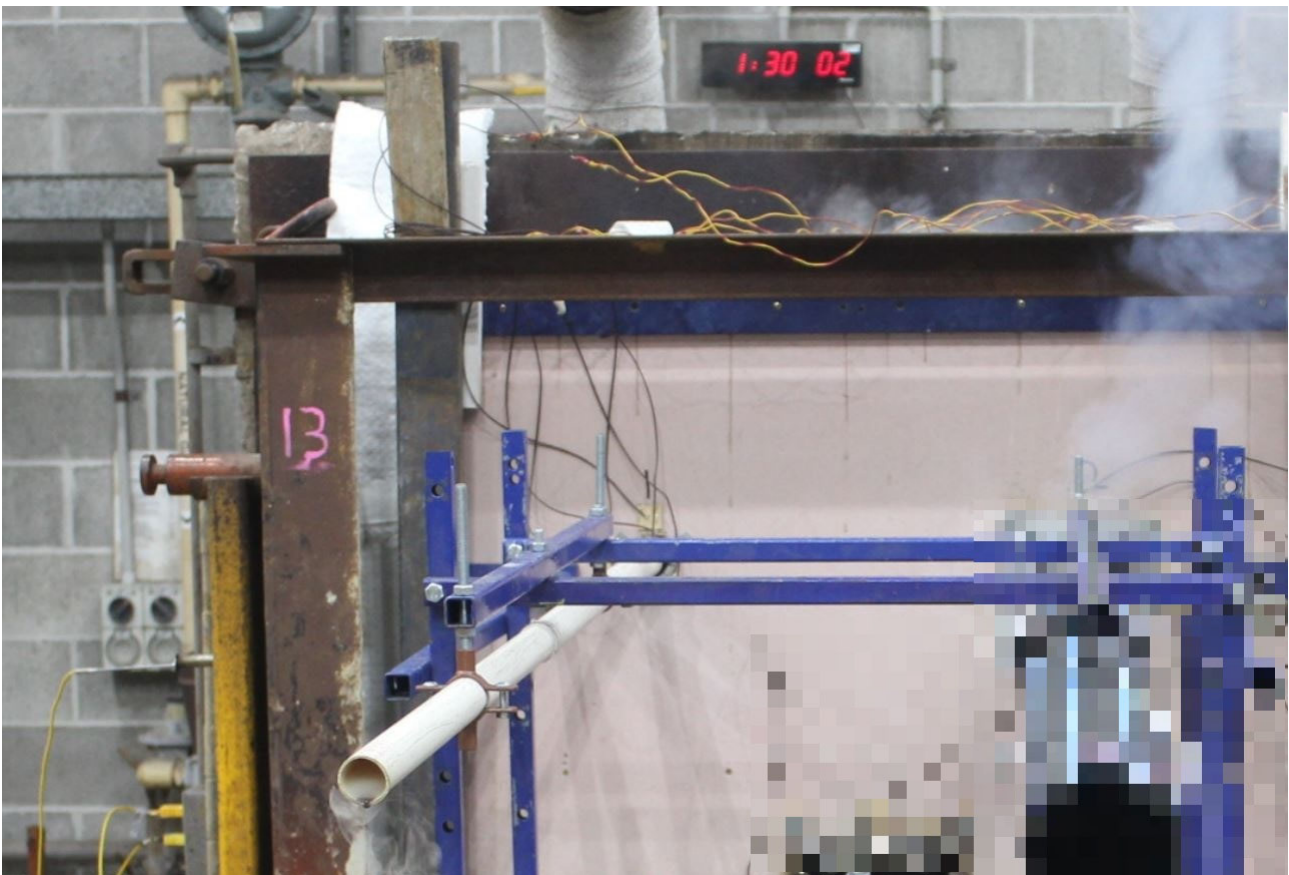
PHOTOGRAPH 6 – SPECIMEN 1 AFTER 90 MINUTES OF TESTING

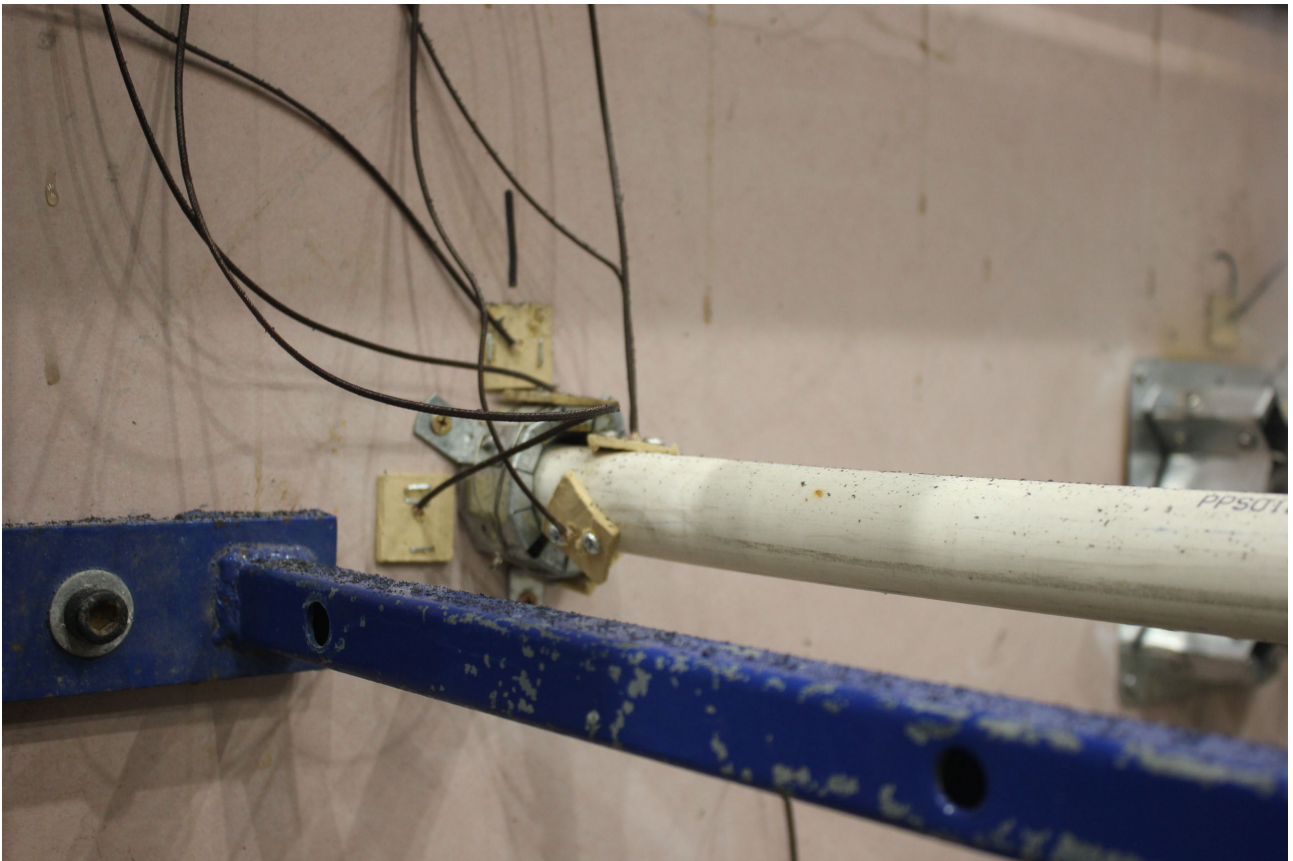
PHOTOGRAPH 7 – BASE OF SPECIMEN 1 AFTER 90 MINUTES OF TESTING

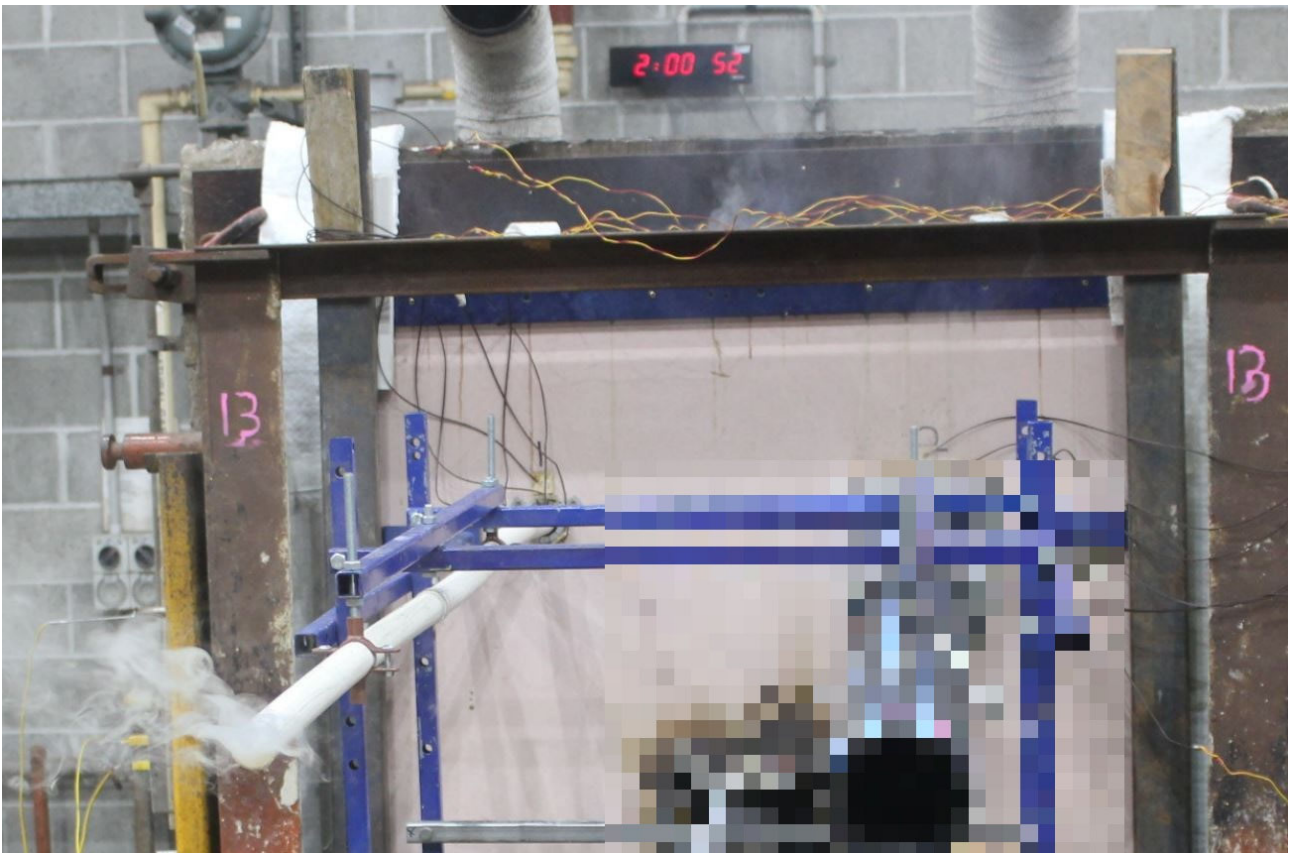
PHOTOGRAPH 8 – SPECIMEN 1 AFTER 120 MINUTES OF TESTING

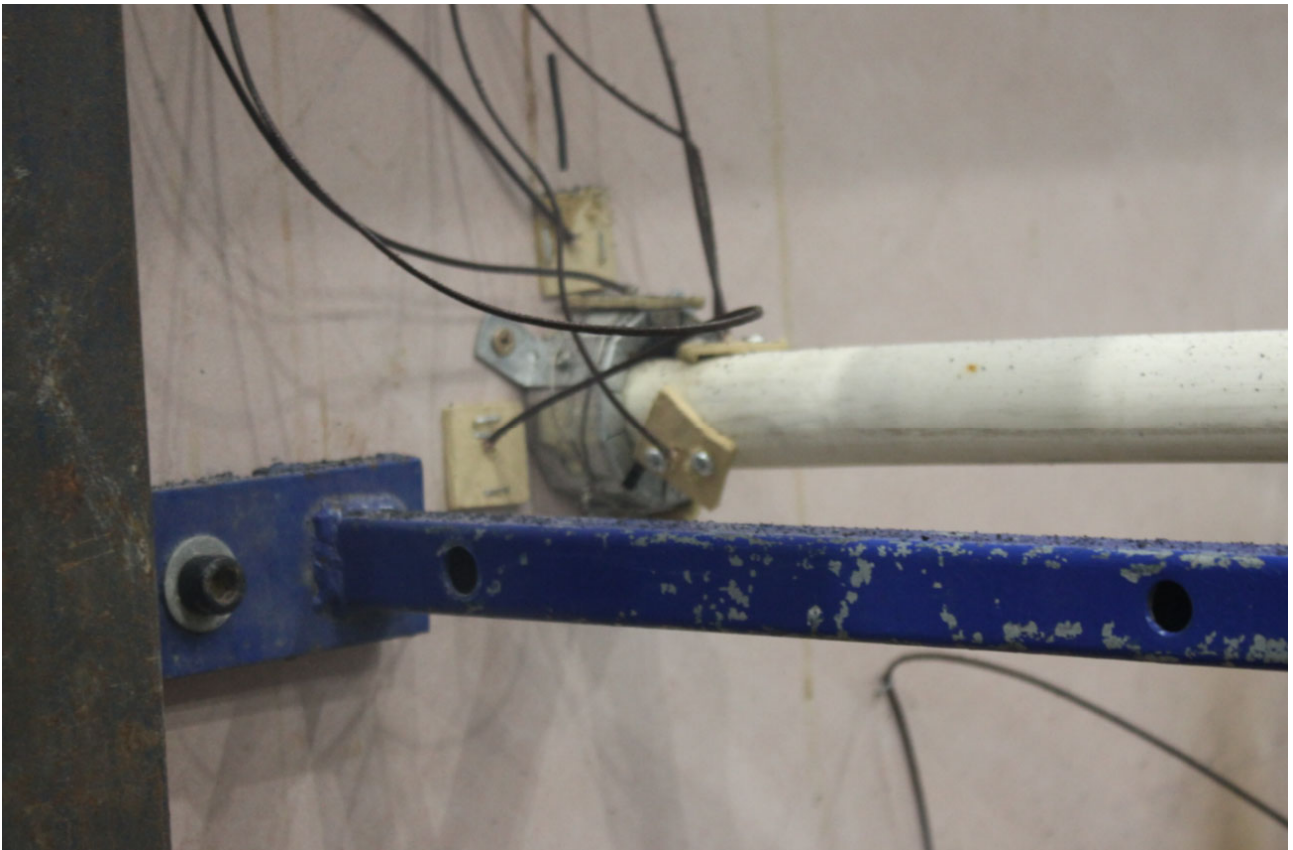
PHOTOGRAPH 9 – BASE OF SPECIMEM 1 AFTER 120 MINUTES OF TESTING

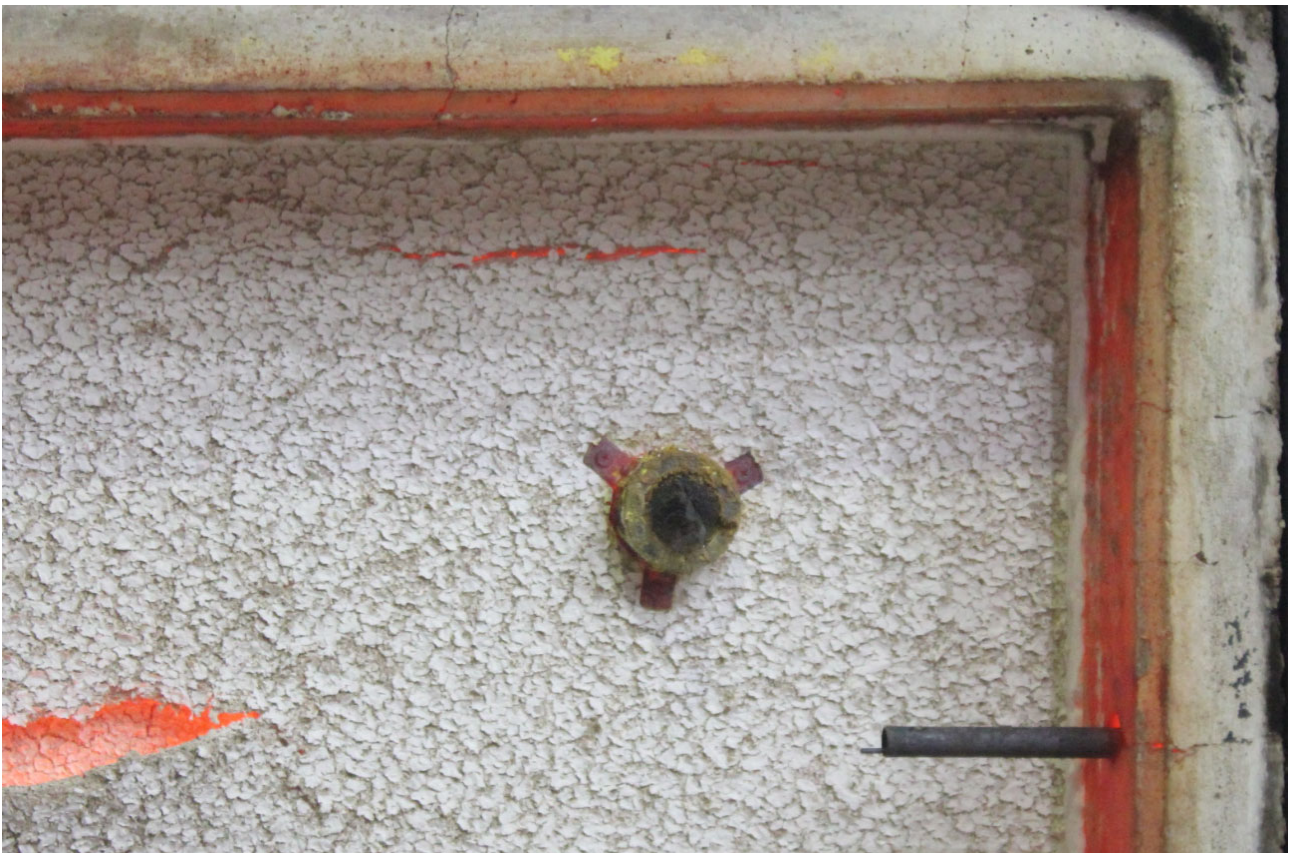
PHOTOGRAPH 10 – EXPOSED FACE OF SPECIMEN 1 AT CONCLUSION OF TESTING

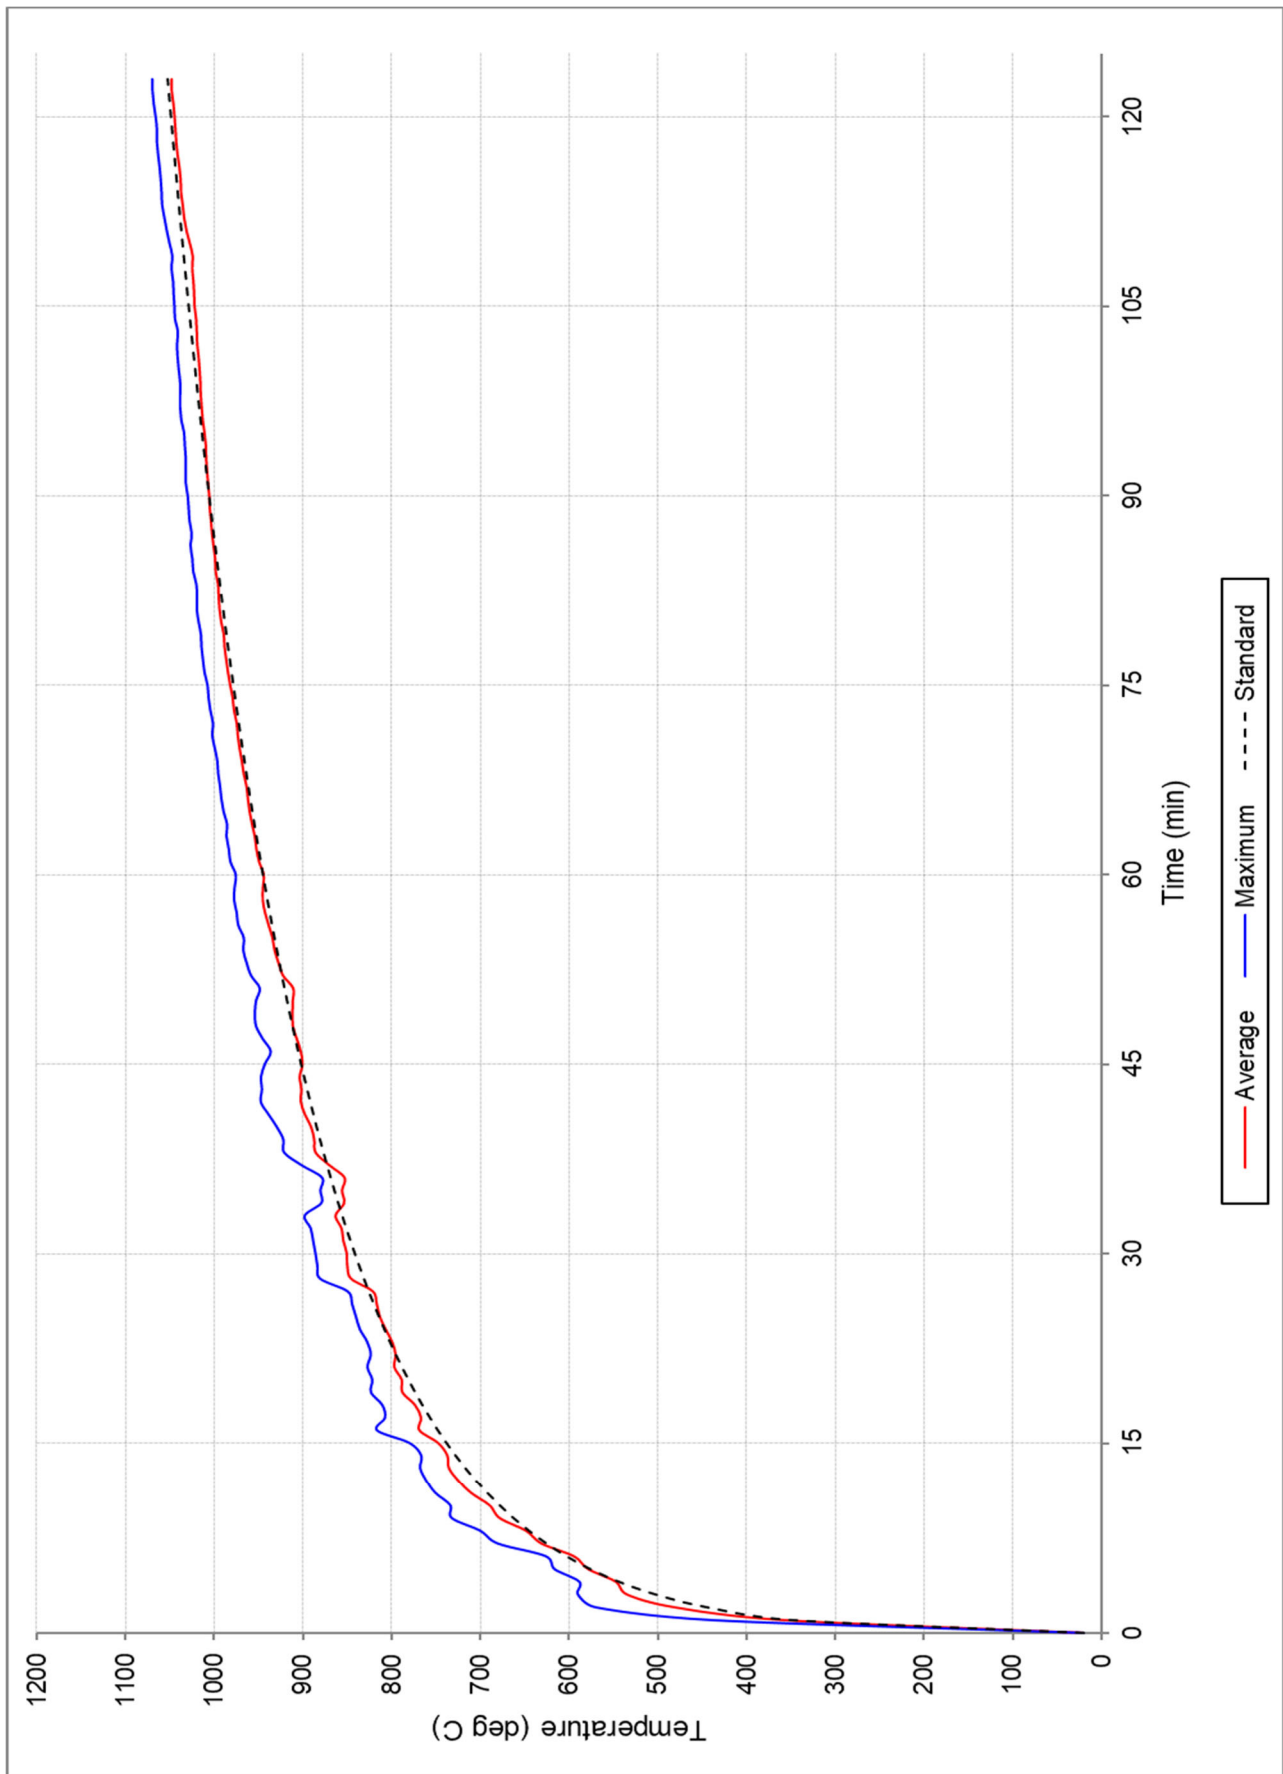
FIGURE 1 – FURNACE TEMPERATURE

Figure 1 shows the standard curves of temperature versus time for heating the furnace chamber and the actual curves of average and maximum temperature versus time recorded during the heating period.

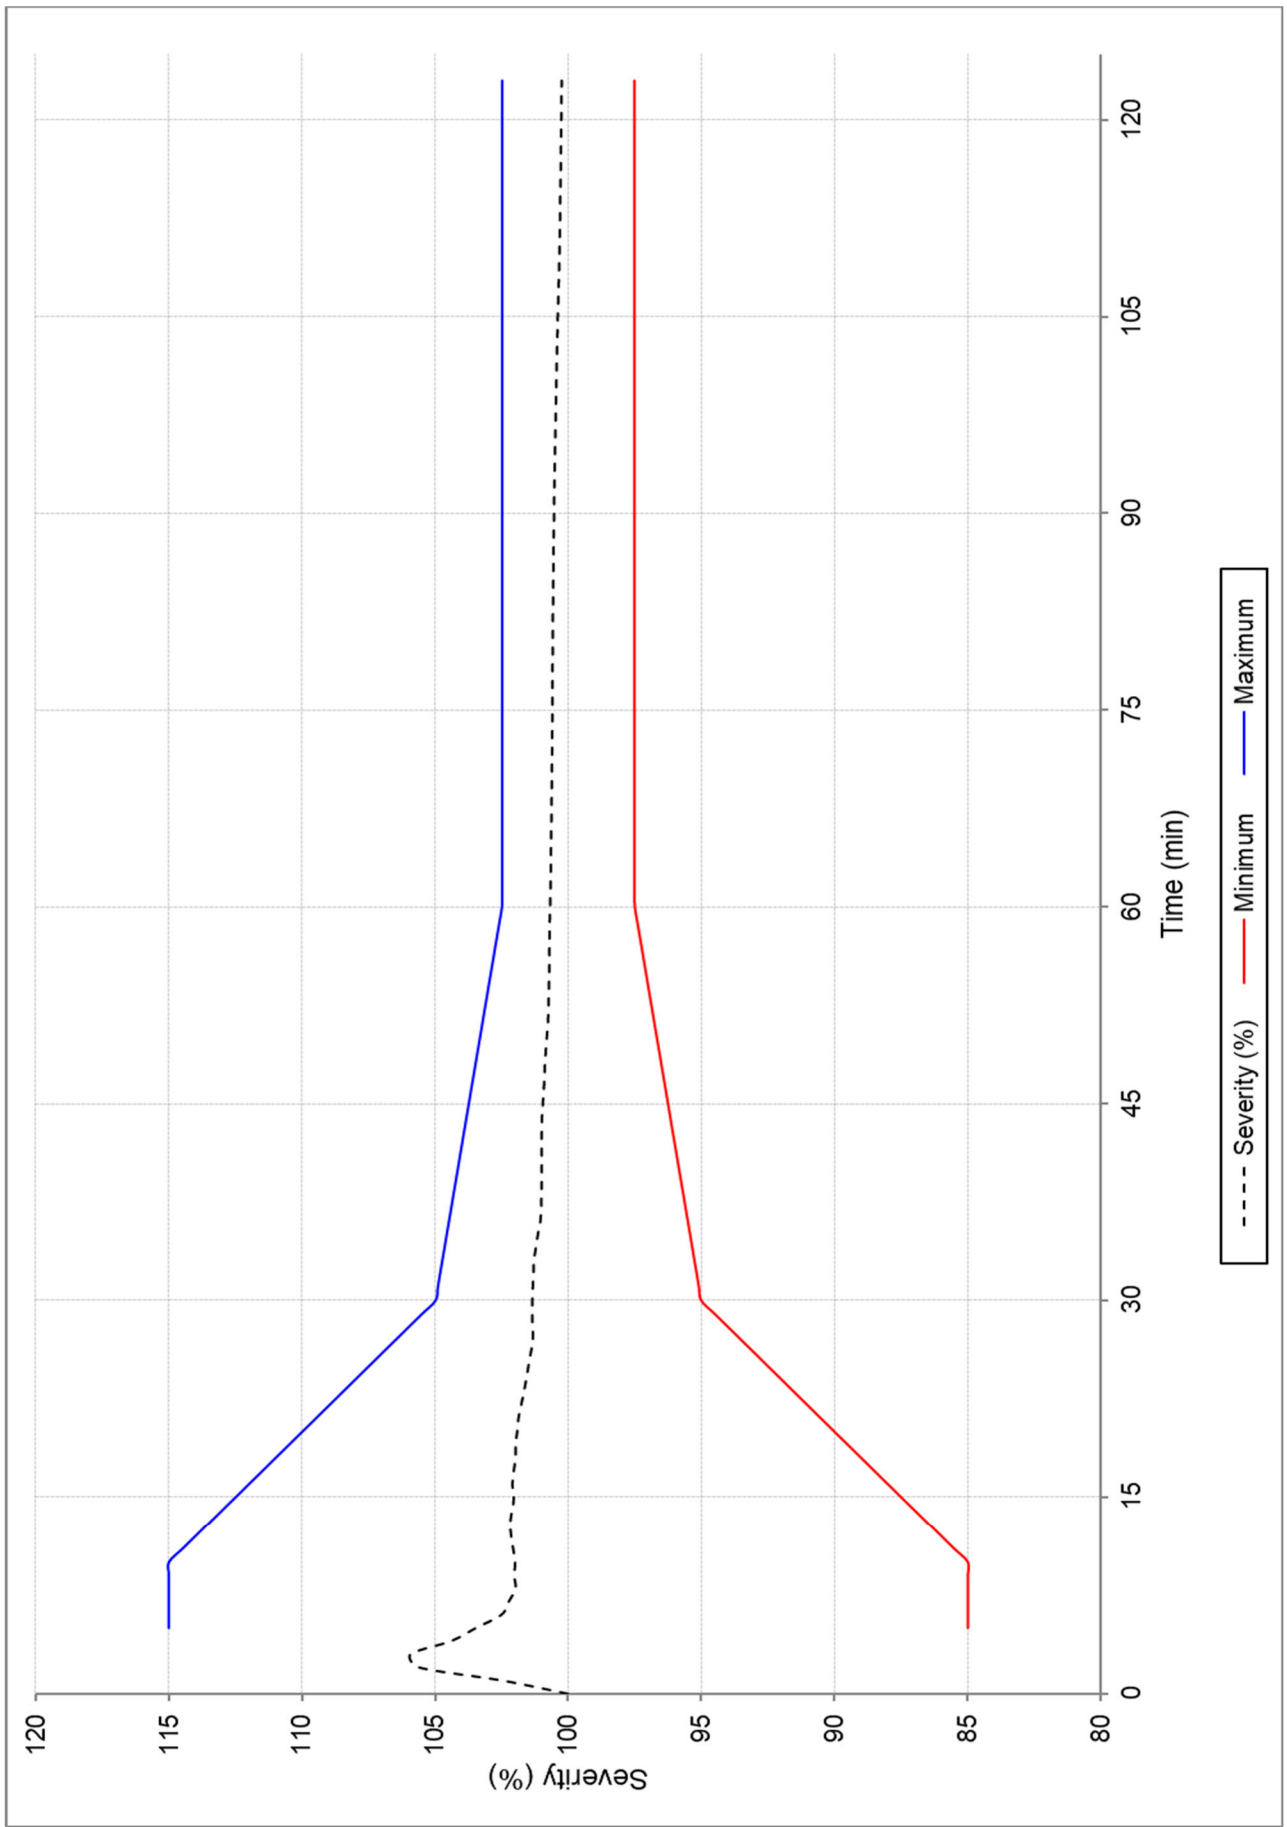
FIGURE 2 – FURNACE SEVERITY

Figure 2 shows the curve of furnace severity versus time during the heating period.

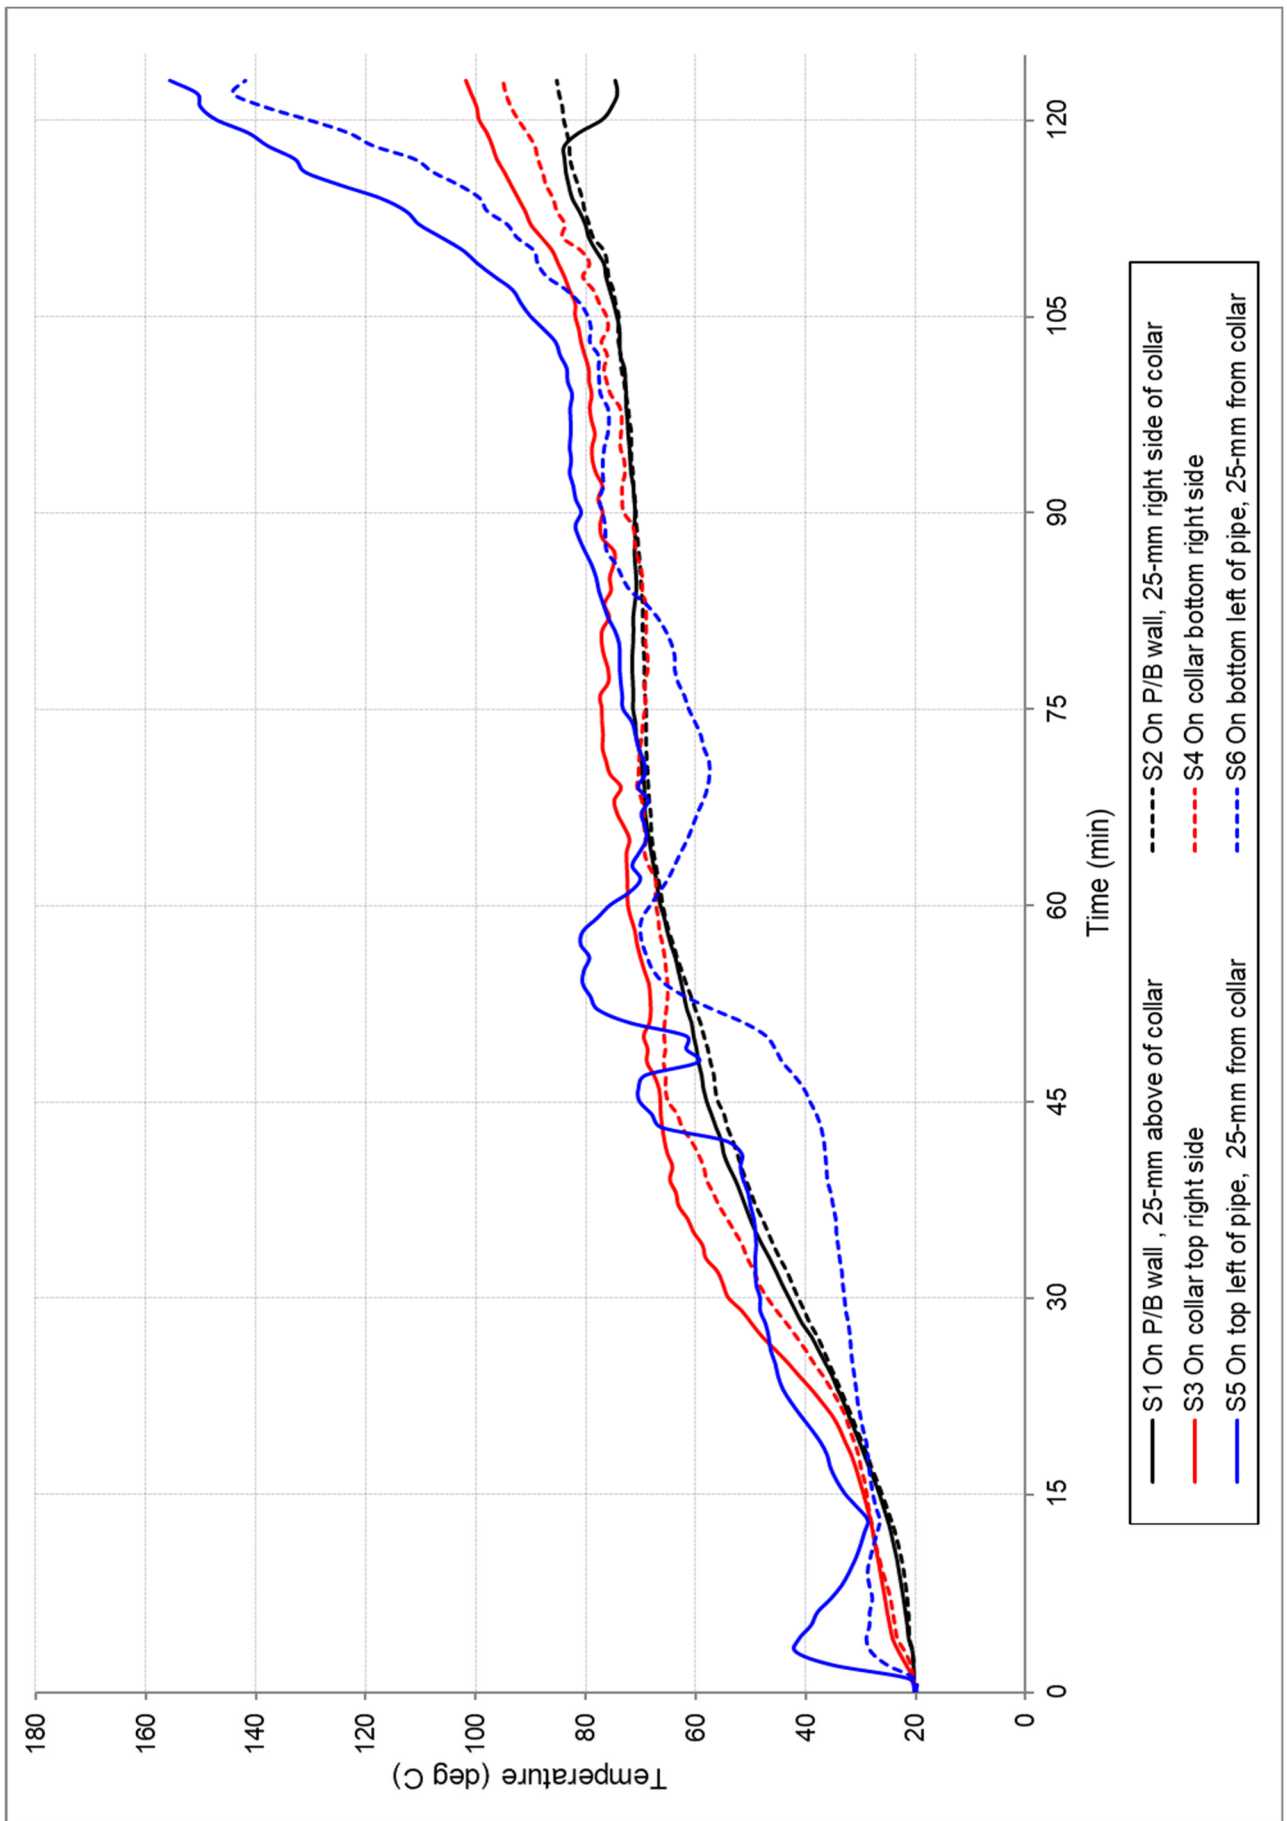
FIGURE 3 – TEMPERATURE VERUS TIME ASSOCIATED WITH SPECIMEN #1

Figure 3 shows the curve of temperature versus time associated with Specimen 1.

SPECIMEN	THERMOCOUPLE POSITION	DESIGNATION
Specimen 1 - SNAP 32R Retrofit fire collars protecting a DN25 PN12 uPVC pipe penetrating a 37-mm diameter aperture.	On P/B wall, 25 mm above of collar	S1
	On P/B wall, 25 mm right side of collar	S2
	On collar top right side	S3
	On collar bottom right side	S4
	On top left of pipe, 25-mm from collar	S5
	On bottom left of pipe, 25-mm from collar	S6
Rover		S20
Ambient		S21

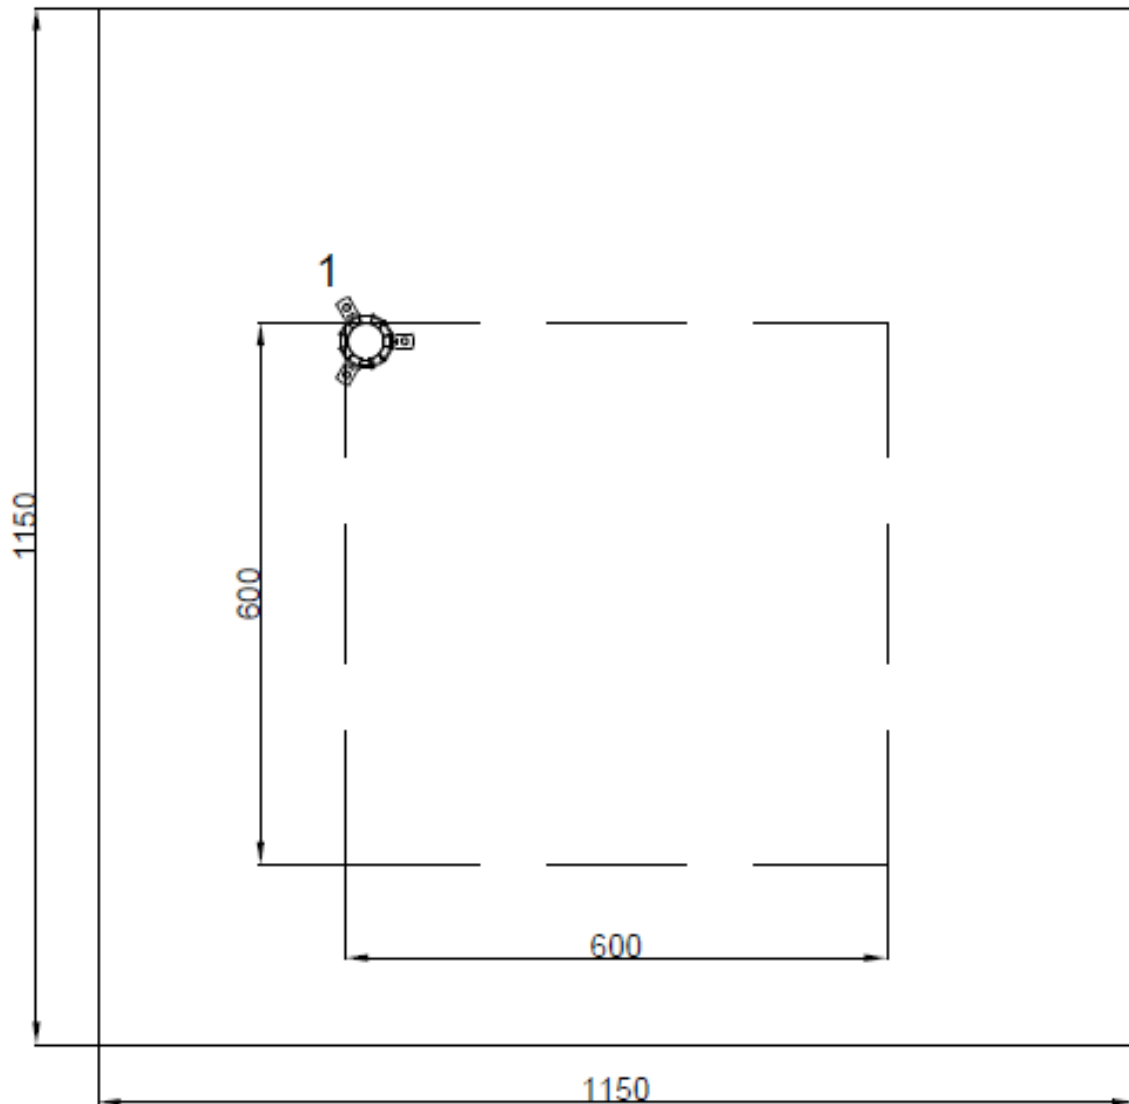
Snap Fire Systems Pty Ltd
Test Wall W-21-A4 Layout
Date:29 JUL 2021

Penetration	Collar Code	Pipe Type	Pipe Diameter
1	32R	PN12 PVC	25

DRAWING TITLED 'TEST WALL W-21-A4 LAYOUT, DATED 29 JULY 2021, BY SNAP FIRE SYSTEMS PTY LTD.

Drawing titled 'Test Wall W-21-A1 Layout', dated 29 July February 2021, by Snap Fire Systems Pty Ltd.

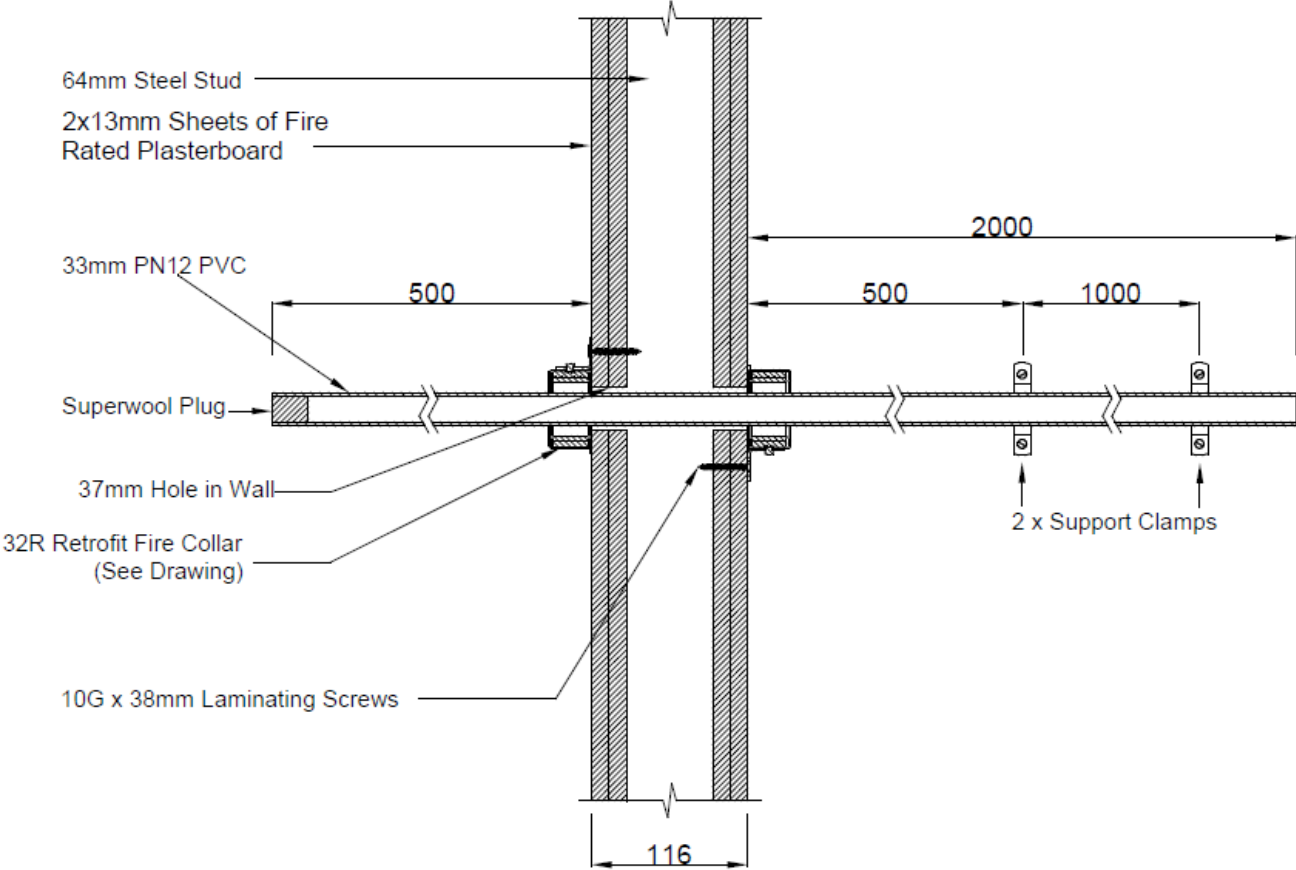
DRAWING TITLED 'SPECIMEN #1 25 PVC PIPE & 32R', DATED 17 AUGUST 2021, BY SNAP FIRE SYSTEMS PTY LTD

The penetrating service comprised an Iplex DN 25 PN12 uPVC 33.8-mm outside diameter pipe, with a wall thickness of 2.1-mm, fitted through the collar's sleeve. The pipe penetrated the wall through a 37-mm diameter cut-out hole as shown in drawing titled 'Specimen #1, 25 PN12 PVC Pipe & 32R', dated 17 August 2021, by Snap Fire Systems Pty Ltd.

Drawing titled 'Specimen #1, 25 PN12 PVC Pipe & 32R', dated 17 August 2021, by Snap Fire Systems Pty Ltd.
