Fire-resistance test on retrofit fire collars protecting a plasterboard wall penetrated by services

Test Report

Author: Peter Gordon
Report number: FSP 2237
Date: 14 December 2021
Client: IG6 Pty Ltd

Sponsored Investigation No. FSP 2237

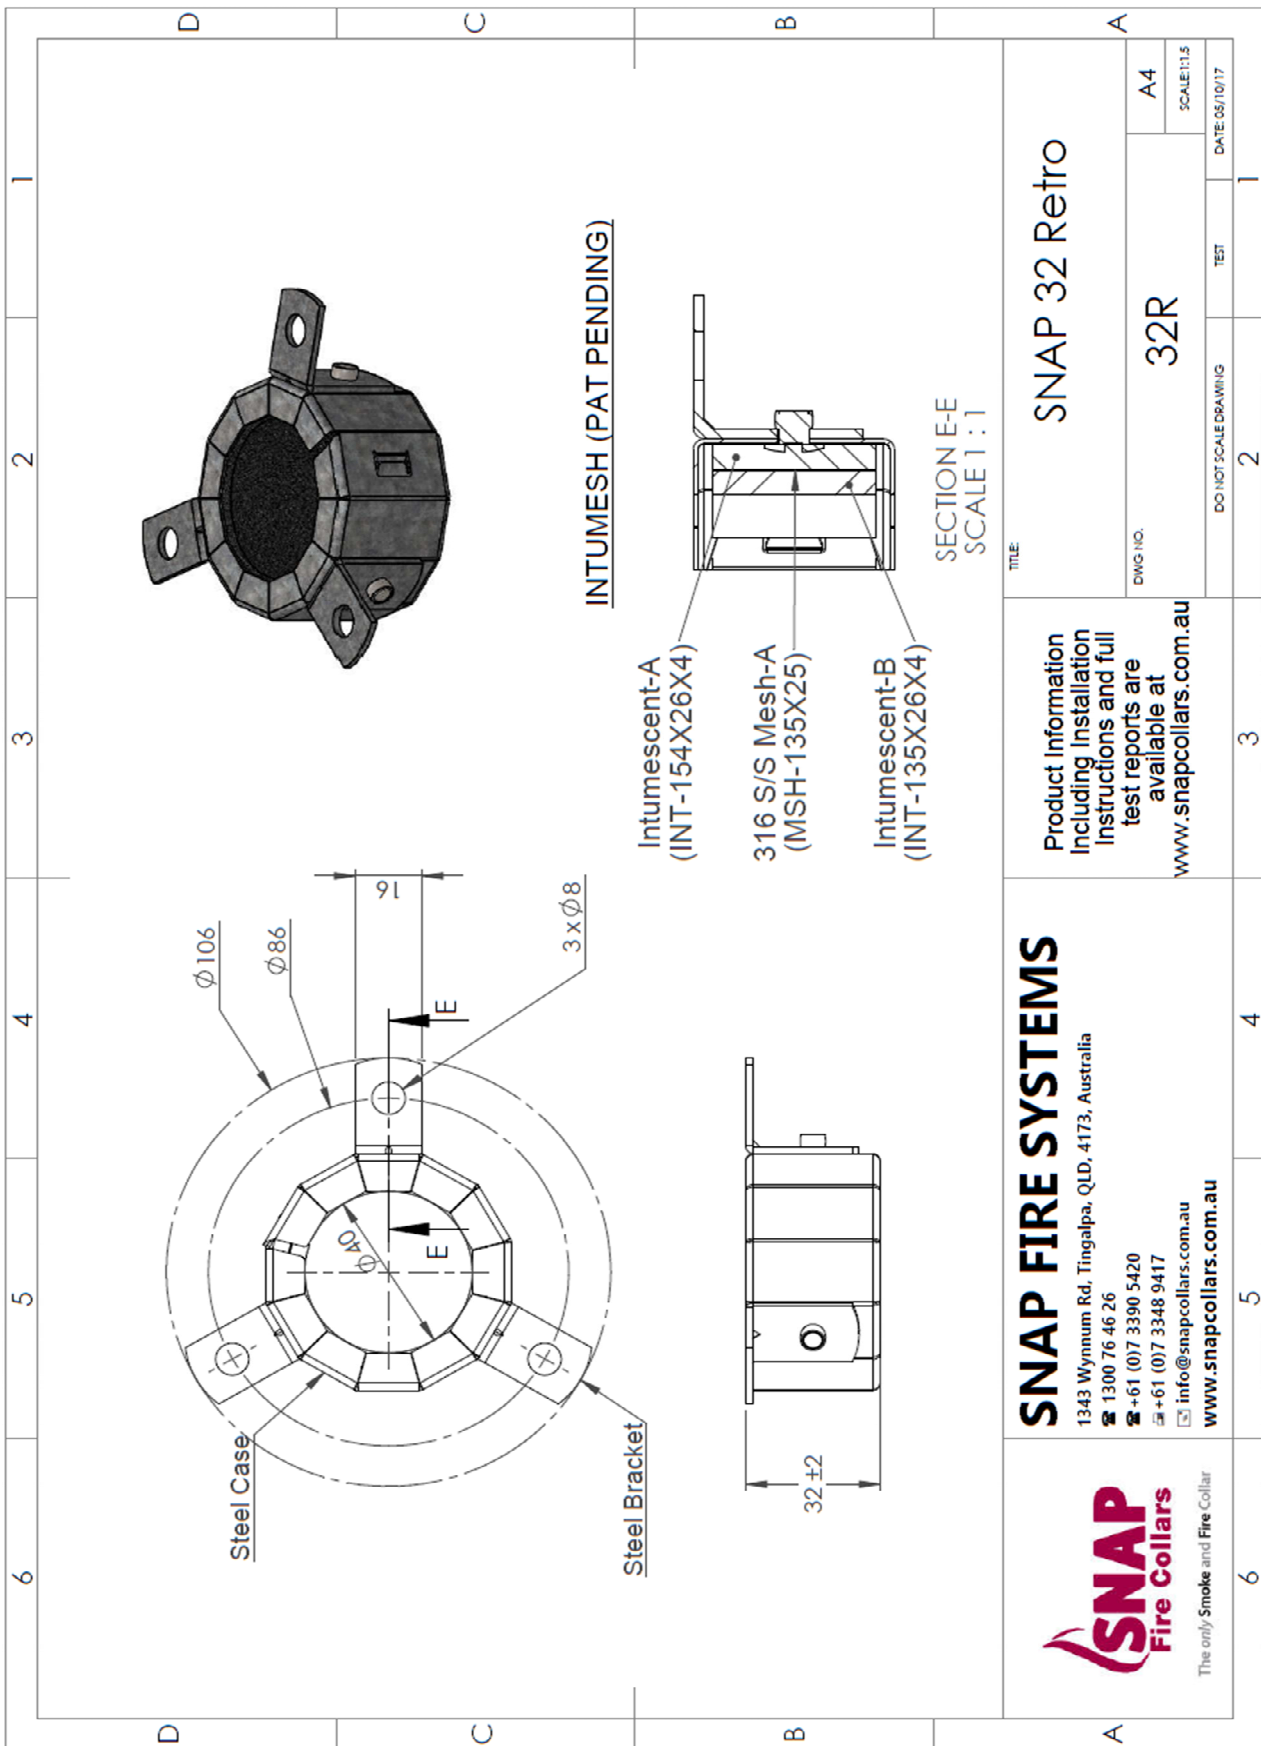
DRAWING TITLED 'SNAP 32 RETRO', DATED 5 OCTOBER 2017, BY SNAP FIRE SYSTEMS PTY LTD.

The SNAP 32R Retrofit fire collar comprised a 0.75-mm steel casing with a 40 mm inner diameter and a 106-mm diameter base flange. The 32-mm high collar casing incorporated a closing mechanism which comprised two soft Intumesh intumescent strips lined within the internal circumference of the collar. The inner and outer strips were 4-mm thick x 26-mm wide x 135-mm long and 4-mm thick x 26-mm wide x 154-mm long, respectively. Between the strips was a layer of 316 stainless steel mesh 135 mm long x 25-mm wide with wire mesh diameter of 0.15-mm, as shown in drawing titled 'SNAP 32 Retro', dated 5 October 2017, by Snap Fire Systems Pty Ltd. One collar was fixed to each side of the plasterboard wall in a back-to-back configuration using three 10g x 38-mm course thread plasterboard screws.

Drawing titled 'SNAP 32 Retro', dated 5 October 2017, by Snap Fire Systems Pty Ltd.
