# Fire-resistance test on retrofit fire collars protecting a concrete wall penetrated by services

## Test Report

**Author:** Peter Gordon  
**Report number:** FSP 2257  
**Date:** 5 July 2022  
**Client:** IG6 Pty Ltd

## Sponsored Investigation No. FSP 2257

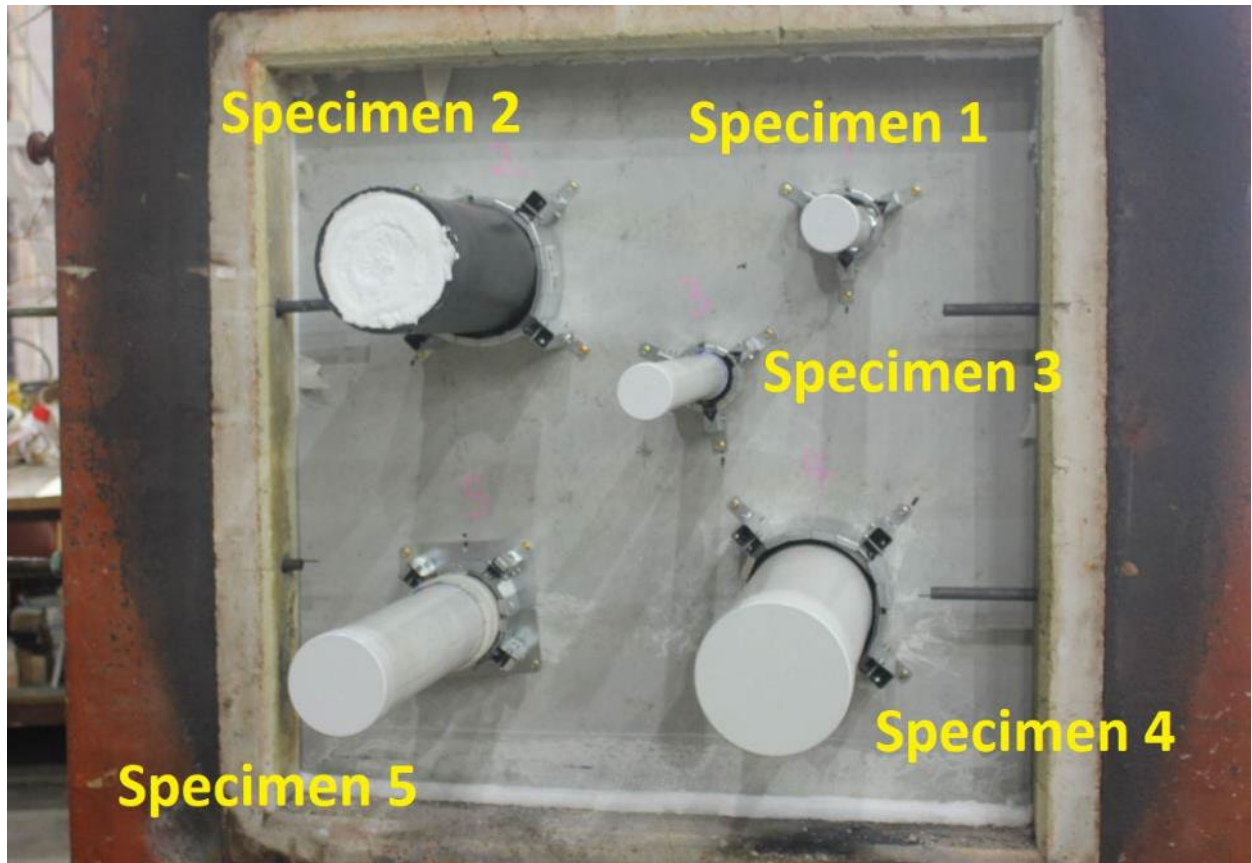
PHOTOGRAPH 1 – EXPOSED FACE OF SPECIMENS PRIOR TO TESTING

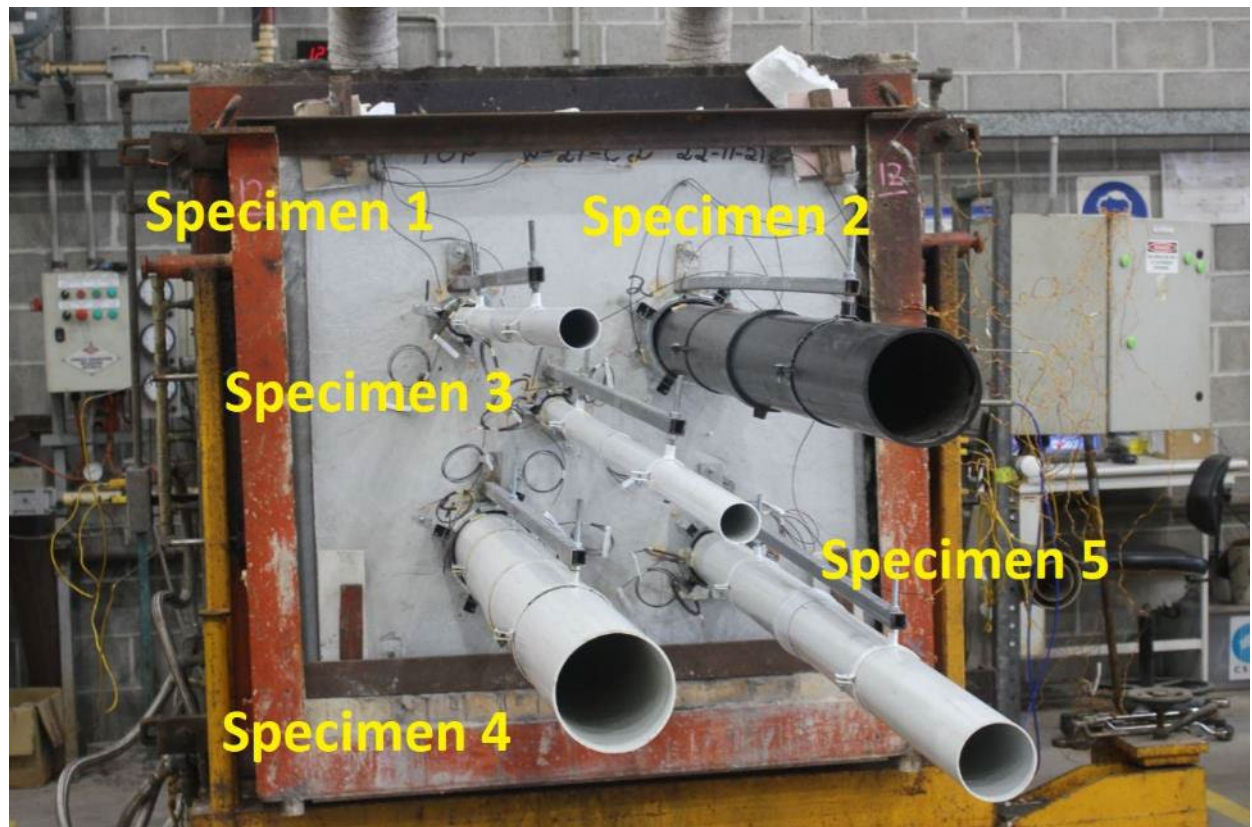
PHOTOGRAPH 2 – UNEXPOSED FACE OF SPECIMENS PRIOR TO TESTING

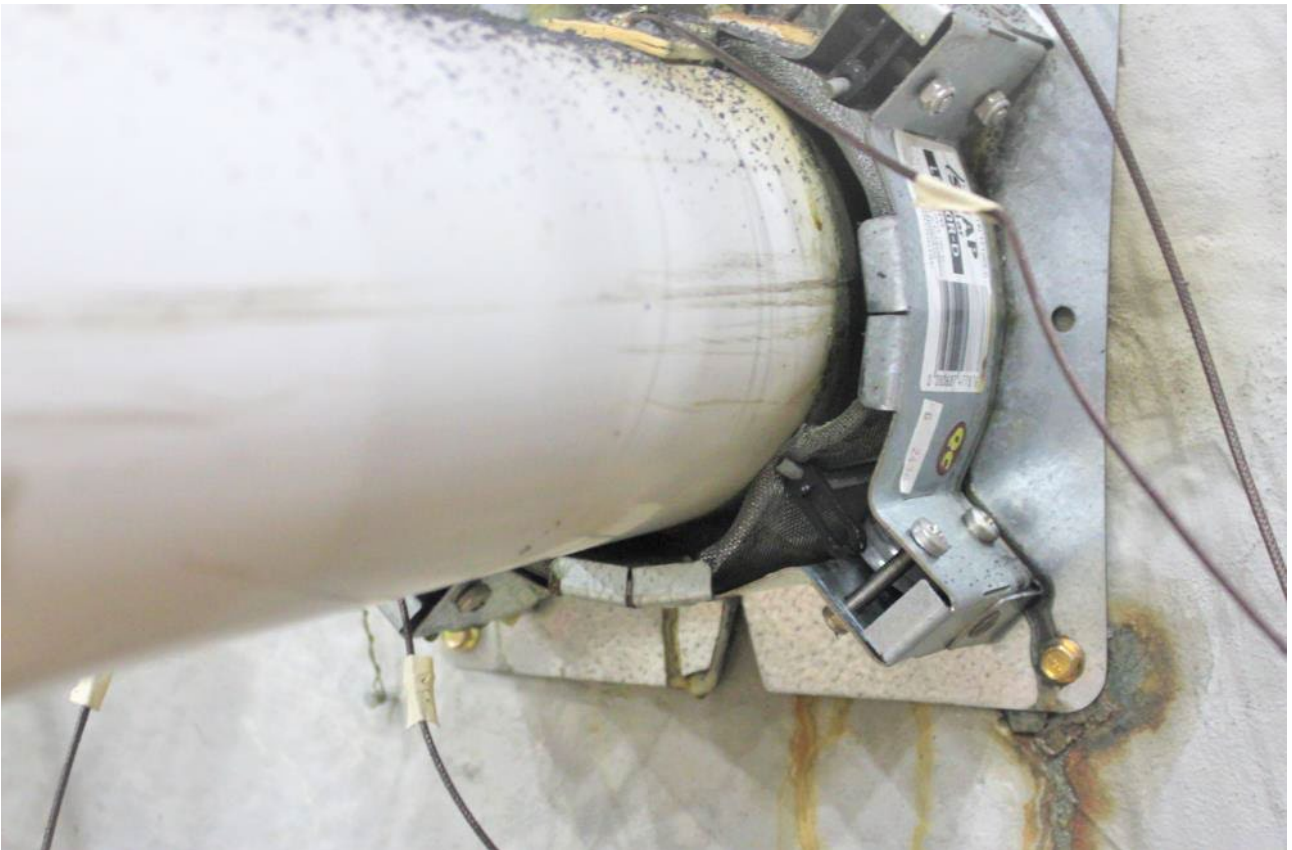
**PHOTOGRAPH 13 –SPECIMEN 4 AFTER 163 MINUTES OF TESTING**

163 minutes -	A loud click was emitted from Specimen 4, the lower right fusible link of the unexposed fire collar has been released (photograph 13). The intumescent material has swollen and is filling the gap between the pipe and the collar of specimen 2.
166 minutes -	Cotton pad test applied over the gap between the deformed pipe and the collar at the base of specimen 4, no ignition of cotton pad noted at this time.

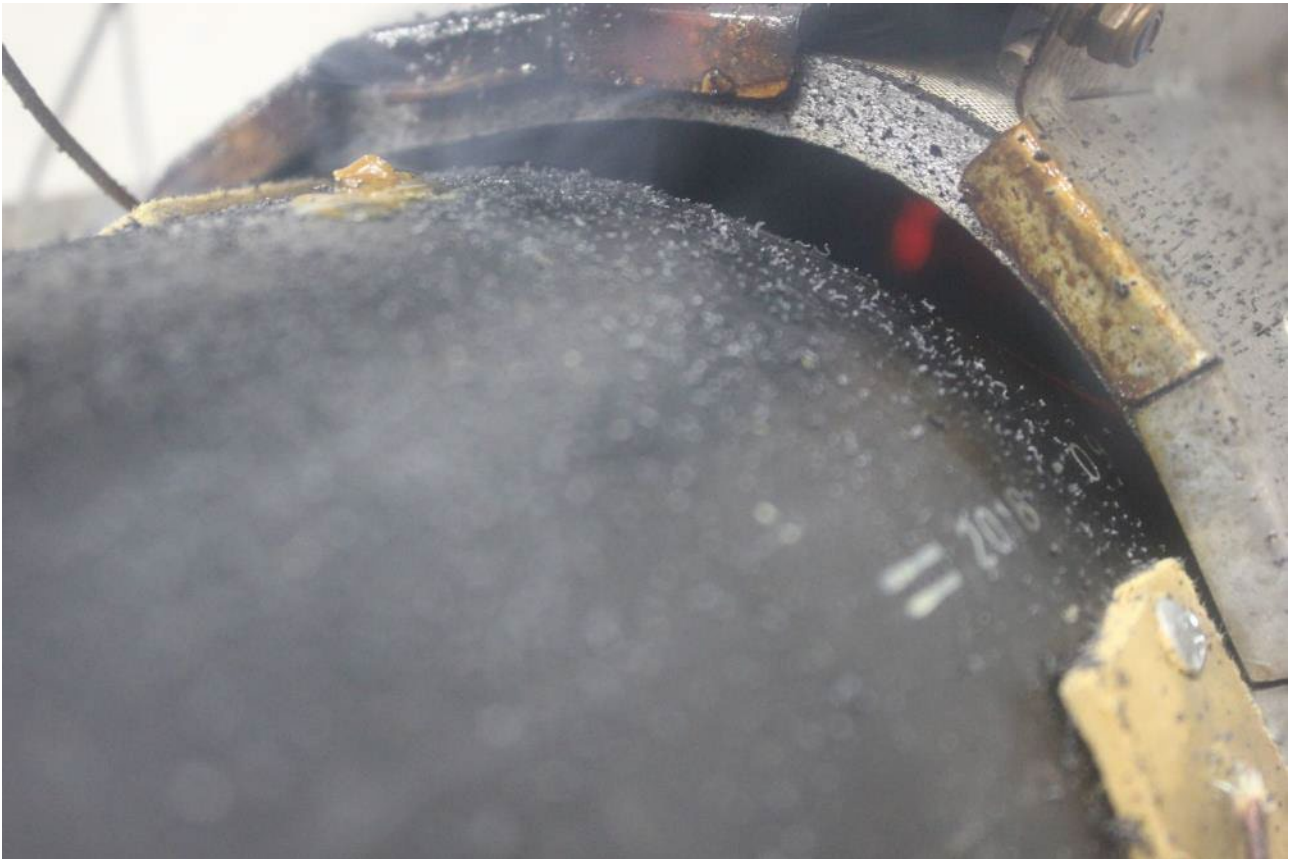
**PHOTOGRAPH 18 – SPECIMEN 2 AFTER 227 MINUTES OF TESTING**

- 227 minutes - A red glow can be seen between the collar and the pipe of specimen 2. Cotton pad test applied over the gap between the pipe and the collar at the base of specimen adjacent to the red glow, no ignition of cotton pad is noted at this time (photograph 18).

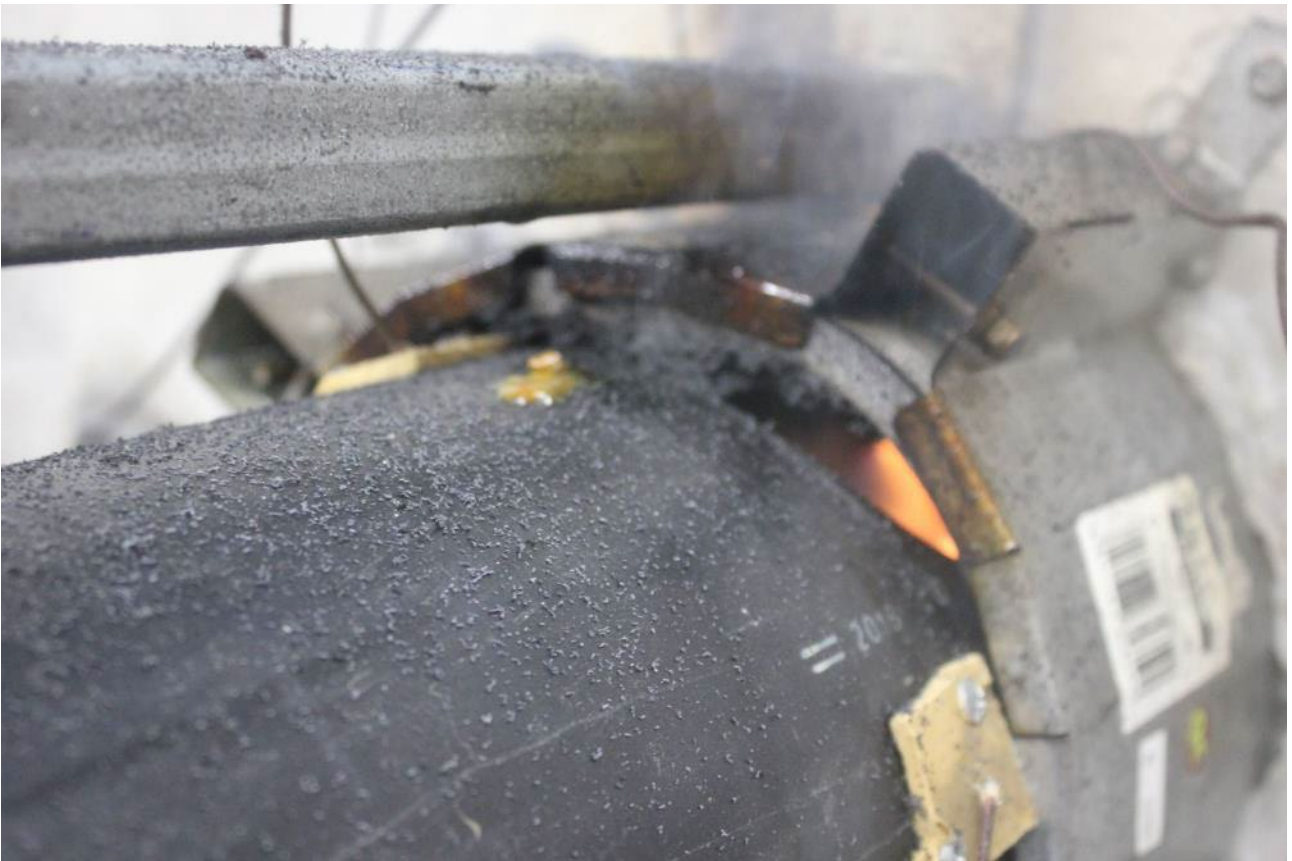
**PHOTOGRAPH 19 – SPECIMEN 2 AFTER 233 MINUTES OF TESTING**

- 233 minutes - Intermittent flaming is visible inside the collar of specimen 2. Cotton pad test applied over the gap between the collar and pipe adjacent to the intermittent flaming, no ignition of cotton pad is noted at this time (photograph 19).

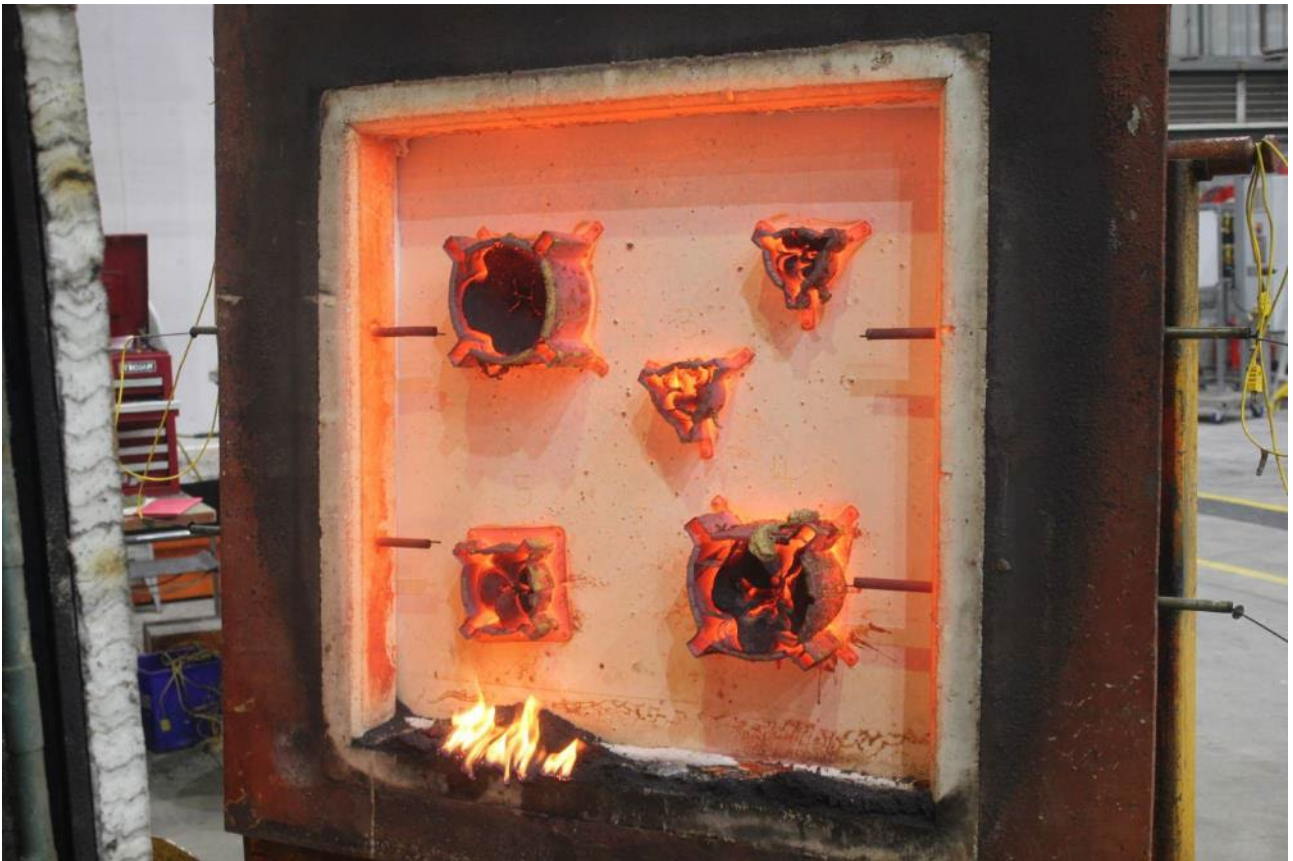
**PHOTOGRAPH 21 – EXPOSED FACE OF SPECIMENS AT CONCLUSION OF TESTING**

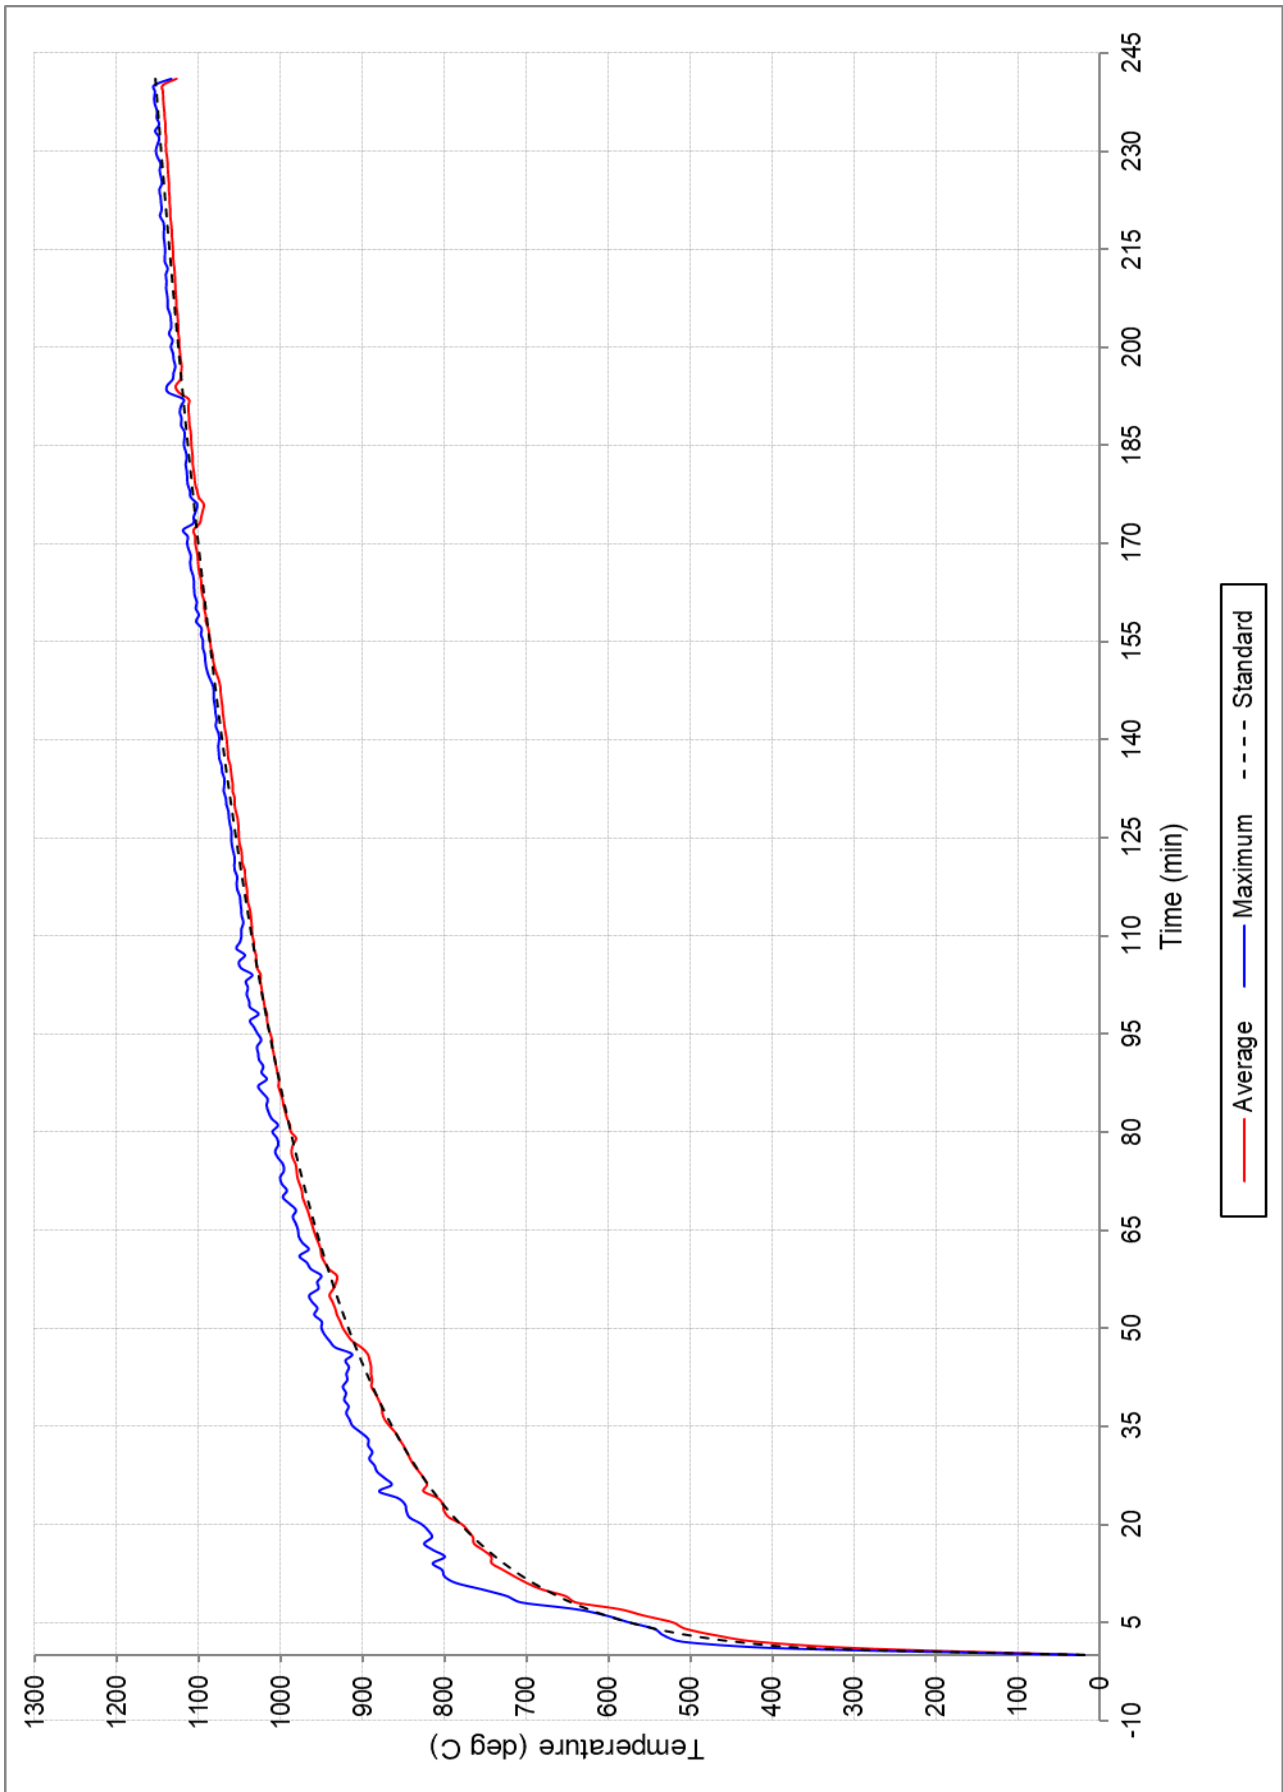
FIGURE 1 – FURNACE TEMPERATURE

The temperature in the furnace chamber was measured by four type K, 3-mm diameter, and 310 stainless steel Mineral Insulated Metal Sheathed (MIMS) thermocouples. Each thermocouple was housed in high-nickel steel tubes opened at the exposed end.

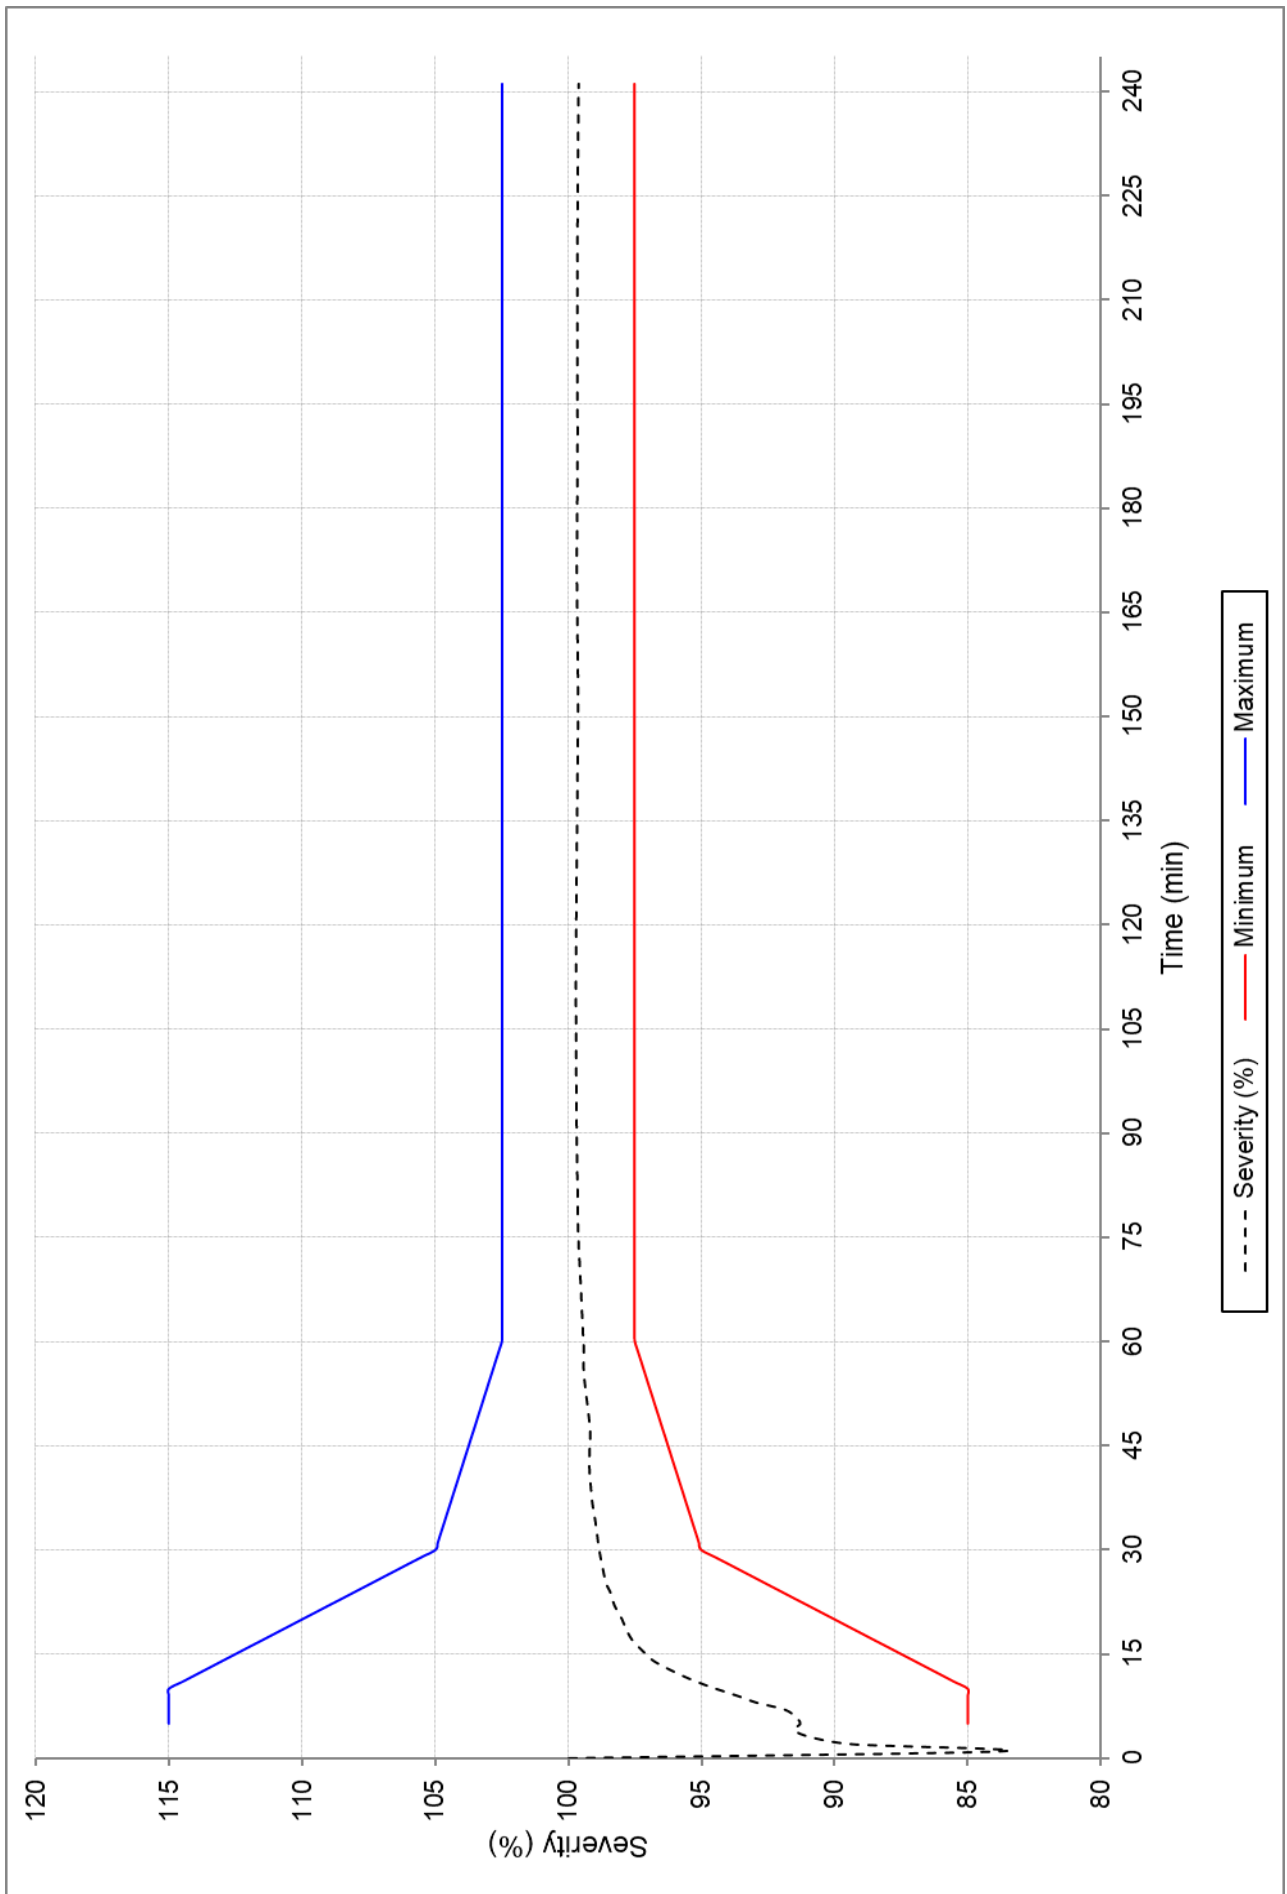
FIGURE 2 – FURNACE SEVERITY

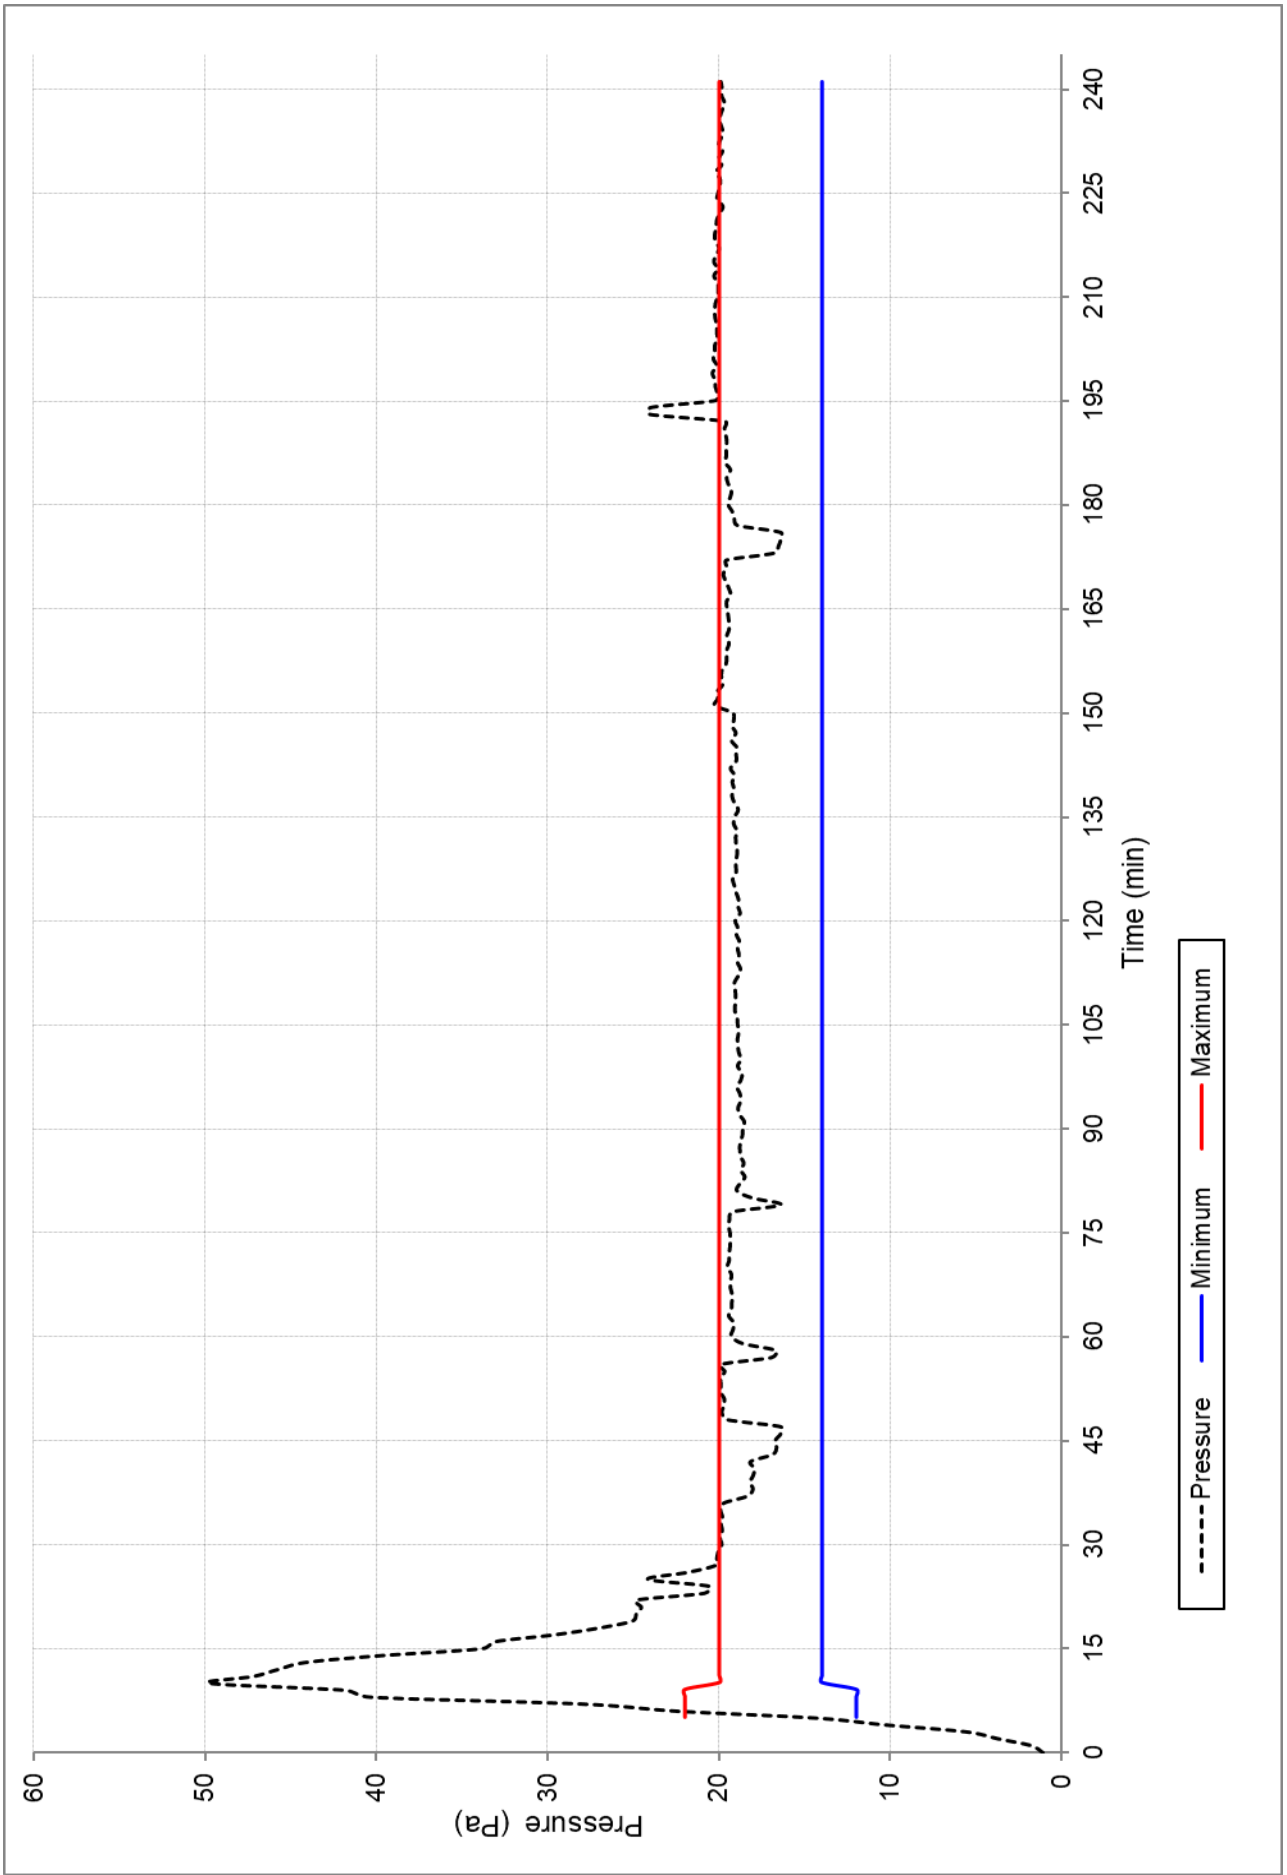
FIGURE 3 – FURNACE PRESSURE

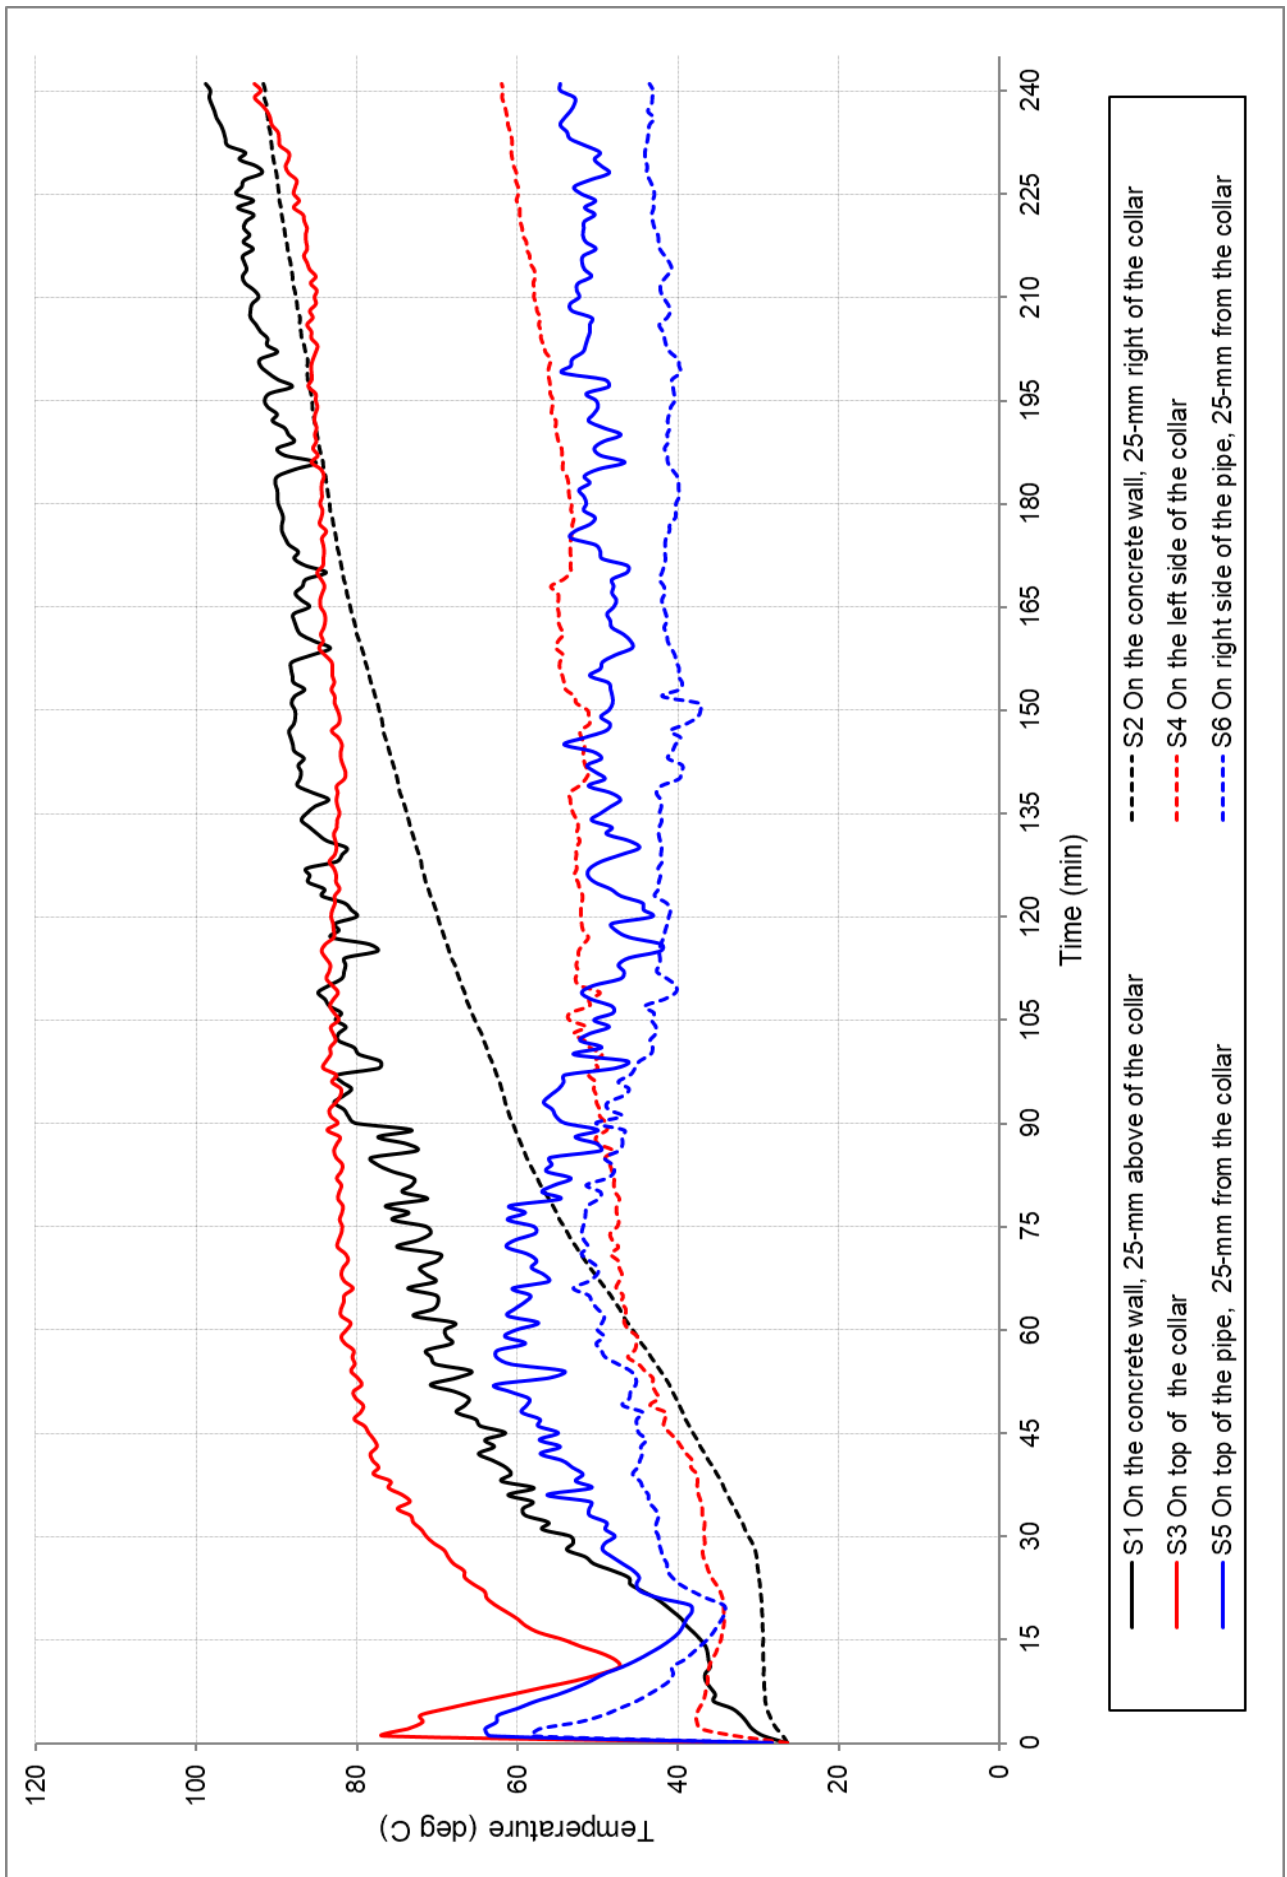
FIGURE 4 - TEMPERATURE VERSUS TIME ASSOCIATED WITH SPECIMEN #1

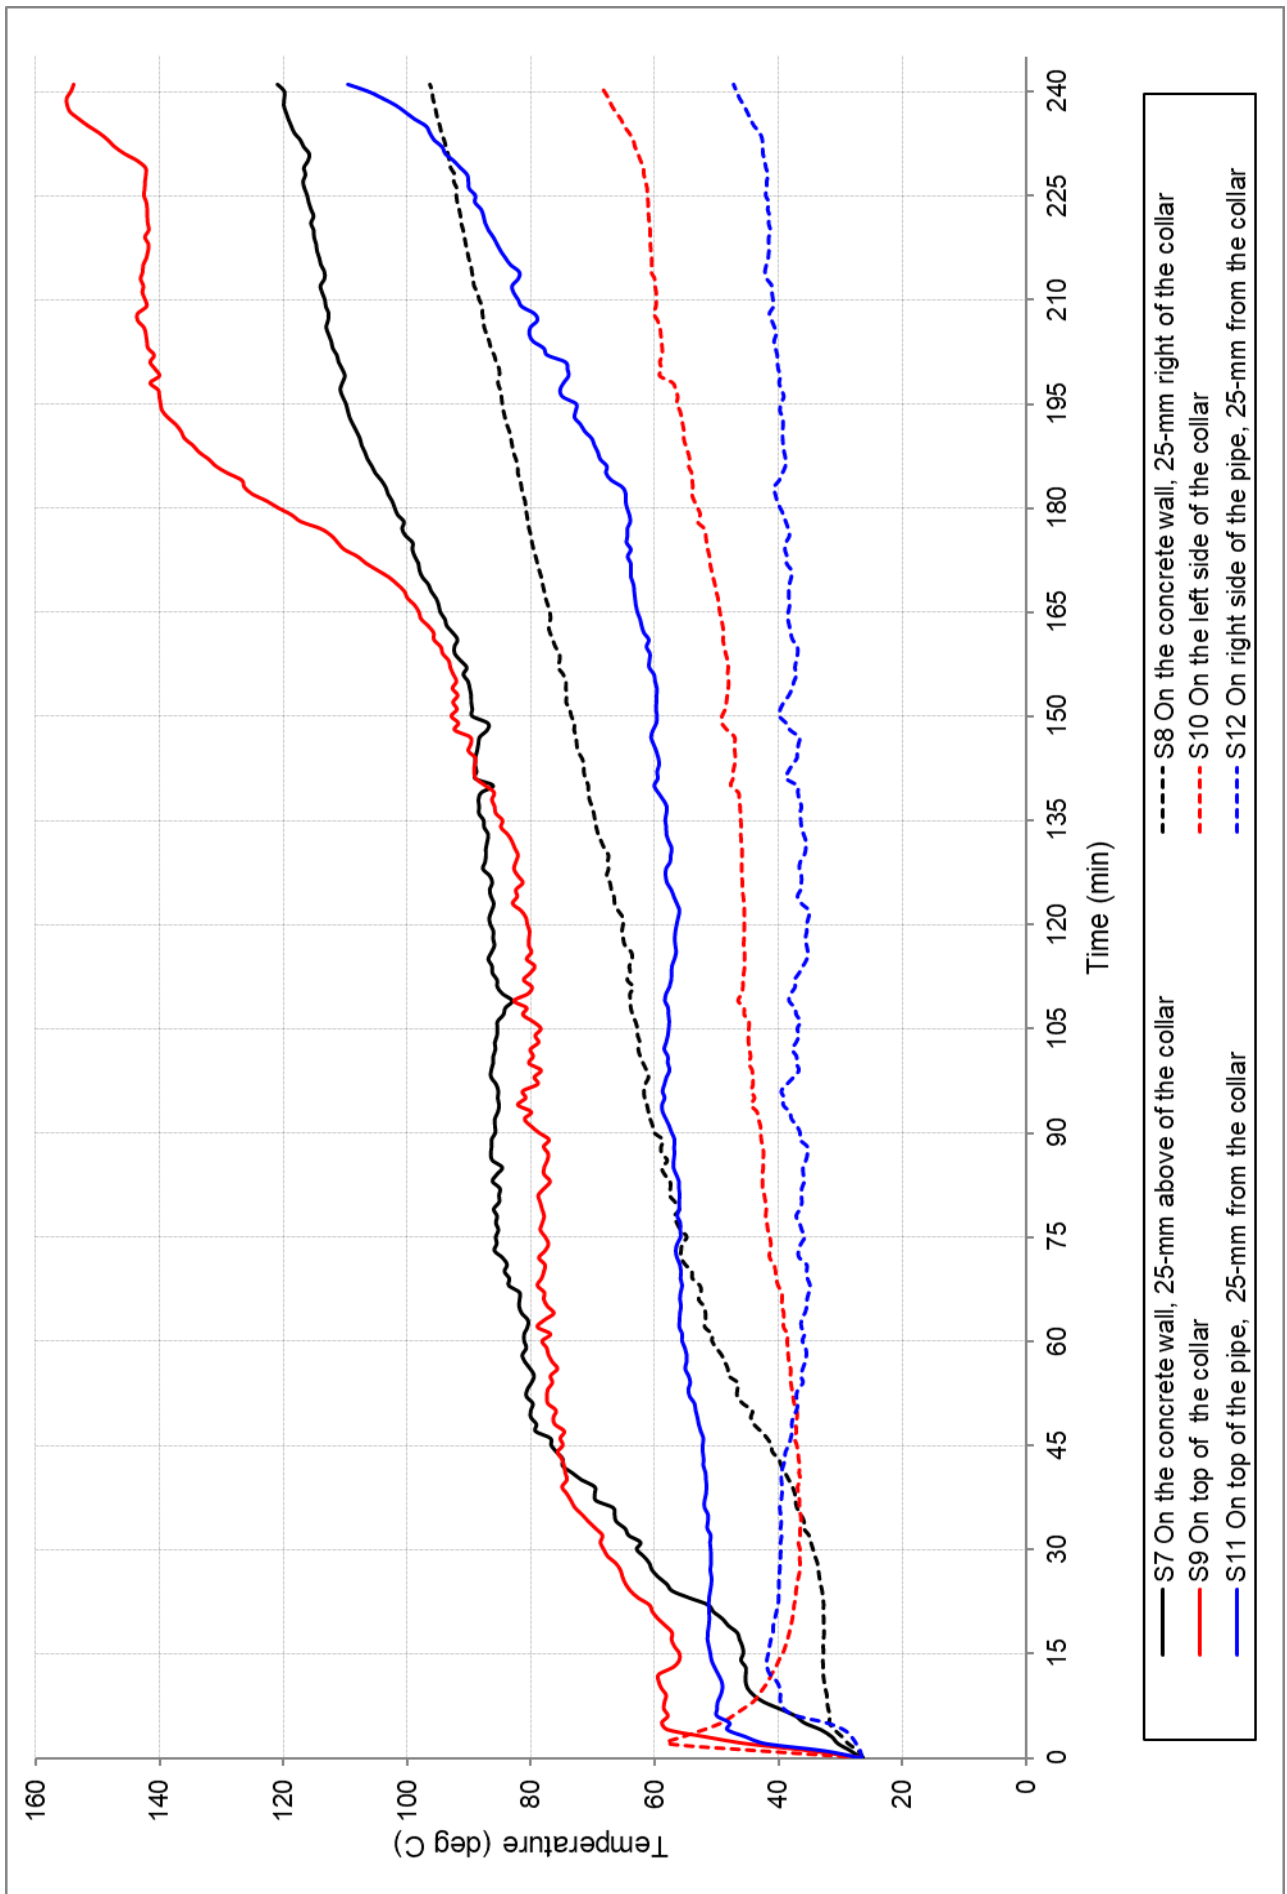
FIGURE 5 - TEMPERATURE VERSUS TIME ASSOCIATED WITH SPECIMEN #2

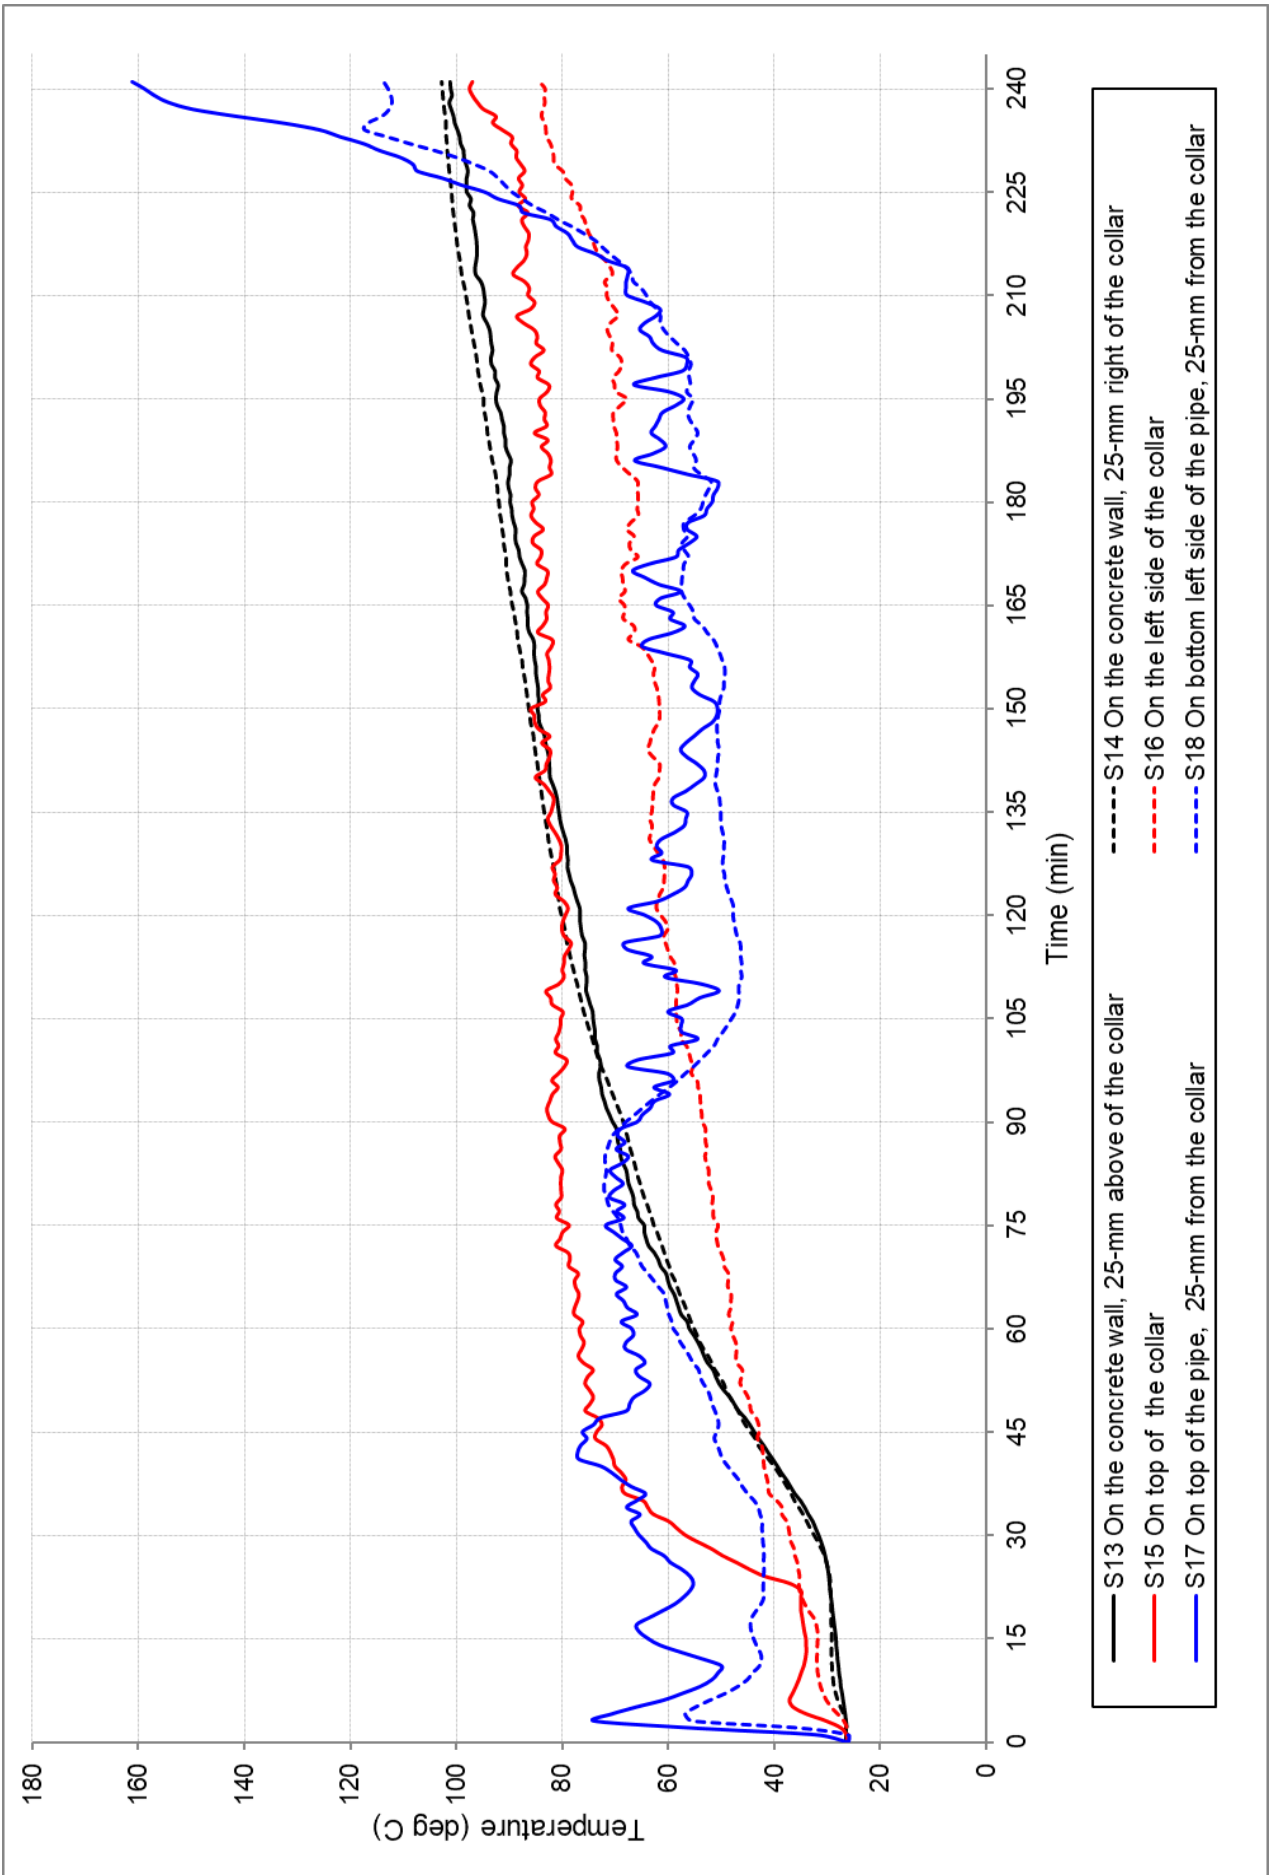
FIGURE 6 - TEMPERATURE VERSUS TIME ASSOCIATED WITH SPECIMEN #3
