# Fire-resistance test on retrofit fire collars protecting a concrete wall penetrated by services

## Test Report

**Author:** Peter Gordon  
**Report number:** FSP 2257  
**Date:** 5 July 2022  
**Client:** IG6 Pty Ltd

## Sponsored Investigation No. FSP 2257

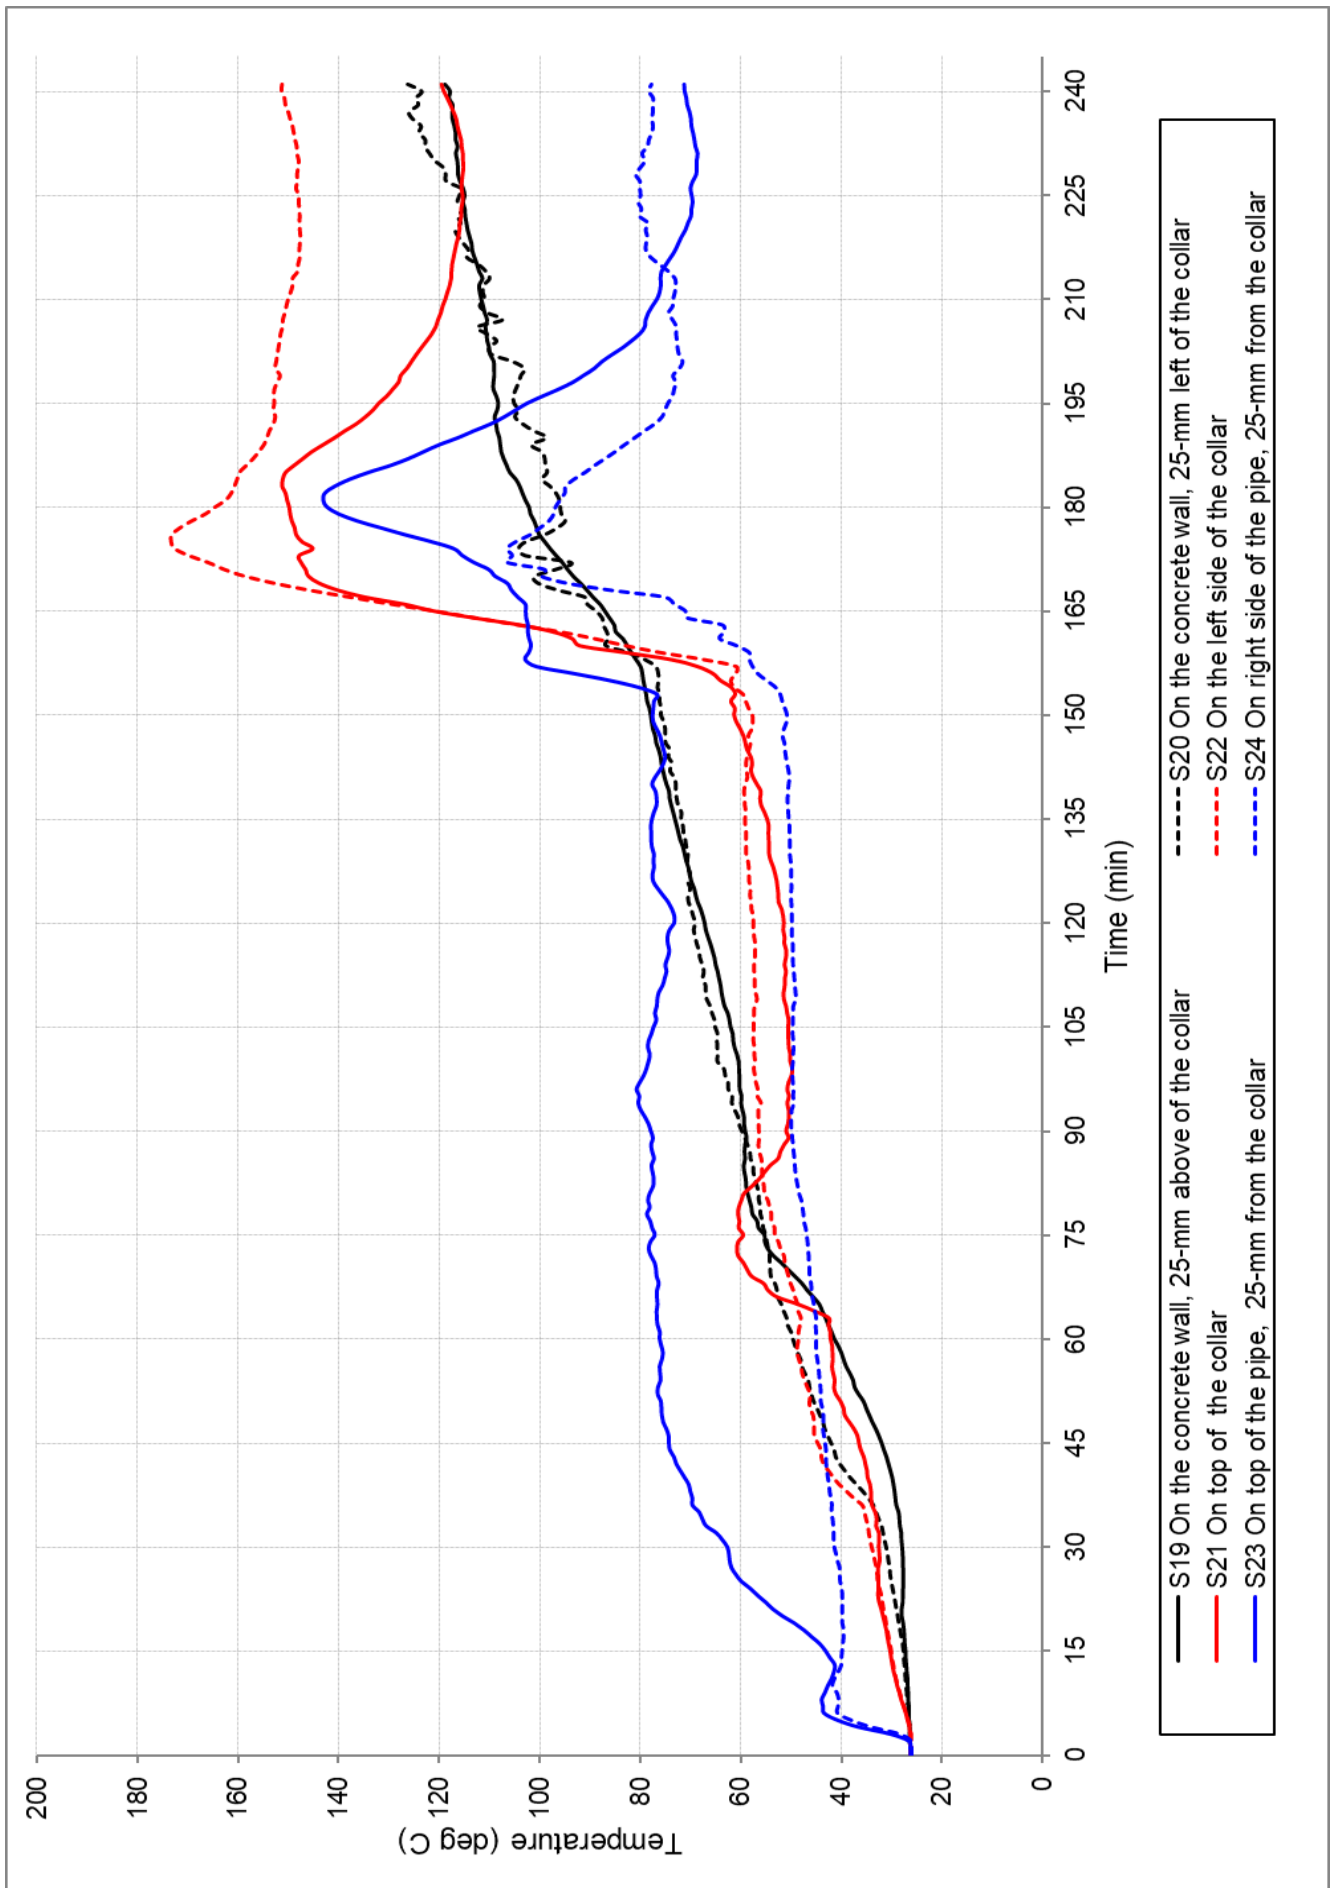
FIGURE 7 - TEMPERATURE VERSUS TIME ASSOCIATED WITH SPECIMEN #4

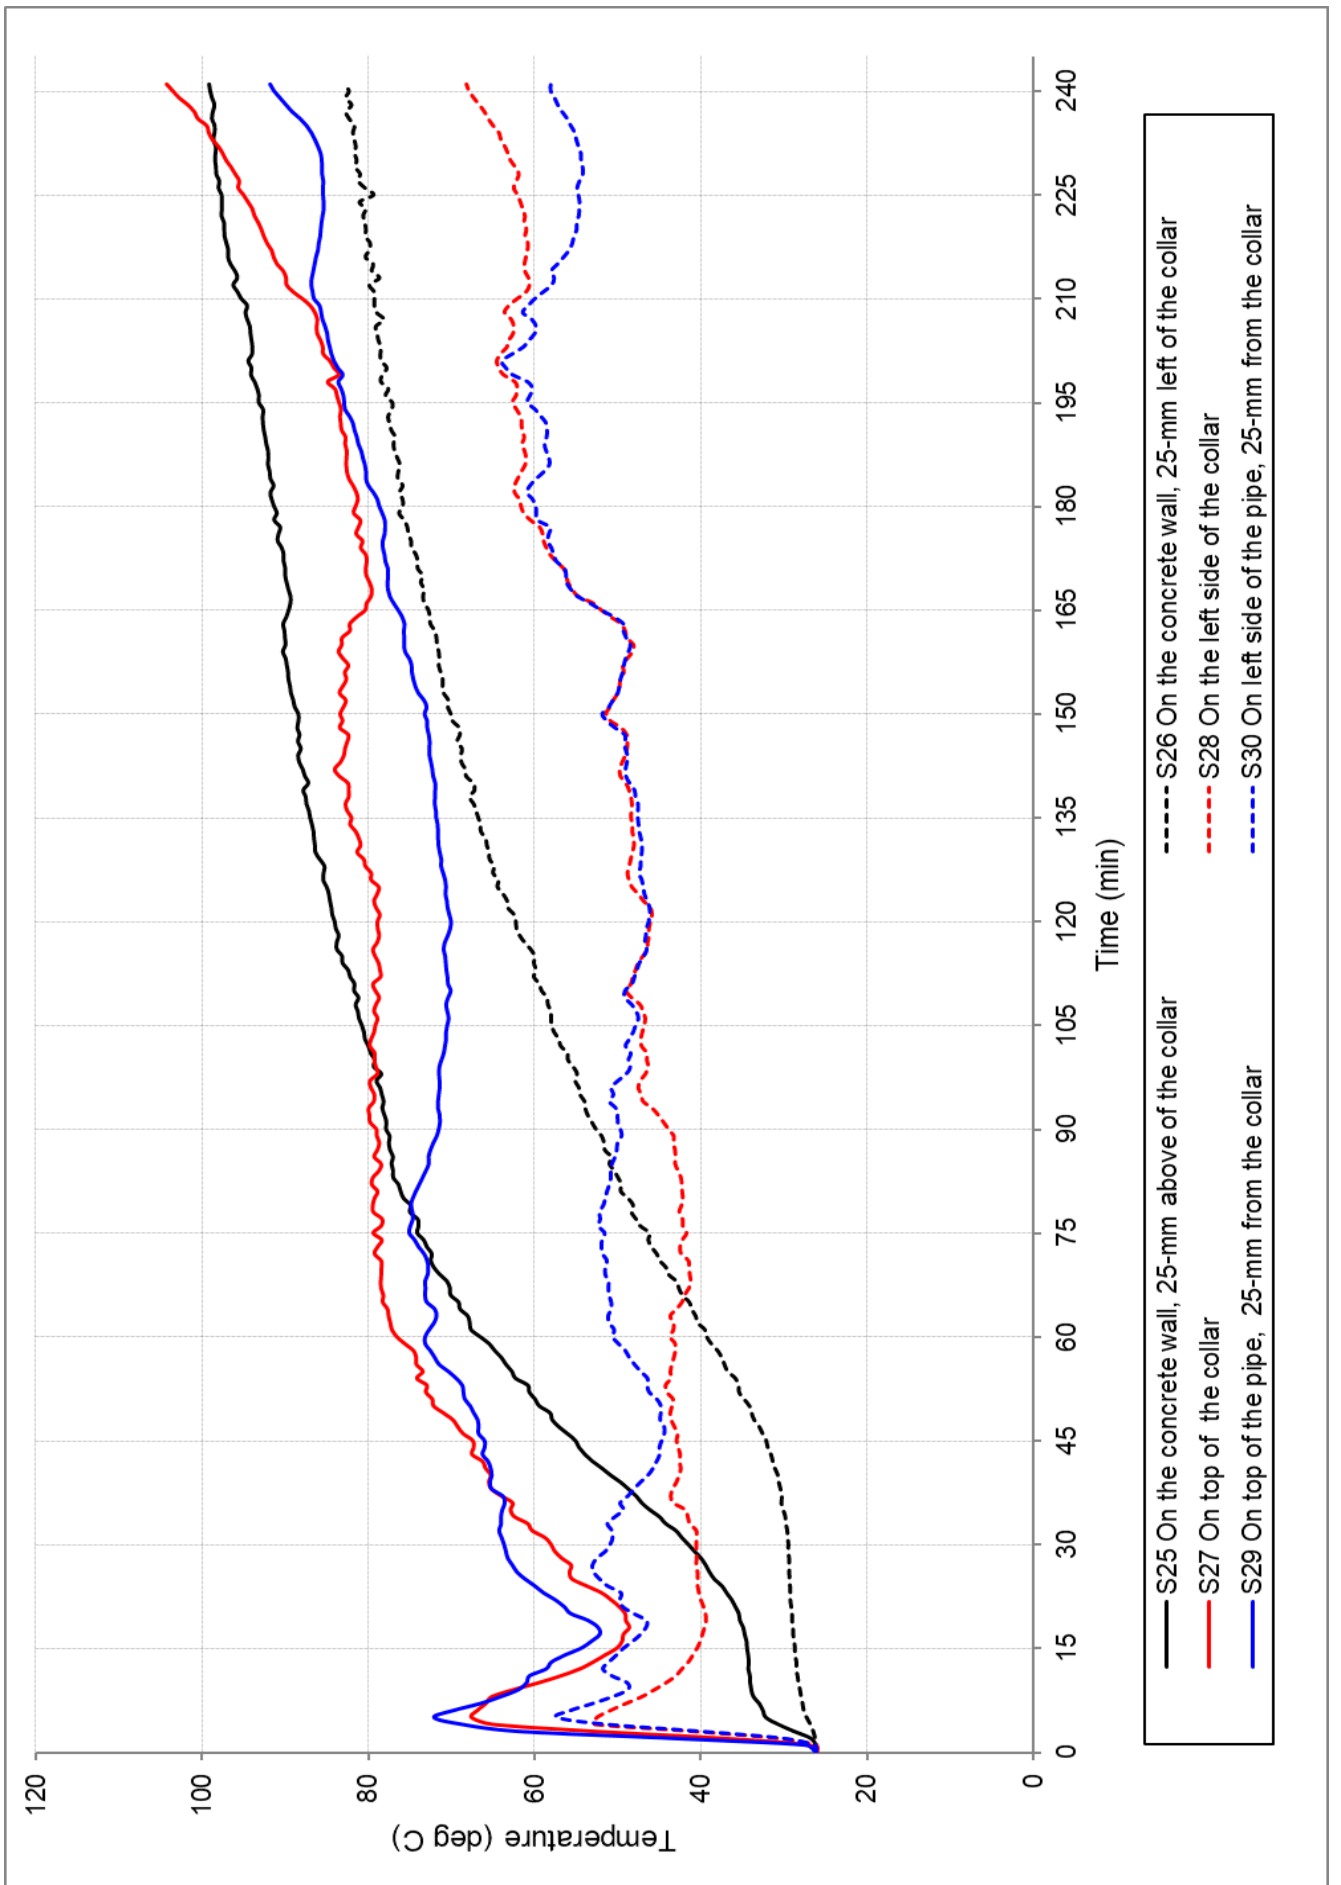
FIGURE 8 - TEMPERATURE VERSUS TIME ASSOCIATED WITH SPECIMEN #5

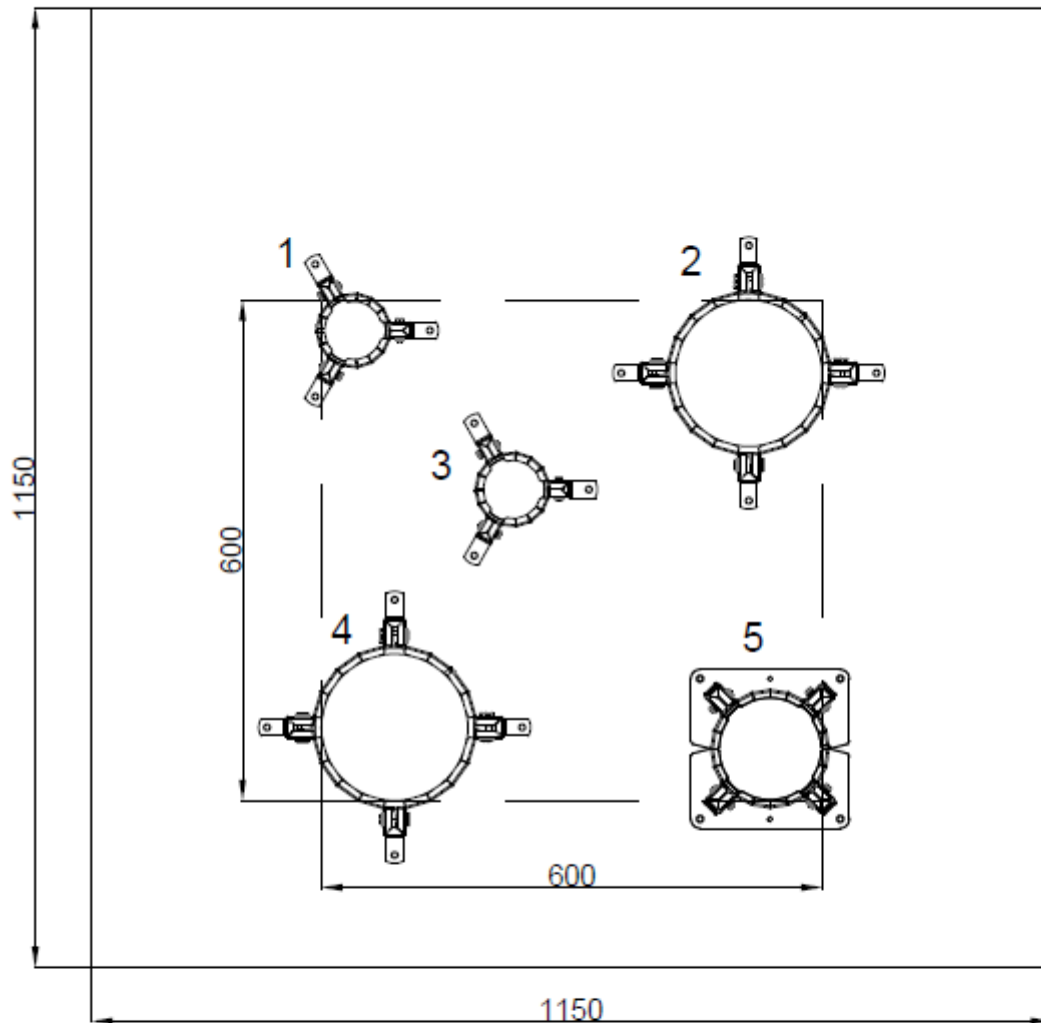
DRAWING TITLED 'TEST WALL W-21-C2 LAYOUT, DATED 16 NOVEMBER 2021, BY SNAP FIRE SYSTEMS PTY LTD

Penetration	Collar Code	Pipe Type	Pipe Diameter
1	LP50R	PVC	50
2	HP150R	HDPE	160
3	LP50R	PVC + Fitting	50
4	HP150R	PVC	150
5	LP100R-D	PVC(SC) + Fitting	100

The specimen comprised an 1150-mm x 1150-mm x 180-mm thick concrete wall panel penetrated by five plastic pipes protected by retrofit fire collars.

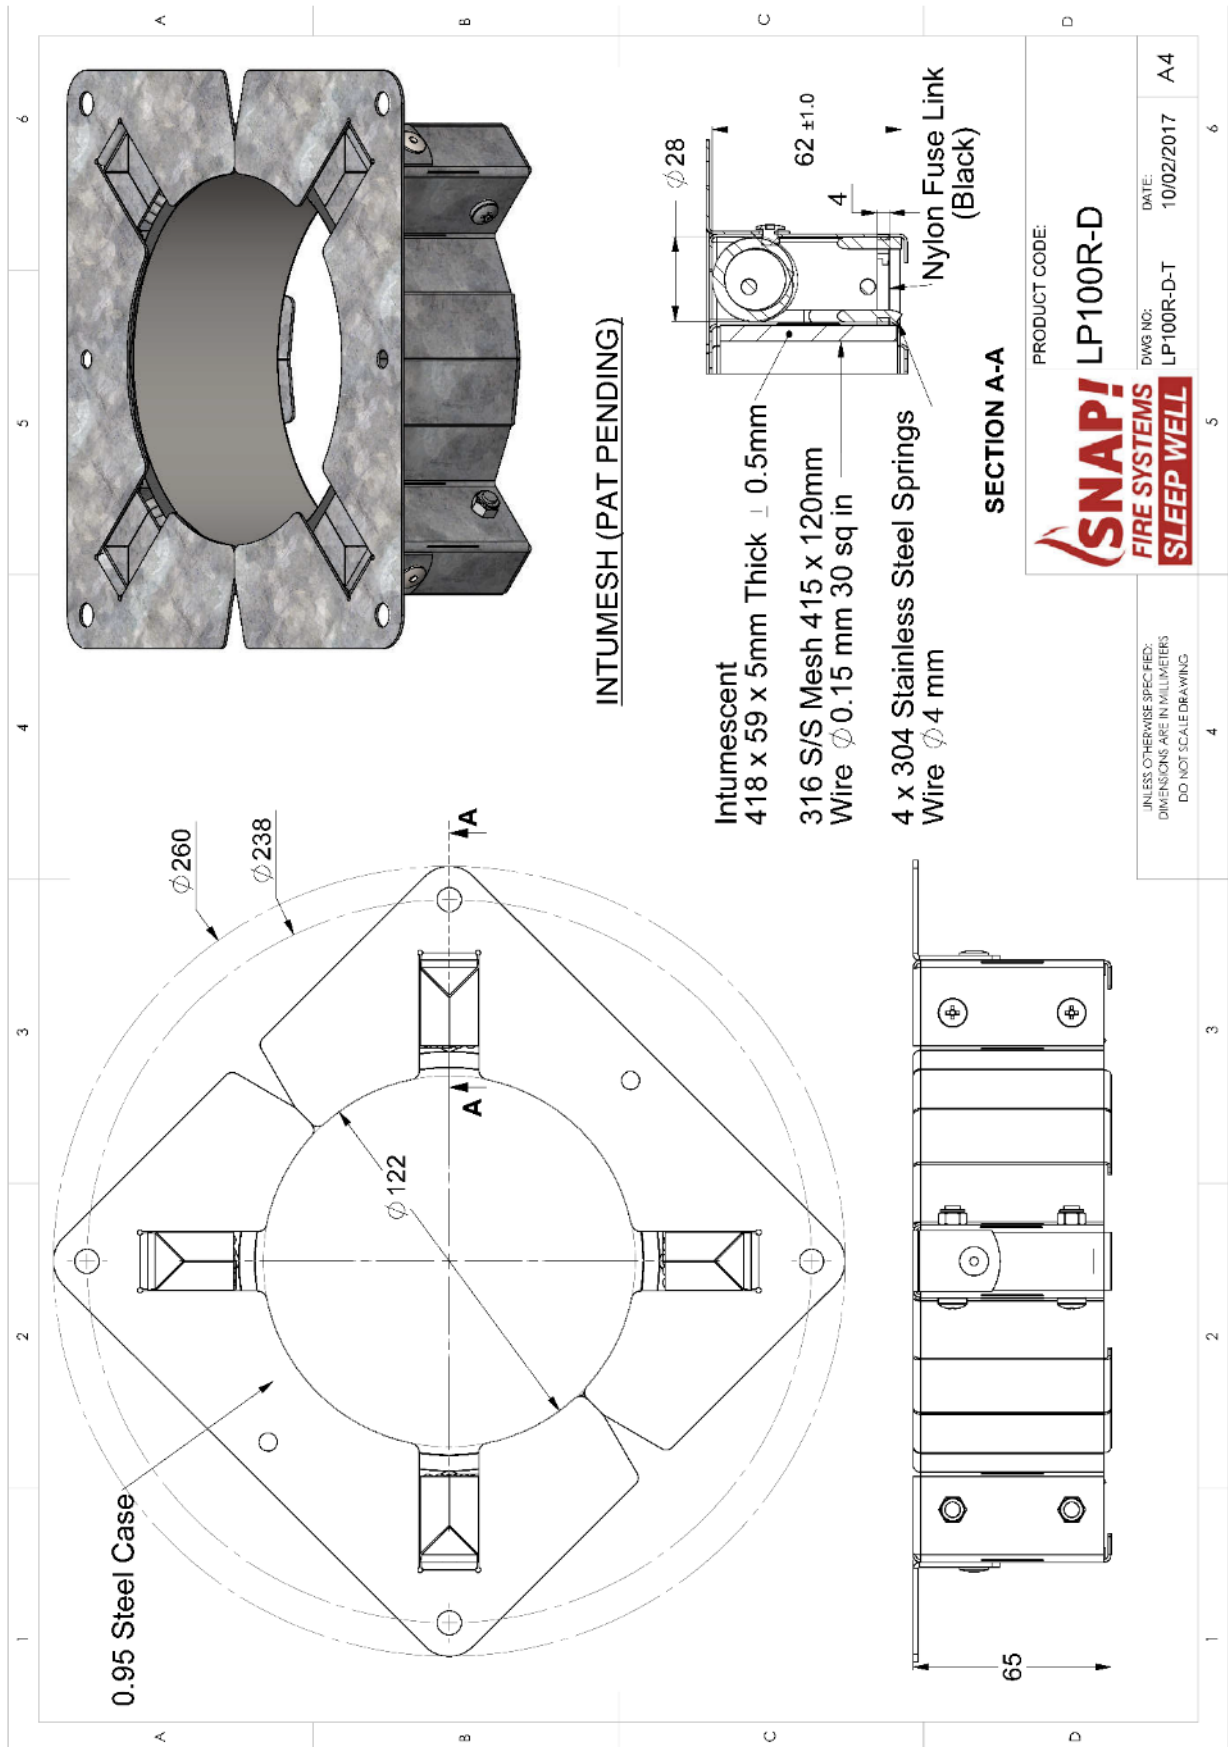
**DRAWING NUMBERED 'LP 100R-D-T', DATED 10 FEBRUARY 2017, BY SNAP FIRE SYSTEMS PTY LTD**

**INTUMESH (PAT PENDING)**

- Intumescent  
418 x 59 x 5mm Thick ± 0.5mm
- 316 S/S Mesh 415 x 120mm  
Wire Ø 0.15 mm 30 sq in
- 4 x 304 Stainless Steel Springs  
Wire Ø 4 mm

The SNAP LP100R-D Low Profile Retrofit fire collar comprised a 0.95-mm steel casing with a 122-mm inner diameter and a 260-mm diameter base flange. The 65-mm high collar casing incorporated a closing mechanism which comprised a 5-mm thick x 59-mm wide x 418-mm long Intumesh intumescent wrap lined within the internal circumference of the collar casing. The closing mechanism comprised four 4-mm diameter 304 stainless steel springs with black nylon fuse links and a 415-mm long x 120-mm wide with a mesh wire diameter of 0.15-mm as shown in drawing numbered LP100R-D-T dated 10 February 2017, by Snap Fire Systems Pty Ltd.

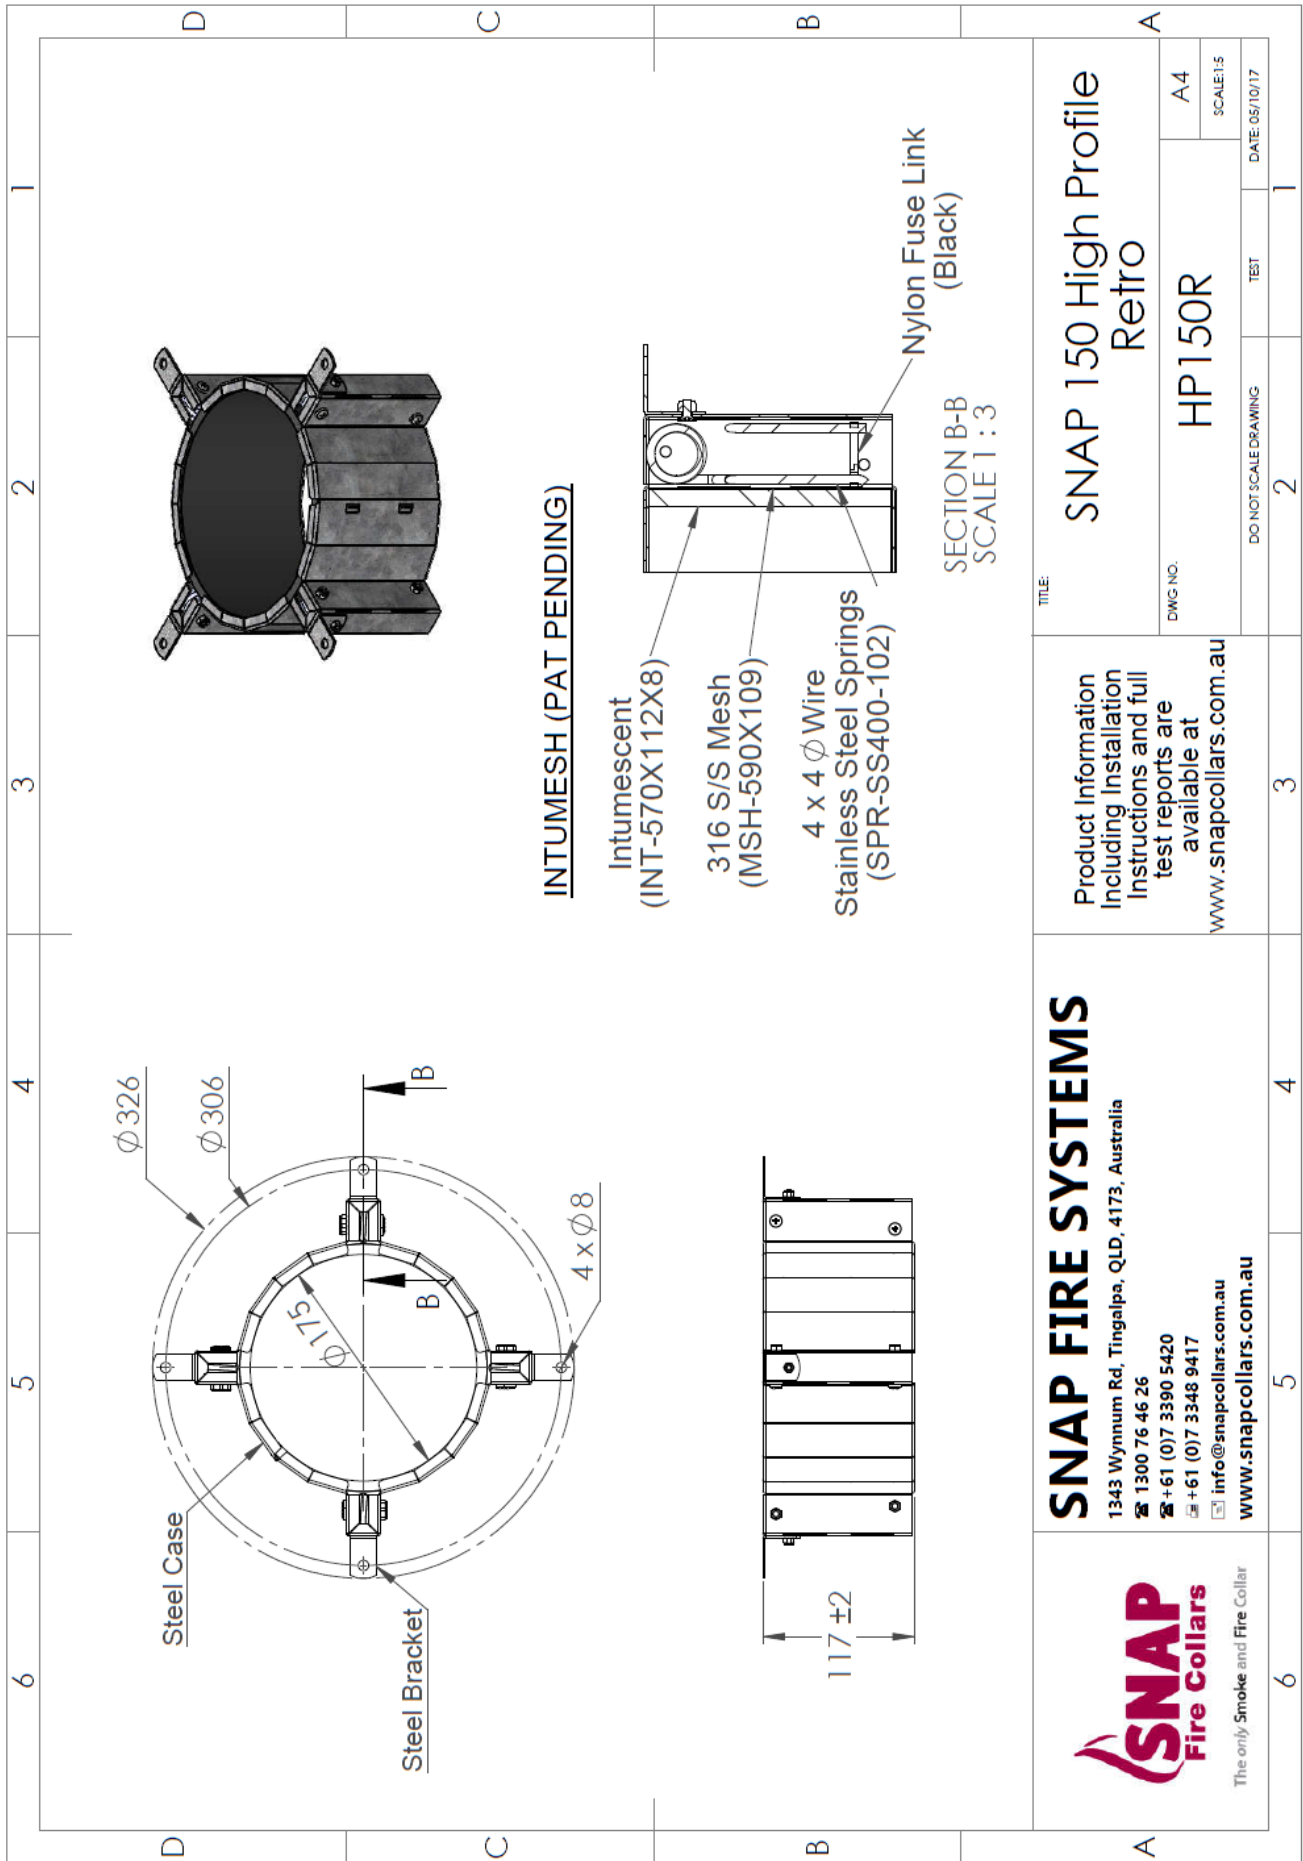
**INTUMESH (PAT PENDING)**

- Intumescent (INT-570X112X8)
  - 316 S/S Mesh (MSH-590X109)
  - 4 x 4 Φ Wire
  - Stainless Steel Springs (SPR-SS400-102)
  - Nylon Fuse Link (Black)
- SECTION B-B  
SCALE 1 : 3

The SNAP HP150R High Profile Retrofit fire collar comprised a 0.95-mm thick steel casing with a 175-mm inner diameter and a 326-mm base flange. The 117-mm high collar casing incorporated a strip of 570 mm long x 112-mm wide x 8-mm thick Intumesh intumescent material. The closing mechanism comprised four SPR-SS400-102 stainless steel springs bound with nylon fuse links, and a 590-mm x 109-mm 316 stainless steel mesh as shown in drawing titled 'SNAP 150 High Profile Retro' dated 5 October 2017, by Snap Fire Systems Pty Ltd.
